US CHEMICAL SAFETY AND HAZARD INVESTIGATION BOARD

INVESTIGATION REPORT VOLUME 1

EXPLOSION AND FIRE AT THE **MACONDO WELL**

DEEPWATER HORIZON RIG

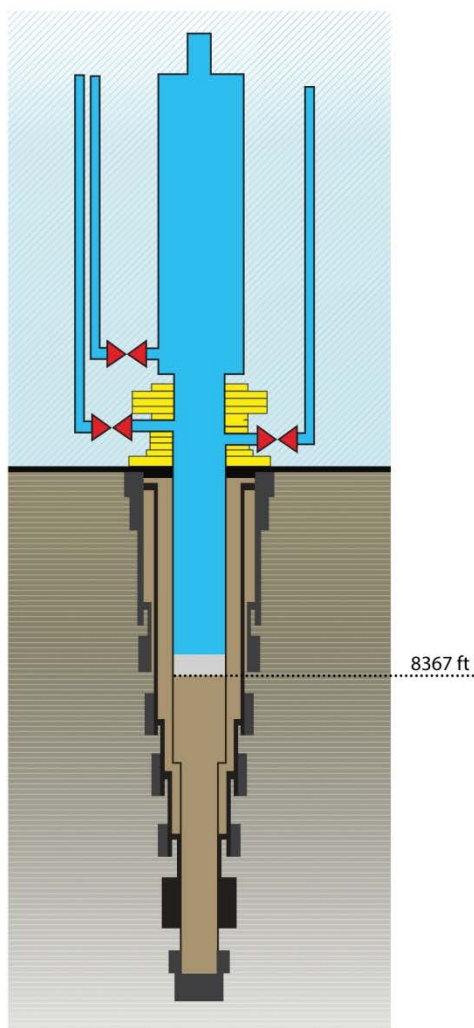
Figure 2-4. The final Temporary Abandonment configuration intended to remove drilling mud down to 8,367 feet to install a cement plug in seawater.

BP did not have a company standard for developing a temporary abandonment plan. For Macondo, BP considered numerous temporary abandonment plan options in the week or so leading up to implementation. These changes included the location of the surface plug, which ultimately affected the negative pressure test conditions used to assess the bottom hole cement integrity (Section 2.3.1) and displacement of the well.⁵⁰ Many variations are possible for cement integrity testing, each with advantages and disadvantages based on the particular circumstances of the well. (See Appendix 2-A, *Deepwater Horizon Blowout Preventer Failure Analysis*, for details.) While the various temporary

abandonment options BP explored improved the procedure, the CSB found no explicit risk assessment for the final procedure used at Macondo.

To prepare for the negative pressure test at Macondo, a drillpipe was lowered to the depth identified for the bottom of the cement plug (Figure 2-4). A viscous and dense water-based Loss Circulation Material (LCM) followed by seawater was pumped down the drillpipe to displace the mud by pushing it above the BOP toward the rig.^e After stopping displacement and closing the BOP,^f the crew observed the pressures and/or flow from the well four times over three hours.^g Each time, they observed unexpected results, so

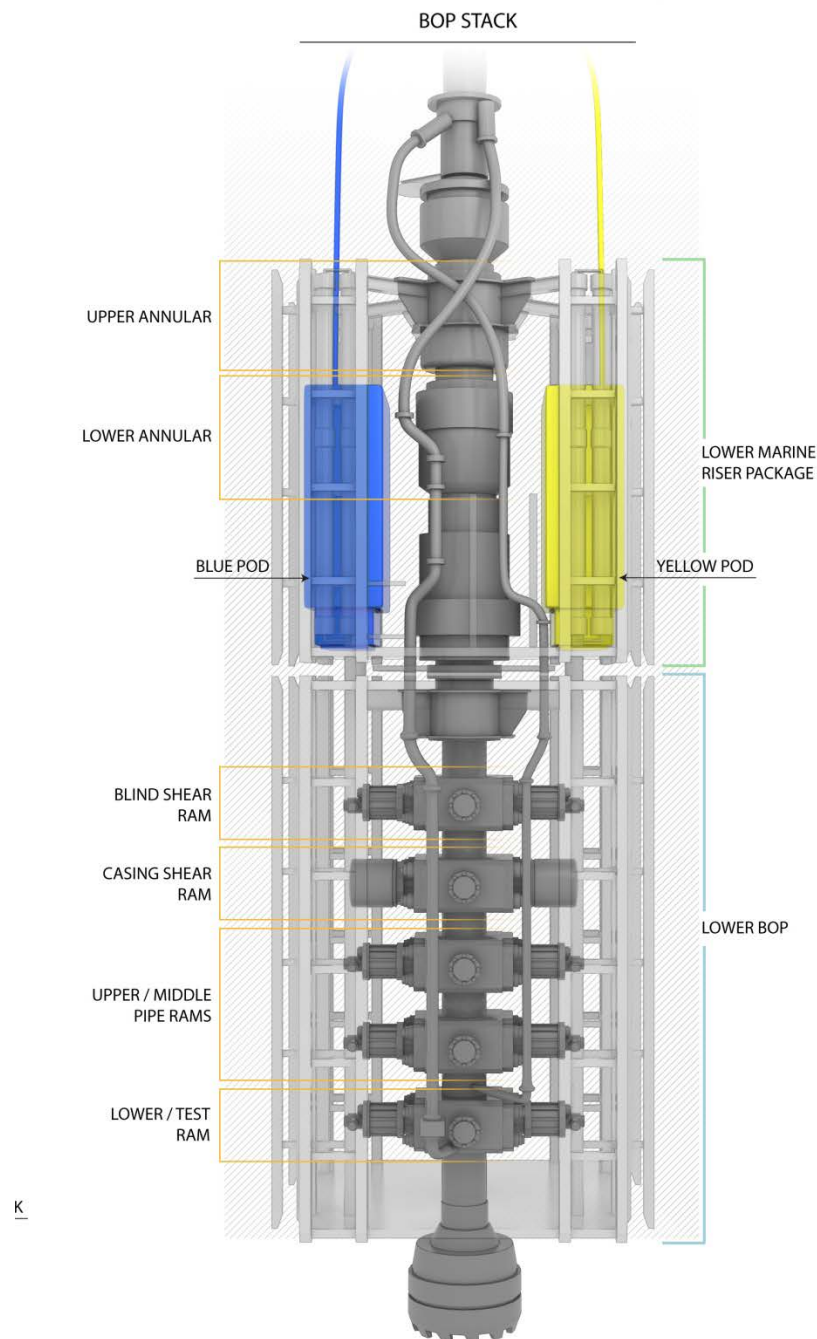
Figure 2-5. The Deepwater Horizon BOP

complexities. These components are identified in Figure 2-5, and the specific details of these components on the Deepwater Horizon BOP are discussed in more detail in Volume 2.

When drilling mud and hydrocarbons began pouring out of the well and onto the Deepwater Horizon, the drilling crew activated a component called an annular preventer, which should have sealed the space around the drillpipe and prevented further hydrocarbons from rising above the BOP.^a However, well data indicate that this component failed to seal the well.^b Not only did the riser fluids—the hydrocarbons, drilling mud and seawater—that already passed above the BOP continue to travel up the riser and release onto the rig floor, but the riser was also being replenished by the flow of even more hydrocarbons through the leaking component.

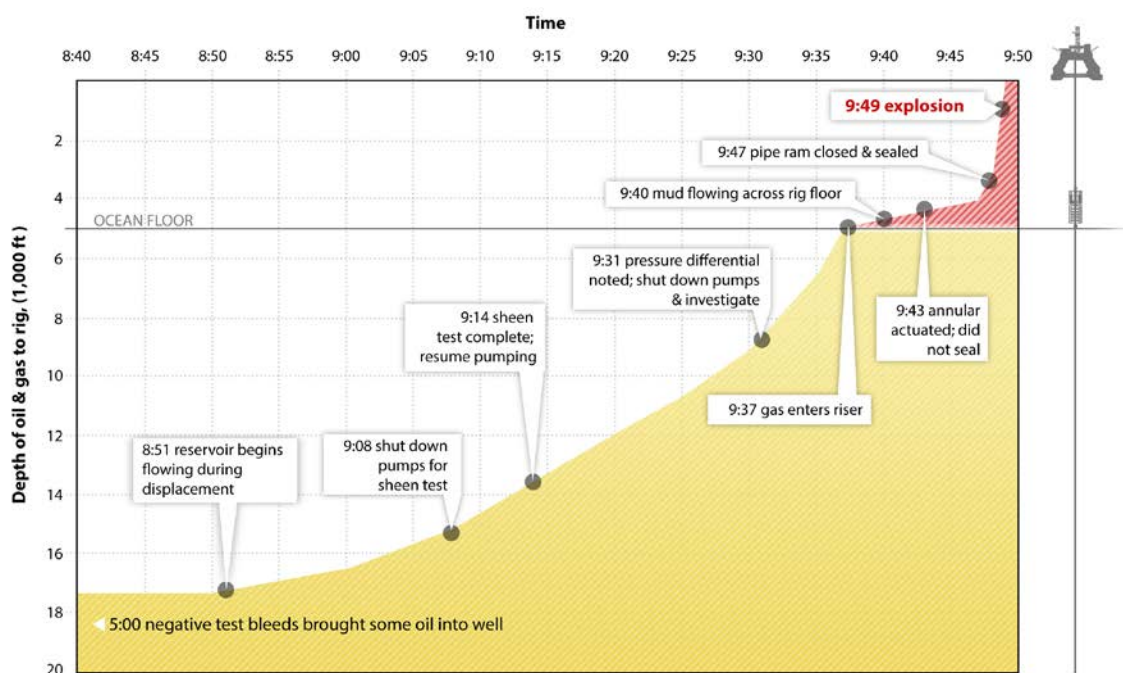
Figure 2-8. Key operation events after reservoir flow began.

^d Others have also generated the computer model to simulate when the influx of hydrocarbons from the well began. Transocean estimated the well became underbalanced between 8:38 p.m. and 8:52 p.m. (Transocean investigation report, Volume II, June 2011, Appendix G, p. 98). The BP account was 8:52 p.m. (BP plc, Deepwater Horizon accident investigation report, September 8, 2010, p. 25.)

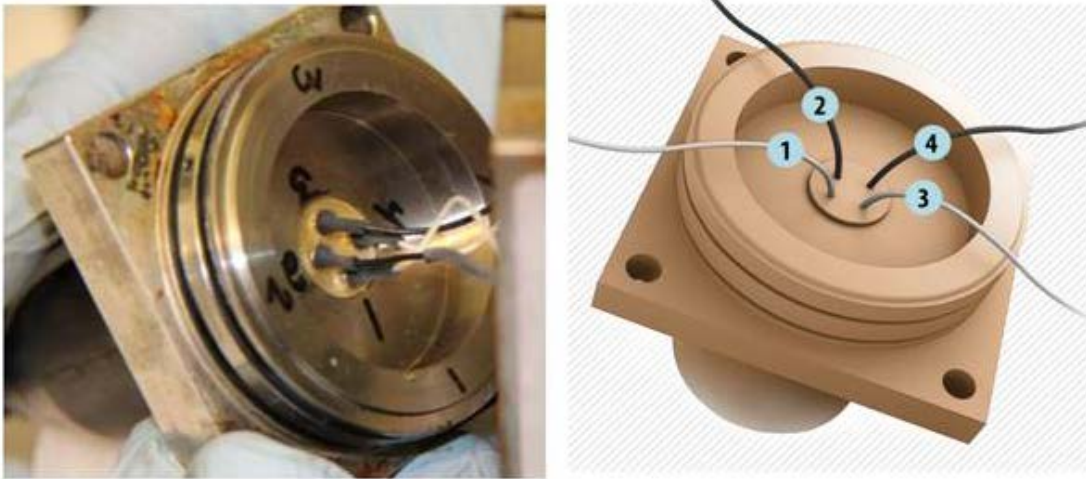
Figure 3-1. (Left) Photograph of Y103 wire arrangement from Phase II testing with pins 1 and 4 connected to white wires and 2 and 3 connected to black wires. (Right) Schematic of correct arrangement of wires, with pins 1 and 3 connected to white wires and 2 and 4 connected to black wires.

Phase II analysis of the Y103 solenoid valve from the yellow pod revealed that it had been miswired. Figure 3-1 shows where pins 1 and 3 should be attached to the white wires and pins 2 and 4 to black wires, which was not the case with Y103. As a result, when both solenoid coils were energized during bench testing, the miswiring produced opposing magnetic fields, which canceled out each other and caused the solenoid valve to remain closed.

Previously published investigation reports assert that attempts to actuate the miswired Y103 solenoid were successful even when both coils were simultaneously energized,³² but Phase II testing revealed

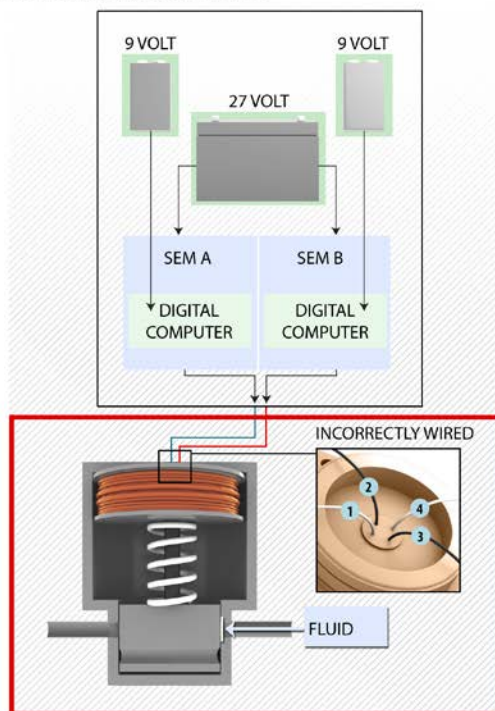
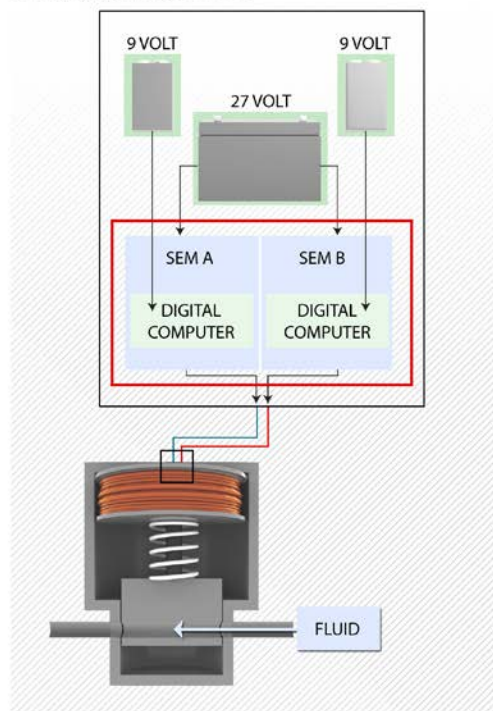
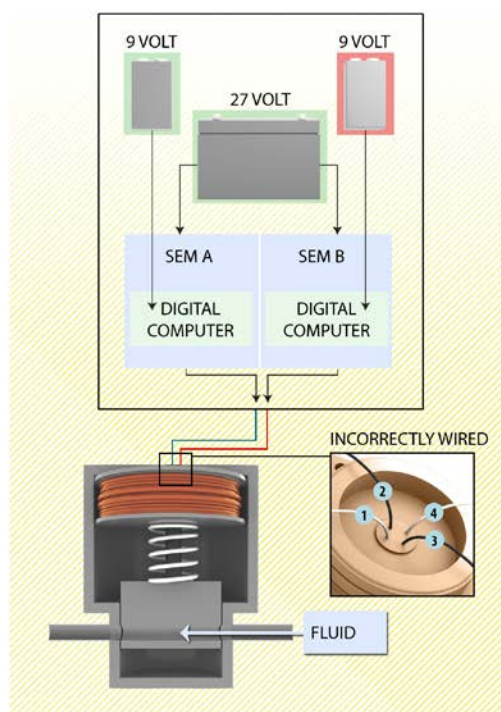
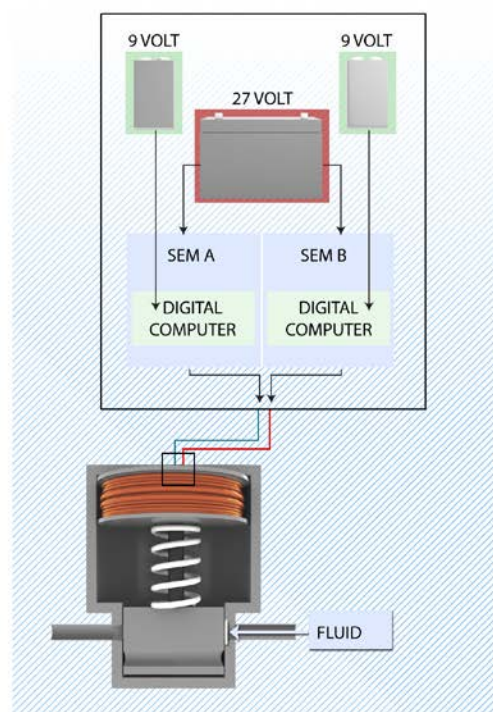
Figure 3-2. Miswiring in the blue pod caused the critical 27-volt battery to drain, rendering the pod inoperable during the incident. A drained 9-volt battery in the yellow pod left one of the coils in the miswired Y103 solenoid valve inoperable, allowing the other coil to activate unopposed and initiate closure of the blind shear ram.

The failure of the SEM B battery during the yellow pod AMF/deadman tests in Phase I occurred when the SEM was operating in an ambient temperature near 21°C (70°F). Borrowing from the car analogy, an SEM battery that barely produced sufficient power when operating in ambient temperatures might not have functioned when operating in subsea temperatures near 2°C (36°F).^a Therefore, on the day of the incident, SEM B in the yellow pod was likely not operational, allowing the SEM A coil of Y103 to function unopposed and successfully execute the AMF/deadman sequence. (See Figure 3-2 and Figure 3-3.)

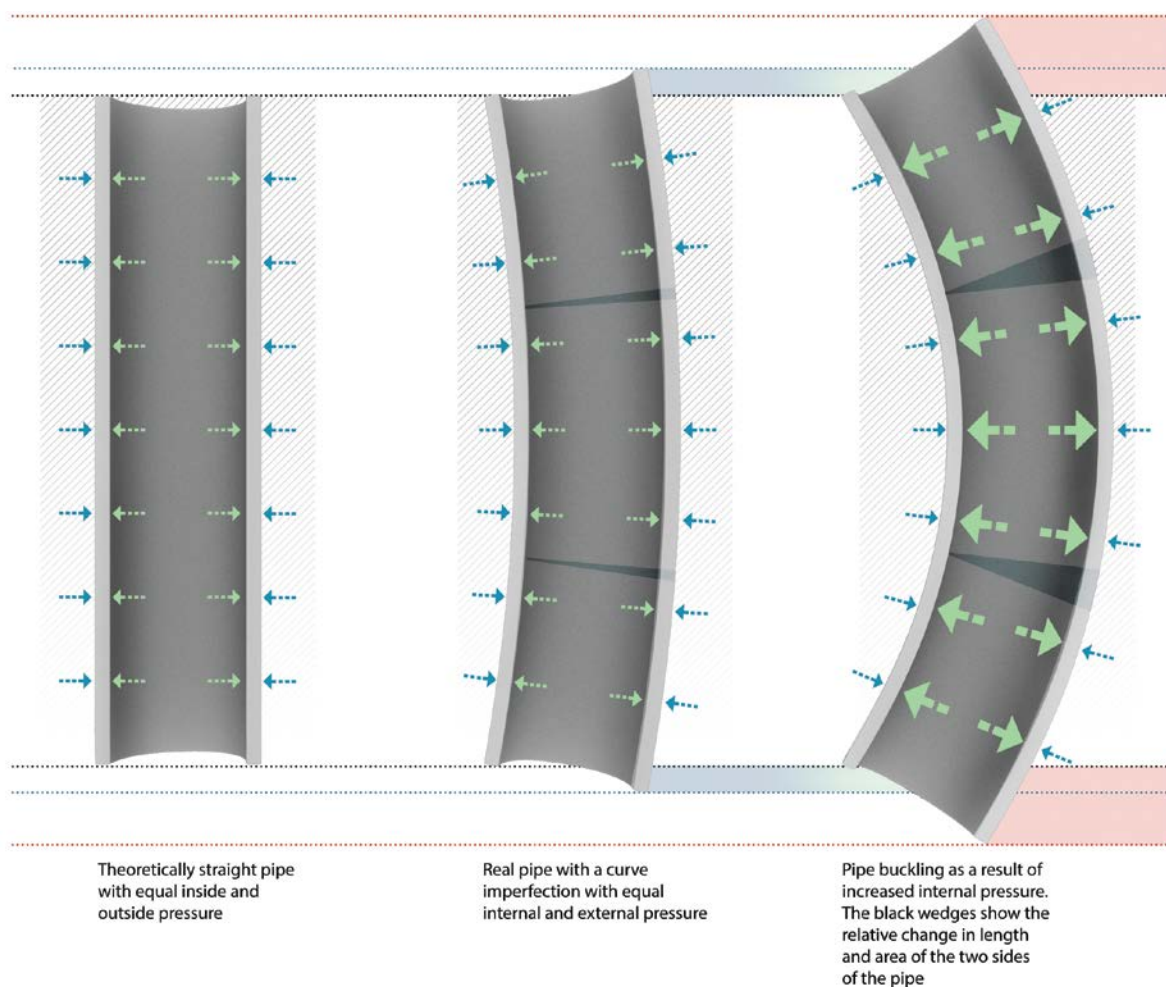
Figure 3-5: Theoretically straight pipe with equal inside and outside pressure (left); real pipe with a curve imperfection with equal internal and external pressure (center); pipe buckling as a result of increased internal pressure (right). The black wedges show the relative change in length and area of the two sides of the pipe.
