# Gas Well Blowout and Fire at Pryor Trust Well 1H-9

# Investigation Report

Published: June 12, 2019

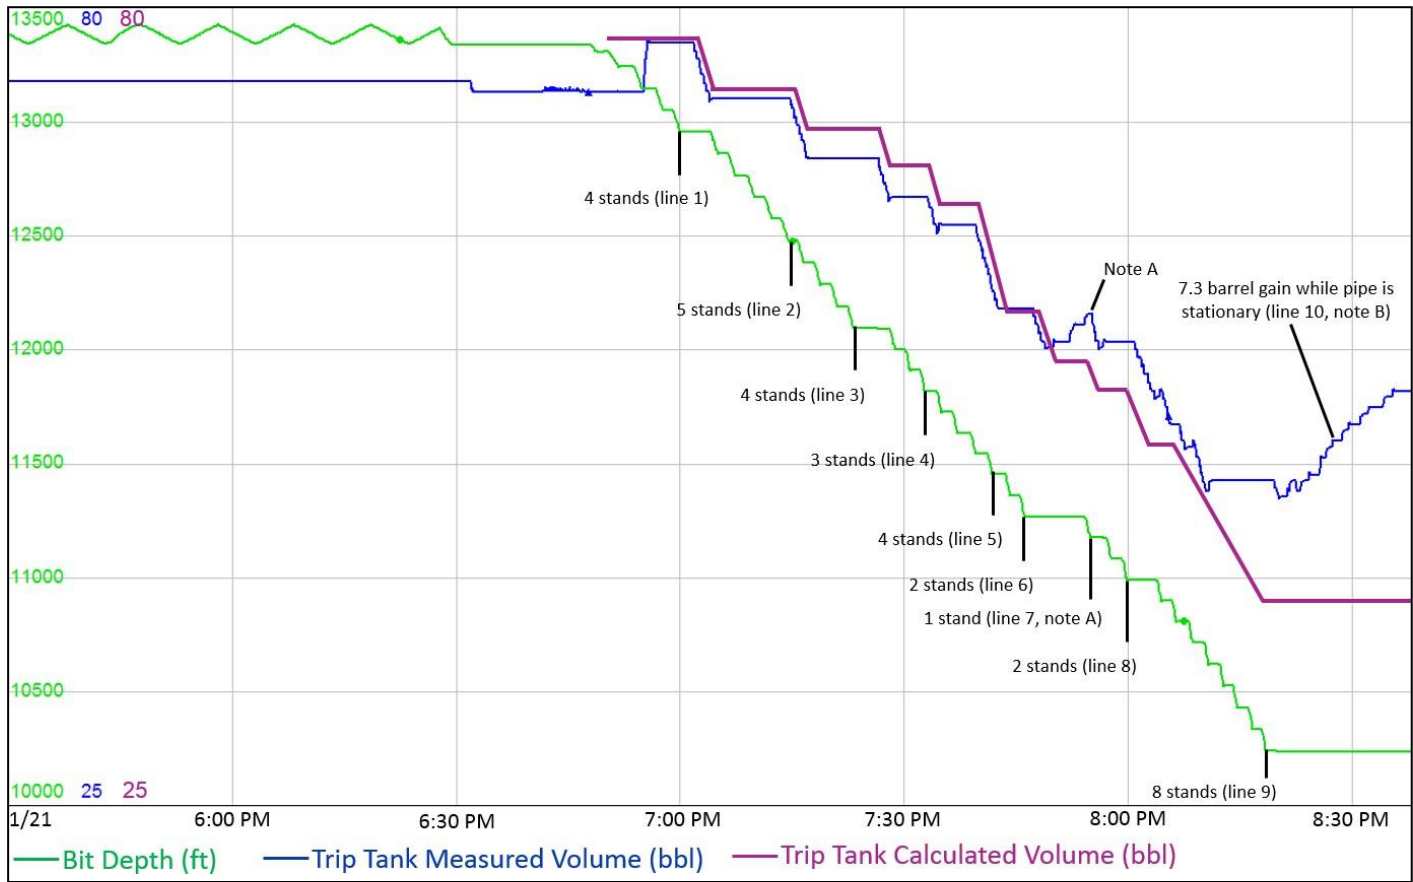
Figure 13. Rig data during the trip out of the wellbore from 13,337 feet to 10,237 feet. The blue line shows the actual, measured trip tank volume, and the purple line shows what the trip tank volume would be had a mud volume equal to the calculated volume of the drill pipe removed been pumped into the well. The line numbers and notes indicated in parentheses correspond to the line numbers and notes in Table 1 below.

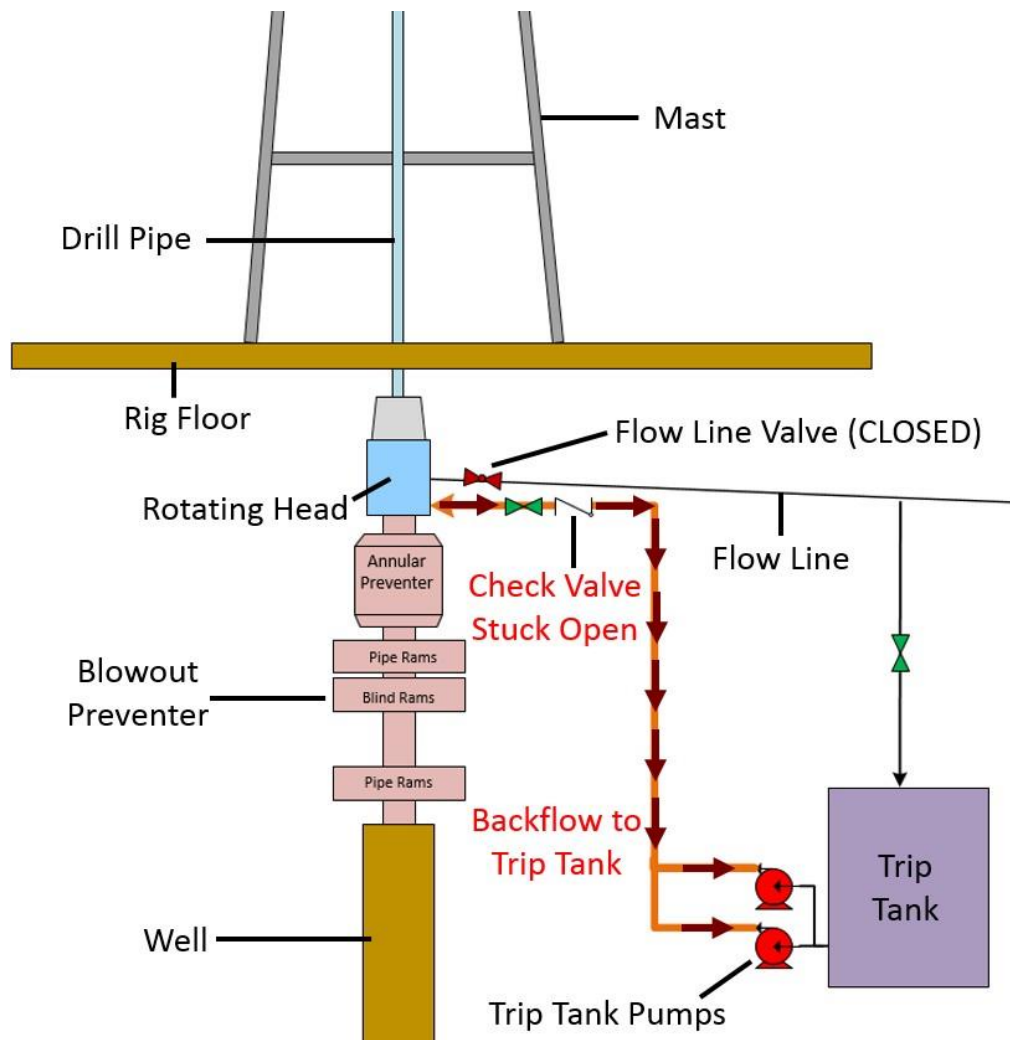
Figure 14. Pressurized mud backflowed through trip tank discharge piping, stuck-open check valve, and centrifugal pumps into trip tank.

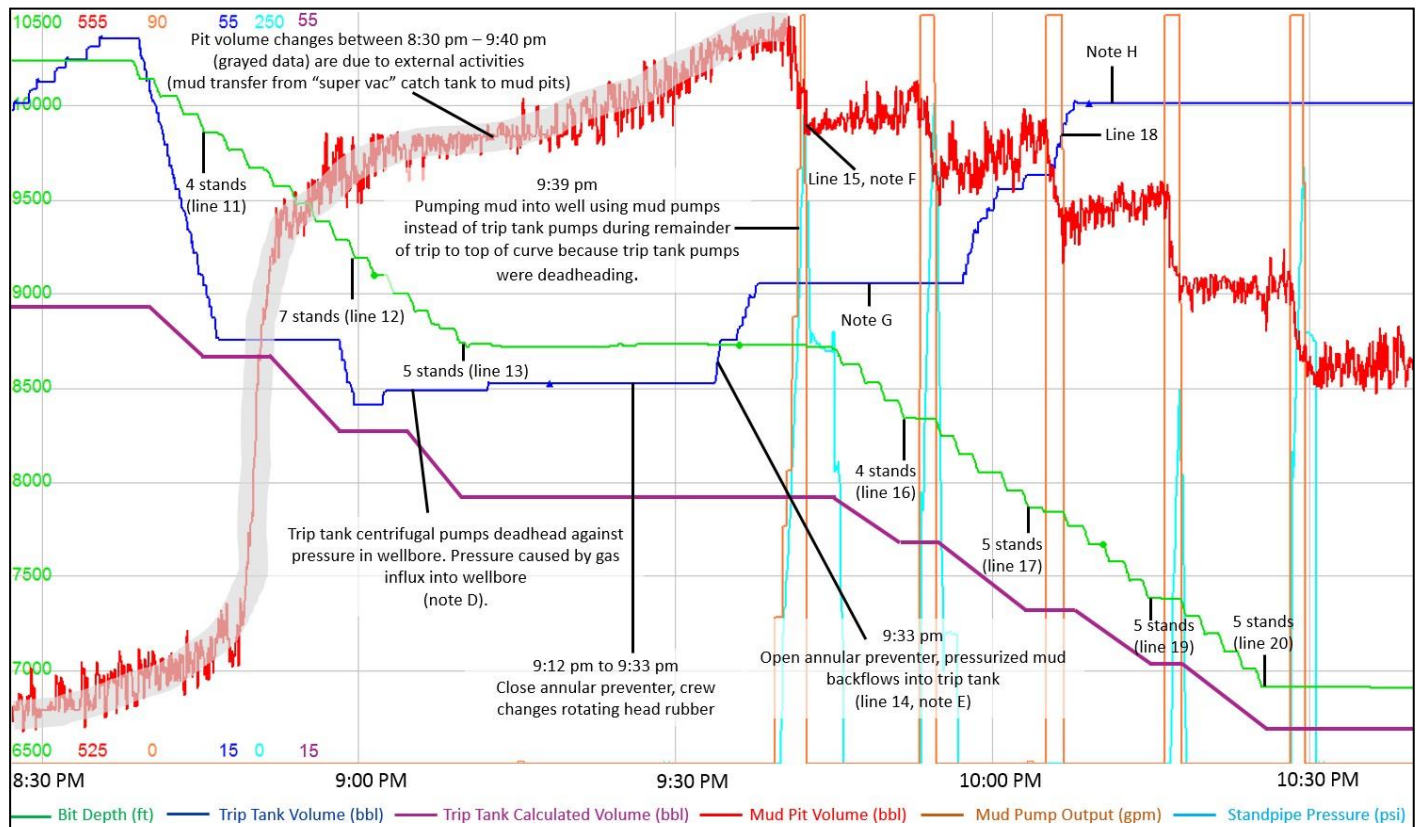
Figure 15. Rig data during the trip out of the wellbore from 10,237 feet to 6,905 feet. The blue line shows the actual, measured trip tank volume, and the purple line shows what the trip tank volume would have been had the calculated drill pipe volume been pumped into the well. The line numbers and notes indicated in parentheses correspond to the line numbers and notes in Table 2 below.

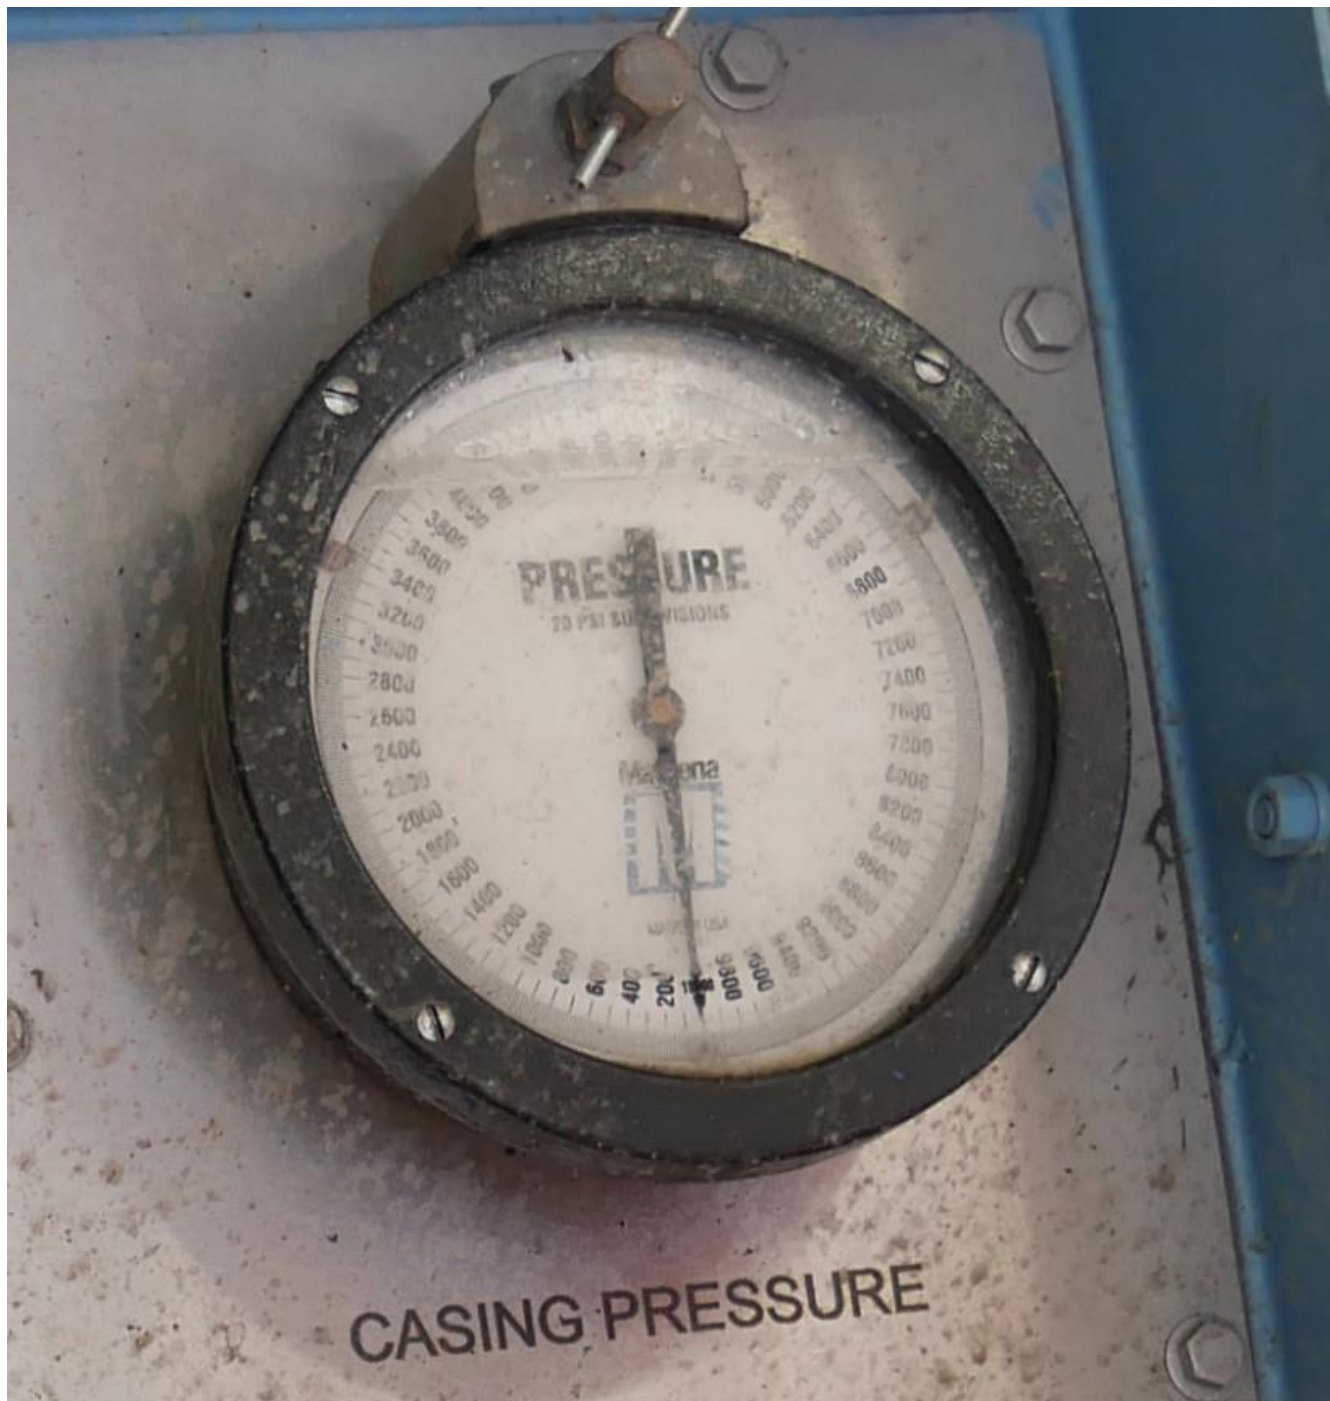
*Figure 16. Photo of casing pressure gauge on an exemplar Patterson drilling rig. The pressure gauge could indicate pressures up to 10,000 psi. Low pressures might have been difficult to read on the Rig 219 pressure gauge, or the pressure gauge might not have worked properly at low pressures. The valve on the choke system (“HCR valve”) that needed to be opened to measure annular pressure might have been closed during pressure readings, or the line might have been plugged.*

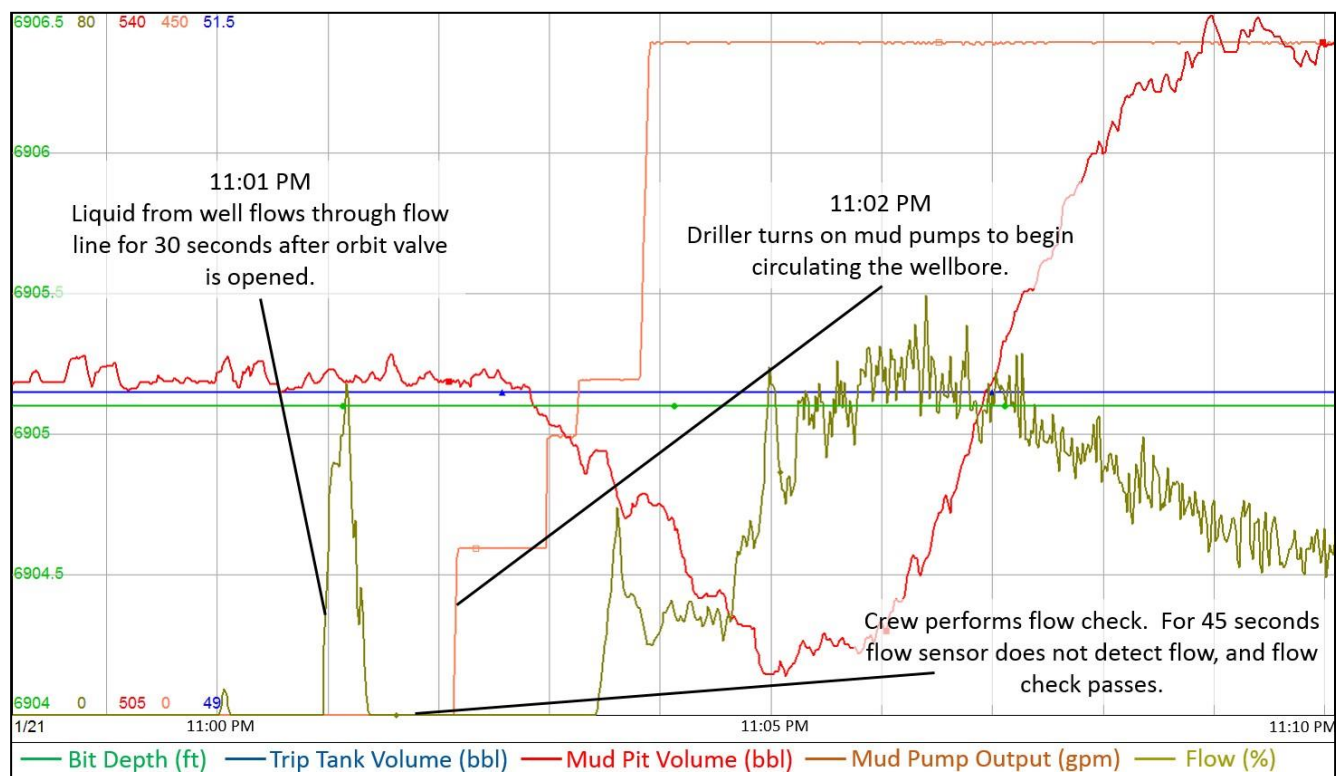
Figure 18. Rig data when the drill bit reached the top of curve. Crew performed a flow check at top of curve. No flow was observed for 45 seconds. Driller turned on pumps to circulate the well.

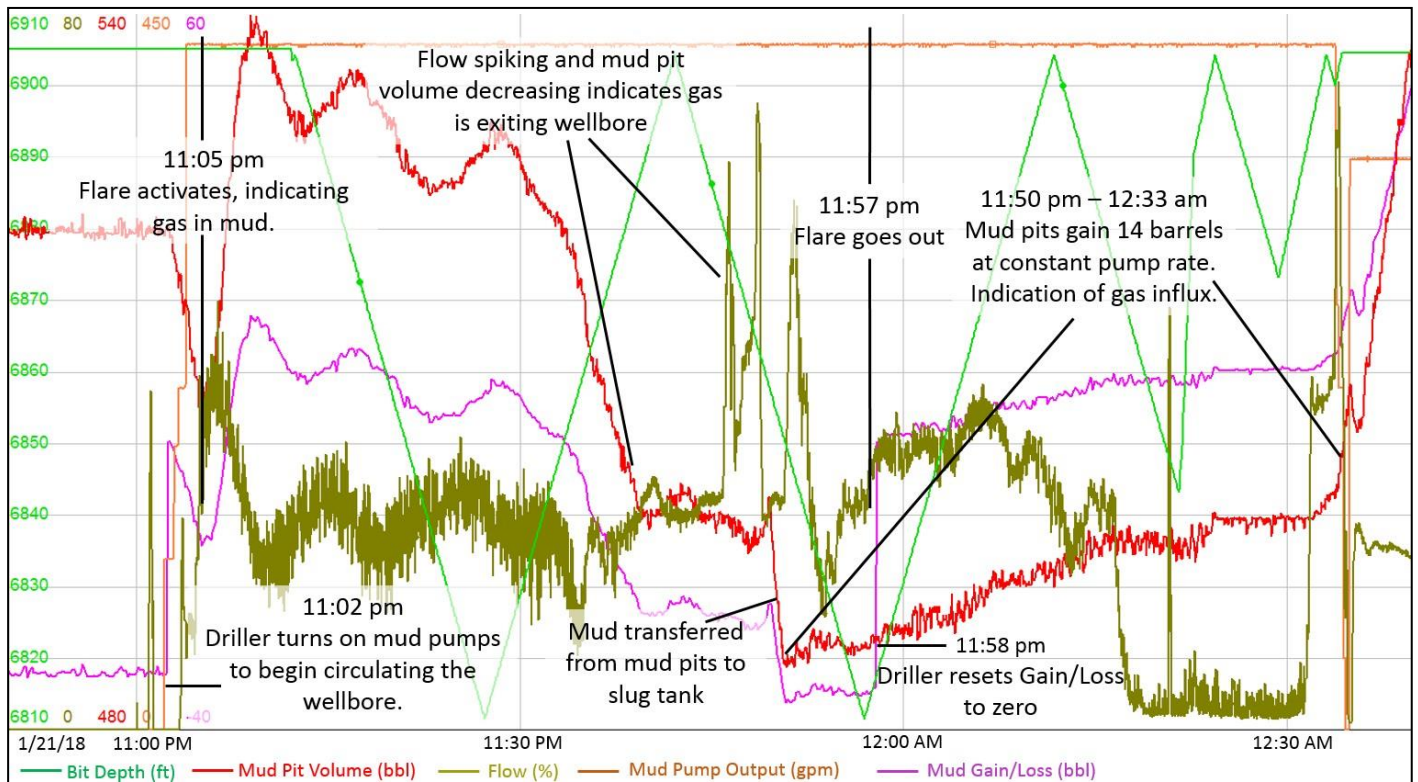
Figure 20. Rig data while circulating the wellbore at the top of the curve. The flare activated while circulating, indicating gas in the mud. Between 11:50 pm and 12:33 am, the mud pits gained 14 barrels while the mud pumps were circulating at a constant pump rate. This pit gain indicates there was gas in the well.

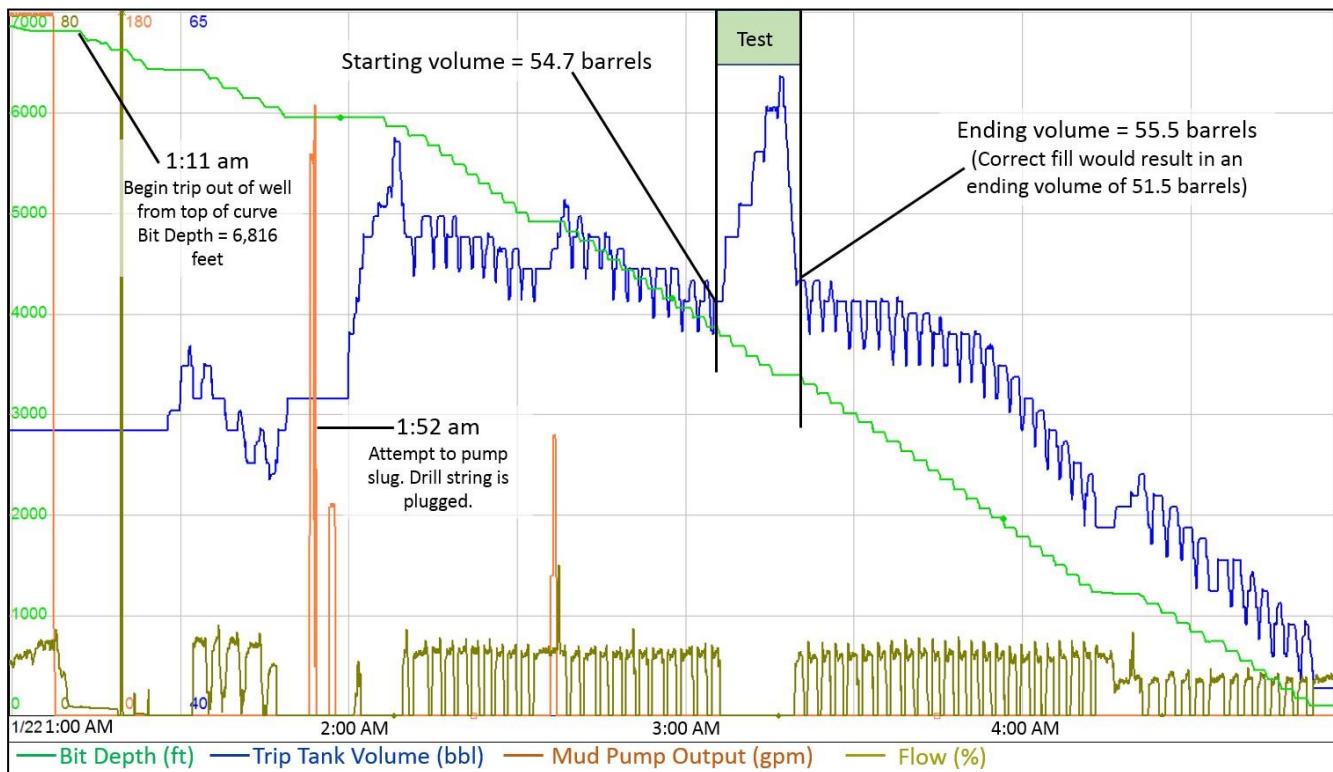
Figure 25. Rig data during trip out of vertical portion of the well on January 22, 2018. The driller and company man were confused by the trip tank volume fluctuations and about what pipe volume to use in trip sheet calculations. The company man and driller incorrectly concluded that the test they performed to determine if the well was taking proper fill had passed.

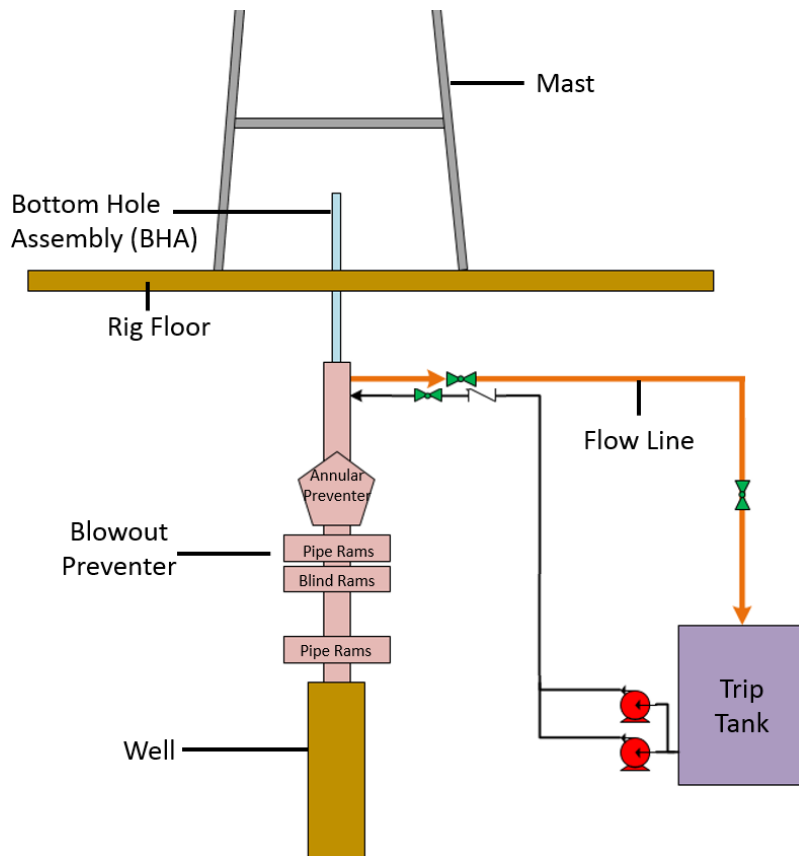
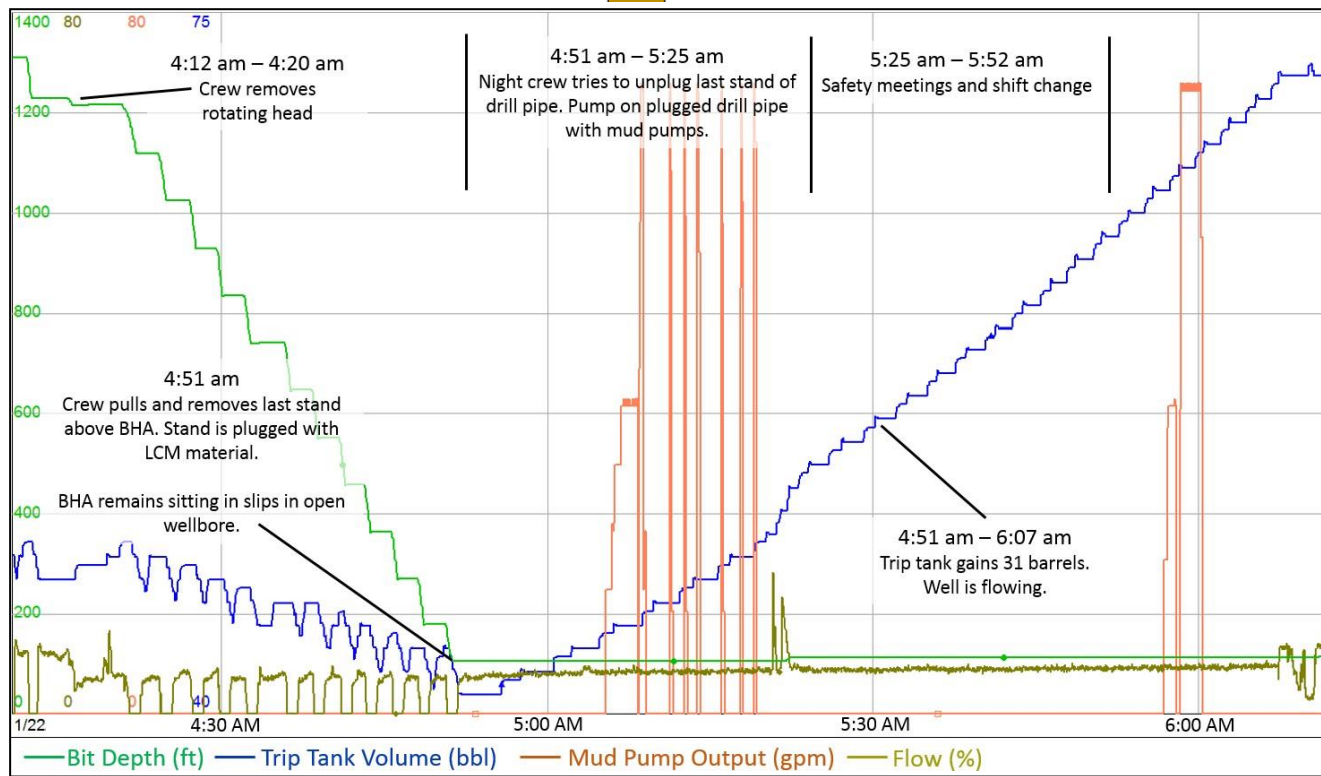
Figure 26. Rig equipment lineup and rig data between 4:10 am and 6:12 am. Between 4:51 am and 6:07 am, the trip tank gained 31 barrels of mud.

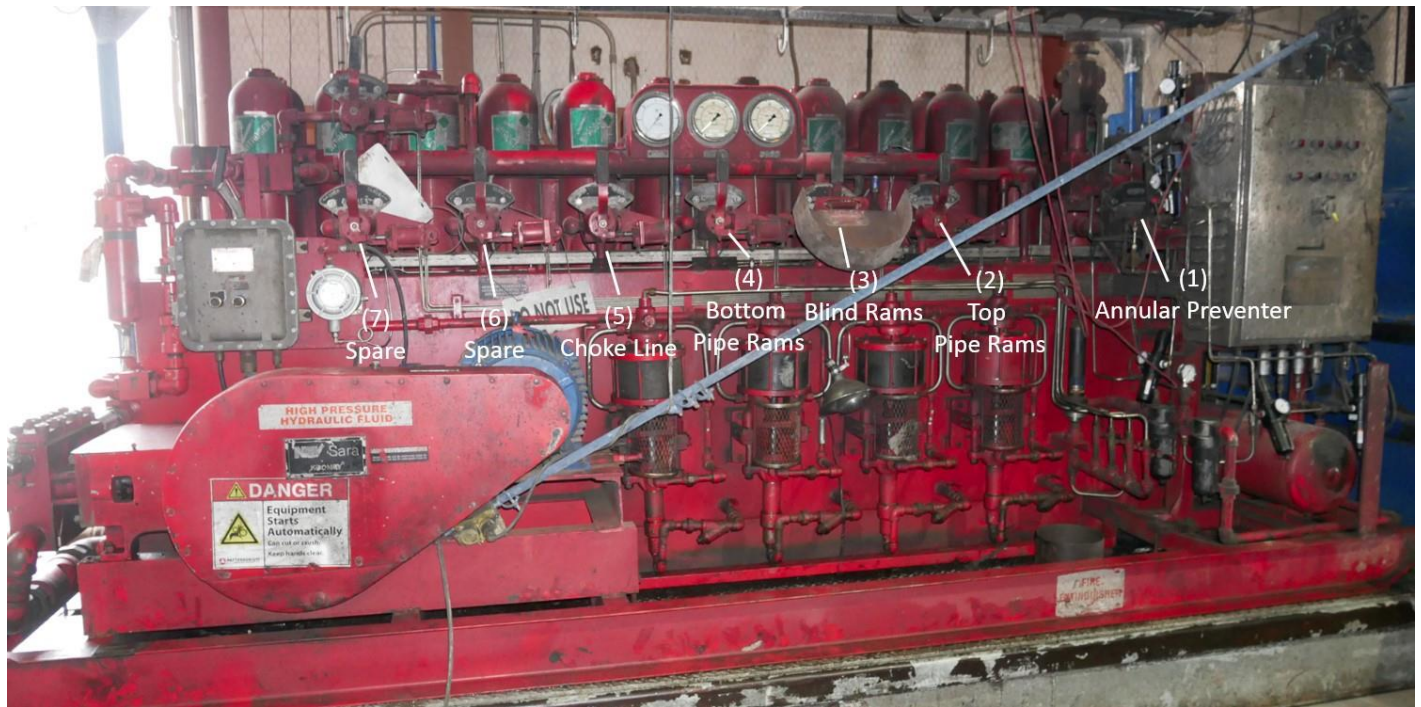
Figure 31. Photo of the BOP accumulator, which is used to function the BOP rams. The rig manager closed the BOP control handles in the following order: (1) annular preventer, (2) top pipe rams, (3) blind rams, and (4) bottom pipe rams. The blowout preventer did not seal the well to stop the blowout when the rig manager functioned the control handles.

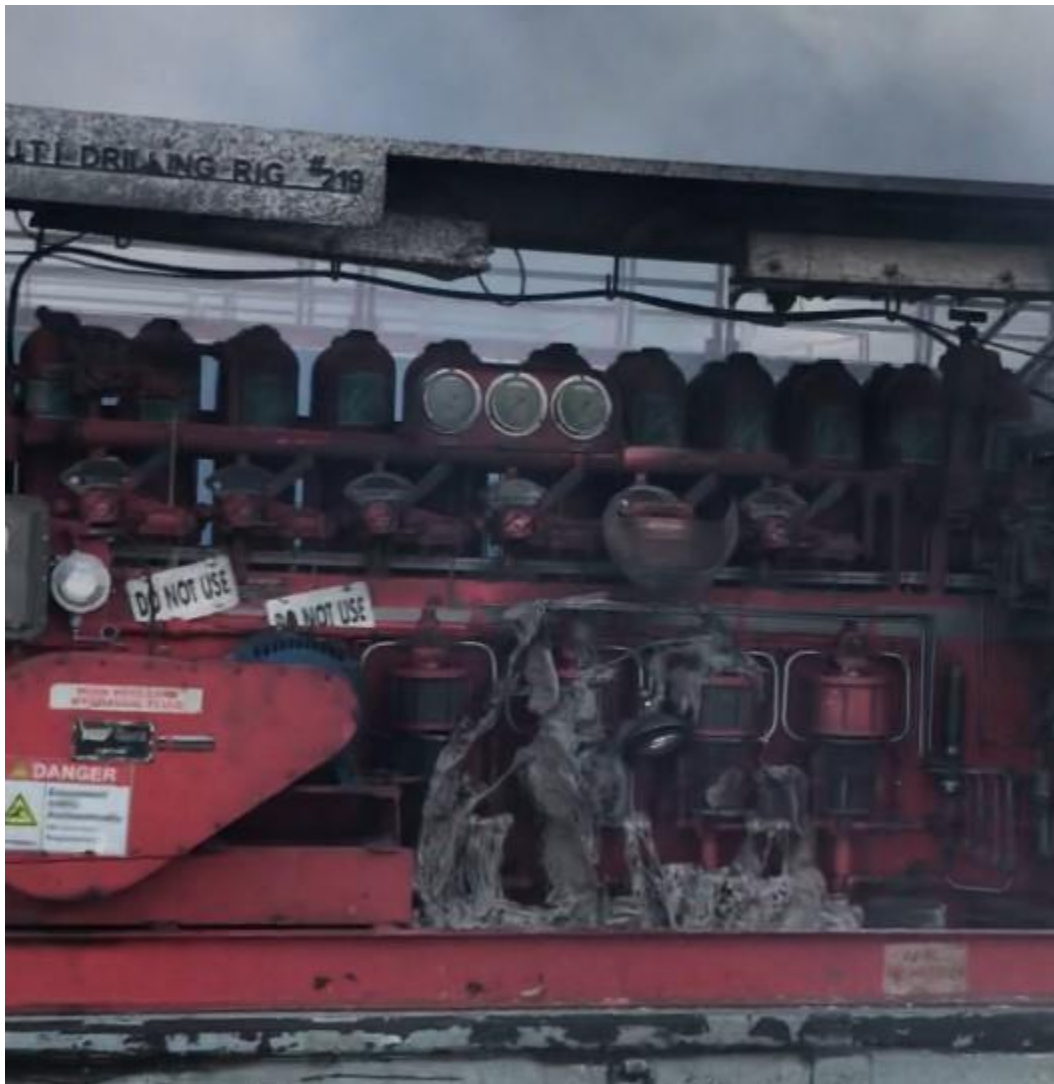
*Figure 32. Video captured at 11:51 am on January 22, 2018 shows all BOP handles in the closed position.*

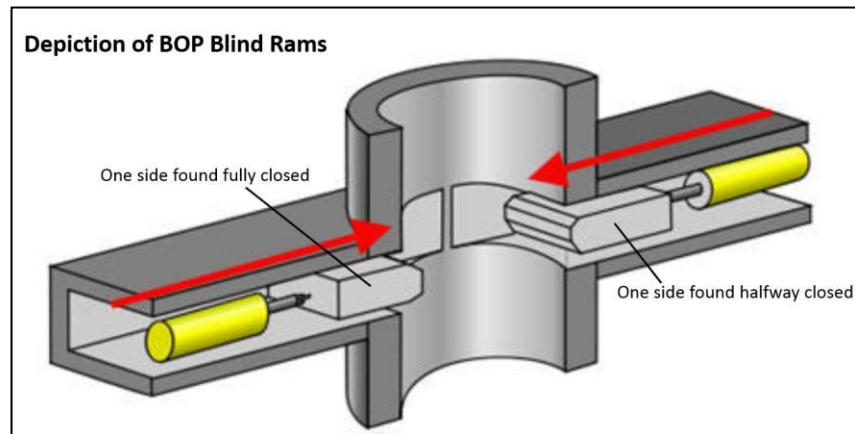
Figure 33. Depiction of BOP blind rams. A Boots & Coots responder found that the south-side blind ram was fully closed, and the north-side blind ram was halfway closed. Source: [drillingformulas.com](http://drillingformulas.com) [11] with notations by CSB.

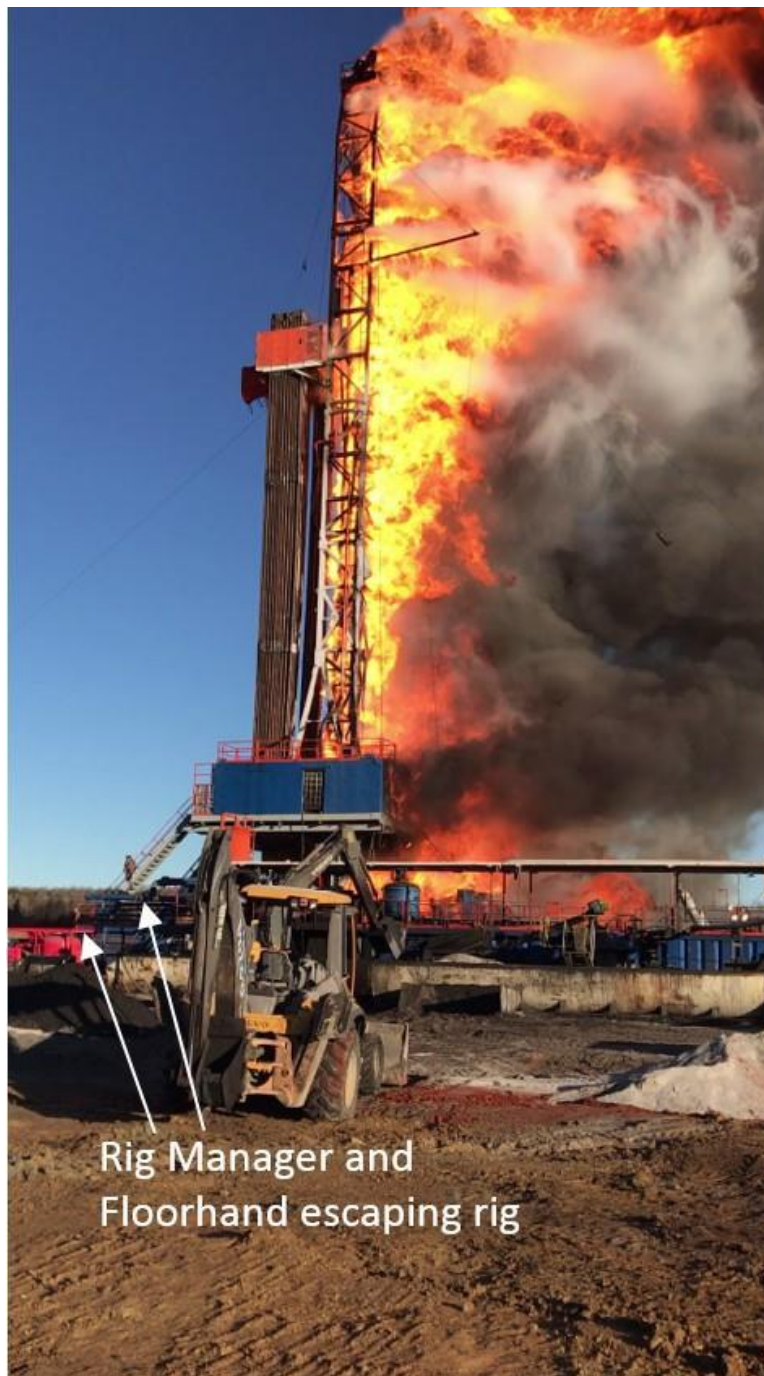
*Figure 43. Still from video captured at 8:36 am, shortly after blowout started. The rig manager and floorhand can be seen escaping the rig. At this point, the fire has engulfed the driller's cabin (far side of photo).*

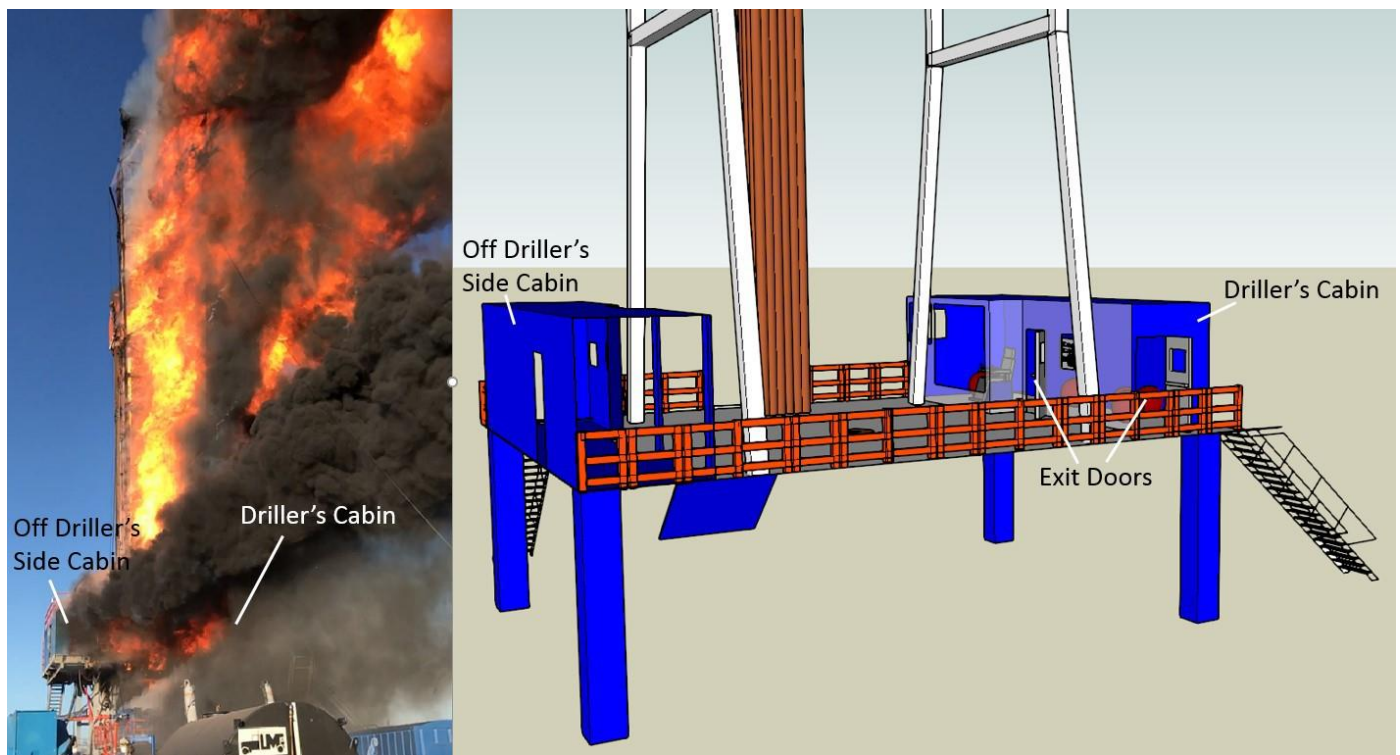
Figure 44. Both exits from the driller's cabin were engulfed by fire.

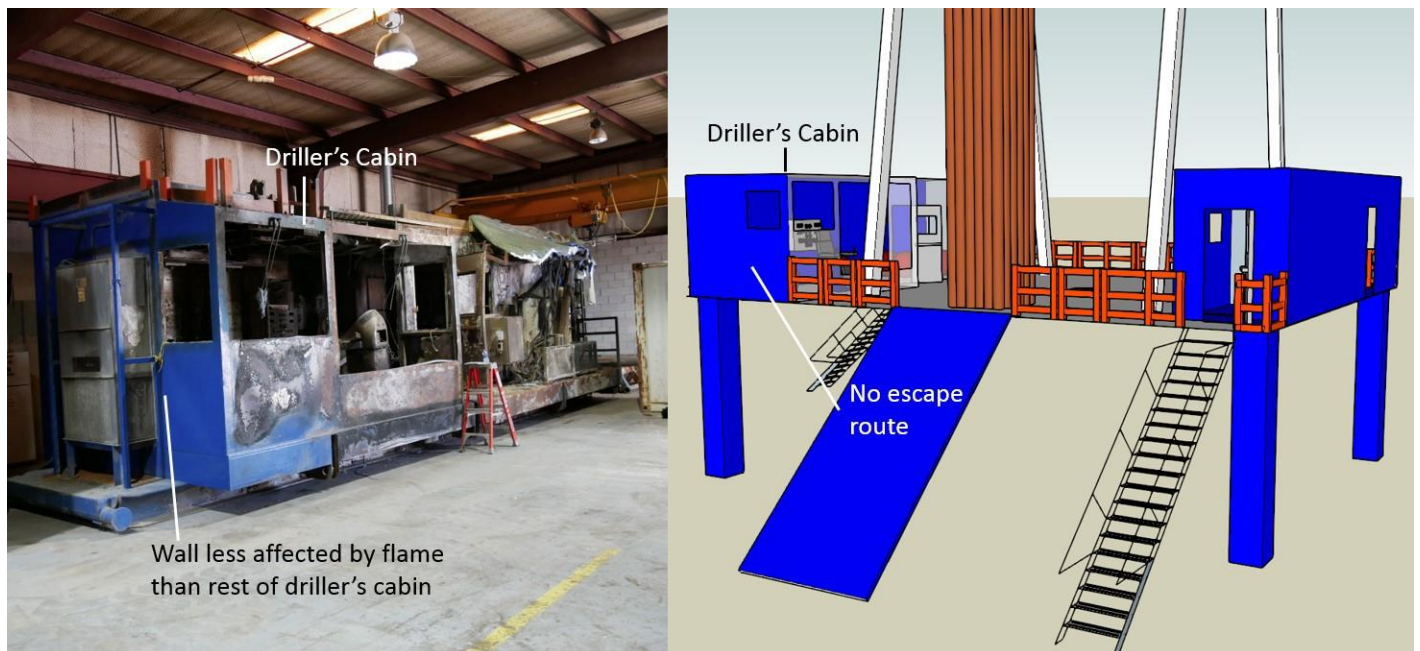
Figure 45. One part of the driller's cabin appeared to be less affected by fire, evident by the paint remaining post-incident. There was no escape route near that location.

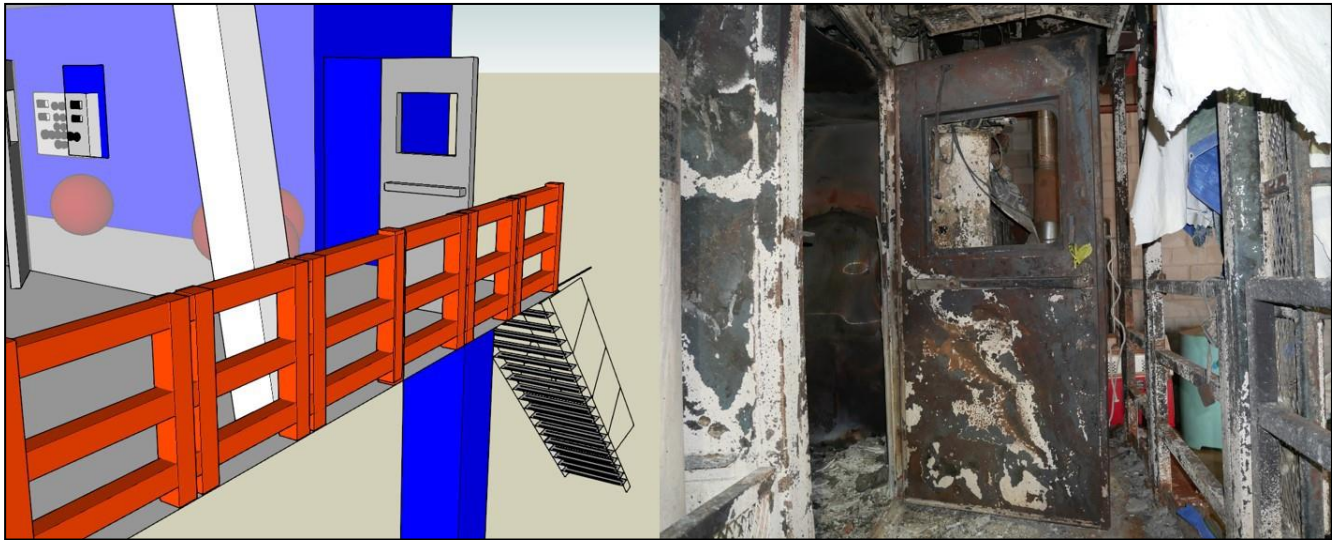
Figure 46. The most viable exit door was hinged such that when the door was opened, the door blocked the escape path to the ground.

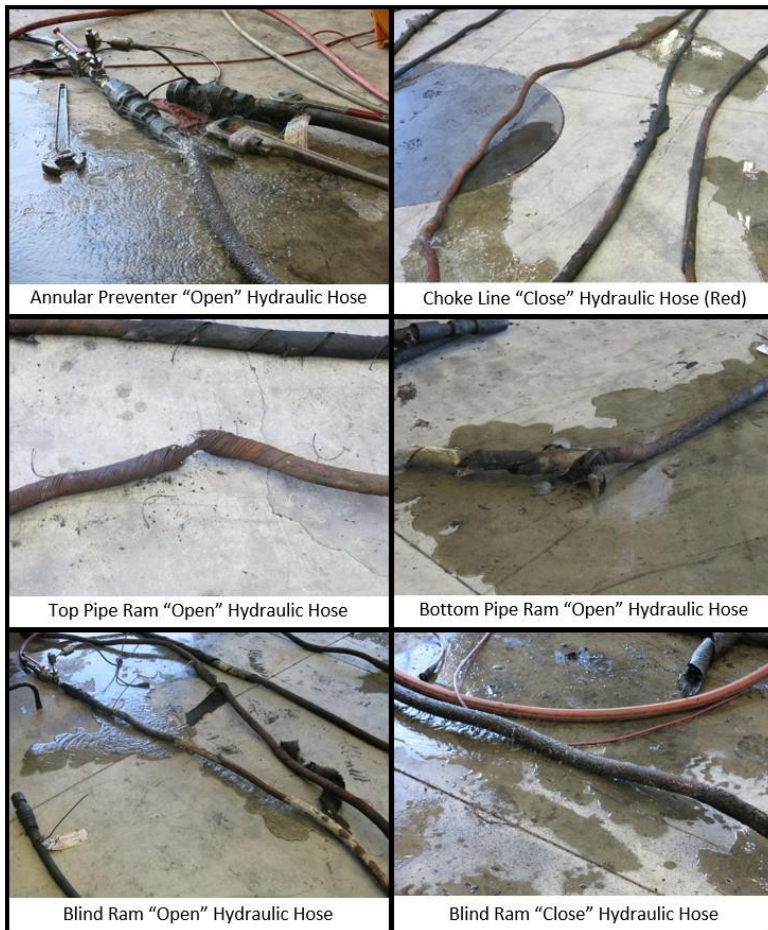
The blowout preventer also failed to close when its activation was attempted after the fire started. The CSB determined the BOP did not function likely because the control hoses that supplied hydraulic fluid to the BOP to function the rams had burned in the fire and leaked the hydraulic control fluid, soon depleting the accumulator stored pressure to the point the blowout preventer could not be closed.

Figure 50. Photos of hydraulic hoses that were installed between the accumulator and BOP, used to send high-pressure hydraulic fluid to the BOP rams to open or close the rams. The hoses were damaged by fire. The hydraulic hoses were leak tested using 40-50 psig water, and all hoses leaked water.

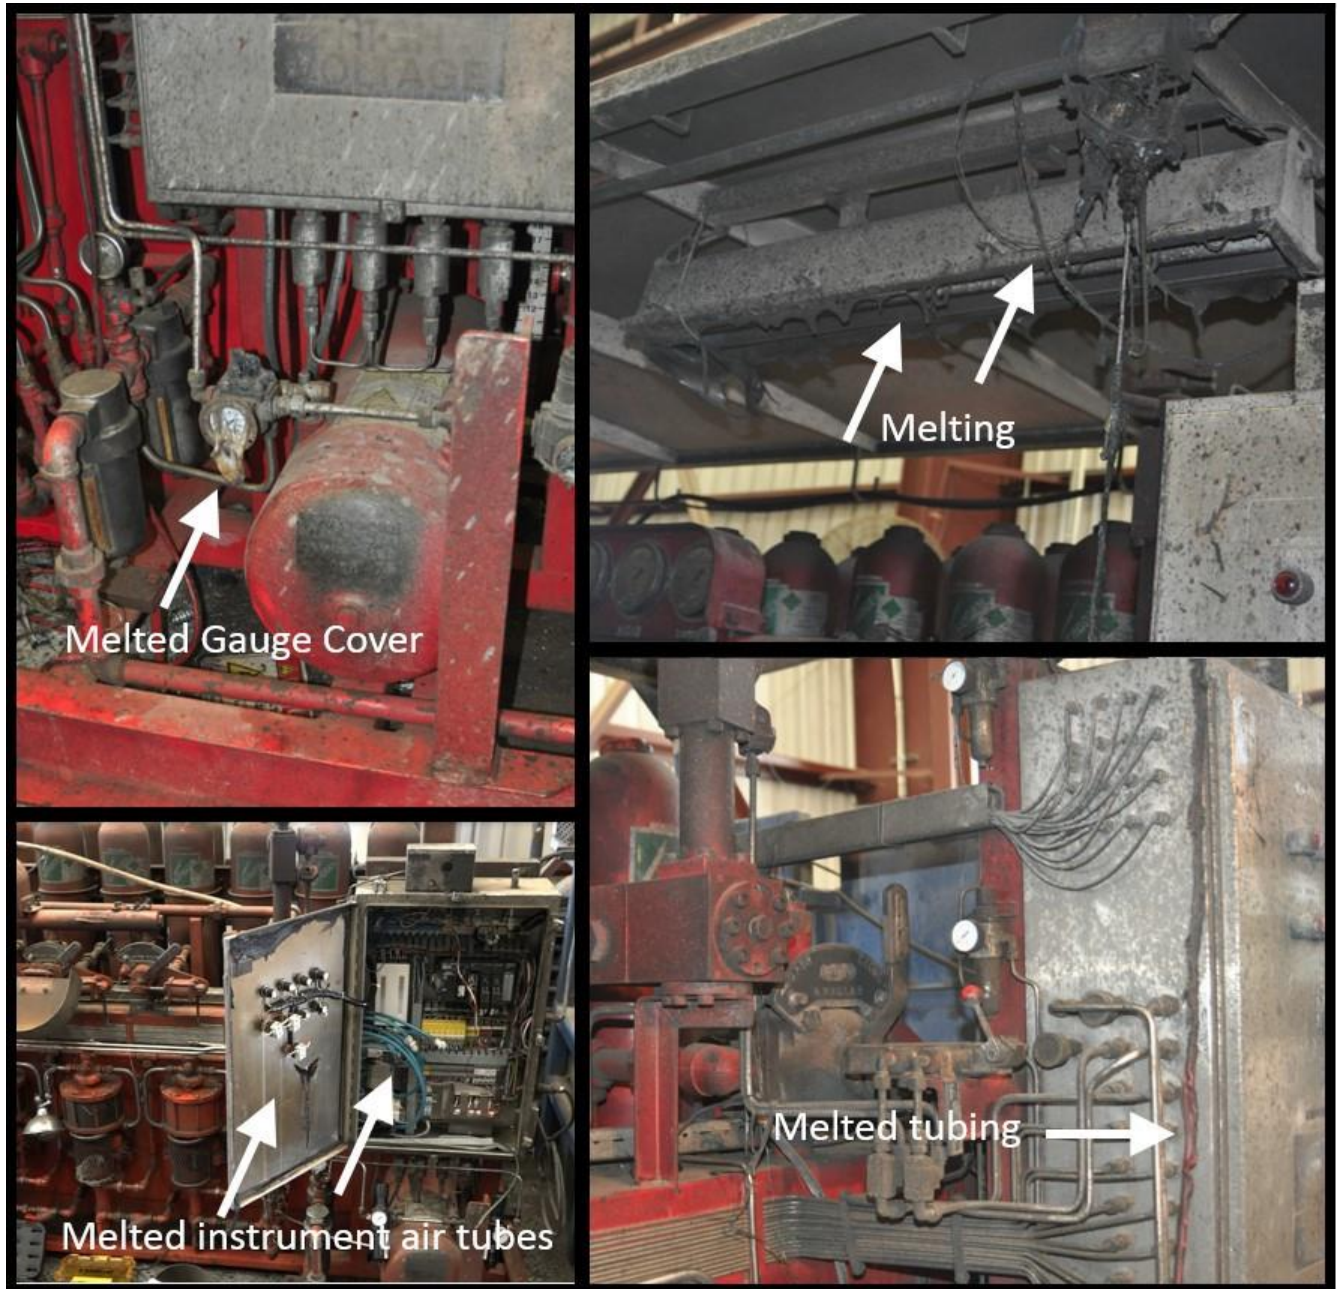
Figure A- 2. Photos of observed heat damage to Patterson Rig 219 accumulator

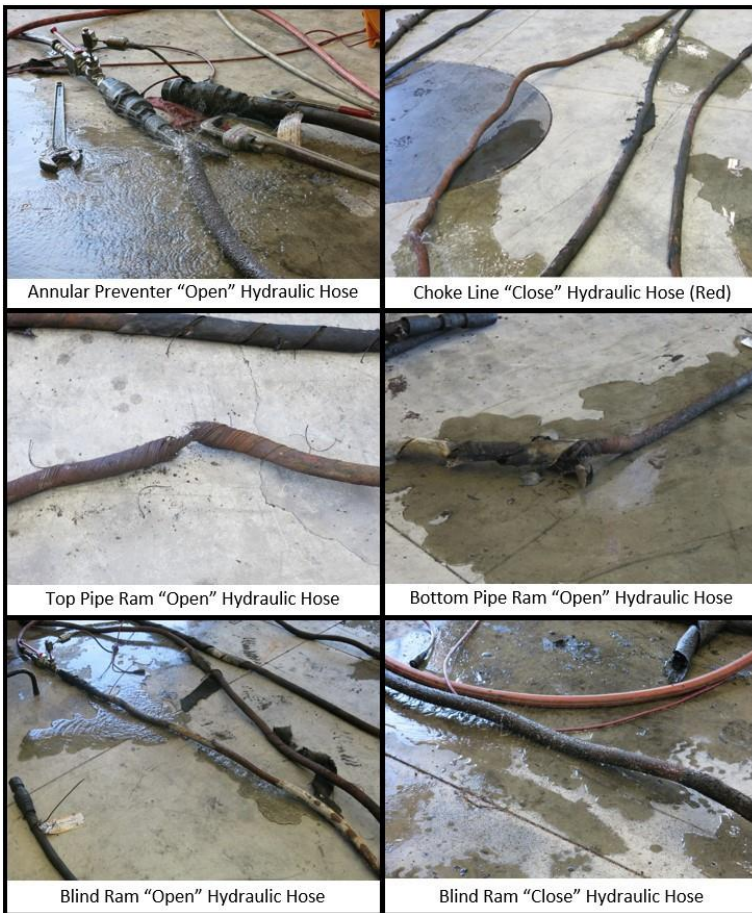
Figure A- 5. Photos of hydraulic hoses that were installed between the accumulator and BOP, used to send high-pressure hydraulic fluid to the BOP rams to open or close the rams. The hoses were damaged by the fire. The hydraulic hoses were leak tested using 40-50 psig water, and all hoses leaked water.

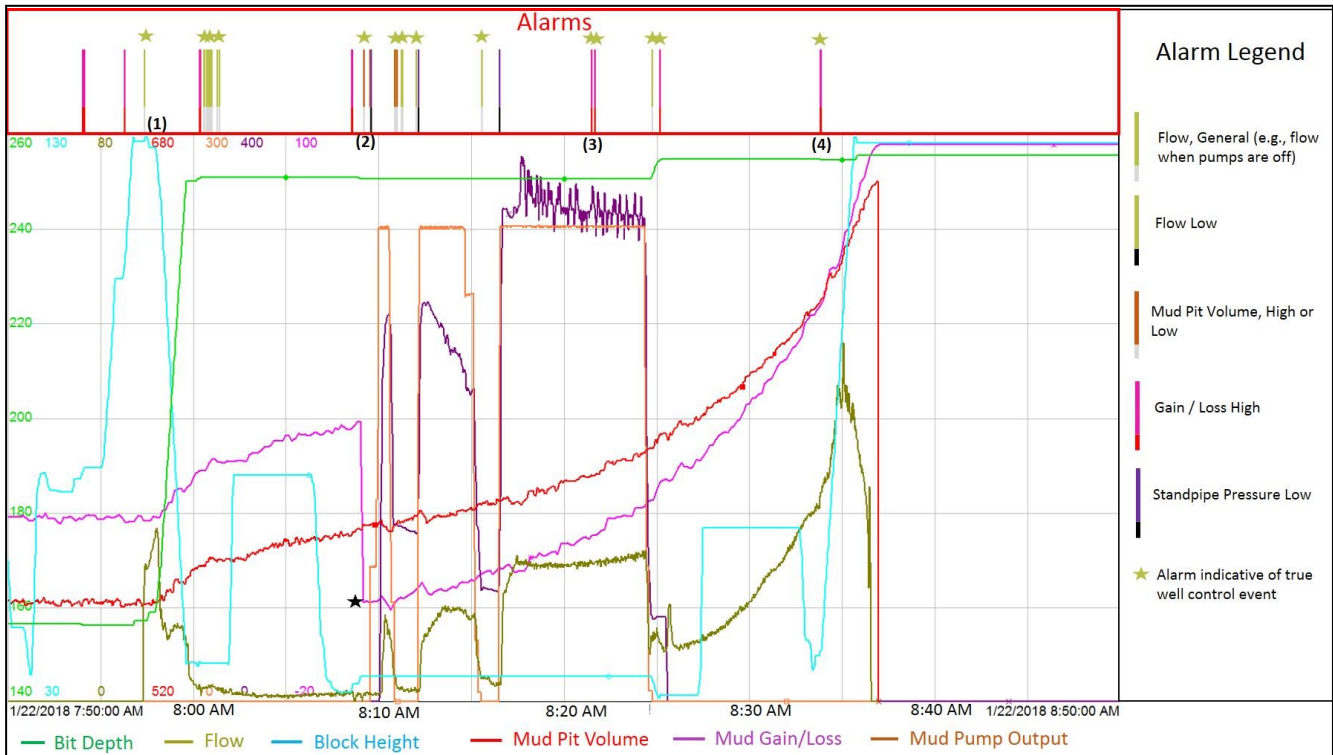
Figure E- 5. Information from alarm system data, indicating what alarms would have activated between 7:50 am and 8:36 am (blowout), if the alarm system was on. Almost all of the alarms would have alerted to the well control event. Information about the specific alarms is in Table E- 5 below. The numbers in parentheses correspond with the note numbers in Table E- 5.
