Collapse of Building Under Construction

**Professional Development Hours (PDH) or
Continuing Education Hours (CE)
Online PDH or CE course**

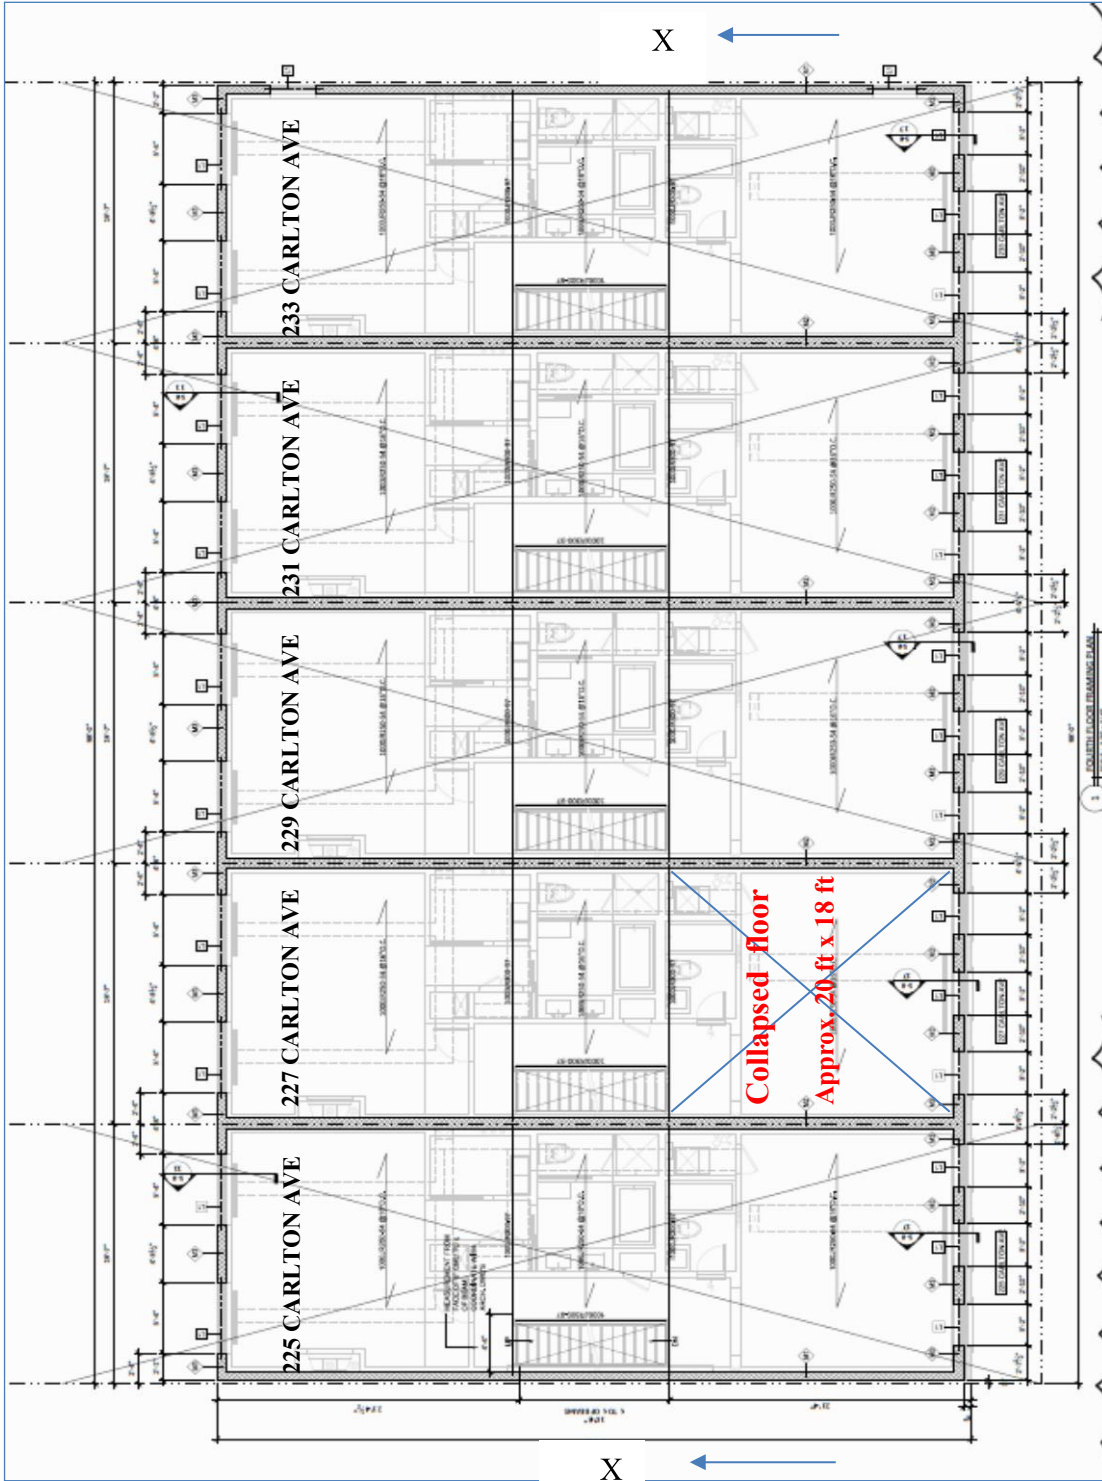
Eyewitnesses reported that soon after the last jumbo bags of sand was placed on the deck near the front of the building, the front 20 feet of the floor collapsed over the third floor which started

a chain of failures of the floors below, and finally the front 20 feet of all the floors were pancaked into the basement, also known as the cellar, see Fig 1 & 2.

Fig. 1 Fourth floor plan - Carlton Row Townhouses - after the floors collapsed

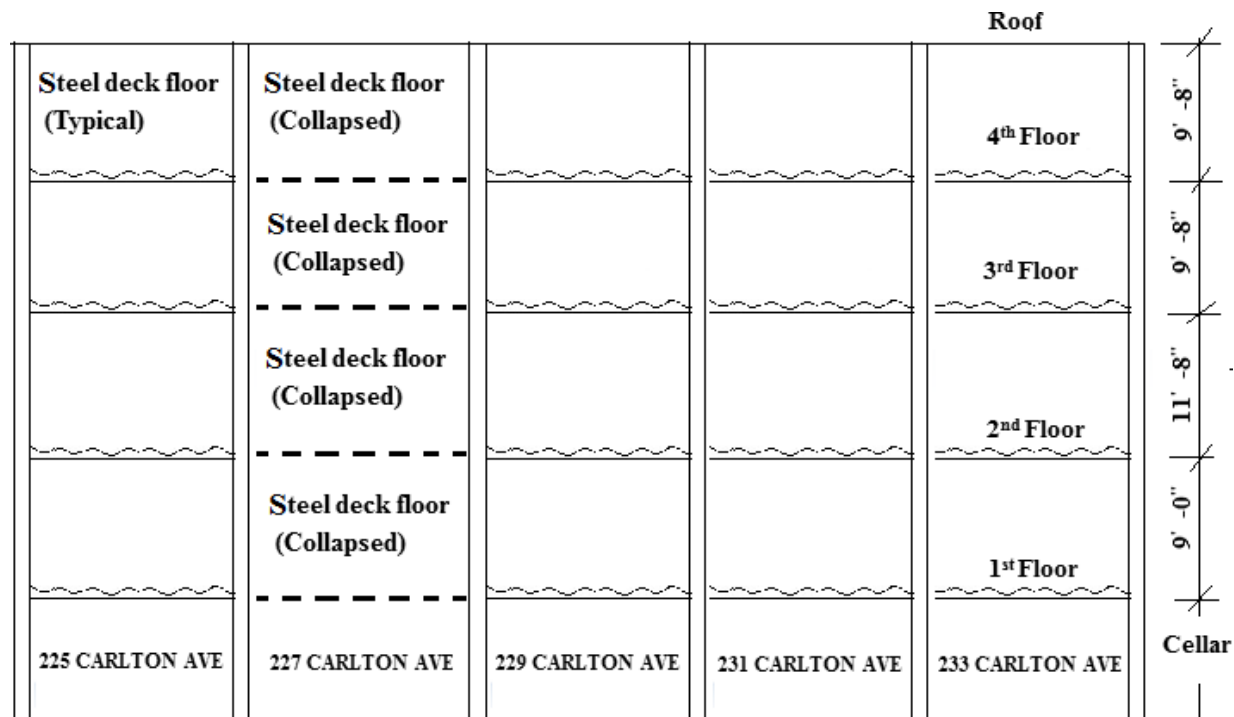
Fig. 2 Vertical section x-x of the building after the floors collapsed.

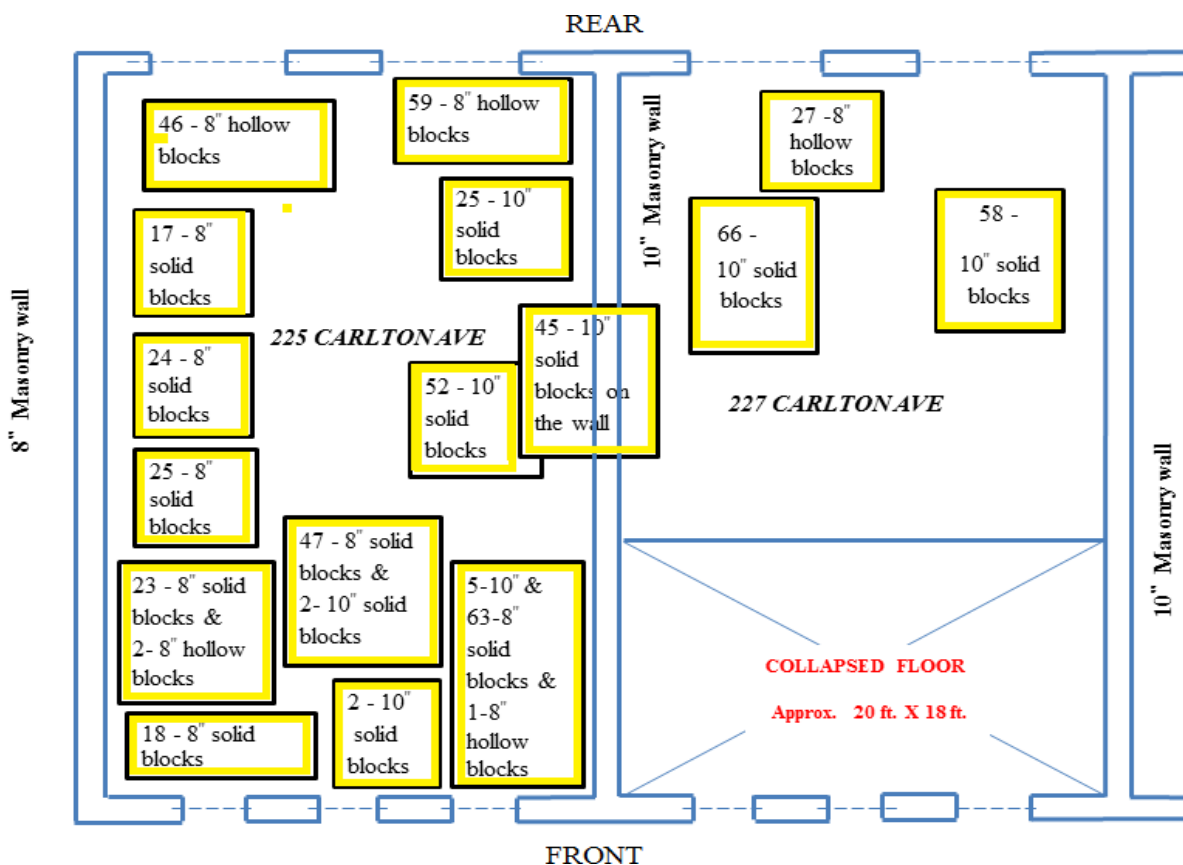
Post-incident observations indicated that the 4th floor deck of the adjoining unit # 225 had 10" solid, 8" solid and 8" hollow blocks piled at different locations. Some 10" solid blocks were also piled up on the incomplete party wall between units # 225 and 227. On the unfailed portion of the fourth floor deck of unit # 227, there were also 10" solid and 8" hollow blocks. Below is the tabulation of the blocks observed on the two 4th floor decks. Fig. 3 shows the approximate distribution of the masonry blocks on the two 4th floors as observed after the incident.

Fig. 3 Masonry blocks observed on the two 4th floors after the incident (Not to scale).

No pallets of cement bags or jumbo bags of sand were found on the 4th floor, either in unit # 225 or unit # 227. This would indicate that all the jumbo sand bags, three according to the majority of the eyewitnesses, and two pallets of cement bags, 10" solid blocks, 8" hollow blocks which were placed near the front of the 4th floor on unit # 227, and a concrete mixer fell with the collapsing floor.

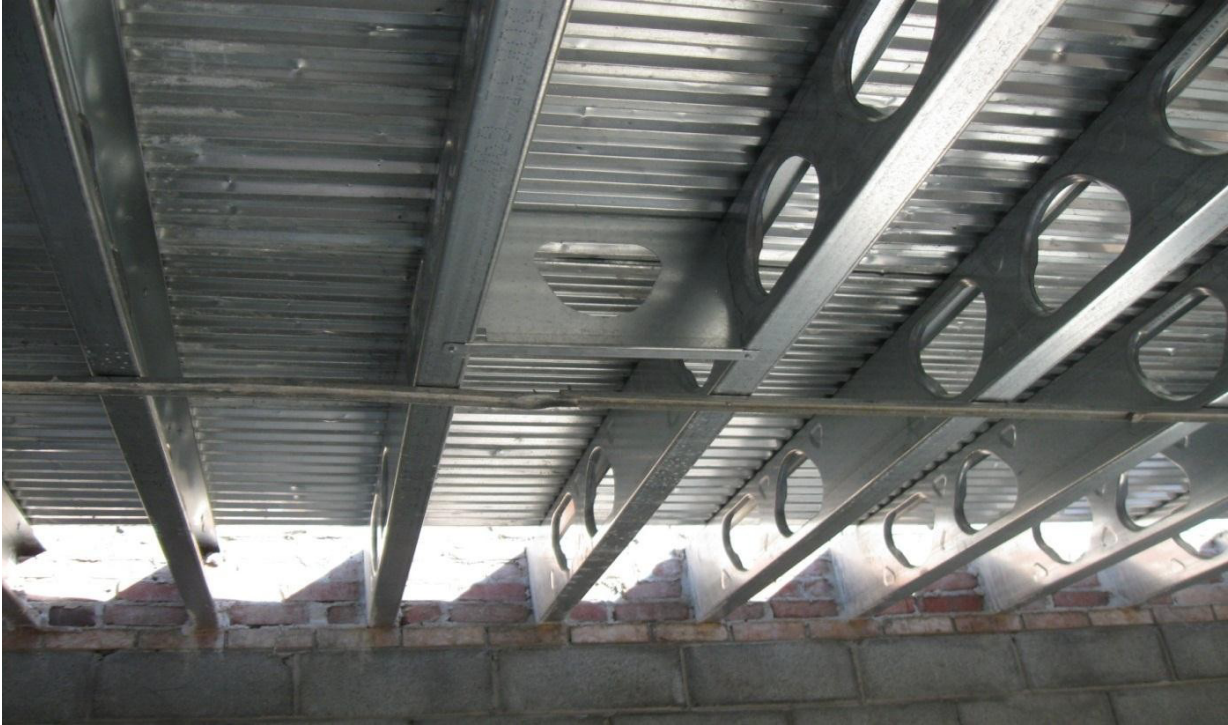
Post-incident observations indicated that there was no uniformity in the providing of lateral bracings to the floor joists. First, the temporary deck which could have provided lateral support to the joists was screwed to the top flange of the joists barely at few locations. Observations on the 4th floor and other floors indicated that the deck was screwed very sparingly, and, therefore, could not be relied upon to provide any lateral support to the floor joists. Second, there was a 2" wide steel strap screwed to the bottom flange of the joists at most locations. However, the top strap which was critical in providing lateral stability was not provided at most of the locations, see Fig. 4. Third, the blockings were provided only at the ends, but not at every 10' as required. Fourth, the straps which were provided at the bottom flange (see Fig. 5) were not spaced at 7' intervals, as required.

Fig. 4 Floor joists with no straps at the top flange.

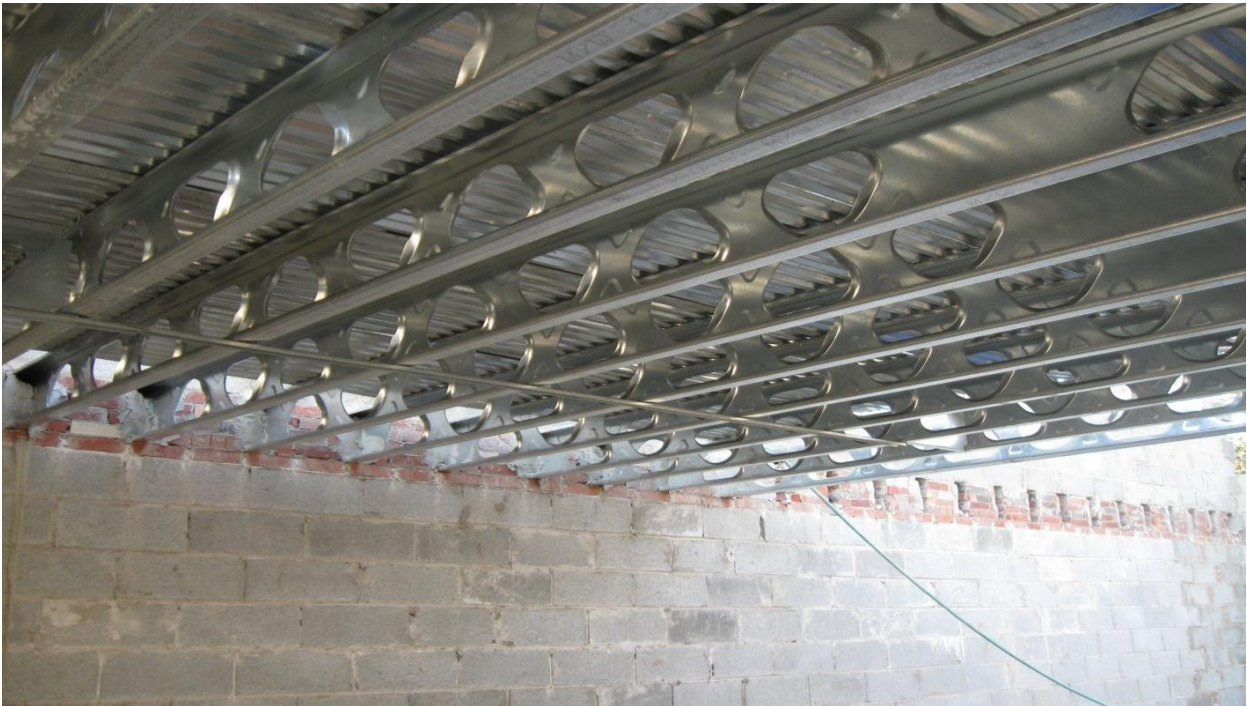
Fig. 5 Floor joists with straps only at the bottom flange.

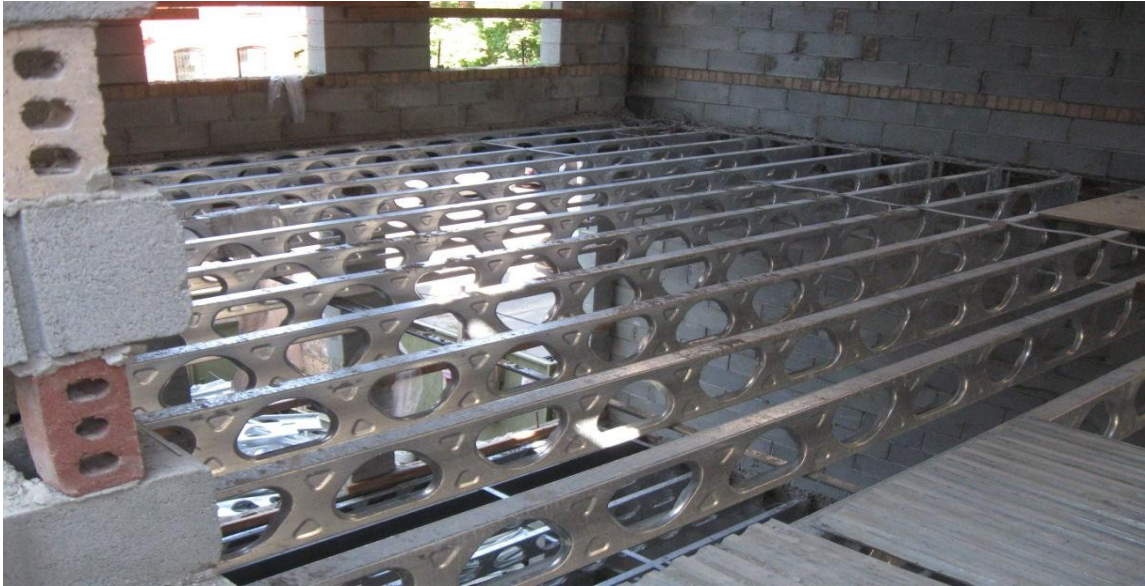
The cold-formed steel joists used to frame the floors of the building were 16-gauge JoistRite sections (Fig. 6 & Appendix) spaced at 16" o.c. (structural drawings S-002.01 to S-006.01 in Ref. 2). JoistRite is a cold-formed steel section manufactured by Marino WARE, see Appendix. The structural drawings called for plywood sheathings to be placed on the floor joists. The contractor, however, decided to place a temporary steel deck (see Fig. 7) on the floor joists during construction to avoid damaging the permanent plywood floor with construction materials.

Fig. 6 Floor joists spaced at 16" o/c.

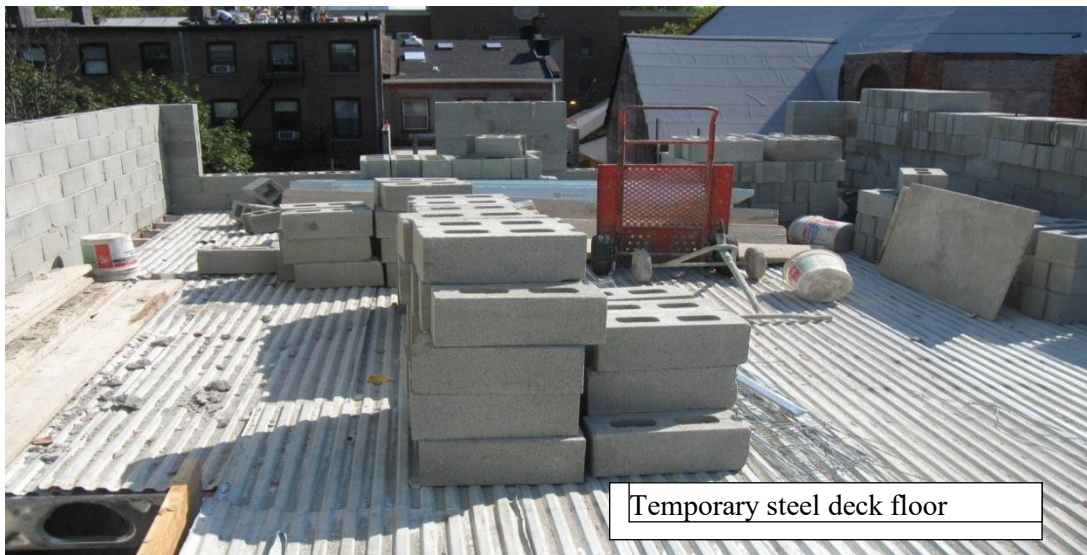
Fig. 7 Temporary steel deck on 225 Carlton Ave. supporting construction loads.

4. The contractor temporarily substituted steel deck for plywood but neither fastened it to the floor joists nor used 2" wide straps.

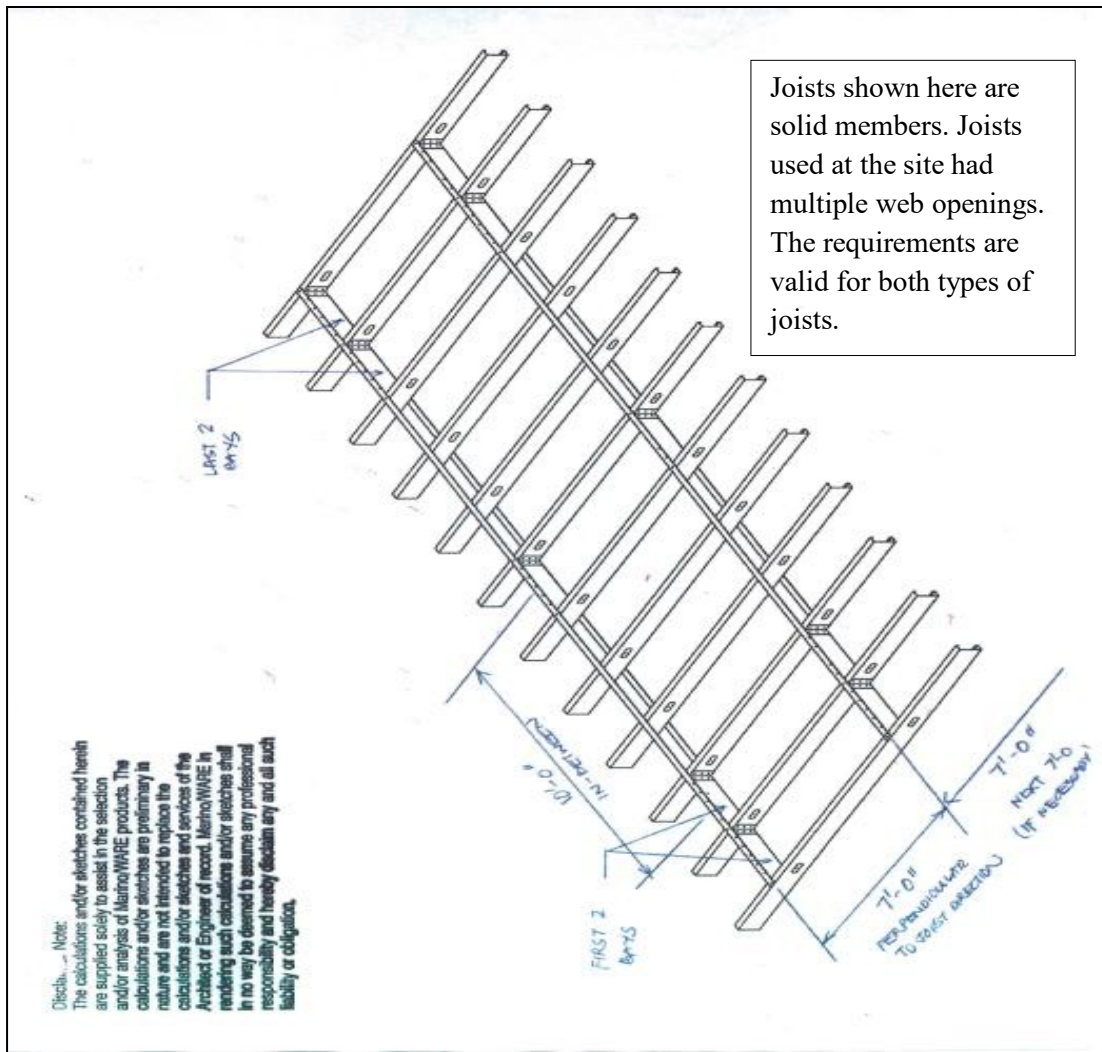
The technical guide specified, *“The compression flange of the section should be braced by the attachment of continuous diaphragm-rated sheathing or decking. The JoistRite blocking shall be located at first and second spaces, each end, and 10'-0" o.c. between and attached to joists through pre-drilled holes. Additionally, mechanical bridging shall be installed at intervals not to exceed 7'-0" on center. The installation of bridging shall be completed before loading the floor/roof system.”* (Italics ours). Fig. 8 shows the bridging/blocking requirements for floor joists by Marino WARE.

Fig. 8 Bridging/blocking requirements by Marino WARE - sketch provided by Marino WARE (Note the 7' requirements).

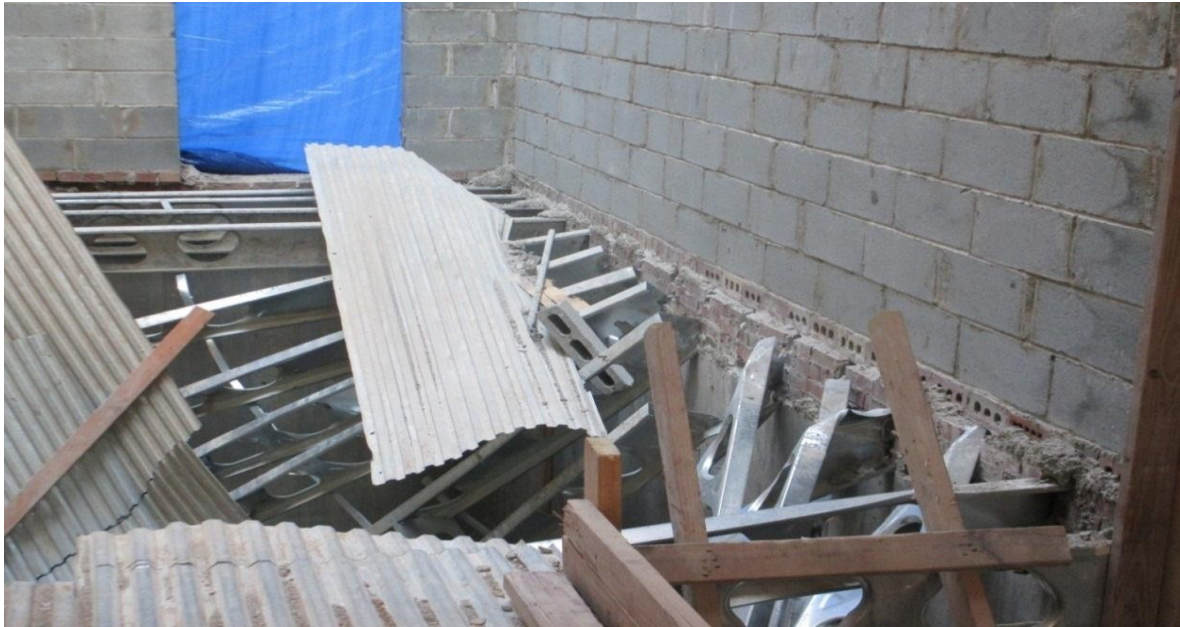
The 4th floor of unit #227 partially failed when construction loads (concrete blocks, bags of sand and masonry cement) were stacked up on the floor and collapsed on the 3rd floor creating a chain reaction on the floors below. All the floors ended up in the basement (cellar). Fig. 9 shows the area of the of the 4th floor unit #227 that collapsed due to construction loads.

Fig. 9 A partially collapsed 4th floor due to construction loads.
