Excavation Collapse

1. SUMMARY

On August 22, 2006, around 11:00 a.m., a more than 40 foot high, steep excavated slope suddenly collapsed. The collapsed earth deposits buried a nearby excavator and killed the operator inside the cab. The excavator was cleaning the base of the slope when the incident occurred.

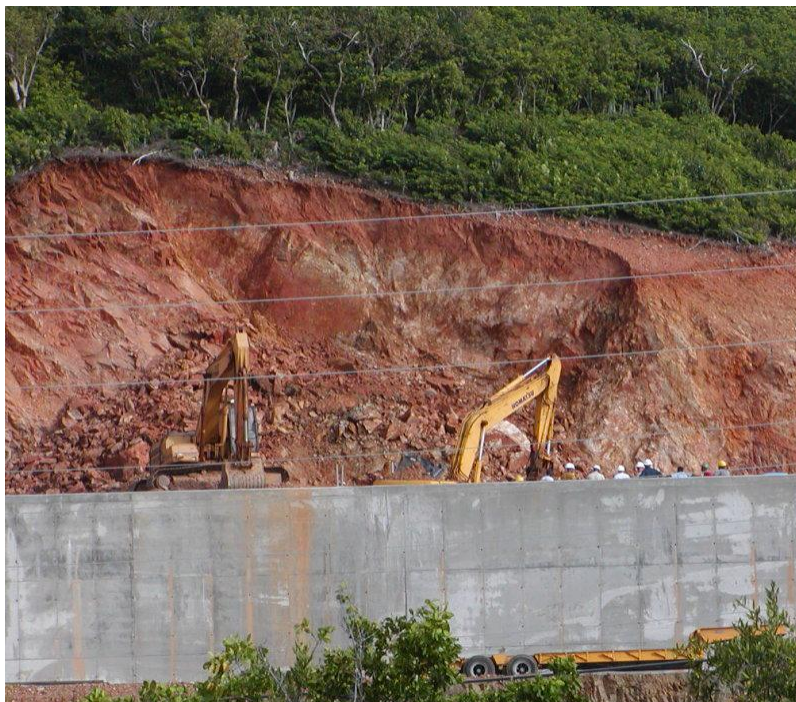
The figure on the cover of this report presents the overall shape of the collapse. As shown, the collapse was in a near circular or spoon shape. Based on references presented in Figures 23 and 24, a collapse of this shape would mostly occur in overburden soil, weathered rock, waste rock or heavily fractured rock. Therefore, the earth deposits in the collapsed area could only be residual soil, weathered rock or heavily fractured rock. They were more soil-like than rock-like deposits.

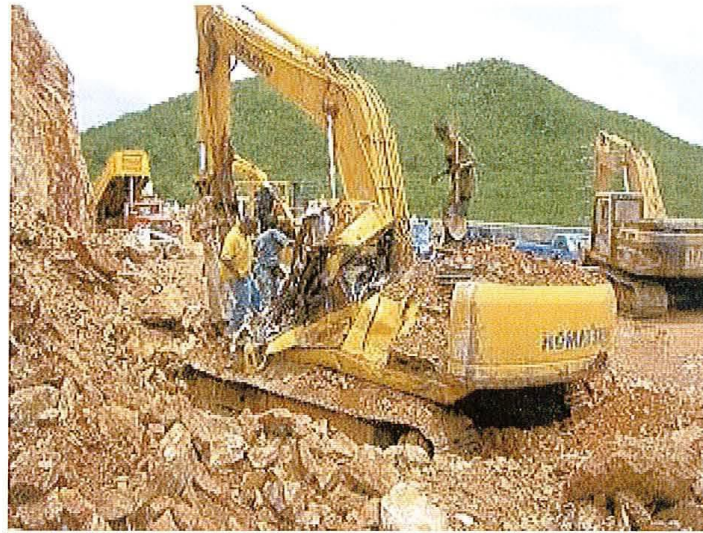
Figure 5. Location of the Komatsu PC 220 Excavator during the Rescue Operation, Looking Toward North (Provided by GEC, LLC.).

Around 11:00 a.m., the over 40 foot high, steep excavated slope suddenly collapsed. The collapsed earth crushed the cab side of the excavator and then buried it entirely (Figures 5 and 6). As a result of the collapse, the employee inside the cab was killed. At the time of the incident, the excavator was breaking the base of the excavated slope.

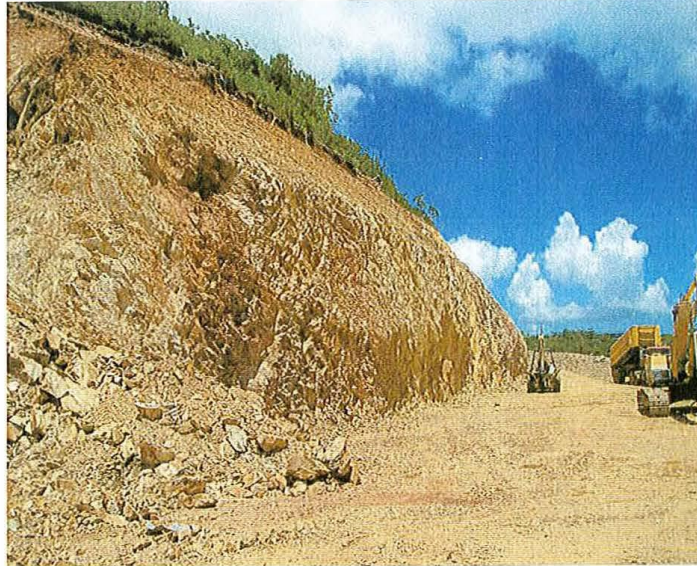
Photographs of the excavated and collapsed surfaces were examined from north to south. Figure 13 represents the excavated surface north of the collapse. As discussed, the exposed surface appeared to be heavily fractured rocks with indentations and over breaks caused by the hydraulic breaker during the excavation. Figures 14 and 15 represent the lower portion of the collapsed surface at its north end. They indicate similar heavily fractured rocks with two large cavities caused either by the excavation over breaks or the collapse.

Figure 15. Another View of Figure 15, Looking Toward Northwest.

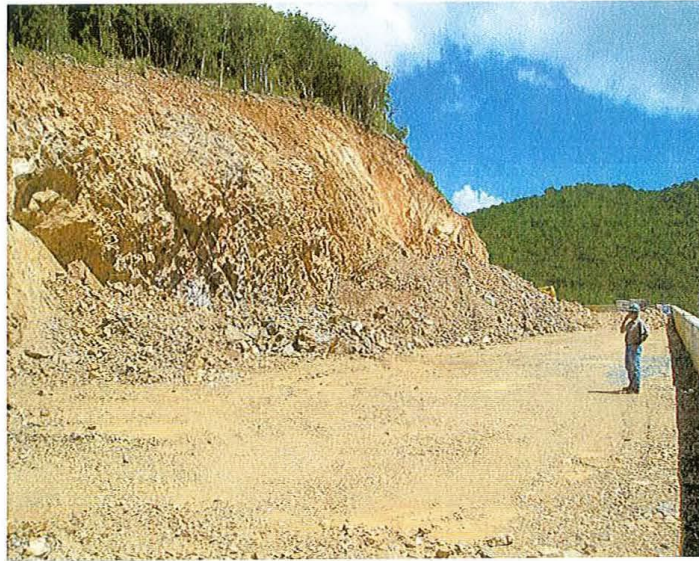
Figures 21 and 22 represent the identifiable rock slabs in the excavated surface south of the collapsed area. However, this rock structure only occurred in less than 10% of the 500 foot long excavation.

Figure 21. Identifiable Rock Slabs in the Excavation Face South of the Collapsed Area, Looking Toward Northwest.

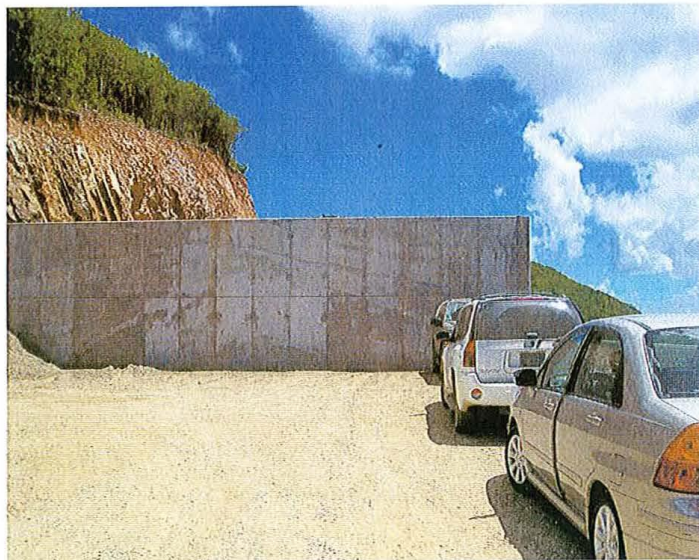
Figure 22. Another Identifiable Rock Slabs in the Excavation Face Further South of the Collapsed Area, Looking Toward North.
