Investigation of the Failures of Three Hammerhead Cranes on September 10, 2017, in Miami and Fort Lauderdale in the Wake of Hurricane Irma

U.S. Department of Labor
Occupational Safety and Health Administration
Directorate of Construction

September 2018

**Report Prepared by
Mohammad Ayub, P.E., S.E.
Alan Lu, Ph.D., P.E.
Office of Engineering Services
Directorate of Construction**

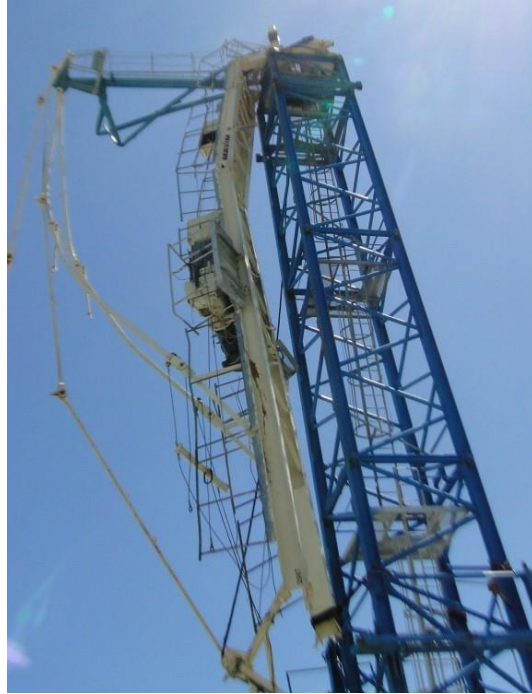
Figure 9 Tower top and counterjib after the incident – the first failure

The failure occurred at approximately 10 a.m. The counterjibs rotated 90 degrees and were hanging upright, though still connected to the turntable. The pendants remained connected to the counterjibs at both locations. The tower top structure also bent 90 degrees toward the counterjib. The two tower-top columns on the counterjib side buckled at approximately mid-height between the top pin and the brace. The jib came off the pinned connection, flipping 270 degrees, and fell over the completed structure with a 90-degree bend where the A-frame (a.k.a. queen post) was located. The last pin of the pendant connecting to the top chord of the jib, and the last pin of the other pendant connecting the A-frame, were opened as the cotter pin loosened. All five pieces of the counterweight fell over the interior of the building, damaging the already-completed floor slab; none fell outside the perimeter of the building. The engineer of record examined the building and

recommended repairs to the slabs. Refer to Figure 9 for the collapsed crane tower top after the failure.

Later, the remnants of the failed crane were examined at the storage yard in Orlando on December 12 and 13, 2017 by the OES structural engineers. Interestingly the inspection indicated similar failure where the tubular frame of the tower on the counterjib side failed at about the same location. All three failures were identical, see Figures 9, 12 and 15.

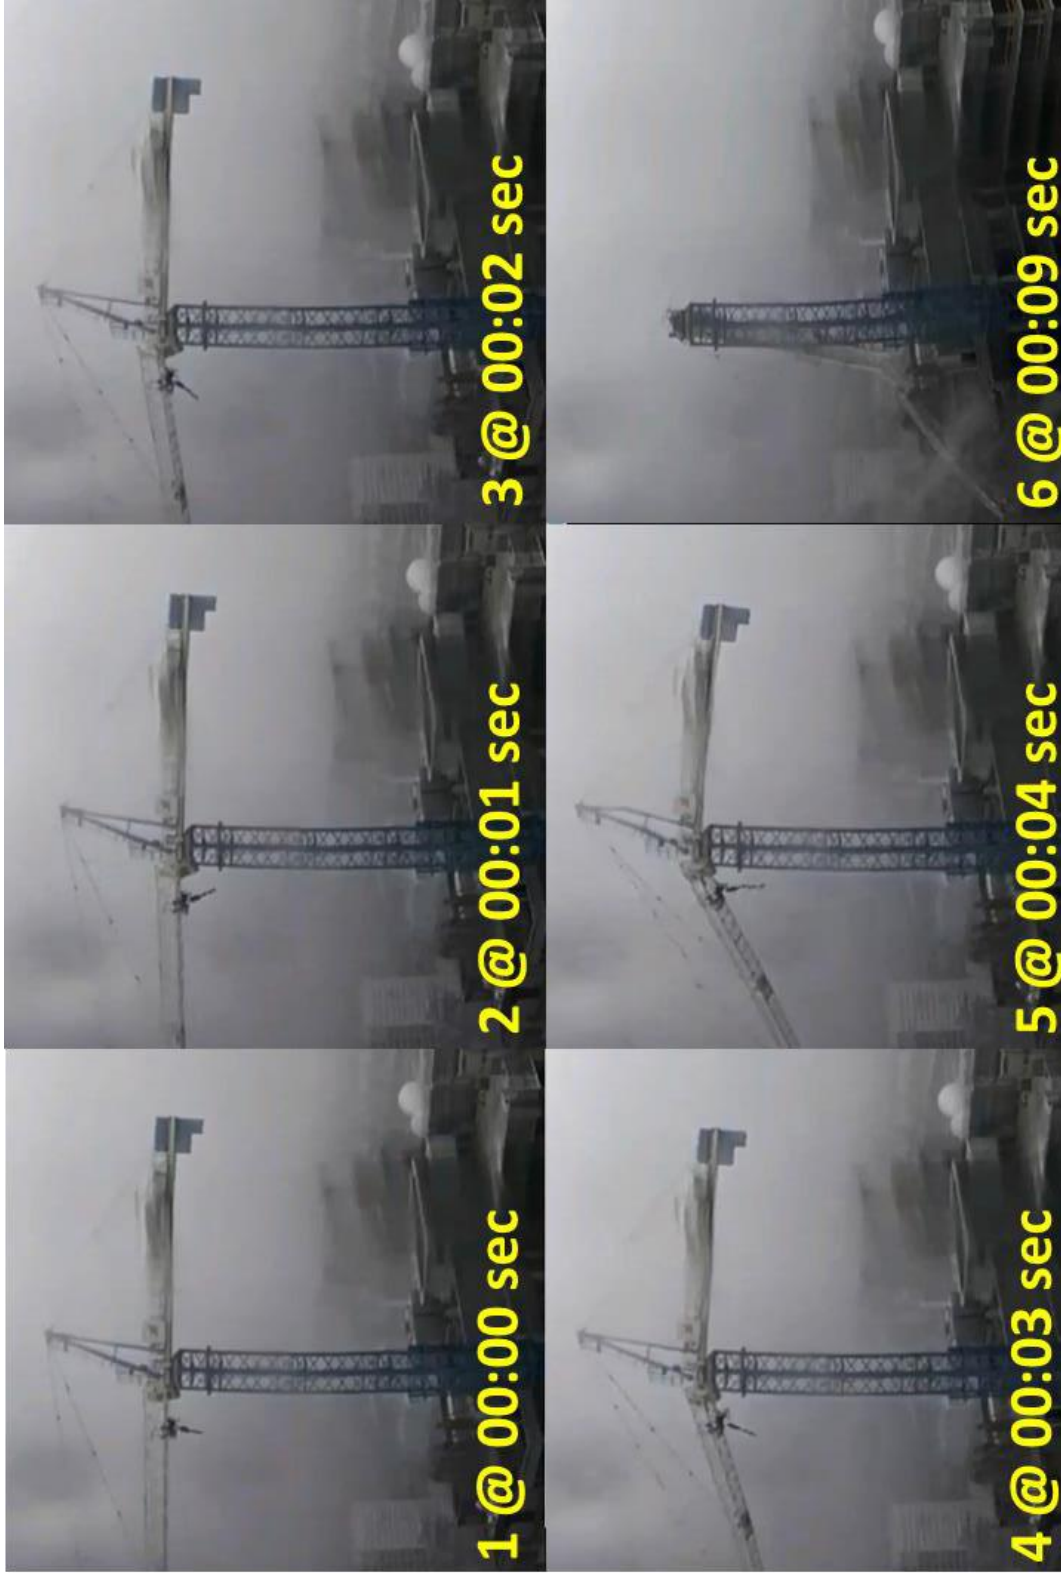
Figure 10 Image sequence showing the crane collapse
(Courtesy of Nick Tangredi)

A YouTube video was later discovered that showed how the collapse occurred (see Figure 10 for pictures extracted from the video footage). It was discovered that the jib itself swayed toward the right, and the left bottom jib chord detached from the turntable. As the jib continued swaying toward the right, the right bottom jib chord separated suddenly from the turntable and the jib started falling. During the fall of the jib, the two jib pendants were unloaded. The tower top changed in seconds from being loaded from both sides to being loaded only from the counterjib side. Then the two tower top columns, swaying toward the counterjib, failed under the change of the transient load.

1. Jib started to sway to the right, and the left jib bottom chord detached from the turntable;
2. Jib kept swaying to the right, and the jib knocked the cabin;
3. Jib kept swaying to the right, and the counterjib started shaking;
4. Jib kept swaying to the right, and the right jib bottom chord detached from the jib foot. Therefore, the entire jib was no longer mounted to the turntable;
5. Jib fell, and the two jib pendants were not loaded. The tower top was loaded from the counterjib pendants only. The two tower top columns, swaying toward the counterjib side, buckled; and
6. The tower crane collapsed.

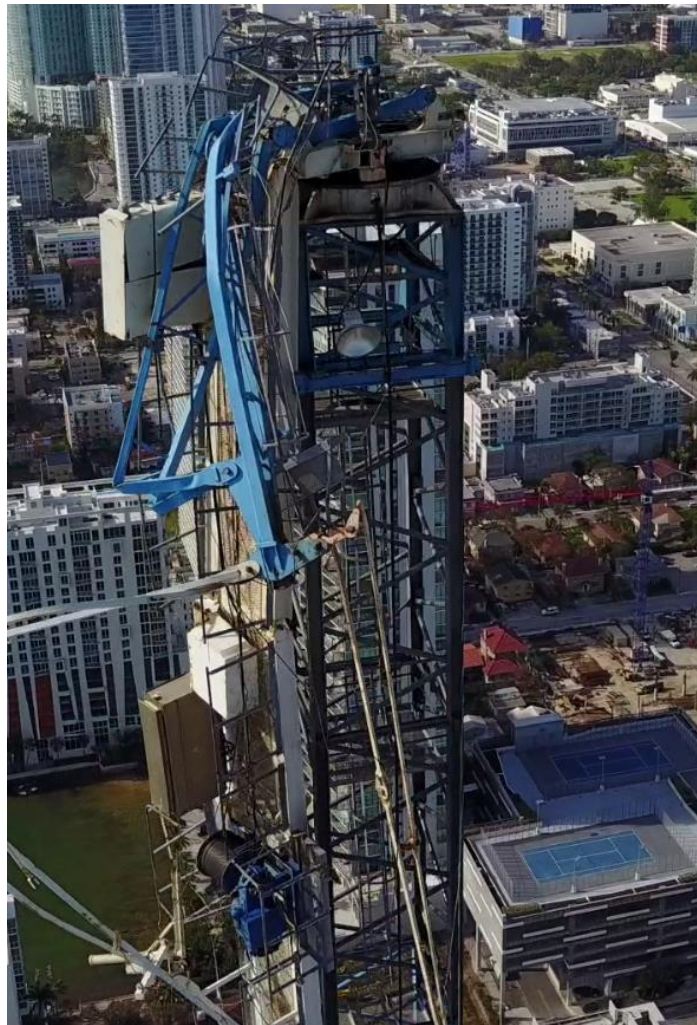
Figure 12 Tower top and counterjib after the incident – the second failure site

The failure of the tower top occurred in a manner similar to the first failure. The counterjib beams rotated 90 degrees and were hanging straight down by the side of the crane mast. The tower also rotated approximately 90 degrees. Again the tubular columns on the side of the counterjib buckled very distinctly between the top pin and the solitary brace about the major axis. All four counterweight pieces fell on the street below piercing the pavement. The City of Miami had ordered an evacuation of adjoining apartments and condos. The street was therefore deserted, and there were no injuries. The jib came off its pinned bearing connection and was bent in a V-shape at the location of the A-frame. During the failure, all pendants remained connected to the jib, and all pins interconnecting the pendants remained intact. A photograph of the crane tower top taken after the crane collapse is shown in Figure 12.

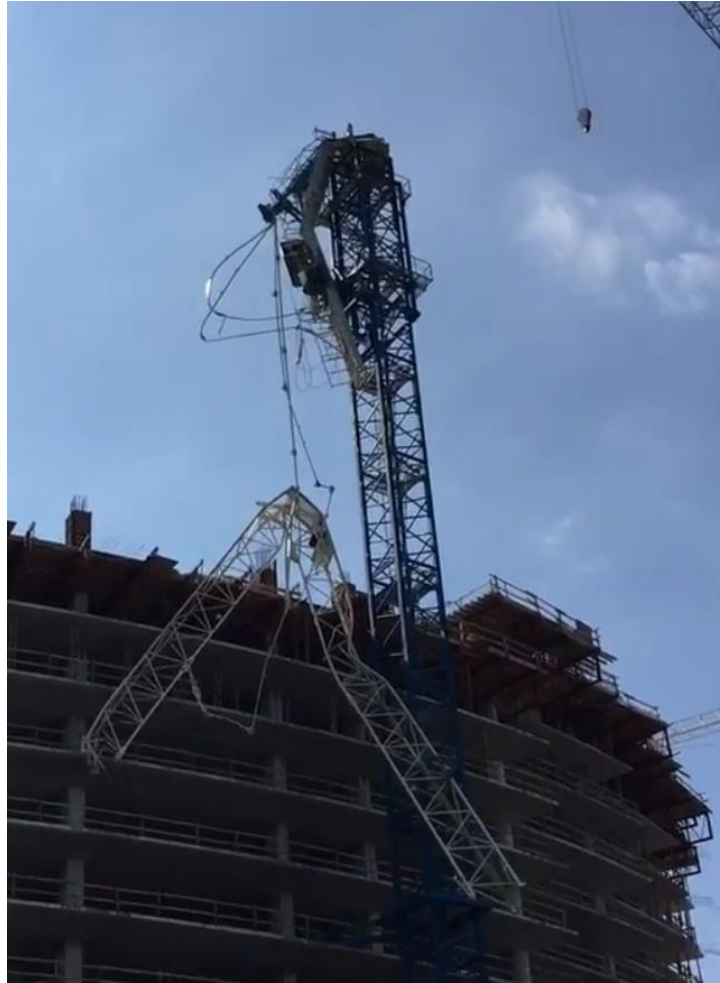
Figure 15 Collapsed crane after the incident – the third failure site

The failure of the tower top occurred in a manner similar to the first two failures. The counterjib beams rotated 90 degrees and were hanging straight down by the side of the crane mast. The tower also rotated approximately 90 degrees. Again the tower top columns toward the counterjib buckled very distinctly between the top pin and the solitary brace about the major axis. All four counterweight pieces fell, but there were no injuries. The jib came off its pinned bearing connections and was bent in a V-shape at the location of the A-frame. During the failure, all pendants remained connected to the jib, and all pins interconnecting the pendants remained intact. A photograph of the crane tower top taken after the crane collapse is shown in Figure 15.

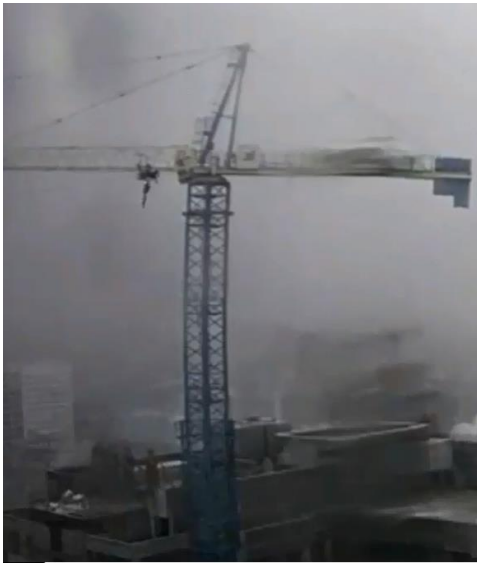
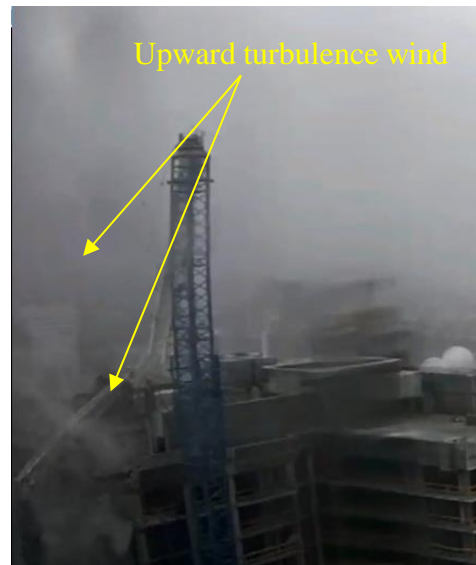
Figure 19 Upward turbulence wind detected when the crane collapsed at the first failure site (Courtesy of Mr. Nick Tangredi)

a) Jib jumped off the left bearing connection

b) Upward turbulence wind detected right after counterweight blocks hit the building

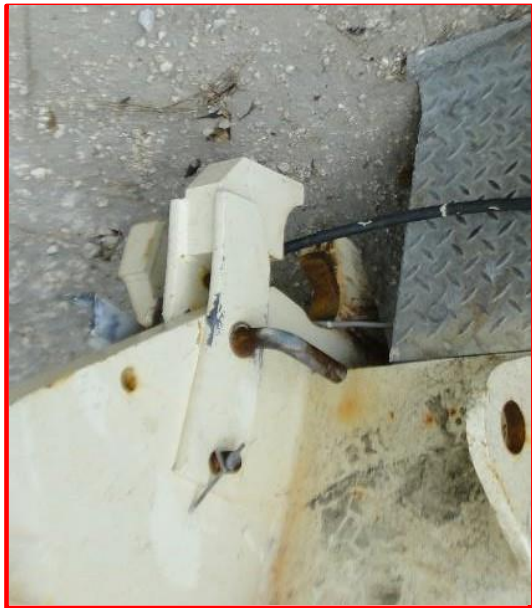
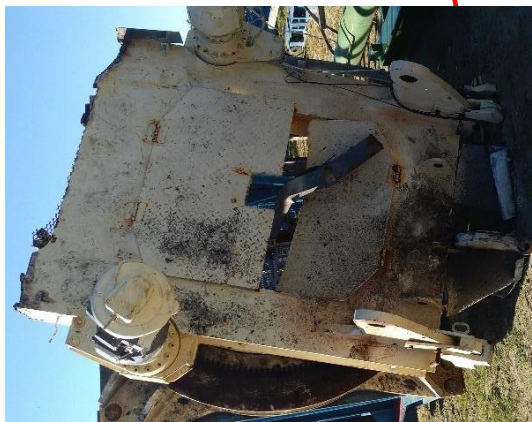
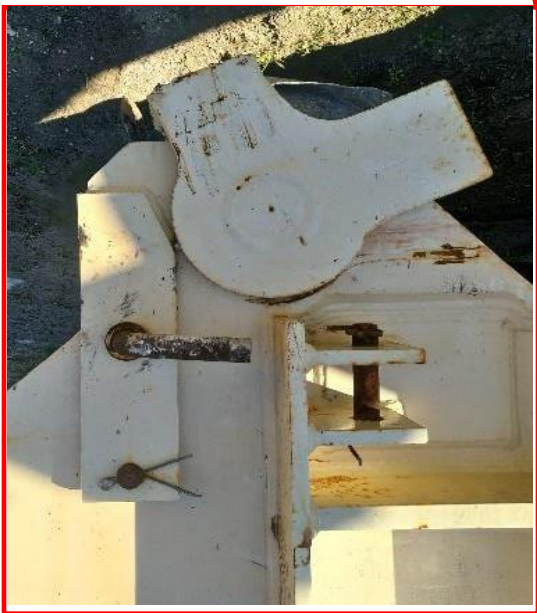
Figure 28 Jib foot bearing connections – turntable side (the first failure)

The right bearing cradle and the right clamp remained intact. However, the right bottom jib chord broke at the weld between the bottom chord tube and the end plate, as shown in Figure 30. The field structural observation is consistent with the collapse of the crane shown in Figure 10. The left jib bottom chord detached from the left turntable cradle because the jib swayed to the right. Once the jib separated from the left turntable cradle, the jib was only supported at the right turntable cradle and the two jib pendants. As the jib continued rotating to the right, the right bottom chord foot broke at the weld between the tube and the end plate, and the jib started falling.

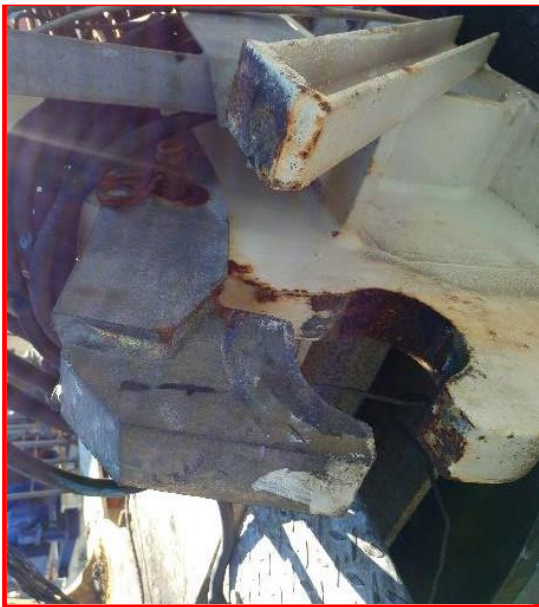
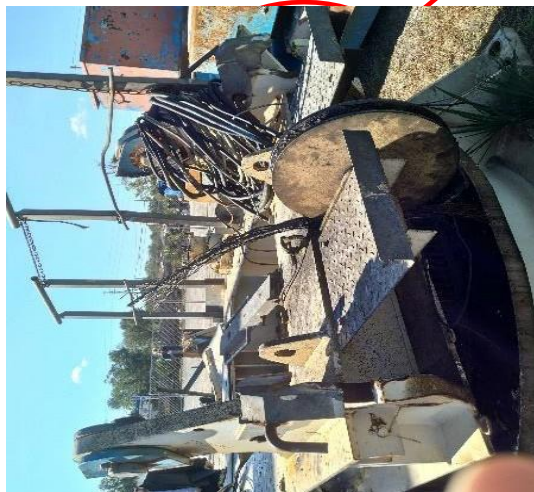
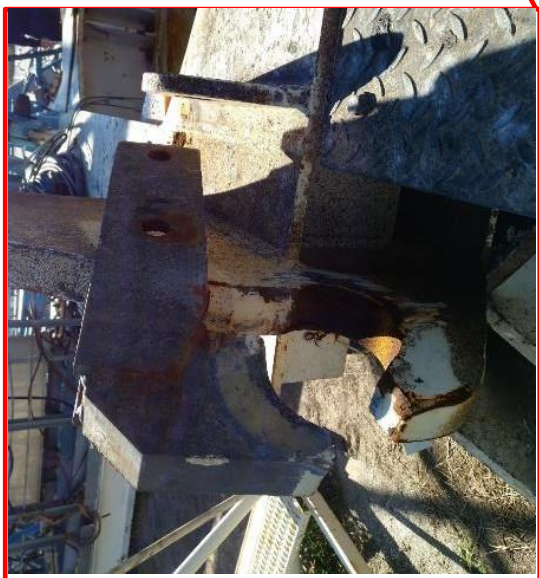
Figure 31 Jib foot bearing connections – turntable side (the second failure)

The front part of the turntable, including the two bracket cradles, is shown in Figure 31. The two jib bottom chord foots after the collapse are shown in Figure 32. It was observed in Figure 32 that the clamp of the left cradle bent vertically and meanwhile, the left bottom jib chord foot remained intact. The clamp of the right cradle bent upward and to the right, while the right bottom jib chord foot, including the end bracket, bent to the right, as shown in Figure 32. The field structural observation indicated that the left jib bottom chord detached from the left turntable cradle because the jib rotated to the right. As the jib continued rotating to the right, the right bracket cradle and the right bottom chord bent to the right till the right bottom chord detached from the right bracket cradle. Per the field observations of the damaged structures the failure modes of the first two cranes' jibs are identical.

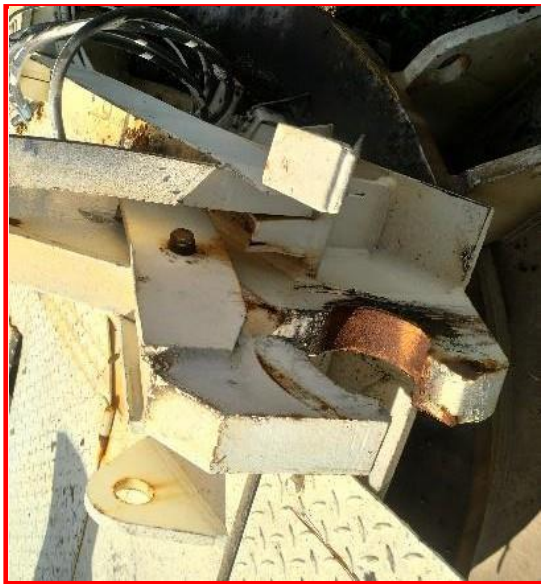
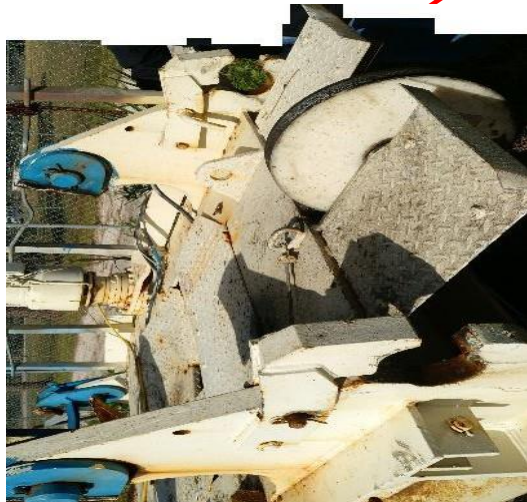
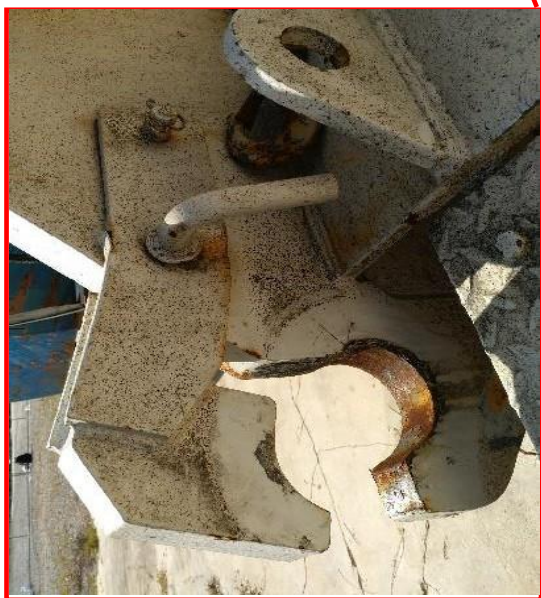
Figure 33 Jib foot bearing connections – turntable side (the third failure)

The front part of the turntable, including the two bracket cradles, is shown in Figures 33, 34, and 35. The two jib bottom chord feet after the collapse are shown in Figure 36. It was observed in Figures 33 to 35 that the clamp of the right cradle bent vertically and, meanwhile, the right bottom jib chord foot remained intact. The clamp of the left cradle bent upward and to the left, while the left bottom jib chord foot remained intact, as shown in Figure 36. The field structural observation indicated that the right jib bottom chord detached from the right turntable cradle first because the jib rotated to the left. As the jib continued rotating to the left, the left bracket cradle bent to the left until the left bottom chord detached from the left bracket cradle. According to field observations of the broken structures, the failure modes of the three cranes' jibs are similar.

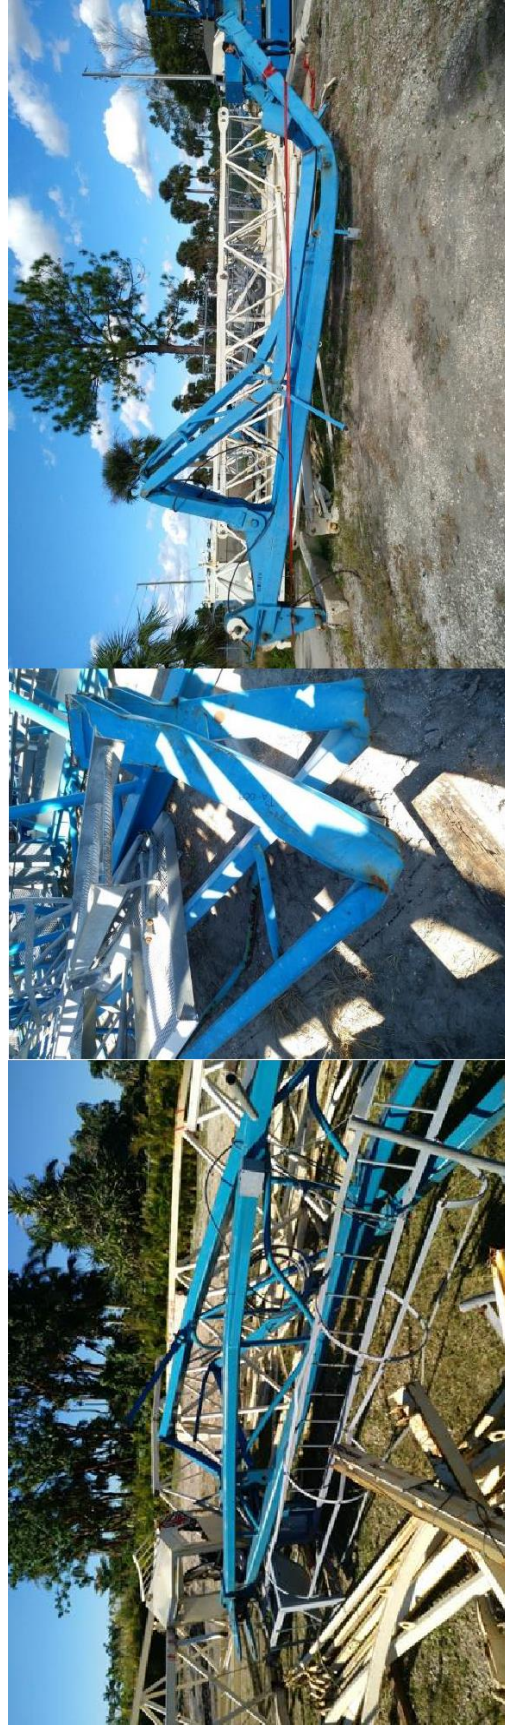
Figure 37 shows the collapsed tower tops from the three failures. All three tower structures bent 90 degrees toward the counterjib. The two tower top columns toward the counterjib bent at approximately mid-height between the top pin and the brace. Considering the crane tower failure of the first incident as shown in Figure 10, it is believed that the tension forces at the tower apex from the two jib pendants disappeared suddenly due to the falling of the jib, and the tower was only loaded from the counterjib pendants. Therefore, compression forces in the two columns on the counterjib side were elevated rapidly, and the two columns failed under the transient forces.

10. To prevent catastrophic collapses of the crane tower top in the future, it is recommended that tower tops be evaluated and designed with a higher safety margin, and the design should also be based with loads applied from only the counterjib.

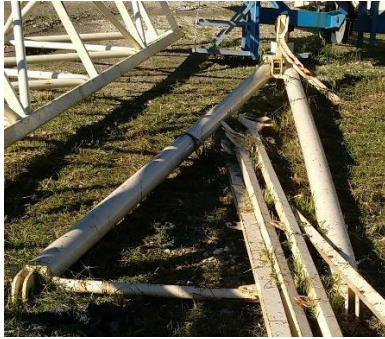
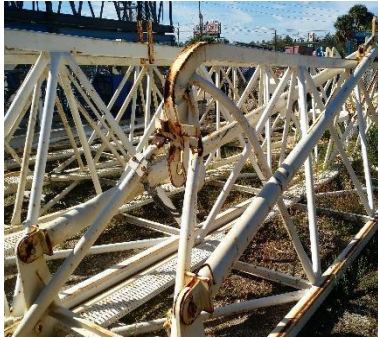
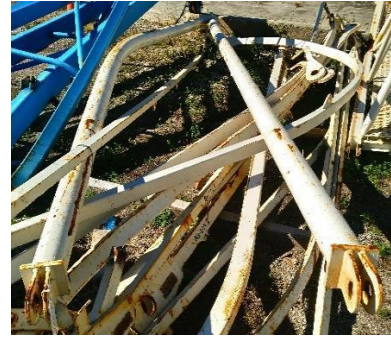
The A-frames of the cranes involved in the first two failures remained intact after the collapses. The two posts of the A-frames remained straight after the collapses, and no bend in the posts could be detected. The A-frame of the crane involved in the third failure was found deformed: the right hand post bent at about the mid-height. It is not clear if the post bent when the jib was falling.

11. The jibs in all three cranes were suspended by single pendants. In the event that the jib begins to sway to the sides, the single pendants could not be expected to secure the stability of the jib. It is, therefore, recommended that two symmetric pendants or cables be considered in the design of the tower cranes. Terex should consider adding pendants to the existing SK-315 models.
12. Although the National Hurricane Centre issued warnings to the residents in South Florida that heavy Squalls with embedded tornadoes were sweeping across South Florida, no tornadoes formed at any of three failure sites on September 10, 2017. However, localized high-altitude strong vortexes cannot be ruled out.
