# Fire during Hot Work at Evergreen Packaging Paper Mill

# Investigation Report

Published: September 24, 2021

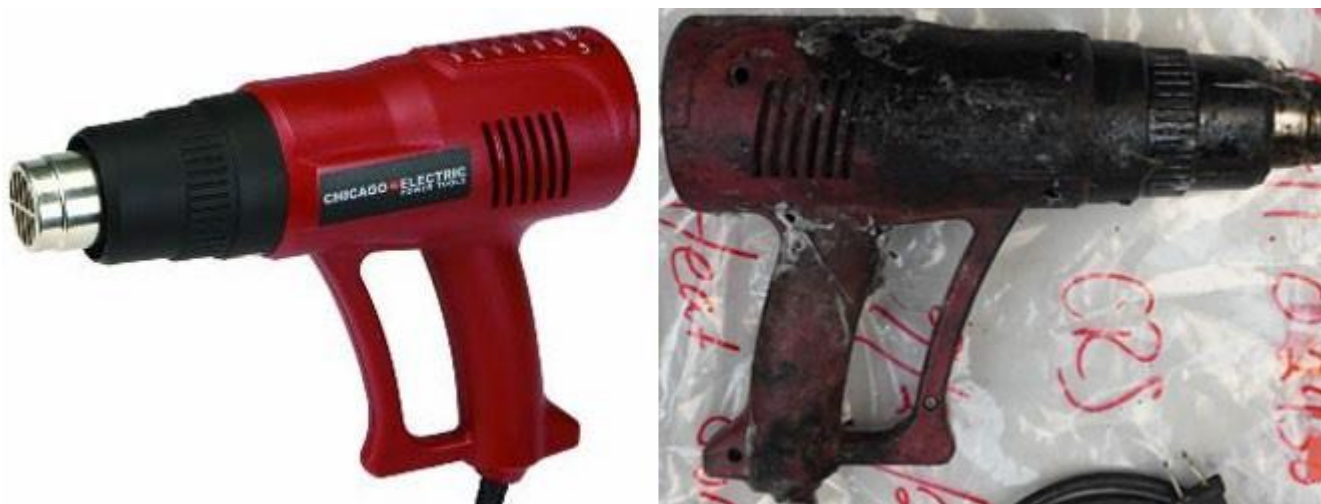
- **Hot Work Safety.** The electric heat gun used to warm the flammable resin could achieve temperatures in excess of the resin's flash point and auto-ignition temperatures. The electric heat gun came into direct physical contact with the flammable resin when it fell into the resin bucket. Blastco did not recognize the ignition hazard presented by the use of the heat gun, did not inform Evergreen or Rimcor of the heat gun's use, and did not take adequate action to prevent the introduction of ignition sources into a confined space containing flammable liquids. In addition, while Evergreen's internal policies defined hot work as "any activity that could serve as a source of ignition," Evergreen's contractor orientation materials limited the hot work definition to only "burning, cutting, brazing or welding." ([Section 3.1](#)).

**Figure 4.** Exemplar heat gun (left). Heat gun recovered from scene (right). (Credit: Harbor Freight [6], CSB.)

The CSB recommends to Blastco to update its hot work policy and employee training program to specifically identify the use of heat guns as hot work. The policy and programs should make clear that hot work encompasses any method of work that can ignite a fire and not just spark- or flame-producing work methods.

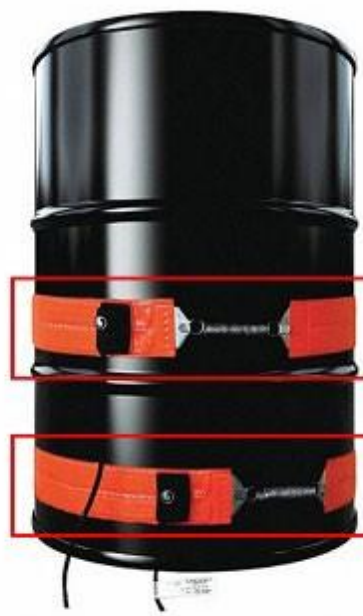
**Figure 7.** Drum heaters. (Credit: Grainger [18].)

Blastco performed a post-incident inventory of its two job trailers and located two drum warmers. According to Blastco, the two drum heaters were located separately, one on each trailer. According to an employee, the company had recently begun renovating and reorganizing one of the trailers but was not yet finished at the time Blastco's work at Evergreen started. The employee stated that when he went to locate the heat bands on the night of the incident, the bands were not in their normal location and he could not locate them on the trailers.

As discussed in Sections 1.8 and 2.2, Blastco workers attempted several alternatives to hot work. According to Blastco, the company had two drum heating bands available at the time of the incident. However, the two heaters were stored separately on Blastco’s two job

The CSB concludes that effective pre-job planning, such as taking into account the potential for poor performance of the resin in cold temperatures and identifying solutions to avoid or correct the problem, could have prevented this incident. The CSB also concludes that to assist with pre-job planning efforts, a Blastco troubleshooting guide or standard operating procedure addressing resin gel time could prevent a similar incident in the future. The CSB recommends that Blastco develop a formalized troubleshooting guide and/or standard operating procedure for the usage of resin and fiberglass matting in FRP operations. The procedure should direct employees on acceptable means of addressing cold-weather resin performance.

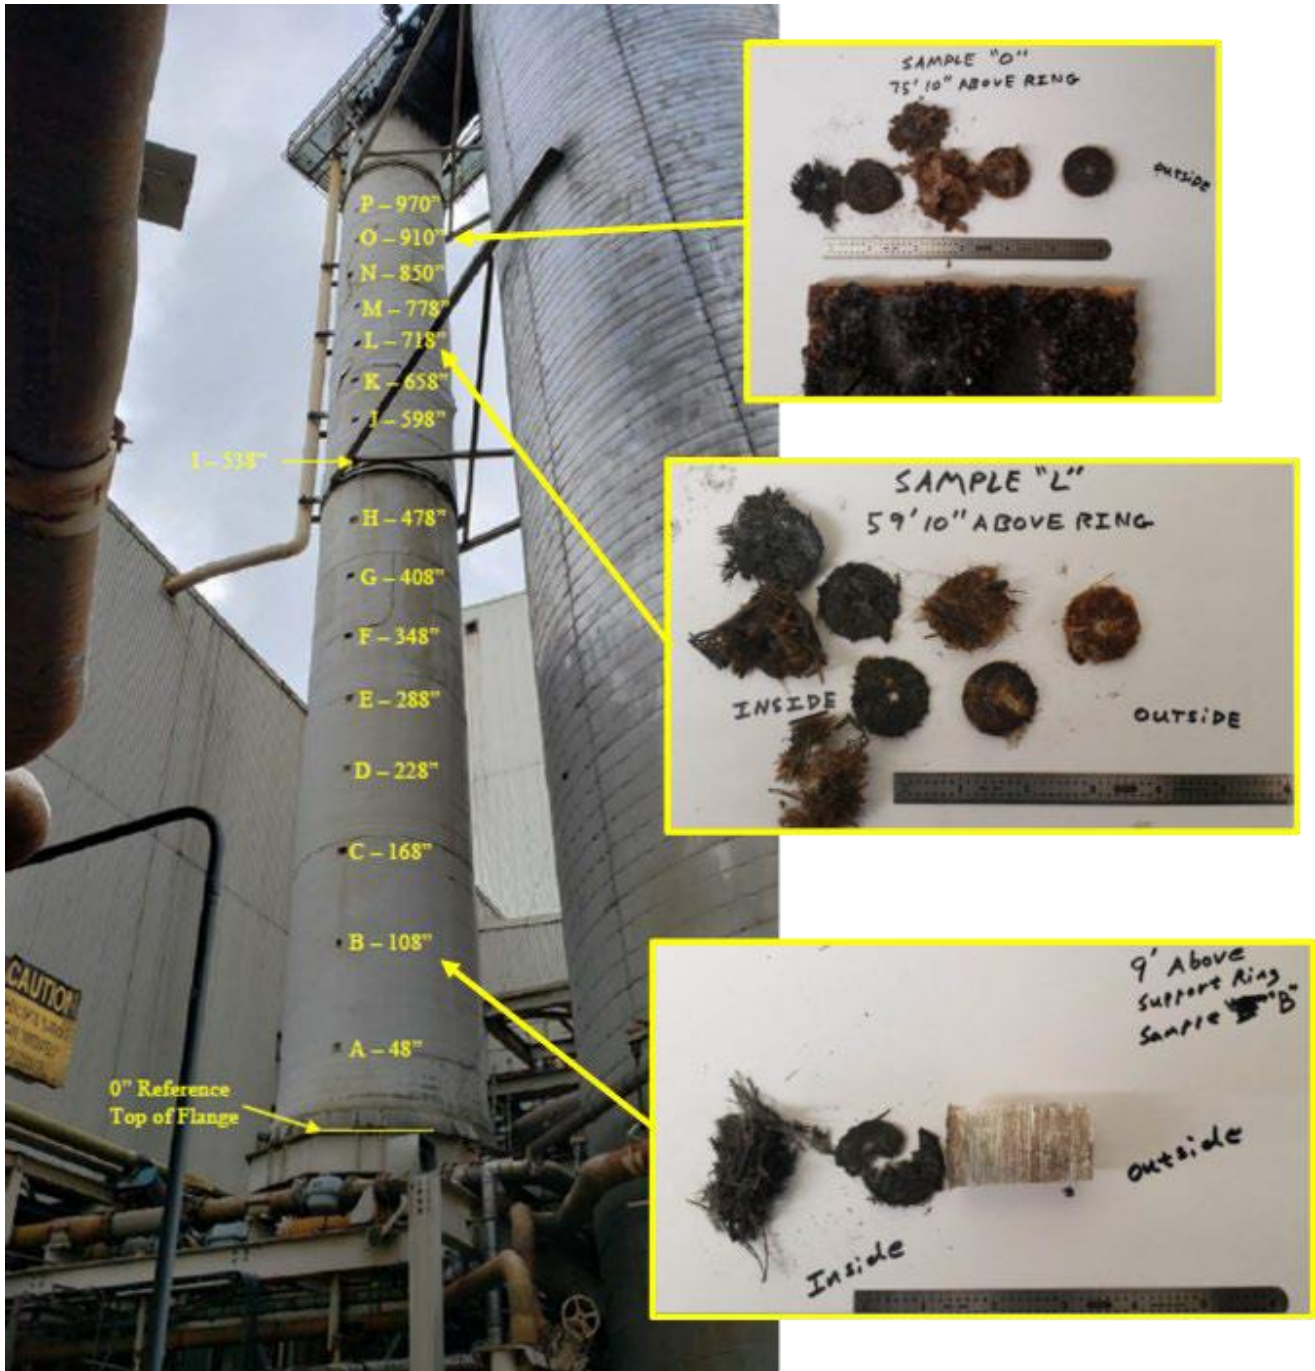
OSHA defines noncombustible materials as those materials which are not capable of burning or igniting. Since FRP is capable of burning in the presence of a flame, OSHA considers such material to be combustible[.] [9]

In order to determine the extent of the fire-induced damage sustained during the incident inside the upflow tower, 16 one- to two-inch circular core samples were removed from the side of the vessel (**Figure 10**). Blastco was working inside the tower from roughly the heights of sample "D" to sample "I." In the figure, the apostrophe symbol (') is used to notate feet and the quotation symbol (") is used to notate inches. During post-incident examination of the upflow tower, burn damage was found on the inside surface of the vessel's insulation near the top of the vessel.<sup>a</sup>

Figure 10. Internal fire damage in the upflow tower. (Credit: Evergreen. Edited by CSB.)
