Masonry Wall Collapse

The Division of Occupational Safety and Health of the State of Tennessee requested the Directorate of Construction, OSHA National Office, to provide assistance in the investigation and causal determination of the April 18, 2013 collapse of a masonry wall during construction of the Goodwill Retail Store in Hendersonville, TN. As a result of the wall collapse, two employees were killed and one was injured. Our investigation and evaluation were based on the information provided by the Division of Occupational Safety and Health of the State of Tennessee. Please note that we did not visit the incident site.

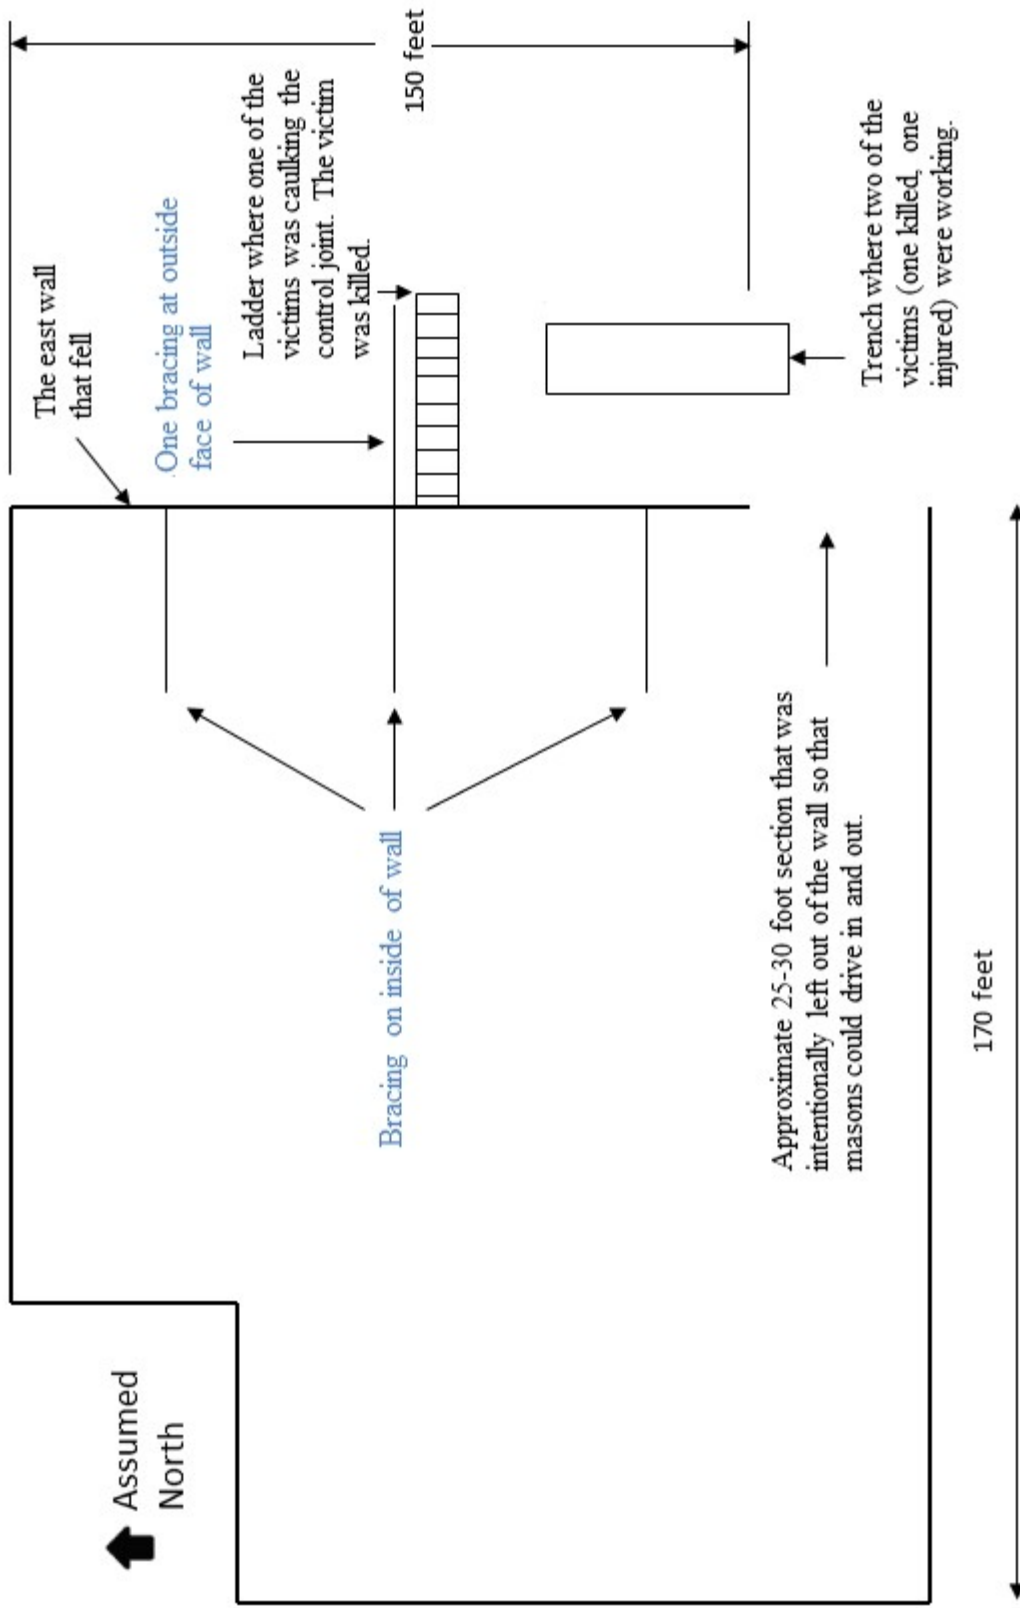
Figure 7 _ Schematic CMU wall plan showing bracing location at east wall

A few days prior to the collapse, all three exterior braces on the north, south and west walls were removed but on the east wall only two exterior braces were removed. The middle exterior brace was left intact on the east wall that fell (see figure 7).

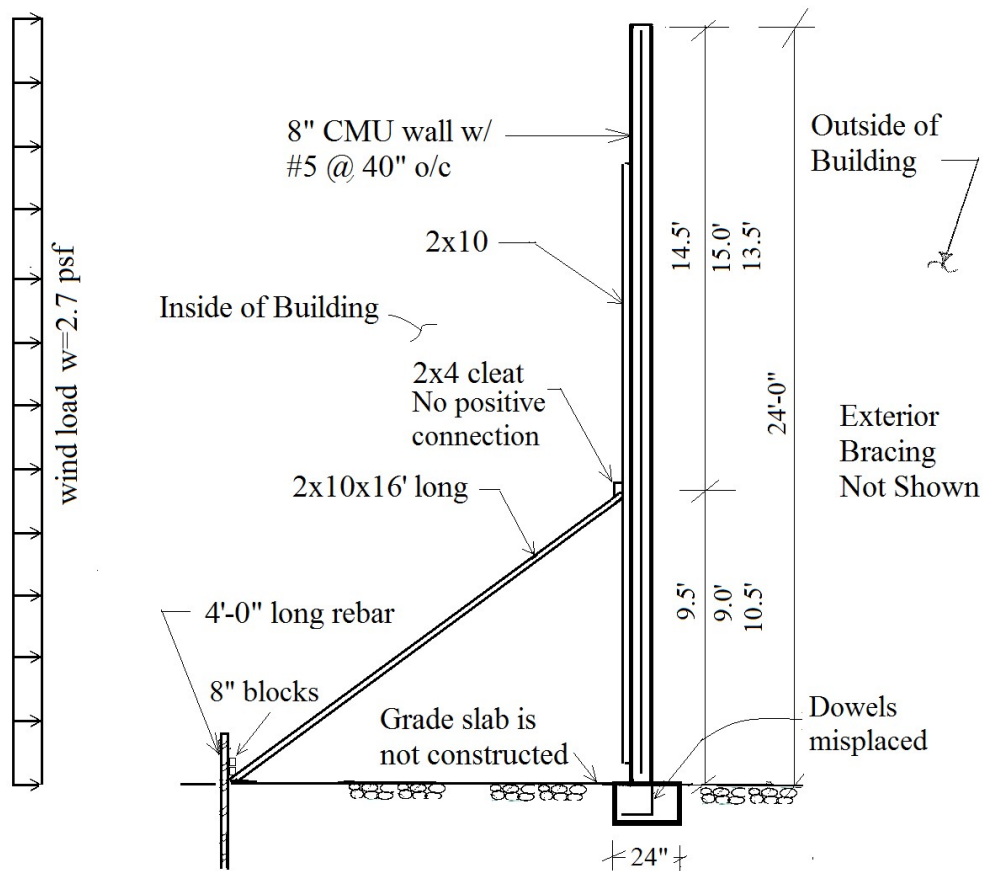
Figure 8 – Section showing interior as-built bracing at east wall

For the installation of the bracing, the contractor installed 2x10 vertical members abutting to the face of the walls (see Figure 8).

5. Based on architectural drawings, vertical control joint at the east wall was considered at 25'-0" on center (see Figure 5).
6. Three interior bracings and one exterior bracing at the east wall were considered to resist the wind loads. For calculation purposes, the top of the brace was considered to be 9'-0" above the top of the footing, and the bottom of the brace was assumed to be supported at the ground level. The CMU wall's upper height of 15' above the top of the brace was considered as a free-standing wall (see Figure 8).

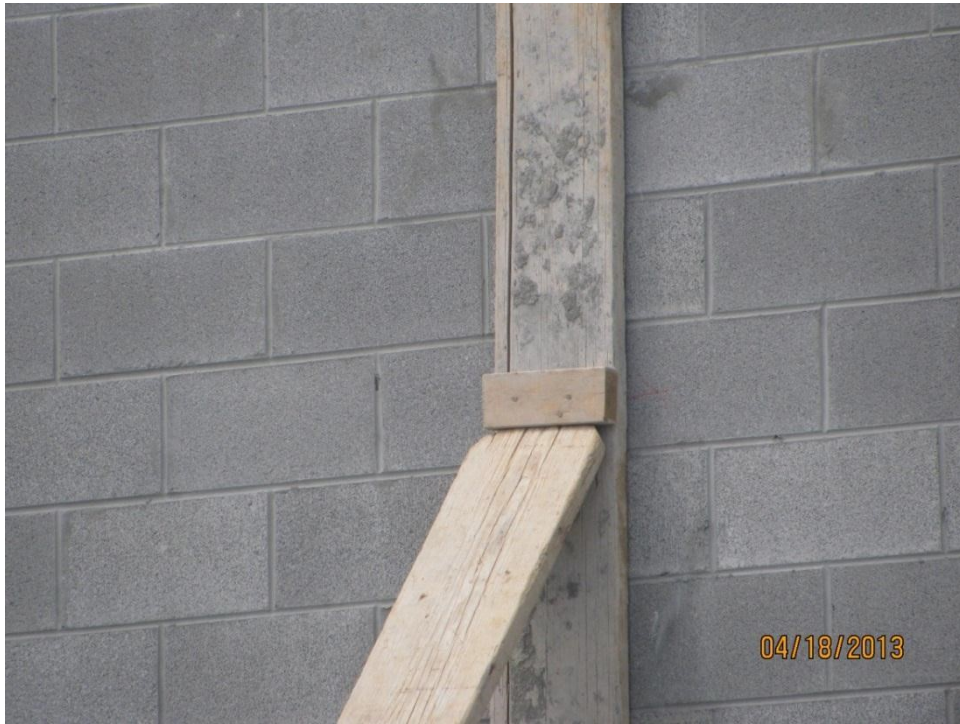
Figure 9 - Top end of brace without positive connection

At mid-height of the vertical member, approximately 10' above, 2x4 horizontal cleats were provided. The 2x4 cleats were nailed to vertical members (see Figure 9). The diagonal bracing member consisted of 2x10 Southern Yellow Pine (SYP) OSHA scaffold plank, the top end of which was held underneath the cleats while the opposite end was held against 4' (\pm) long rebar. The rebar was embedded into the soil for a depth of approximately 2'-6" and projecting out around 1'-6". On top of the plank near the rebar, two CMU blocks were placed (see Figure 10).

Even the few braces that were provided did not meet the industry standards because they were not anchored to the wall either by bolts or screws. They were susceptible to sliding and falling off the walls. The wall could maintain its capability to prevent overturning either by the presence of an adequate number of braces properly fastened to the wall or by the internal strength derived from the flexural capacity due to rebars. In this case, neither was provided.

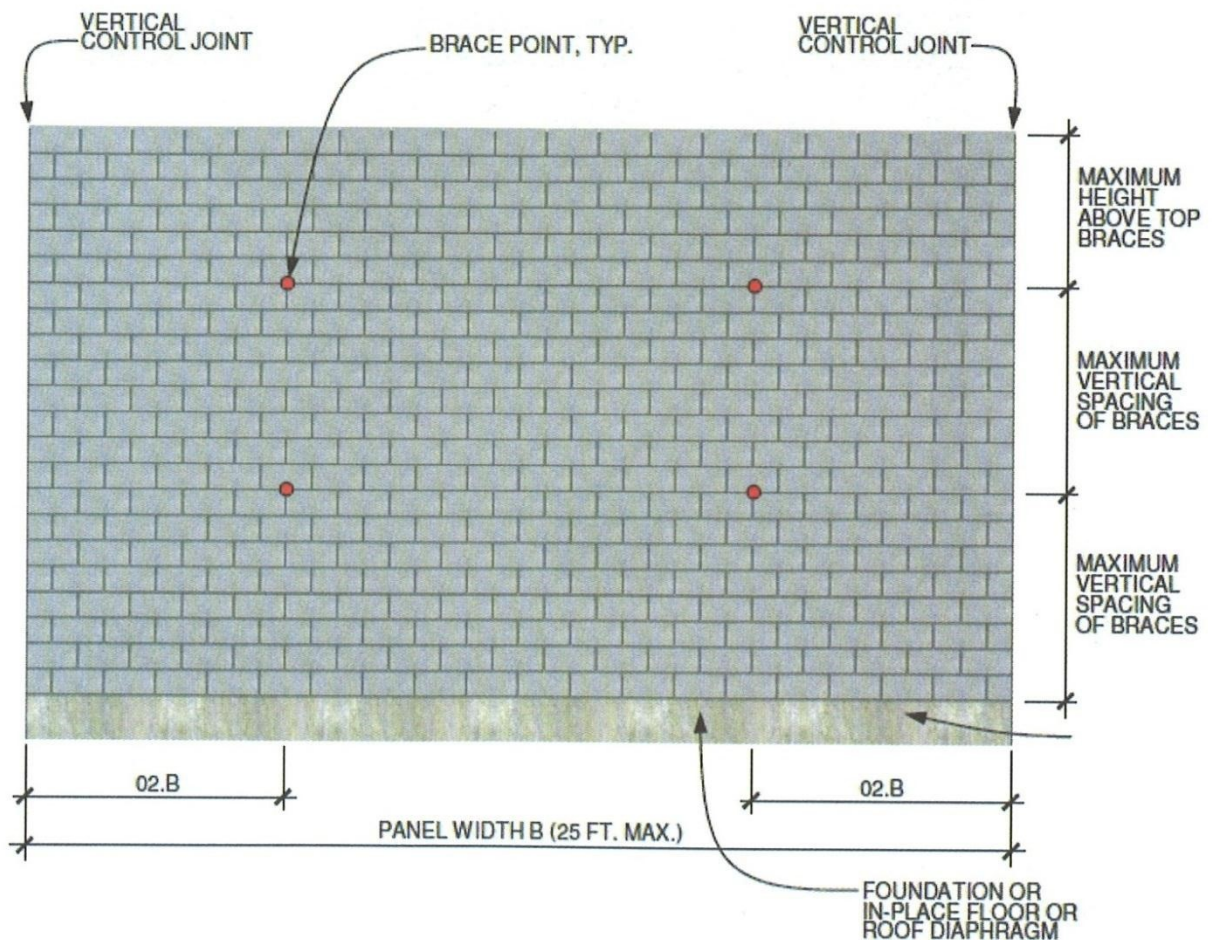
Figure 11 - Brace spacing requirement for masonry wall between control joints

The design of the bracing members was not performed by any contractor or by an engineer. Bracings were installed randomly based on the contractor's judgment. "Standard practice for Bracing Masonry Walls under construction," developed by the Council for Masonry Wall Bracing, was not followed (see Figure 11).

Note: Industry practice required two braces between control joints

The masonry contractor provided too few braces between the control joints of the 150'-long masonry wall that fell. In this project, the control joints in the masonry wall were designed and detailed as a complete separation (see Figure 5) similar to an expansion joint which necessitated a minimum of two braces for the masonry walls between the control joints (see Figure 11). Only three interior and three exterior braces for the entire wall were provided instead of the twelve specified in the industry standard, "Standard practice for Bracing Masonry Walls under construction" developed by the Council for Masonry Wall Bracing. Two exterior braces of the east wall were removed a few days prior to the collapse. All required braces should have been left in place until permanent supporting elements were constructed, e.g., the roof deck and its attachments to the bond beam at the top of the wall. If the masonry contractor had provided an adequate number of braces as per the industry standard, this incident could have been avoided.

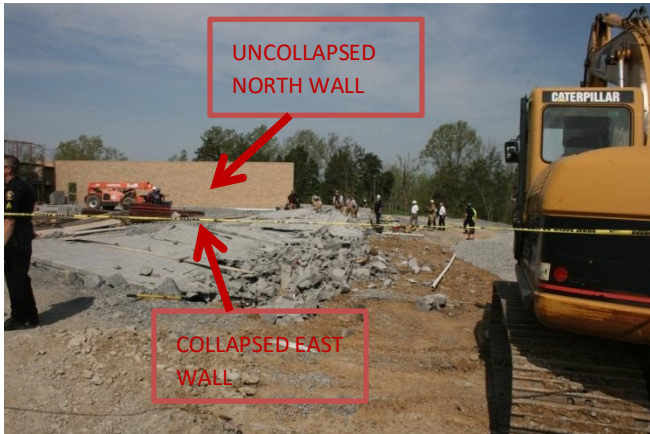
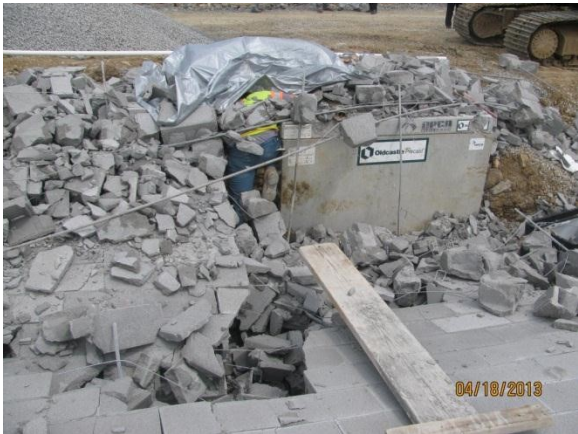
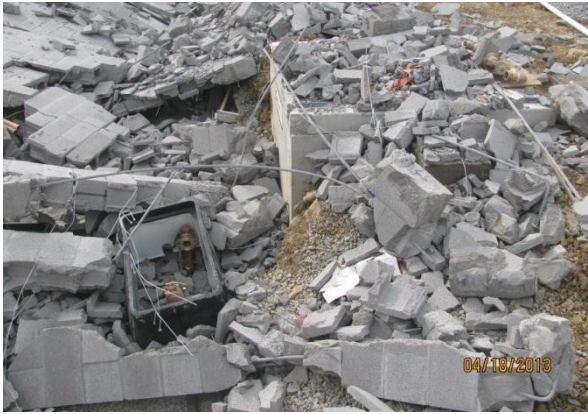
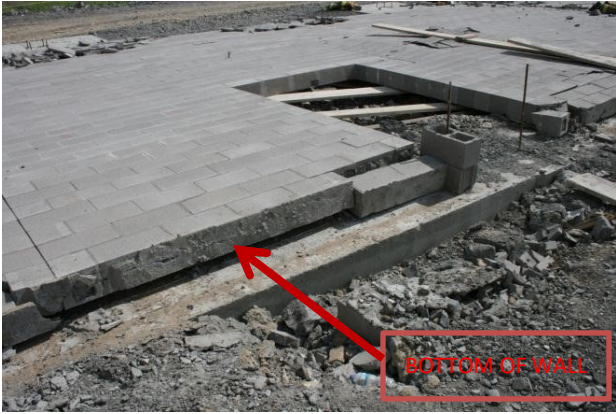
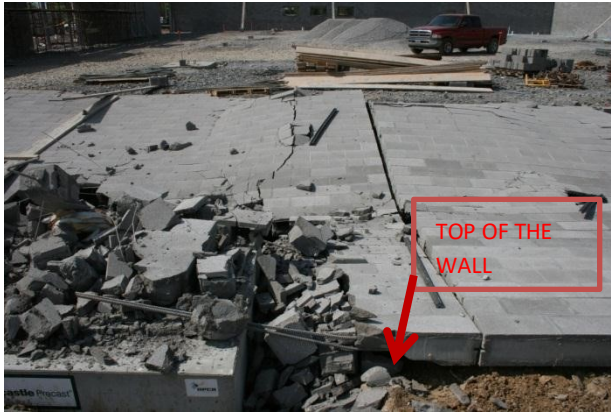
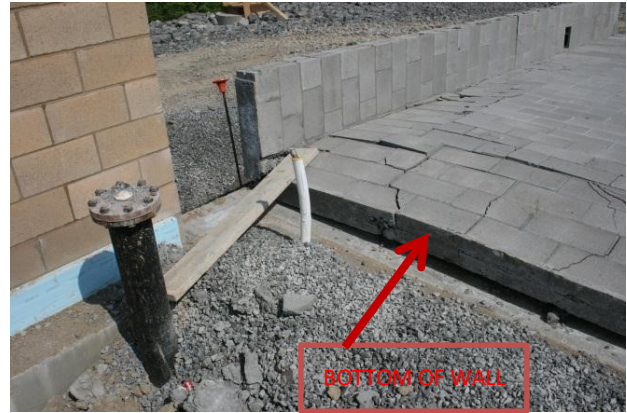
On April 18, 2013 at approximately 9:45 A.M. under a west wind with gusts of 33 mph, the east wall collapsed outwards towards the east. The remaining three walls at the perimeter of the building did not collapse. At the time of the east wall collapse, three employees were installing a backflow preventer in a trench that ran parallel to the east wall (see Figure 6). One of those employees was killed and another employee in the trench was injured when the wall fell outwards. Also, an employee on a ladder caulking the masonry control joints on the east wall (near the middle of the wall at the 2nd control joint, see Figure 6) was killed when the wall fell over him. During the review of the collapsed east wall photos (see Figure 16 to 21), the following items were noticed.

- Three interior braces and one exterior brace on the east wall fell along with the wall.

- The base of the entire east wall overturned outward and was completely separated from the top of the footing with no bent rebar dowels either coming out from the footing or from the wall.
- Some of the wall dowels from the footing to the wall were observed to have fractured at the base of the wall.
- Parts of the masonry blocks were disintegrated and turned into rubble.
- At certain areas of the fallen wall, cracks were visible.
- Parts of the bond beams were completely disintegrated and rebars from the bond beams were exposed, visible and were bent.
- At certain locations, the marks of the fractured rebars were visible either at the center of the CMU wall or at the edge of the CMU wall.

The above statement indicated that the contractor had placed wall dowels at the required locations (i.e., at the center of the CMU wall) but that is not supported by the photographs taken after the incident, and in statements made by the masonry contractor. When the masonry contractor began to build the wall, he noticed that the wall dowels (rebars) of the east wall at many locations (at north and south of the 6'-0" wide door opening) were offset from the correct location. He notified the general contractor of the misplacement of the dowels. Rather than stopping the work and getting guidance from the structural engineer of record, the general contractor advised the masonry contractor to bend the rebars and maneuver them in the block cells. Since the rebars were bent and placed near the inside edge of the CMU wall rather than being at the center of the CMU wall, rebars were not effective in resisting lateral loads arising out of the westerly wind. If the general contractor or inspector had

The analysis indicated that if the contractor had placed the rebar dowels correctly in the footing at the center of the CMU wall, the incident would not have occurred because the masonry had gained adequate strength in 15 days, and the grouted rebar would have provided adequate flexural strength to resist the lateral loads. A significant number of the dowel reinforcements of the east wall that fell

were misplaced to the outside edge of the masonry wall instead of being at the center of the wall. This compromised the flexural capacity of the free-standing wall under the lateral load coming from the west at the time of the incident. In addition, overturning moment due to lateral wind load was much higher than the resisting moment induced by the self-weight of the CMU wall.

promptly reported the misplacement of the rebars to the structural engineer of record, the structural engineer would have recommended corrective measures and the incident could have been prevented. One of the corrective measures was to drill new holes for the rebars in the footing at the center of the masonry wall and epoxy grout to meet the design intent.
