Investigation of the June 10, 2009 Mast Climbing Platform Collapse in Austin, Texas

U.S. Department of Labor
Occupational Safety and Health Administration
Directorate of Construction

December 2009

Report Prepared by
Mohammad Ayub, P.E., S.E.

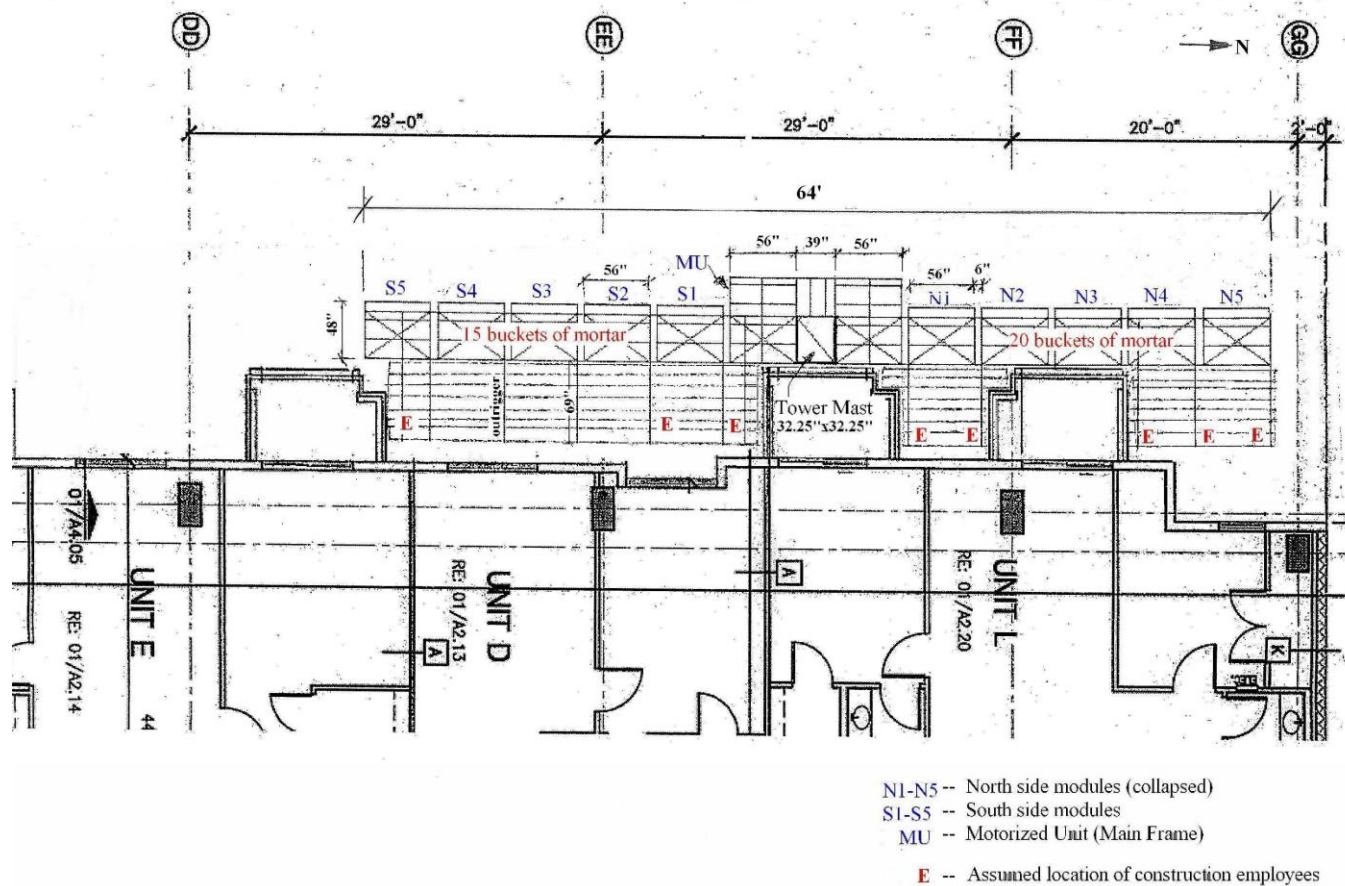
According to interview statements, the loading on the platform at the time of the collapse could have been as much as 15 buckets of stucco and 3 people on the south side and as much as 20 buckets of stucco and 5 people on the north side. Employees started out on the 13th floor in the morning, then reloaded stucco from the 13th floor, and then went down a floor, and worked on the 12th floor. After that they went back to the 13th floor, loaded the platform with stucco and

then the platform descended and stopped at the eleventh floor, when the deck modules from the north side got separated from the main frame and fell down.

Figure 6 - Location of Platform - Prior to Collapse
