# Minor Road Damage Repair

## **EXECUTIVE SUMMARY**

## **1.1 Description of Study**

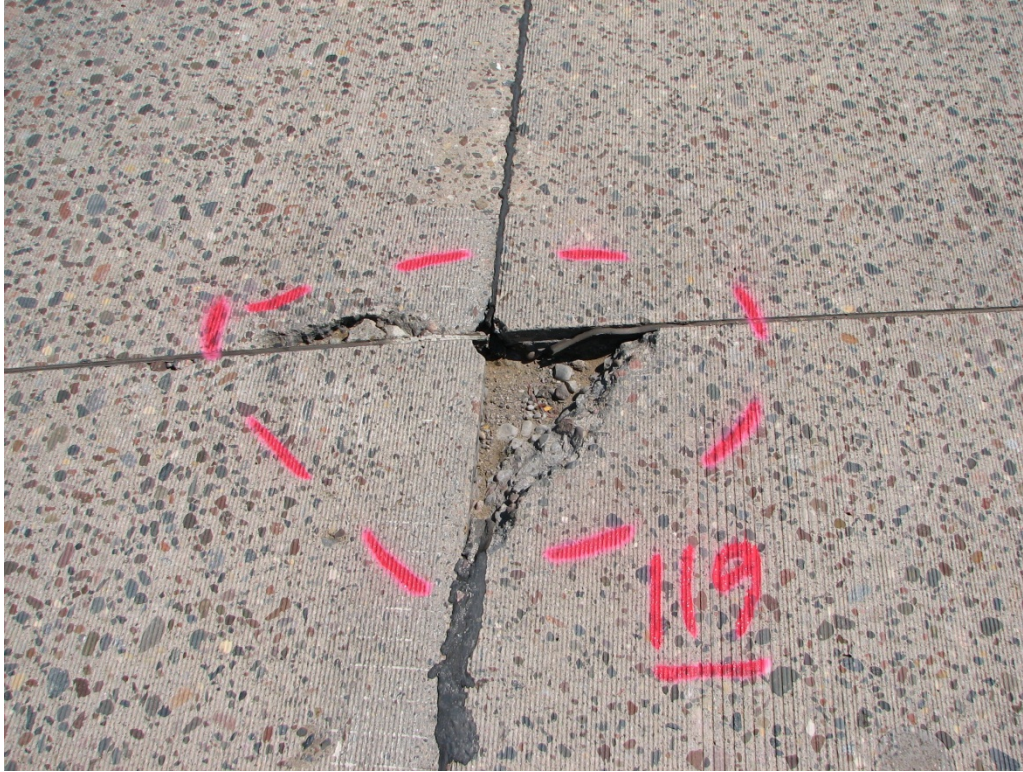
Older generation MnDOT concrete pavements (circa 1990) placed on slow draining base layers commonly develop joint distress both near the top and bottom regions of the joints. Near the surface of the pavement, cracking and material loss becomes visible in the vicinity of the joints (both transverse and longitudinal). Cracking, scouring, and material loss can occur both at mid-depth and near the bottom of joints, particularly with slow draining base layers under the pavement[3]. Examples of these types of distress at the MnROAD facility are shown in Figures 1.1 through 1.3.

**Figure 1.1 Distress near the surface of a concrete pavement at intersection of transverse and centerline joints.**

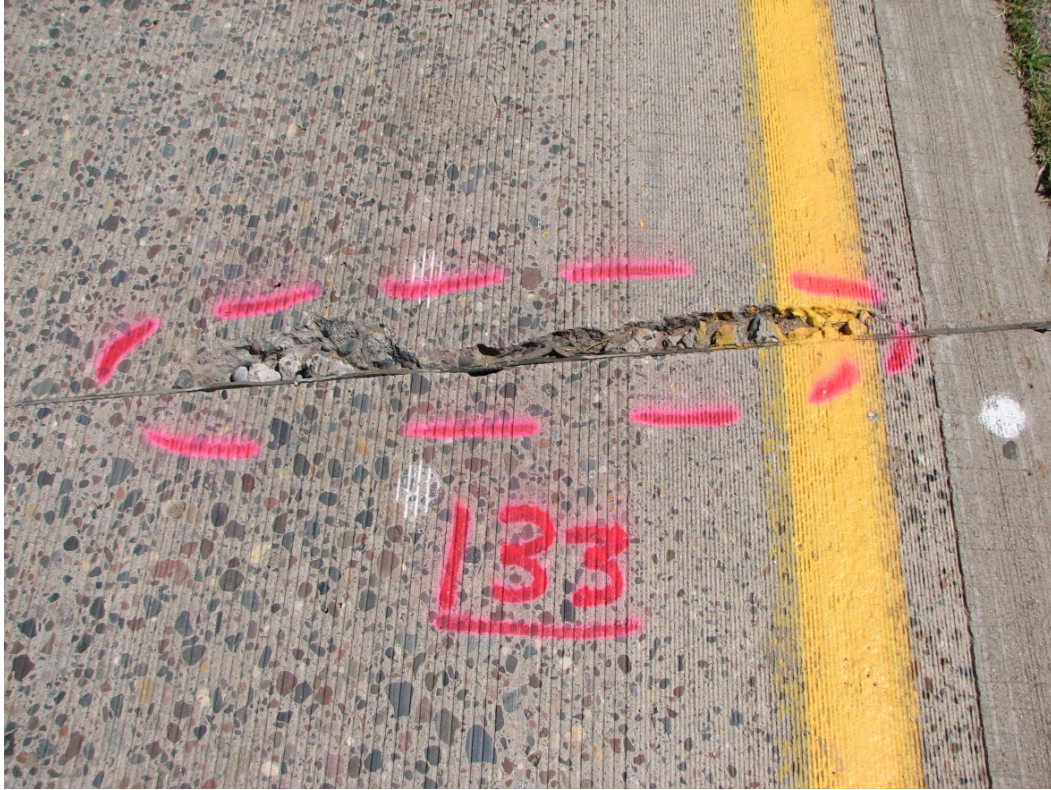
**Figure 1.2. Distress near the surface of a concrete pavement along a transverse joint.**

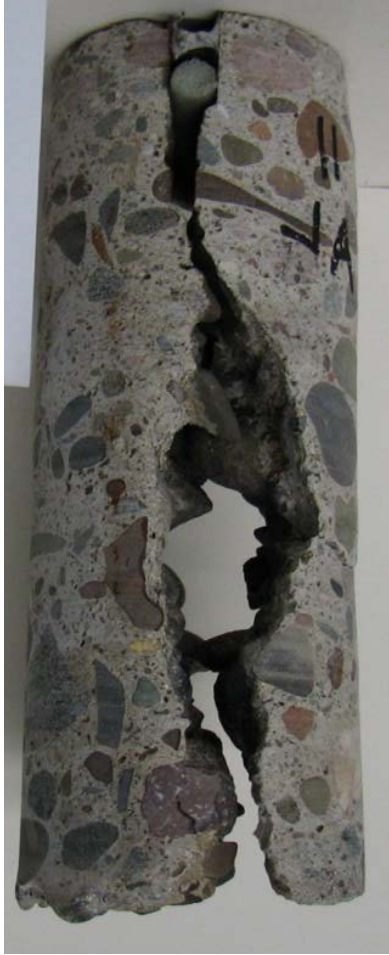
**Figure 1.3. Distress at mid-depth and bottom of transverse joint placed on slow draining base layer [3].**

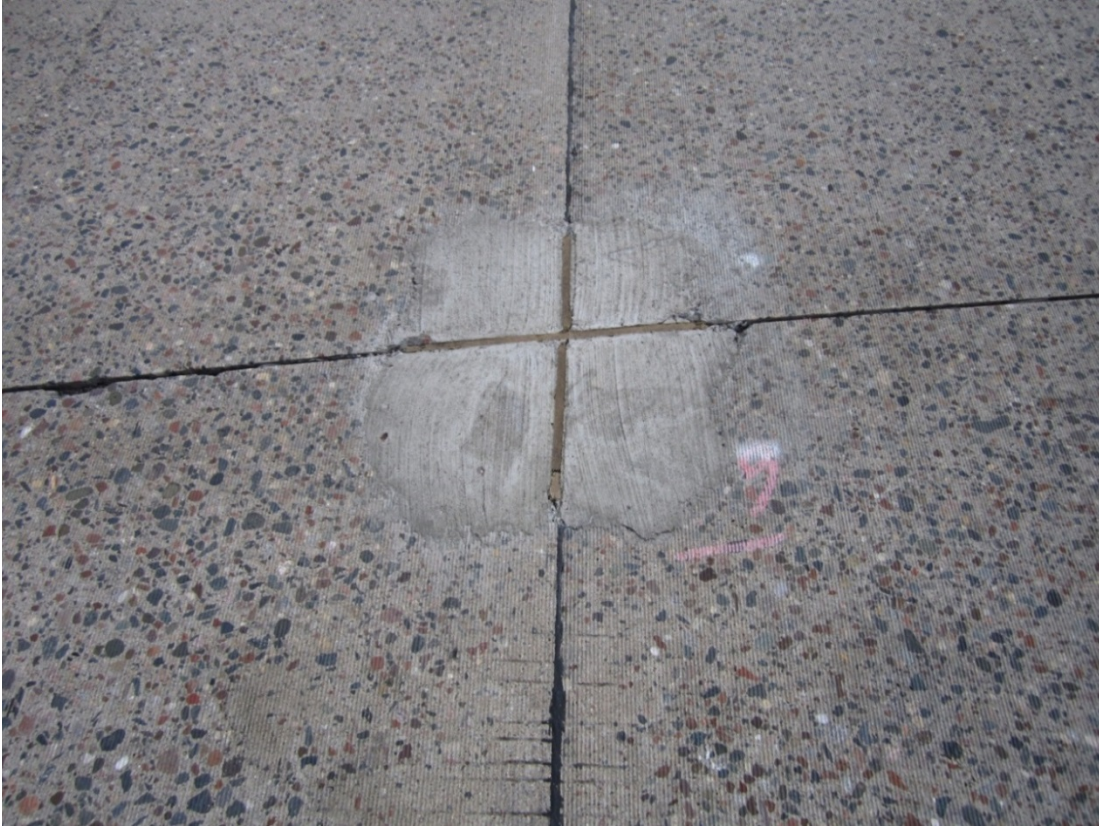
**Figure 1.4. Typical MnROAD partial-depth repair with cementitious-based material.**

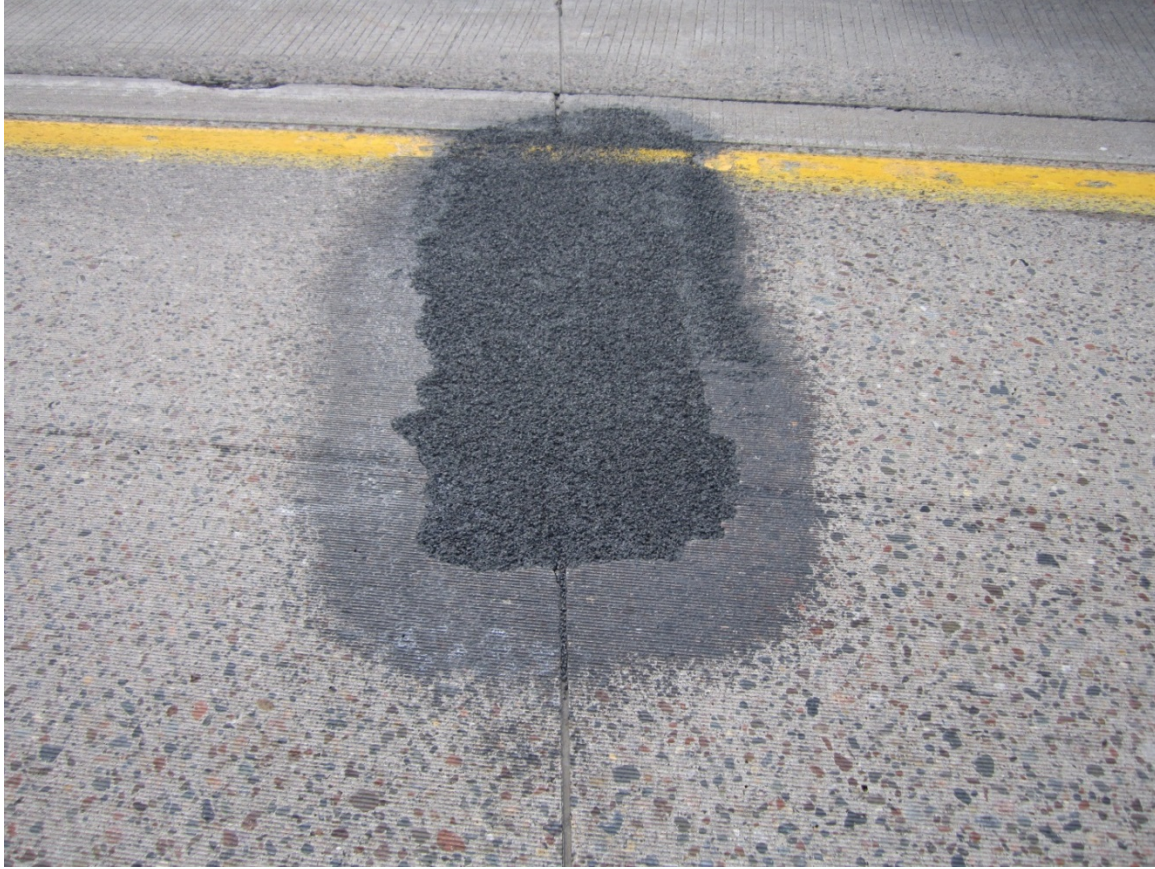
**Figure 1.5. Typical MnROAD partial-depth repair with asphalt-based material.**
