Pedestrian Bridge Collapse in Miami, Florida

1. Executive Summary

On March 15, 2018, at approximately 1:45 p.m., a pedestrian bridge under construction in Miami, Florida, collapsed. One employee and five motorists were fatally injured, and another employee permanently disabled, when the bridge fell as the motorists waited for the traffic light underneath the bridge and as the employees were performing work activities on top of the bridge structure. The bridge at the present stage of construction consisted of a single concrete truss spanning approximately 174 feet and weighing approximately 930 tons. It was placed over the piers just five days prior to the collapse. An adjoining span of concrete truss was to be constructed next over the canal to make a continuous bridge of 289 feet. The concrete bridge was cast at a nearby off-site location using what is known as Accelerated Bridge Construction (ABC) and then transported to its final location. ABC provides minimal traffic disruption. The bridge was financed through federal grants, and constructed at the campus of Florida International University (FIU) in Miami. The FIU project was a class A Local Agency Program (LAP) project. The

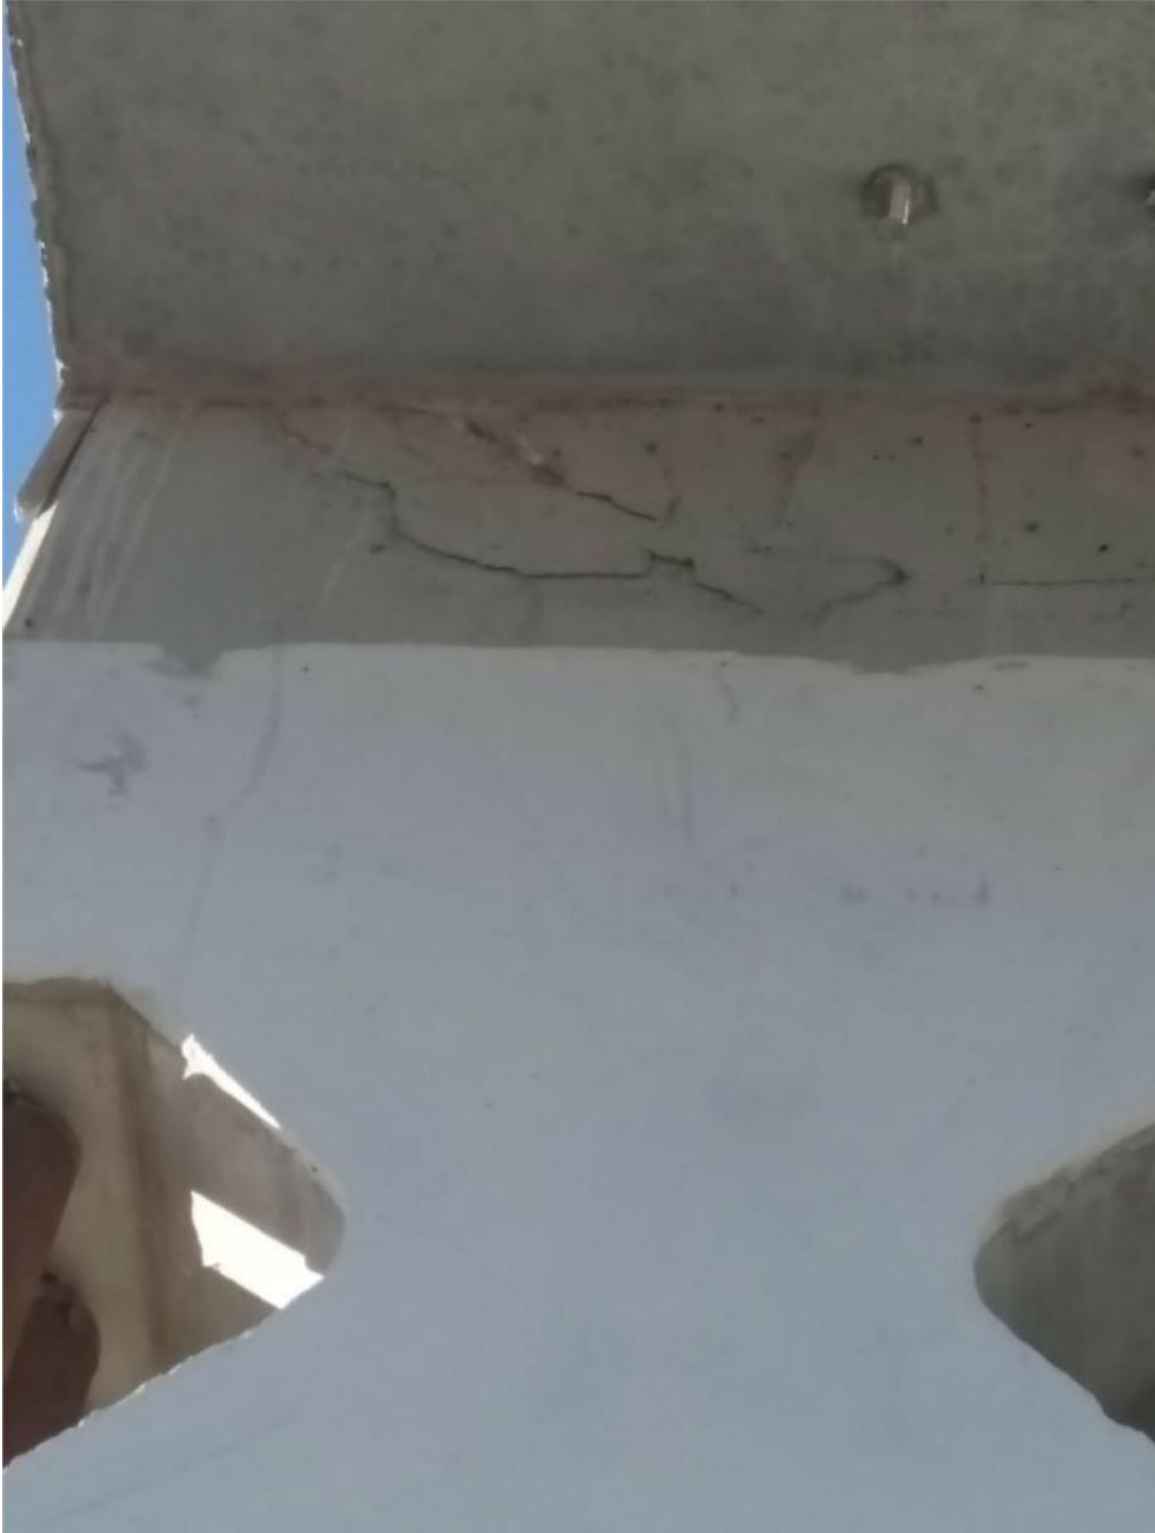
26, 2018 Photographs of the cracks were taken by BPA.

February 28, 2018 BPA forwarded the photos of cracks to MCM asking for response from FIGG, as cracks needed “special attention.”

Figure 15 Photo #1 in 2/28/2018 E-mail from MCM to FIGG

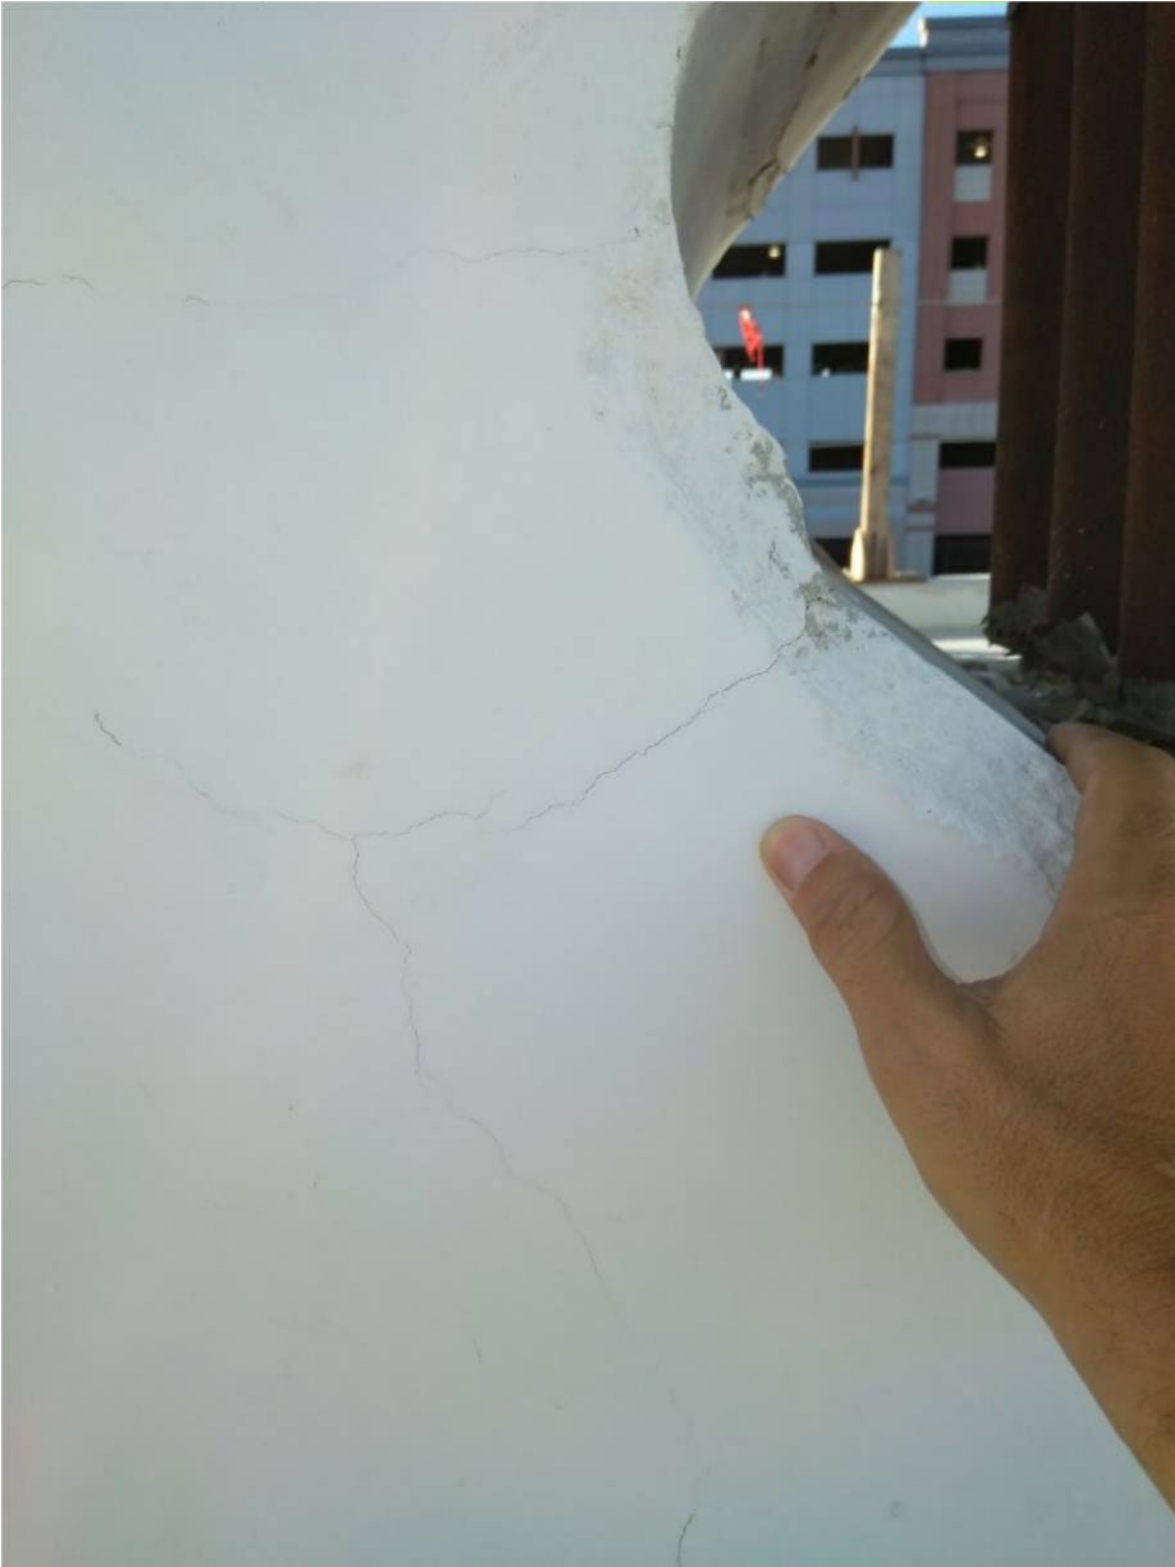
Figure 41 Photo #2 in 2/28/2018 E-mail from MCM to FIGG

(Figure 16): Cracks expected.

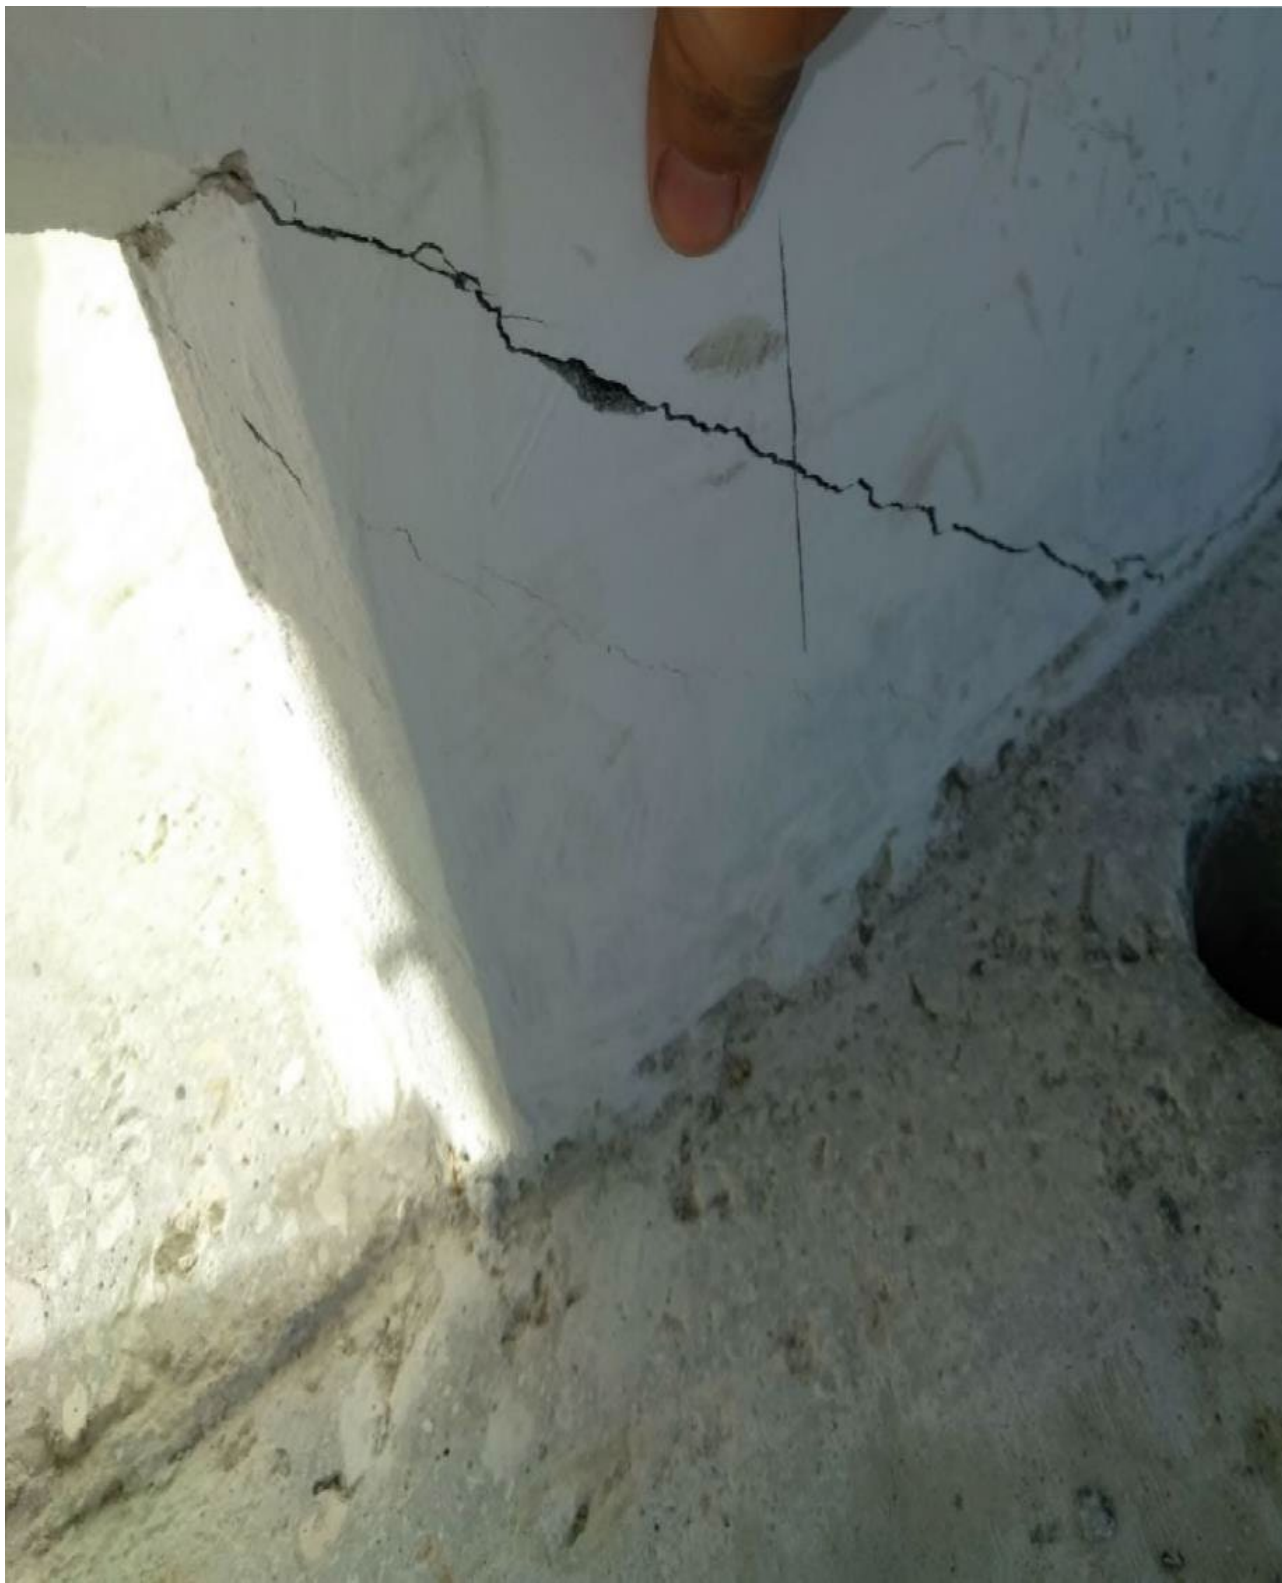
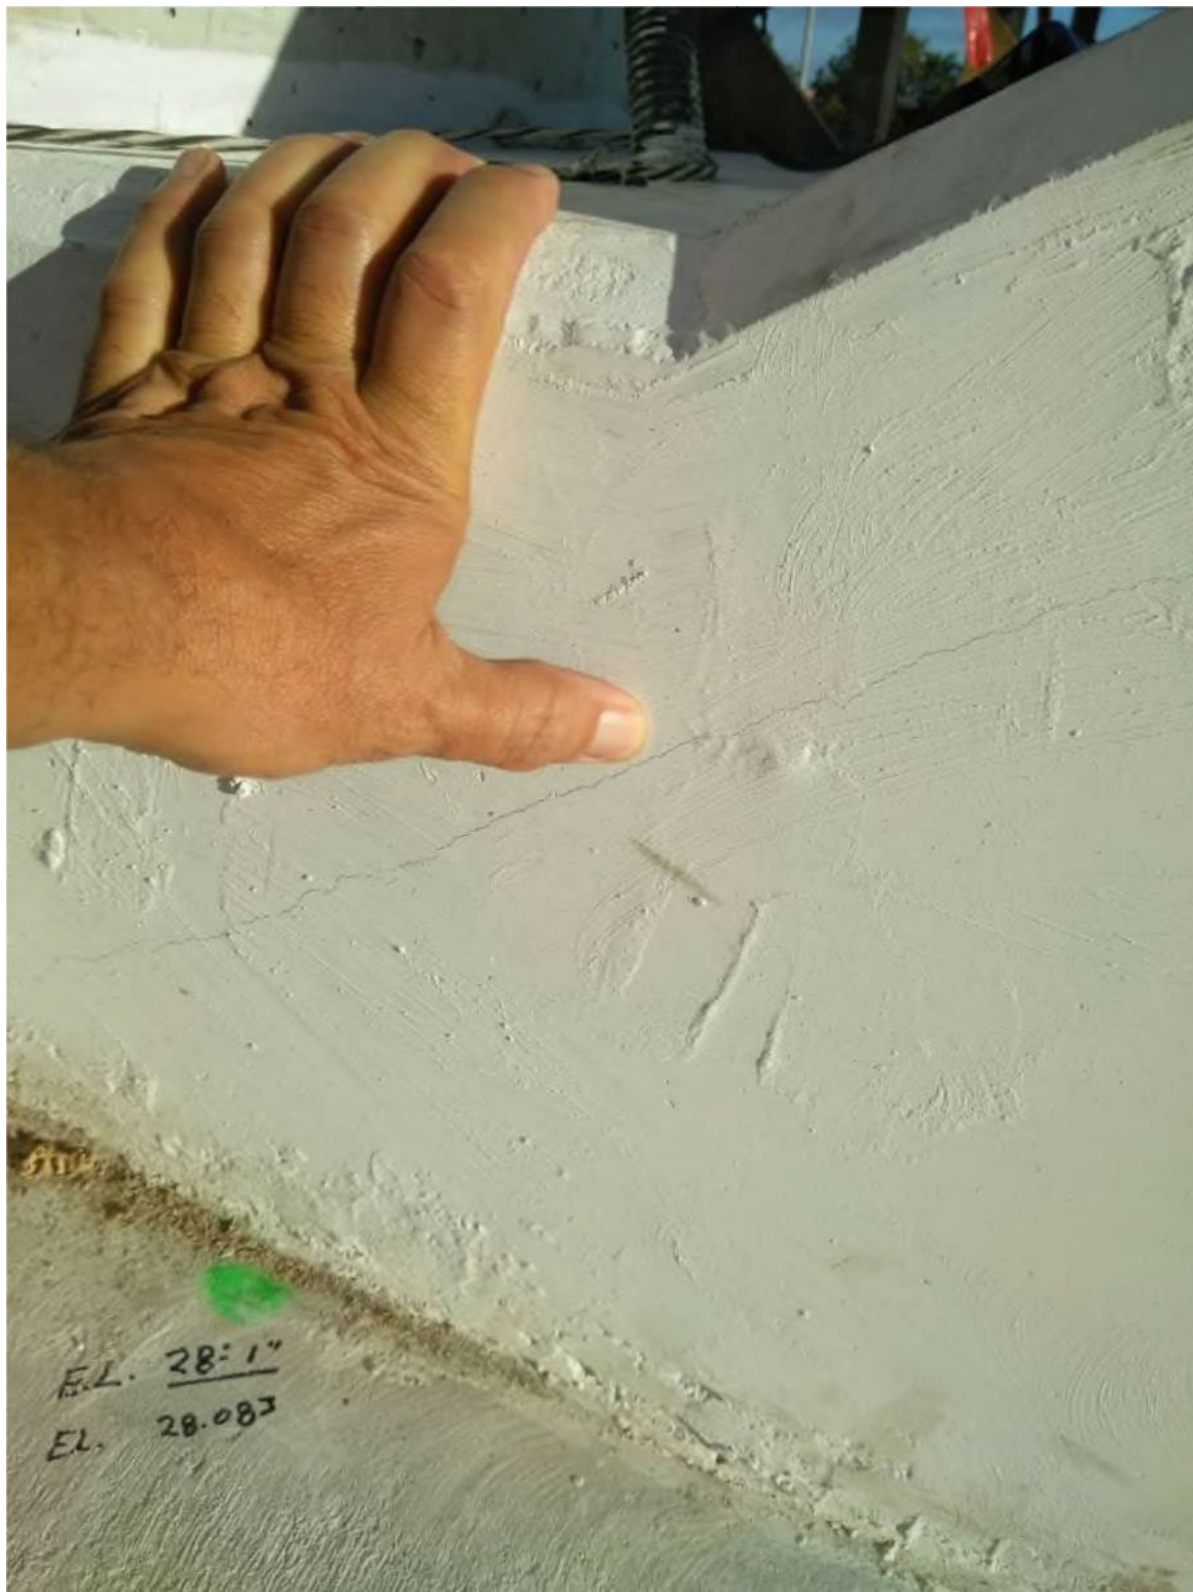
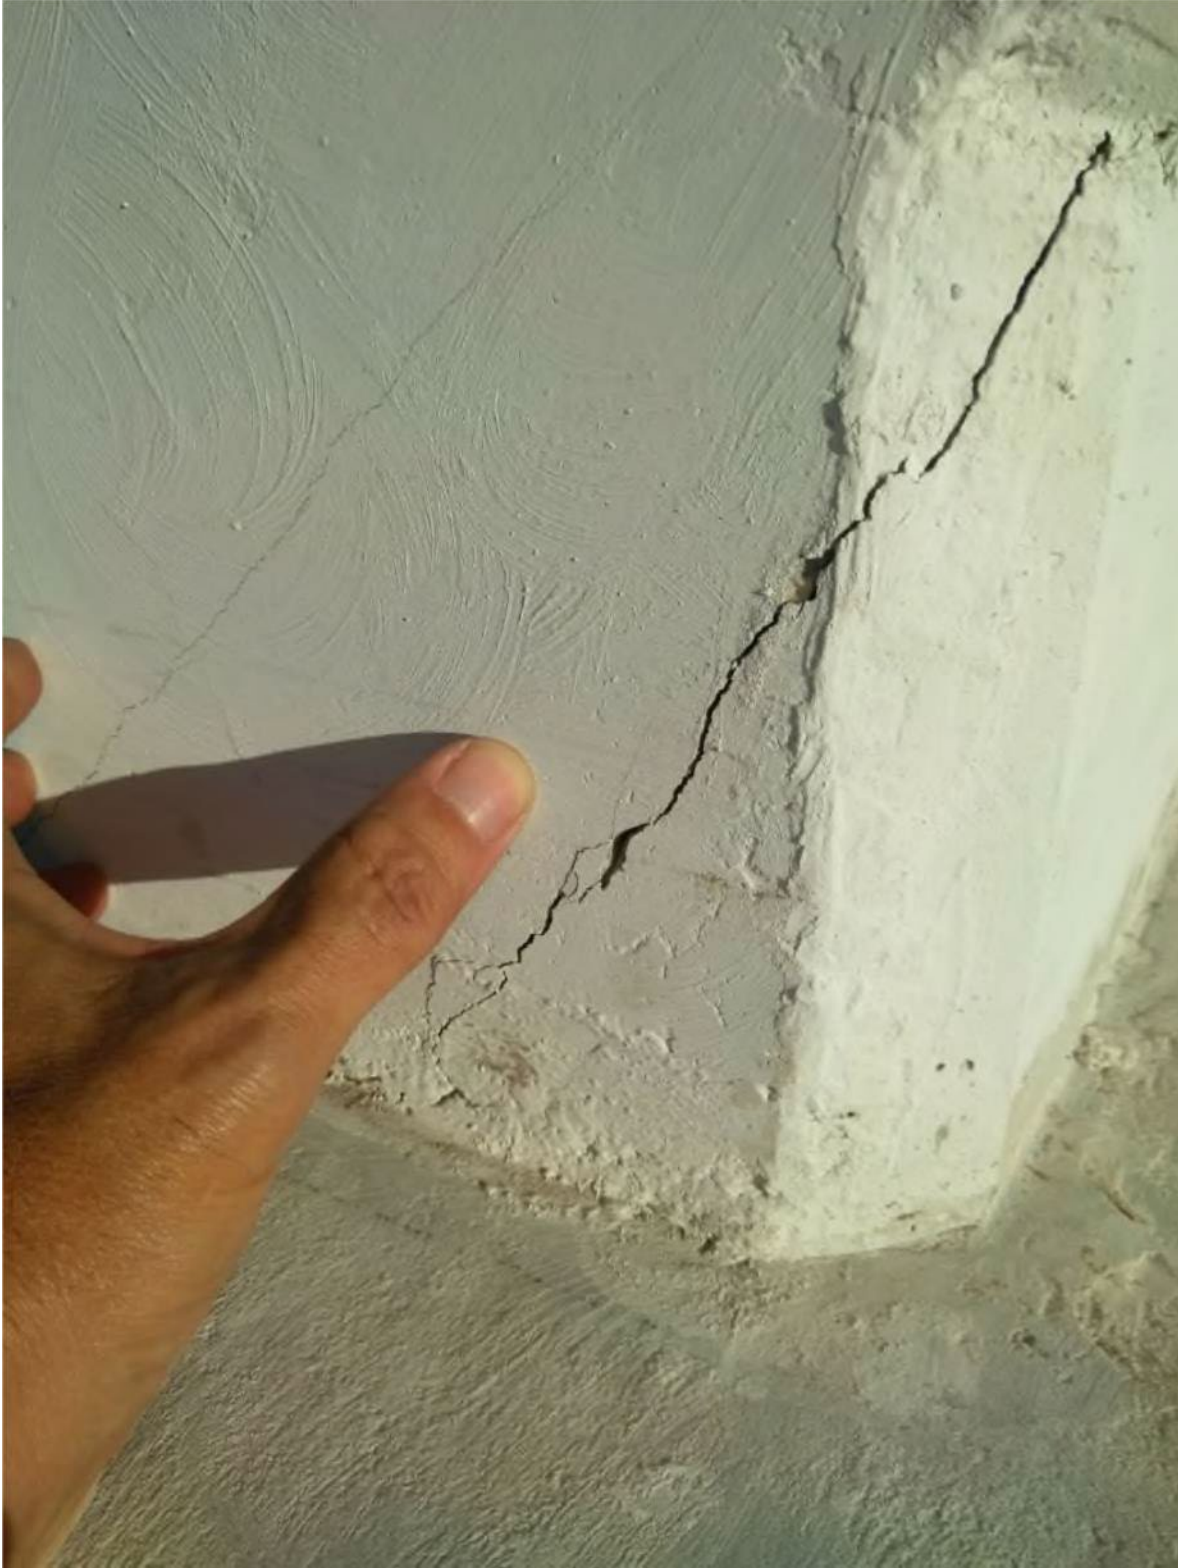
Figure 18 Photo #4 in 2/28/2018 E-mail from MCM to FIGG

Figure 19 Photo #5 in 2/28/2018 E-mail from MCM to FIGG

Figure 20 Photo #6 in 2/28/2018 E-mail from MCM to FIGG

Photos 4, 5 and 6 (Figure 18, Figure 19 and Figure 20): Cracks developed at diagonal 11 and its bottom chamfer. No concern expressed by FIGG. FIGG anticipated that “MCM will seal these cracks in accordance with FDOT Standard Specifications.” These cracks were, however, never sealed.

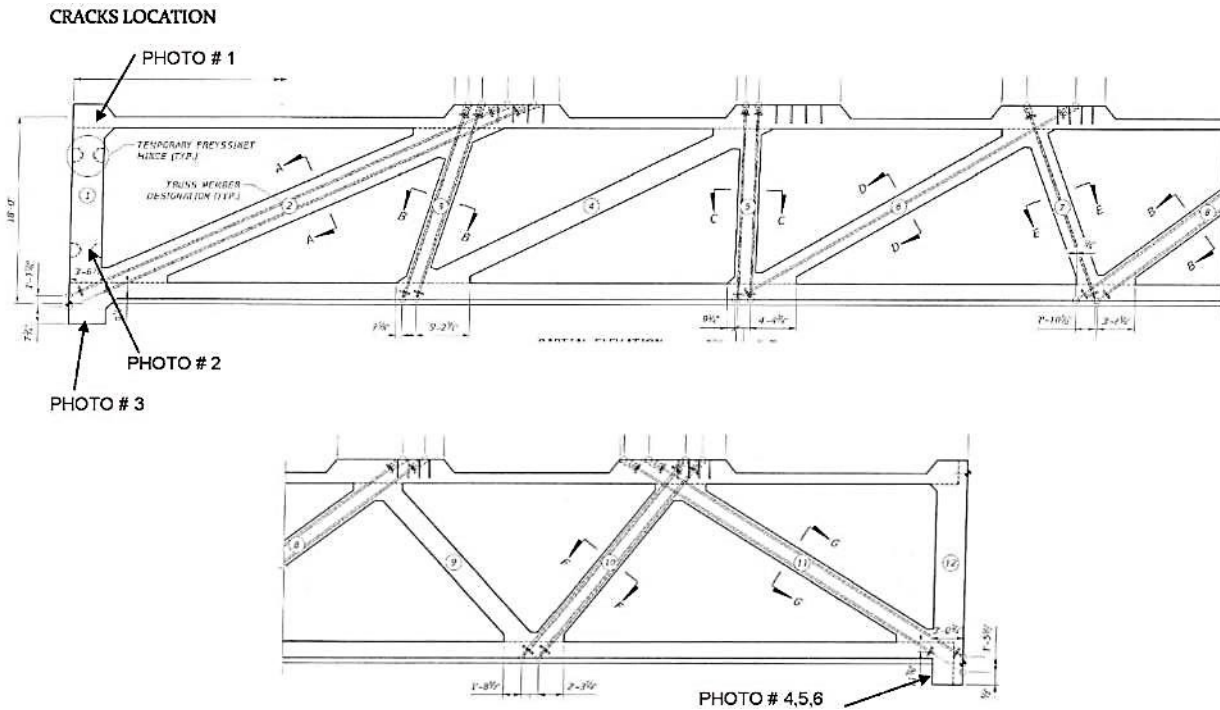
Figure 21 Location of cracks in 2/28/2018 E-mail from MCM to FIGG as per BPA March 7,

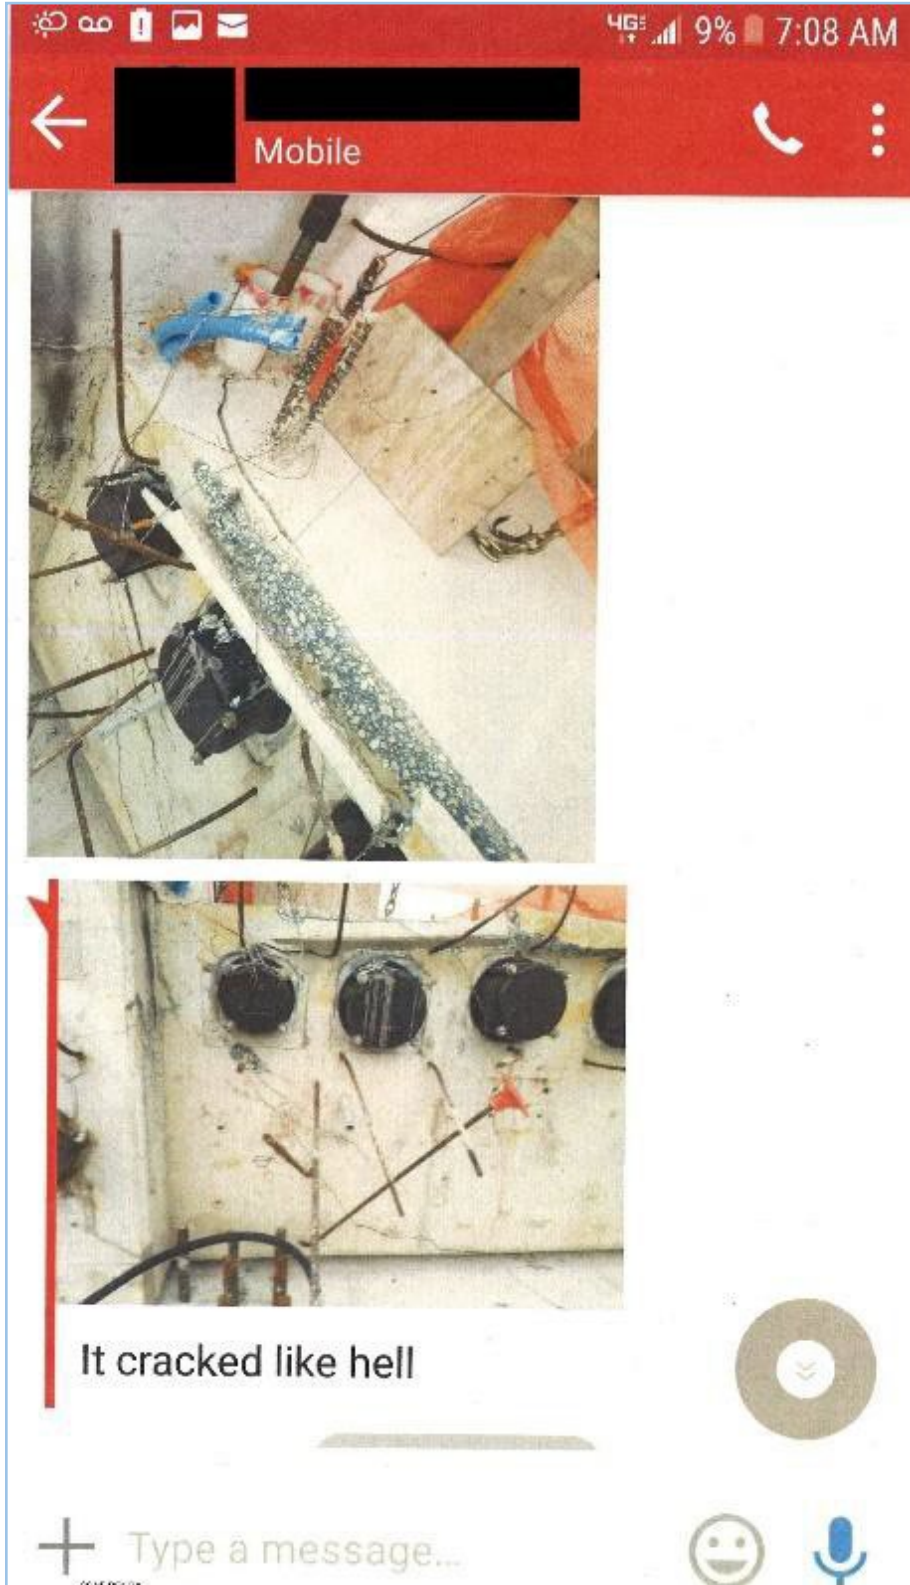
of the cracks, and sent them to his supervisor, Sam Nunez, stating that “it cracked like hell”, see Figure 23. Reproduced below is Kevin’s text. Ashley mentioned to OSHA that Kevin went to MCM to show the photos of the cracks. Sam Nunez of VSL stated during an OSHA interview that the photos he received subsequent to March 10 were different, showing spalling and cracks in the diaphragm II implying that additional cracks took place after March 10, 2018.

Figure 23 Screenshot of Kevin Hanson’s message to Sam Nunez on March 10, 2018
March 12, 2018 MCM employees, Ernesto Hernandez, and Pedro Cortes took pictures of the cracks.
At 4:51 pm, MCM Senior Project Manager, Rodrigo Isaza, sent an email to Dwight
FDA, Inc.

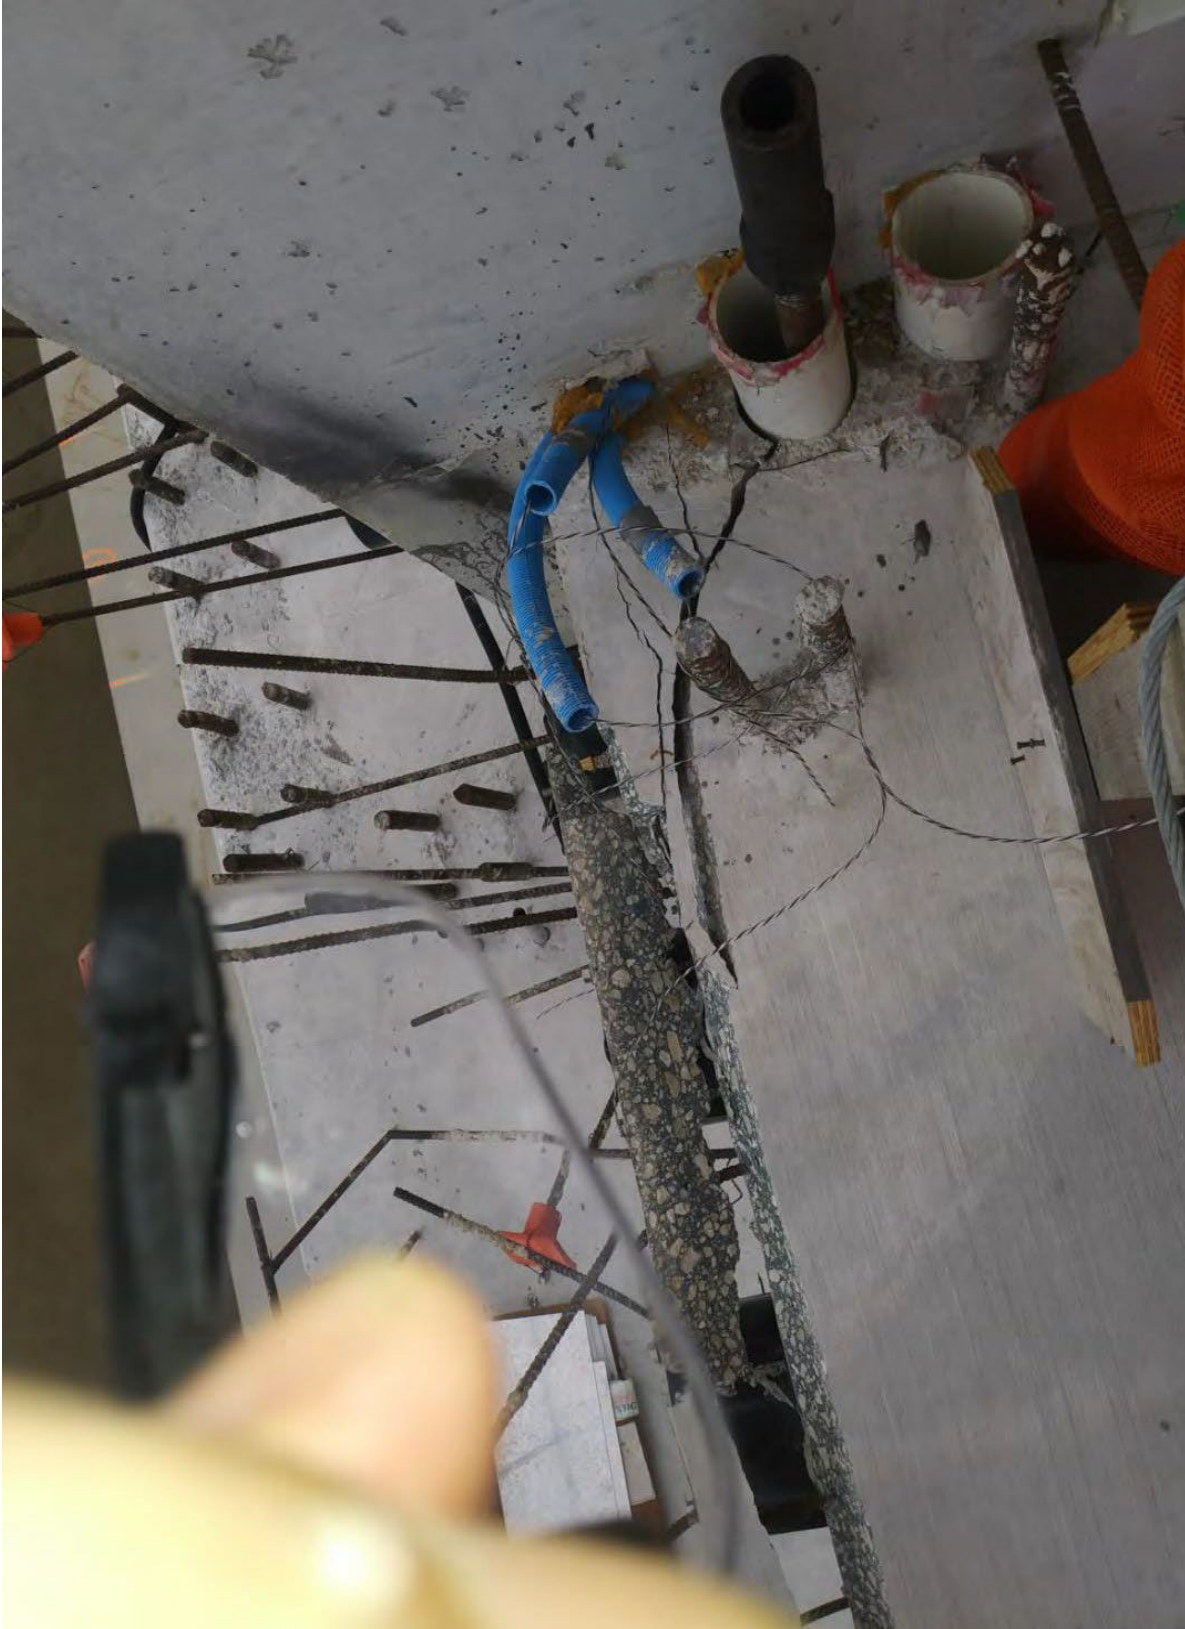
Dempsey, PE of FIGG, with copies to other engineers (Denney Pate, Franklin Hines, Eddy Leon, and Manuel Feliciano) of FIGG asking them to comment and review the pictures of the cracks as promptly as possible. Mr. Isaza had a sense of urgency, and opined that “**some of these cracks are rather large and/or of concern**” (emphasis ours). MCM stated “your immediate attention and response is required.” Ernesto Hernandez, MCM superintendent, on March 22, 2018 during an OSHA interview stated that Cortez, MCM quality control, went back to see the cracks and told him that “the cracks had increased.” Mr. Hernandez went himself to look at the cracks and that “the cracks had gotten wider and larger.”

Figure 24 Cracks at the west side diaphragm II MCM email of 3/12/2018 – top face, by BPA.

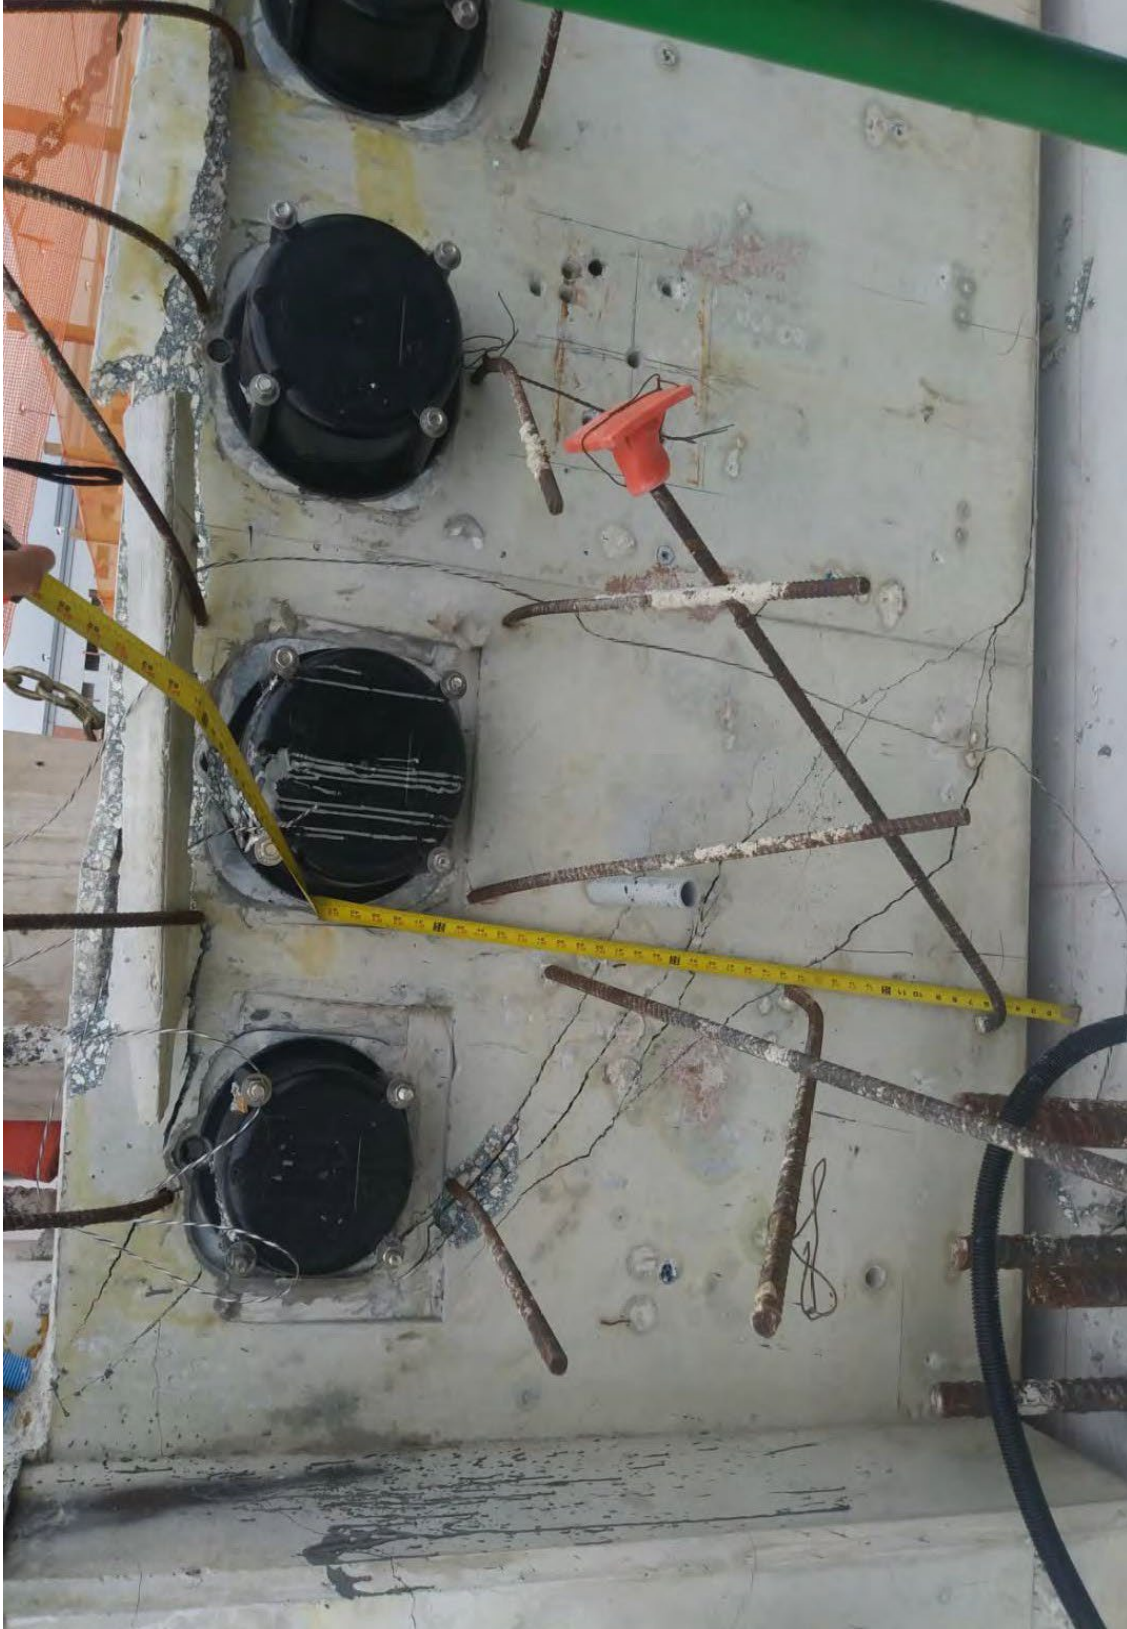
Figure 25 Cracks at the west side diaphragm II MCM email of 3/12/2018, by BPA – side face

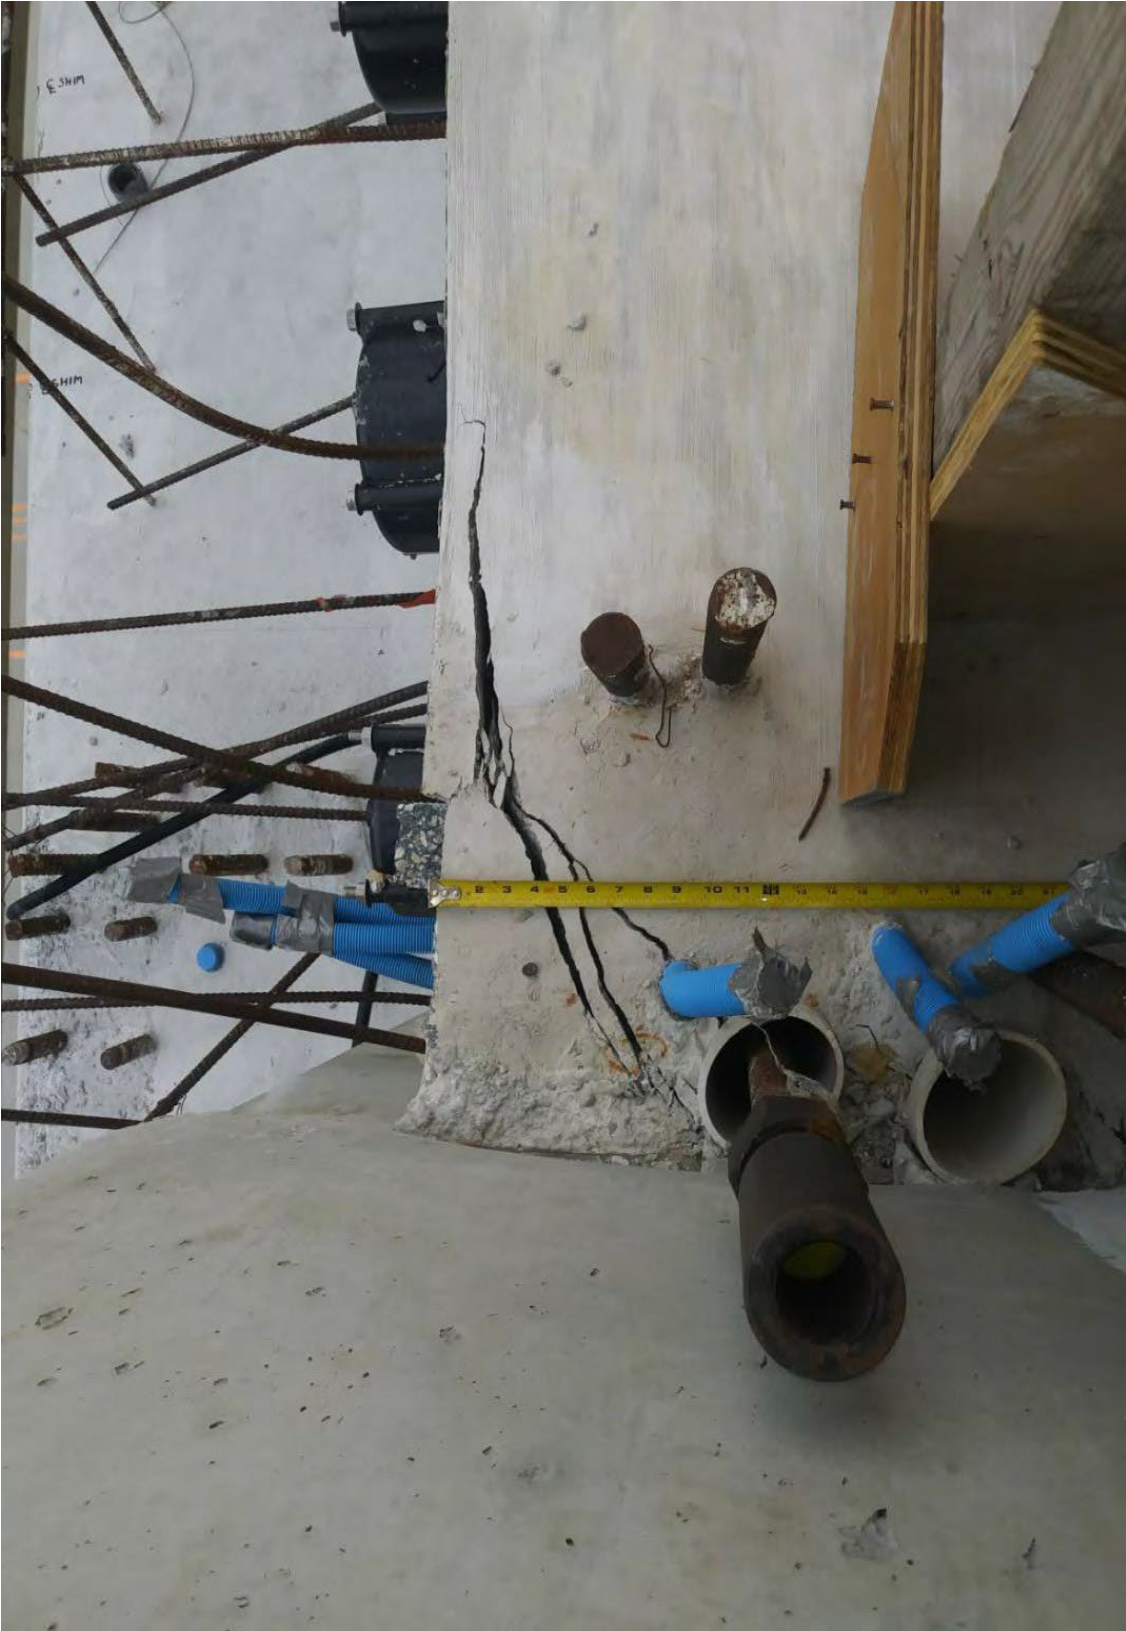
Figure 26 Cracks at the east side diaphragm II MCM email of 3/12/2018, by BPA – top face

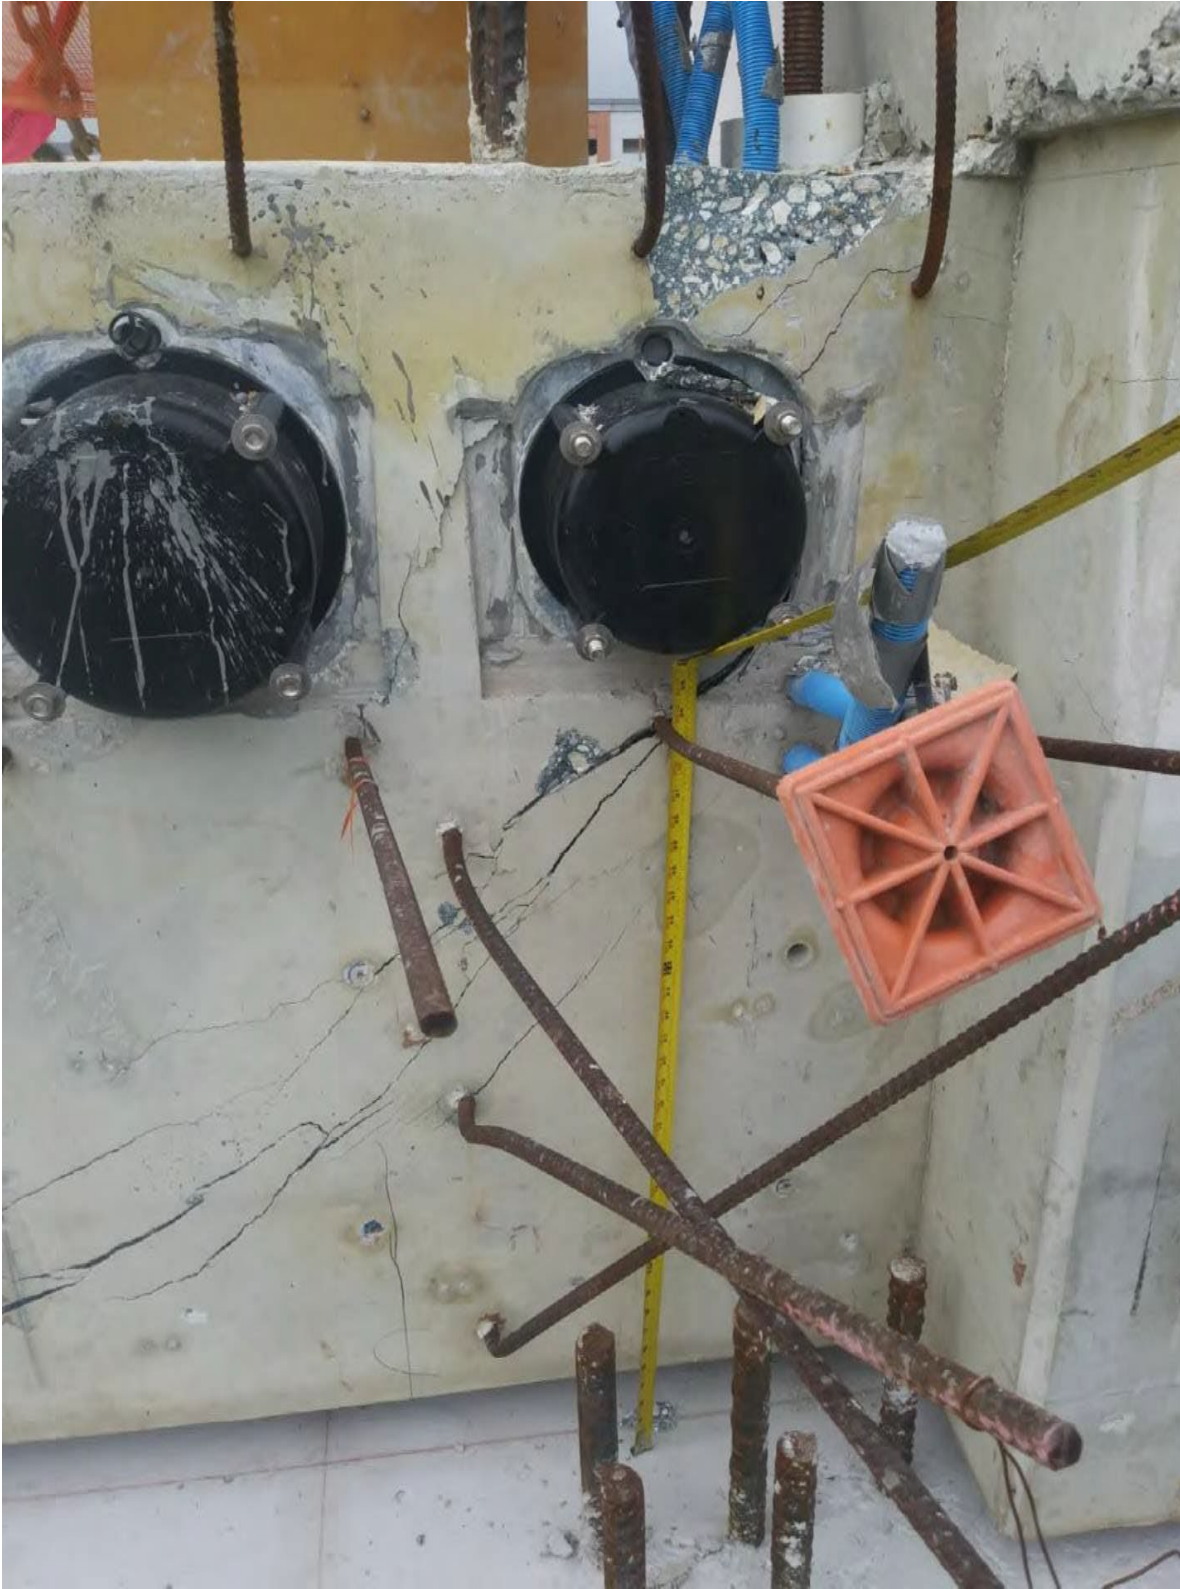
Figure 27 Cracks on the east side diaphragm II MCM email of 3/12/2018, by BPA – side face
March 13, 2018 As the email was sent by MCM in the evening of March 12, 2018, FIGG did not
open MCM’s email containing the photos of the cracks until the next morning on
FDA, Inc.

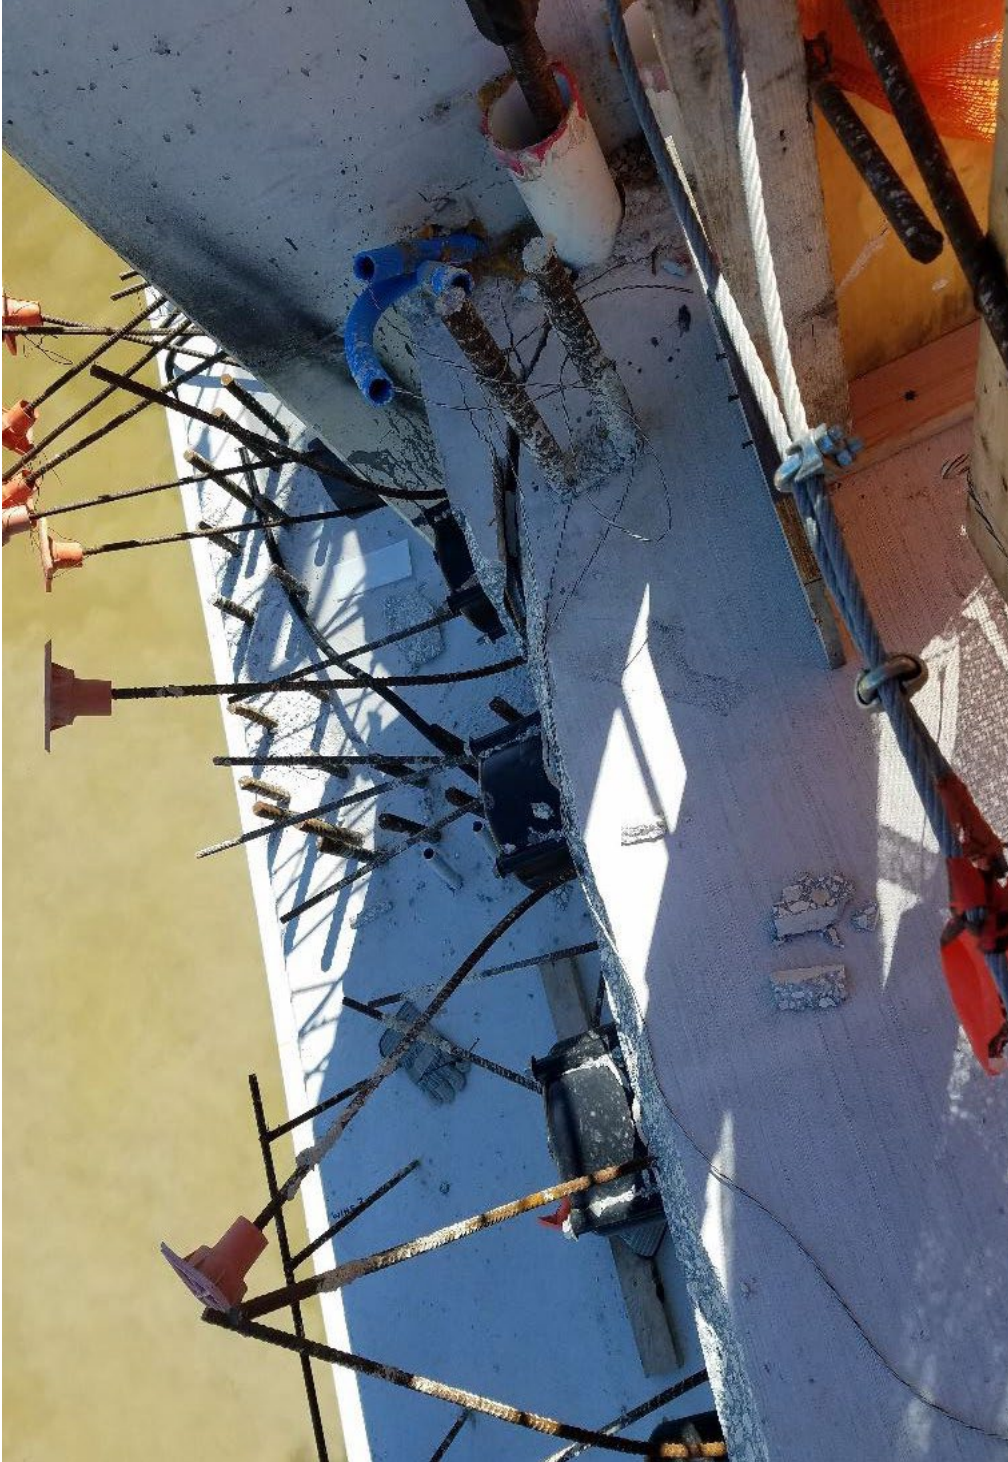
Figure 28 Diagonal cracks on the west side of diaphragm II on 3/13/2018, by BPA – top face
