Pedestrian Bridge Collapse in Miami, Florida

1. Executive Summary

On March 15, 2018, at approximately 1:45 p.m., a pedestrian bridge under construction in Miami, Florida, collapsed. One employee and five motorists were fatally injured, and another employee permanently disabled, when the bridge fell as the motorists waited for the traffic light underneath the bridge and as the employees were performing work activities on top of the bridge structure. The bridge at the present stage of construction consisted of a single concrete truss spanning approximately 174 feet and weighing approximately 930 tons. It was placed over the piers just five days prior to the collapse. An adjoining span of concrete truss was to be constructed next over the canal to make a continuous bridge of 289 feet. The concrete bridge was cast at a nearby off-site location using what is known as Accelerated Bridge Construction (ABC) and then transported to its final location. ABC provides minimal traffic disruption. The bridge was financed through federal grants, and constructed at the campus of Florida International University (FIU) in Miami. The FIU project was a class A Local Agency Program (LAP) project. The

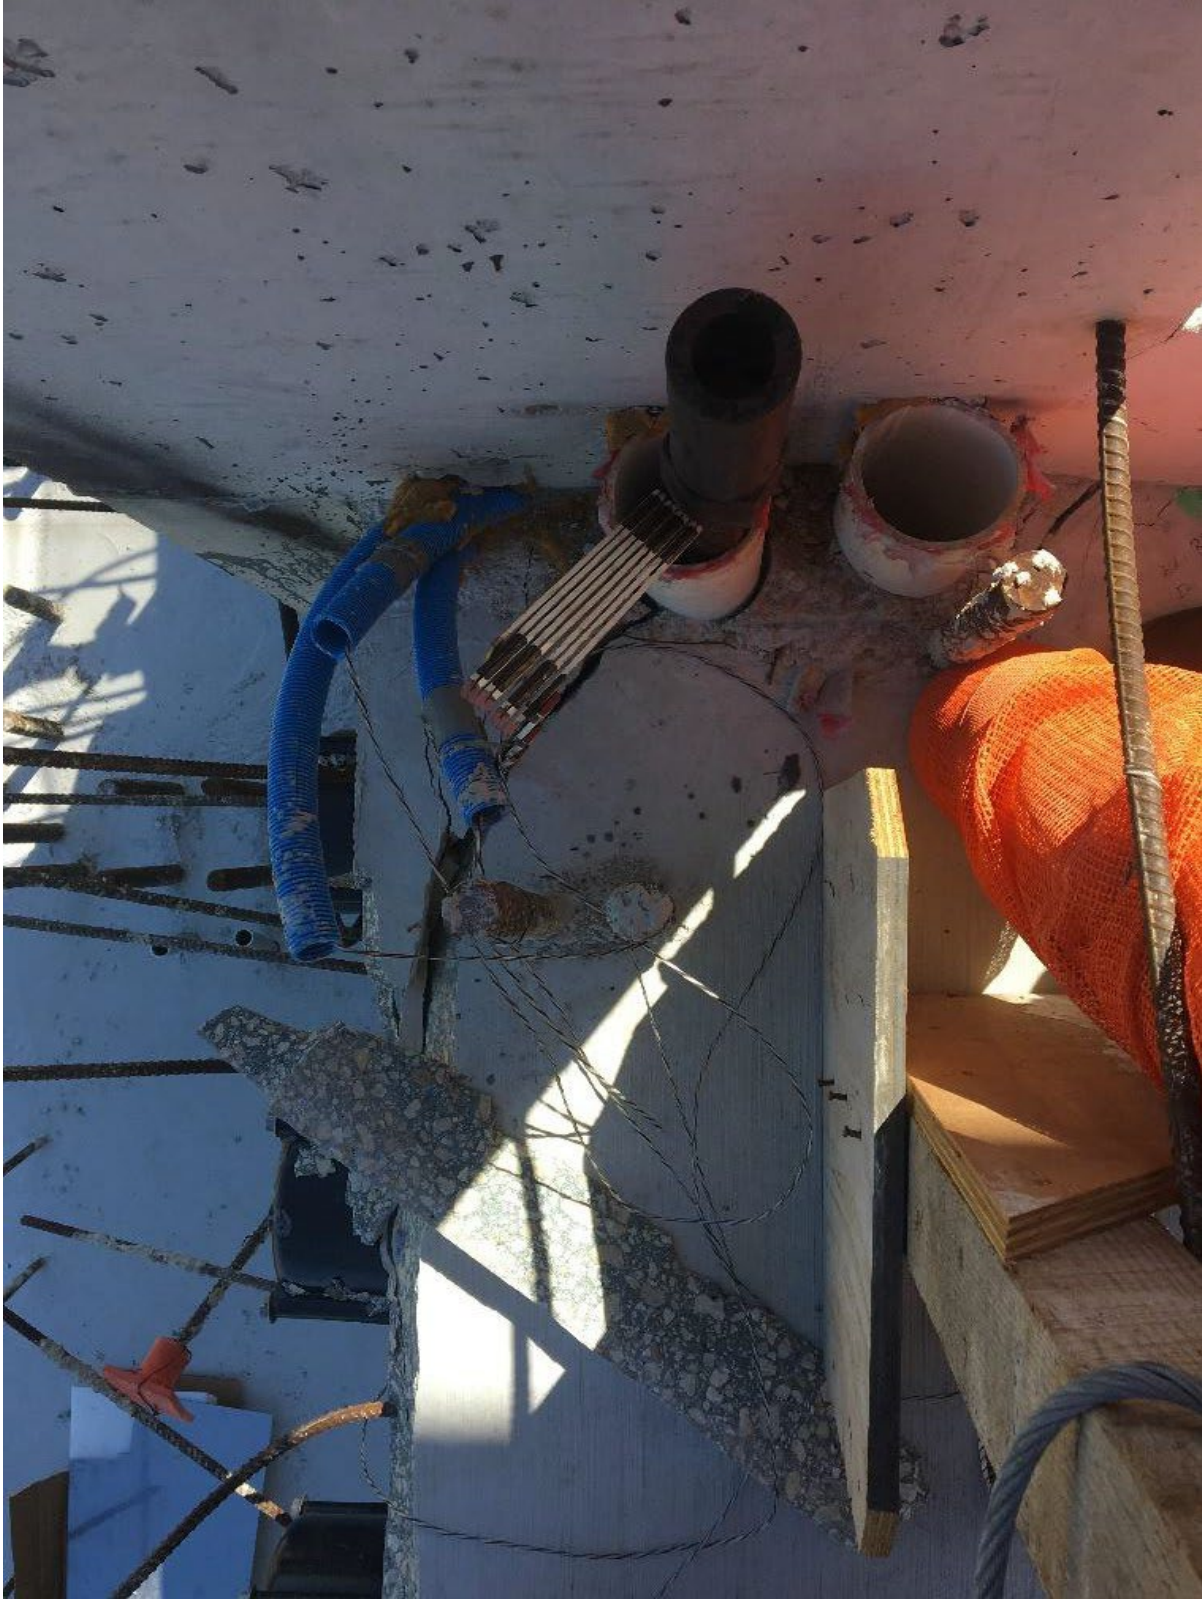
Figure 29 Close-up of cracks at the west side of diaphragm II on 3/13/2018, by BPA

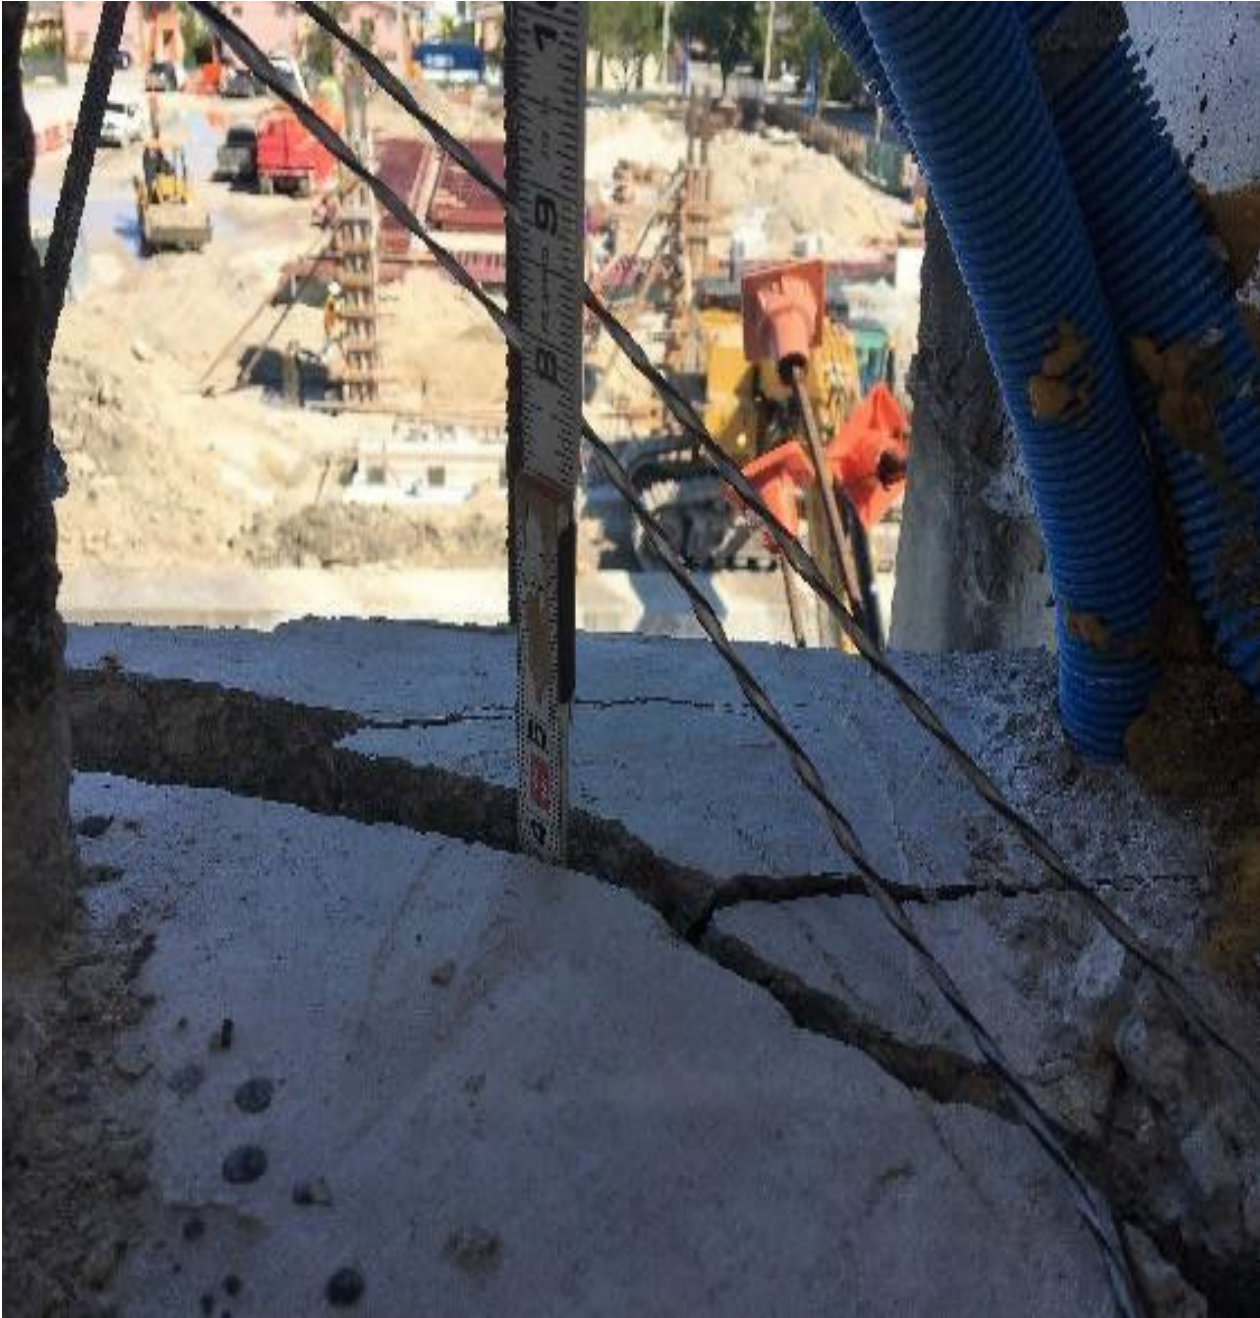
Figure 30 Notice the depth and width of diagonal cracks at the west side of diaphragm II on 3/14/2018
by BPA

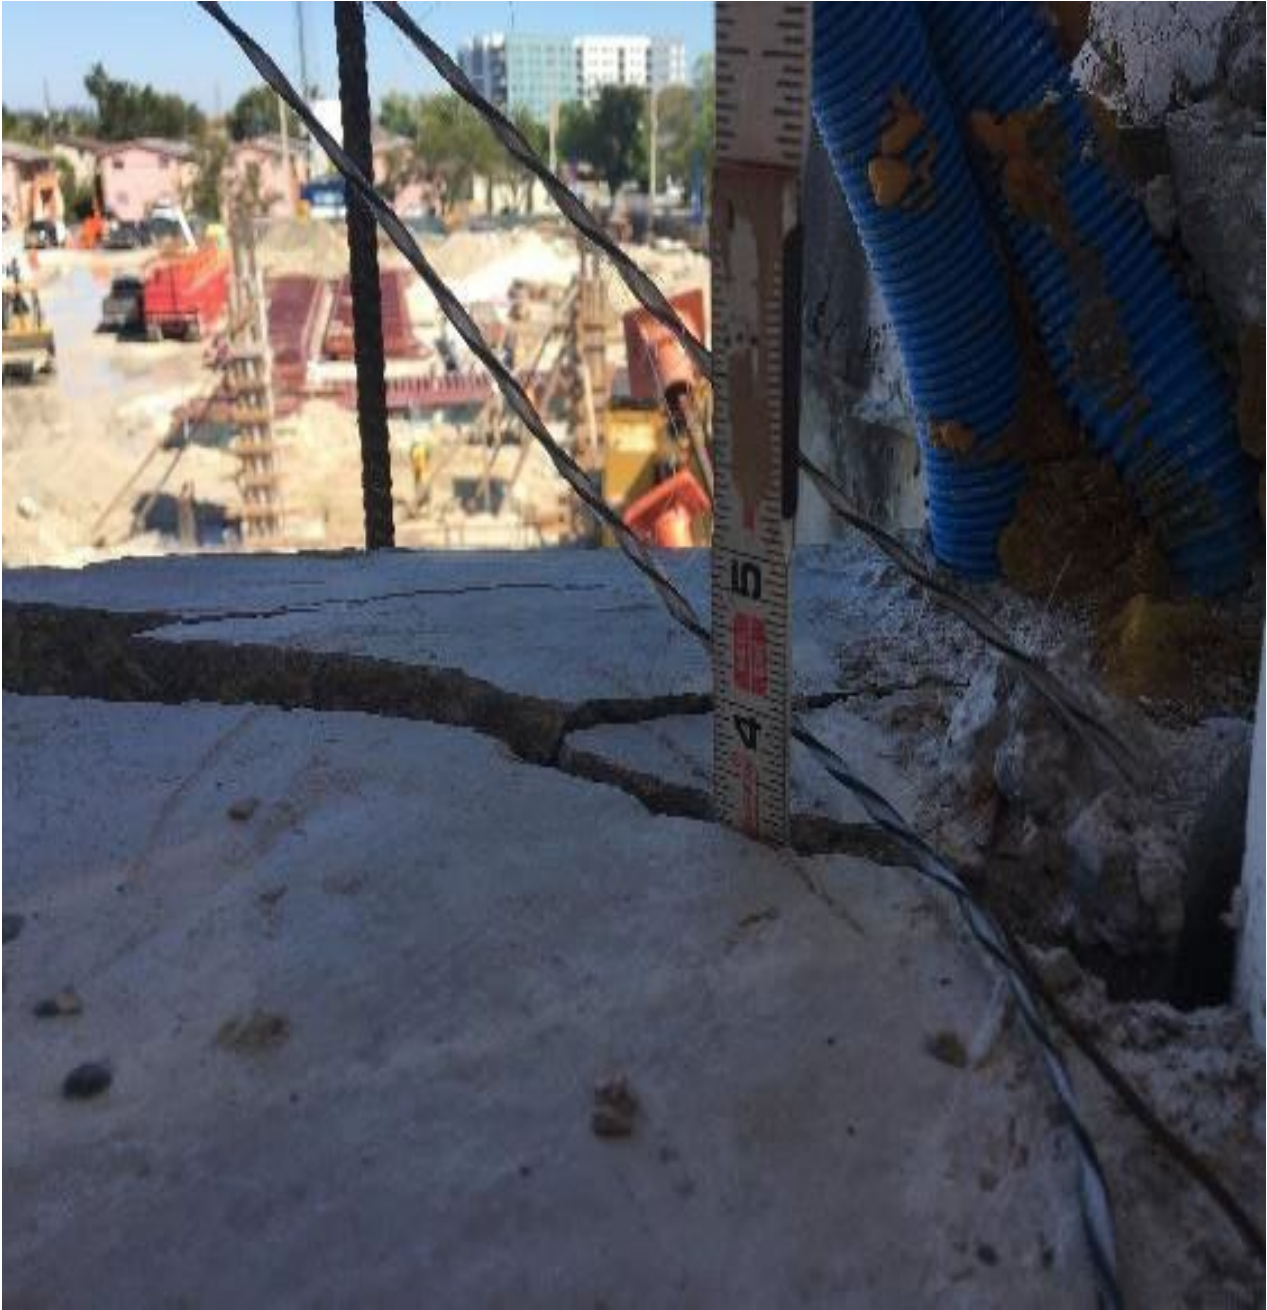
Figure 31 Notice the depth and width of cracks near column 12 at the west side of diaphragm II on
3/14/2018 by BPA

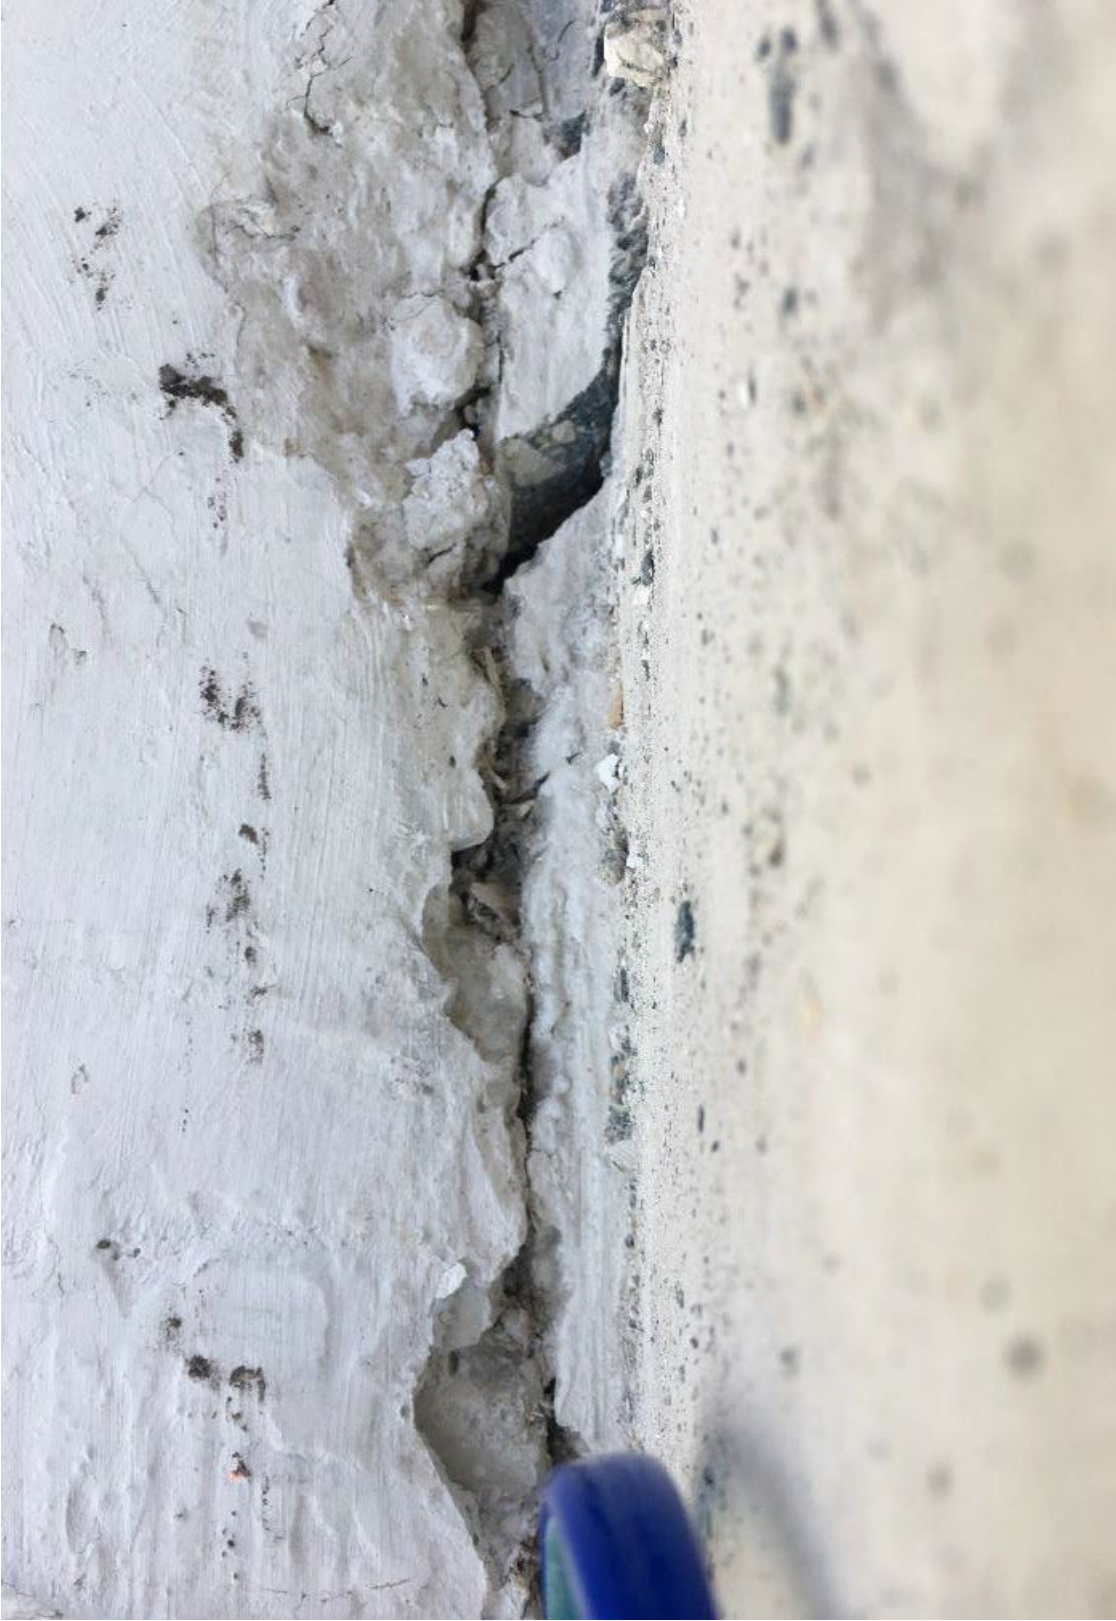
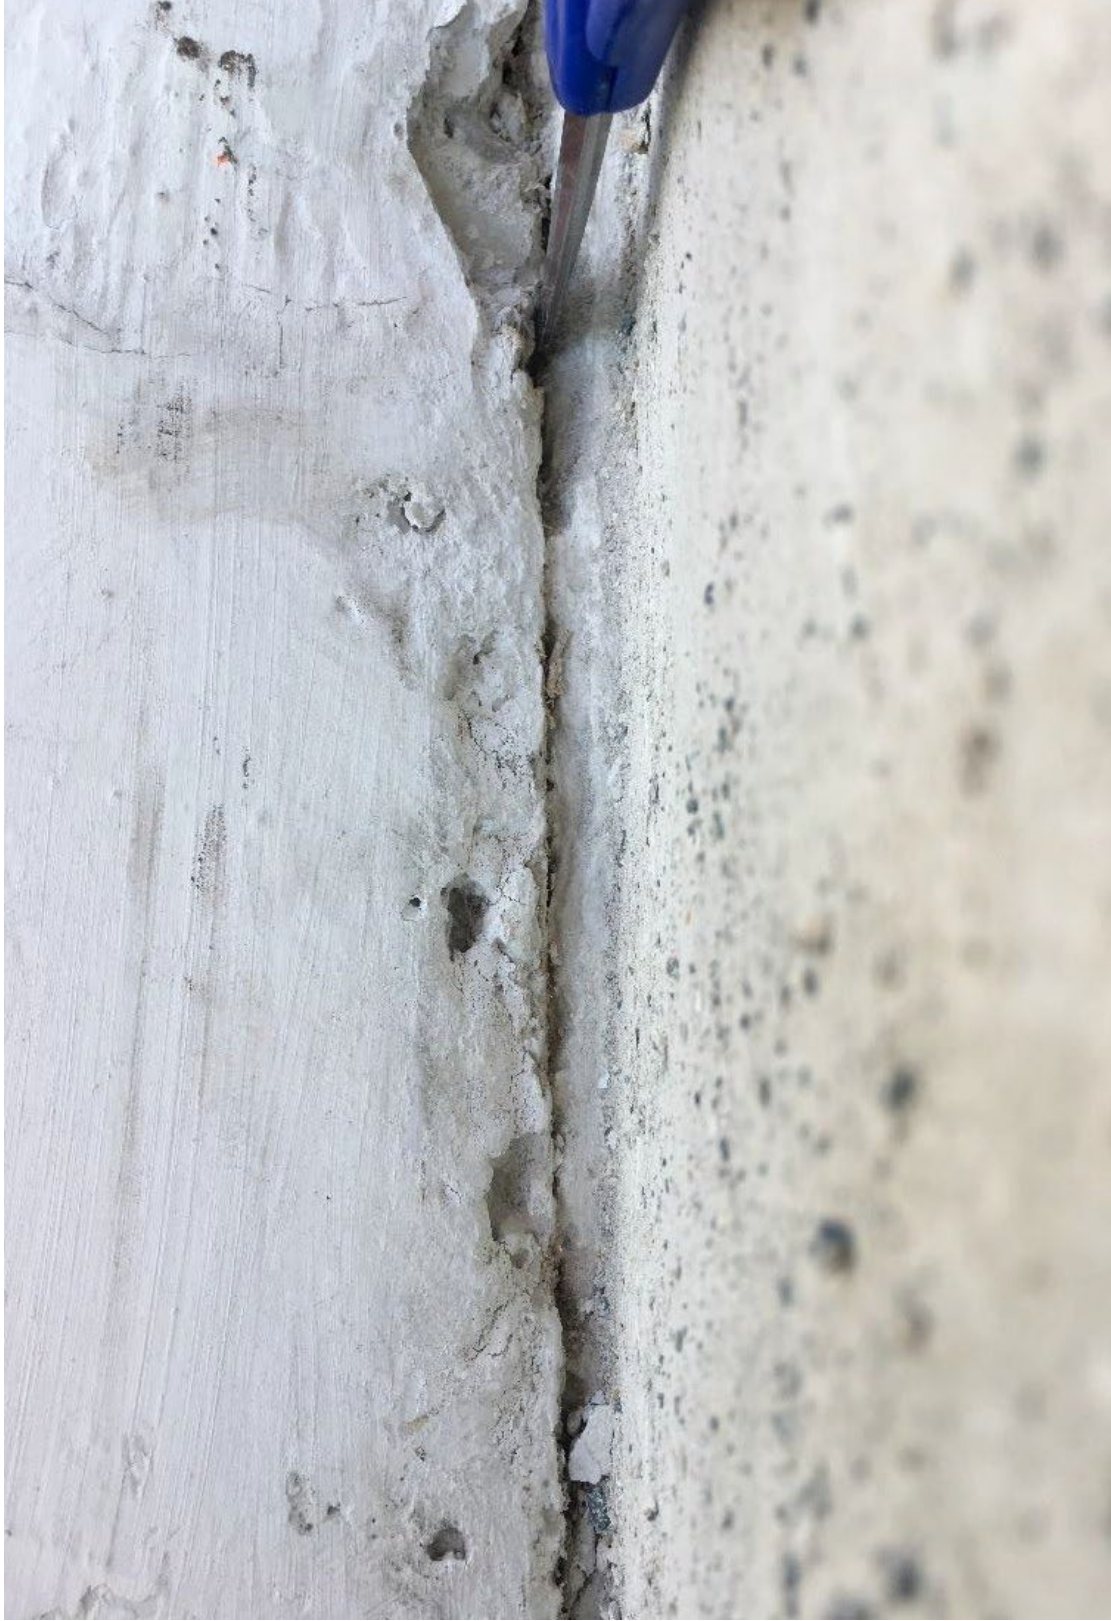
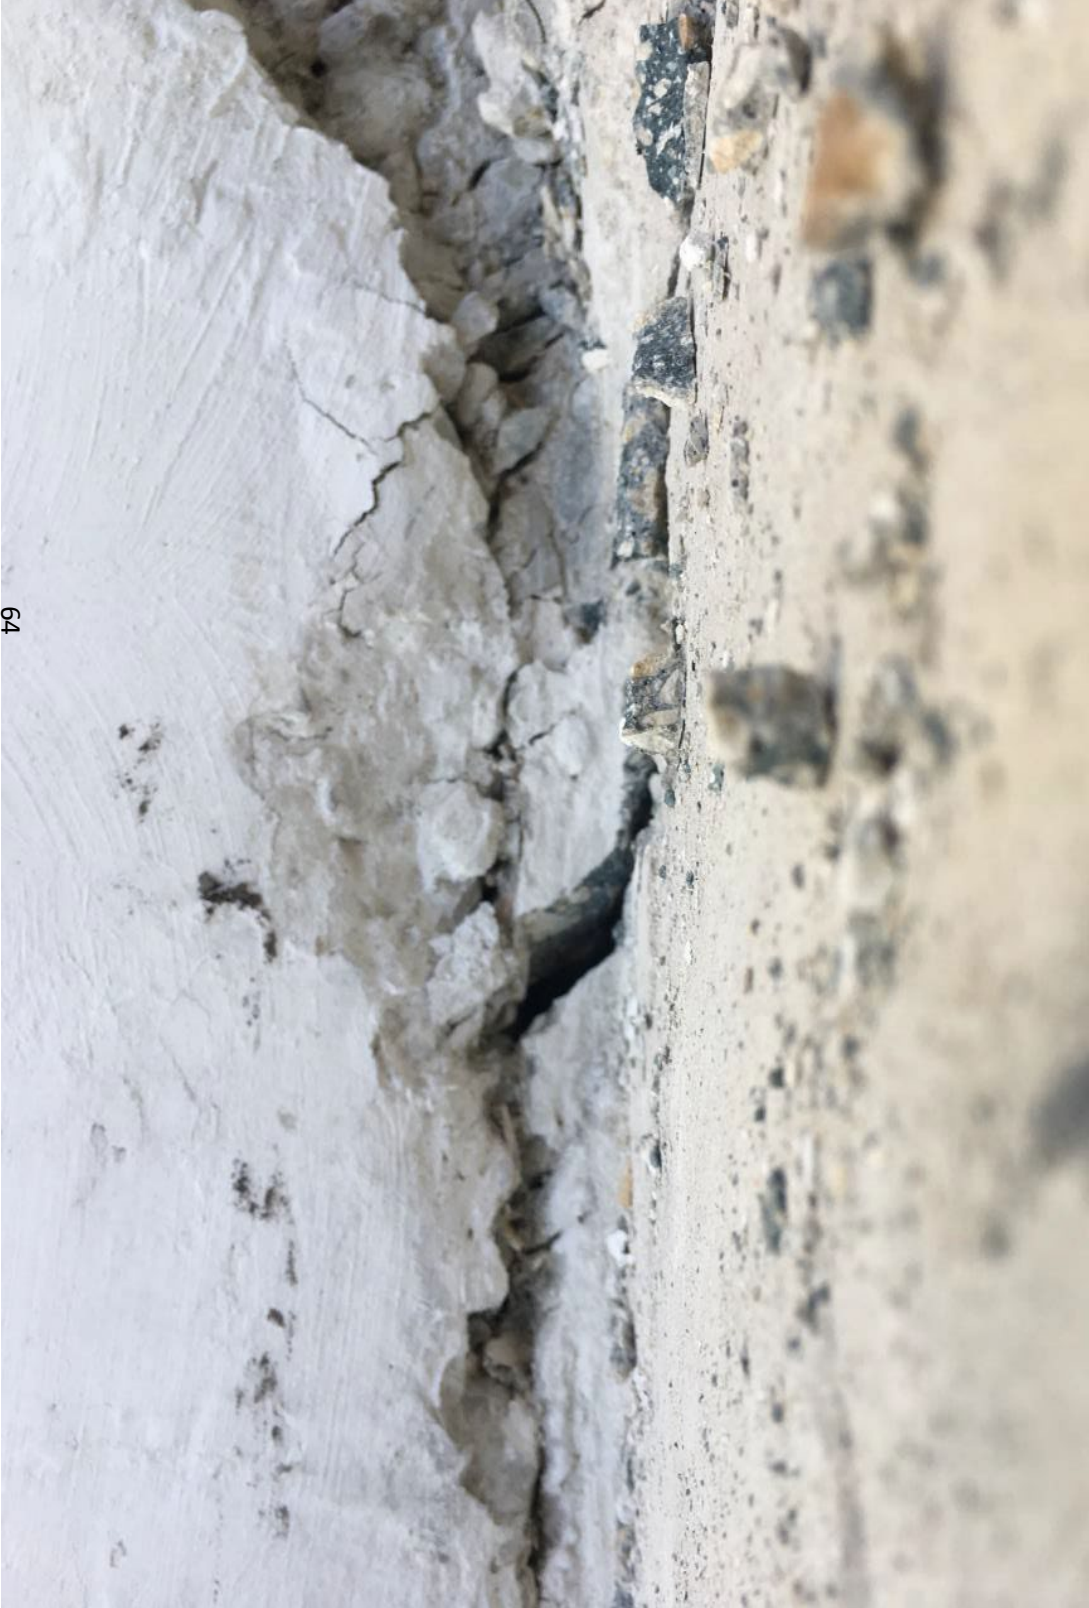
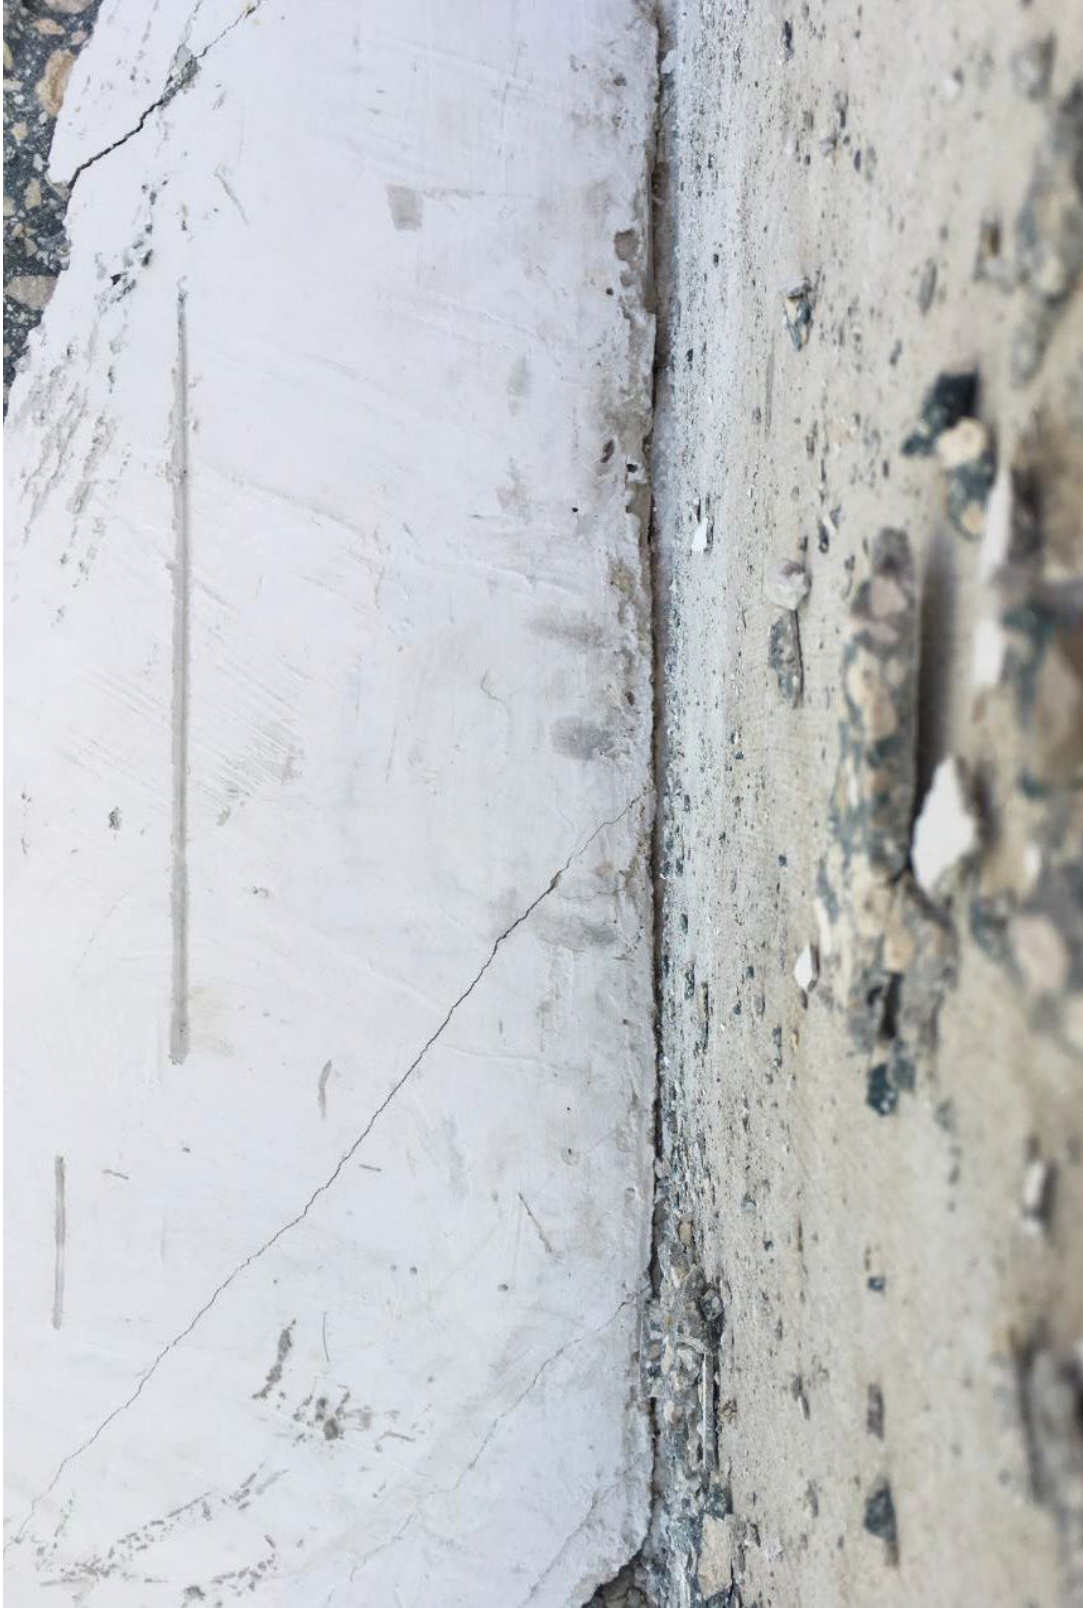
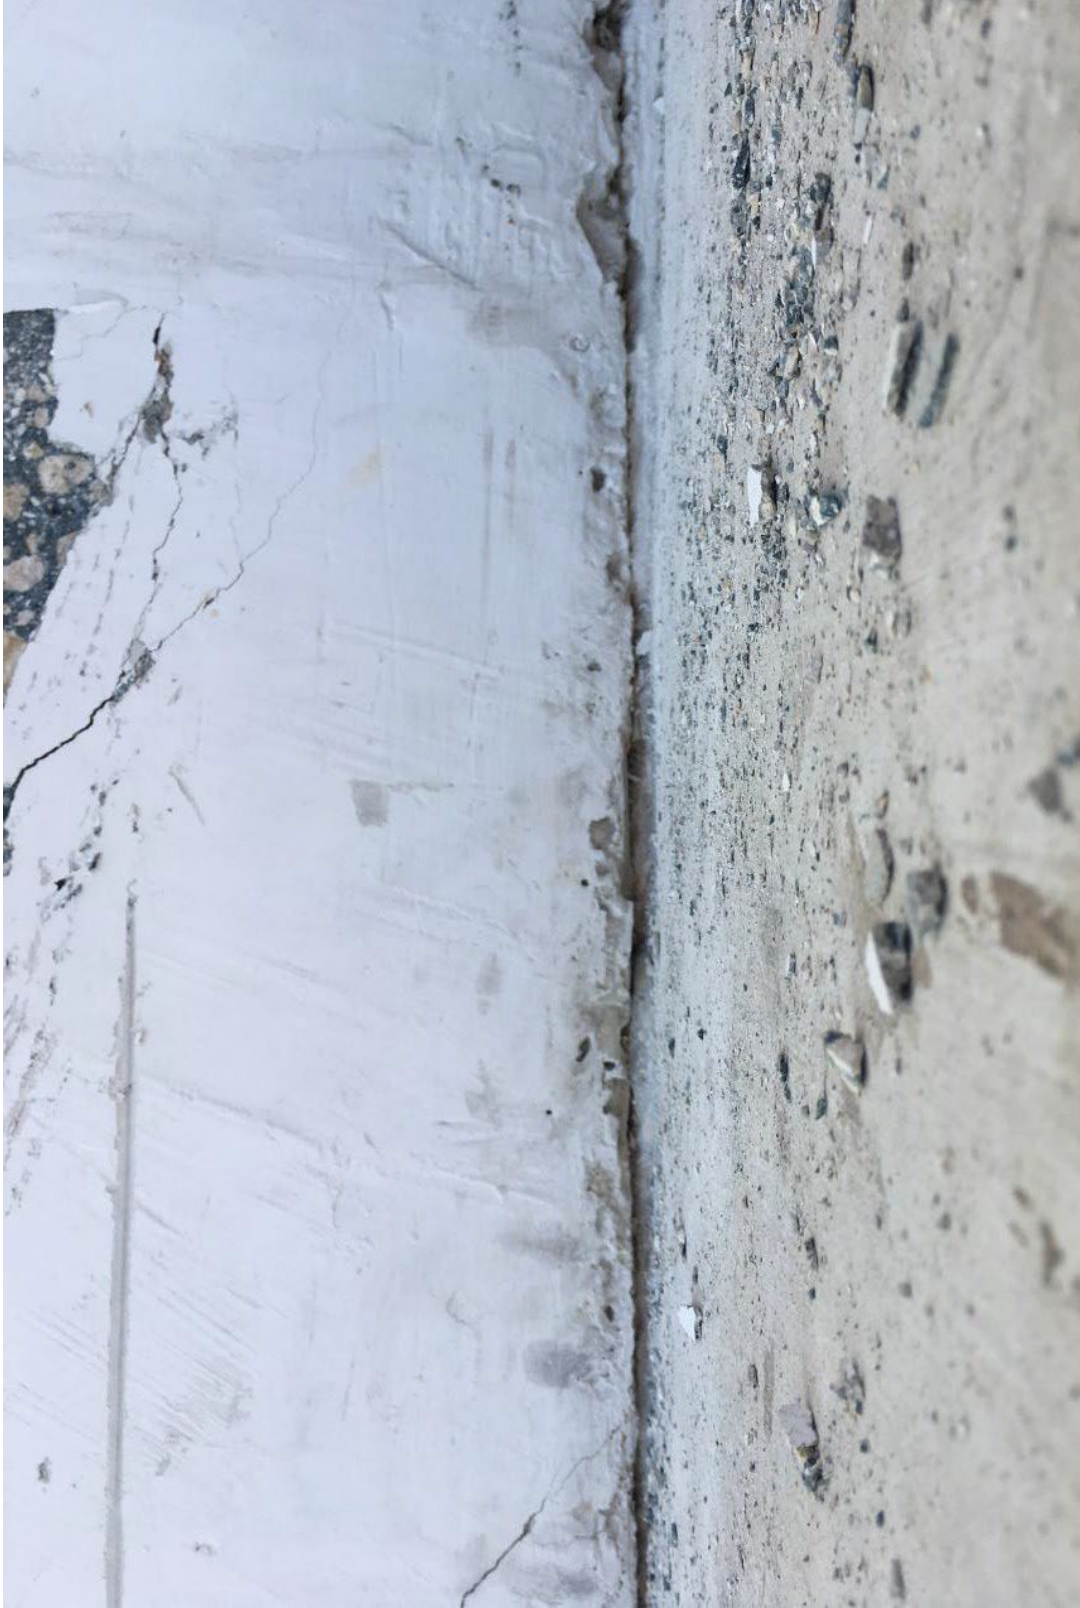
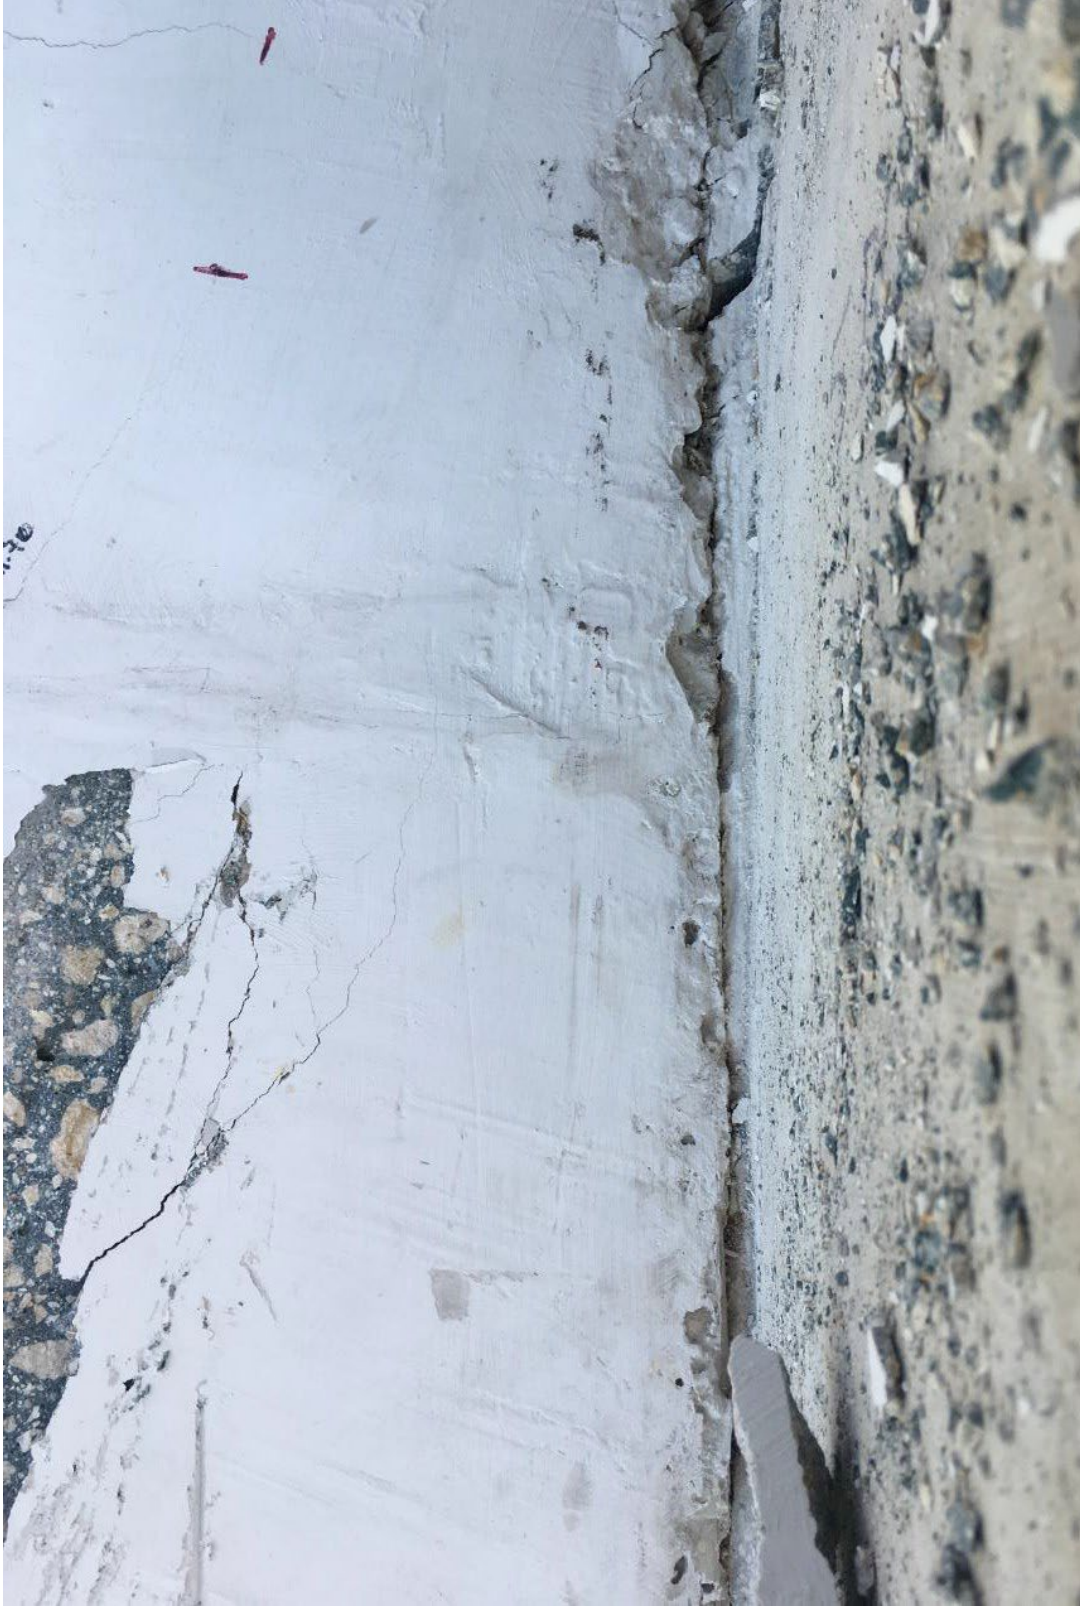
Figure 32 Cracks at the construction joint of the main span deck and diagonal 11 on 3/13/2018 by BPA

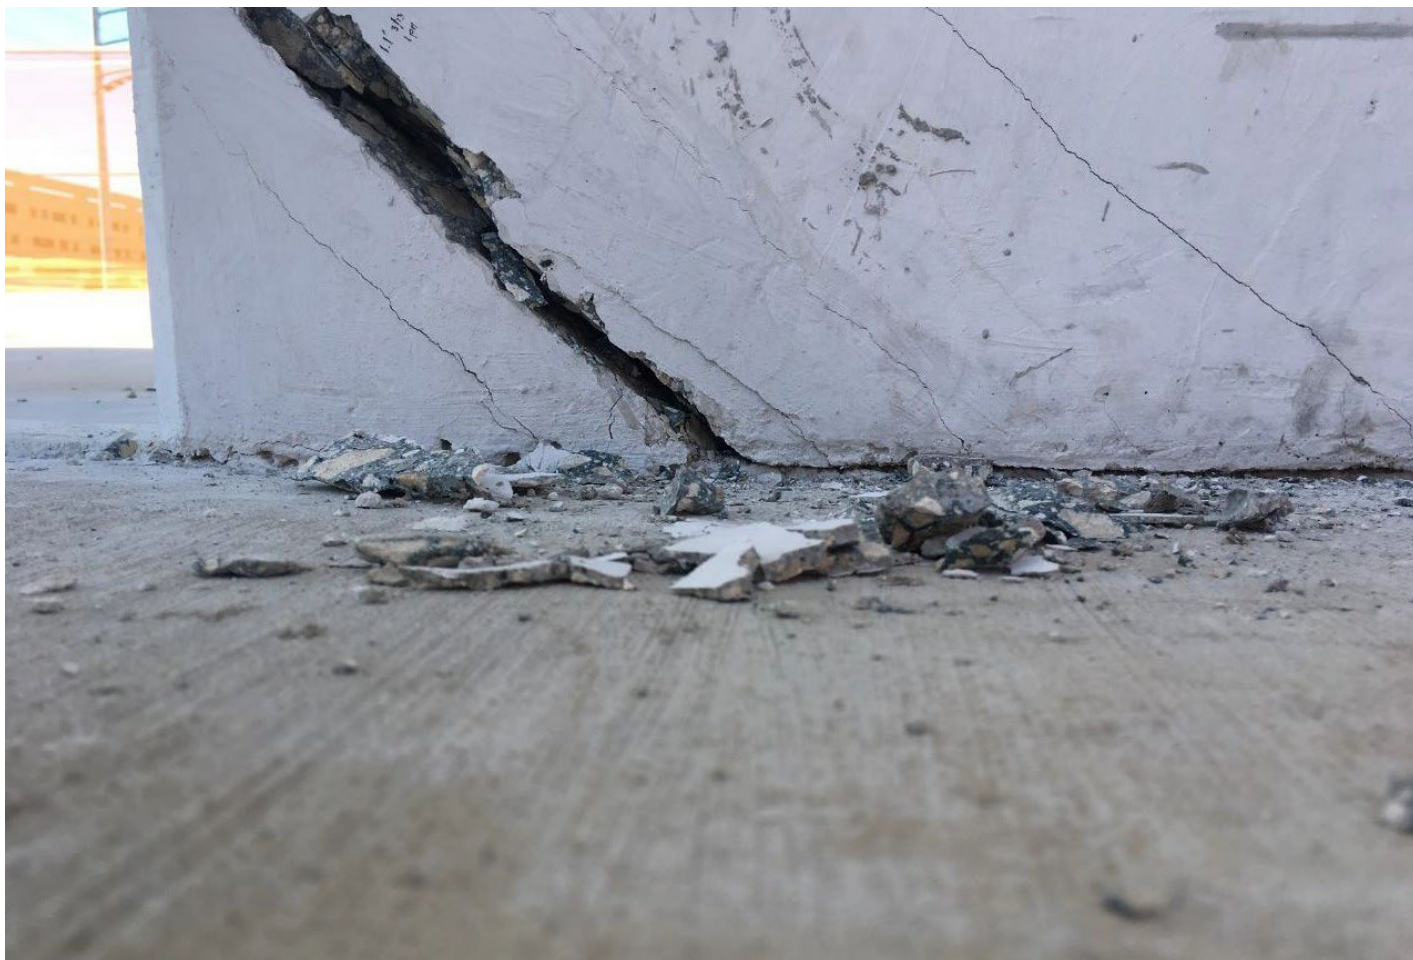
Figure 35 Cracks at the construction joint of the main span deck, diagonal 11 and the chamfer of diagonal 11 on 3/13/2018 by BPA

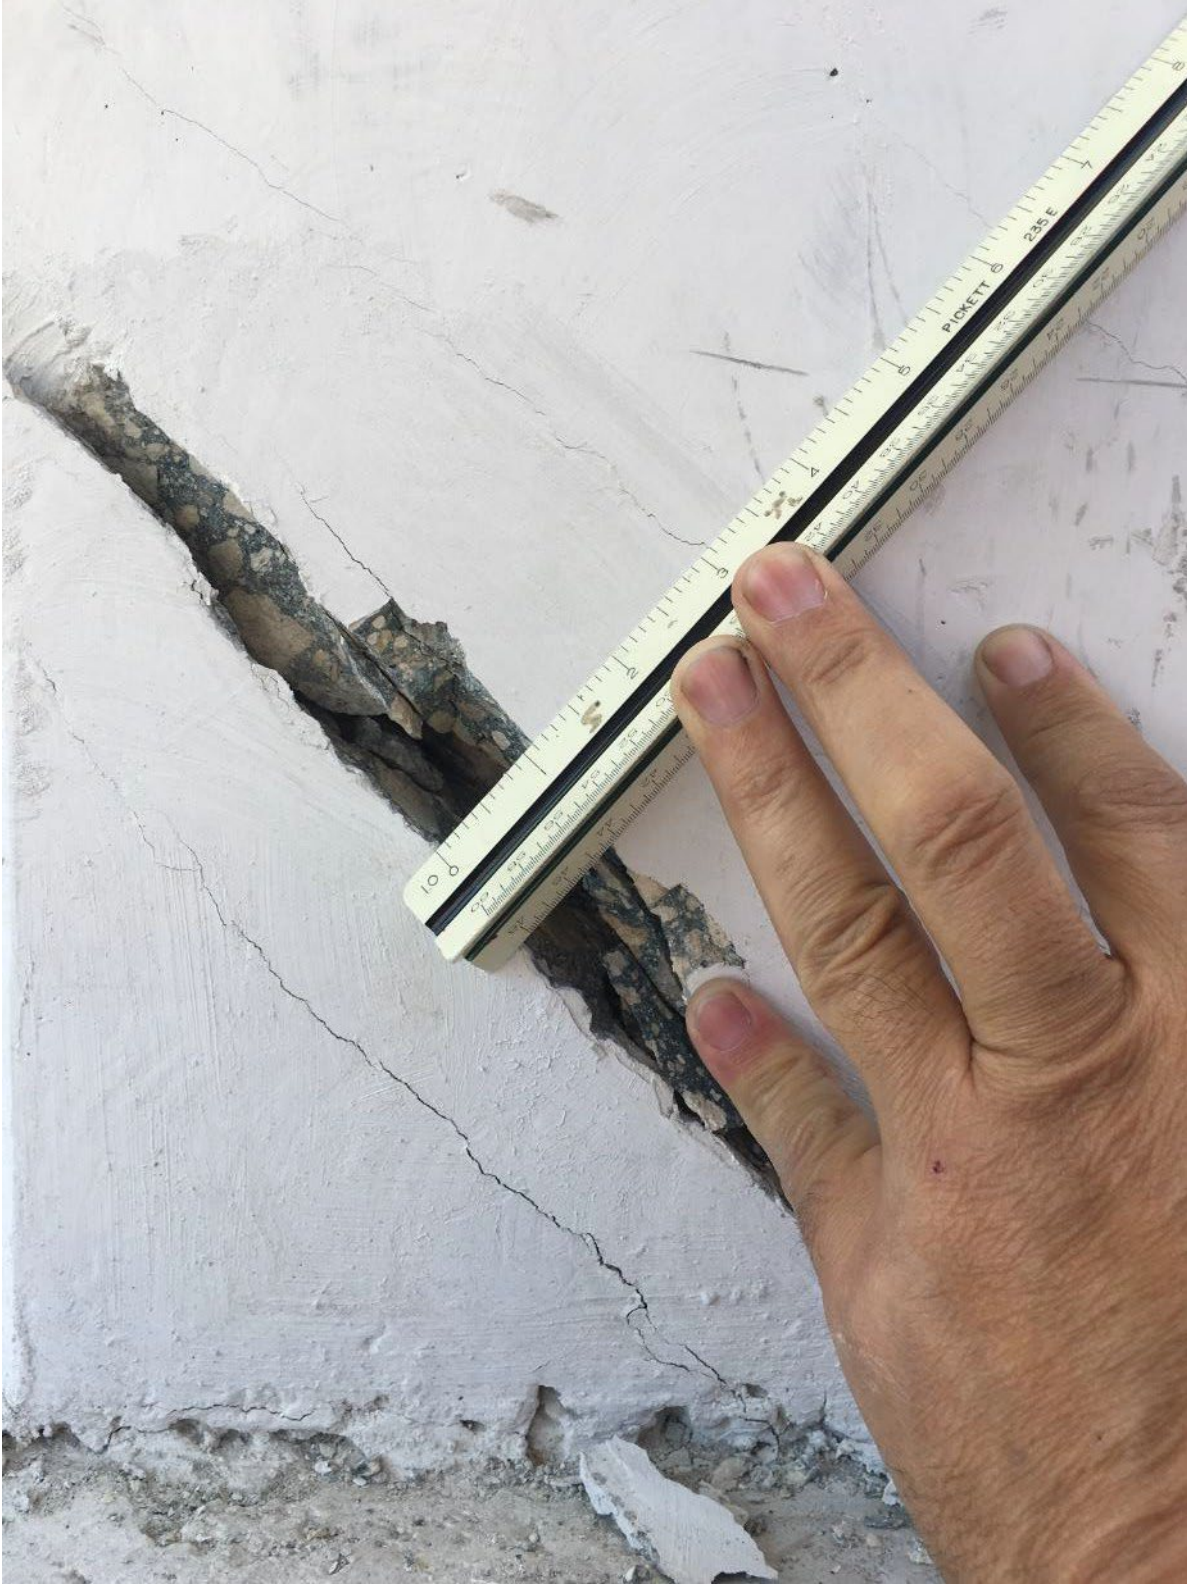
Figure 40 Close-up of longitudinal cracks in diagonal 11 on 3/13/2018 by BPA

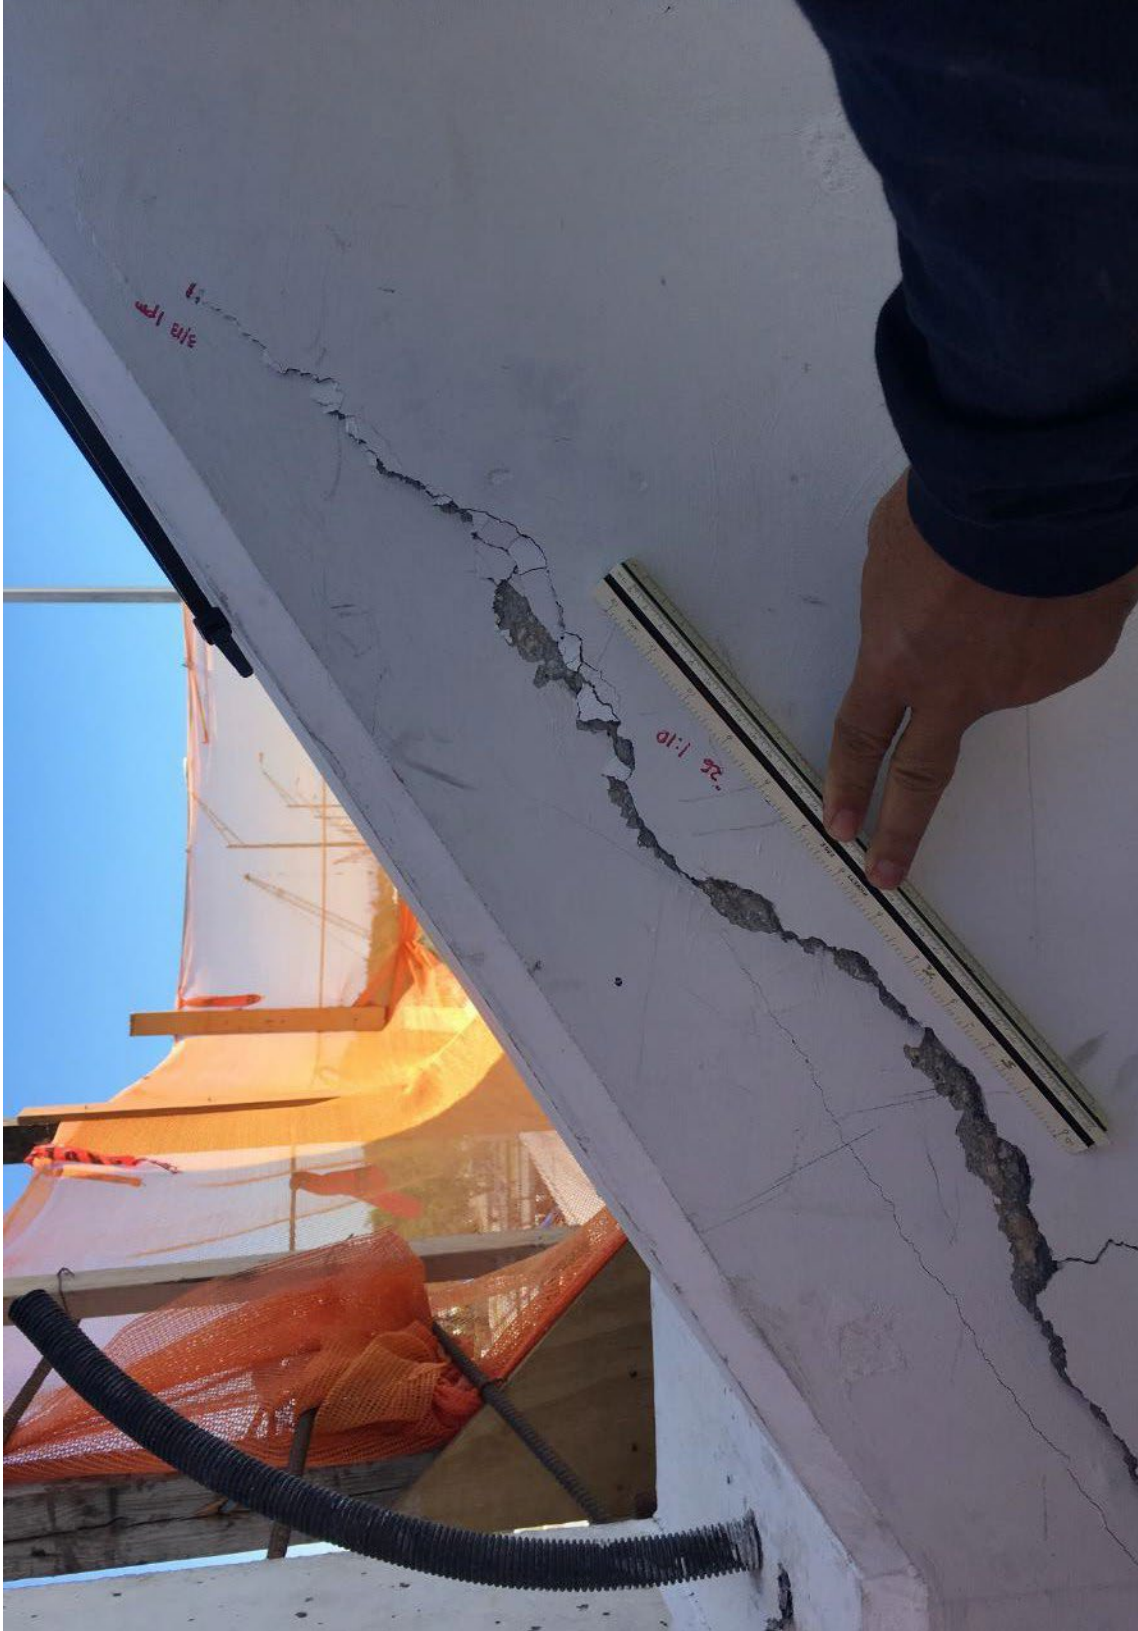
Figure 41 Close-up of longitudinal cracks in diagonal 11 on 3/13/2018 by BPA

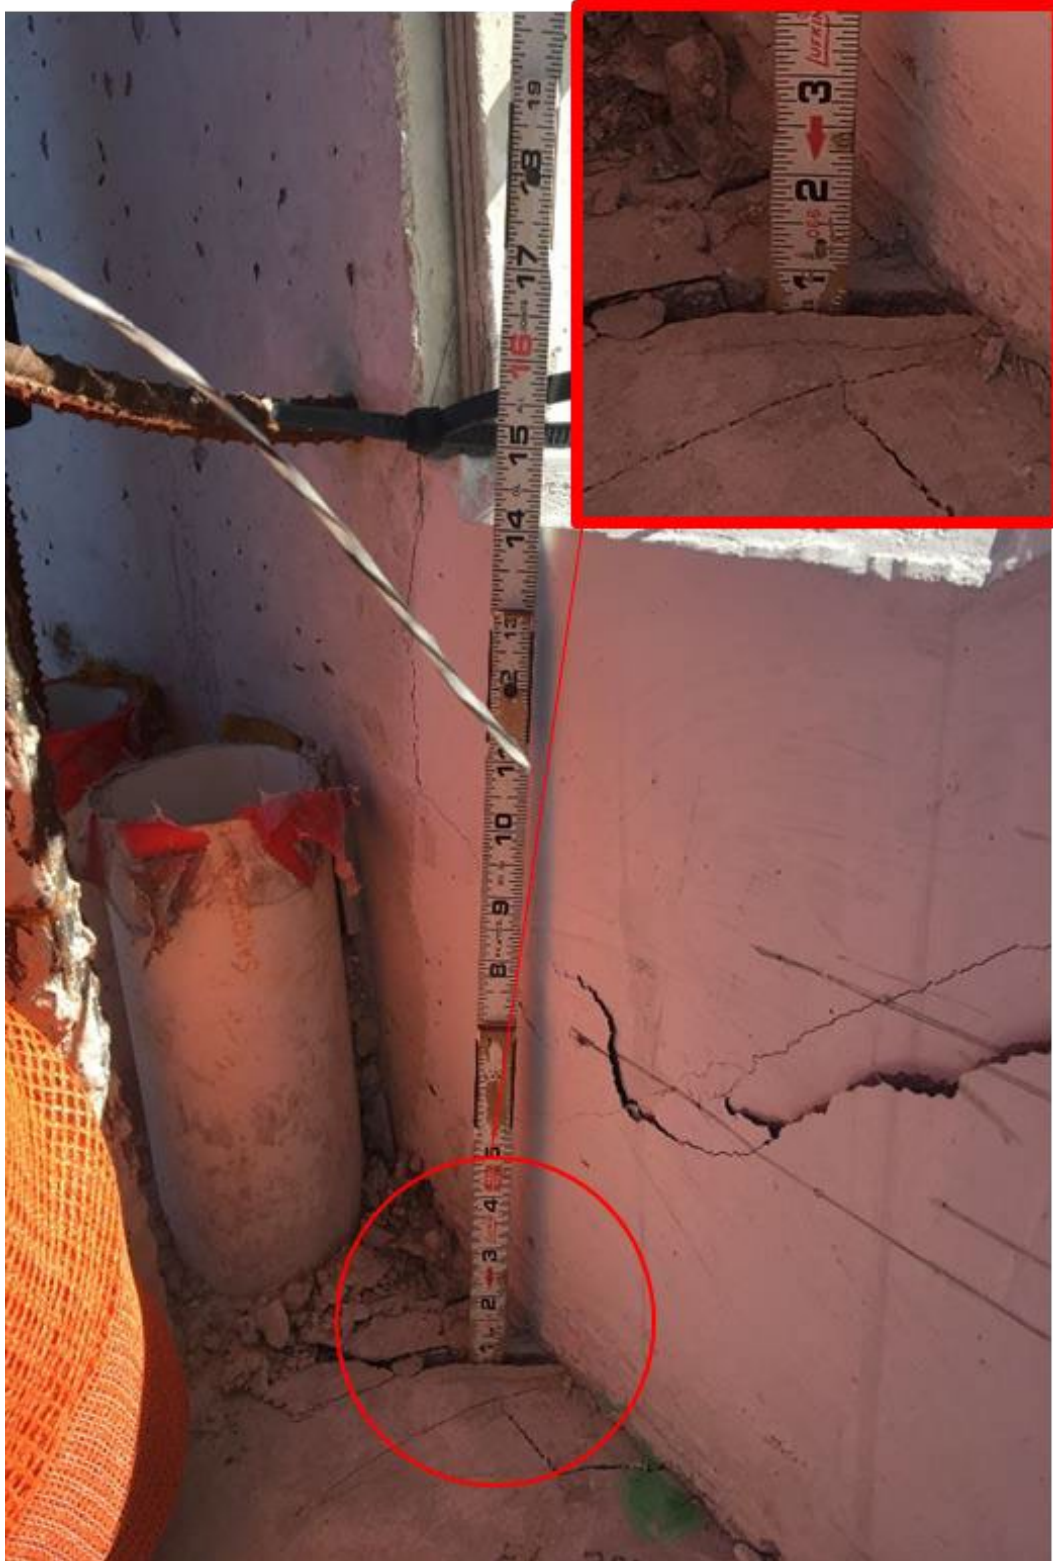
Figure 42 Cracks at the west side of diaphragm II on 3/14/2018 by BPA
