Pedestrian Bridge Collapse in Miami, Florida

1. Executive Summary

On March 15, 2018, at approximately 1:45 p.m., a pedestrian bridge under construction in Miami, Florida, collapsed. One employee and five motorists were fatally injured, and another employee permanently disabled, when the bridge fell as the motorists waited for the traffic light underneath the bridge and as the employees were performing work activities on top of the bridge structure. The bridge at the present stage of construction consisted of a single concrete truss spanning approximately 174 feet and weighing approximately 930 tons. It was placed over the piers just five days prior to the collapse. An adjoining span of concrete truss was to be constructed next over the canal to make a continuous bridge of 289 feet. The concrete bridge was cast at a nearby off-site location using what is known as Accelerated Bridge Construction (ABC) and then transported to its final location. ABC provides minimal traffic disruption. The bridge was financed through federal grants, and constructed at the campus of Florida International University (FIU) in Miami. The FIU project was a class A Local Agency Program (LAP) project. The

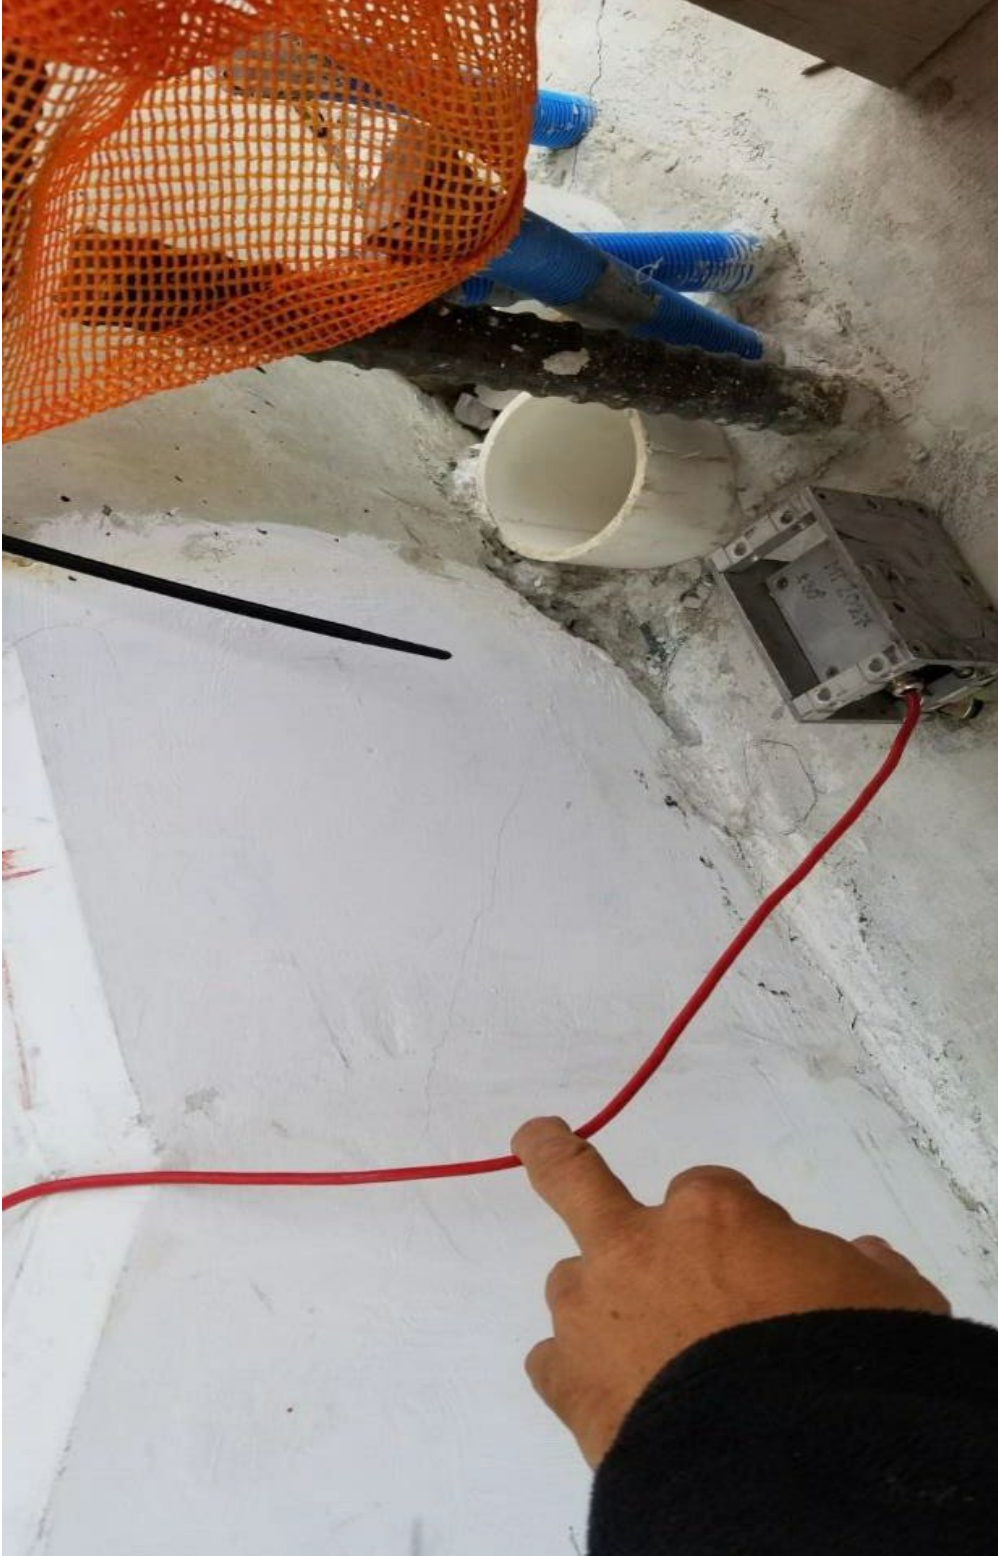
Figure 43 Cracks at the east side diaphragm II on 3/10/2018 – top face, by Corradino

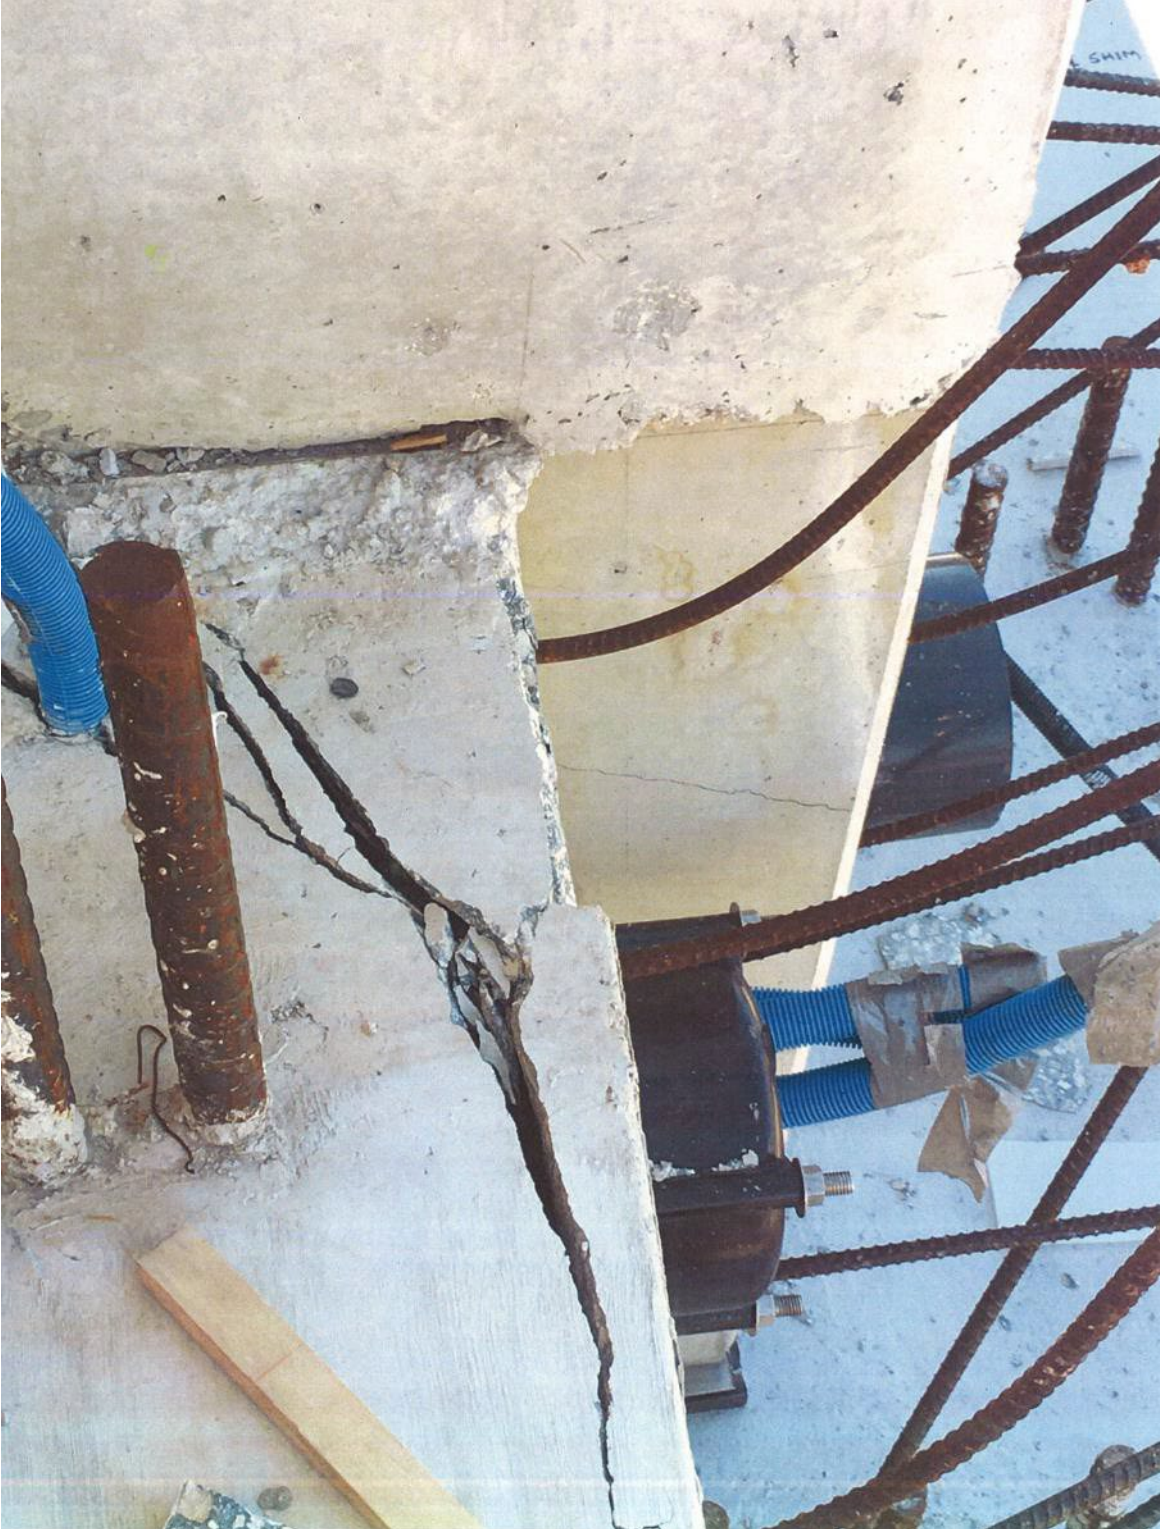
Figure 44 Cracks and movement of the column at the east side of diaphragm II on 3/14/2018 by
BPA

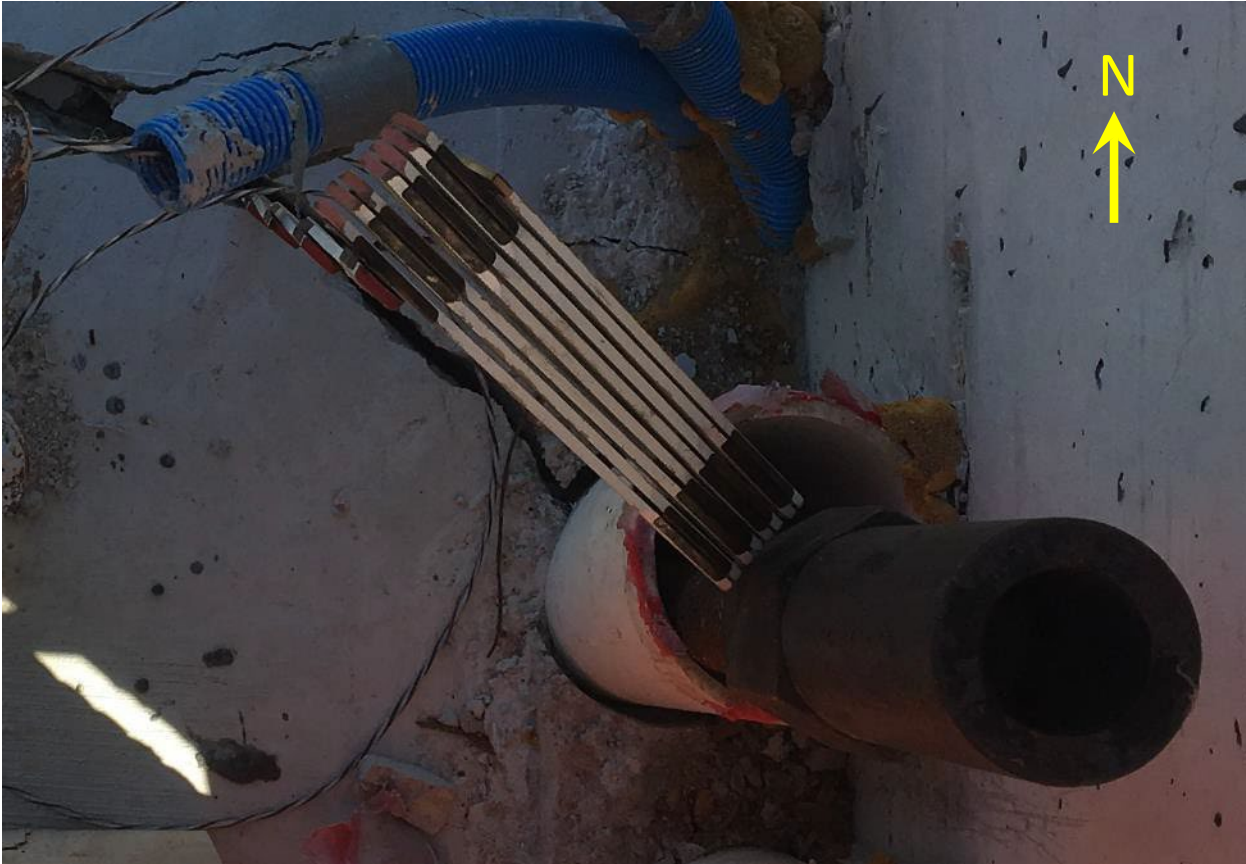
Figure 45 Note the gap indicative of movement between sleeve pipe and concrete, pictured on 3/13/2018 by
BPA

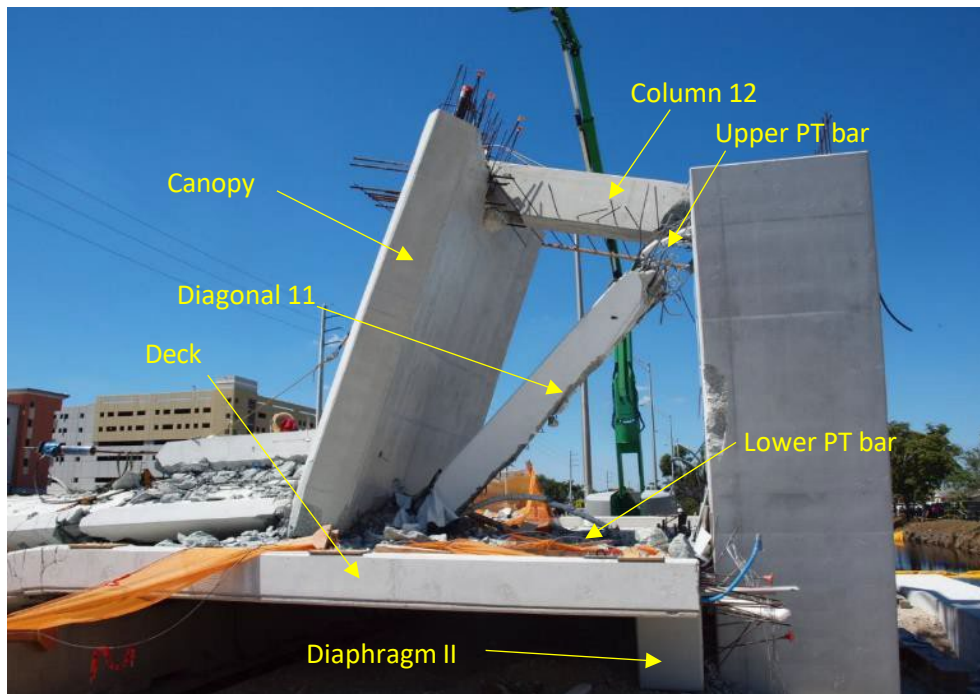
Figure 52 Column 12, diagonal 11 and part of the canopy after bridge deck and diaphragm fell to the ground, March 17, 2018, by OSHA
 FDA, Inc.

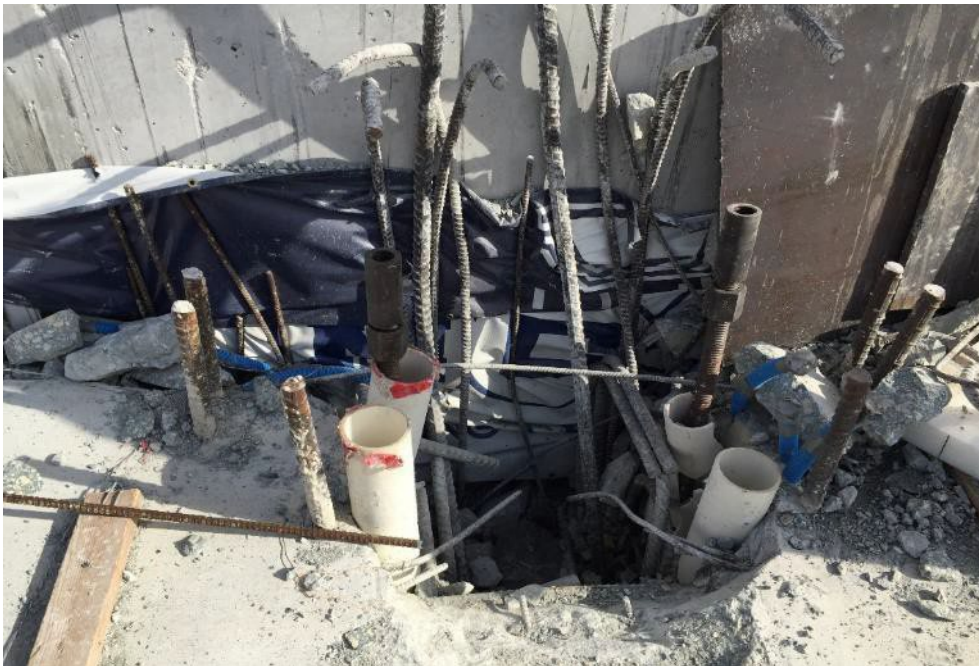
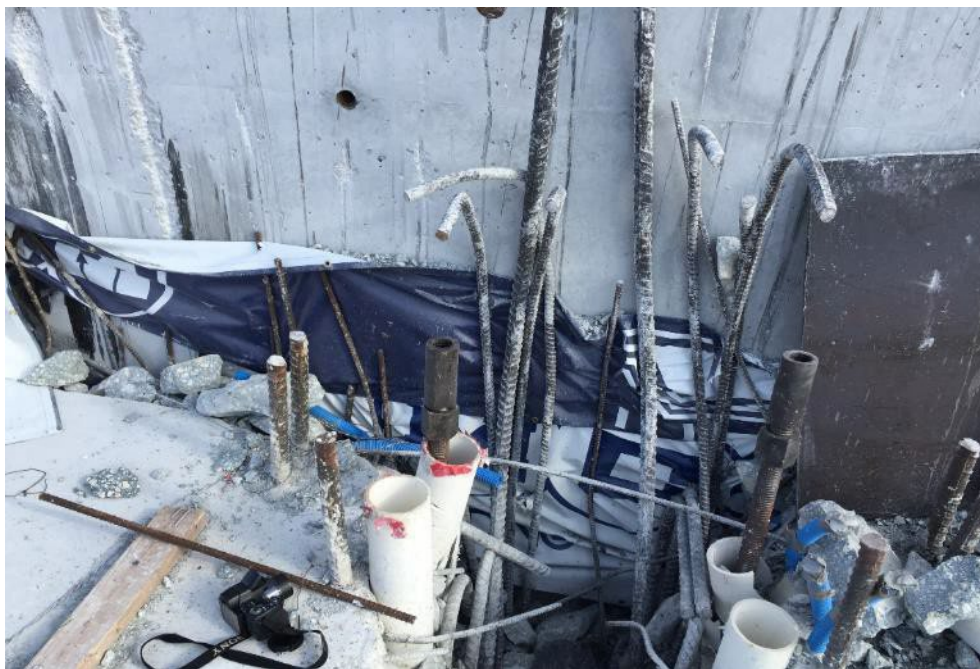
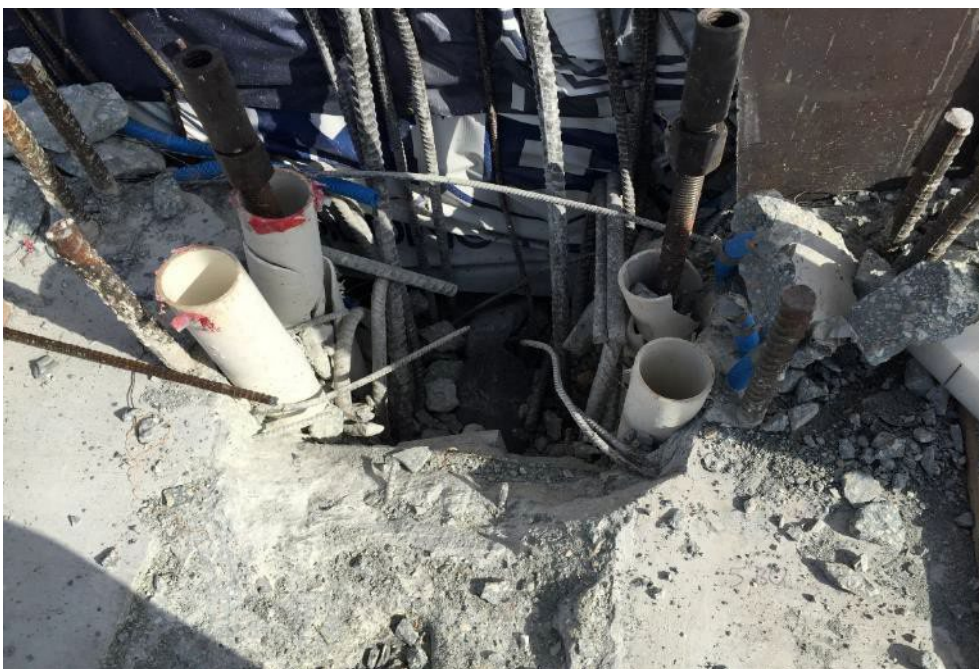
Figure 58 Concrete blow-out failure in Diaphragm II at the time of bridge collapse at the site looking north from south, March 21, 2018, by OSHA

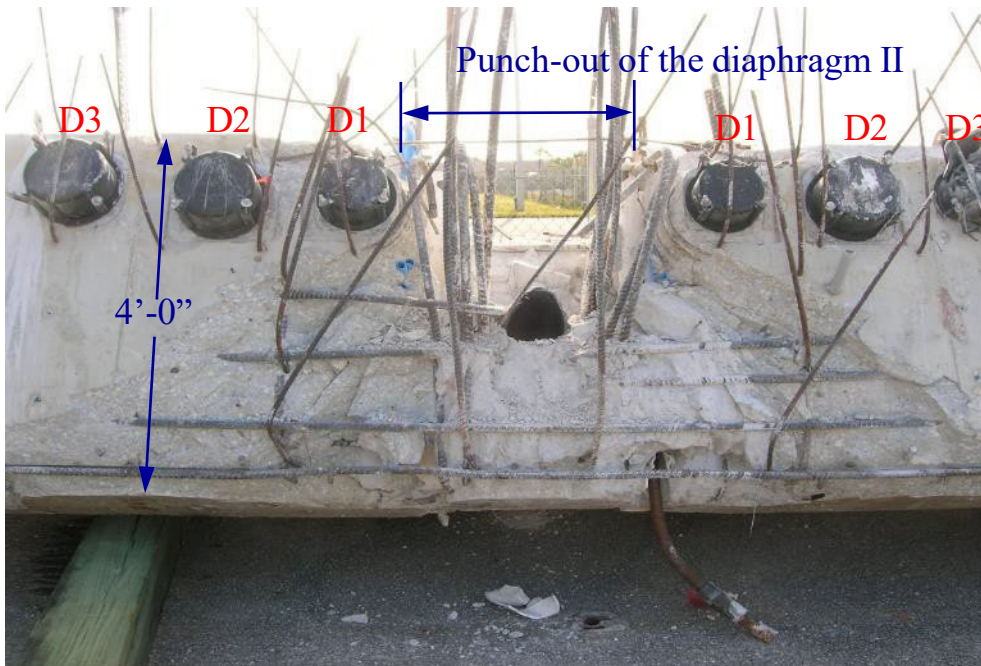
Figure 62 Concrete blow-out failure in Diaphragm II at the time of bridge collapse in the storage yard looking north from south, April 9, 2018, by OSHA

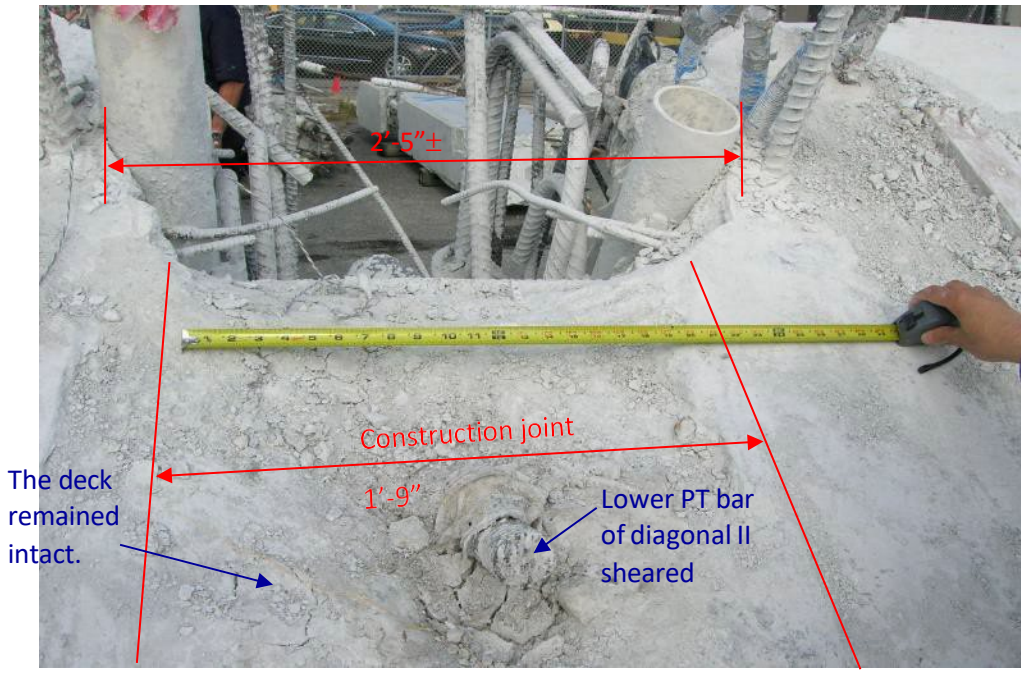
Figure 63 Blow-out hole in Diaphragm II at the time of the bridge collapse in the storage yard looking north from south, April 9, 2018, by OSHA

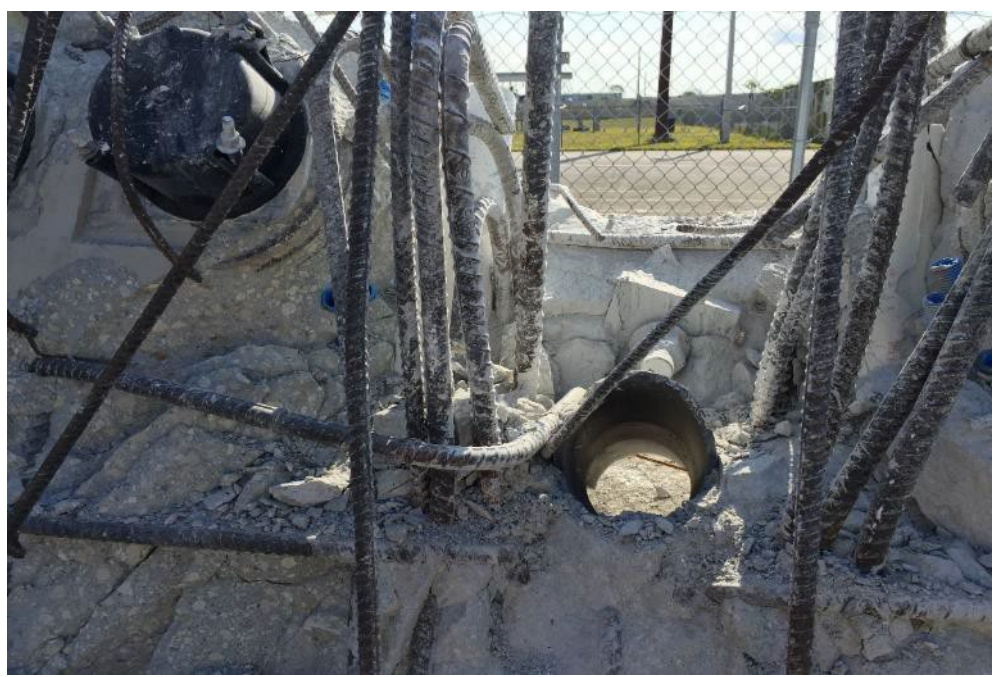
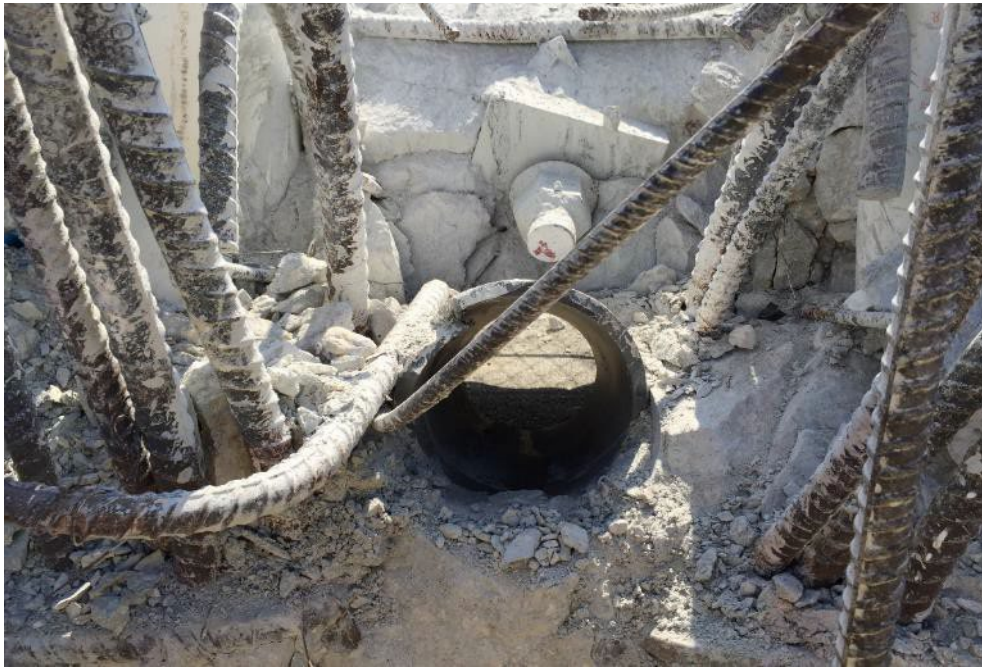
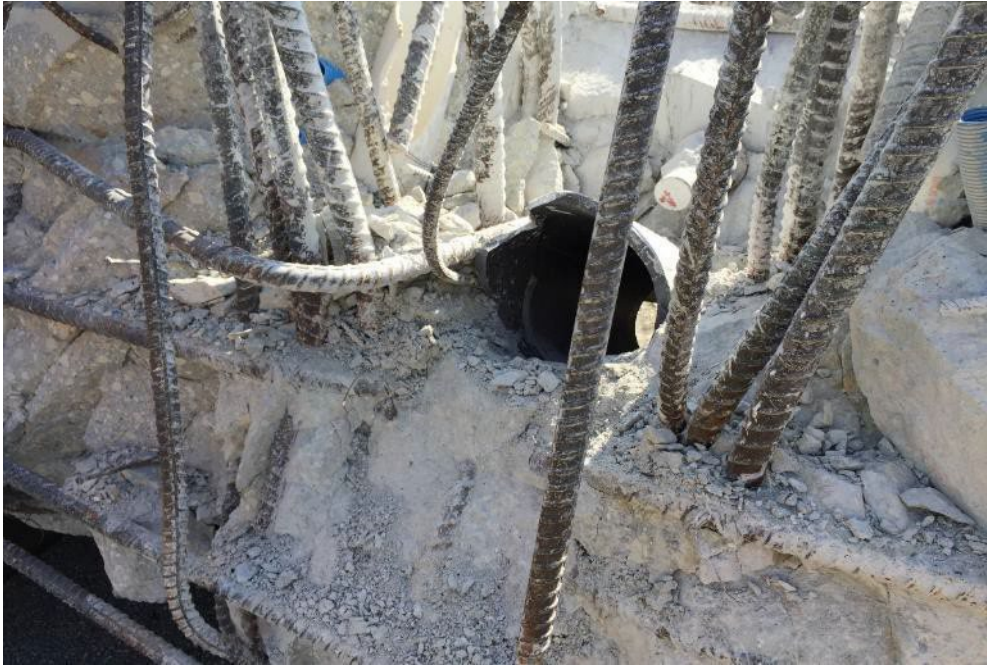
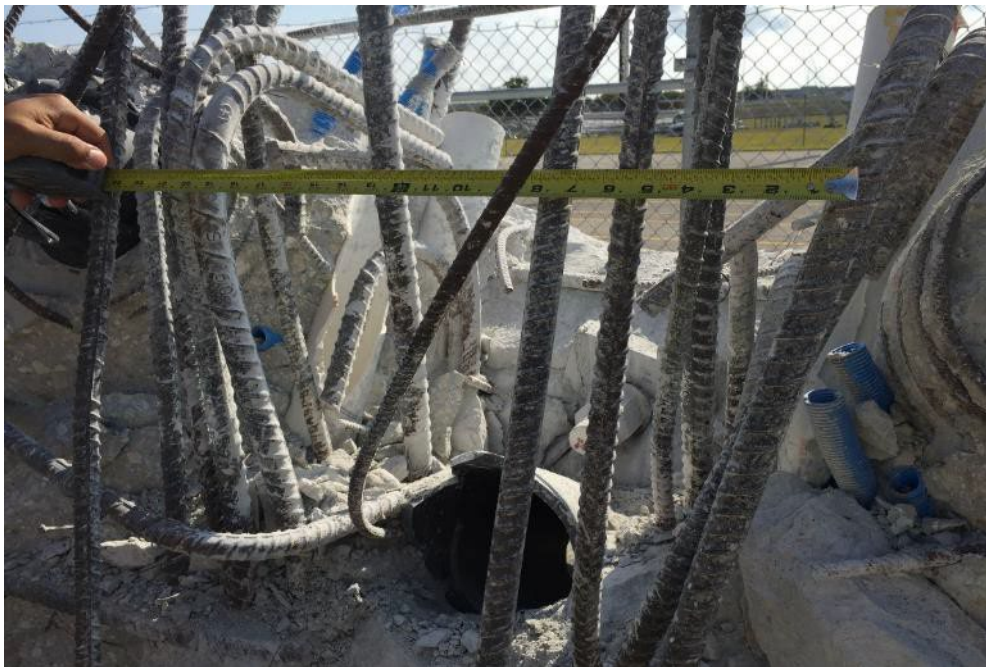
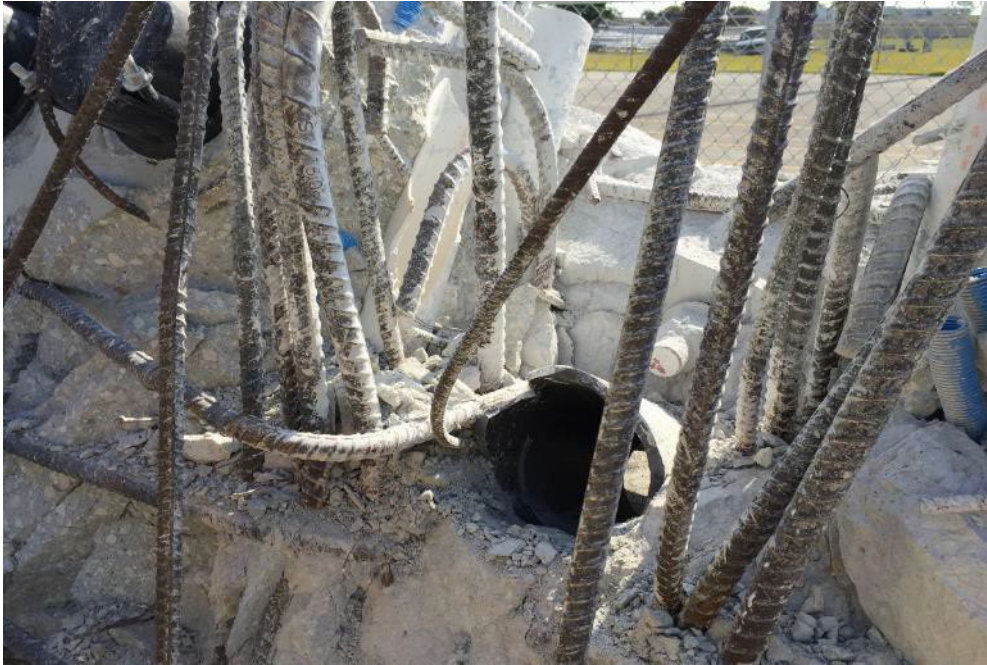
Figure 67 Punched hole in Diaphragm II at the time of the bridge collapse – from south looking towards north, April 9, 2018, by OSHA

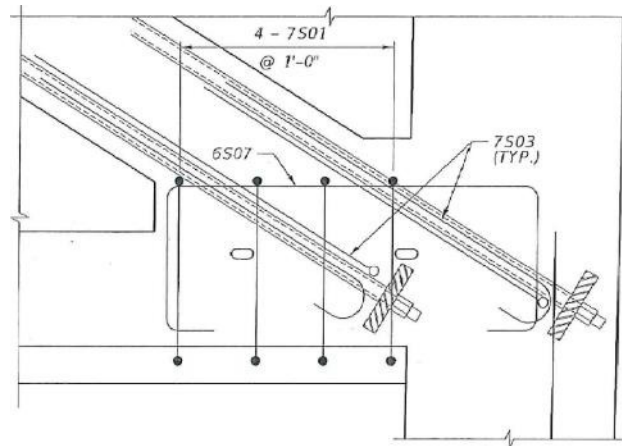
Reproduced below in Figure 77 is the detail entitled “Truss members 11 & 12 connection detail” from drawing B-61 with construction joint identified. Industry standard is to “consider shear transfer across a given plane, such as an existing or potential crack, an interface between dissimilar materials or an interface between two concrete cast at different times.” The construction joint at the bottom of the diagonal 11, therefore, qualifies for evaluation of the shear friction. This bridge is a concrete truss bridge weighing approximately 1,900 kips. Therefore the forces in the truss members are high. We will analyze the construction joint for shear friction by LRFD Bridge Design Specifications by AASHTO, seventh edition.

Figure 77 Construction joint detail at diagonal 11 and deck.

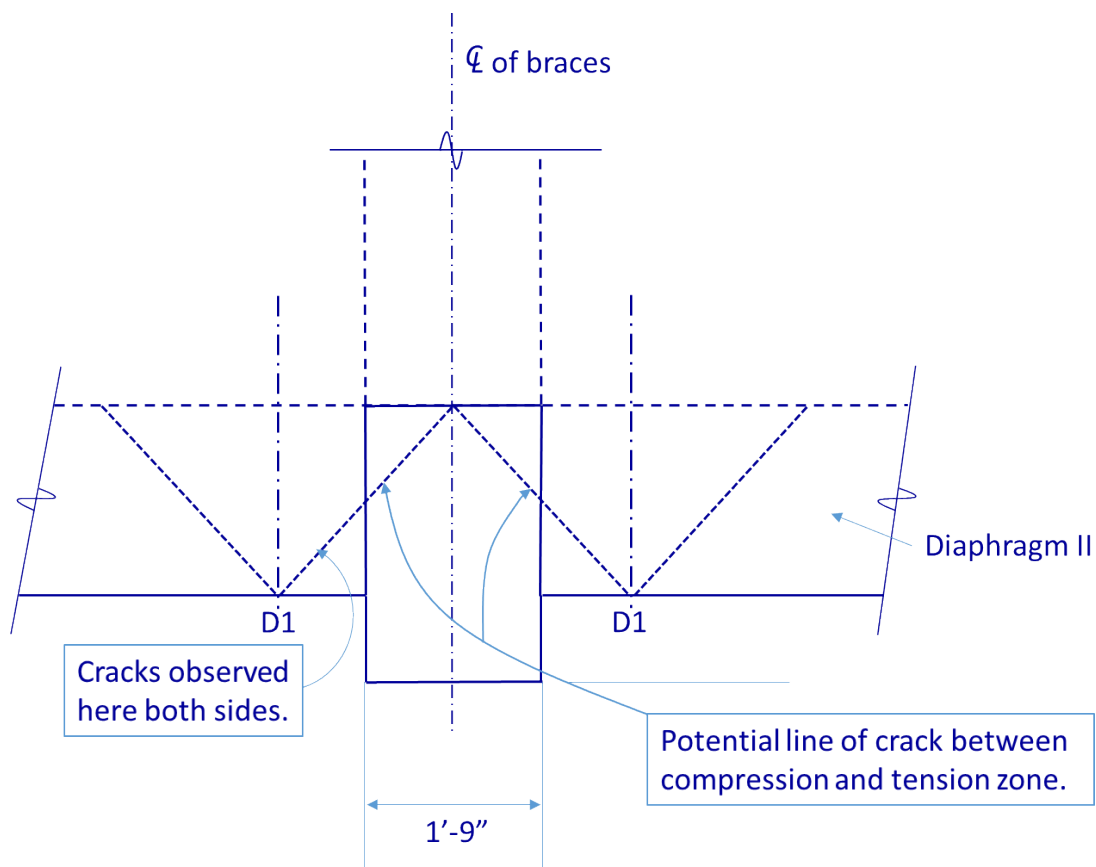
A 12" dia. semicircular cut was made in the center of the deck to accommodate an 8" round drain pipe. This not only reduced the cross sectional area of the deck at the key location but prevented the placement of any PT tendons or heavy mild reinforcement to capture the horizontal force from the deck. There was a 4" and 4½" diameter plastic pipe placed right against the columns in diaphragm II. Such locations often act as a crack initiator.

Figure 78 Potential line of crack – plan view

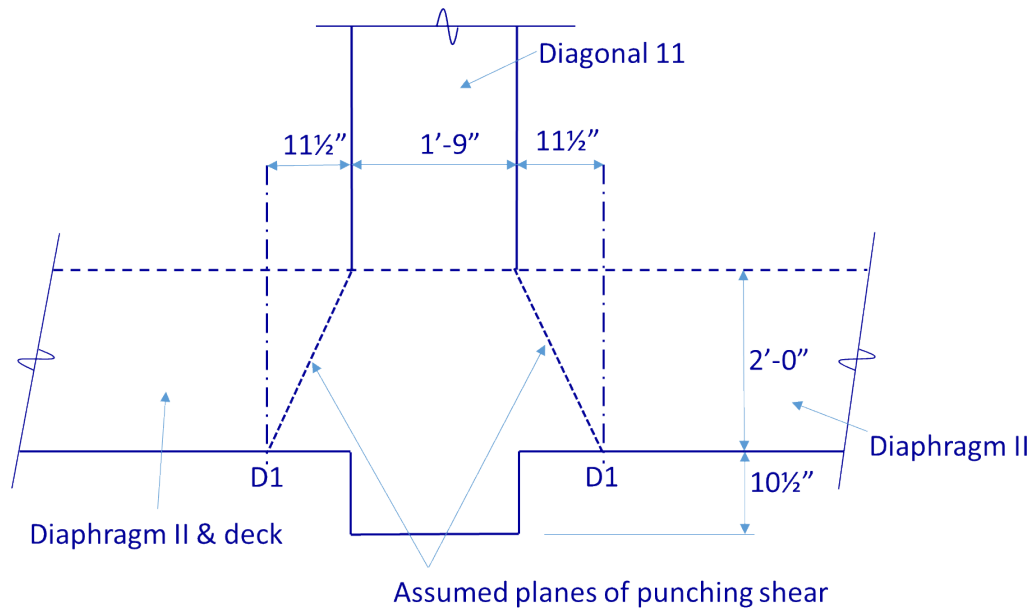
Figure 79 Potential Punching shear failure at north end – plan view
