U.S. Department of Labor  
Occupational Safety and Health Administration  
Directorate of Construction

# **Structural Investigation of the January 20, 2014 Plant Collapse at International Nutrition Facility in Omaha, NE**

July 2014

Report Prepared by  
Mohammad Ayub, P.E., S.E.  
Office of Engineering Services  
Directorate of Construction

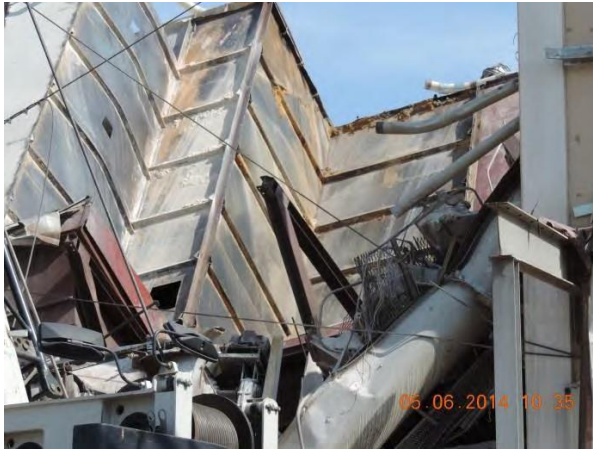
**Fig. 10** Bin construction

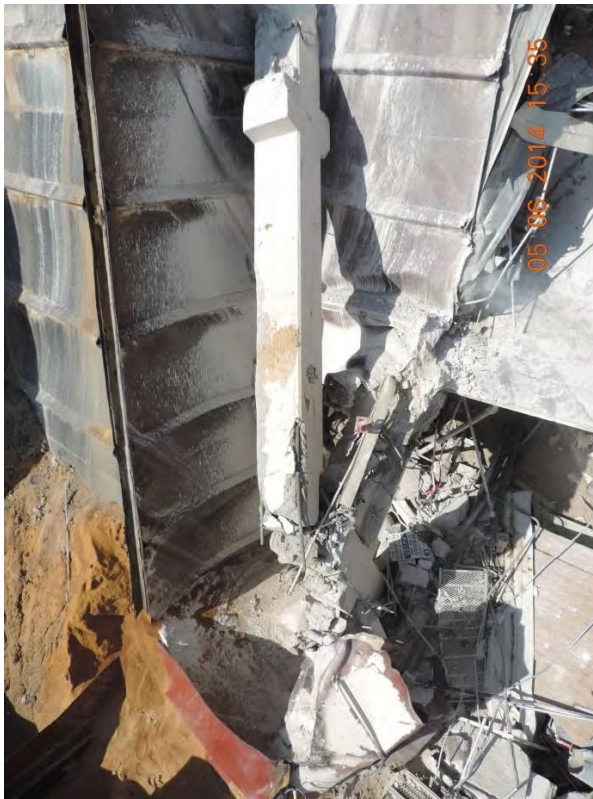
**Fig. 12** NE concrete column in bin No. 1

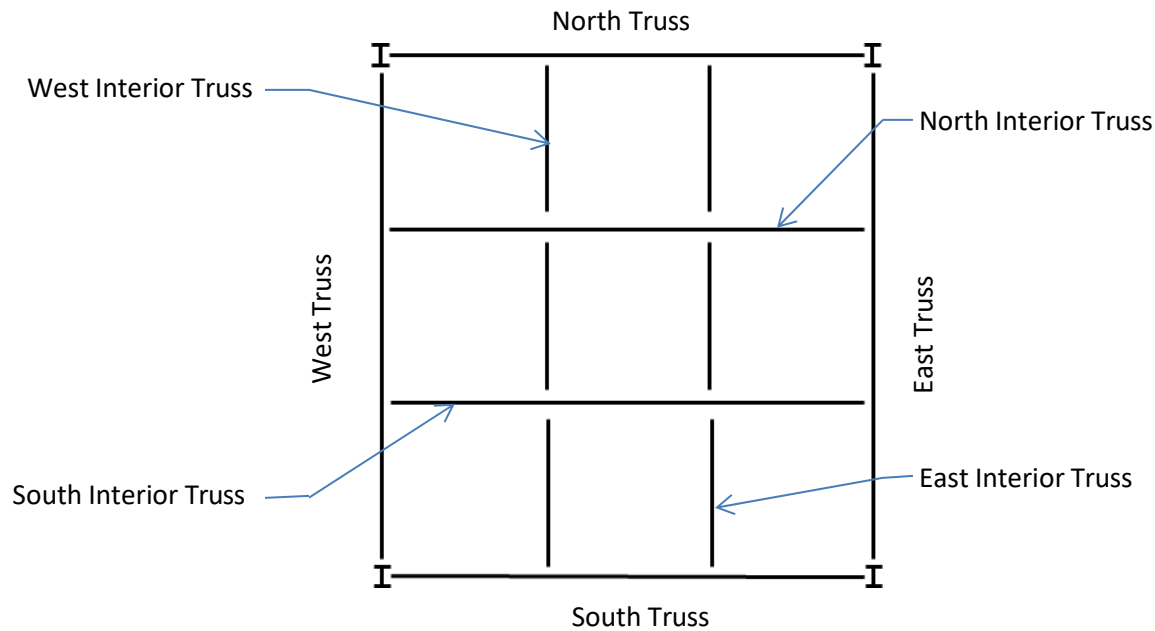
**Fig. 106** Bin supporting structure

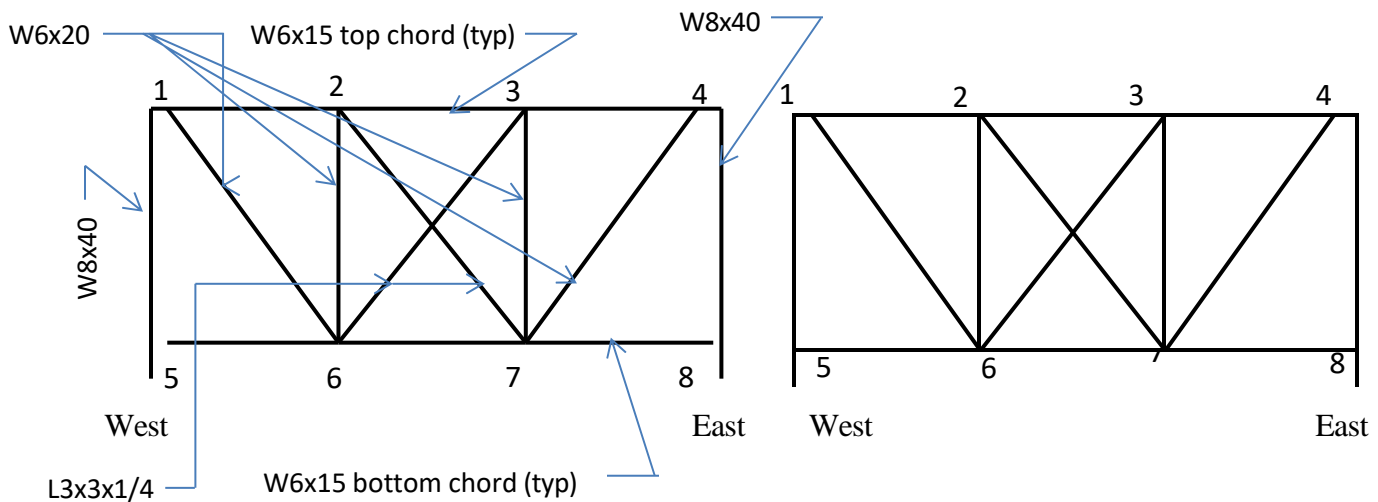
All four beam-bearing connections on the east and west exterior trusses failed when the 3/8" stiffener plate buckled. The four connecting bolts remained mostly intact, see Figs. 34, 39 and 44. The north and south trusses are shown in Figs. 86 and 87 respectively. Their joints are shown in Figs. 16 thru 33 below.

**Fig. 86** North Truss

**Fig. 87** South Truss

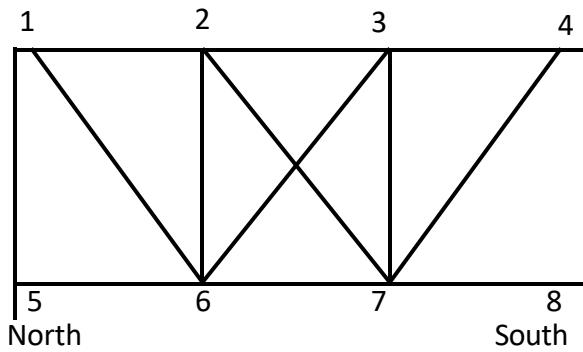
**Fig. 88** East Truss

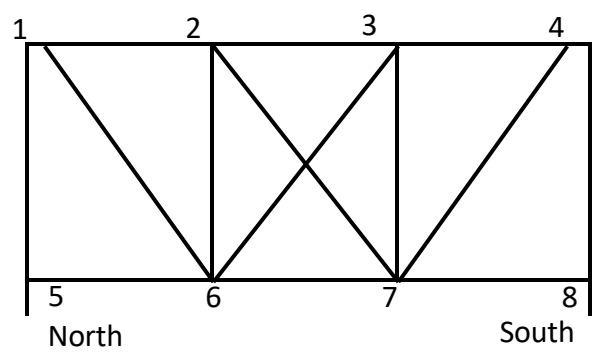
**Fig. 89** West Truss

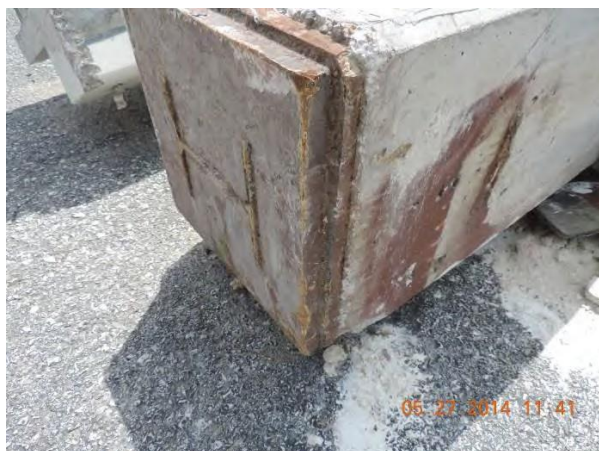
The four corner columns, W8x40, remained intact and did not exhibit any signs of distress. The failure occurred at the bottom of the columns where the welds to the column base plate failed, see Figs. 78 thru 85. The column base plate remained connected to the embed plates of the concrete columns; see Figs. 78 thru 85 and 95. For typical hoppers pictures after they have been retrieved from the debris, see Figs. 96 thru 98.

**Fig. 78** – W8x40 base plate

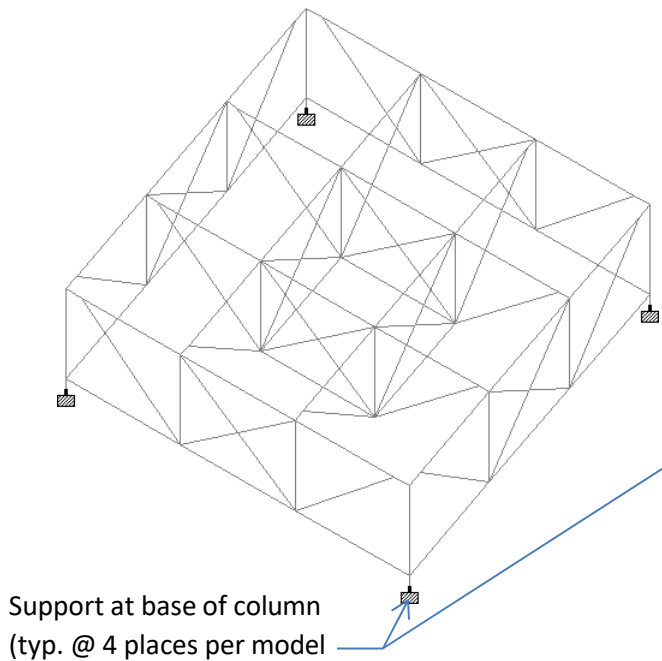
Fig. 90

STAAD MODEL 2

Seated beam support at east and west truss ends (typ. @ 4 places).

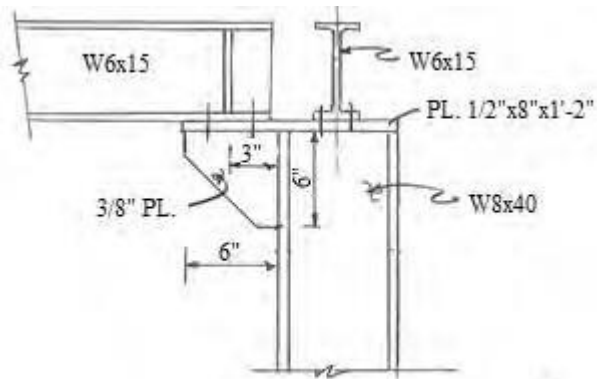
Fig. 93 Elevation  
(Seated beam connection of the east and west truss)

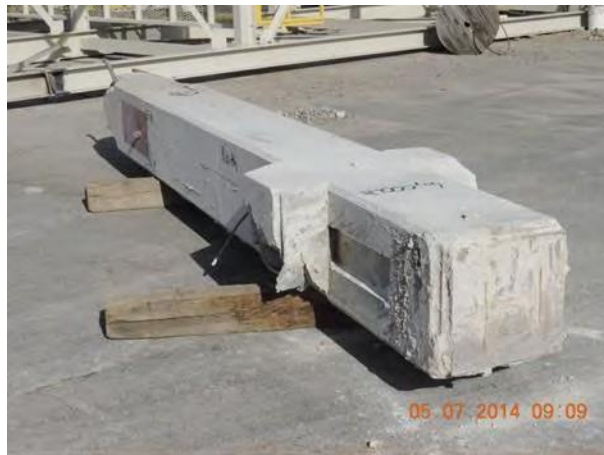
**Fig. 95** – Intact column base plate

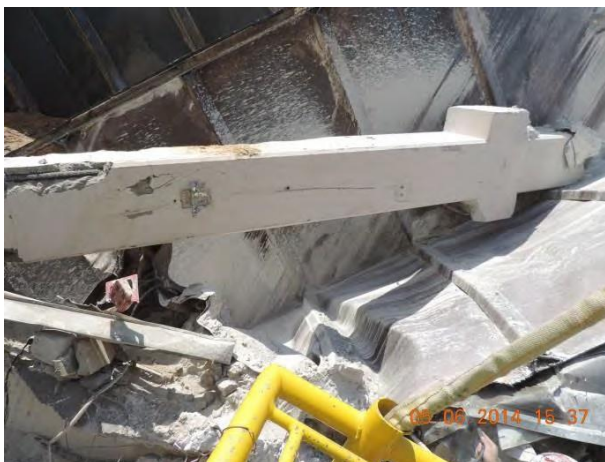
During the collapse, all four concrete columns remained intact except the NE column which was sheared at approximately the level of the inverted tee beam at the third floor, and was found inside bin No.1 during the demolition and recovery. The reason of the shear at that location was the lack of adequate lap splice of the longitudinal bars on one face of the column, see Figs. 99-103.

**Fig. 99** – NE corner column lying in bin No. 1

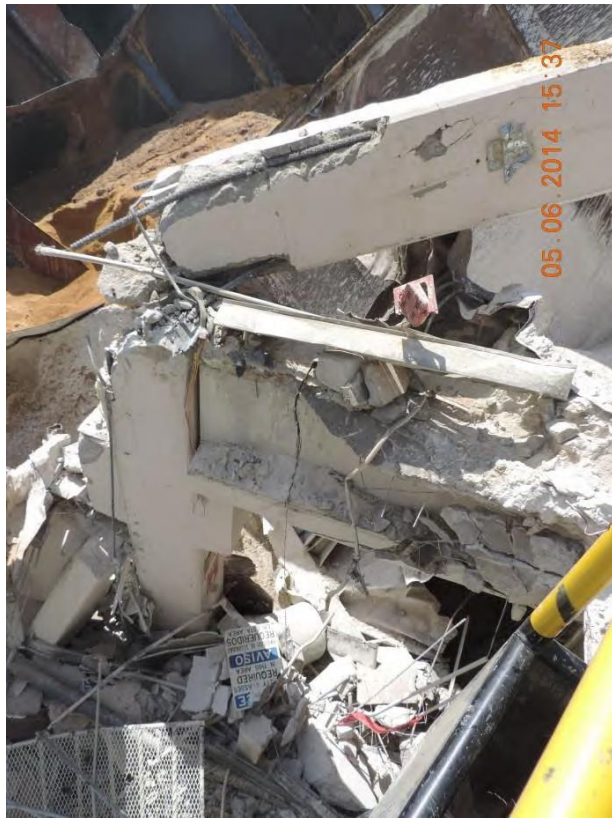
**Fig. 100** Fracture of NE corner column at 3<sup>rd</sup> floor

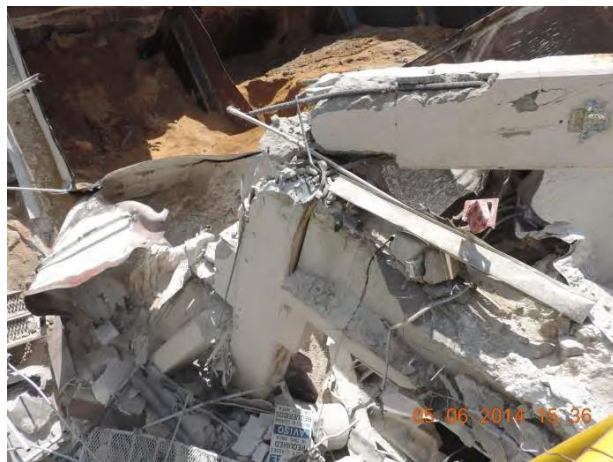
**Fig. 101** Another view of fracture of NE column at 3<sup>rd</sup> floor

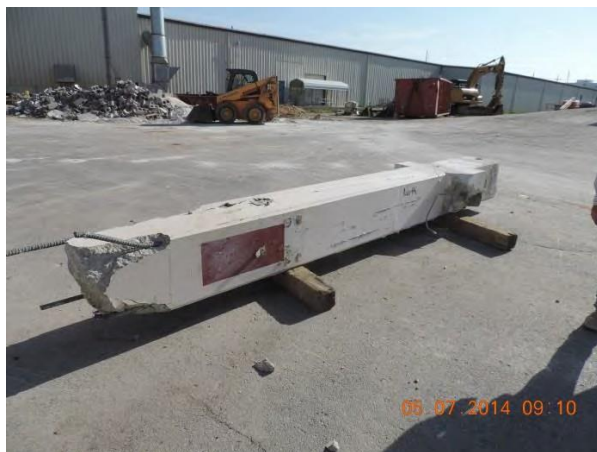
**Fig. 102** NE corner column showing inadequate lap splice

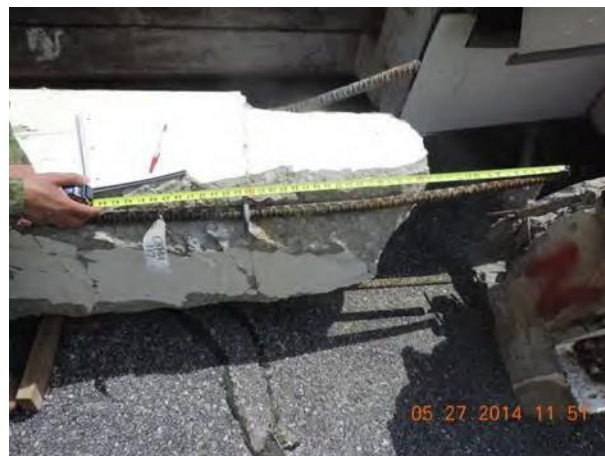
**Fig. 103** NE corner column showing inadequate lap splice

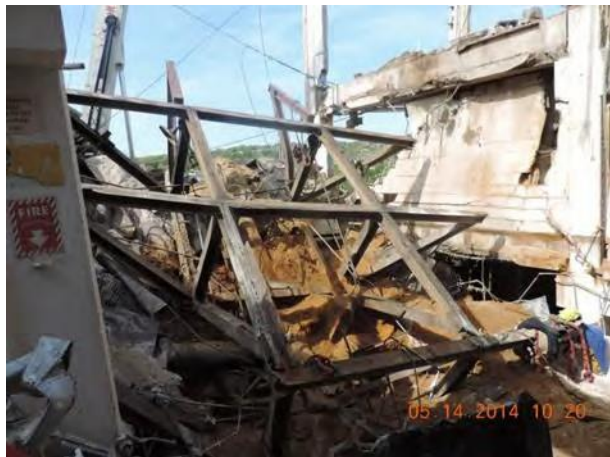
The four interior trusses escaped serious damage and emerged relatively intact from the debris see Figs. 104 and 105. The top chords of the north and south interior trusses were continuous

**Fig. 104** Interior trusses lying in debris

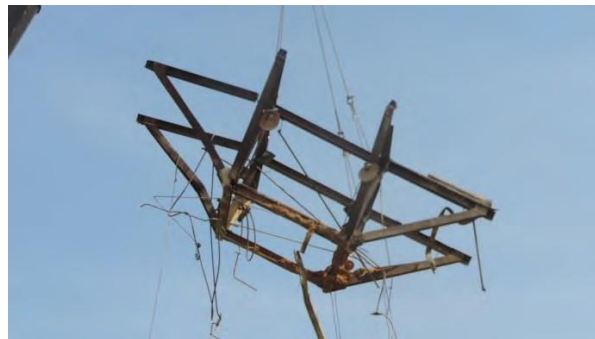
**Fig. 105** Interior trusses being retrieved

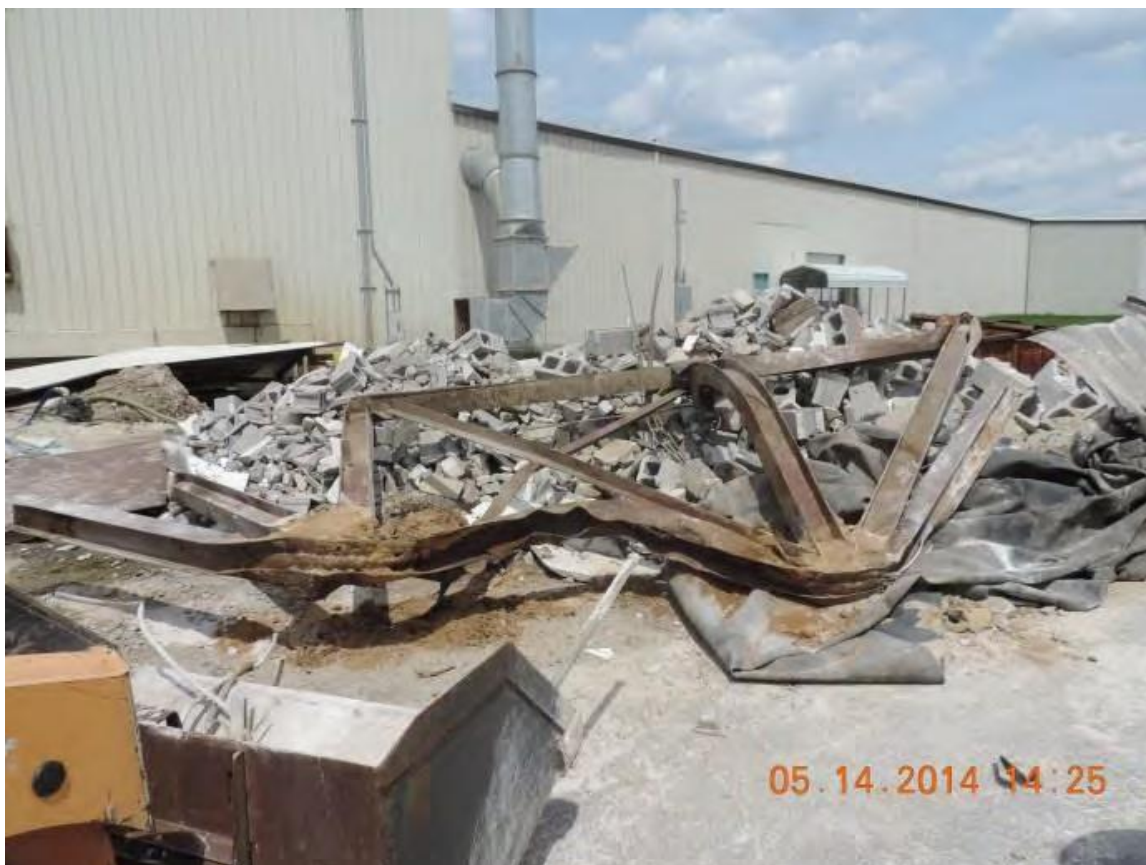
**Fig. 107** Exterior truss after being retrieved
