# Pressure Vessel Explosion at Loy-Lange Box Company

# Investigation Report

Published: July 29, 2022

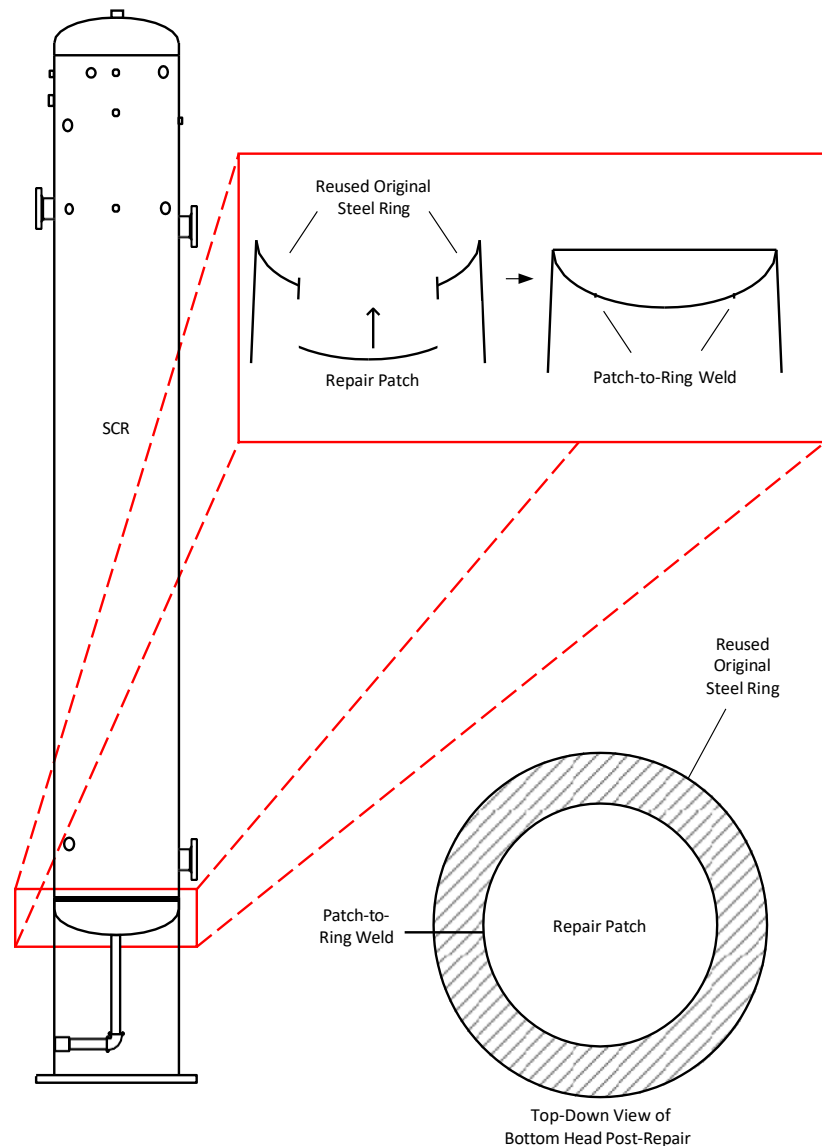
As illustrated in **Figure 7**, Kickham cut the SCR shell from the bottom head, leaving the bottom head attached to the skirt. With the bottom head and skirt removed from the SCR shell, Kickham inspected the inside surface of the SCR. A Kickham employee who oversaw the repair said Kickham observed pitting corrosion damage in the bottom head.

The employee said that the corrosion pits were isolated in the center of the head.

With access to the inside surface of the bottom head, Kickham cut out a circular portion of the center of the bottom head. According to a Kickham employee, the size of the circular portion was chosen to remove all the pitting and corrosion damage. The Kickham employee also told CSB investigators that the repair removed all corrosion damage in the SCR bottom head. In interviews, CSB investigators asked whether Kickham did any ultrasonic thickness (UT) measurement during the course of its repair. CSB investigators also asked whether Kickham inspected visually or used a micrometer.

**Figure 7.** Conceptual diagram showing repair made to SCR bottom head in 2012. (Credit: CSB)

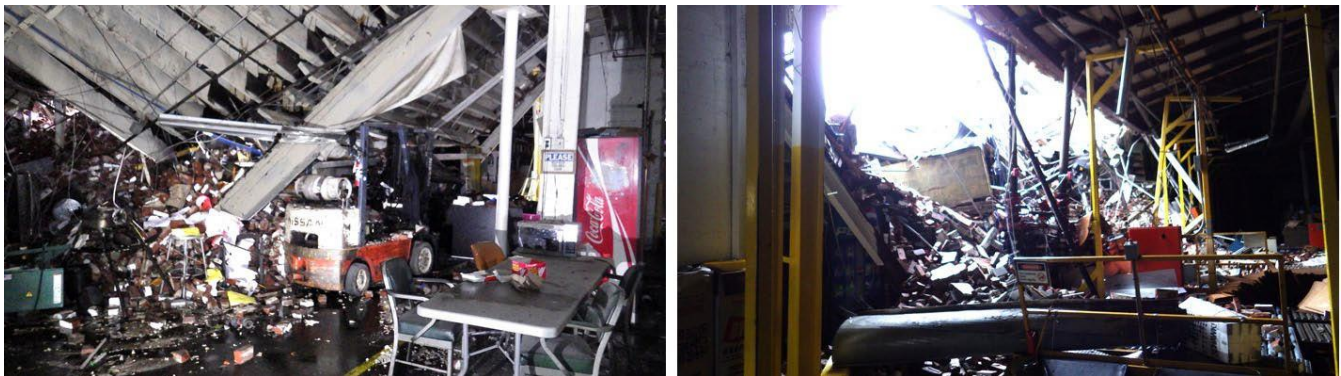
**Figure 10.** Photos of damage caused by SCR explosion. (Credit: St. Louis Fire Department)

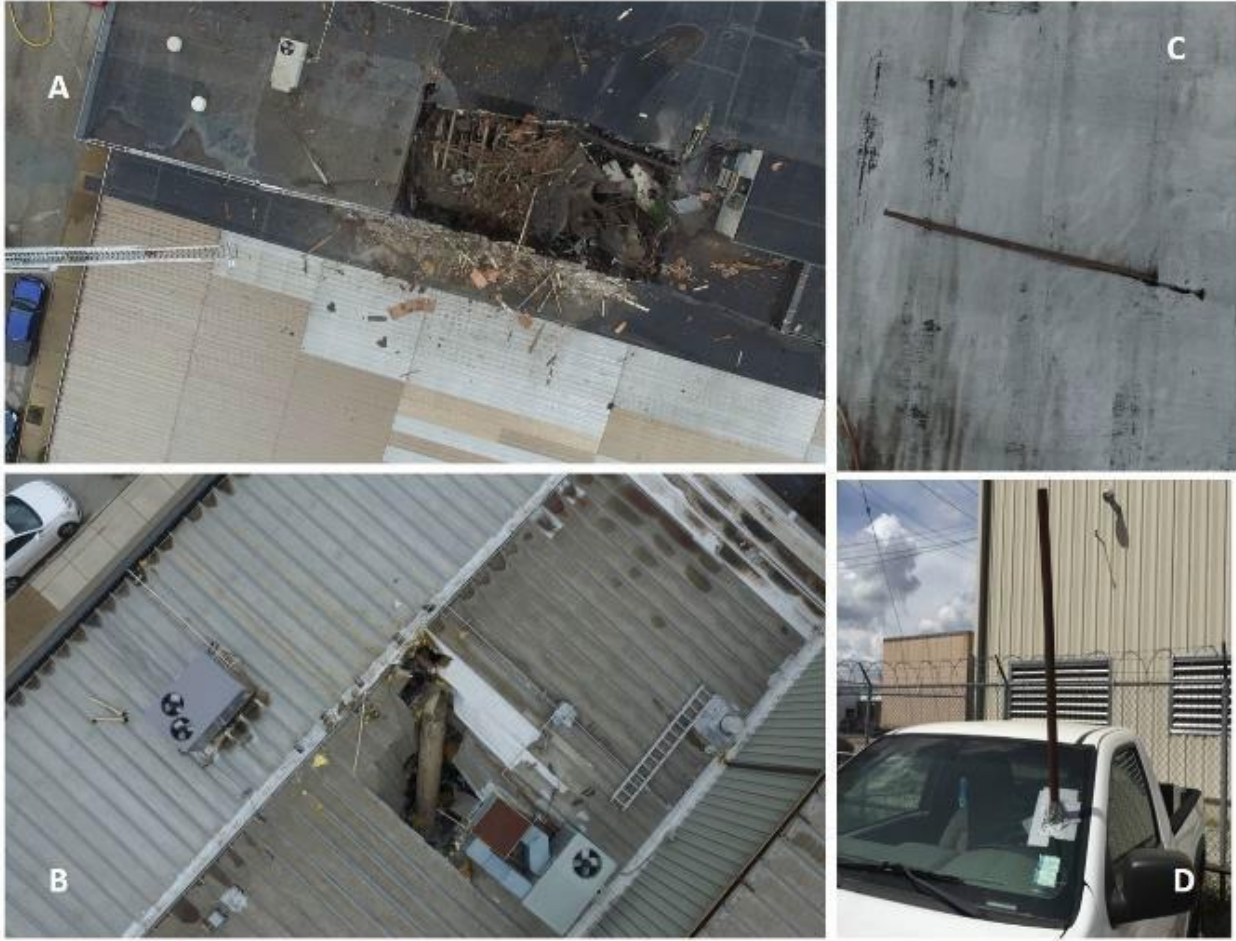
(**Figure 11C**). A section of 1.5-inch pipe approximately seven feet in length pierced the windshield and embedded in the dashboard and through the floorboard of an unoccupied pickup truck parked in the area (**Figure 11D**). A map of the debris field is shown in **Figure 12**. As a result of the incident, one stationary engineer at Loy-Lange was fatally injured. At Faultless Healthcare Linen, three employees were fatally injured when the SCR fell through the roof.

**Figure 11.** Damage from the incident. (Credit A-C: St. Louis Fire Department, D: CSB)

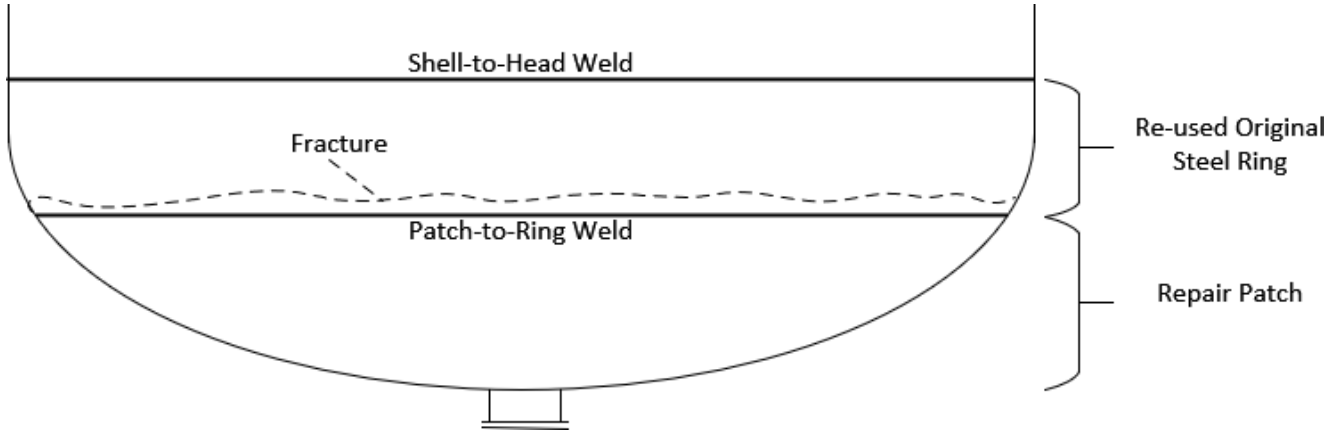
**Figure 14.** Conceptual illustration of fracture in SCR bottom head. (Credit: CSB)

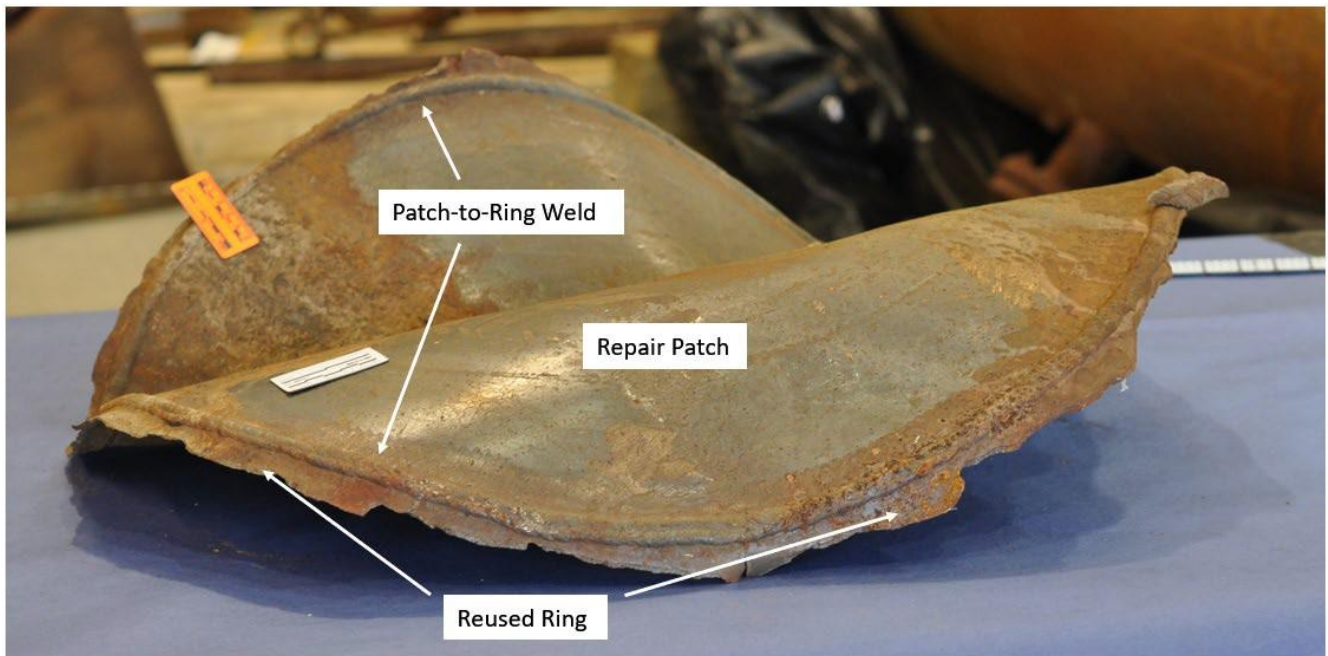
**Figure 15.** Photo of failed section of SCR bottom head. (Credit: CSB)

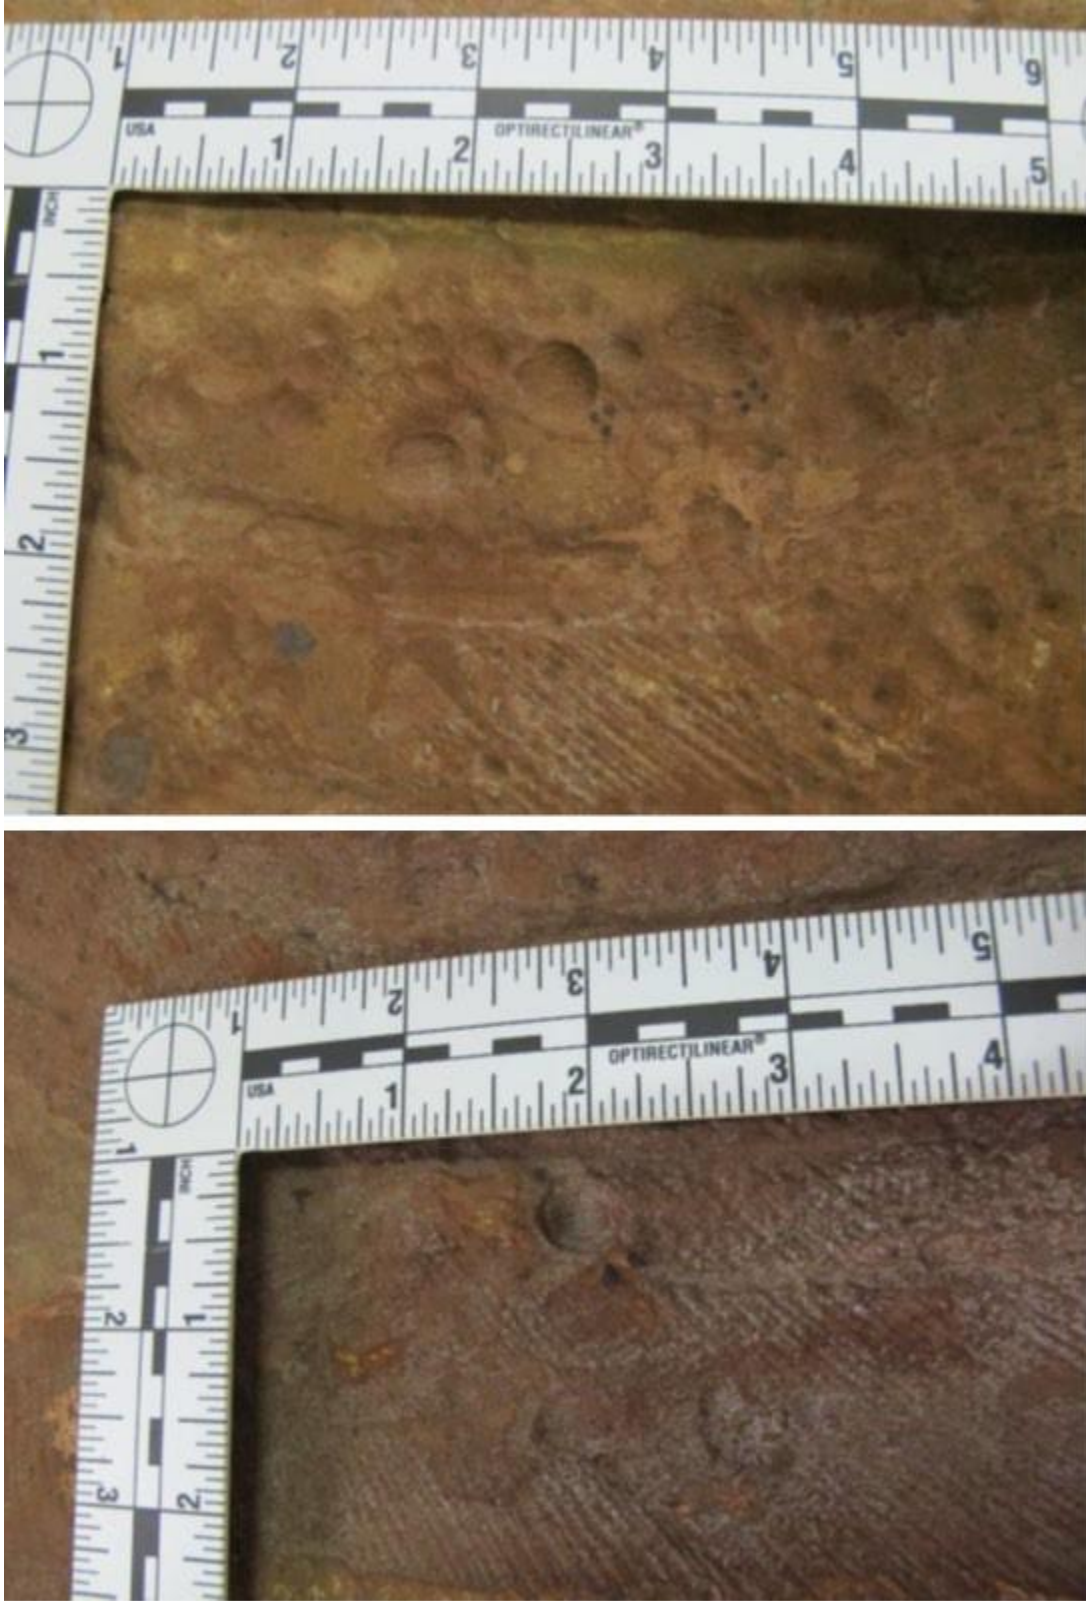
Extensive pitting and generalized corrosion damage (**Figure 16**) was found in both the separated portion of the bottom head and in the portion of the bottom head that remained attached to the SCR shell. This pitting and generalized corrosion damage is consistent with the appearance of oxygen pitting and corrosion damage. The shell and upper head were found to be relatively unaffected by corrosion damage, as pictured in **Figure 17**.

**Figure 16.** Pitting corrosion damage in SCR bottom head. (Credit: CSB)

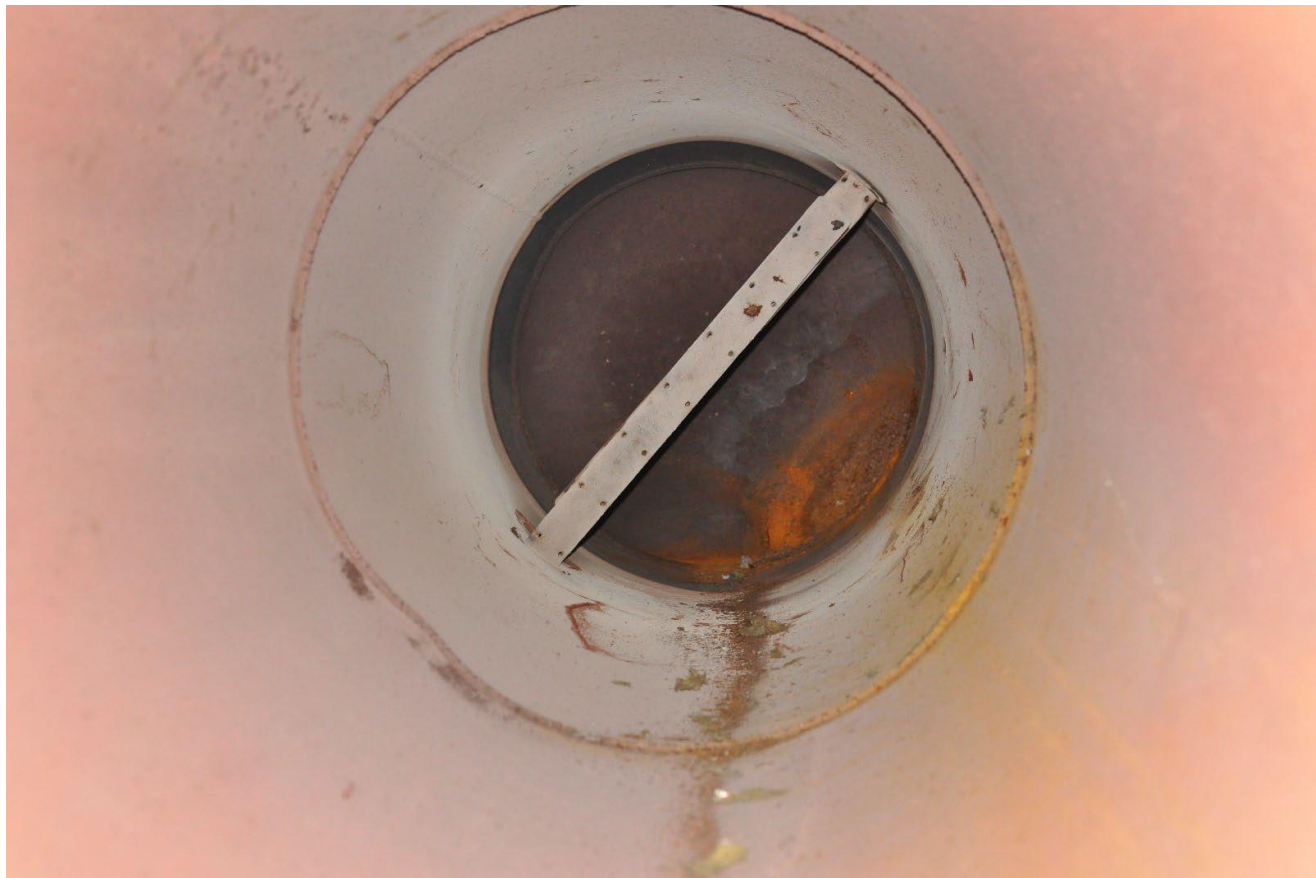
**Figure 17.** Photo of the inside surface of the SCR shell and upper head. (Credit: CSB)

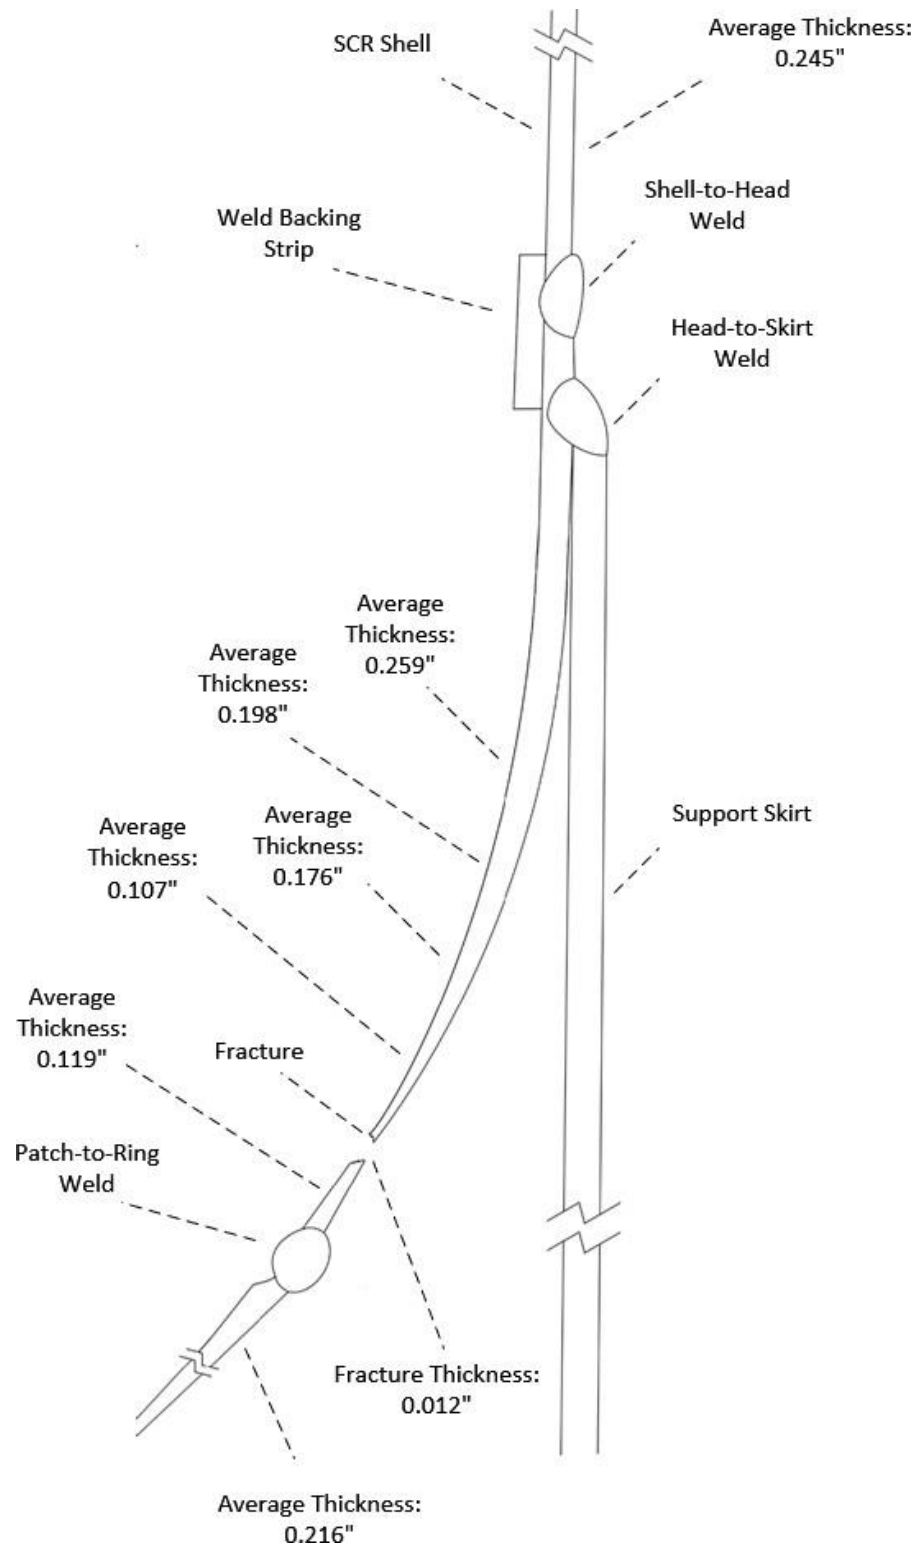
The CSB commissioned comprehensive non-destructive thickness examination of the SCR after the incident. Some of the examination findings are illustrated in **Figure 18**. The thickness of adjacent spots on either side of the patch-to-ring weld were measured and compared (**Figure 19**). On average, the repair patch was almost twice as thick as the re-used original steel ring.

**Figure 18.** Conceptual cross-sectional diagram of the SCR bottom head, showing examination findings. (Credit: CSB)

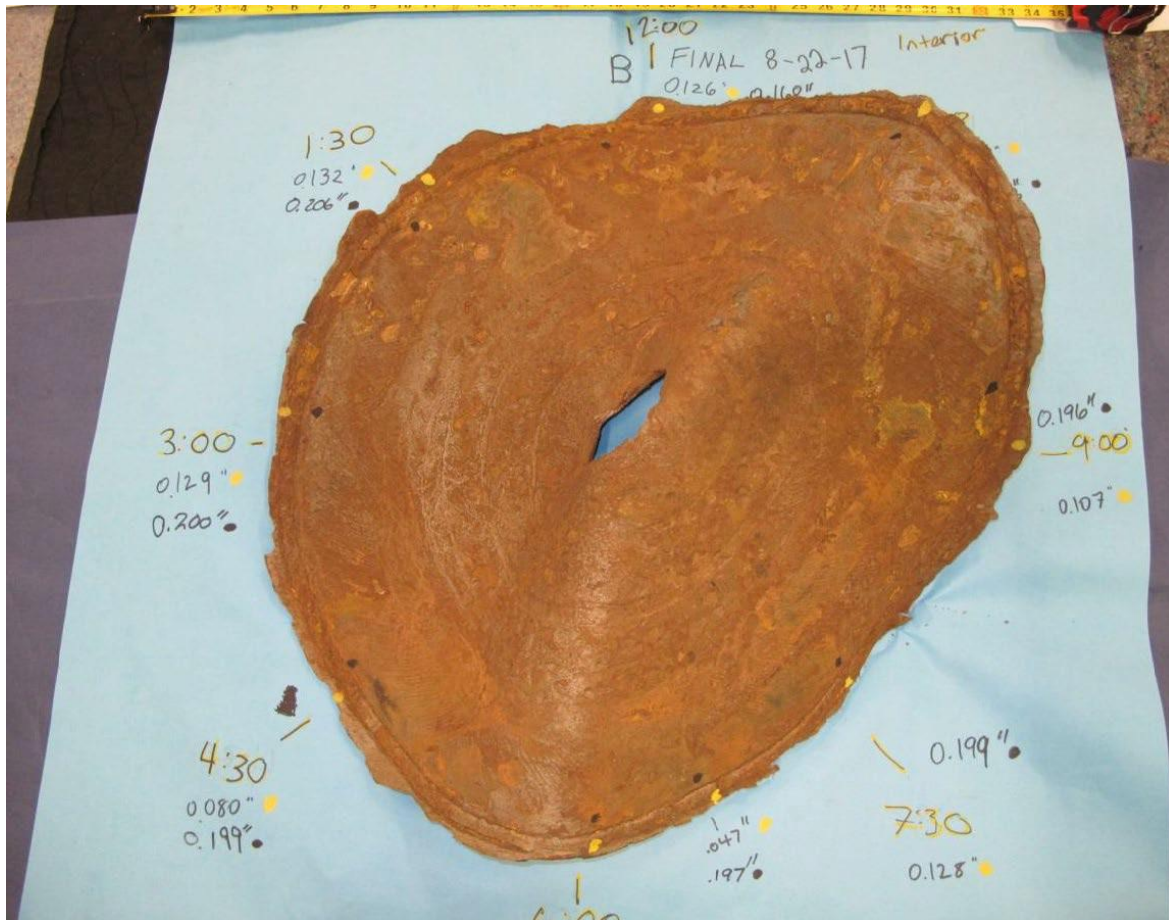
**Figure 19.** Thickness comparison on either side of patch-to-ring weld. (Credit: CSB)

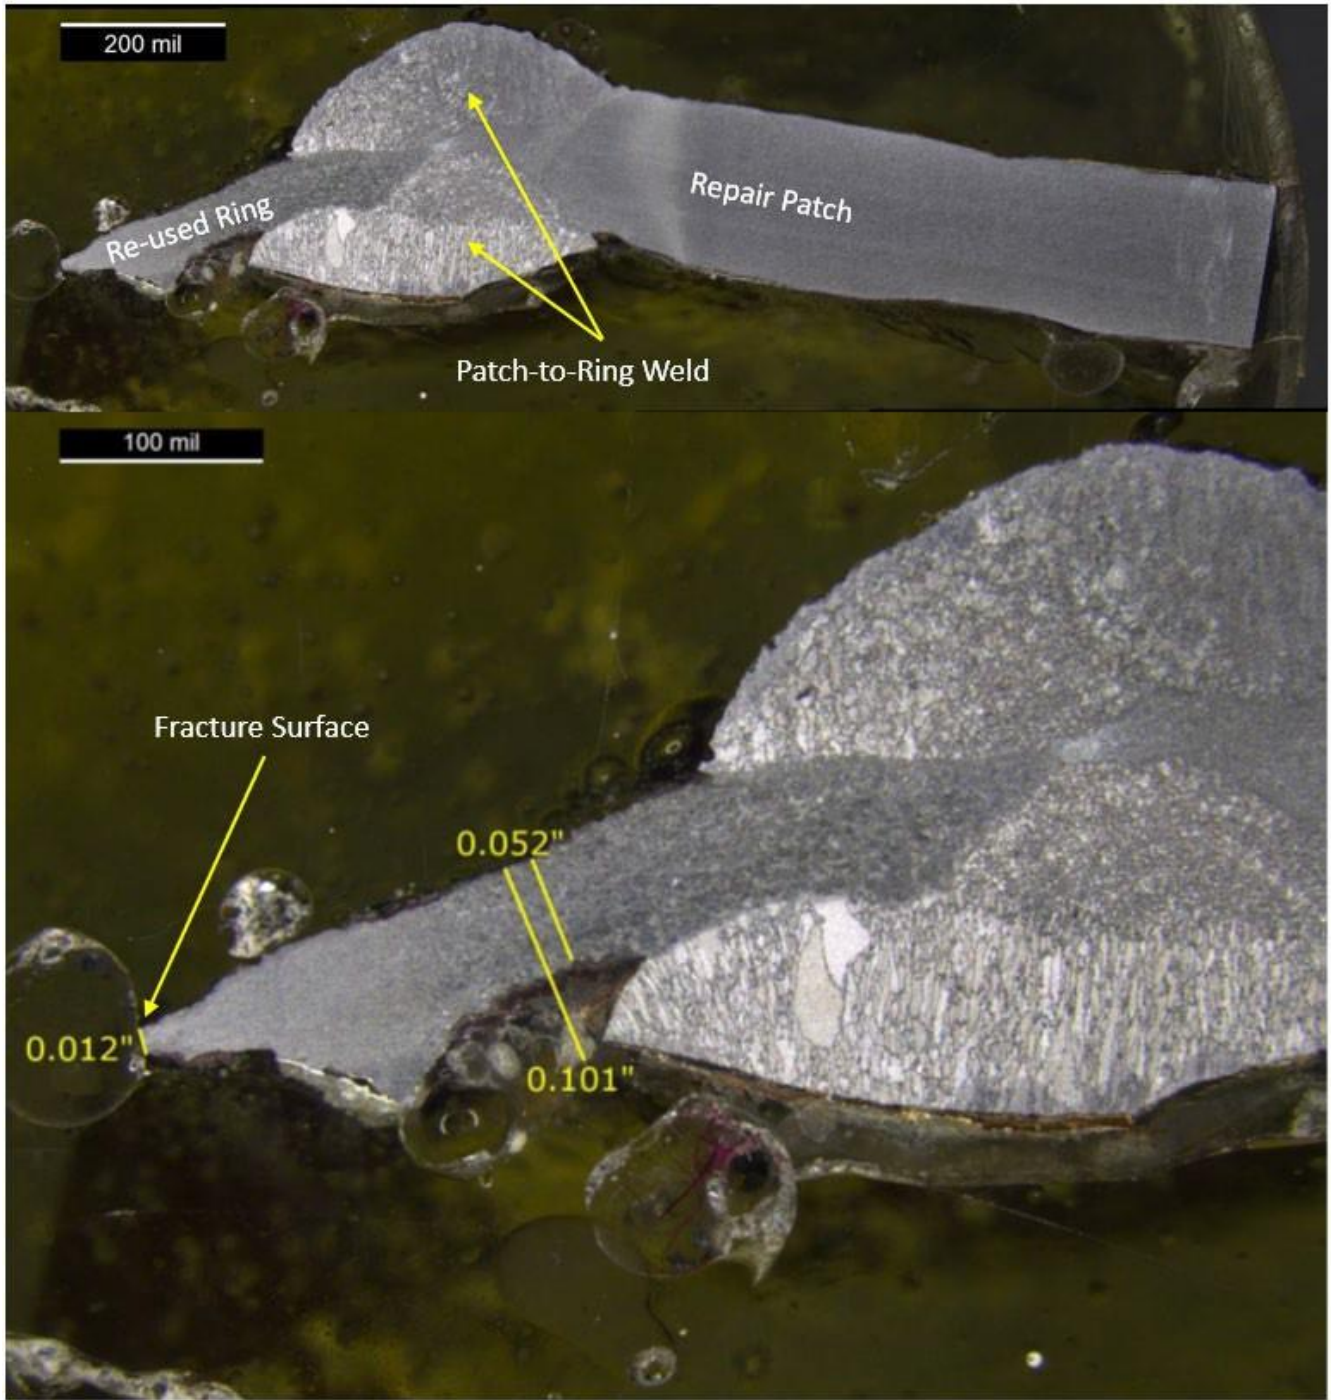
Destructive thickness examination found that corrosive attack reduced the nominally 0.250-inch steel to 0.012 inches at the thinnest spot measured, a thickness loss of 95 percent (**Figure 20**). The spot that measured 0.012 inches was at the fracture edge, in the re-used ring. The average post-incident thickness of the re-used ring around the periphery of the fracture, as measured by calipers, was 0.107 inches. The examination also discovered four weld repairs in the portion of the re-used ring that remained attached to the shell. These welds were cross-sectioned and examined. Three of the four welds were weld overlays, used to fill in thin spots from the inside of the vessel. The fourth was a plug weld, used to plug a full penetration through the thickness of the head. All four of these welds were made to the ring of bottom head material that remained attached to the SCR shell. A photo documenting one of the weld overlays is shown in **Figure 21**, and photos documenting the plug weld are shown in **Figure 22**.

Figure 20. Post-Incident metallurgical examination of patch-to-ring weld and fracture. (Credit: CSB)

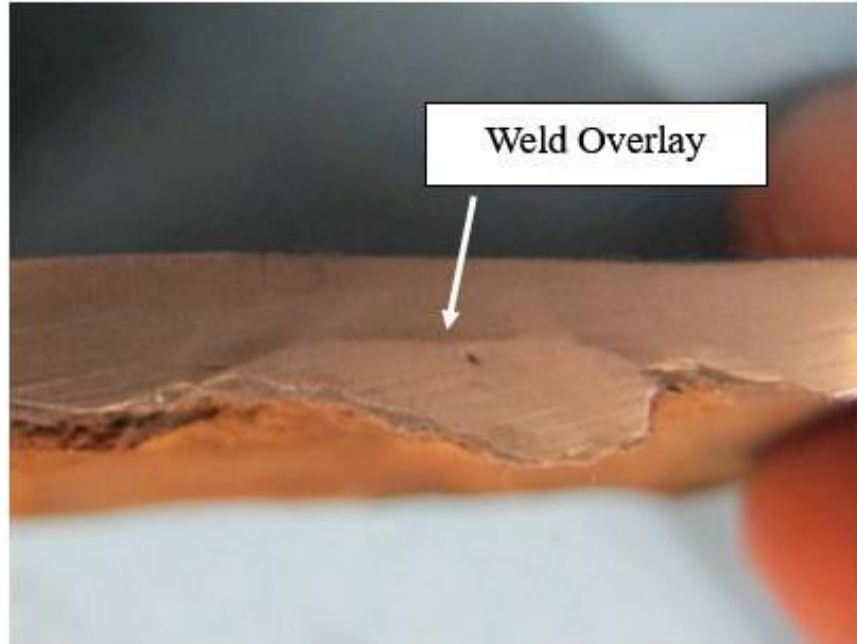
**Figure 21.** Weld overlay found in the ring of steel still attached to the shell, cross-sectioned. (Credit: CSB)

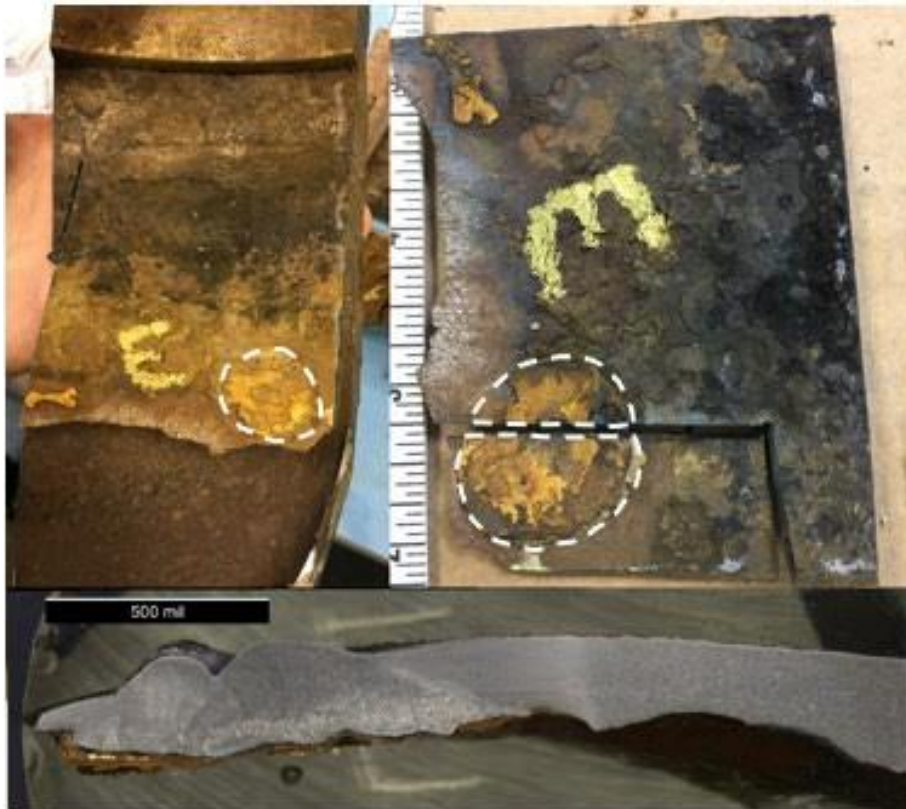
**Figure 22.** Plug weld found in the ring of steel still attached to the shell, cross-sectioned. (Credit: CSB)

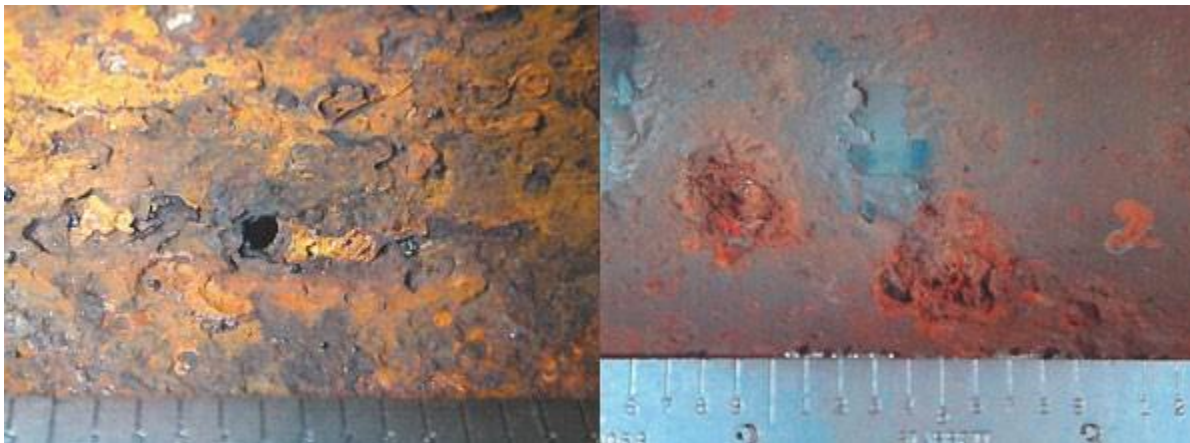
In addition to these leaks in the SCR, Loy-Lange experienced corrosion in other parts of the steam system. The CSB found documentation of one known steam separator leak and four generator coil failures.<sup>a</sup> **Figure 28** shows the oxygen pitting corrosion found in two of the four generator coil failures. The images were taken by Clayton after Loy-Lange submitted the failed coils to Clayton for warranty replacement consideration. The left image is of a 2002 coil failure and the right image is of a 2004 coil failure.

**Figure 28.** Pitting damage in two of Loy-Lange’s steam coils. (Credit: Clayton)

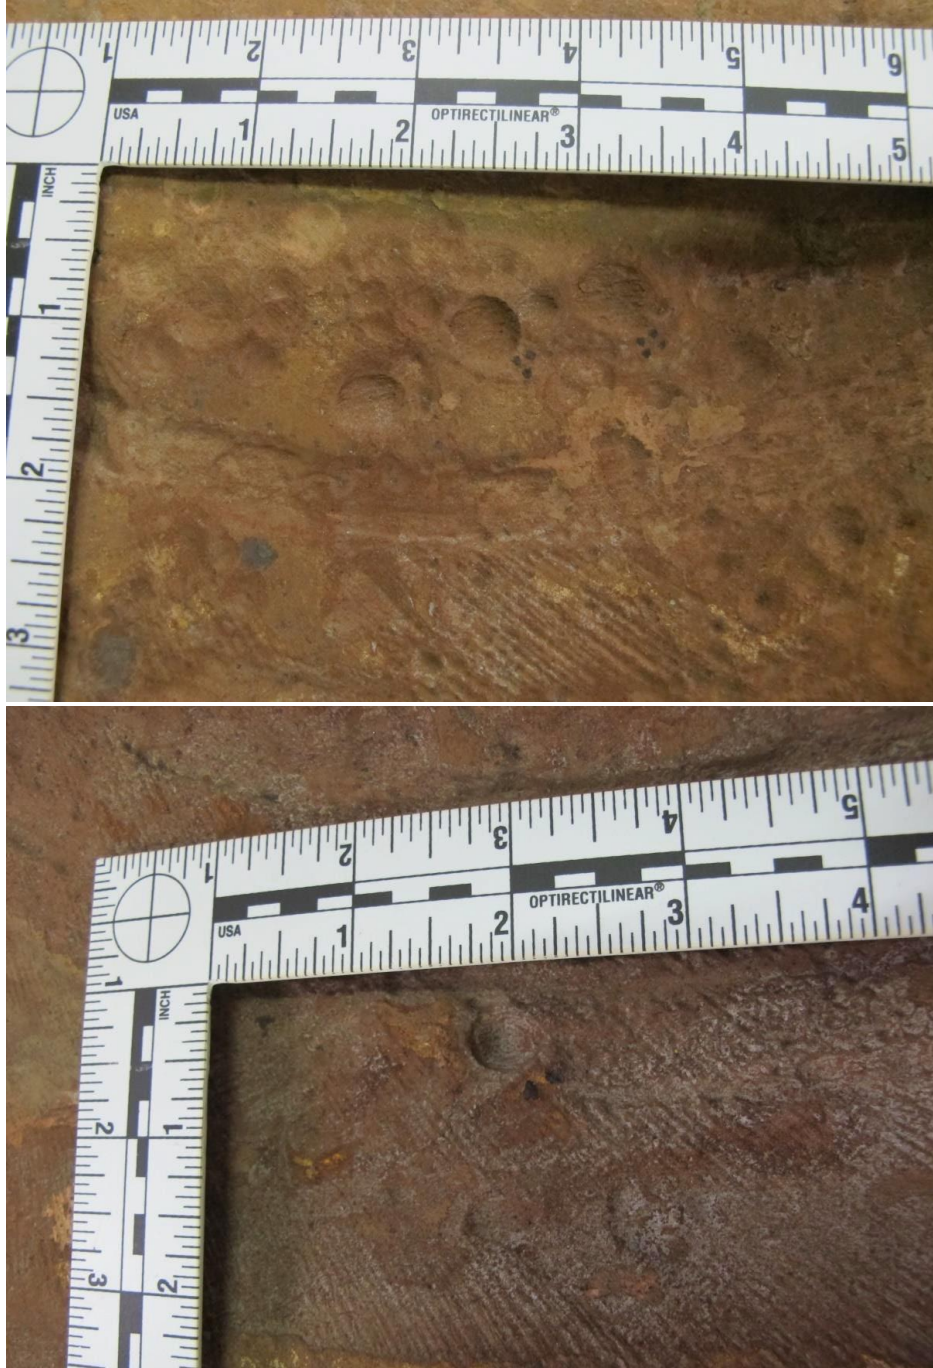
**Figure 30.** Pitting corrosion damage in SCR bottom head. (Credit: CSB)

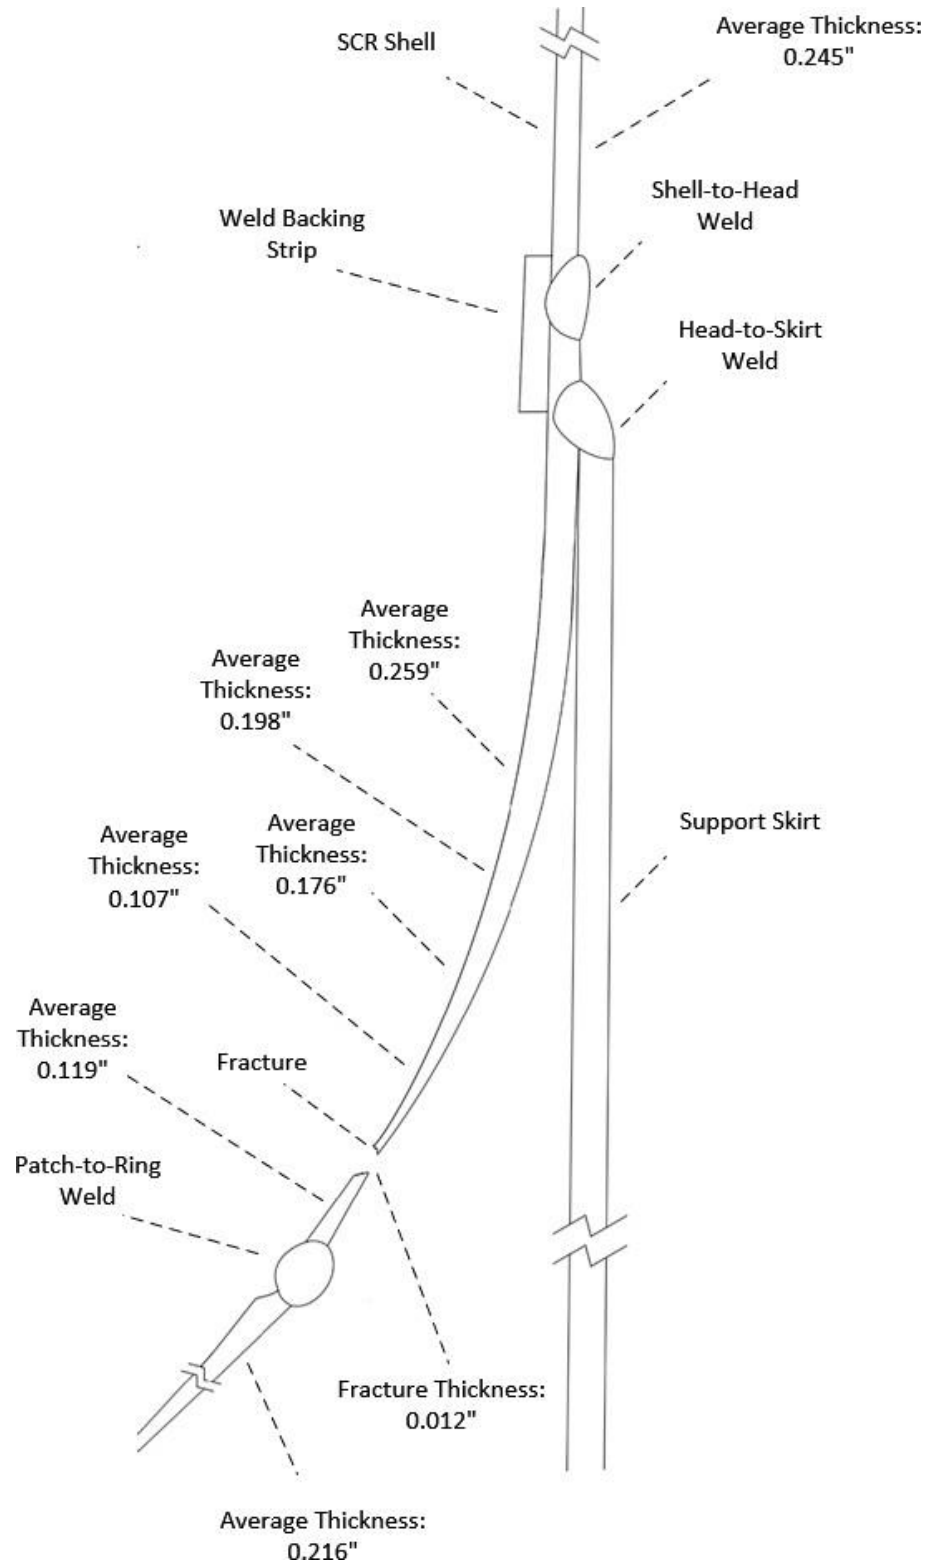
Nondestructive and destructive thickness measurement showed that corrosion primarily occurred in the SCR bottom head and was minimal elsewhere in the vessel (Section 1.6). **Figure 31** below shows a summary of some of the thickness findings:

**Figure 31.** Conceptual cross-sectional diagram of the SCR bottom head, showing examination findings. (Credit: CSB)

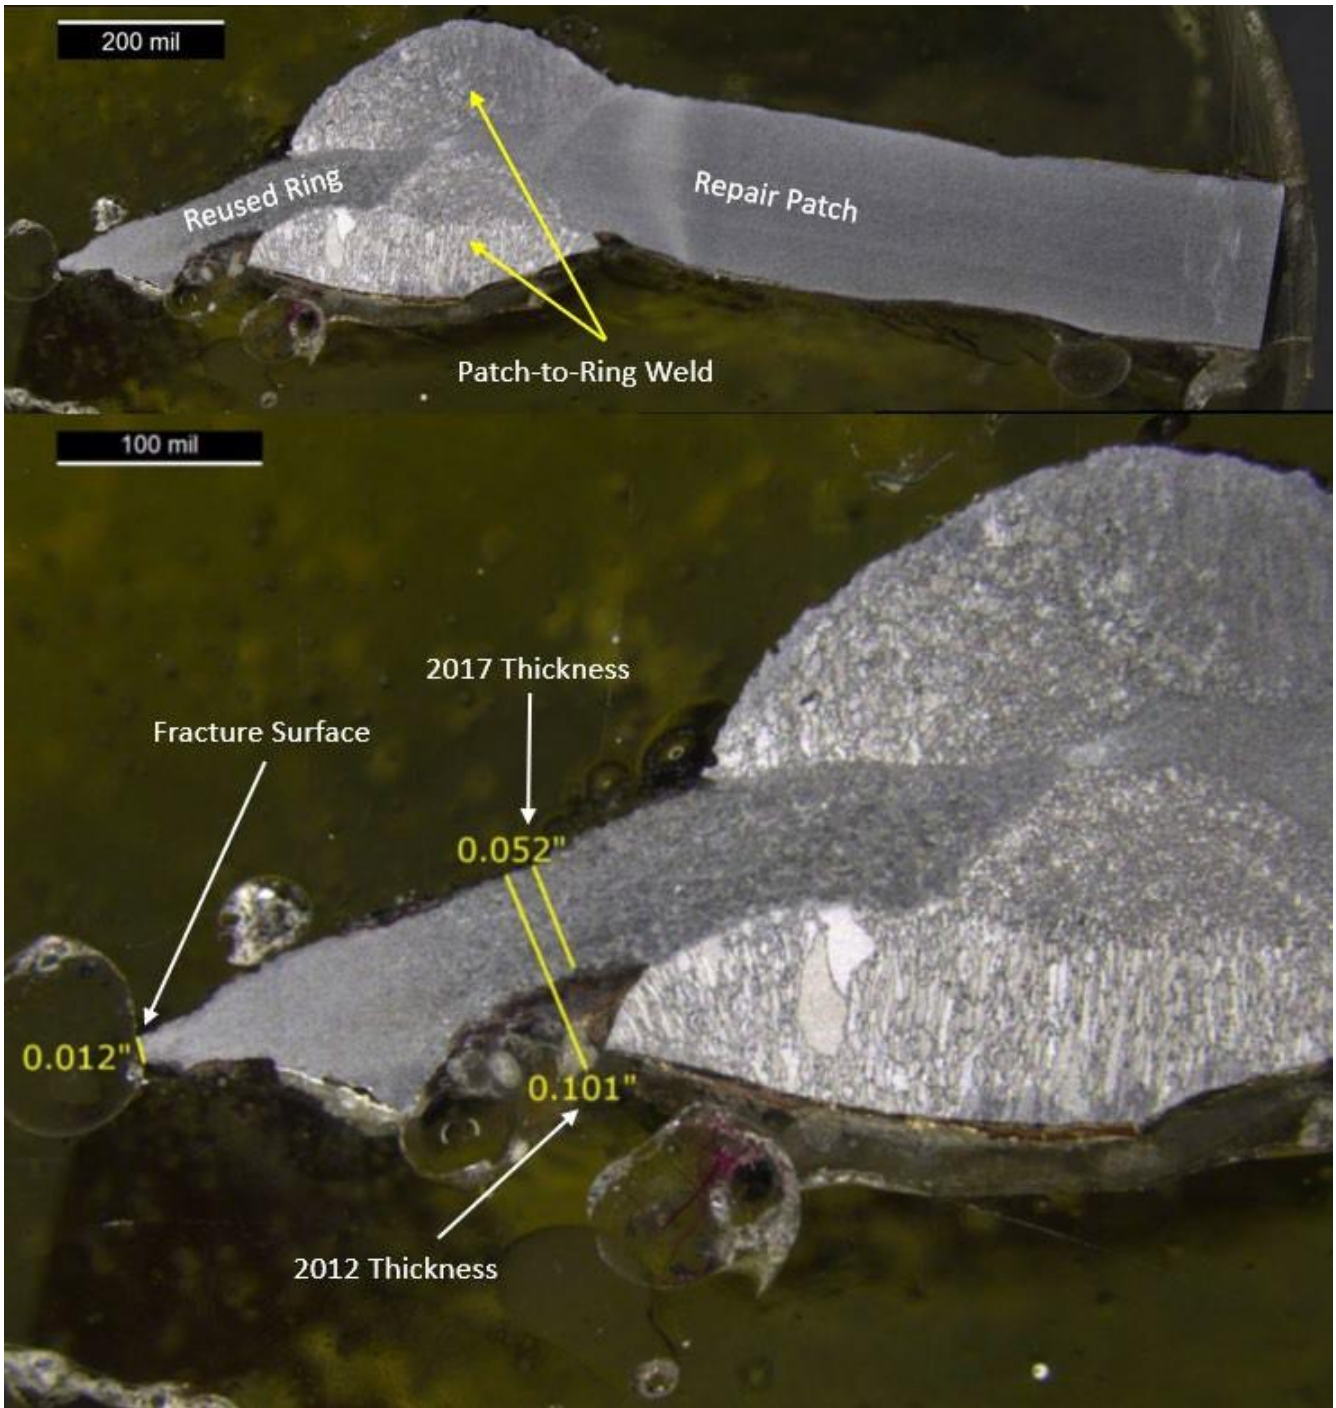
Figure 33. Metallurgical mount examination of a portion of the reused ring. (Credit: CSB)

Based on the metallurgical examination and corrosion calculations, there is evidence that the 2012 repair did not remove all existing corrosion damage. It is important to remove all corroded material that is too thin to meet the vessel's minimum thickness requirements because a decrease in thickness could impact the pressure retaining ability of the vessel. The CSB concludes that Kickham likely left thinned material in place when it repaired the SCR bottom head in 2012, and in so doing did not adhere to the requirements of *NBIC Part 3 Repair and Alterations*.

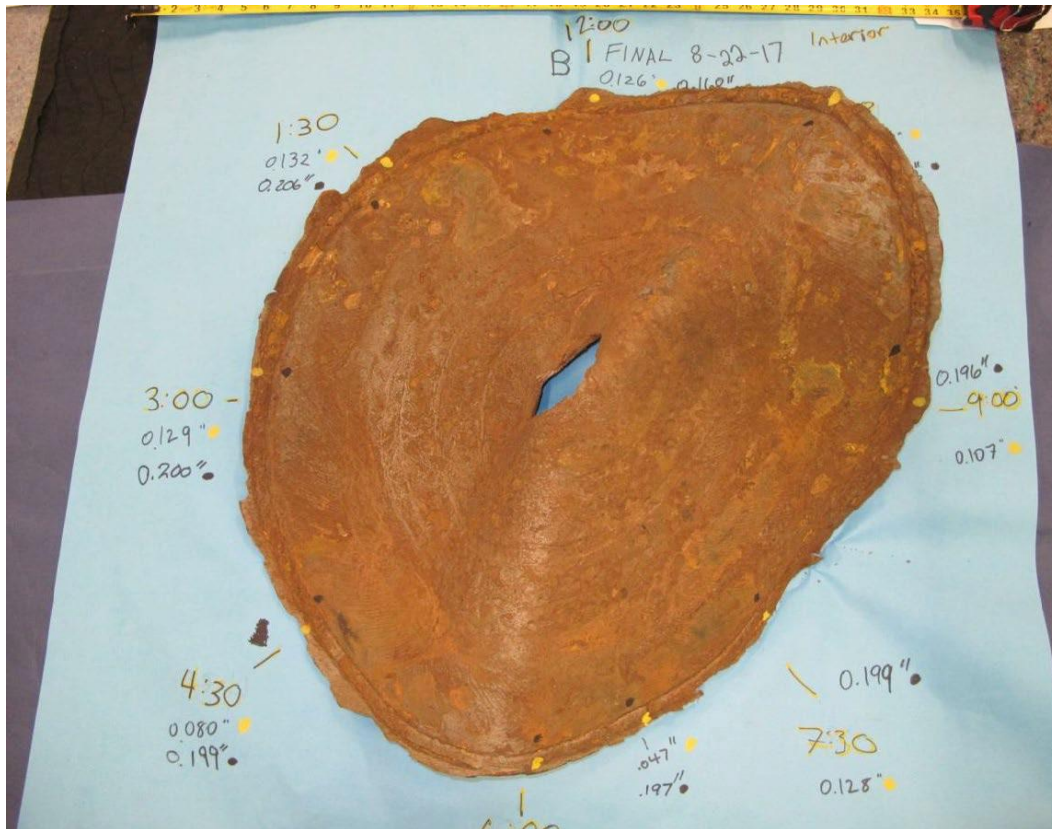
**Figure 34.** Thickness comparison on either side of patch-to-ring weld. (Credit: CSB).
