# BUILDING PERFORMANCE ASSESSMENT REPORT

PRELIMINARY REPORT

## *Midwest Tornadoes of May 3, 1999*

FEDERAL EMERGENCY MANAGEMENT AGENCY  
Mitigation Directorate, Washington DC and Region VI, Denton, TX  
and Region VII, Kansas City, MO

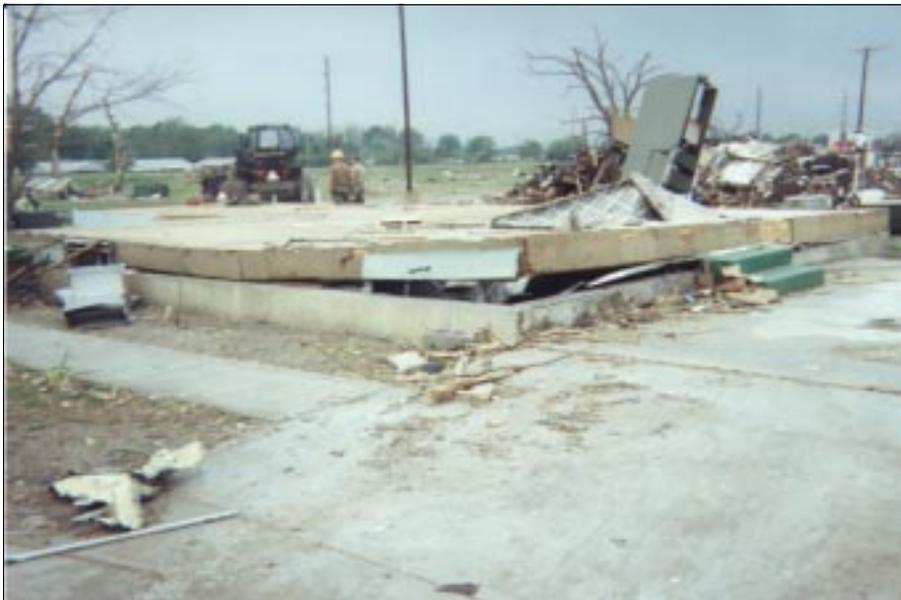
**FIGURE 3-3:** Wind uplift acting on this house in Haysville, Kansas, resulted in this corner of the building being lifted off its foundation.

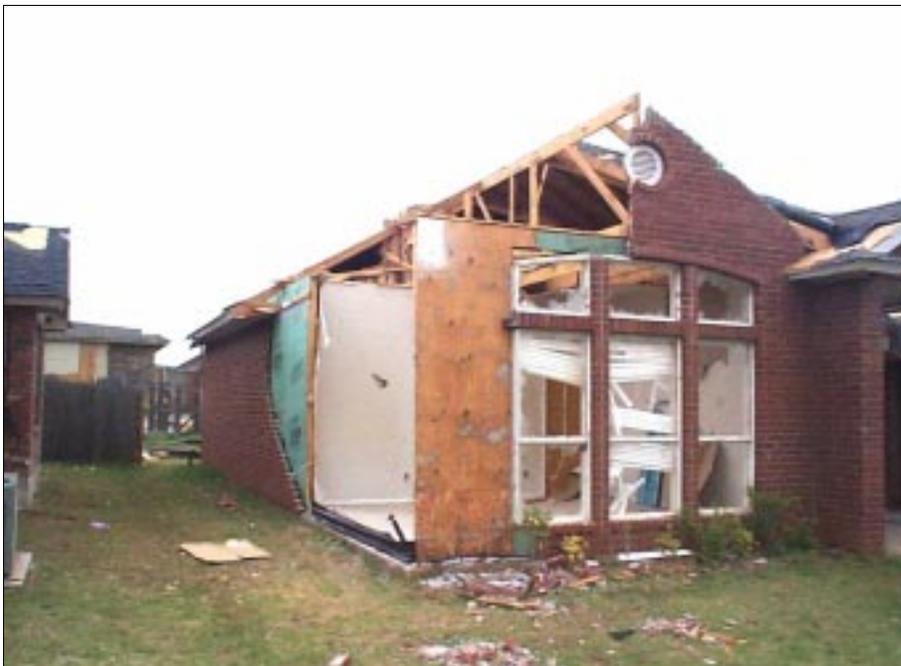
**FIGURE 3-7** Failure of this exterior wall and roof section in Moore, Oklahoma, occurred when the windows broke and the front room saw an increase in internal pressure. Most of the debris from the roof and exterior wall had been cleaned up prior to this photograph. This home in Moore, Oklahoma, was located on the periphery of a violent tornado track.

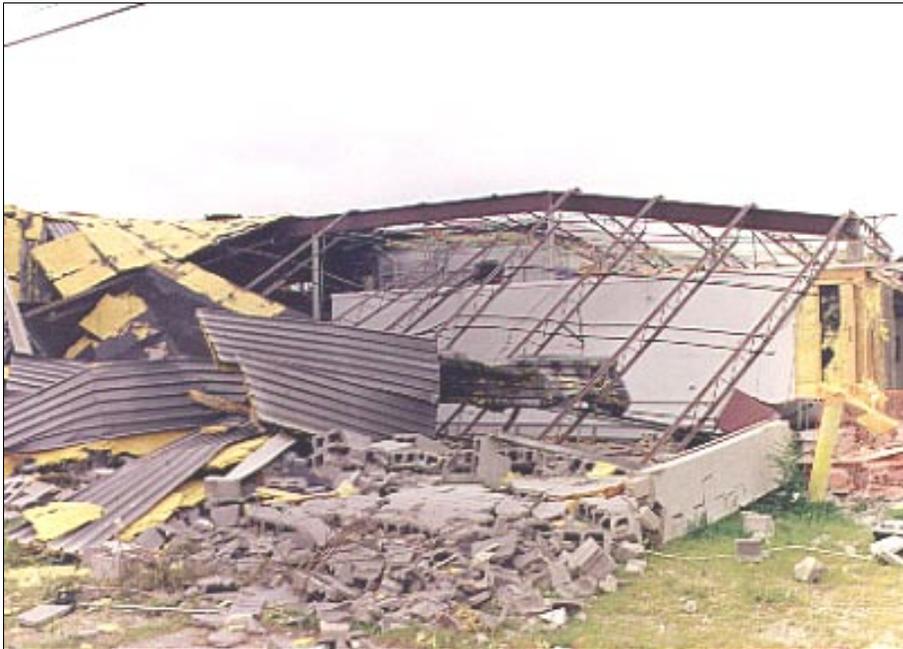
**Figure 3-9:** This URM wall failed when inflow winds from a severe tornado acted on this building in Wichita, Kansas.

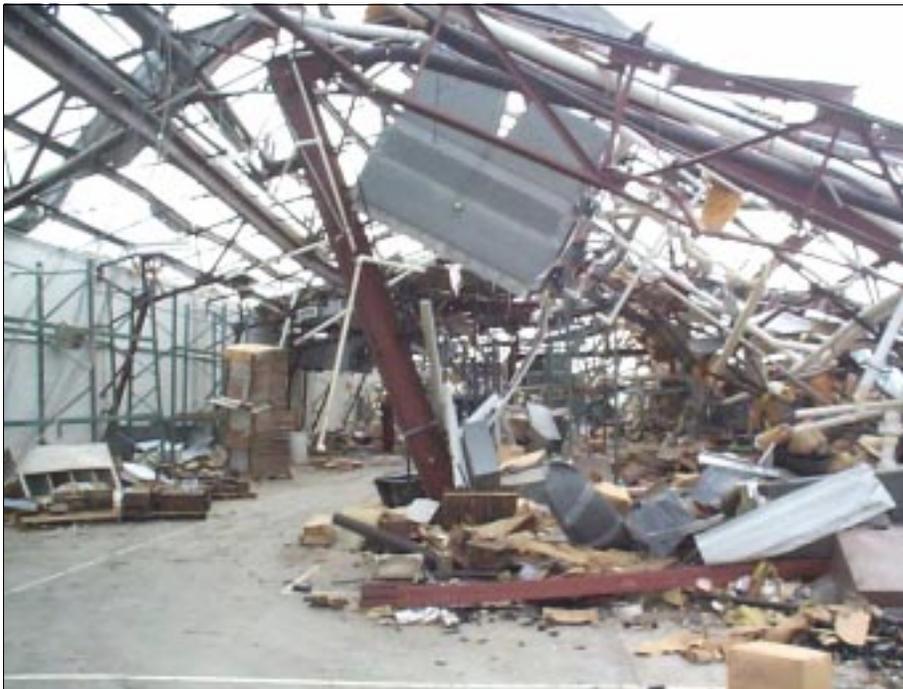
**Figure 3-10:** The vortex of a violent tornado passed within 100 yards of this plastics manufacturing plant in the City of Haysville, Kansas. The wind forces caused the failure of its primary structural system: a steel frame with masonry infill walls.

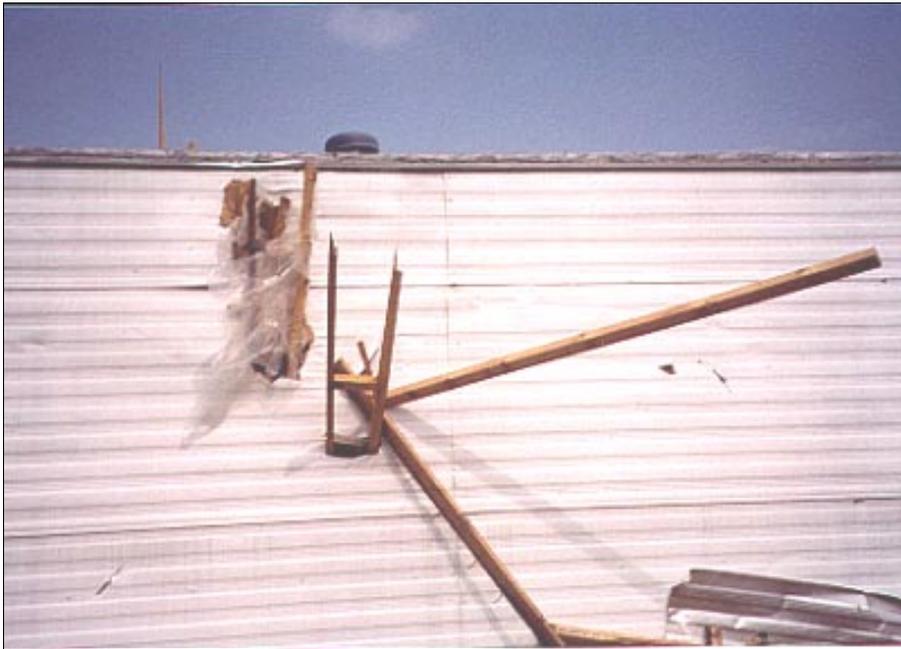
**FIGURE 3-12** *These medium sized missiles struck and remained embedded within this manufactured home in Wichita, Kansas.*

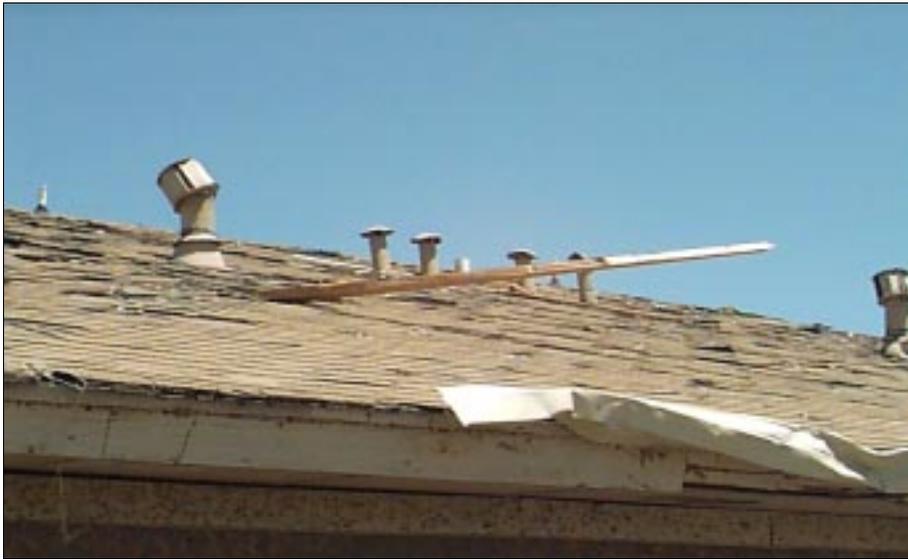
**FIGURE 3-15: Windborne missile striking a house located in Moore, Oklahoma.**

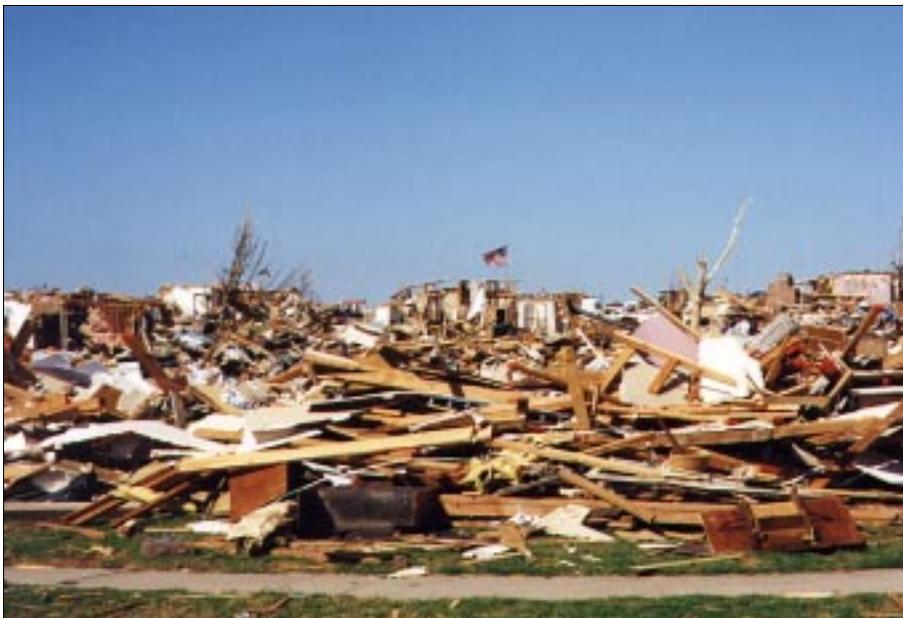
**FIGURE 3-24:** Debris generated by the vortex of a violent tornado in Moore, Oklahoma creates a layer of rubble across the ground.

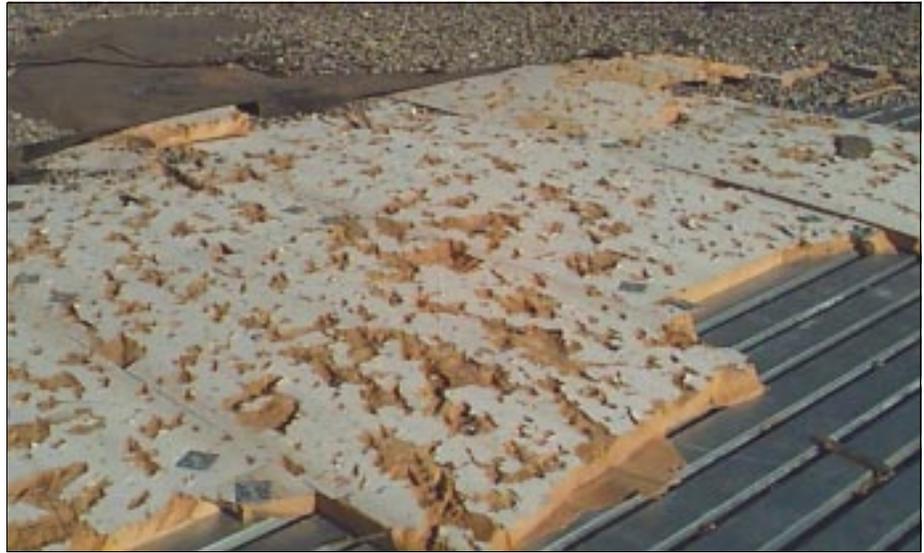
**FIGURE 3-26:** This house was on the periphery of a violent tornado damage area in Moore, Oklahoma. Two large missiles struck this area of the roof.

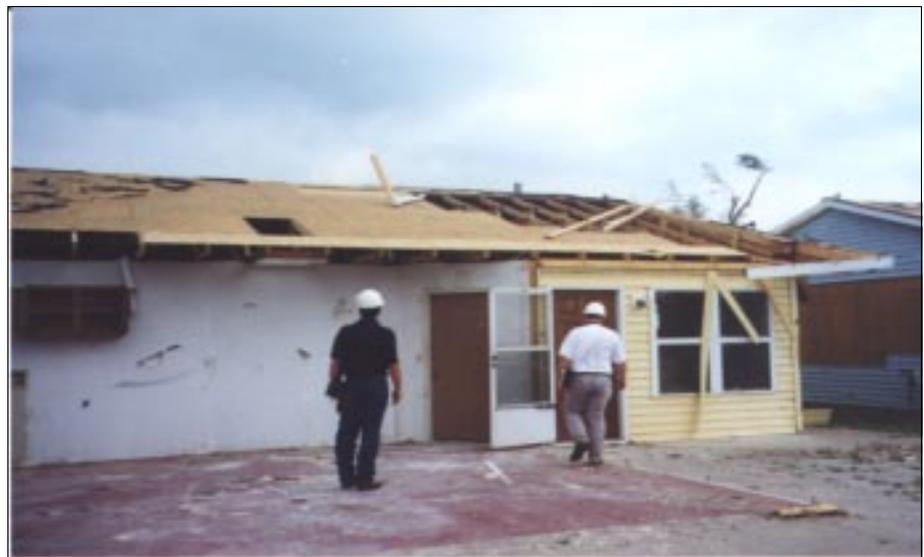
**FIGURE 4-4: Although roof sheathing was lost at this Wichita, Kansas, home code requirements of staggering joints in sheathing applications was observed. This house experienced inflow winds from a severe tornado.**

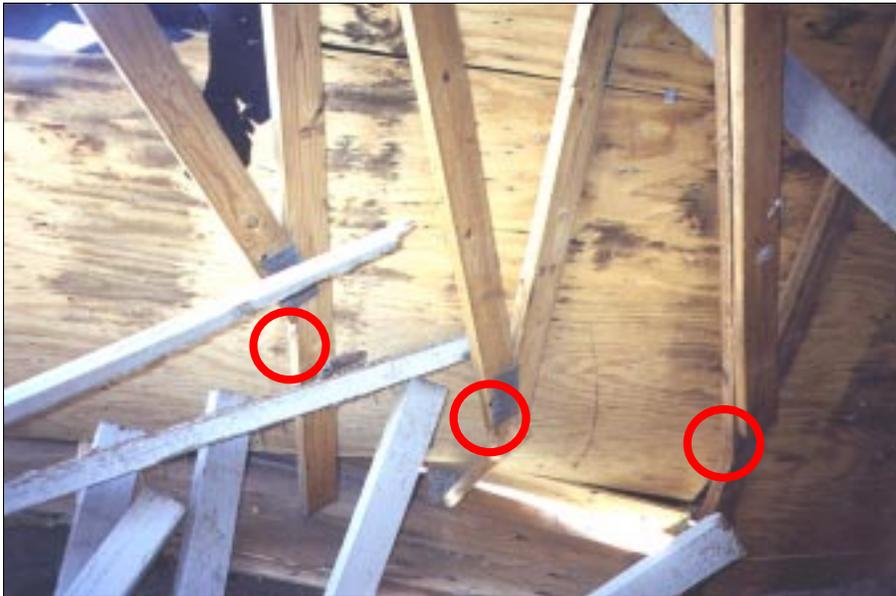
**FIGURE 4-7: Roof truss failure. A single nail (circled) was used to connect each truss to the top plate. This house was in Midwest City, Oklahoma and experienced inflow winds from a violent tornado.**

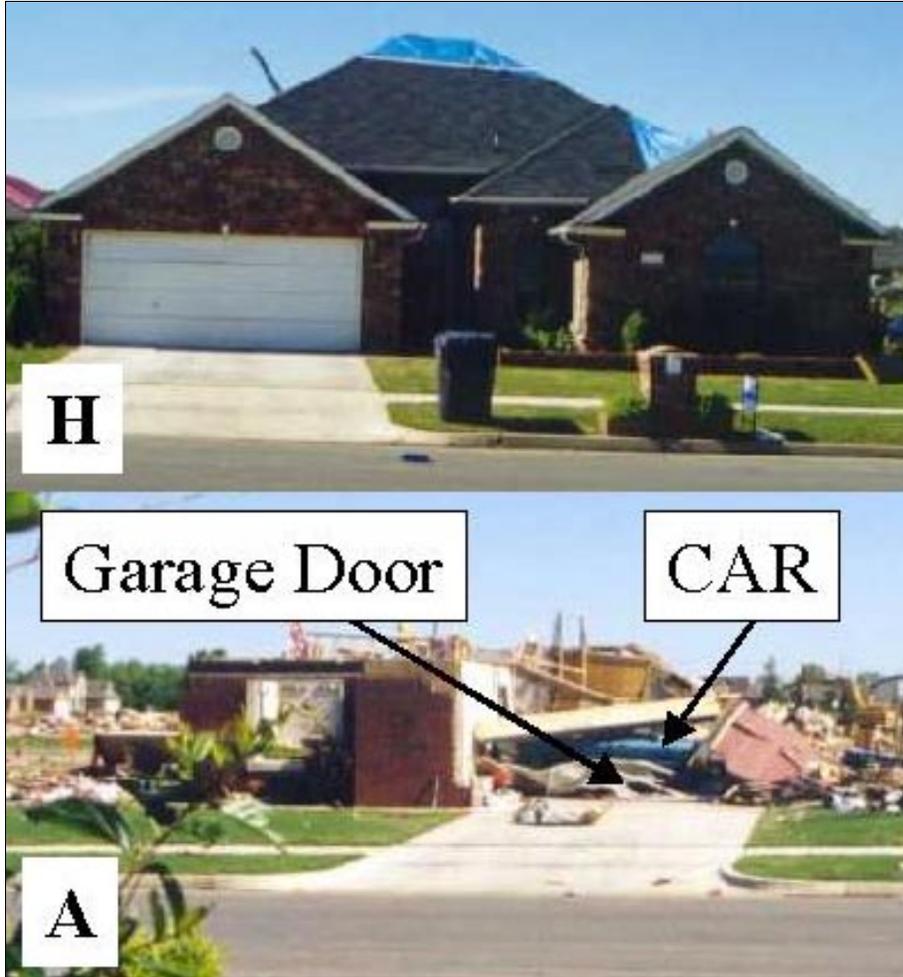
**FIGURE 4-20: Home in Moore, Oklahoma, with partial roof loss (H) vs. home with total roof loss due to garage door failure (A) under positive pressure.**

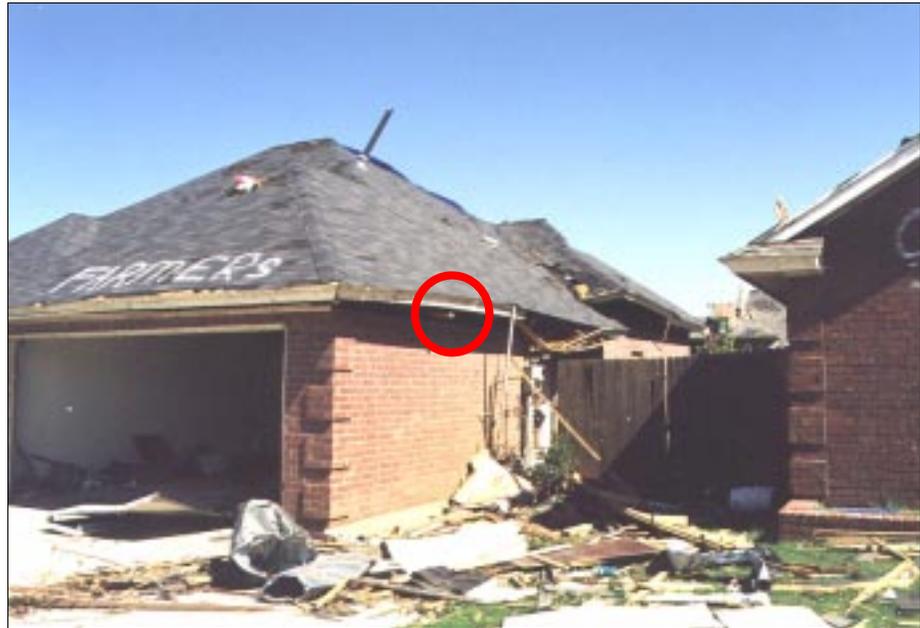
**FIGURE 4-22:** Garage door failure possibly resulting in the localized partial roof failure on the left side of this home located in Moore, Oklahoma.

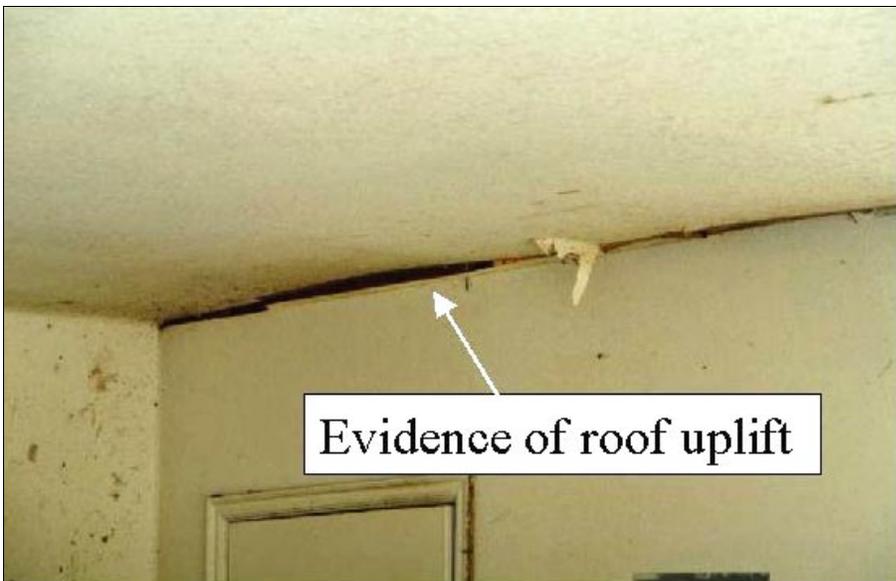
**FIGURE 4-24:** Roof uplift between garage roof and exterior wall at home G.

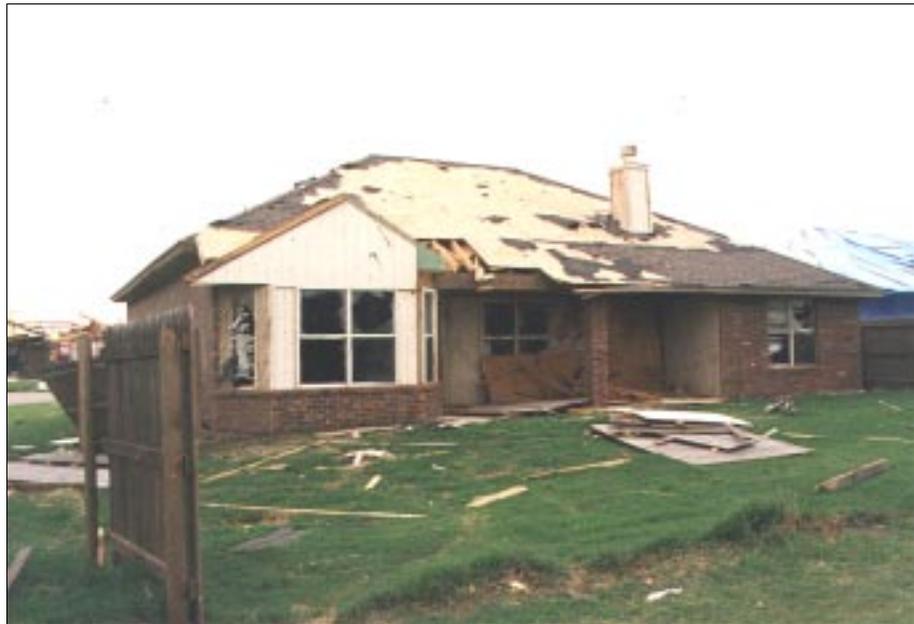
**FIGURE 4-27:** *Front of home in Figure 4-26 where several pieces of roof decking failed.*

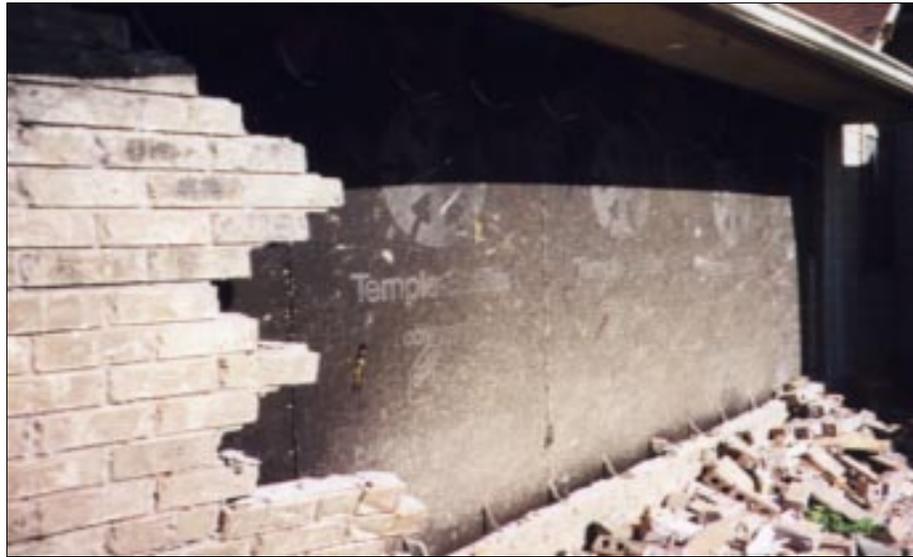
**FIGURE 4-33: Failure of masonry veneer wall, close-up view, Moore, Oklahoma. This home was located along the periphery of a violent tornado.**

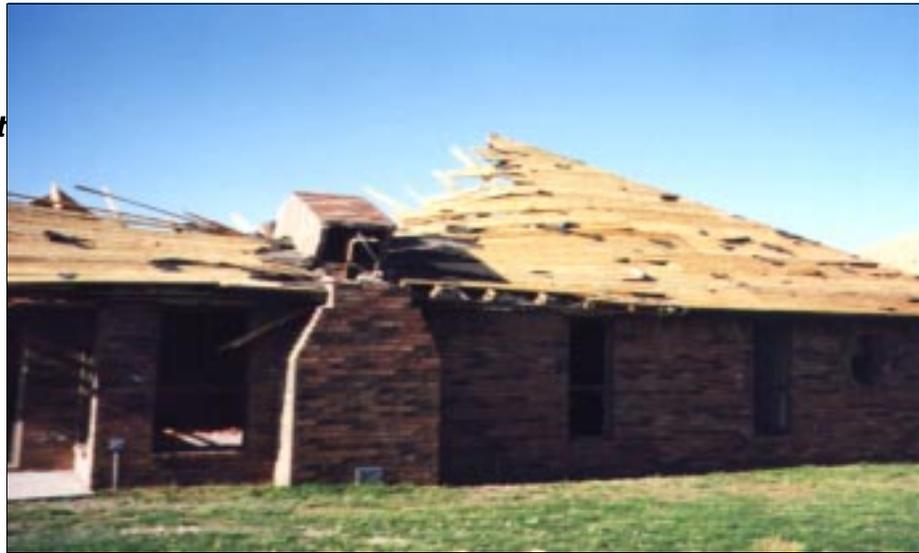
***FIGURE 4-41: Close-up view brick chimney failure in Figure 4-40.***

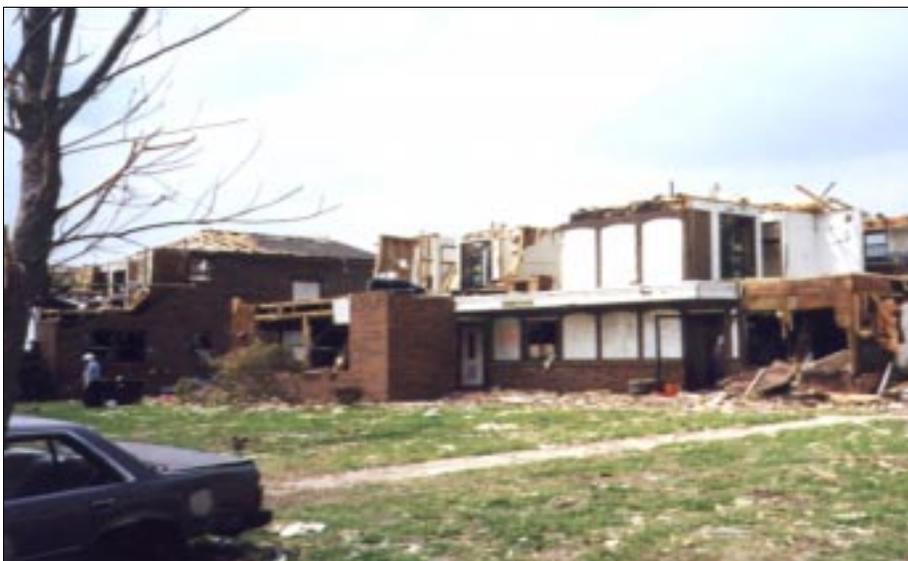
**FIGURE 4-43: Failure of masonry veneer.**

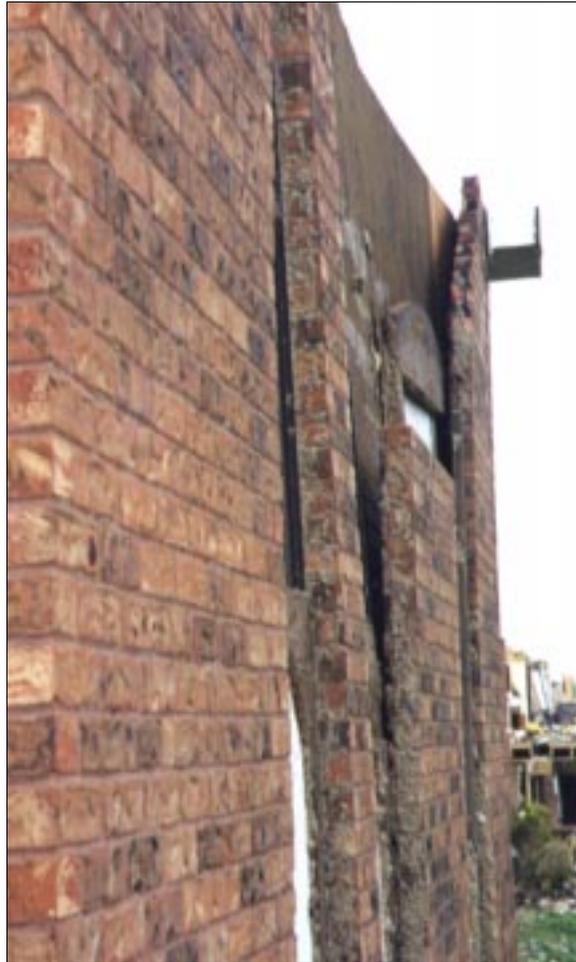
**FIGURE 4-45:** Failure of masonry veneer in multifamily housing located along the periphery of a severe tornado, Wichita, Kansas.

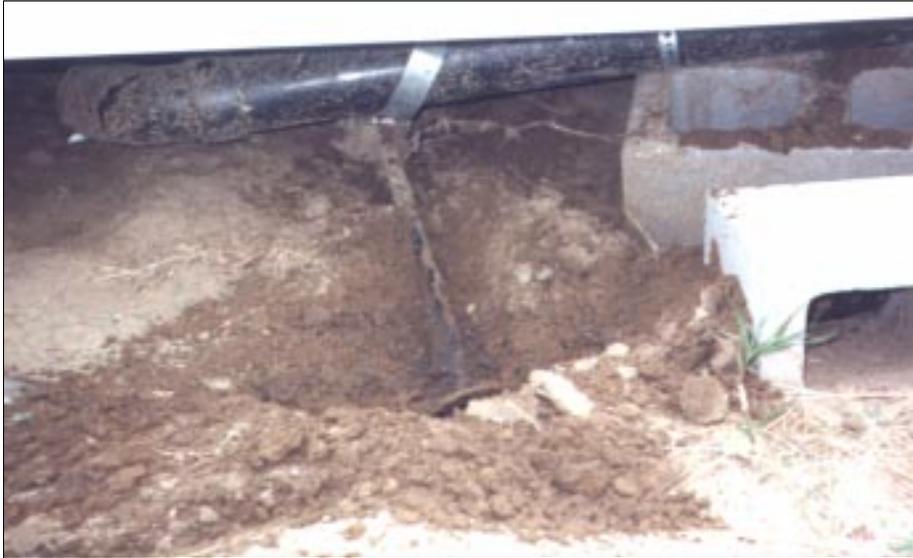
**Figure 4-51: Ground anchor of manufactured home pulled from soil. This home in Wichita, Kansas, was located within the inflow area of a severe tornado.**

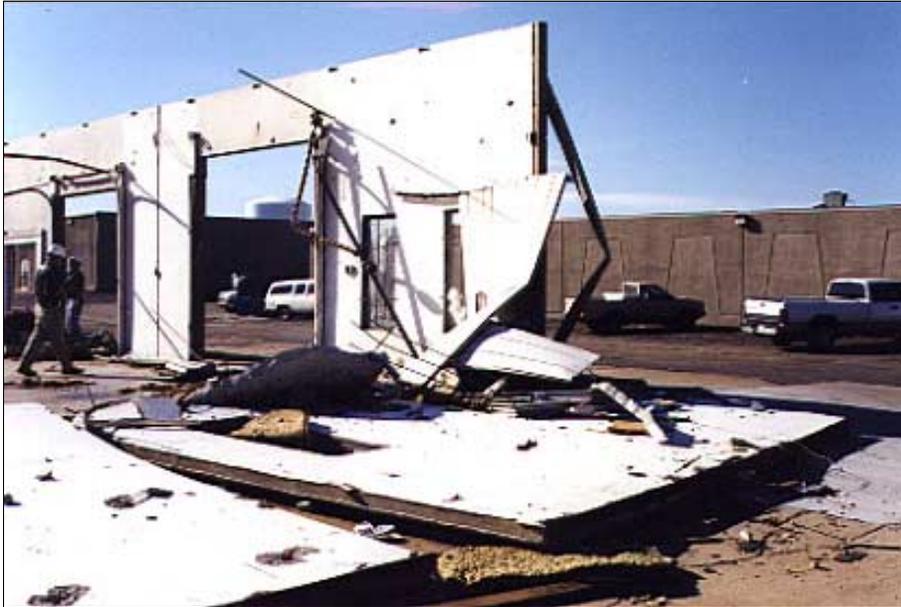
**FIGURE 5-2: Tilt-up precast concrete walls at a storage building located outside Del City, Oklahoma. After the roof joists separated from the walls, this end wall became unable to withstand suction forces and failed.**

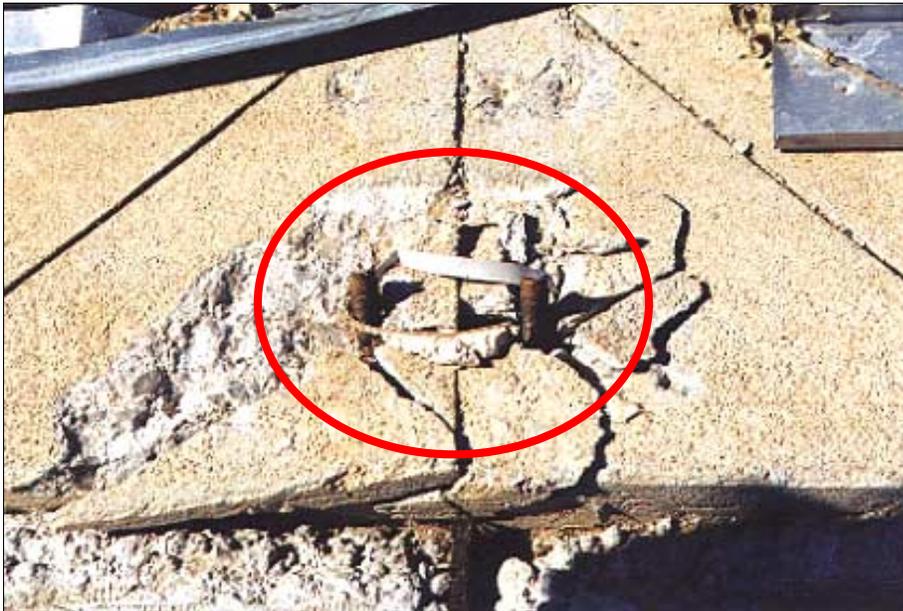
**FIGURE 5-7:** Column anchors that exhibited ductile failure at the regional outlet mall in Stroud, Oklahoma, hit by moderate tornado vortex.

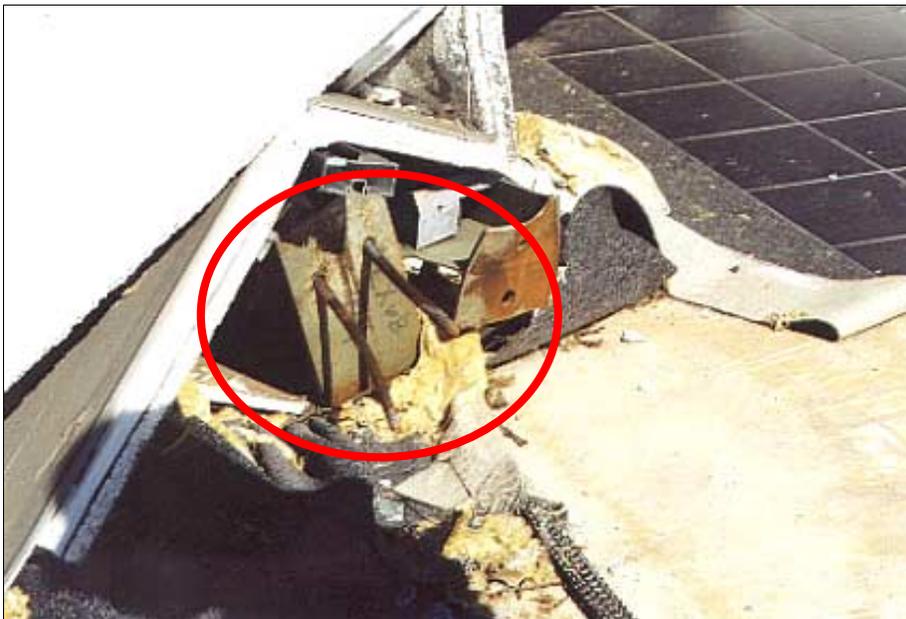
**FIGURE 5-8:** Column anchors that withdrew from concrete foundation at the regional outlet mall in Stroud, Oklahoma, hit by moderate tornado vortex.

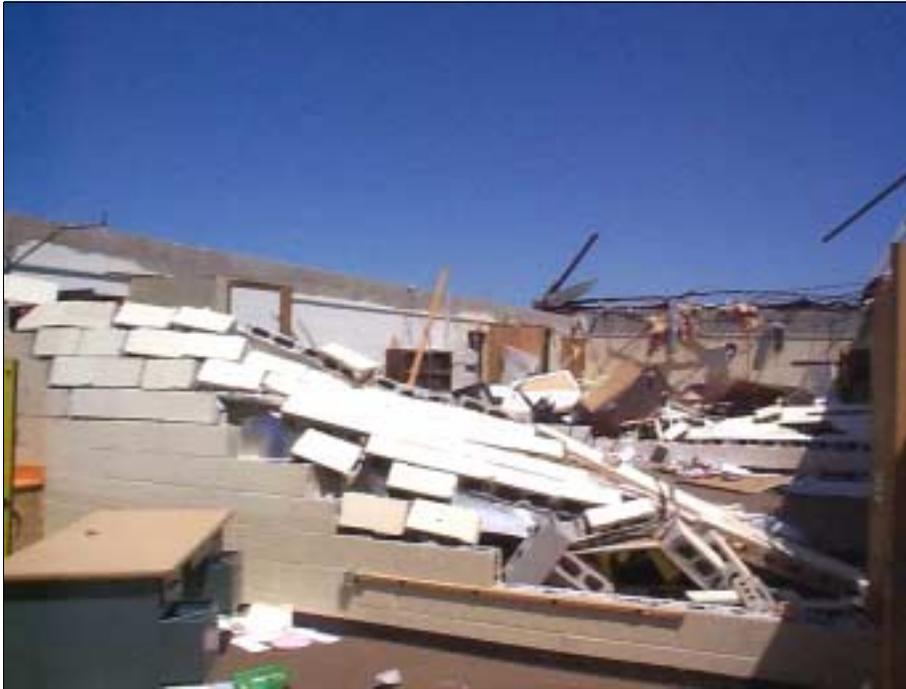
**Figure 5-20: Damage to interior and exterior unreinforced masonry walls when bond beam failed at Kelly Elementary School in Moore, Oklahoma. The school was struck by the vortex of a violent tornado.**
