Tank Explosion in West Virginia

Investigation Report

Published: December 2019

On May 24, 2017, an explosion occurred at the Midland Resource Recovery (MRR) facility in Philippi, West Virginia, killing two workers^a and severely injuring another worker. The founder and president of MRR was one of the victims. The CSB initiated an investigation of the incident and deployed an investigative team on May 28, 2017. While the CSB was investigating this incident, the MRR facility experienced a second explosion, on June 20, 2017. This explosion fatally injured a contractor^b employed by Specialized Professional Services, Inc. (SPSI). MRR had hired SPSI to perform investigation and mitigation work at its Philippi facility following the May 24, 2017, explosion.

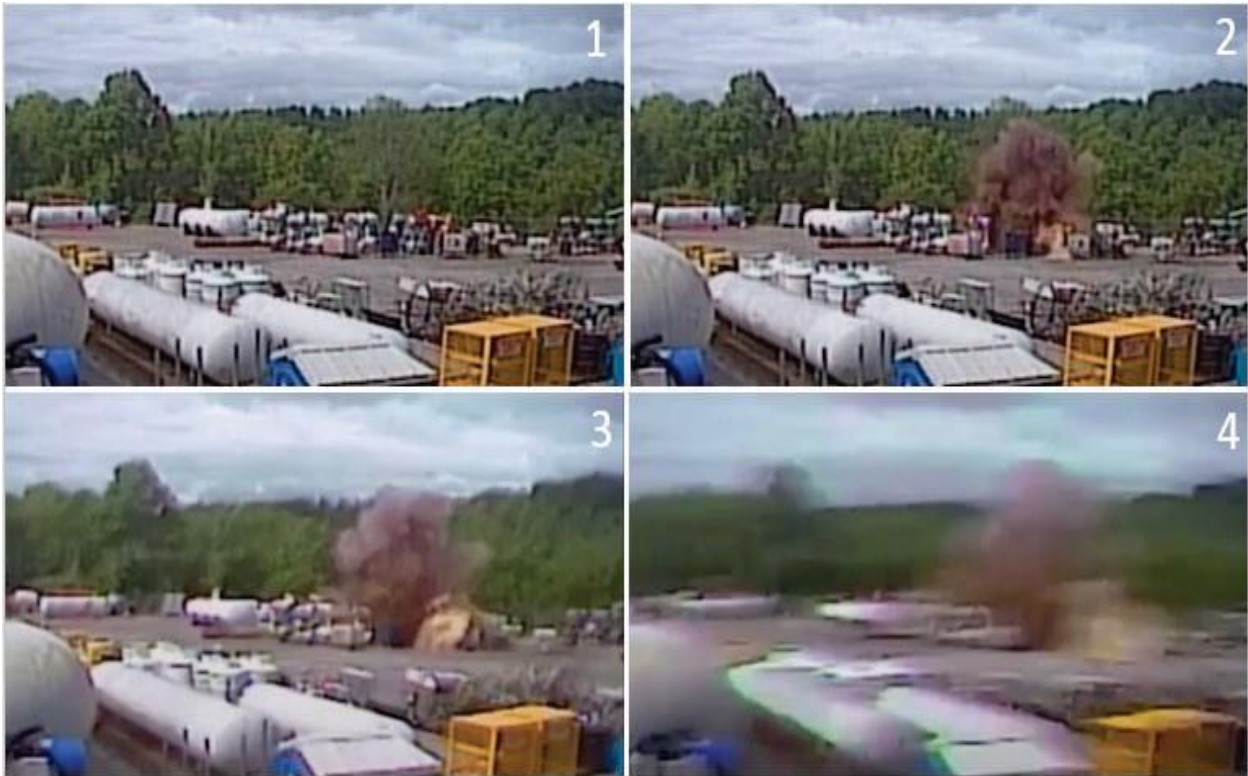
Figure 9. Surveillance Video Capturing May 24, 2017, Explosion. These still frames from an MRR surveillance camera capture the May 24, 2017, explosion. (Credit: MRR).

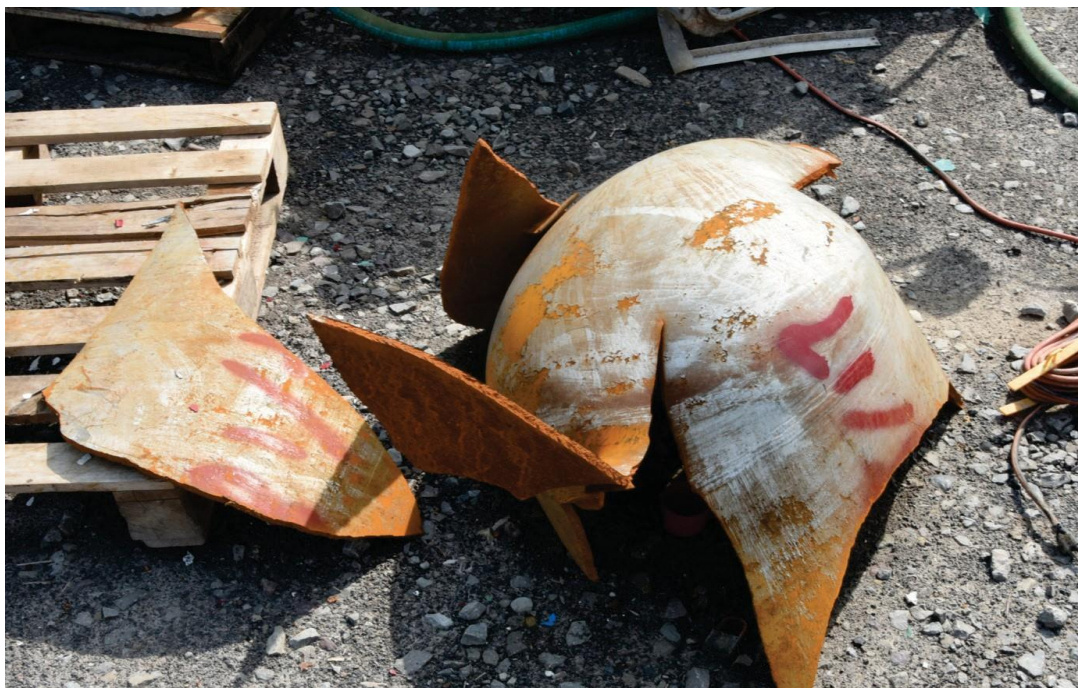
Figure 11. MP Odorizer Fragment from May 24, 2017, Explosion. This photo shows a portion of the top chamber of the MP odorizer after the May 24, 2017, explosion. (Credit: CSB).

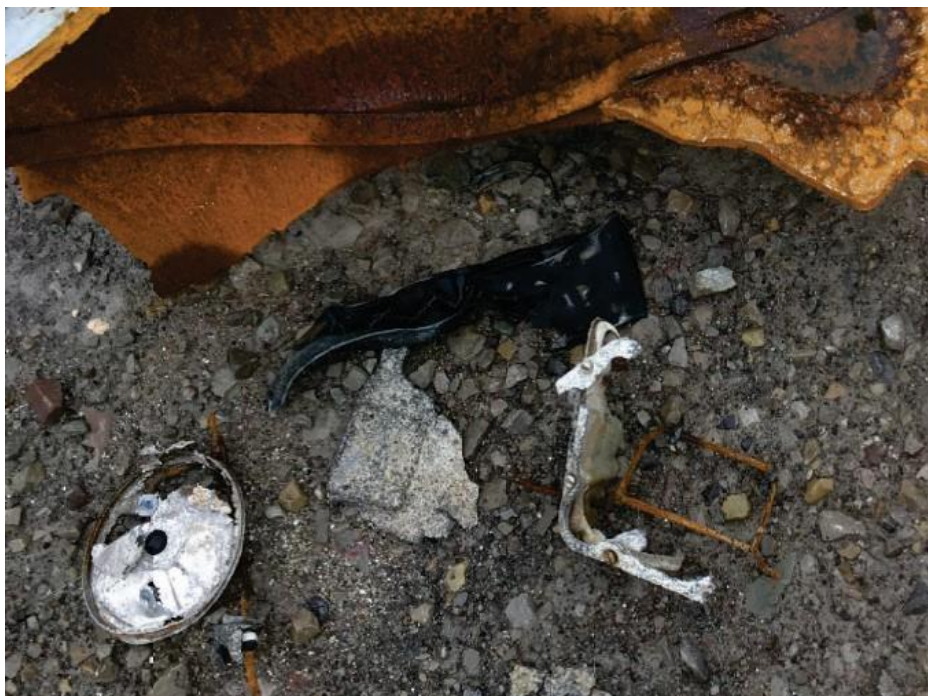
provided the CSB documents from 1964, showing that Peerless used aluminum components in the middle chamber as part of the gas metering and odorant delivery system.

Figure 13. Aluminum Parts. This photo shows aluminum internal components that were likely in the middle chamber of the MP odorizer, found after the May 24, 2017, incident. The explosion destroyed the aluminum pan and components that were inside the middle chamber of the MP odorizer. (Credit: SPSI).

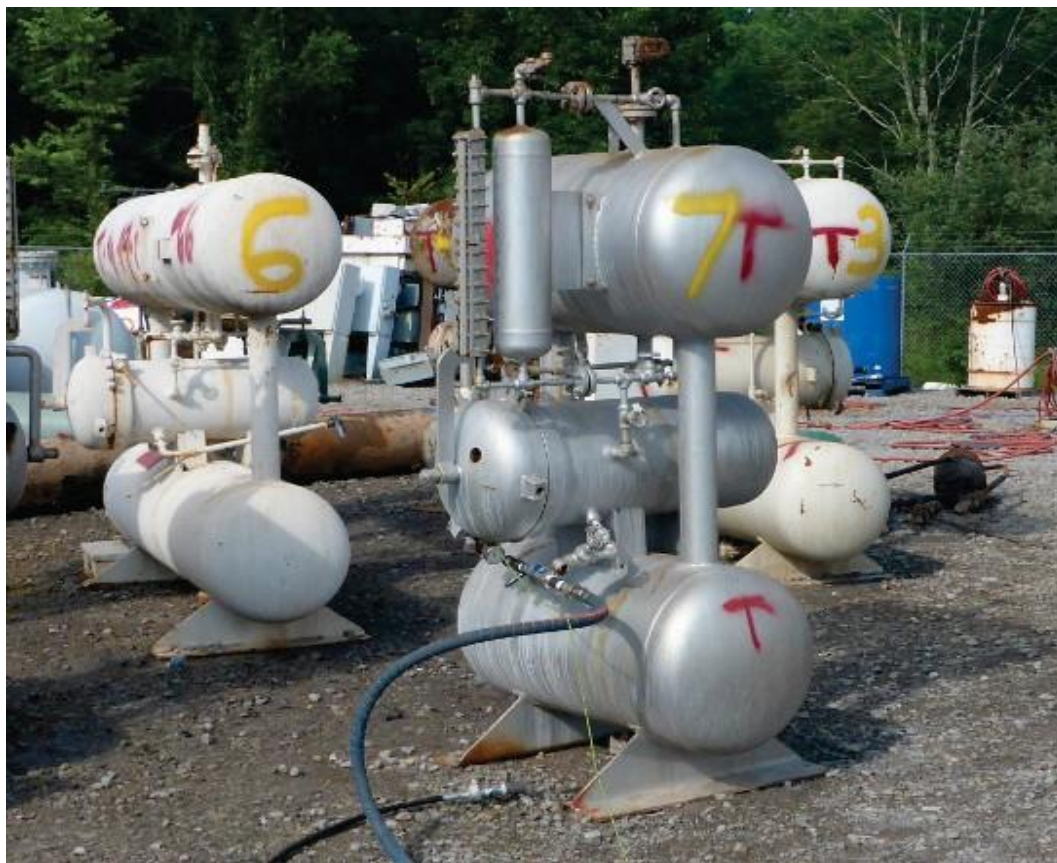
SPSI first tried to drain an MP odorizer that SPSI personnel believed, based on not seeing liquid through the sight glass, did not have any liquid in its second chamber (Figure 14). In other MP odorizers where SPSI had concluded liquid was present, SPSI workers could see “liquid there, various shades of yellow liquid.”

SPSI had installed an additional (new) valve and pressure gauge into the piping coming off the middle chamber (Figure 14—piping to the left of sight glass). SPSI had also put a rope on the existing valve on the pipe, for use in opening the valve (Figure 14). To start the draining operation, SPSI's field supervisor opened the valve using the rope. The pressure gauge indicated zero pressure in the MP odorizer. SPSI's procedure called for halting the operation if the pressure gauge showed more than 30 psig. Because the pressure gauge showed no pressure, the operation continued.

Figure 14. MP Odorizer Before June 20, 2017 Explosion. This pre-incident photo shows the MP odorizer and equipment connections that SPSI workers were using to drain liquid when the June 20, 2017 explosion occurred.^a (Credit: CSB).

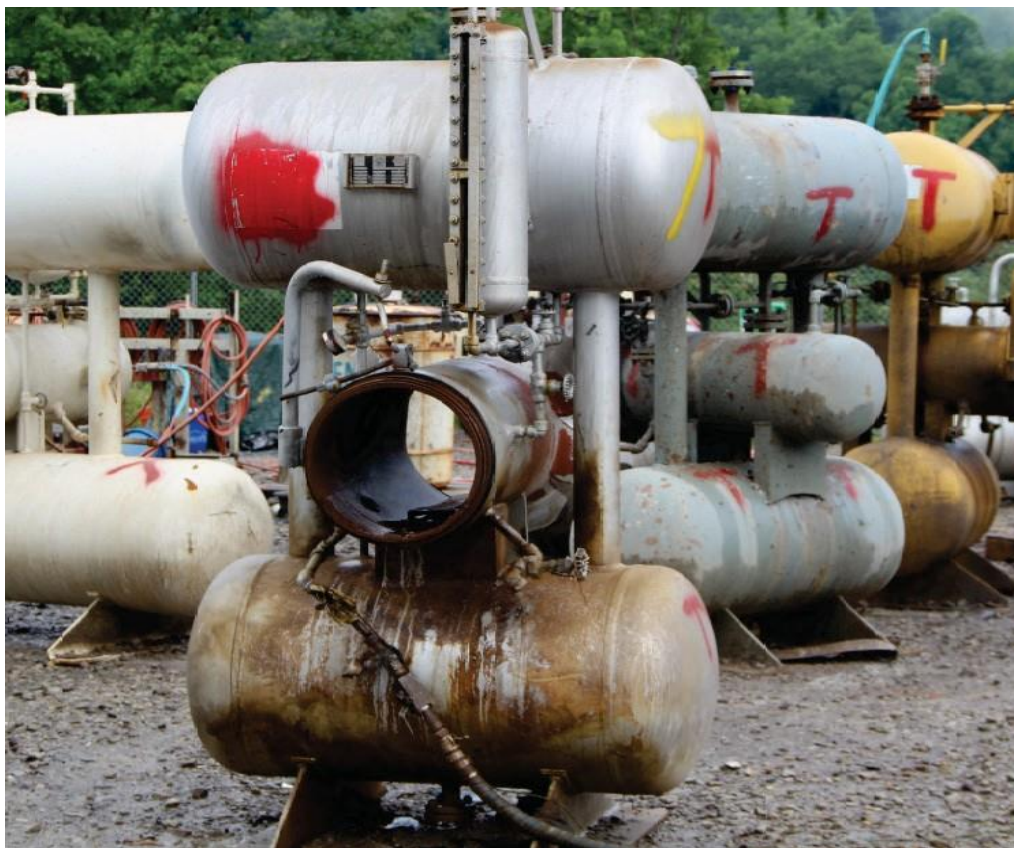
Figure 16. MP Odorizer Vessel That Exploded. This photo shows the MP odorizer that exploded on June 20, 2017. The back portion of middle chamber ruptured (see also Figure 17) and the front threaded section blew off. The aluminum tray and mechanical parts that were inside the middle chamber were expelled from the MP during the event. (Credit: SPSI).

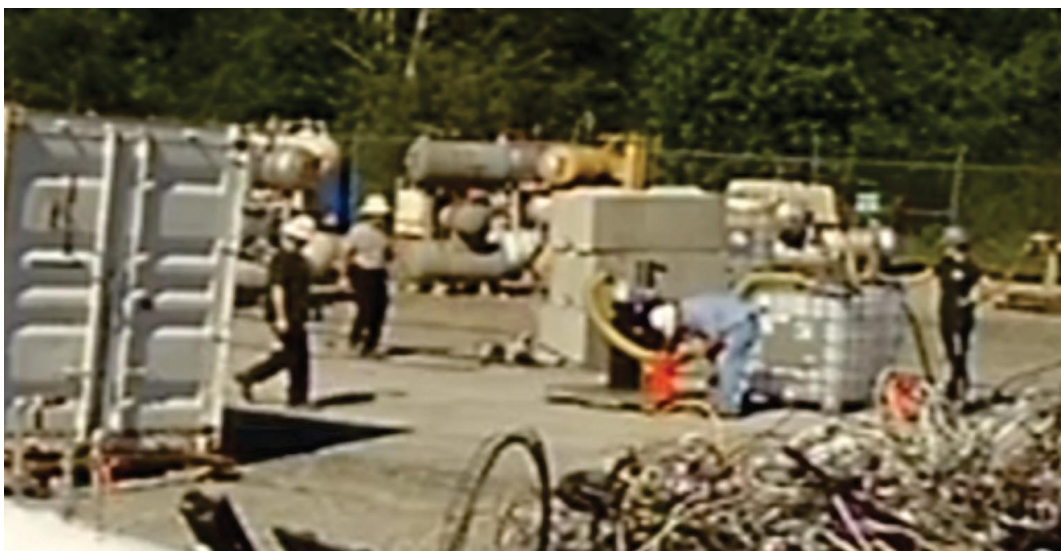
The SPSI manager’s statement about the concrete barriers is consistent with the protocol SPSI developed to drain the process water from the MP odorizers. The protocol does not mention the concrete barriers, establish any type of exclusion zone near the MP odorizer, or suggest that SPSI workers would use the concrete barriers as a safeguard while performing the work. The SPSI manager’s statement is also consistent with the worker actions that took place on June 20, 2017. During the nearly five minutes from when SPSI started their activities to drain the process water from the MP odorizer up to the time of the explosion, only one of the four SPSI employees consistently remained behind the concrete barrier wall (Figure 18).

Figure 18. Concrete Barriers. This surveillance video image from June 20, 2017 at 9:56 a.m., shows only one of four SPSI workers positioned behind the concrete barrier. Two other concrete barriers were placed, but they are outside the view of this surveillance camera (Credit: MRR).

Based on SPSI worker actions captured by the surveillance video leading up to the explosion, MRR and SPSI needed to provide more barriers and strengthen their work plan for these concrete barriers to properly serve as a worker protection safeguard. Had MRR and SPSI established a more robust barrier system, such barriers may have helped to protect the SPSI field supervisor from being struck and fatally injured by the projectile when the MP chamber

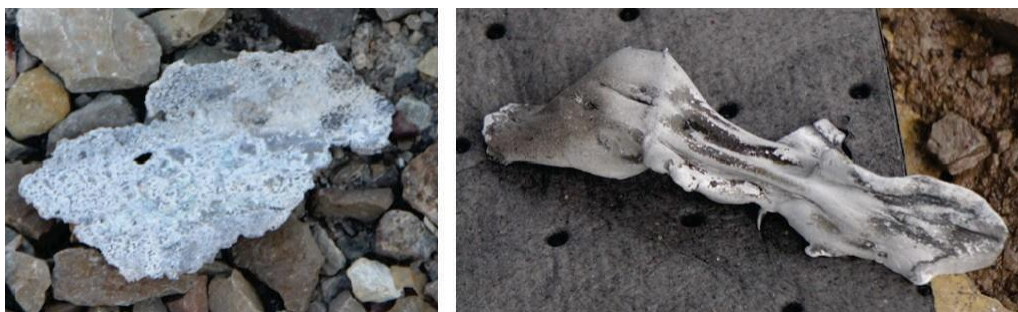
Physical evidence from the May 24, 2017, and June 20, 2017, incidents show differences in the aluminum MP odorizer components. For example, aluminum components from the May 24, 2017, incident have a general corrosion appearance while aluminum parts from the June 20, 2017, incident show signs of melting from heat (Figure 21). These differences could be related to how much exposure the aluminum parts had with the sodium hypochlorite and whether or not liquid was present in chamber two, affecting how much these parts were heated by the explosion. It is also possible that the physical difference in the aluminum parts may indicate that the reactive chemical mechanism involved was not the same.

Figure 21. Aluminum Parts. The picture on the left shows an aluminum part from the MP odorizer involved in the May 24, 2017, incident that appears to have general corrosion. The photo on the right shows an aluminum part from the MP odorizer involved in the June 20, 2017, incident that appears to show signs of melting from heat. (Credit: MRR (left), SPSI (right)).
