Corrosion Protection of Steel Bridges

Steel Bridge Design Handbook: Corrosion Protection of Steel Bridges

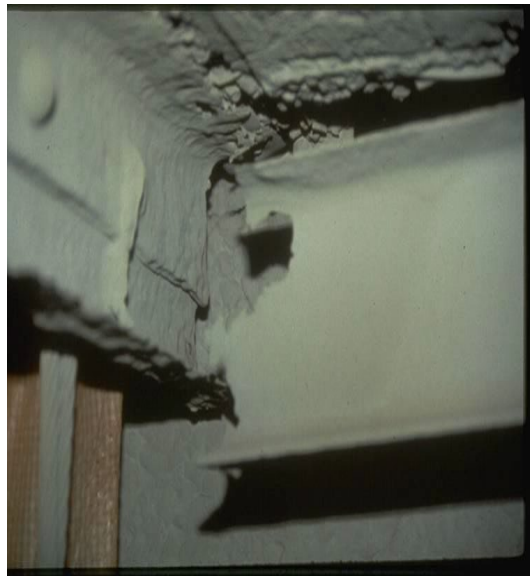
Figure 1. Photo. Photograph of a severed connection due to corrosion.

Two prominent bridge collapses were the Silver Bridge (Point Pleasant, WV) in 1967 and the Mianus River Bridge (Greenwich, CT) in 1983.^(1,2) While corrosion was a player in these two failures, it was not the sole reason either. The Silver Bridge collapsed due to fracture of a non-redundant eyebar where a stress-corrosion crack led to fatigue growth and ultimately fracture. The Mianus River bridge failed when pack rust almost pushed a hanger bar off its pin, but ultimate failure occurred when the tip of the pin fractured. In either case, the collapse would have been prevented with a different structural design, more judicious materials selection, or closer attention to in-service inspection. Regardless, corrosion was a player in the collapses and it demonstrates that corrosion mitigation also needs to be a design consideration. Corrosion has been cited as a contributing factor in bridge failures of varying severity, including several failures and many load postings due to section loss in primary members. An example of bridge corrosion is exhibited in Figure 1 that shows a broken connection due to corrosion. Therefore, corrosion is not an issue to be taken lightly by the designer.

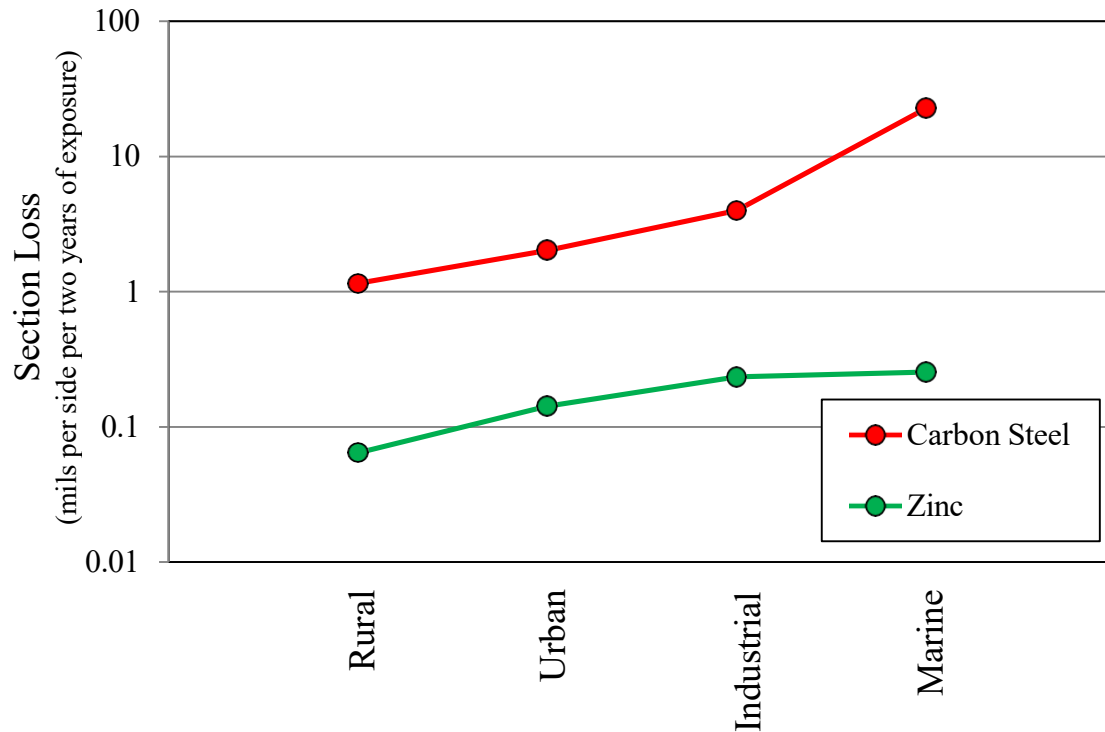
Figure 2. Graph. North America corrosion rates for carbon steel and zinc in various exposure environments.

Table 1 shows section loss data developed in a comprehensive study conducted by the American Society for Testing and Materials (ASTM) from 1961-1964.⁽⁸⁾ The study was performed worldwide, but only North American results are presented in Table 1. For each location, carbon steel and zinc, 4 inch by 6-inch panels were exposed for one and two years each, and the mass loss was converted to a uniform value expressed as mils per year, per side. Results for zinc are discussed because it will become evident throughout the remainder of this document that it plays an integral role in many corrosion protection systems. The data show the general increase in corrosion rates when moving from rural to industrial to marine exposure sites, with a rapid increase in rate as the salt and moisture content of the environment increases in marine environments. The data also show that there is a wide variation in corrosion rates within each macro-environment depending on such variables as distance from the shoreline, height above ground level, and others. The data is graphically shown in Figure 2, which plots the average section loss per material for each exposure condition, using just the two-year exposure data. The vertical axis is plotted on a logarithmic scale. The data indicate that section loss is logarithmic with the severity of the environment (the data plot fairly linearly), and the zinc erosion data is roughly one to two orders of magnitude less than carbon steel. It is also important to note that these are corrosion rates for ambient conditions with no direct exposure to deicing salts. Direct, frequent contact between bare steel or zinc and deicing salts will produce corrosion rates closer to those listed for a marine environment, even in non-marine locations. Lastly, since this study was conducted in the early 1960s at the height of industrialization in America, pollution was likely near its peak, and the corrosion rates are likely conservative in today’s environment. Clean air regulations have led to less aggressive environments from airborne pollution, and the steel bridge designer needs to be cognizant mostly of marine exposures and of frequent exposure to deicing chemicals.

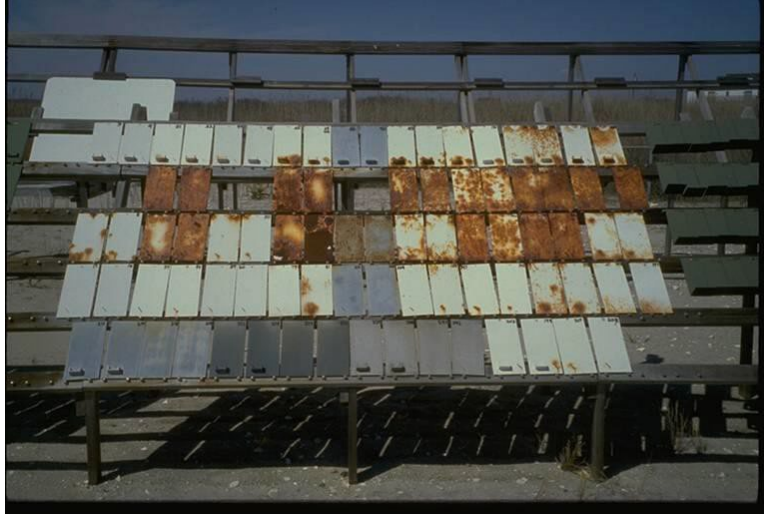
Figure 3. Photo. Testing of various generically similar paint systems shows wide variations in performance.

Zinc-rich primers are almost always topcoated for added corrosion resistance and additional functionality (color and gloss). Testing of zinc coating systems is required by most states to confirm the acceptability of individual paint systems. Testing via natural marine exposure, as seen in Figure 3, is a direct method of paint performance evaluation; however, this method requires a long time to discriminate between high performance systems. For practicality, natural exposure testing must be complemented with accelerated laboratory testing to rank the durability of paint formulations. Of important note, paints must be tested and specified as *systems*, designed and supplied by a single manufacturer to be used together; paints supplied by separate manufacturers are not always compatible. Specification of coatings by generic type or using an “or equal” approach can lead to disappointing performance results.

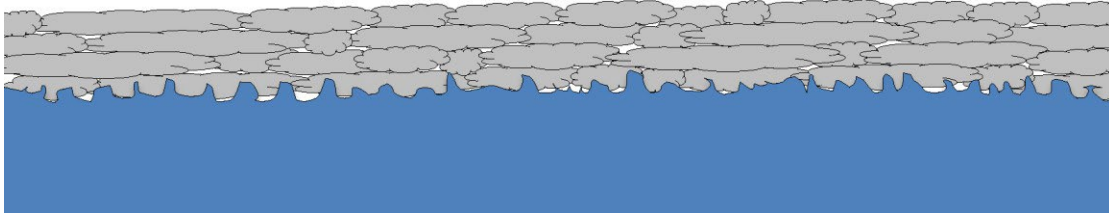
Figure 4. Illustration. Metalized coating formed on top of blast-cleaned steel surface in the form of overlapping “splats”.

far the dominant choices for bridge steel are pure zinc, 85 percent zinc/15 percent aluminum alloy, and pure aluminum. Metalized coatings are applied using a heat source to melt a metal feedstock (typically in a wire or powder form) at the tip of a spray gun that uses compressed air to propel the molten metal onto the target steel. The heat source can be either flame or electric arc, similar to the heat sources for welding equipment. Once the molten metal hits the steel surface, it immediately re-solidifies into a solid sacrificial coating. The coating is built up with a series of overlapping “splats” of metal. Achieving proper specified thickness is important to mitigate the possibility of porosity through the coating.⁽²³⁾ Figure 4 shows a depiction of this application. Figure 5 illustrates a typical field metalizing application.

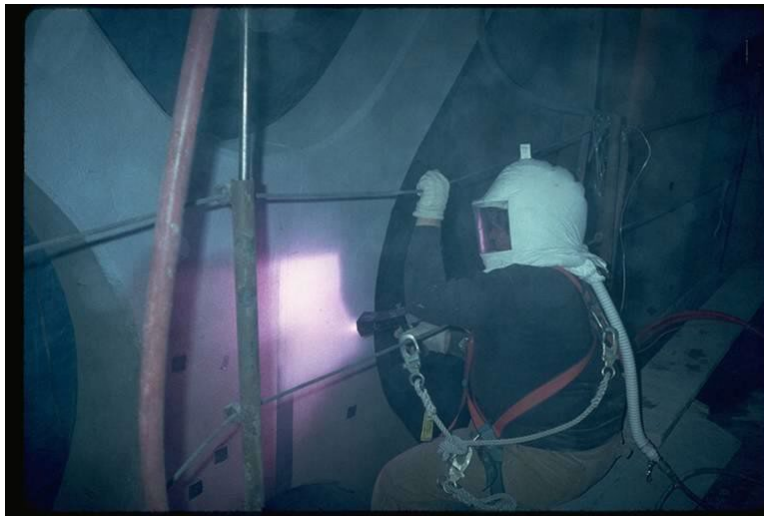
Figure 5. Photo. Metalizing of a bridge member in the field (photo courtesy of R. Kogler).

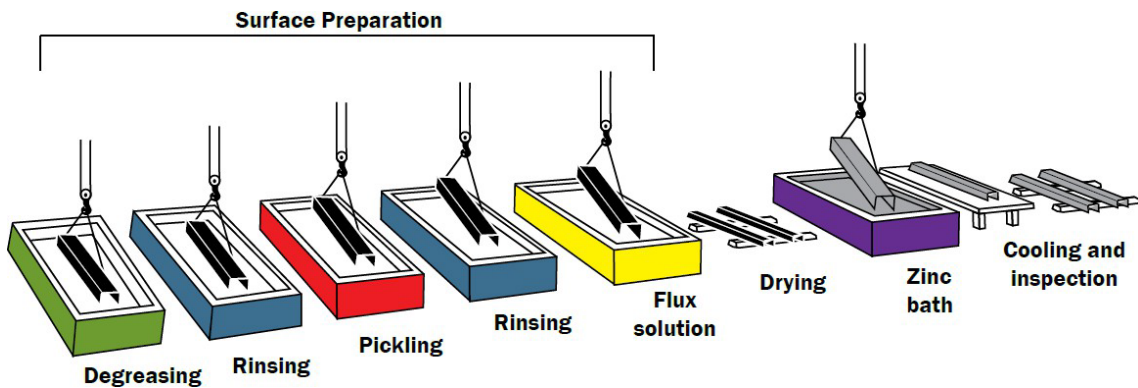
Figure 6. Illustration. Stages of the hot-dip galvanizing process. Taken from reference 28.

or kettles (as seen in Figures 6 and 7). The final dip in the process is immersing the component into molten kettle of pure zinc, typically at temperatures between 820 and 900 °F. These kettles are typically around 40 feet long, but kettles up to 60 feet long exist. The heat from this zinc dip creates a metallurgical bond between the zinc and steel, and creates a layer of sacrificial zinc. The composition of zinc layer depends on the chemistry of the steel and largely plays into the thickness of the coating, therefore a designer cannot specify a desired coating thickness for a hot-dipped galvanized component. When the silicon level in the steel is between 0.04 and 0.15 percent or above 0.22 percent the steel is considered “reactive”.⁽²⁶⁾ For reactive steels, the entire galvanized layer is zinc/iron intermetallics that can be excessively thick (generally thicker than 10 mils) and also brittle. The other problem with reactive steels is the intermetallic layer can continue to grow, and overall galvanized thickness is controlled by dwell time in the tank, but this can be mitigated by abrasive blasting in lieu of acid pickling. For non-reactive steels, the intermetallics form with a gradient in the zinc/iron ratio being more iron bearing near the steel and decreasing through the thickness to the outer layer that is pure zinc. The nonreactive steels develop a thickness that is on the order of 4 mils thick, and dwell time in the tank does not cause coating thickness to increase. Most of the time, the galvanizer does not know the chemistry of the steel being dipped, and therefore through experience has developed a knowledge of dwell time the piece should be immersed to get a galvanized coating that meets the quality control requirement of ASTM A123 for both reactive and nonreactive steels. ASTM A123 defines the sampling requirements for hot-dipped pieces by which coating thickness is assessed and accepted by.⁽²⁷⁾ For the typical thickness of plate used in bridges, ASTM A123 generally would require a minimum galvanized coating thickness of 3.9 mils or thicker.

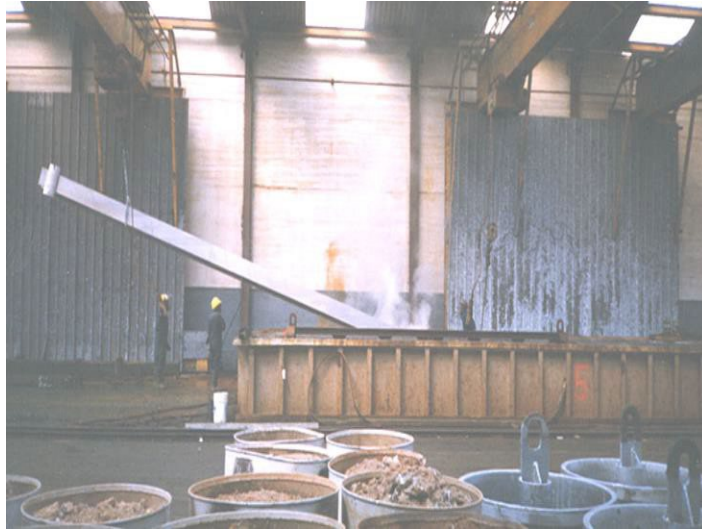
Figure 7. Photo. Hot dip galvanizing kettle with long beam being dipped at one end.

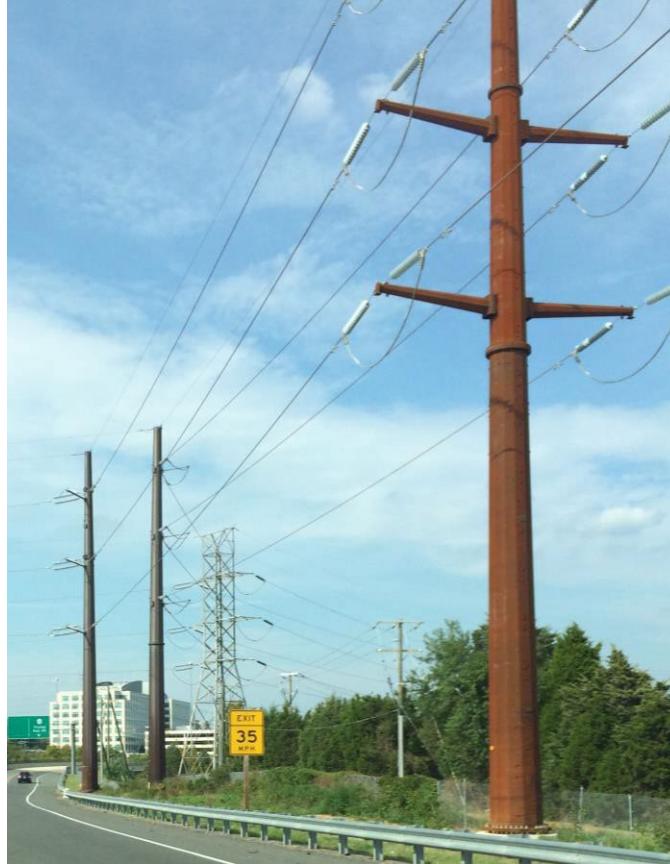
Figure 8. Photo. Different color of rust patina in new transmission tower (close) and older (far).

Oxidation of steel is the process of corrosion. Most people understand that “rusting” is the oxidation of steel, though in this case the oxides that develop continually flake off and expose new uncorroded steel, which is an unstable for of rusting. Alloying the steel can enhance its corrosion resistance. For instance, alloying with small amounts of copper, nickel, chromium, silicon, and phosphorus creates a class of corrosion-resistant steels referred to as “weathering” steels. Under a wide range of exposure conditions, weathering steels also rust, but form oxides that remain tightly adherent to the steel substrate and develop a much more stable oxide layer than non-weathering steel. Shortly after blast cleaning to remove mill scale, weathering steel turns “rusty” in appearance, but as the stable “patina” (oxide) develops over many wet and dry cycles (usually between 6 and 24 months depending on environment), the oxide layer will stabilize to a deep brown, almost purple color when the patina is fully developed.⁽¹²⁾ While not a bridge, the transmission towers shown in Figure 8 show the difference is recently erected weathering steel transmission tower with a brown patina versus one that has been in-service for many years with the dark chocolate/purple color.

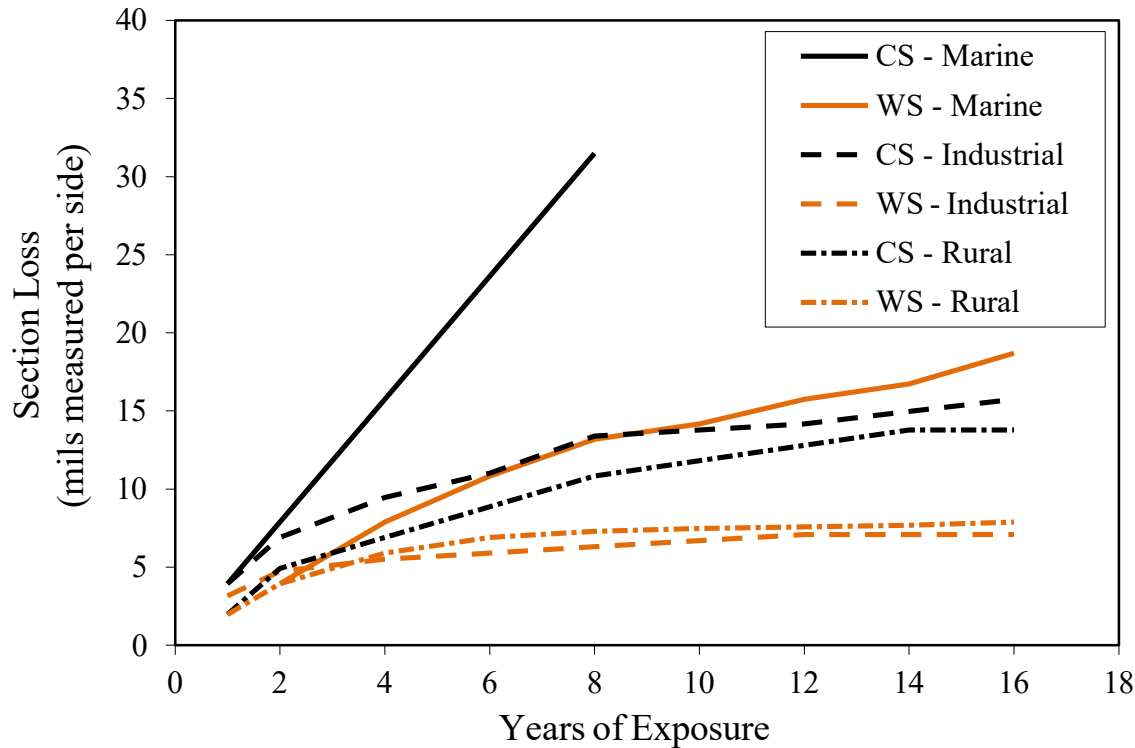
Figure 9. Graph. Relative corrosion rates of carbon and weather grade steels in various environments.

Figure 9 was constructed as a composite from long-term corrosion exposure data available in the literature.⁽³⁴⁾ The values used are averages from various exposure programs under a variety of conditions and do not represent worst-case estimates for the particular cited macro-environment. The data show that in the three exposure categories, weathering steel (denoted “WS” in figure) does corrode at a lesser rate than carbon steel (denoted “CS” in figure). However, the more important distinction is that for the marine environment, the rate never plateaus and corrosion continues, though for the industrial and rural environments, the corrosion does stabilize. In these two environments the rate of corrosion stabilizes to a very low (i.e. negligible) corrosion rate of approximately 0.3 mils per year per side (or lower in many cases). Understanding the steady state corrosion rate of weathering steel allows for the designer to determine the amount of sacrificial plate thickness to include in the design once the service life has been established.

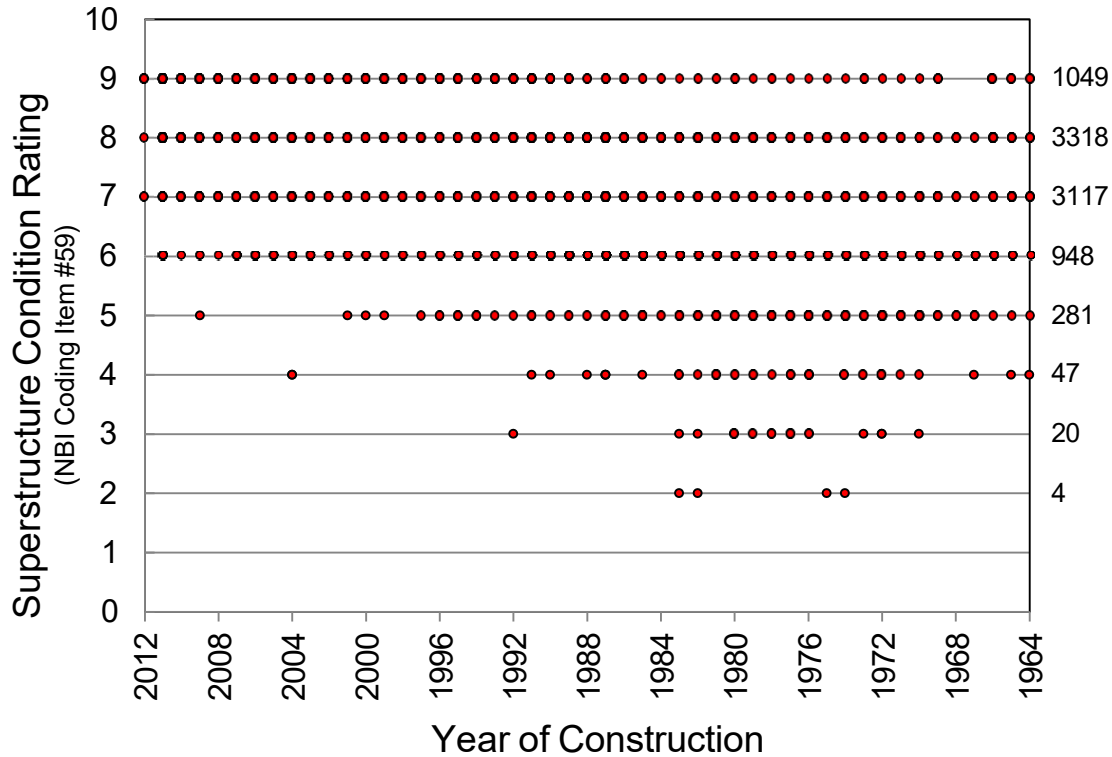
Figure 11. Graph. Superstructure condition ratings of uncoated weathering steel bridges by year built.

- A negative perception of uncoated weathering steel still persists with some agencies on performance, despite an overall good condition rating from querying those agencies NBI data. It was hypothesized that a few poorly performing bridges generally caused an overall negative perception.
- Overall, FHWA Technical Advisory T5140.22 is preventing bridges from being built in harsh environments, or with detailing that is not conducive to good performance. Of the 4,653 uncoated weathering steel bridges built since 1990, 94.5 percent of them have SCRs of 7 or higher (i.e. good, very good, and excellent condition).

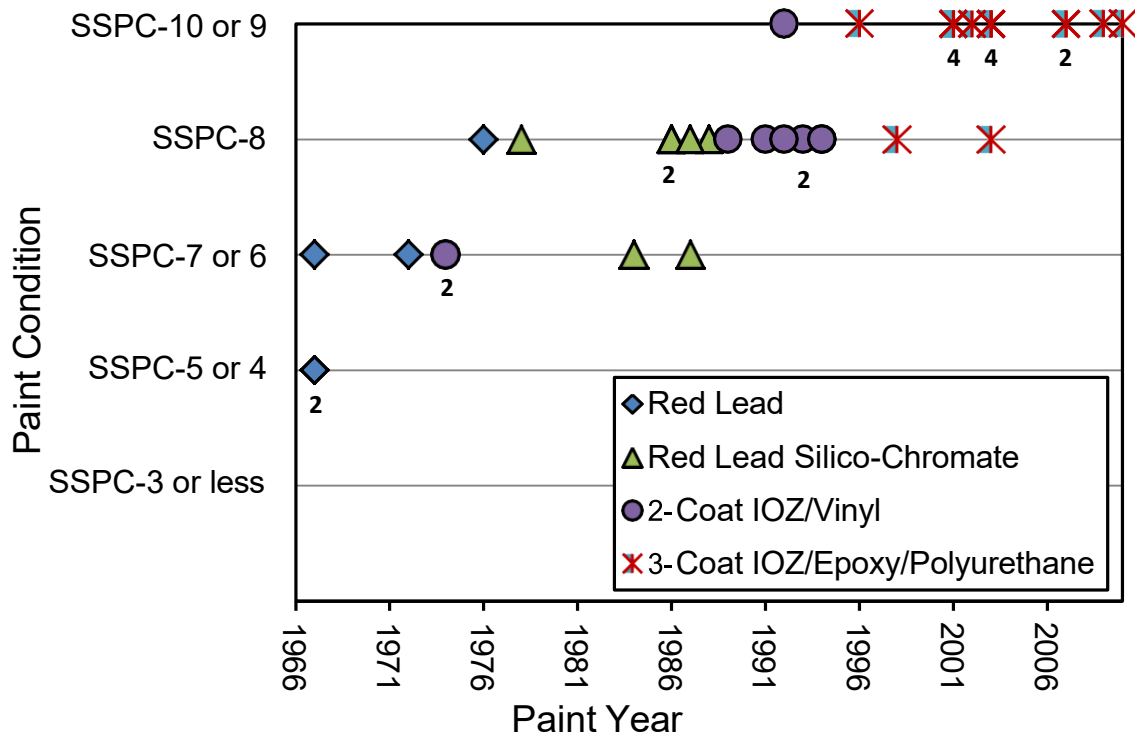
Figure 12. Graph. Condition ratings of original coating systems in Missouri (numbers by data points represent replicates).^(reproduced from 61)

Missouri conducted an assessment of their current coating practice and surveyed the performance of paint systems from November 2009 to July 2010.⁽⁶¹⁾ Figure 12 is reproduced from Missouri's collected data and shows the performance of coatings that had not received any maintenance throughout their life. Coatings were assessed at beam ends and midspan to the SSPC VIS 2 guidelines. Interestingly, there was a small population of bridges with 20 to 42 years of service with red lead coatings that still only had about one percent rusting. All of the bridges using the conventional zinc-rich 3-coat system were in very good condition, with one being in service for 14 years. One of the major conclusions from the study was that the bridges performing well (regardless of the coating system used), were those that had a deck in good condition, a jointless design, well operating drainage systems, or large deck overhangs.

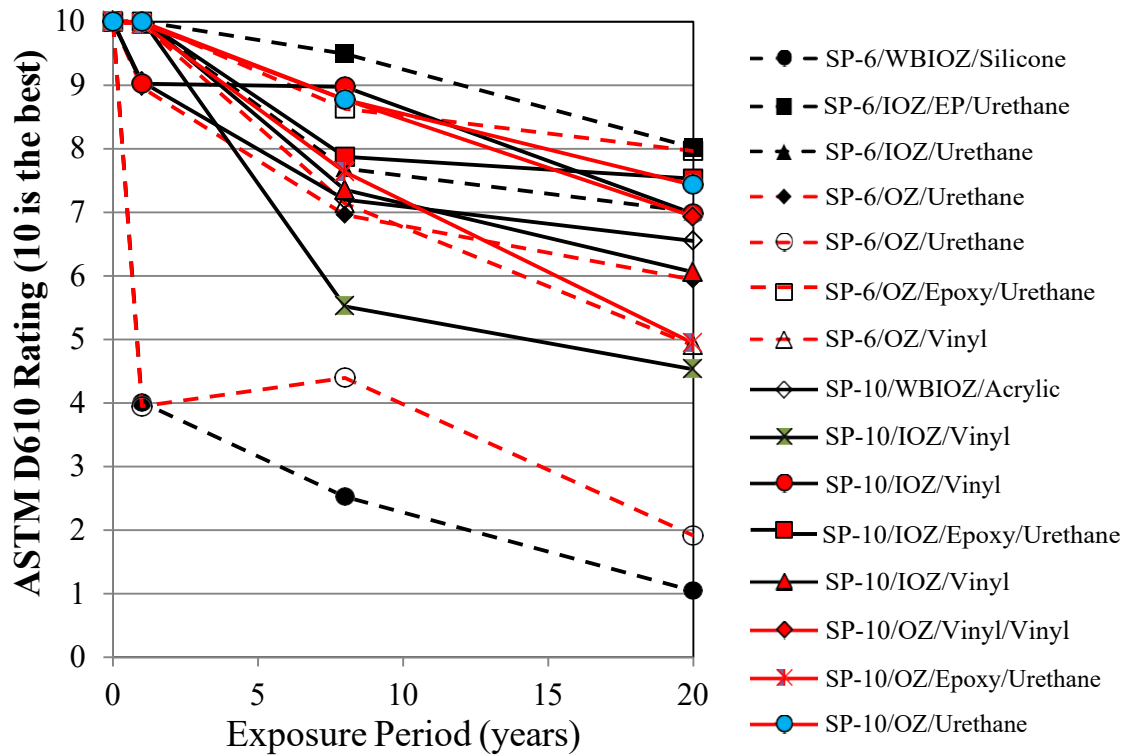
Figure 13. Graph. 20-year performance of zinc-rich systems on the Mathis Bridge. (reproduced from 53)

In the Mathis Bridge study described in 4.1.2, systems using both IOZ and OZ primer with both SSPC-SP 6 and SP 10 preparation were also evaluated after 20 years of marine exposure.⁽⁵³⁾ This study evaluated a number of different systems, even some that did not use zinc-rich primers (so-called “barrier” systems). The performance data validated the trend that for these conventional coatings, three coats of paint is generally more effective than two or one coat (however, more recent developments in the coatings industry have produced materials that provide high levels of durability with two or even one coat at a higher build). The data show that systems with zinc-rich primers prove to be the best performers, but not all zinc rich primer systems performed well. The coating performance ratings after 1, 8, and 20 years of exposure are represented in Figure 13 for just those systems that used zinc-rich primers. Looking strictly at the five 3-coat systems, after 20 years of exposure in this marine environment, the ratings ranged from five to eight on the ASTM D610 scale. However, of those 15 zinc-rich systems, the top seven performers (roughly the top half) survived to a rating of 7 or higher after 20 years in a very severe exposure, applied as a maintenance coating over previously deteriorated steel. Interestingly, this data set does not show a clear separation between systems applied over SSPC-SP 6 versus SSPC-SP 10 blasted surfaces. But in a practical sense, there is often only a slight difference between those two specifications in field work.

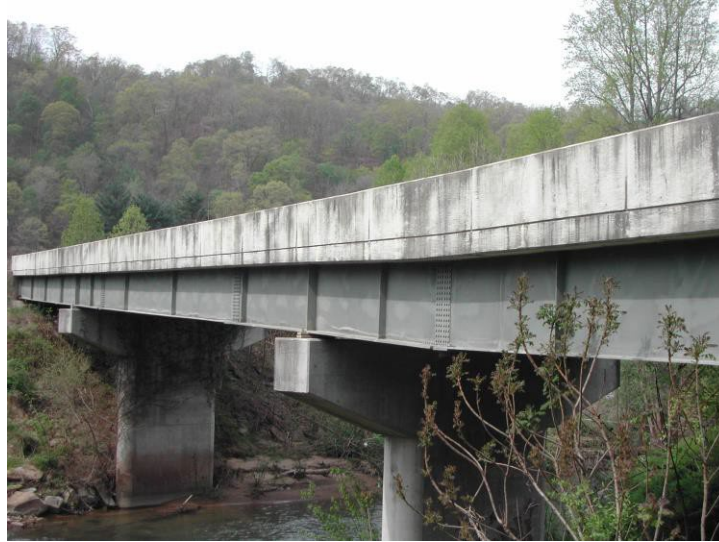
Figure 14. Photo. Bridge in West Virginia with a single-coat inorganic zinc-rich paint system after 25 years.

result reinforces the overriding premise that holds for all of these highly durable corrosion resistant coatings—the life of the coating is often determined by the very severe local conditions created by detailing of the structure as it intersects with concentrated salt-containing runoff, splash and drainage.

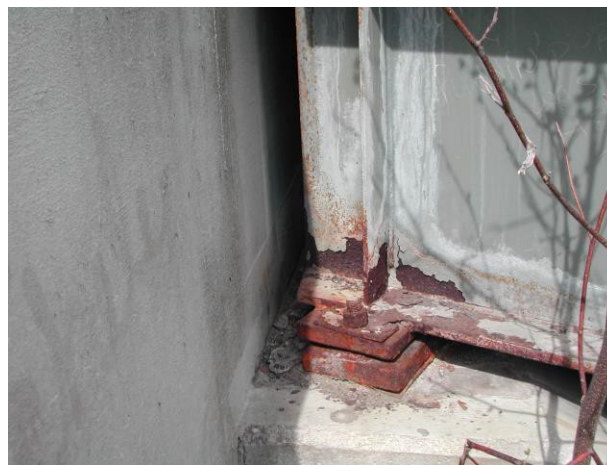
Figure 15. Photo. Deterioration of bearing area beneath a leaking joint with only single-coat inorganic zinc-rich paint.

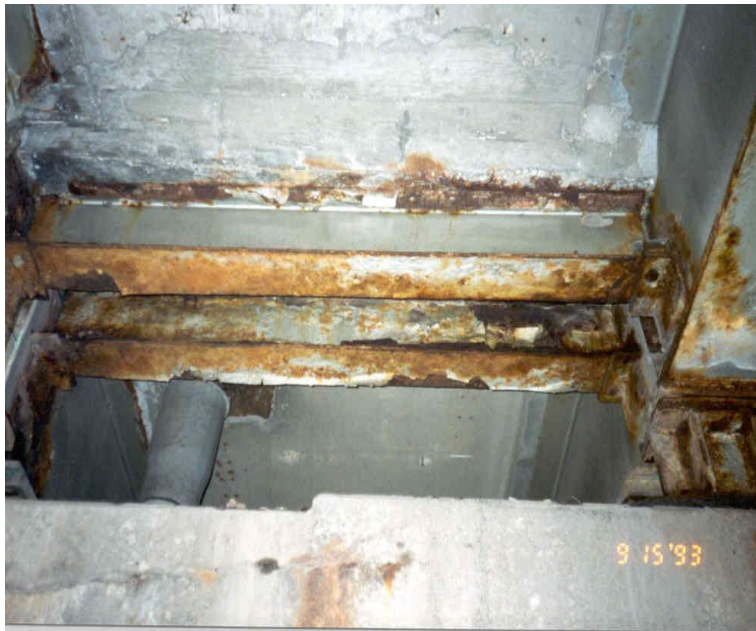
Figure 16. Photo. Steel directly beneath transverse expansion joints that have leaked corrosive runoff from the deck.

debris over time, limiting their effectiveness. Consider use of sealed modular joints in place of multiple single compression seal joints.⁽⁷¹⁾ Figure 16 and Figure 17 depict corrosion due to water leakage and entrapment.

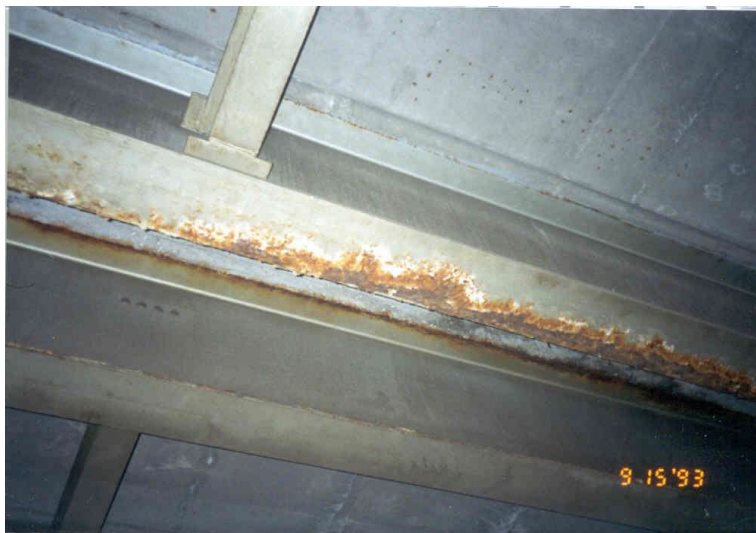
Figure 17. Photo. Steel directly beneath longitudinal expansion joints that have leaked corrosive runoff from the deck.

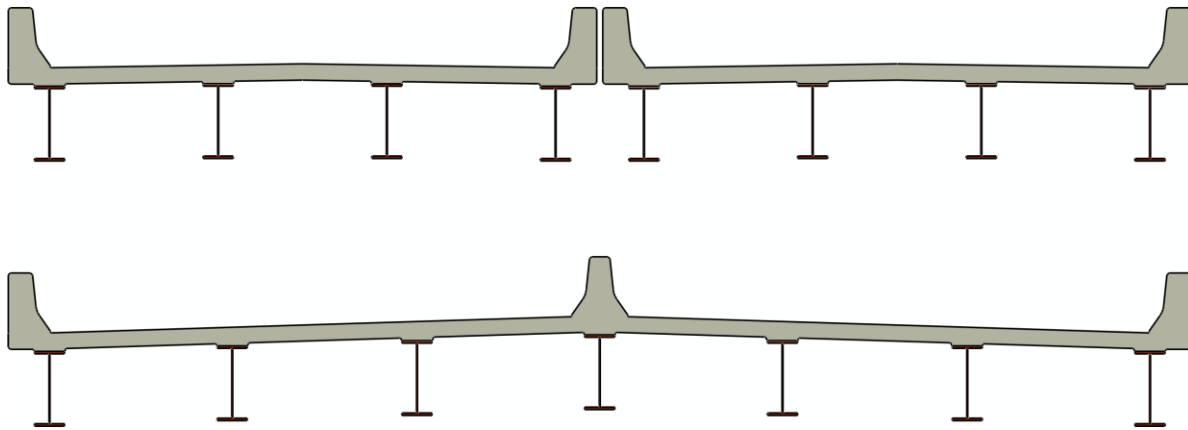
Figure 18. Illustration. (Top) Closely spaced parallel bridges. (Bottom) One bridge carrying both directions of travel.

It would be better, and more economical to eliminate the girder line and combine both structures, as shown in Figure 18 (bottom). Additionally, this eliminates closely spaced girders as highlighted in Figure 19. The closely spaced girders may promote a microclimate with high time of wetness, but also create a space that is difficult to access for performing maintenance activities such as painting, and the quality of the maintenance painting will be expectedly low with poor surface preparation, coverage, and film thickness due to the restricted access. The effect of closely spaced members is also highlighted in Figure 16 where a transverse joint leads to closely spaced end diaphragms, which for the same reasons would lead to poor coating quality in maintenance activities. This could have been avoided if the span was continuous.

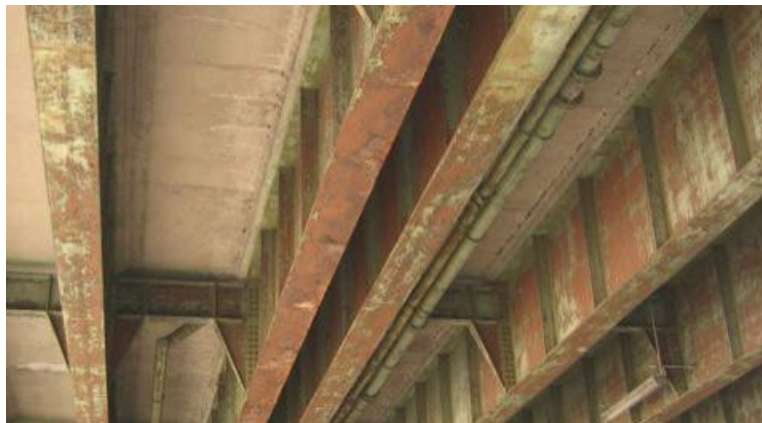
Figure 19. Photo. Closely spaced girders lead to difficult access for maintenance activities.

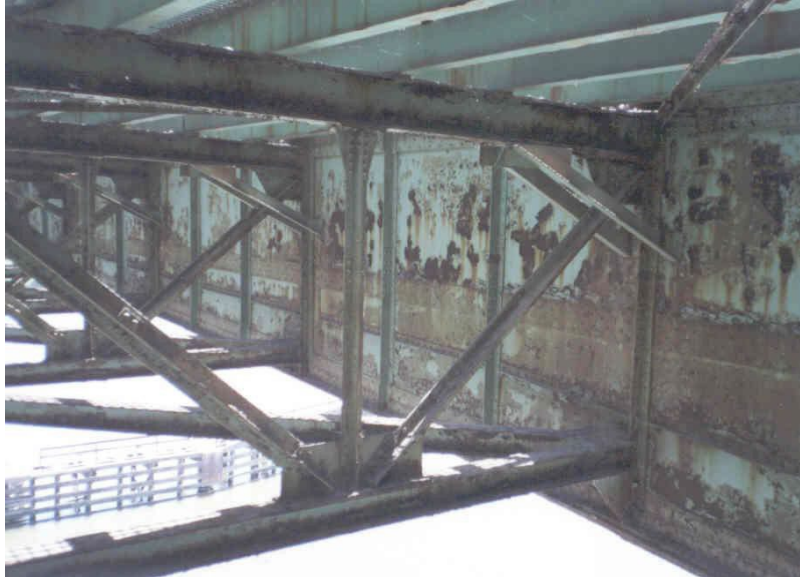
Figure 20. Photo. The area under an open grid deck acting as one large leaking joint.

is shown in Figure 20, in which it can be seen that the majority of the steel coating has failed and active corrosion is occurring.

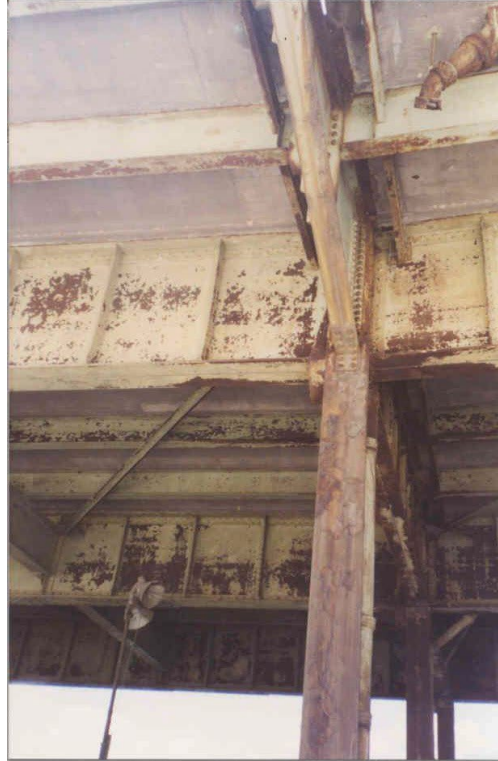
Figure 21. Photo. Missing portion of deck drain downspout.

Certain areas of the steel structure below the roadway surface will see the majority of drainage and runoff from the deck above. These areas will have a higher time of wetness than the rest of the steel structure. They will also receive an increased level of dirt and debris from the roadway. This is critical in areas that receive significant amounts of deicing salt. These areas will often have a much higher corrosion rate relative to the rest of the bridge. Designed, directed drainage is often inadequate and deck-mounted expansion joints often leak as well. An example of corrosion due to drainage can be seen in Figure 21 where a drain pipe can be seen coming from deck, but there is a missing section of pipe between the portion coming from the deck to the vertical drain pipe attached to the steel column, thus allowing water to directly splash the vertical steel column. Figure 22 illustrates a drain that has clogged and is leaking directly on the structural steel.

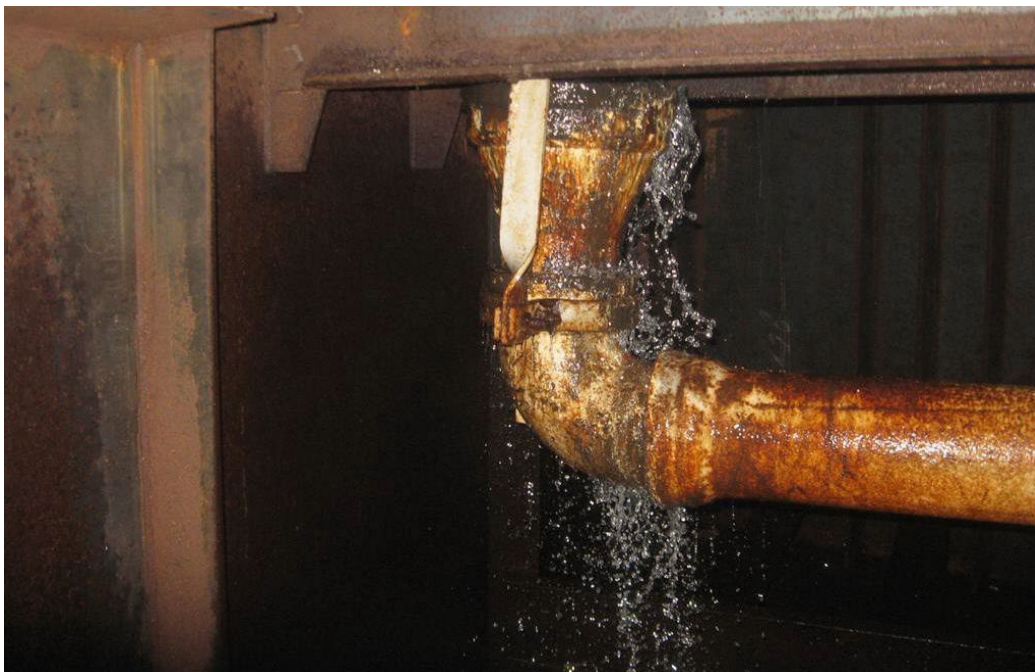
Figure 22. Photo. Clogged drain leaking water onto superstructure.

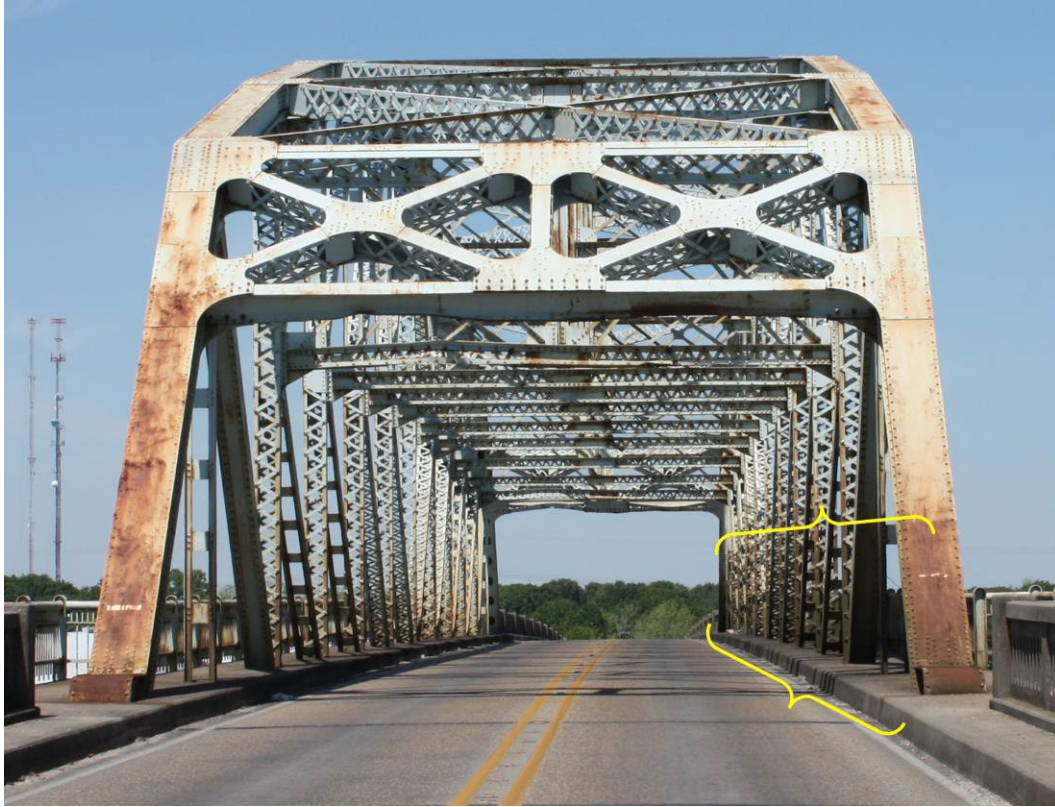
Figure 23. Photo. Through truss showing darkened area in close proximity to the travel lane (i.e. splash zone) that is corroding faster than other parts of the truss outside the splash zone.

Splash zones exist in the lower parts of bridges over any body of water and also in areas that receive significant splash and spray from traffic. These areas include the lower parts of towers and pilings; parapets, curbs, and guardrails; and lower portions of overhead truss structures and overpasses. For example, splash zones are prevalent on through trusses where traffic travels very closely to the truss members, and the zone ranges from the curb level to about ten feet over the roadway; this is shown in Figure 23. The area highlighted in the figure with yellow brackets denotes the zone that would be frequently wetted by spray from vehicle tires, and it can be seen that the coating is starting to break down in this zone. Another situation is illustrated in Figure 24 with two closely spaced parallel structures with an elevation difference. Traffic or snow removal equipment on the left span will inevitably inundate the left fascia girder of the right-hand span. In this case, it would be ideal if the two structures could be combined, eliminating the longitudinal joint between them. If there must be parallel structures, they should be spaced 30 feet or more away from each other to avoid splashing. Splash zones may be unavoidable, but consideration should be given to using a more durable protection scheme in these locations, and providing accessibility for maintenance of the protection system.

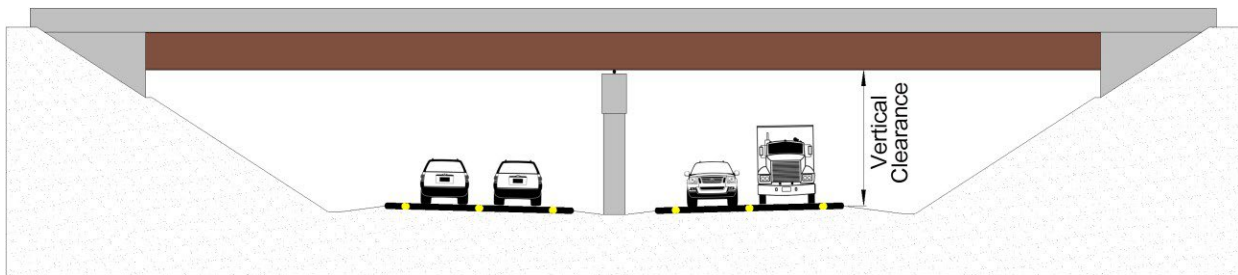
Figure 25. Illustration. Vertical clearance of a grade separated structure.

Vertical clearance is required to prevent the splash and spray of traffic from increasing local corrosion rates in the structure, particularly over travel lanes. This is frequently encountered at grade separation structures as highlighted in Figure 25 and it is sometimes referred to as the “tunnel effect”, where the grade separated structure forms the “ceiling” of the “tunnel.” A common observation is the inbound fascia girder will receive the majority of the spray, with a lighter concentration of spray deposited on the outbound side. This is shown in Figure 26, where in the direction of travel the fascia girder has a coating failure over the right travel lane (coincidentally the most frequently used lane, particularly for truck traffic) and the outbound fascia girder on the other side of the freeway is still pristine. There is no defined vertical clearance number that would eliminate any of these effects; however, the effect is accentuated by proximity of the abutment/pier to the travel lane, the average daily traffic, and local wind conditions. Historically, minimum vertical clearance on the Interstate system has been 16 feet, and this has proven to be susceptible to “tunnel effect” conditions.

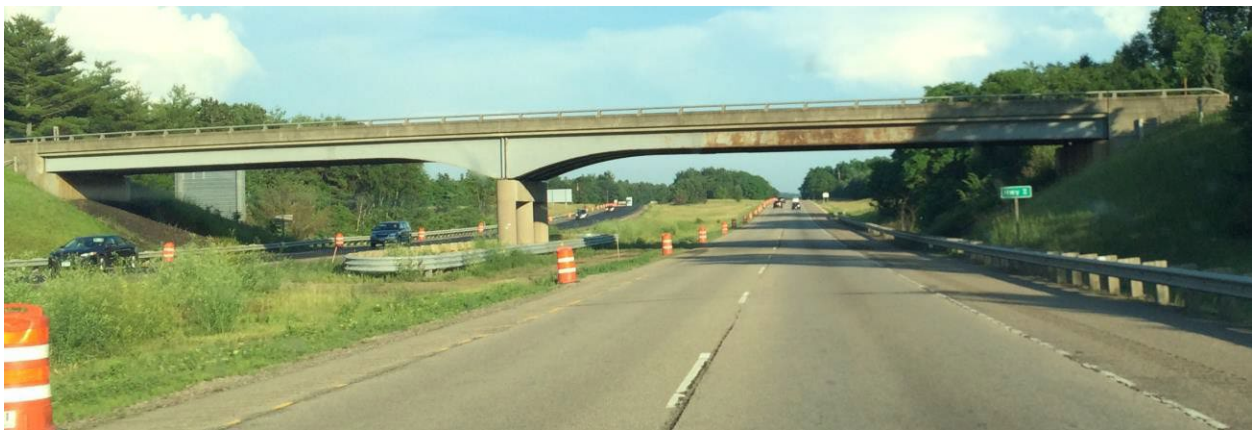
Figure 26. Photo. Accelerated corrosion on the inbound fascia girder of a grade separate structure, particularly over the right travel lane.

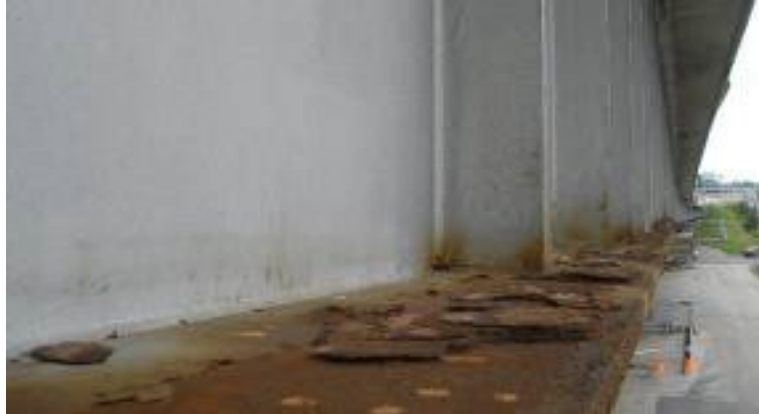
Figure 27. Photo. Corrosion localized to upper surface of lower flange, the rest of the bridge is fine.

Commonly it is observed that the upper surface of I-shaped bottom flanges will corrode before the rest of the I-shape, as seen in Figure 27 and Figure 28. The lower portions of flanged structures corrode early due to higher times of wetness for these parts relative to the rest of the bridge, because they are likely horizontal and can pond water. The higher time of wetness is also caused by preferential condensation on the lower portions of a steel element. While not a recommendation of this handbook, an ideal solution would be to curve the lower flange such that water could not pond on it. This is illustrated in Figure 29 where the right-hand girder in the zoomed in view has a transversely curved lower flange. Certainly, there are logistical issues with the concept; such as how to bend the flange, cutting transverse connection plates to fit, and making bearings to accept the curved surface. However, it illustrates that prevention of ponding water is the goal, but it is not always attainable (unless the entire bridge has a vertical grade). In the case of lower flanges, designing away the problem is not possible and only more durable protection schemes can be specified.

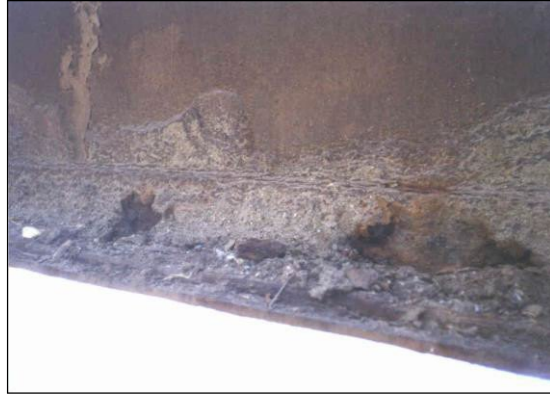
Figure 28. Photo. Heavy corrosion of bottom flange and web due to collection of poullice.

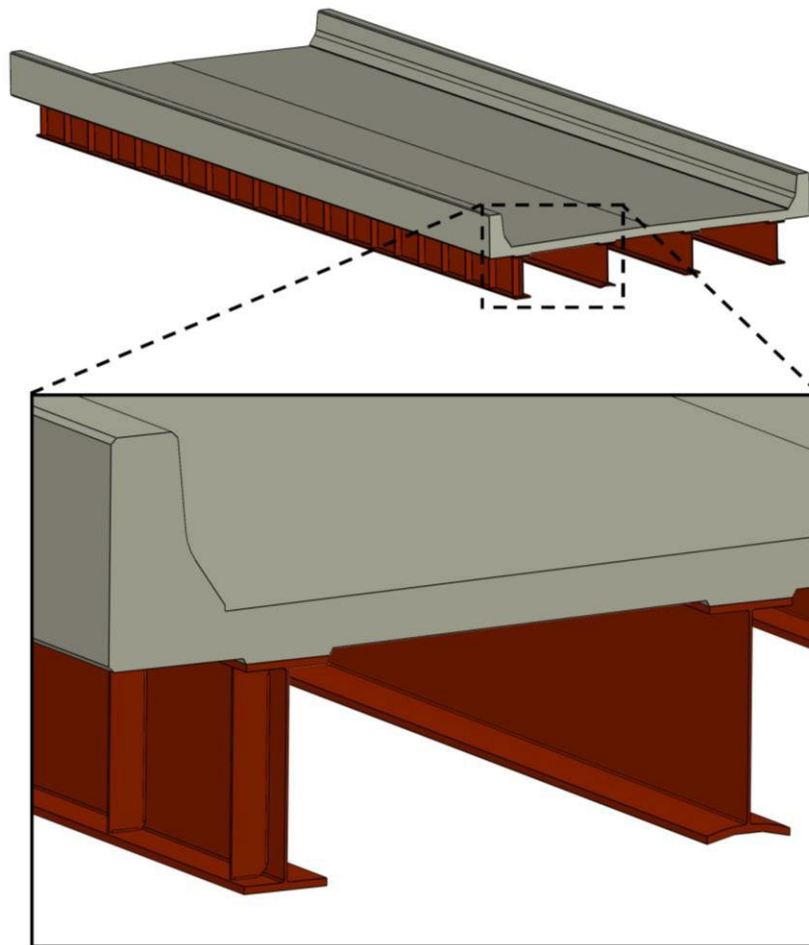
Figure 29. Illustration. Flat flange (left) and transversely curved flange (right).

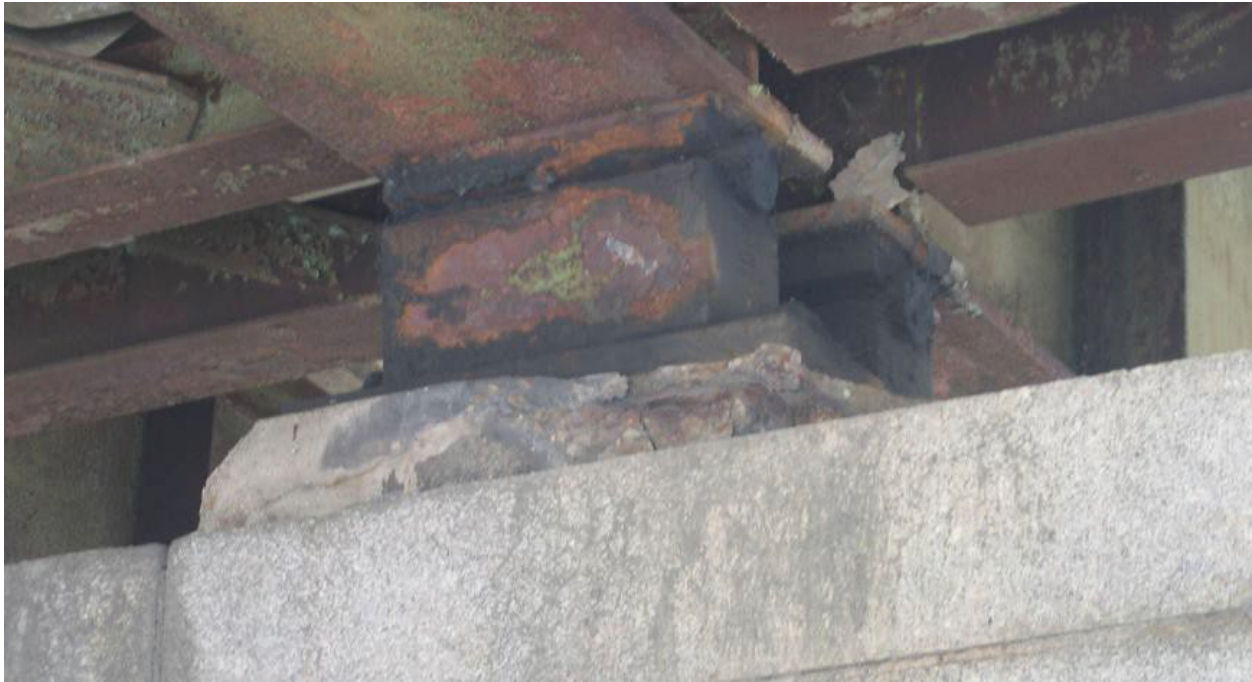
Figure 30. Photo. Corroded bearing.

These elements are difficult and inefficient to paint in the traditional manner. Bearings represent the lowest point on the superstructure, and as such are likely subject to the highest time of wetness, and typically are difficult to protect from corrosion. An example of a corroded bearing is shown in Figure 30. Consideration should be given to galvanize, metalize or fabricate these types of elements from inherently corrosion-resistant alloys.

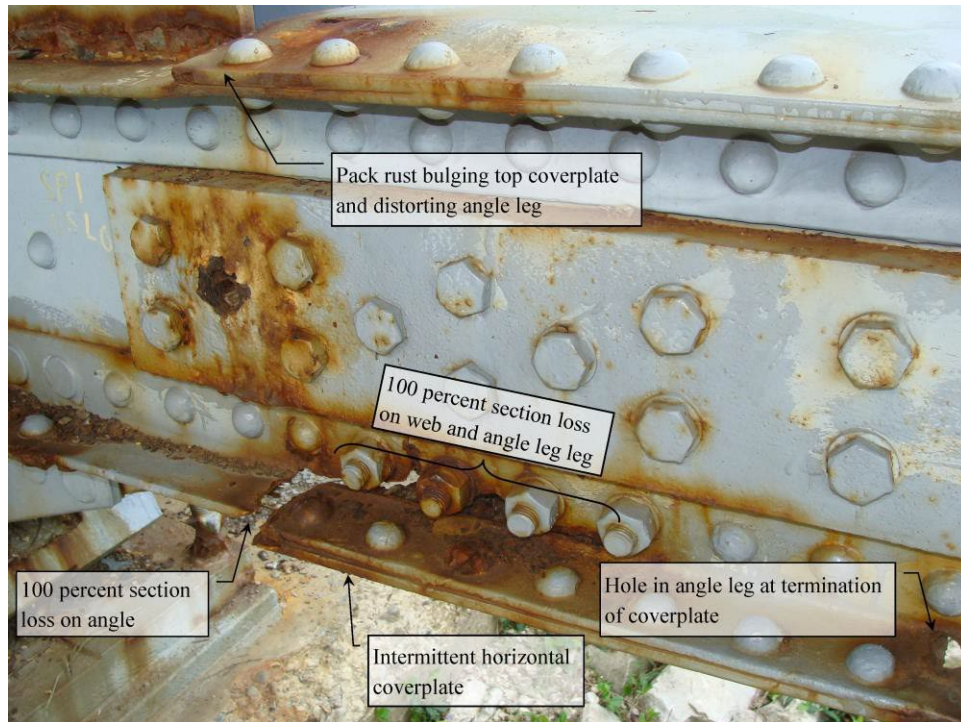
Figure 31. Photo. Annotated picture of riveted, built-up lower chord truss member.

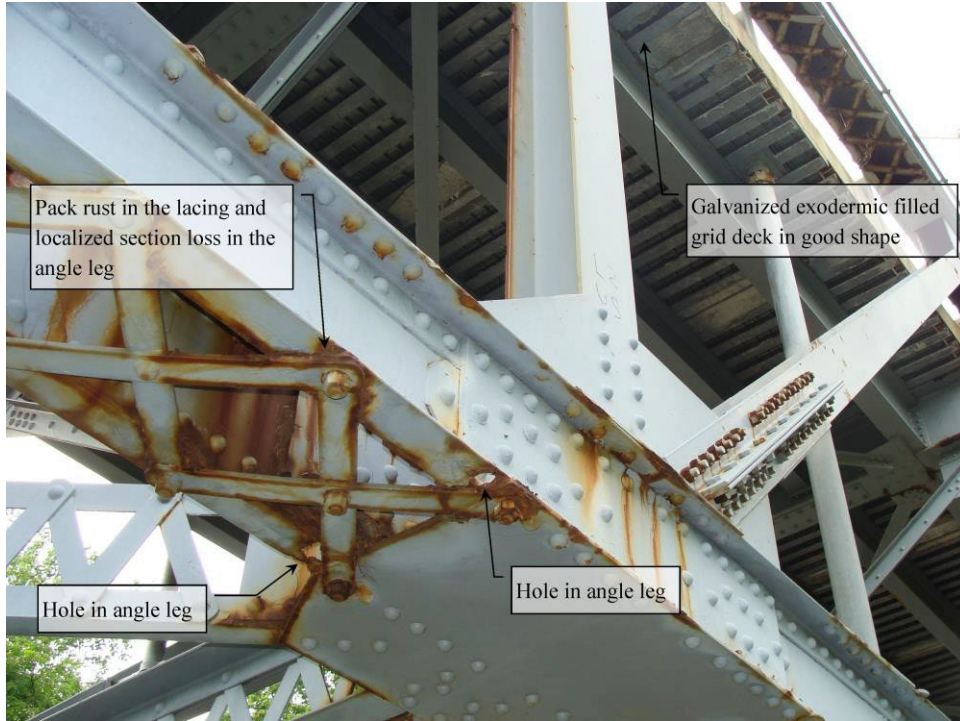
Figure 32. Photo. Annotated picture of riveted lower truss chord connection.

picture from the same truss, but of a lower chord connection. The lower chord elements are tied with lacing, which creates many intersecting surfaces that all show corrosion and pack rust.
