Corrosion Protection of Steel Bridges

Steel Bridge Design Handbook: Corrosion Protection of Steel Bridges

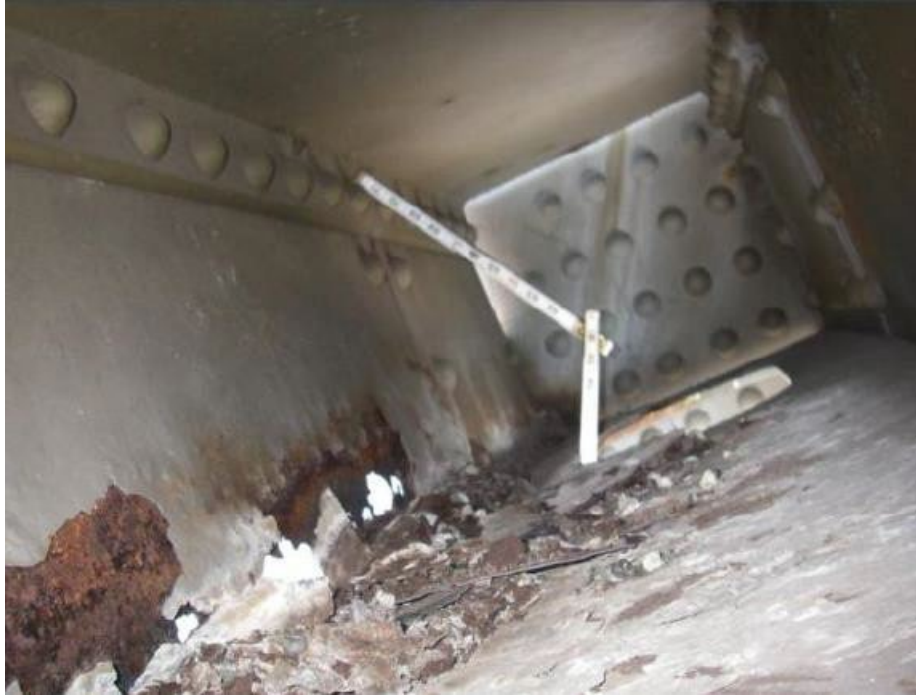
Figure 33. Photo. Inside of built-up box member.

Figure 33 shows the inside of a closed, built-up box member from a truss. The picture was taken through an access hole and not oriented with respect to gravity, but the member was horizontal. Because the member was horizontal, water ponded on the inside atop the bottom box cover plate, and caused through-thickness corrosion in the box web plate over an approximate four-foot length. Small box members also pose maintenance and corrosion remediation challenges due to limited access.

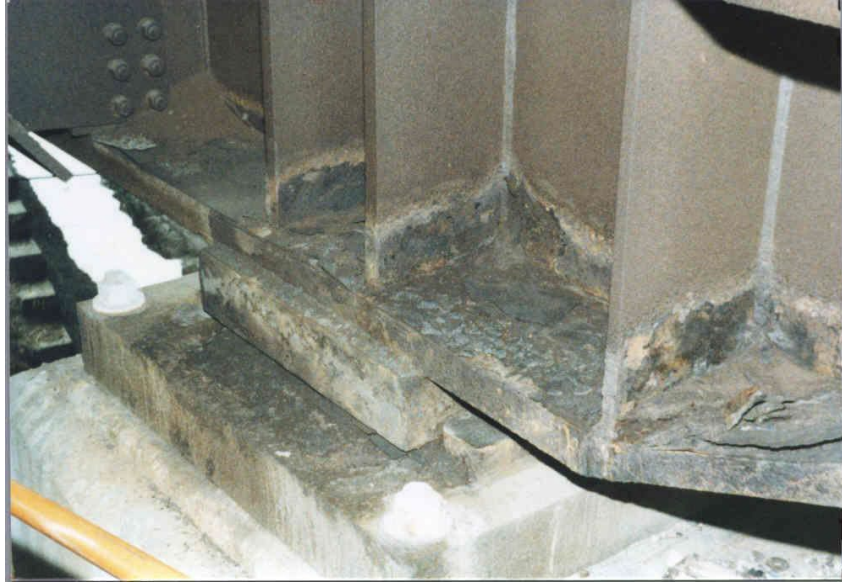
Figure 34. Photo. Girder end on a bearing below a leaking deck joint. Horizontal flange and vertical stiffeners create an excellent trap for debris and moisture.

Water traps are the hardest details to identify in design. Figure 34 illustrates a bearing stiffener detail that was below a leaking joint. Since the flange is horizontal, water can become trapped near each of the stiffeners because it cannot flow away from the area. This also has cascading consequences because as rust product develops in this area, the rust itself begins to hold moisture that further exacerbates the corrosion. Also note in the background of this picture is the connection plate detail bolted to a transverse element; there is an accumulation of dirt and rust between the girder flange and connection plate.

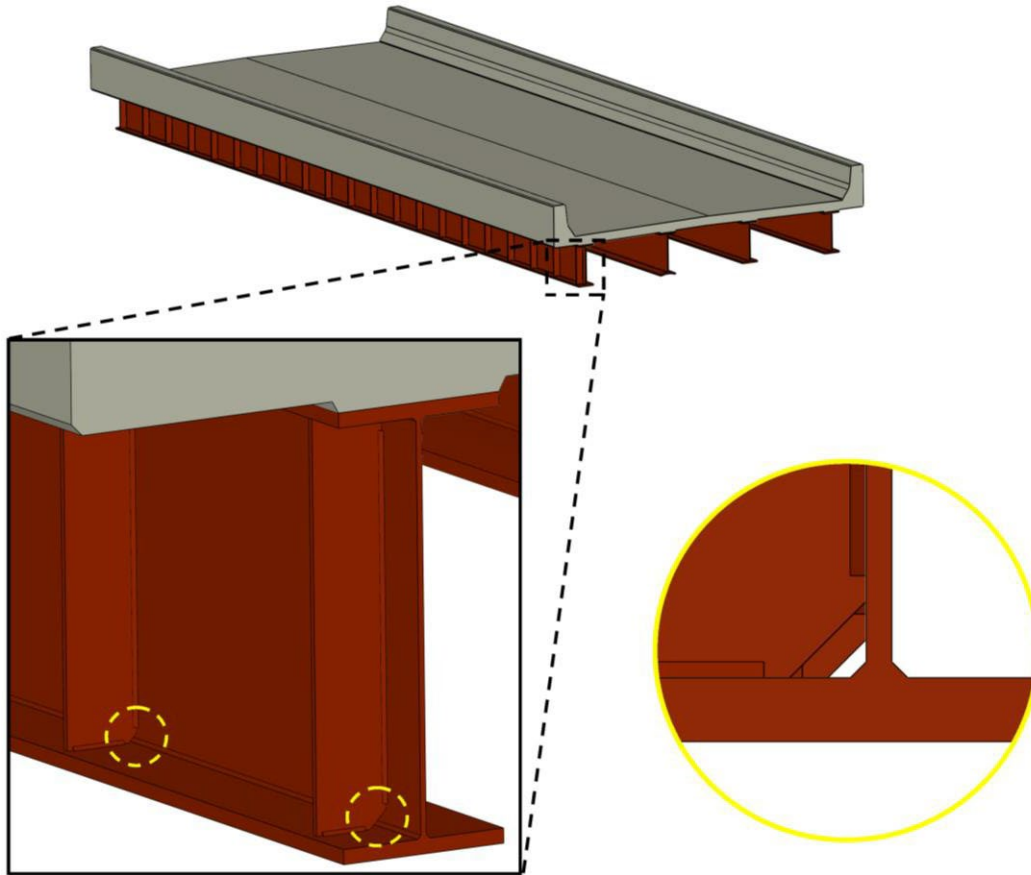
Figure 35. Illustration. Transverse plate snipe size, larger is better.

If the bridge has connection plates, or transverse stiffeners that are connected to the bottom flange, this represents a localized dam for water. Typical detailing practice would be to snipe the corner of the plate to provide clearance for the web-to-flange welds. If the snipe is too small, it could easily trap debris and create a dammed condition. Figure 35 highlights two connection plates with different sized snipes, and the larger would be preferred for reduced tendency to trap debris and become clogged. AASHTO has no guidance for minimum/maximum size of the snipe, but it should be as large as possible. Experience has found that one by one inch snipes are not adequate. If coatings will be applied, larger snipes also facilitate easier blast cleaning and ability to achieve adequate film thickness within the snipe. Proper snipes are an important consideration on bridges with a vertical grade so water can freely flow downhill, rather than being trapped behind every connection plate.

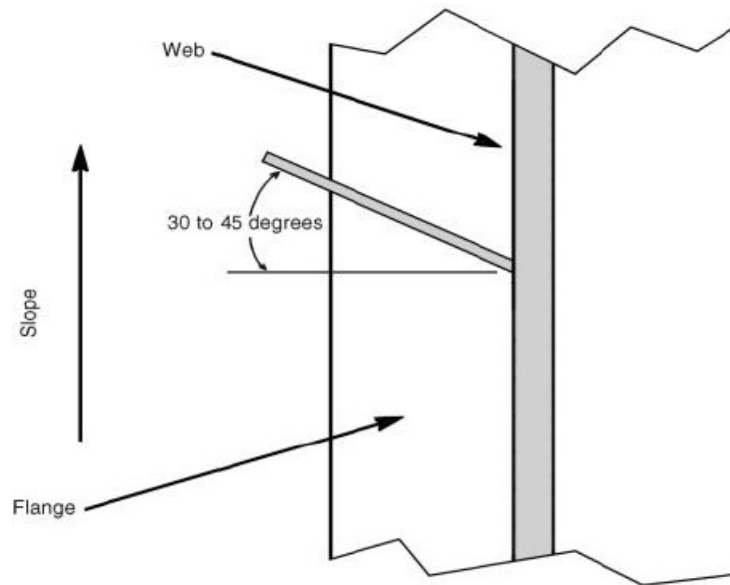
Figure 36. Schematic. Proper orientation of drip bar. Taken from Reference 14.

Drip bars can also be welded in place to divert water before getting to a trap. However, careful attention must be paid to orient them at the correct angle so they themselves do not become a water trap. Figure 36 illustrates how to determine the orientation of a drip bar.

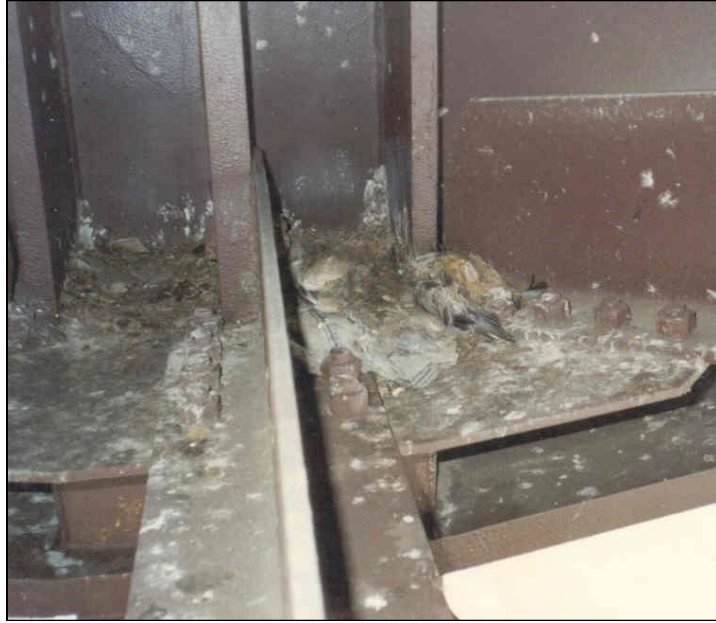
Figure 37. Photo. Debris accumulation at a lateral gusset plate detail.

Figure 37 shows a picture of a lateral gusset plate detail and the accumulation of dirt, bird guano, and even a dead bird. Since the lateral plate is horizontal, poulitice tends to collect on it and not freely drain away, causing localized high times of wetness, leading to corrosion. Figure 38 shows a lateral gusset plate detail that has mostly corroded away because it was perfectly horizontal and ponded water. It is not practical to slope these plates, but drainage holes can be provided to help mitigate any ponding. Where members such as horizontal gusset plates must be used, consider using a high level of corrosion protection (duplex galvanizing/painting or metalizing) for these specific elements.

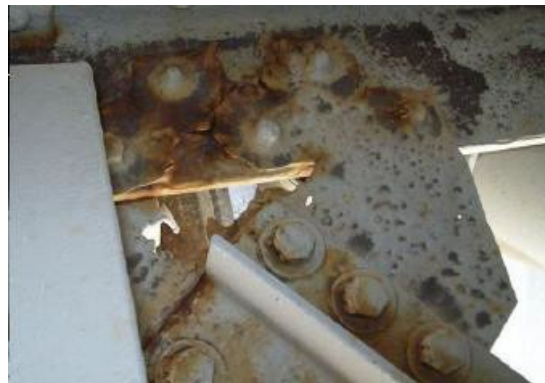
Figure 38. Photo. Corroded lateral gusset plate detail.

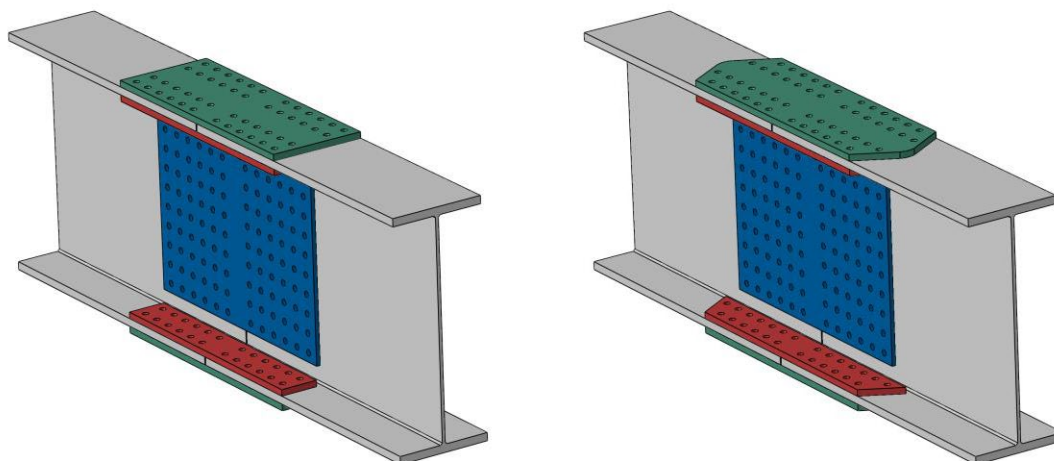
Figure 39. Illustration. Difference between squared off flange splice plates (left), and tapered flange splice plates (right). Bolts not shown for clarity.

Another less commonly identified water trap is flange splice plates within a bolted field splice. If the girder is on a vertical grade, water flowing down the flange will get trapped by the flange splice plates. A solution is to combine the functionality of the drip bar into the flange splice plate itself so it can shed water away from the web. This is illustrated in Figure 39 where the left-handed splice has square-ended splice plates, and the right-handed splice has a downhill taper.

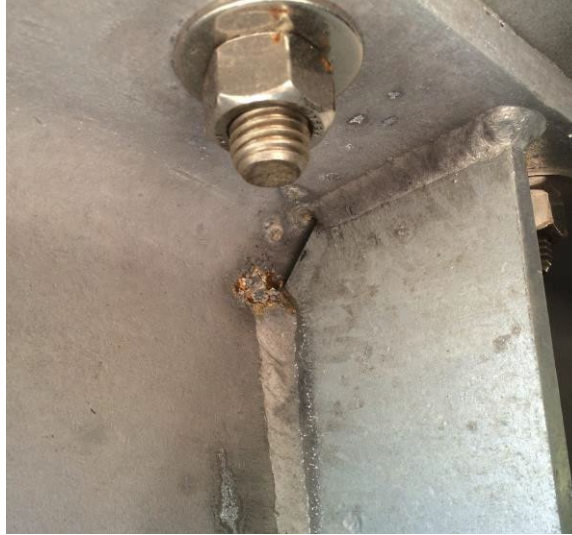
Figure 40. Photo. Connection plate welded to rolled I-beam along with corrosion emanating from unsealed weld.

in opposing directions around a common plane is prohibited, in particular Clause 2.8.8 in D1.5 and Clause 2.9.3.5 in D1.1. ^(40, 73) First, this type of weld is difficult to implement because the welding position has to change and second, there is a high likelihood of undercut when wrapping welds in different directions. Steel bridges always have connection plate details that are unsealed when being welded to the flange because of potential undercut, though wrapping this particular weld has been shown not to be detrimental to fatigue. ⁽⁷⁴⁾ Designers should work with owners to reach consensus about how to handle seal welds as there are consequences to both the long-term corrosion performance and possibly the structural function.

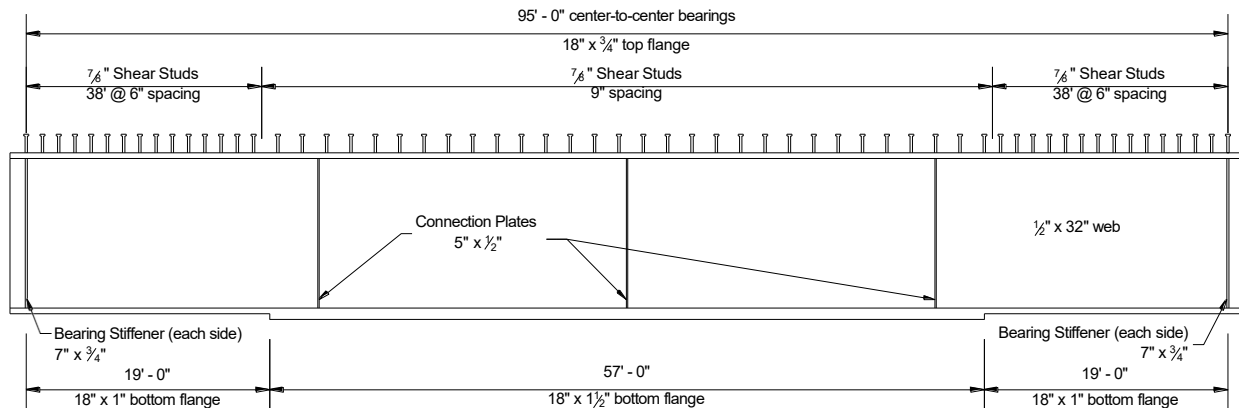
Figure 42. Schematic. Elevation view of girder detailing.

As part of this publication in 2016, the National Steel Bridge Alliance queried four of their member fabricators to provide differential steel bridge fabrication cost estimates for an example girder. The sample of four fabricators was diverse representing large and small production abilities, and located on each coast and in the north and south. The detailing of the girder is shown in Figure 42. Each fabricator was asked to provide a cost estimate to fully fabricate the girder considering five corrosion mitigation strategies; uncoated weathering steel, non-weathering grade steel with 3-coat paint system, galvanized non-weathering grade steel, metalized non-weathering grade steel, and ASTM A709 Gr. 50CR (ASTM A1010) steel.
