Chapter 1: Introduction

Introduction

The Federal Emergency Management Agency (FEMA) first published the *Coastal Construction Manual* (FEMA-55) in 1981. The manual was updated in 1986 and has provided guidance to public officials, designers, architects, engineers, and contractors for over a decade. In that time, however, construction practices and materials have changed, and more information on hazards and building performance has been developed. There has also been an explosion in coastal development, leading to greater numbers of structures at risk. Many of the residential buildings being constructed today are larger and more valuable than those of the past, leading to the potential for larger economic losses when disasters strike. The increase in coastal development has also brought about greater use of sites located in areas where the risk is higher, such as lots closer to the ocean, lots on high bluffs subject to erosion, or lots artificially created on fill deposits.

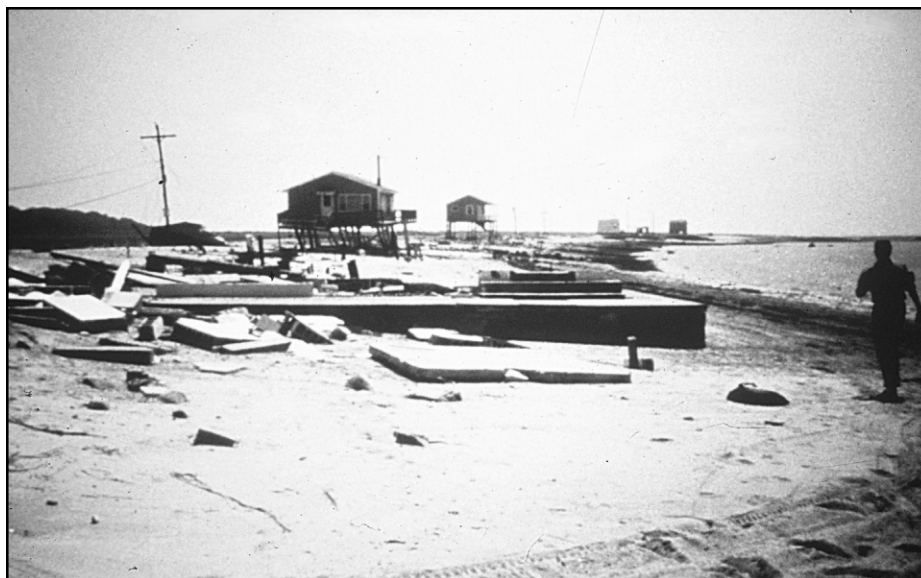
Figure 2-3
Hurricane Bob (1991)
destroyed 29 homes along
this reach of Mattapoisett,
Massachusetts. Photograph
by Jim O'Connell.

Hurricane Bob, a Category 2 hurricane, followed a track similar to that of the 1938 New England hurricane. Although undistinguished by its intensity (not even ranking in the 65 most intense hurricanes to strike the United States during the 20th century), it caused \$1.75 billion in damage (1996 dollars) (see Figure 2-3), ranking 18th in terms of damage (NOAA 1997). A FEMA Flood Damage Assessment Report (URS 1991c) documented damage in the Buzzards Bay area. The wind speeds during Hurricane Bob were below the design wind speed and the storm tide (corresponding to a 15-year tide) was at least 5 feet below the Base Flood Elevation (BFE). Nevertheless the results of the storm allowed an evaluation of the performance of different foundation types.

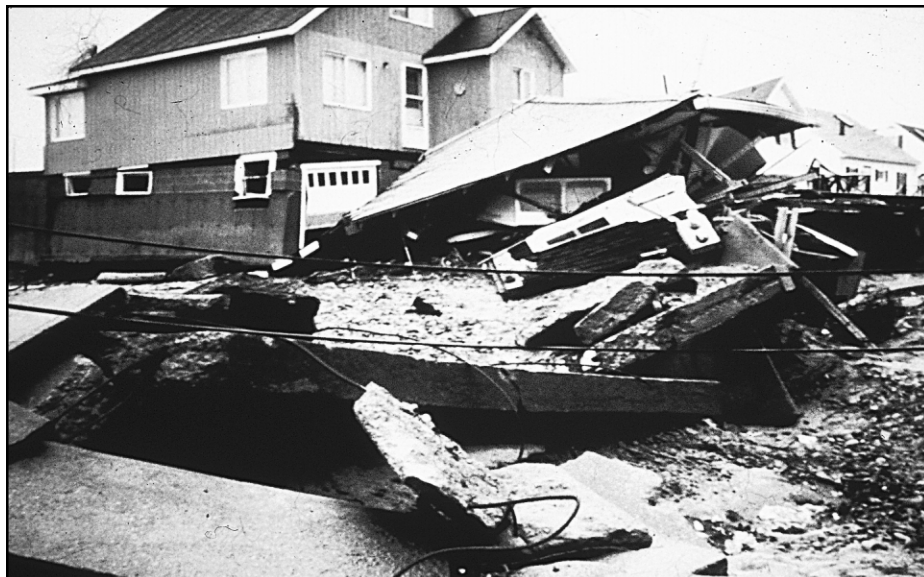
**Figure 2-4**

October 1991 northeaster damage to homes at Scituate, Massachusetts. Photograph by Jim O'Connell.

- Buildings atop continuous masonry block foundations (such as those permitted in A zones) commonly were damaged or destroyed when exposed to flooding, wave action, erosion, and/or localized scour (see Figure 2-4).

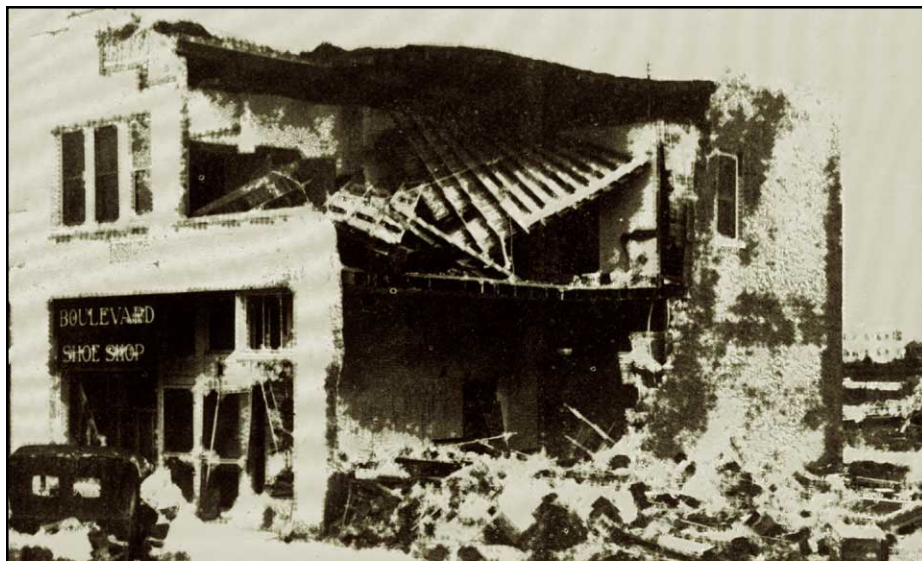
Figure 2-6
Building damage from 1926 hurricane, Miami, Florida.

1926, September 18 – Hurricane, Miami, Florida. Those who believe we have only recently come to understand storm-resistant design and construction will be surprised by the insight and conclusions contained in a 1927 article by Theodore Efting, a south Florida engineer, 1 year after the 1926 hurricane (see Figure 2-6) struck Miami, Florida (Efting 1927). The article points out many weaknesses in buildings and construction that we still discuss today:

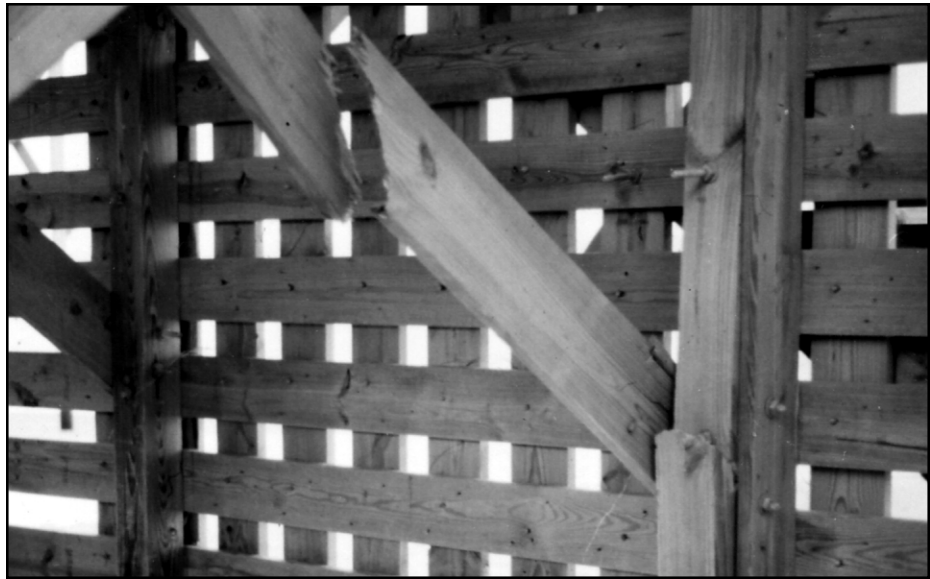
March 1989 northeaster.
Failure of cross-bracing.

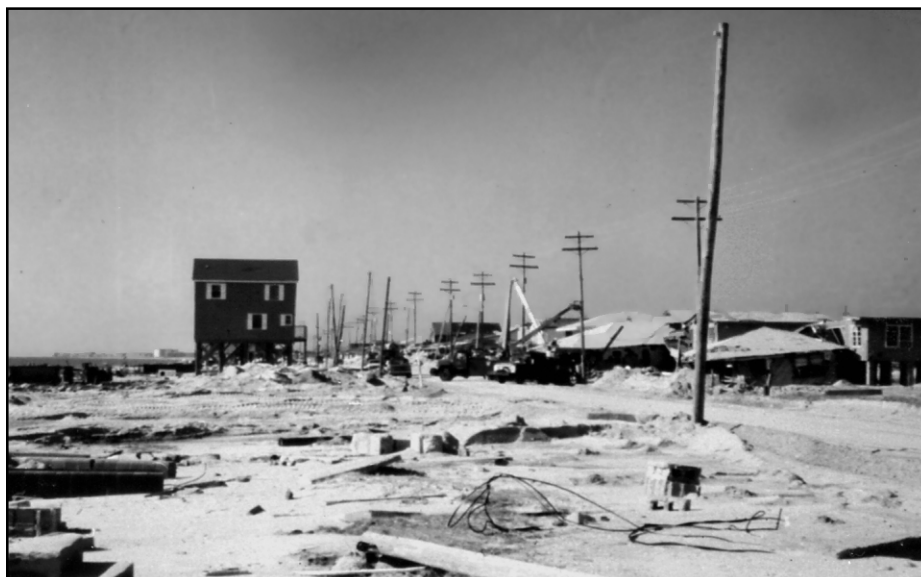
Figure 2-11
Hurricane Hugo (1989),
Garden City Beach, South
Carolina. House on pilings
survived while others did
not.

- Post-FIRM buildings that were both properly constructed and elevated survived the storm (see Figure 2-11). These buildings stood out in sharp contrast to pre-FIRM buildings and to post-FIRM buildings that were poorly designed or constructed.

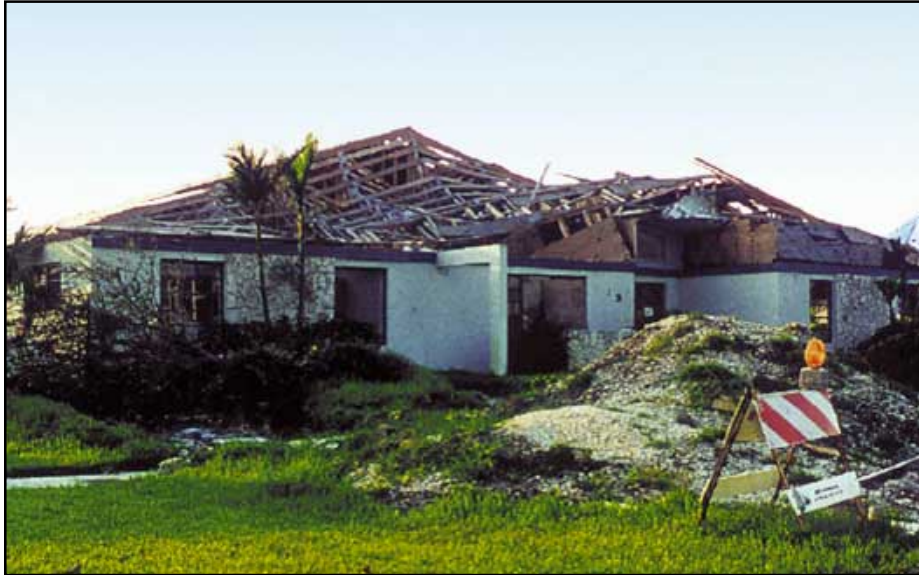
**Figure 2-13**

Hurricane Andrew (1992).
Roof structure failure due to
inadequate bracing.

- c) inadequate roof truss bracing or bridging (see Figure 2-13)
- d) improper sillplate-to-foundation or sillplate-to-masonry connections

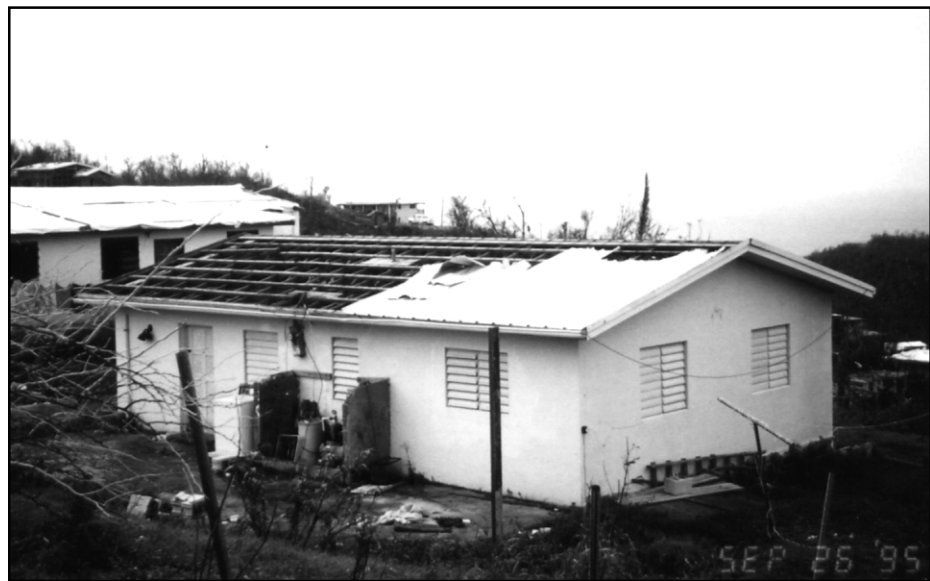
Figure 2-14
Hurricane Marilyn (1995). This house lost most of the metal roof covering. Neighbors stated that the house also lost its roof covering during Hurricane Hugo, in 1989.

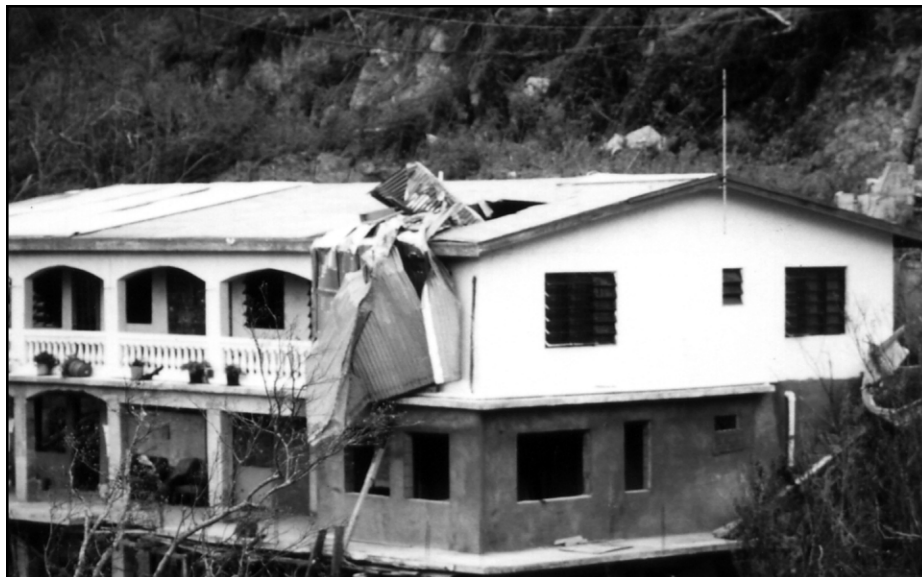
**Figure 2-15**

Hurricane Marilyn (1995). The roof of this house was penetrated by a large wind-driven missile (metal roof covering).

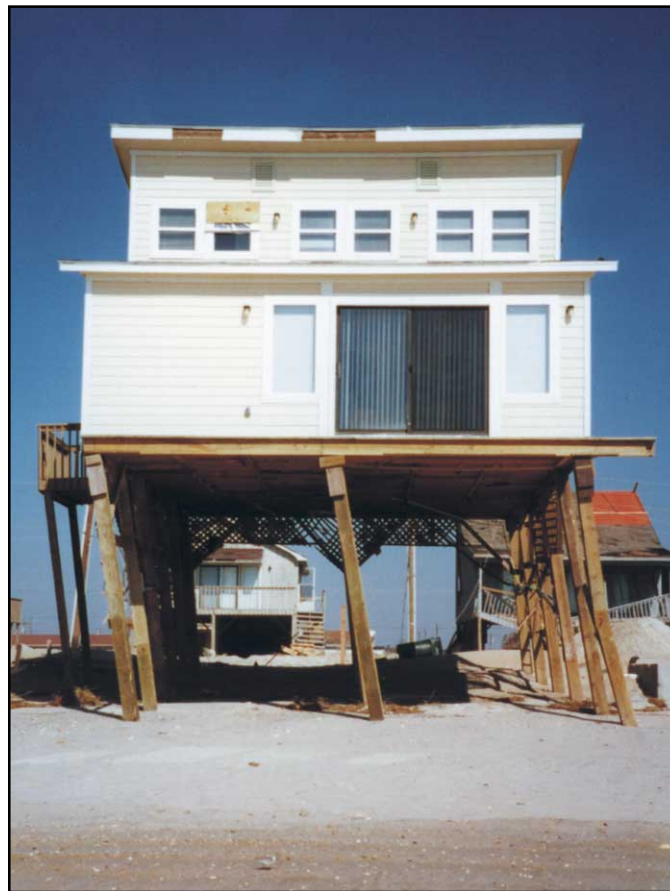
Hurricane Fran (1996). Many oceanfront houses built before the enactment of the 1986 North Carolina State Code were found to be leaning or destroyed.

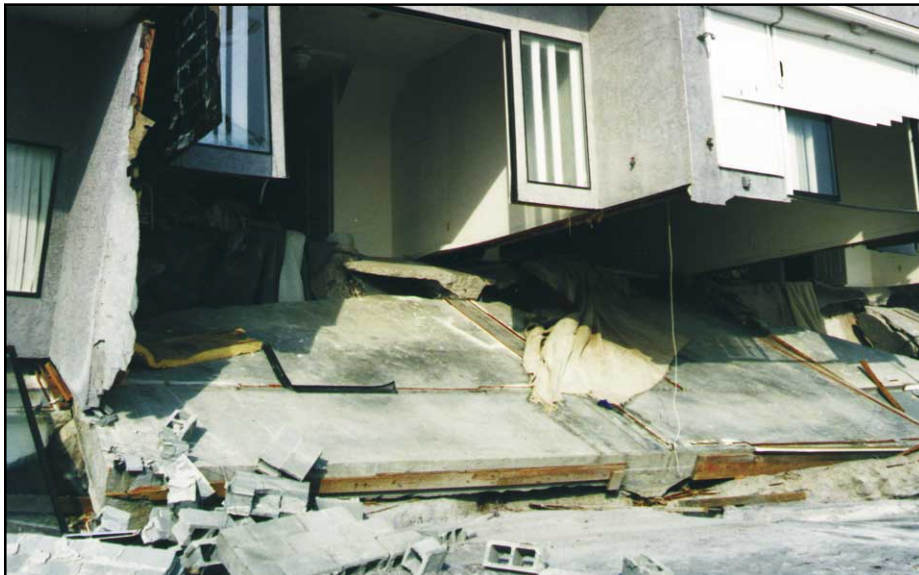
Figure 2-20
Hurricane Opal (1995), Bay County, Florida. Building damage from erosion and undermining.

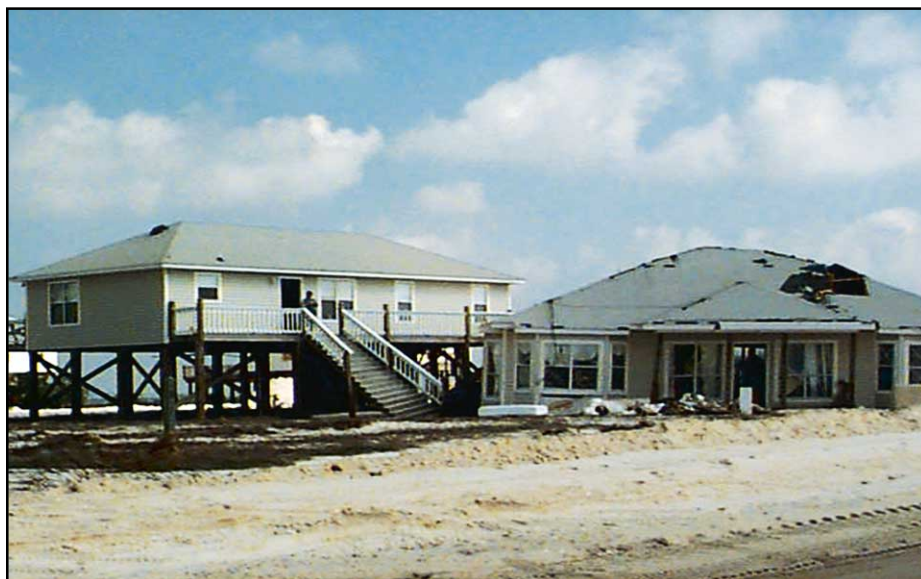
Figure 2-21
Hurricane Georges (1998),
Dauphin Island, Alabama. As
a result of erosion, scour, and
inadequate pile embedment,
the house on the right was
washed off its foundation
and into the house on the
left.

- inadequate pile embedment depths on coastal structures (see Figure 2-21)
- inadequately elevated and inadequately protected utility systems
- inadequate designs for frangible concrete slabs below elevated buildings in coastal areas subject to wave action
- impacts from waterborne debris on coastal buildings
- lack of consideration of erosion and scour in the siting of coastal buildings
- corrosion of metal fasteners (e.g., hurricane straps) on coastal buildings

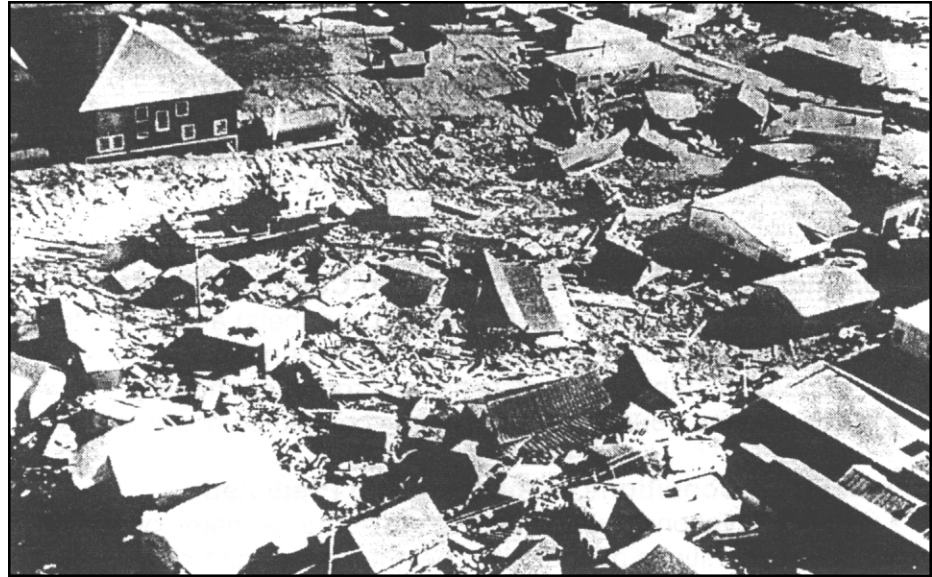
1964 Good Friday earthquake. Damage in Kodiak City, Alaska, caused by the tsunami of the 1964 Alaskan earthquake (from Wilson and Tørum 1968).

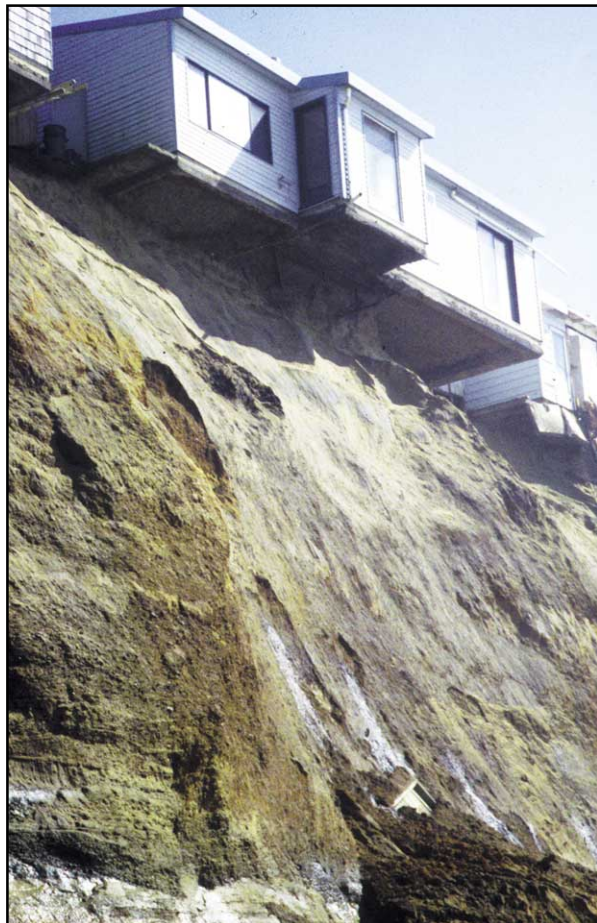
Winter coastal storms, California and Oregon (1997–1998). House in Pacifica, California, undermined by bluff erosion. Photograph by Lesley Ewing, courtesy of the California Coastal Commission.

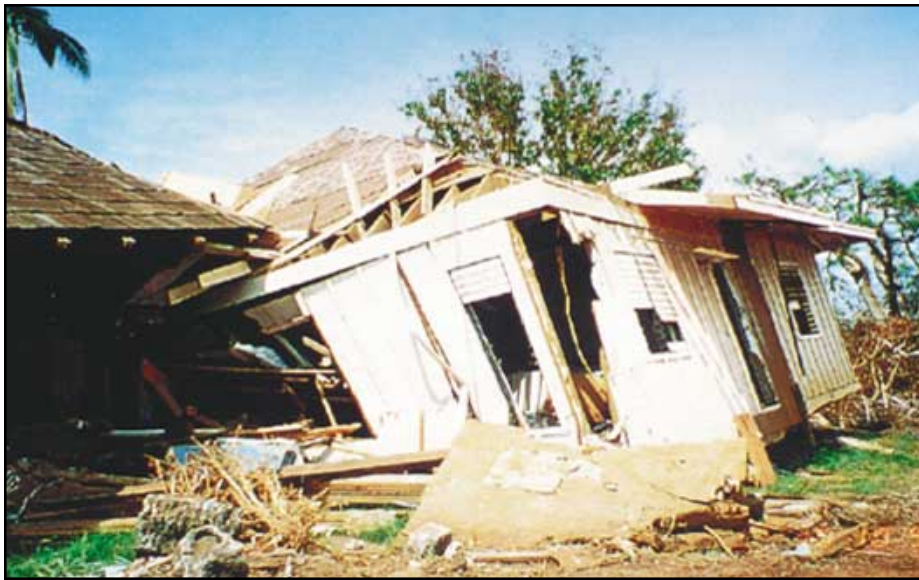
Figure 2-24
Hurricane Iniki (1992).
Non-elevated house at Poipu Beach that floated off its foundation and was pinned against another house and destroyed by waves.

- inadequate connections between buildings and their pier or column foundations, which allowed flood waters to literally “float” buildings off their foundations (see Figure 2-24)
- embedment of foundations in unconsolidated sediments (see Figure 2-25)
- improper connection of foundations to underlying shallow rock
- impact of floodborne debris, including lava rock and parts of destroyed structures (Most of the lava rock debris originated from rock landscaping and privacy walls, which were common in the area.)

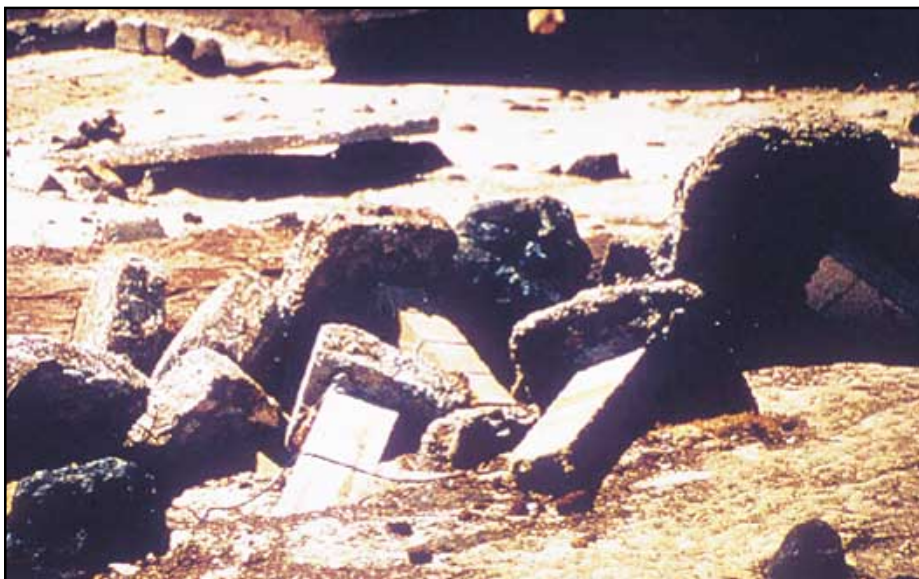
Figure 2-25
Hurricane Iniki (1992).
Undermining of shallow footings supporting columns at Poipu Beach due to lack of sufficient embedment below erosion level.

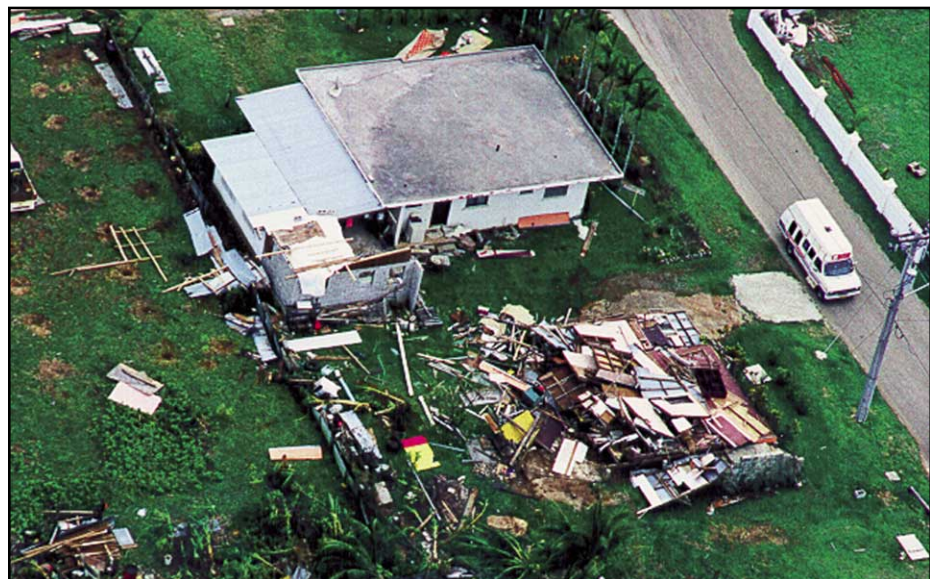
Typhoon Paka (1997). Although damaged by the storm, the concrete house in the upper part of the photograph survived, while the wood-frame house next to it was destroyed.

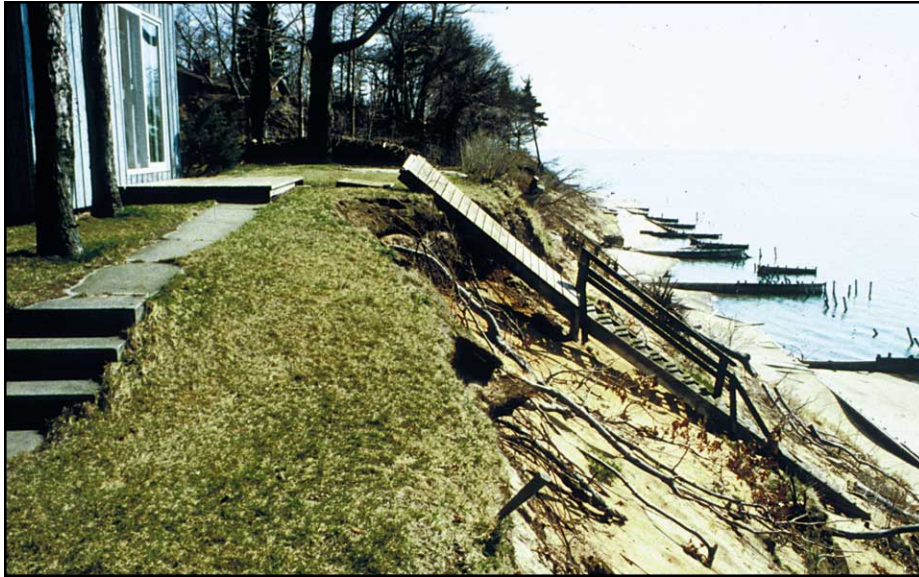
Figure 2-28
August 1988. Erosion along the Lake Michigan shoreline at Holland, Michigan, resulting from high lake levels and storm activity (photo courtesy of Mark Crowell).

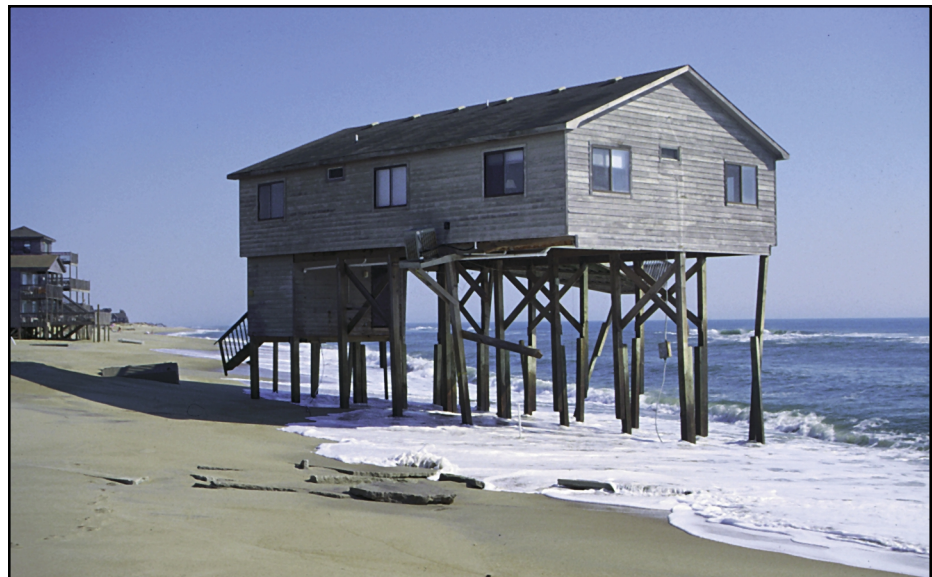
**Figure 4-2**

Although this North Carolina house appears to be a structural success, long-term erosion has left it standing on the beach.

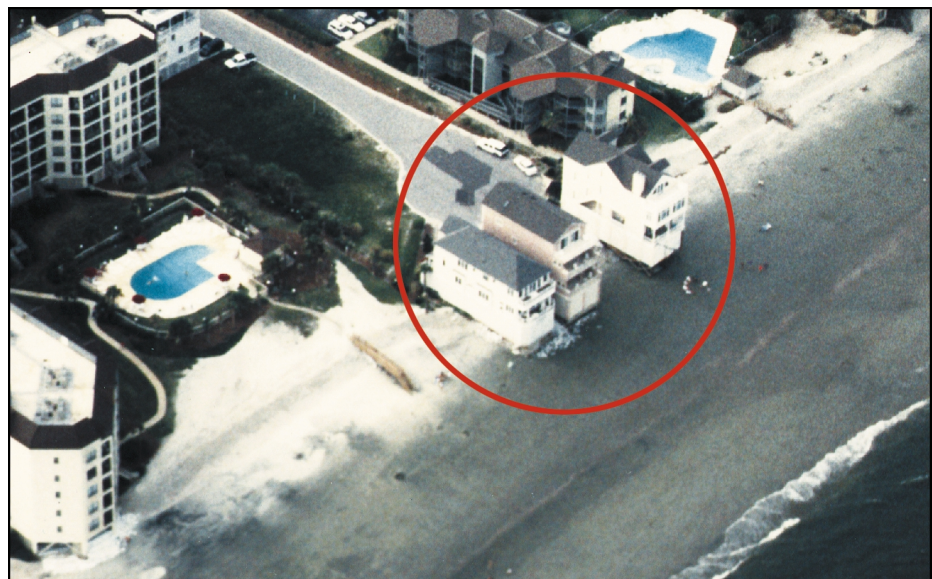
These three South Carolina houses were built at least 100 feet landward of the vegetation line, but rapid erosion associated with a nearby tidal inlet has left the houses standing on the beach. Although these buildings are structurally intact, their siting can be considered a failure. (July 1997 photograph)

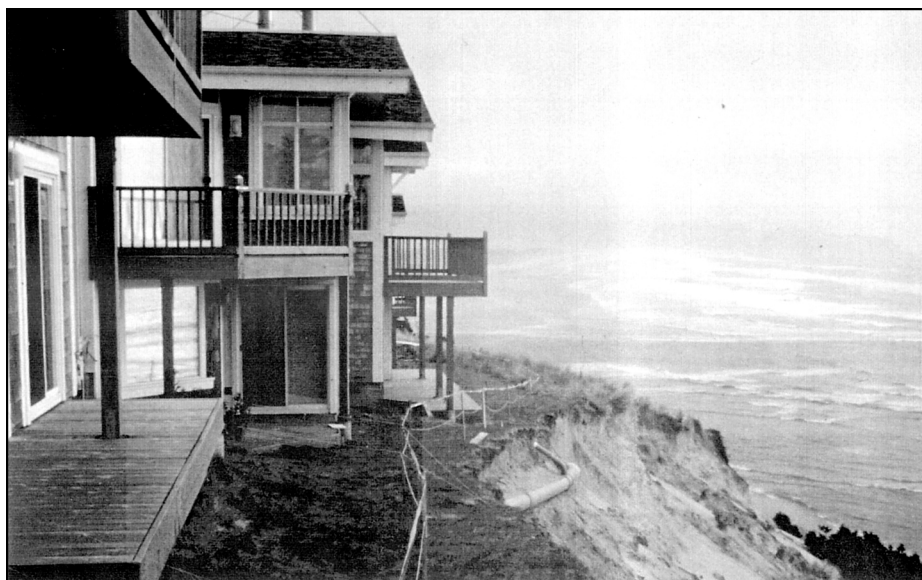
**Figure 4-3**

These Oregon townhouses were built as little as 10 feet landward of a 170-foot-high bluff, after an expert assured the local government that the site was suitable. Storm- and inlet-related erosion at the base of the bluff has destabilized the bluff and threatened some of the buildings. (April 1998 photograph)

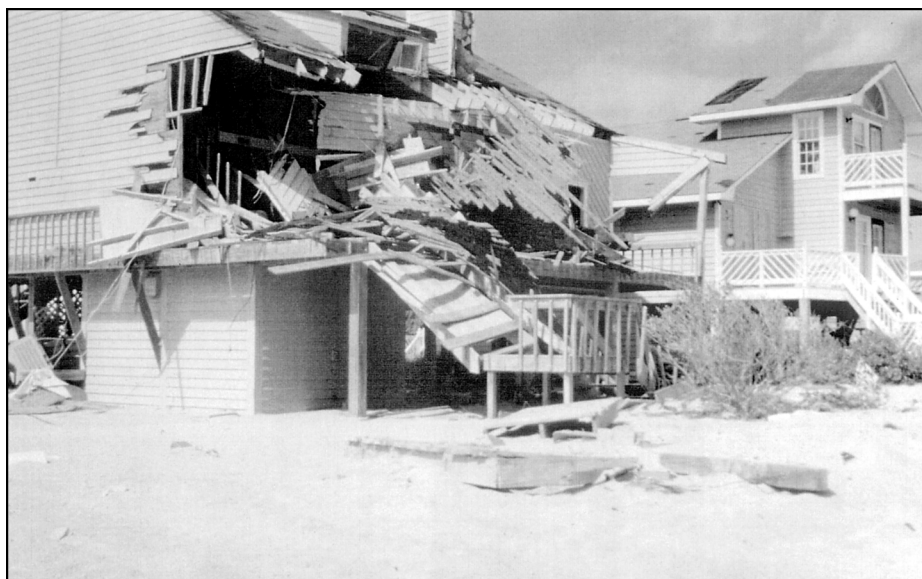
**Figure 4-4**

- A siting success can be overshadowed by poor design, construction, or maintenance. The house shown in Figure 4-4 was set back from the shoreline, and safe from long-term erosion. However, it could not resist wind from Hurricane Fran.

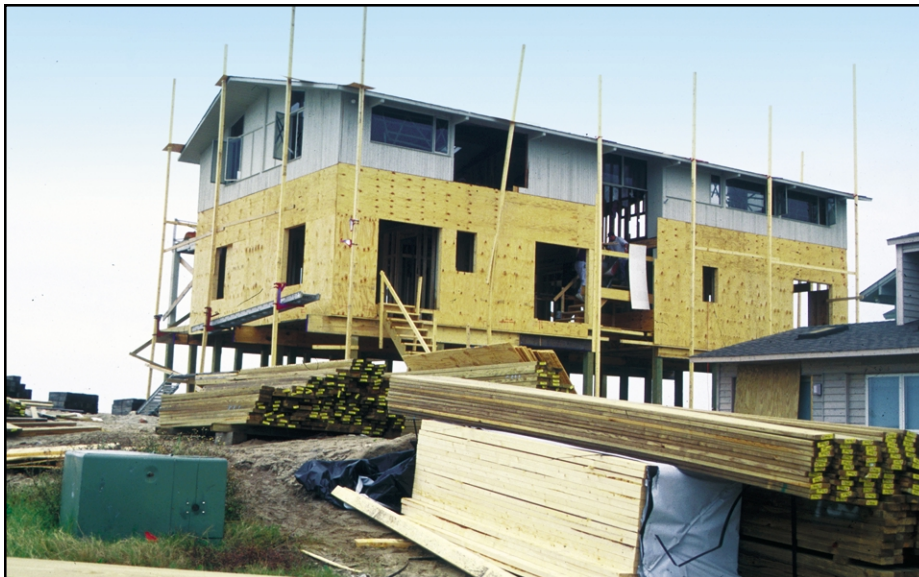
Figure 5-2

Coastal development sometimes involves development of subdivisions or large residential projects from raw land. However, coastal development increasingly involves infill development between adjacent buildings or redevelopment of previously developed property, such as this post-Hurricane Fran elevation and reconstruction project on Figure Eight Island, North Carolina.

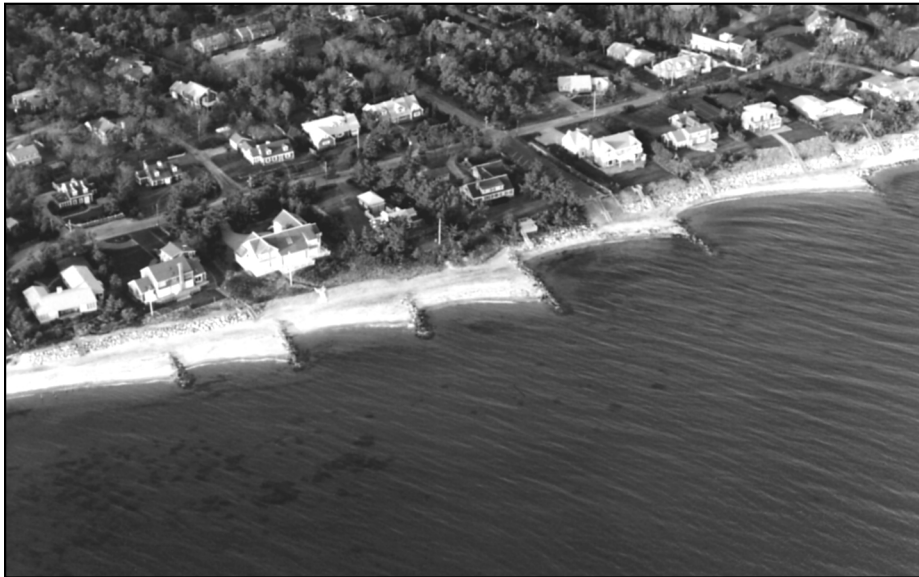
Figure 5-3

Narrowing the search for coastal property suitable for development or redevelopment requires careful consideration of a variety of property and area characteristics, including the nature and success of previous erosion control efforts (e.g., groins and revetments at this Massachusetts community). Note that some communities and states restrict or prohibit the construction or reconstruction of revetment, seawall, and groin structures such as those shown in the photograph.

- An **existing erosion control structure** on a lot or parcel is an indication of prior erosion, but the structure **may or may not be adequate to protect** a building or development in the future; moreover, many states and communities limit or prohibit construction or reconstruction of erosion control devices (see Figure 5-3).

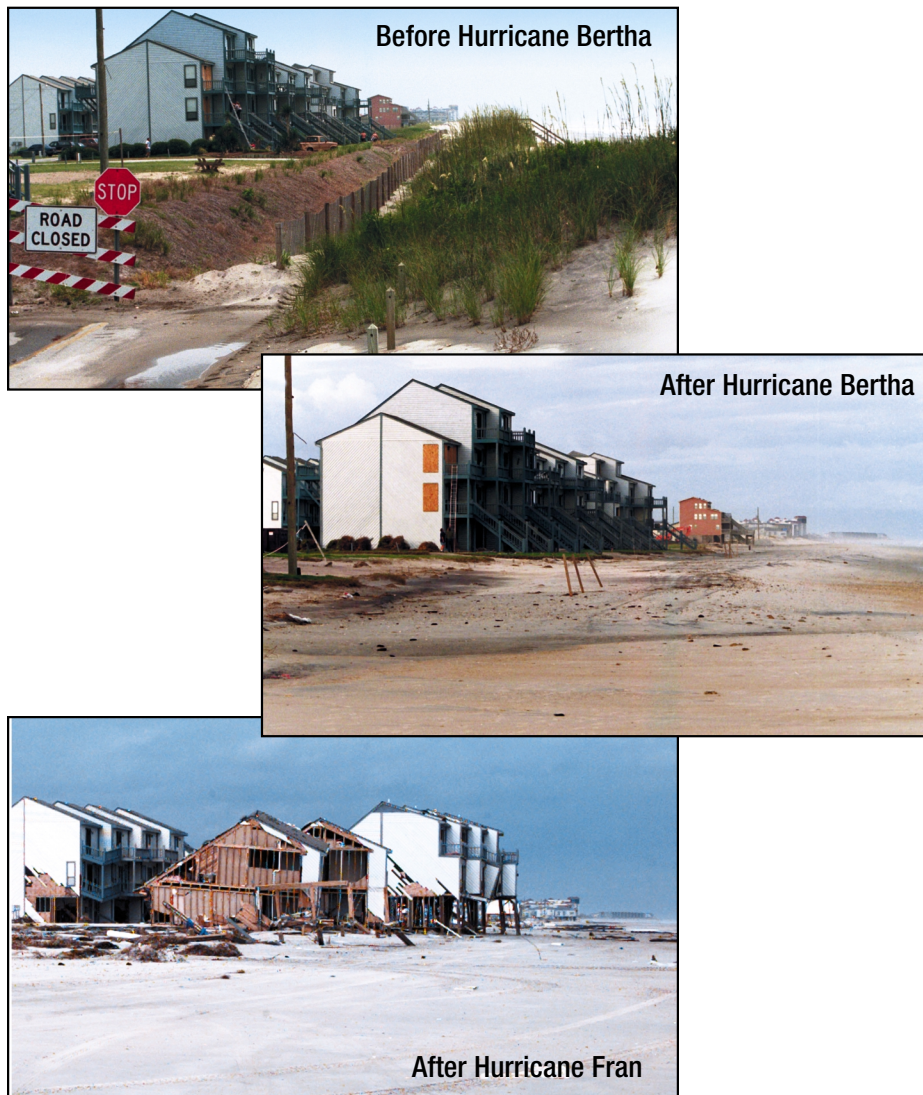
**Figure 5-5**

Siting and design should include consideration of multiple storms or hazards within a short period, whose cumulative effects can exceed those of a design-level event. Photograph by John Althouse, Jacksonville, North Carolina.

See Figure 5-5, in Chapter 5, for an example of the effects of multiple storms.

Designers should consider the effects of low-frequency, rare events (e.g., major storms, extreme water levels, tsunamis, earthquakes) and multiple, closely spaced lesser events (see Figure 5-5). For example, many of the post-storm damage assessments summarized in Chapter 2 show that the cumulative erosion and damage caused by a series of minor coastal storms can be as severe as the effects of a single, major storm.

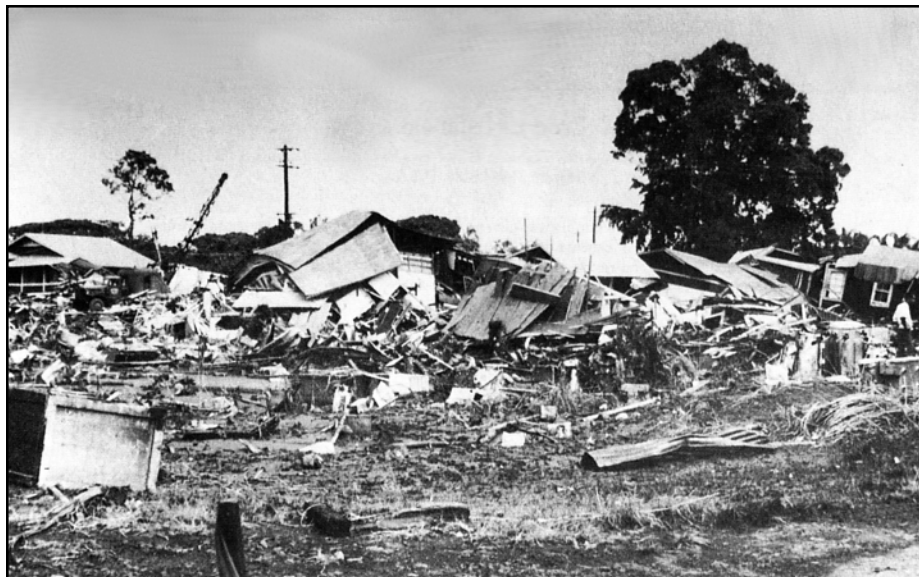
Figure 7-6

Hilo, Hawaii. Damage from the 1960 Tsunami (from Camfield 1994). Courtesy of *Journal of Coastal Research*.

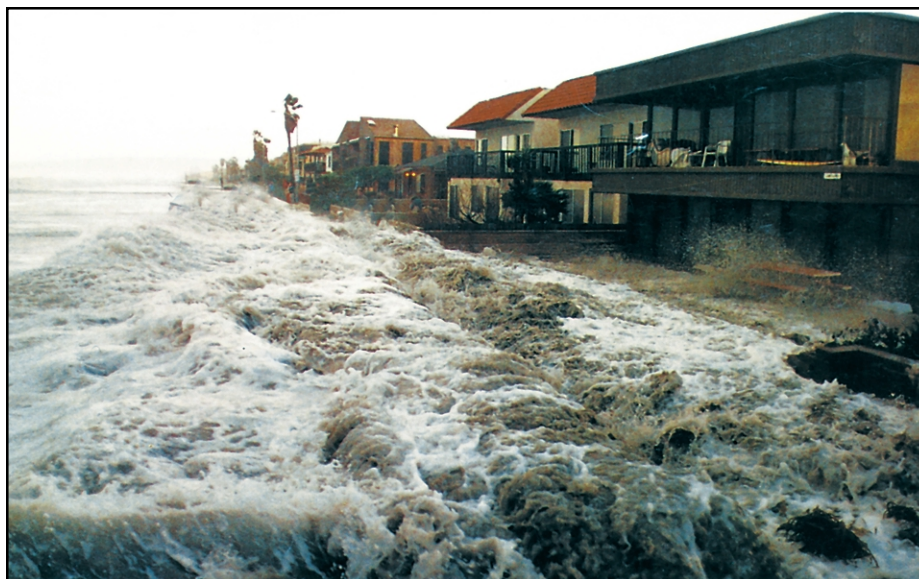
Figure 7-9

Storm surge and wave runup across boardwalk at South Mission Beach, California, during January 1988 storm. Photograph by Dana Fisher, courtesy of *Shore and Beach*.

- storm surge and wave runup flowing landward, through breaks in sand dunes or across low-lying areas (see Figure 7-9)
- tsunamis
- outflow (flow in the seaward direction) of floodwaters driven into bay or upland areas
- strong currents parallel to the shoreline, driven by the obliquely incident storm waves

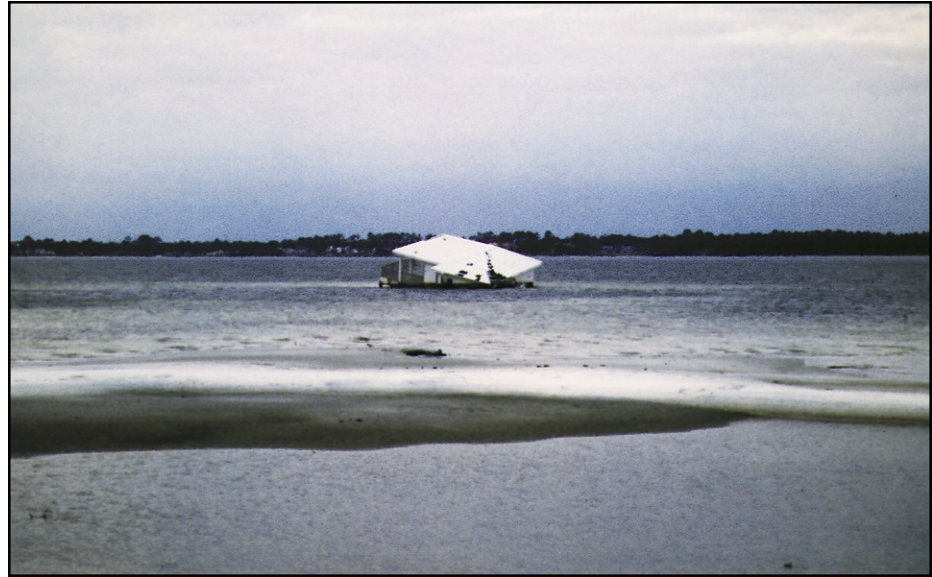
Figure 7-12

This house was also in an area of channeled flow during Hurricane Opal. The house was undermined and washed into the bay behind the barrier island; as a result, the house is now a total loss and a threat to navigation.

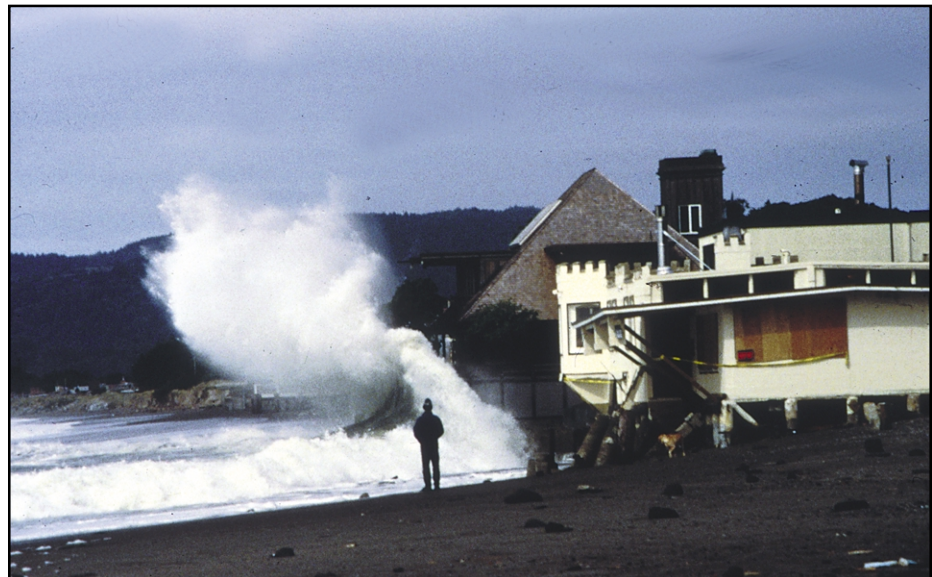
Figure 7-13

Storm waves breaking against a seawall in front of a coastal residence at Stinson Beach, California. Photograph by Lesley Ewing.

Waves can affect coastal buildings in a number of ways. The most severe damage is caused by *breaking waves* (see Figure 7-13). The force created by waves breaking against a vertical surface is often 10 or more times higher than the force created by high winds during a storm event.

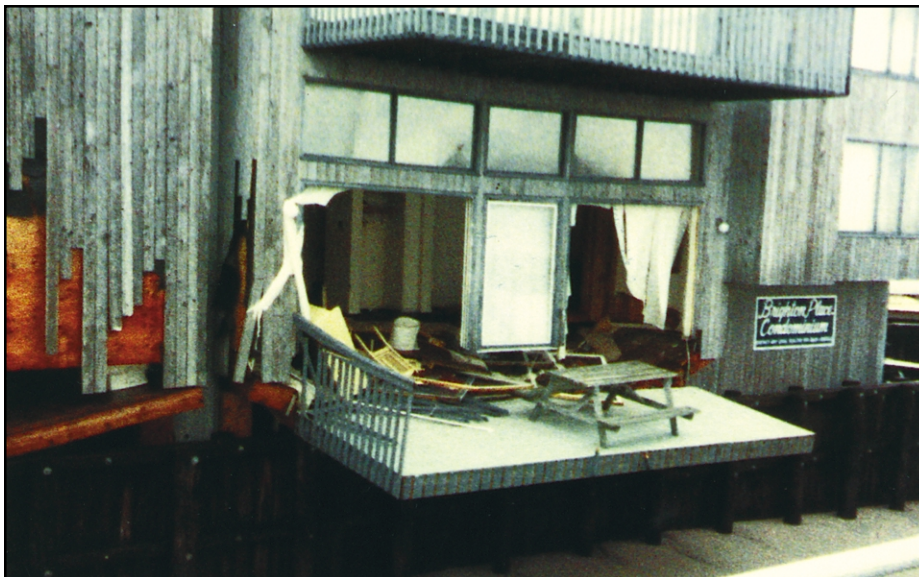
Figure 7-15

Damage to oceanfront condominium in Ocean City, New Jersey, caused by wave runup on a timber bulkhead. April 1984 photograph by Mark Mauriello.

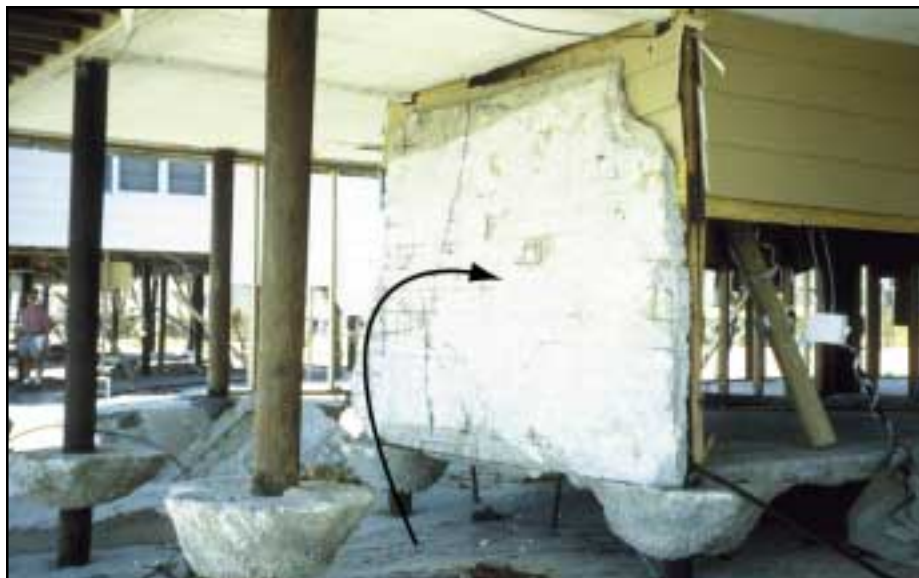
Figure 7-16
Hurricane Fran (1996).
Concrete slab-on-grade
flipped up by wave action
came to rest against two
foundation members,
generating large
unanticipated loads on the
foundation.

Shoaling waves beneath elevated buildings can lead to *wave uplift* forces. The most common example of wave uplift damage occurs at fishing piers, where pier decks are commonly lost close to shore, when shoaling storm waves lift the pier deck from the pilings and beams. The same type of damage can sometimes be observed at the lowest floor of insufficiently elevated but well-founded residential buildings and underneath slabs-on-grade below elevated buildings (see Figure 7-16).

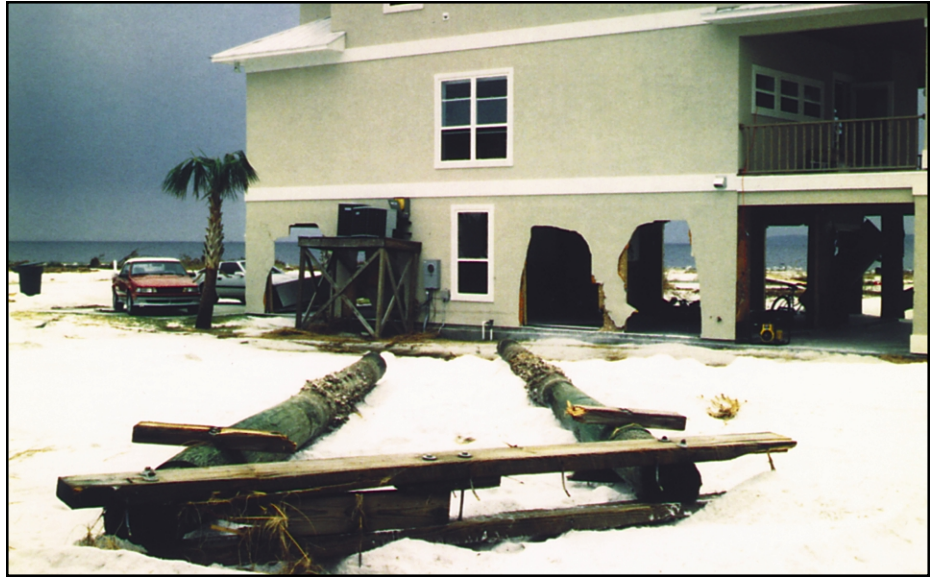
**Figure 7-19**

Hurricane Opal (1995). Pier pilings were carried over 2 miles by storm surge and waves before they came to rest against this elevated house in Pensacola Beach, Florida.

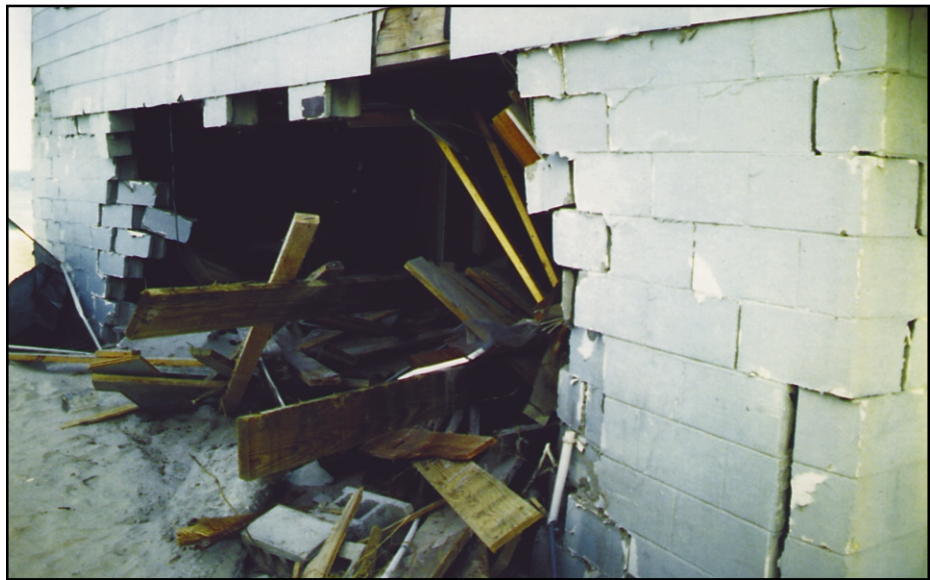
Hurricane Fran (1996). Debris lodged beneath a Topsail Island, North Carolina, house elevated on unreinforced masonry walls. The wall damage could have resulted from flood and wave forces, debris loads, or both.

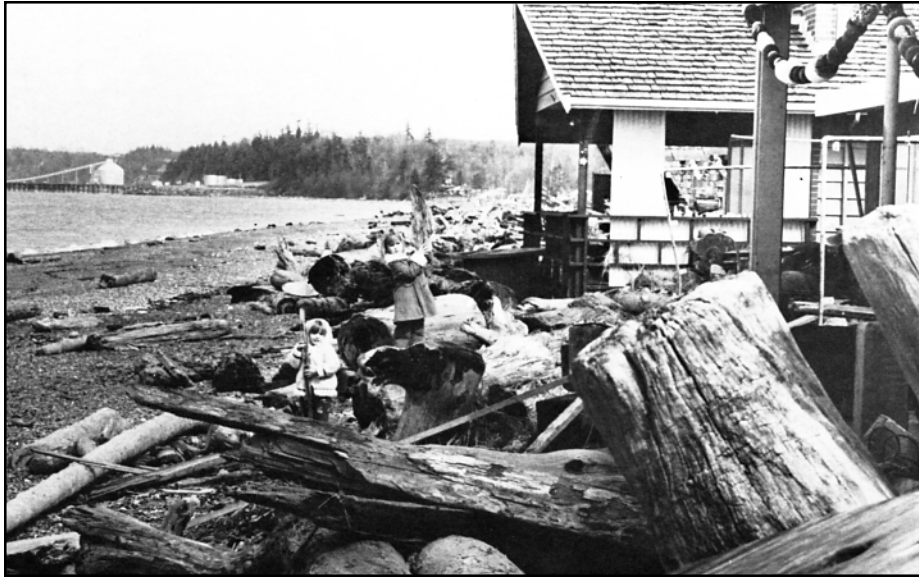
**Figure 7-20**

March 1975 storm. Drift logs driven into coastal houses at Sandy Point, Washington (from Knowles and Terich [1977]). Courtesy of *Shore and Beach*.

Floodborne debris produced by coastal flood events and storms typically includes decks, steps, ramps, breakaway wall panels, portions of or entire houses (see Figure 7-17), heating oil and propane tanks, vehicles, boats, decks and pilings from piers (see Figure 7-18), fences, destroyed erosion control structures, and a variety of smaller objects. Floodborne debris is often capable of destroying unreinforced masonry walls (see Figure 7-19), light wood-frame construction, and small-diameter posts and piles (and the components of structures they support). Debris trapped by cross bracing, closely spaced pilings, grade beams, or other components or obstructions below the Base Flood Elevation (BFE) is also capable of transferring flood and wave loads to the foundation of an elevated structure. Parts of the country are exposed to more massive debris, such as the drift logs shown in Figure 7-20.

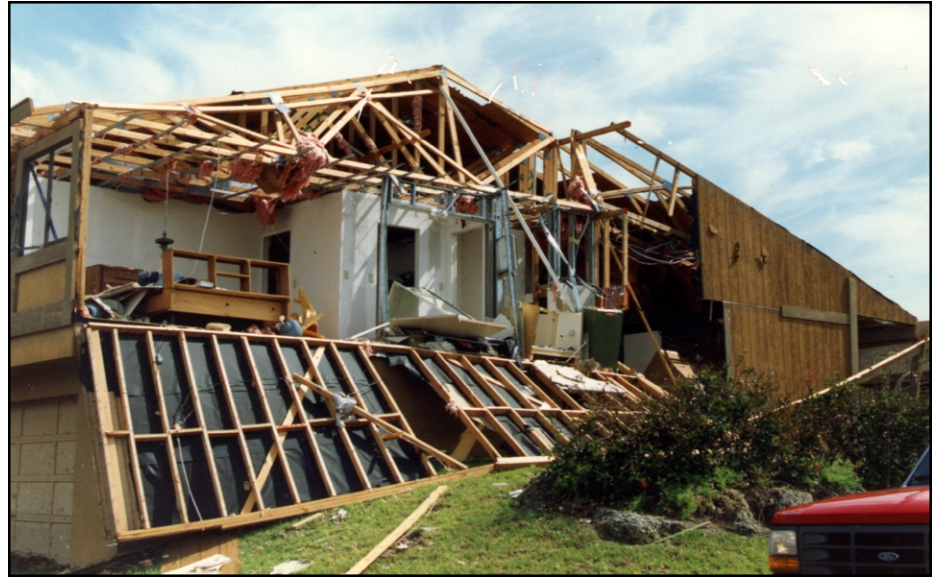
Figure 7-24

Hurricane Andrew (1992).
End-wall failure of typical
first-floor masonry/second-
floor wood-frame building in
Dade County, Florida.

High winds are capable of imposing large lateral (horizontal) and uplift (vertical) forces on buildings. Residential buildings can suffer extensive wind damage when they are improperly designed and constructed and when wind speeds exceed design levels (see Figures 7-24 and 7-25). The effects of high winds on a building will depend on several factors:

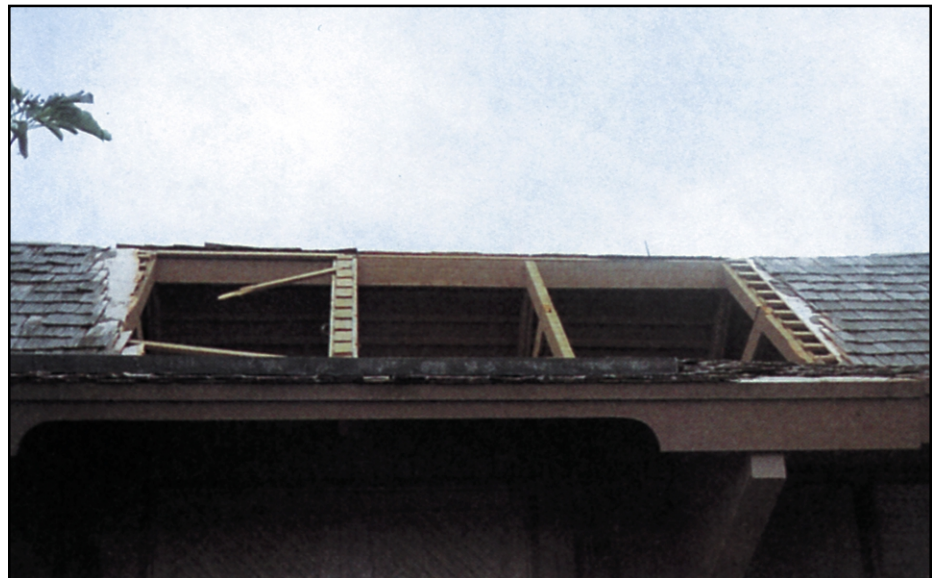
**Figure 7-25**

Hurricane Iniki (1992), Kauai
County, Hawaii. Loss of roof
sheathing due to improper
nailing design and schedule.
