Chapter 1: Introduction

Introduction

The Federal Emergency Management Agency (FEMA) first published the *Coastal Construction Manual* (FEMA-55) in 1981. The manual was updated in 1986 and has provided guidance to public officials, designers, architects, engineers, and contractors for over a decade. In that time, however, construction practices and materials have changed, and more information on hazards and building performance has been developed. There has also been an explosion in coastal development, leading to greater numbers of structures at risk. Many of the residential buildings being constructed today are larger and more valuable than those of the past, leading to the potential for larger economic losses when disasters strike. The increase in coastal development has also brought about greater use of sites located in areas where the risk is higher, such as lots closer to the ocean, lots on high bluffs subject to erosion, or lots artificially created on fill deposits.

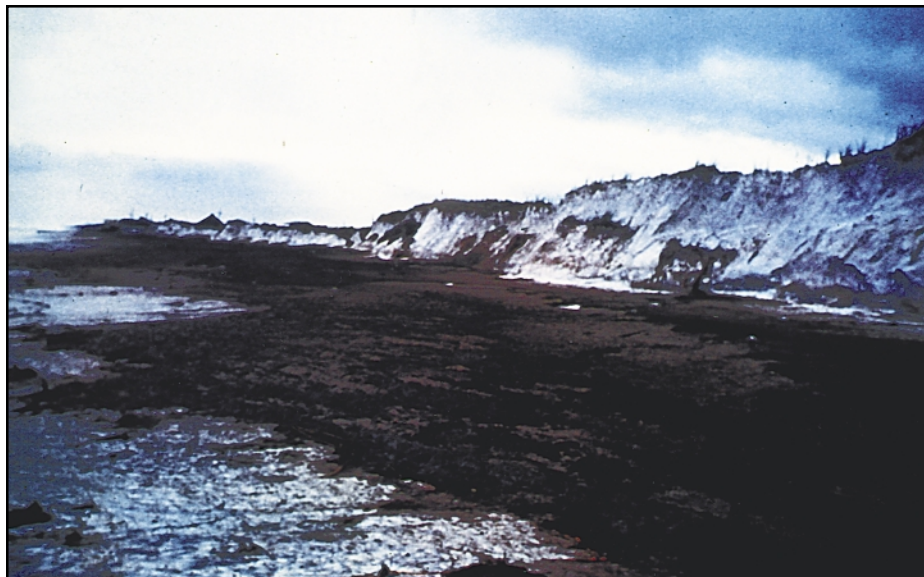
Figure 7-26
Dune erosion in Walton County, Florida, caused by Hurricane Eloise, 1975.

- destroying dunes or other natural protective features, (see Figure 7-26)
- destroying erosion control devices (see Figures 7-27 and 7-28)
- lowering ground elevations, undermining shallow foundations, and reducing penetration of deep foundations such as piles (see Figures 7-29 and 7-30)

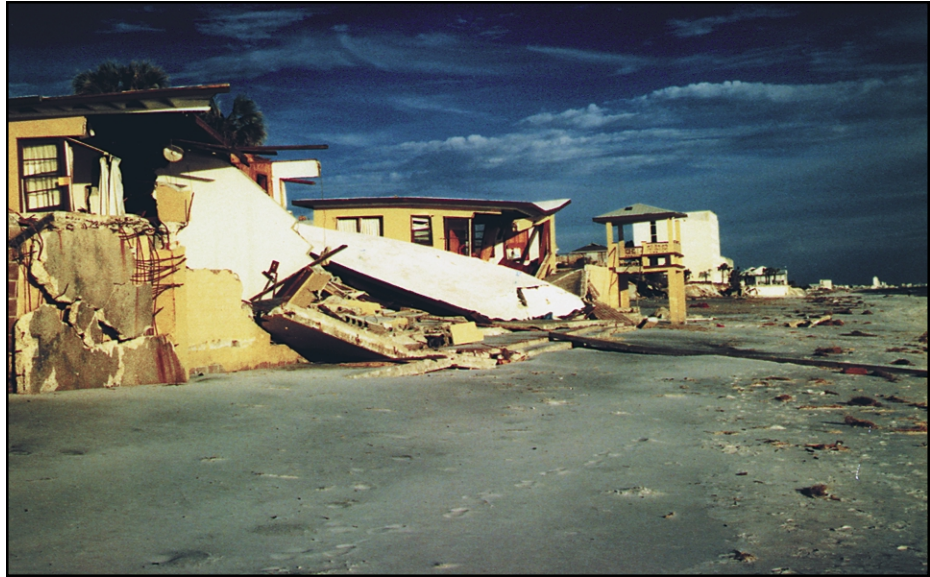
Figure 7-28

Hurricane Opal (1995). Failure of seawall in Bay County, Florida, led to undermining and collapse of the building behind the wall.

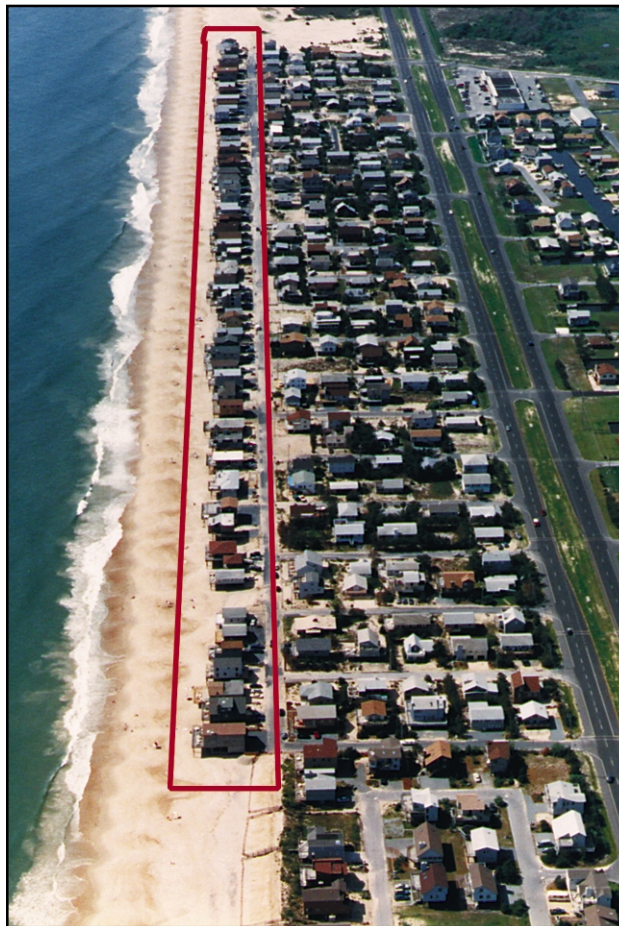
**Figure 7-29**

Long-term erosion at South Bethany Beach, Delaware, has lowered ground elevations beneath buildings and left them more vulnerable to storm damage. 1992 photograph.

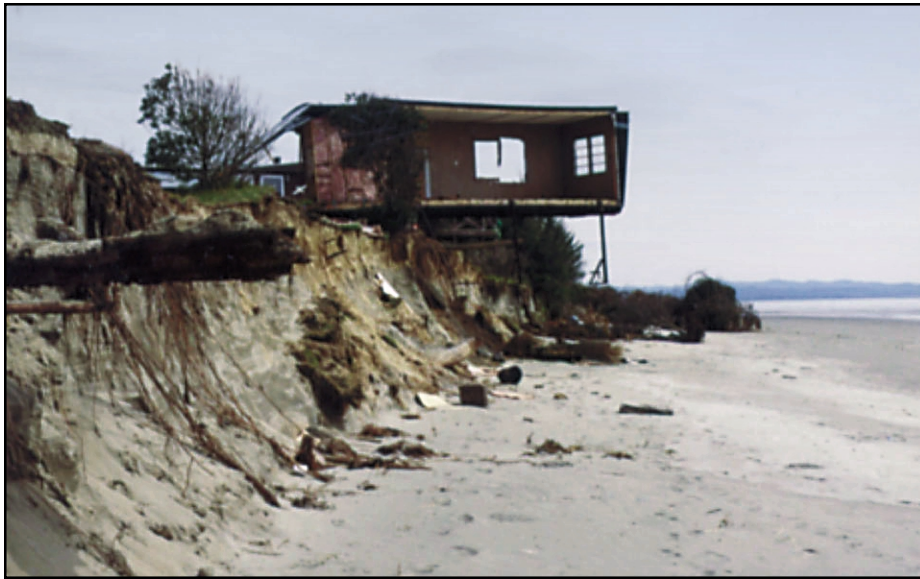
**Figure 7-30**

Erosion undermining a coastal residence at Cape Shoalwater, Washington. 1992 photograph by Washington Department of Ecology.

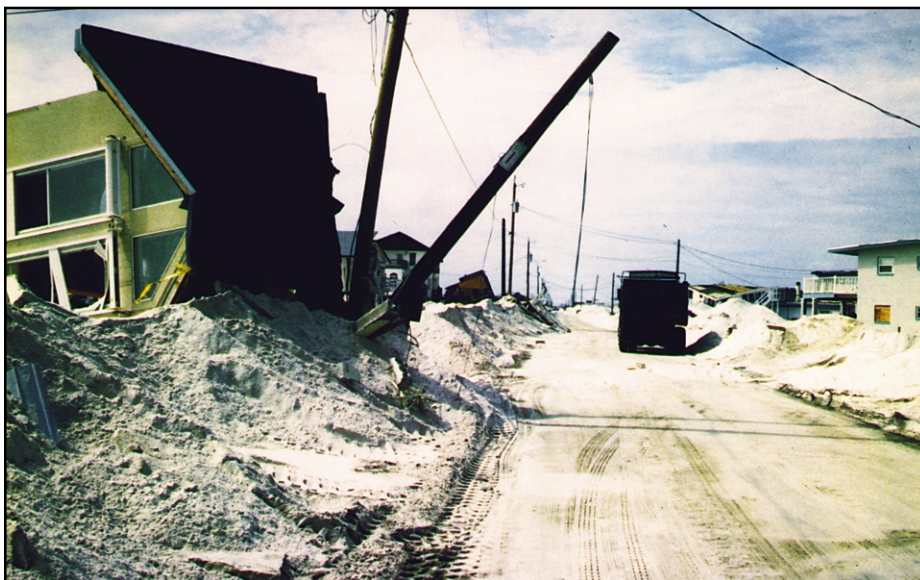
**Figure 7-31**

Removal of Hurricane Opal overwash from road at Pensacola Beach, Florida. Sand washed landward from the beach buried the road, adjacent lots, and some at-grade buildings to a depth of 3–4 feet.

- supplying overwash sediments that can bury structures farther landward (see Figure 7-31) (Note that overwash can permanently reduce the width and elevation of beaches and dunes by transporting sediments landward into marsh areas, where its recovery is difficult, if not impossible—see Figure 7-32.)

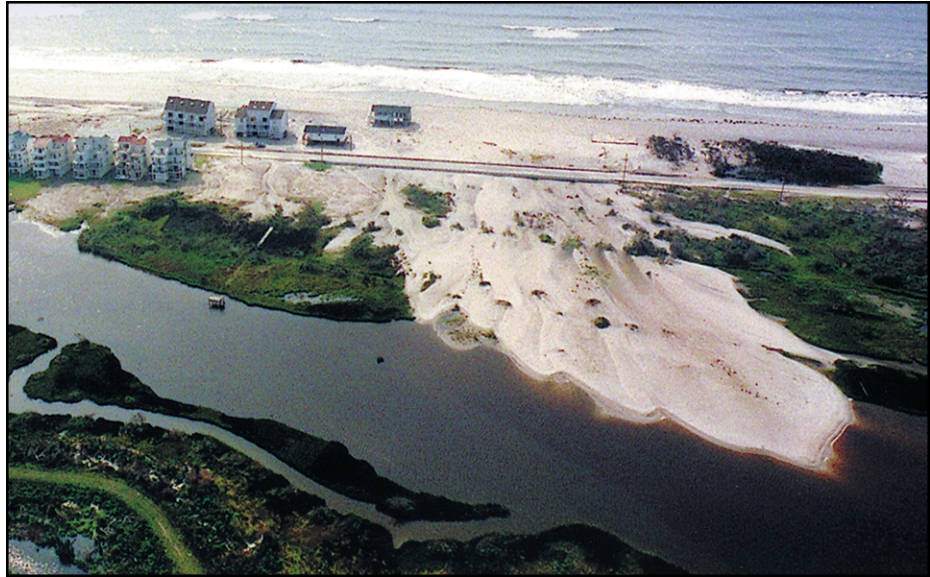
Figure 7-32

Hurricane Bonnie (1998).
Overwash on Topsail Island,
North Carolina. Photograph
by Jamie Moncrief,
Wilmington Morning Star.
Copyright 1998, Wilmington
Star-News, Inc.

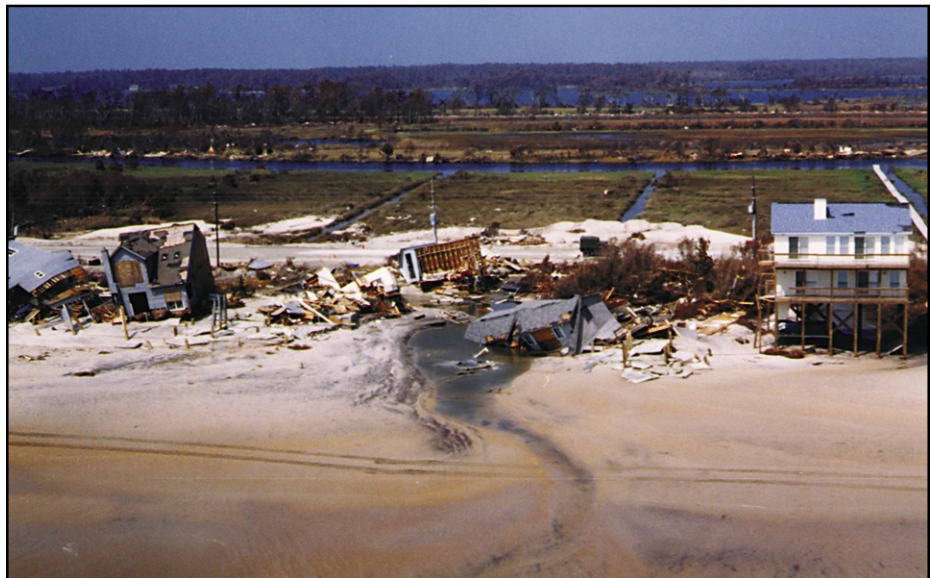
**Figure 7-33**

Hurricane Fran (1996).
Breach and building damage
at North Topsail Beach, North
Carolina.

- breaching low-lying coastal barrier islands, destroying structures at the site of the breach (see Figure 7-33), and sometimes exposing structures on the mainland to increased flood and wave effects (see Figures 7-34 and 7-35)

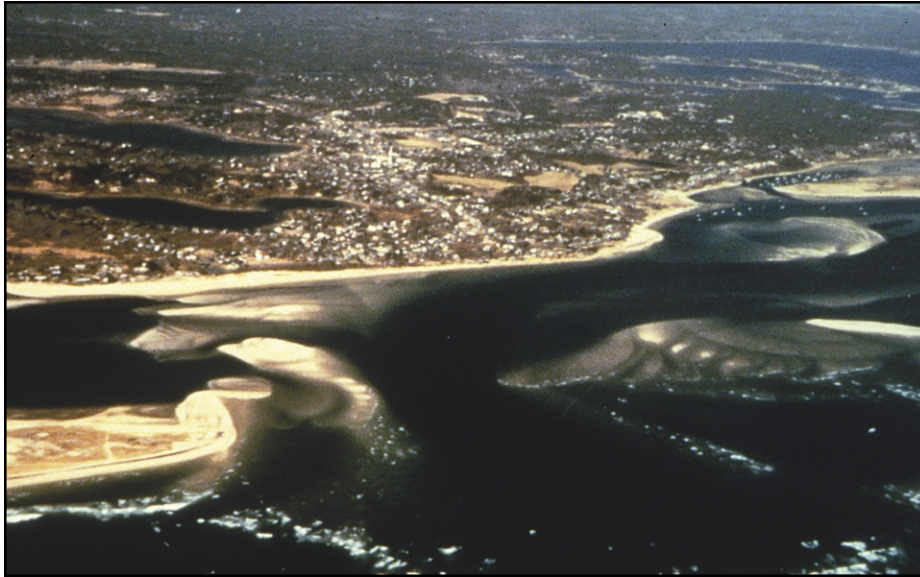
**Figure 7-34**

A breach was cut across Nauset Spit on Cape Cod, Massachusetts, by a January 1987 northeaster. The breach grew from an initial width of approximately 20 feet to over a mile within 2 years, exposing the previously sheltered shoreline of Chatham to ocean waves and erosion. Photograph by Jim O'Connell.

- Formation or closure of an inlet during a storm will alter local tide, wave, current, and sediment transport patterns and may expose previously sheltered areas to damaging waves (see Figures 7-34 and 7-45, in Chapter 7).

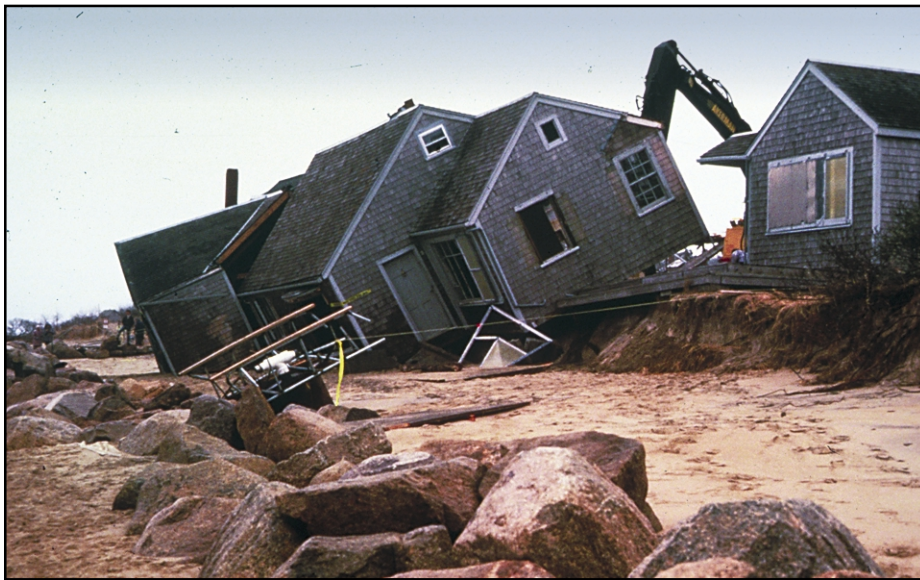
**Figure 7-35**

1988 photograph of undermined house at Chatham, Massachusetts. Nine houses were lost as a result of the formation of the new tidal inlet shown in Figure 7-34. Photograph by Jim O'Connell.

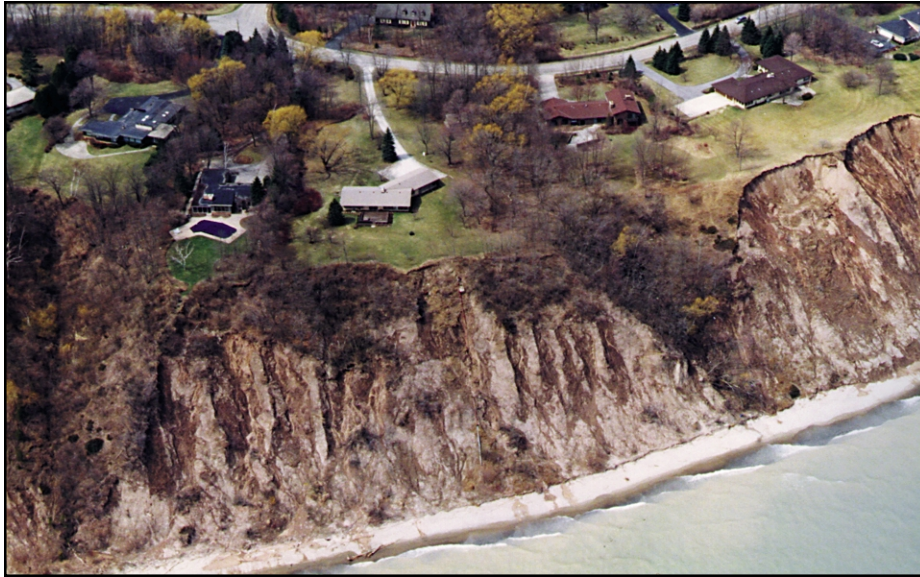
**Figure 7-38**

Long-term erosion along the Lake Michigan shoreline in Ozaukee County, Wisconsin, increases the threat to residential buildings outside the floodplain. 1996 photograph.

2. Siting a building too close to a coastal bluff edge can result in building damage or loss (see Figure 4-3, in Chapter 4, and Figures 7-38 and 7-39, in Chapter 7). Keillor (1998) provides excellent guidance regarding selection of appropriate construction setbacks for bluffs on the Great Lakes shorelines, but the general concepts are applicable elsewhere (see Figure G-17, in Appendix G).

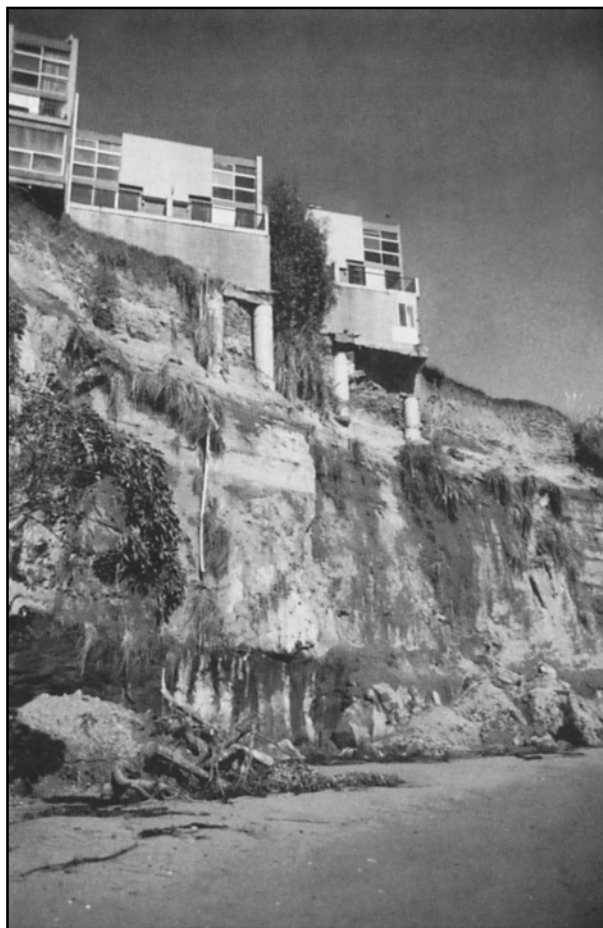
**Figure 7-39**

Bluff failure by a combination of marine, terrestrial, and seismic processes led to progressive undercutting of blufftop apartments at Capitola, California. Six of the units were demolished after the 1989 Loma Prieta earthquake. 1989 photograph from Griggs (1994), courtesy of Journal of Coastal Resources.

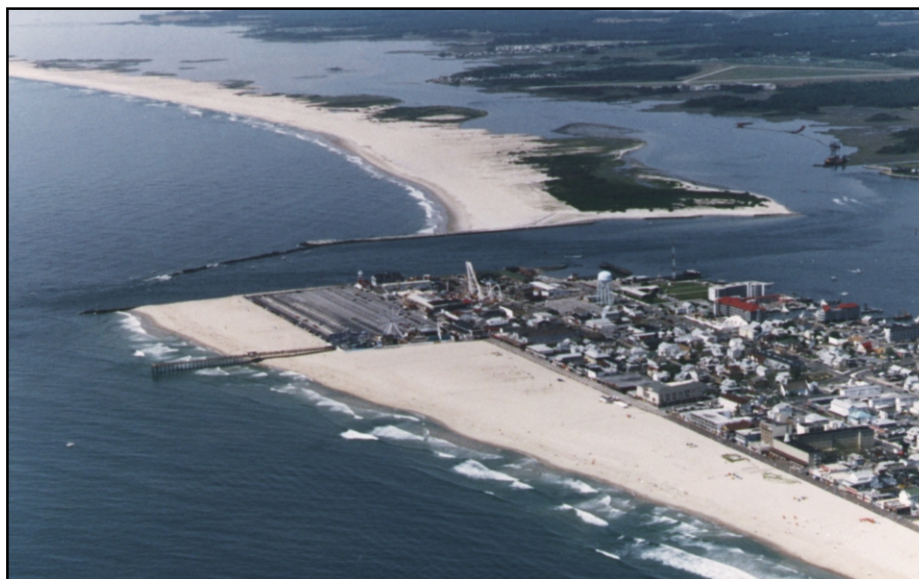
Figure 7-45
Ocean City Inlet, Maryland, was opened by a hurricane in 1933 and stabilized by jetties in 1934–35. Note extreme shoreline offset and downdrift erosion resulting from inlet stabilization. 1992 photograph.

Construction of jetties or similar structures at a tidal inlet or a bay, harbor, or river entrance often results in accretion on one side and erosion on the other, with a substantial shoreline offset. This offset results from the jetties trapping the *littoral drift* (wave-driven sediment moving along the shoreline) and preventing it from moving to the downdrift side. Figure 7-45 shows such a situation at Ocean City Inlet, Maryland, where formation of the inlet in 1933 by a hurricane and construction of inlet jetties in 1934-1935 have led to approximately 800 feet of accretion against the north jetty at Ocean City and approximately 1,700 feet of erosion on the south side of the inlet along Assateague Island (Dean and Perlin 1977). The downdrift erosion is ongoing. Stauble and Cialone (1966) report that post-inlet shoreline change rates on Assateague Island have been documented between -30 feet/year and -40 feet/year (pre-inlet shoreline change rates were approximately -4 feet/year).

8. Layout of lots and infrastructure along shorelines near tidal inlets, bay entrances, and river mouths is especially problematic. Figures 4-2 and 4-3, in Chapter 4, and Figures 7-45, 7-46, 7-47, 7-48, and 7-49, in Chapter 7, all show instances where the recent subdivision and development of oceanfront parcels near ocean-bay connections has led to buildings being threatened by inlet-caused erosion. Infrastructure development and lot layout in similar cases should be preceded by a detailed study of historical shoreline changes, including development of (at least) a conceptual model of shoreline changes. Projections of potential future shoreline positions should be made, and development should be sited well-landward of any areas of persistent or cyclic shoreline erosion.

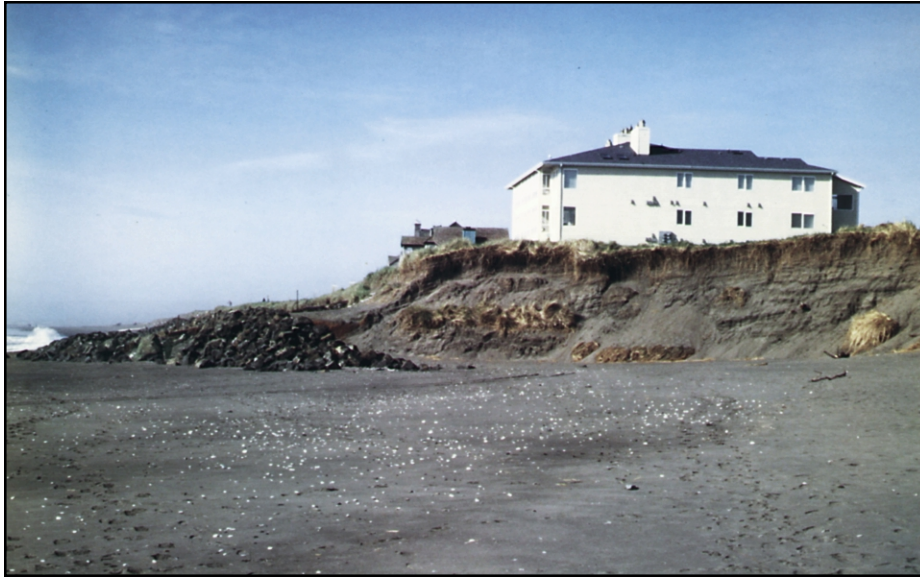
**Figure 7-46**

Buildings threatened by erosion at Ocean Shores, Washington. The rock revetments were built in response to shoreline erosion along an area adjacent to a jetty and thought to be accretional. 1998 photograph.

It should be noted that erosion and accretion patterns at stabilized inlets and entrances sometimes differ from the classic pattern occurring at Ocean City Inlet. In some instances, accretion occurs immediately adjacent to both jetties, with erosion beyond. In some instances, erosion and accretion patterns near a stabilized inlet change over time. Figure 7-46 shows recently constructed buildings at Ocean Shores, Washington, now threatened by shoreline erosion, despite the fact that the buildings were located near an inlet jetty on a beach that was historically viewed as accretional.

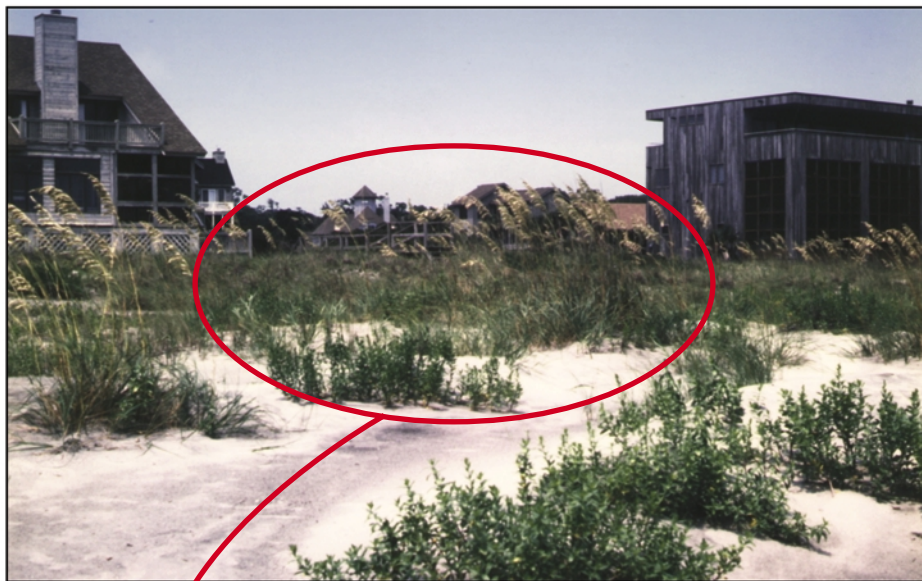
Figure 7-47

July 1989 photograph of vacant lot owned by Lucas, Isle of Palms, South Carolina.

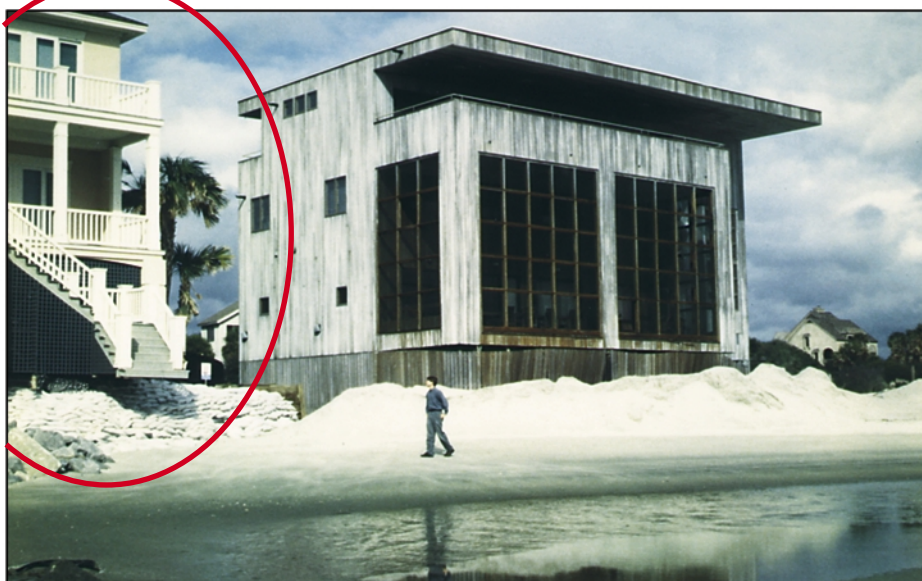
**Figure 7-48**

December 1997 photograph taken in the same area as Figure 7-47. Erosion and undermining of the houses is a result of shoreline changes associated with changes in inlet sand bars and wave patterns. Note that this area is approximately 0.5 mile from the houses shown in Figure 4-2.

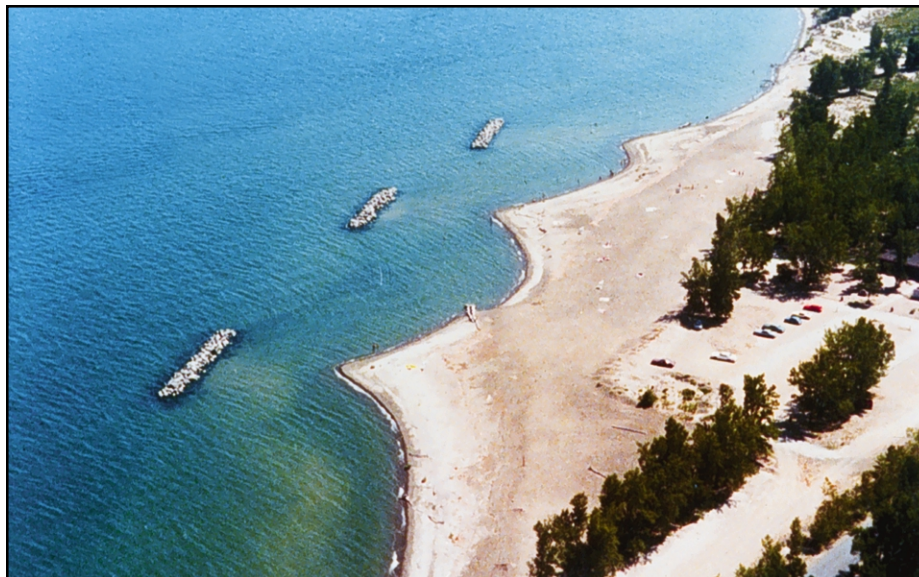
Figure 7-50

Trapping of littoral sediments behind offshore breakwaters, Presque Isle, Pennsylvania. Photograph courtesy of USACE.

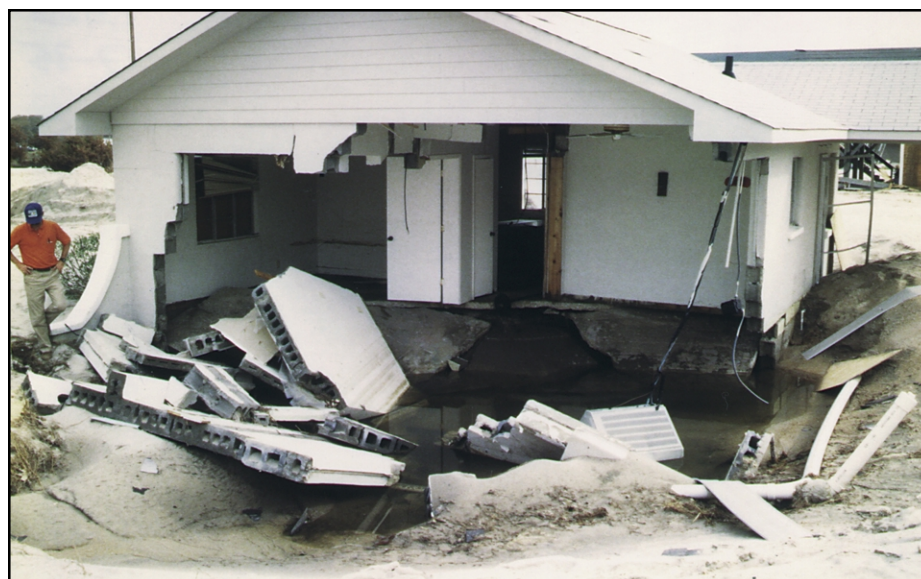
Figure 7-52

Hurricane Fran (1996).
Extreme case of localized
scour undermining a slab-
on-grade house on Topsail
Island, North Carolina. The
lot was several hundred feet
from the shoreline and
mapped as an A zone on the
FIRM prior to the storm. This
case provides one argument
for the treatment of these
areas as coastal A zones.

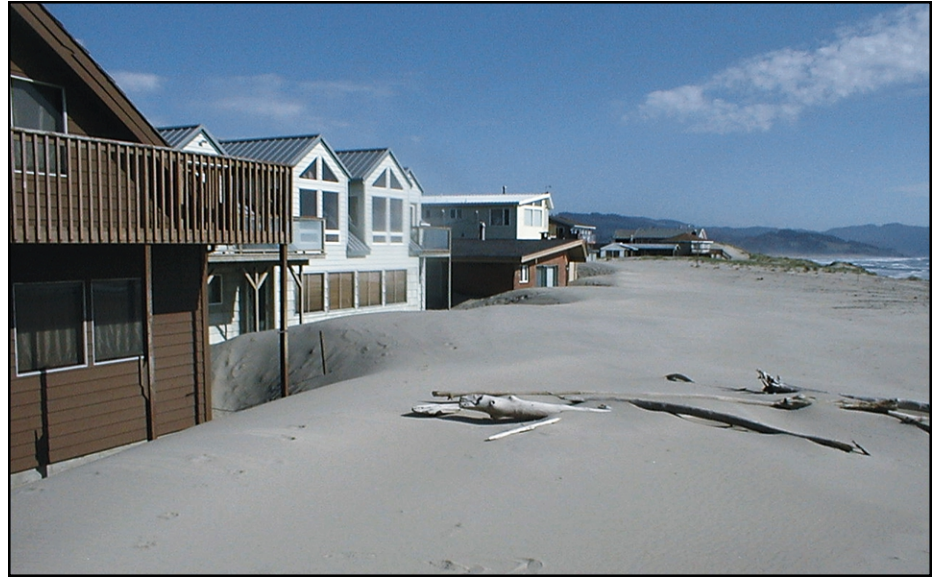
Figure 7-53

Windblown sand drifting against coastal residences in Pacific City, Oregon.
Photograph by Jim Good.

Some coastal areas suffer from an excess of sand rather than from erosion. The excess usually translates into accretion of the shoreline and/or significant quantities of windblown sand. Unless this windblown sediment is stabilized by vegetation or other means, it will likely be blown inland by coastal winds, where it can bury non-elevated coastal residential buildings and at-grade infrastructure—such as drainage structures and ground-mounted electrical and telephone equipment—and drift across roads (see Figure 7-53).

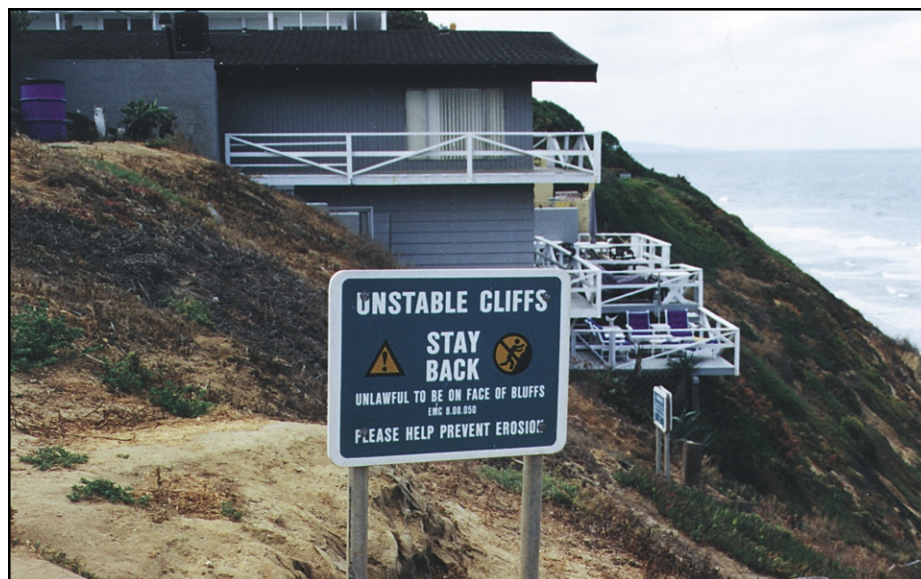
Figure 7-56
Unstable coastal bluff at
Beacon's Beach, San Diego,
California. Photograph by
Lesley Ewing.

floods, or heavy rains, but can be worsened by human actions such as destruction of vegetation or uncontrolled pedestrian access on steep slopes (see Figure 7-56). An extreme example is Hurricane Mitch in 1998, where heavy rainfall led to flash flooding, numerous landslides, and an estimated 10,000 deaths in Nicaragua.

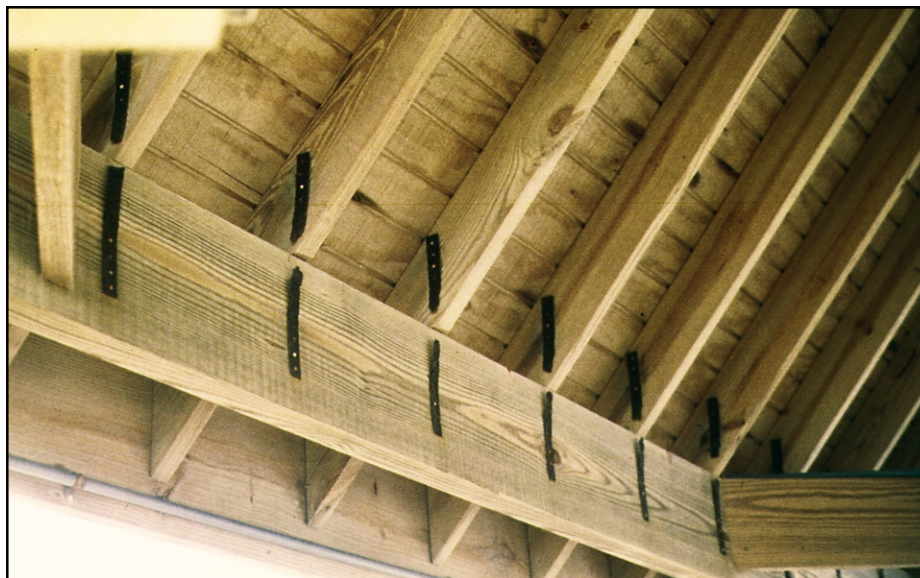
Figure 7-58

Example of corrosion, and resulting failure, of metal connectors. Photograph by Spencer Rogers.

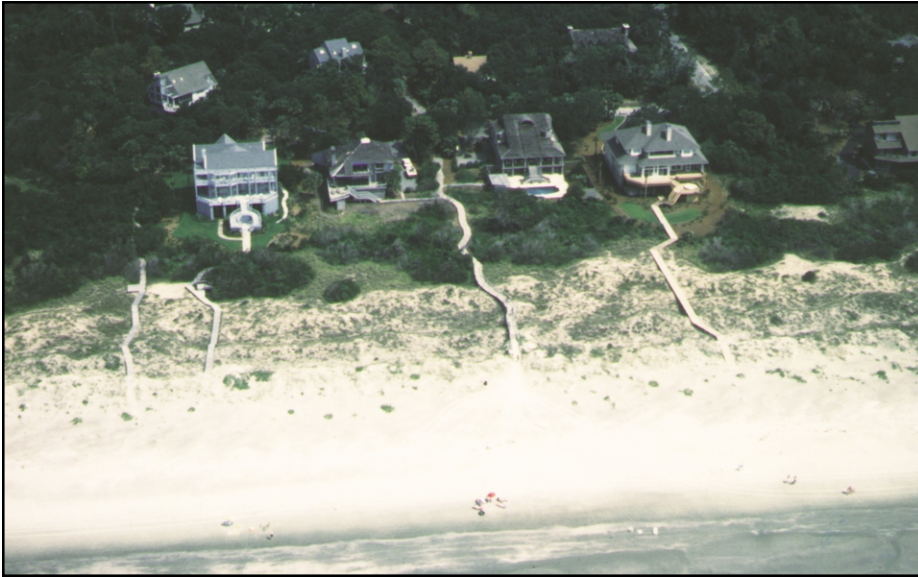
**Figure 8-3**

Example of coastal development well-suited to the land: deep lots, generous setbacks, and avoidance of dune areas should afford protection against erosion and flood events for years to come.

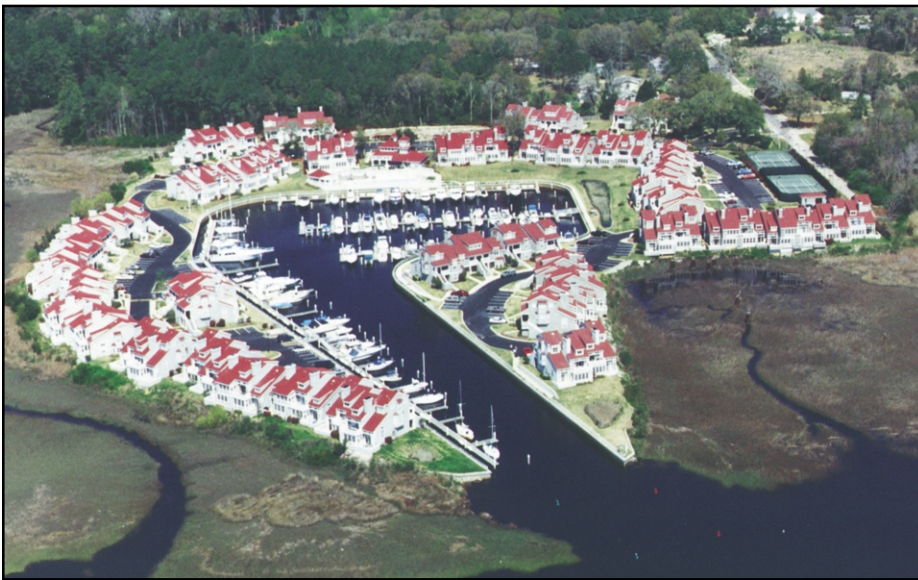
**Figure 8-4**

Increasingly, coastal residential structures are being planned and constructed as part of mixed-use developments, such as this marina/townhouse development. These projects can involve a new set of environmental and regulatory issues, as well as more difficult geotechnical conditions and increased exposure to flood hazards.

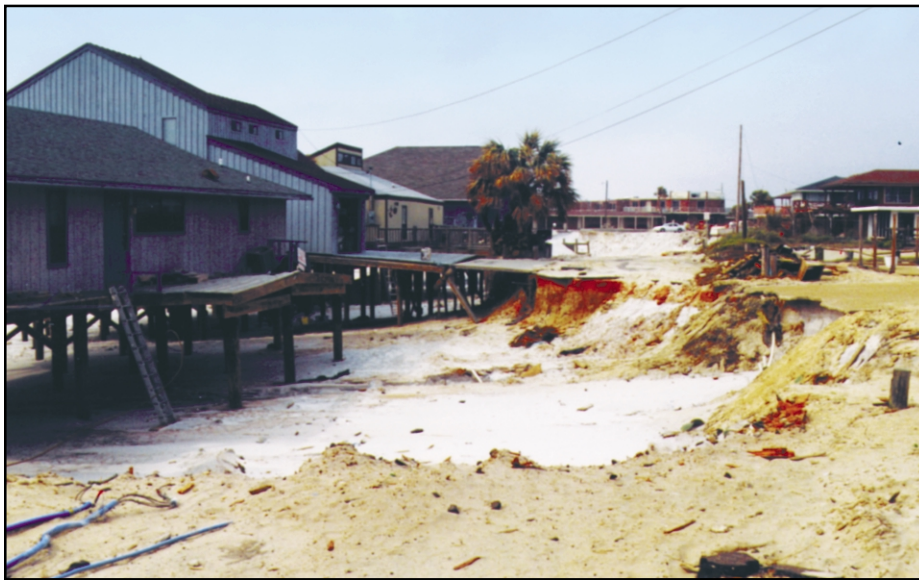
Figure 8-6

View along a washed-out, shore-parallel road in Bay County, Florida, after Hurricane Opal. Homes to the left are standing on the beach and have lost upland access; some homes to the right have also lost their roadway access.

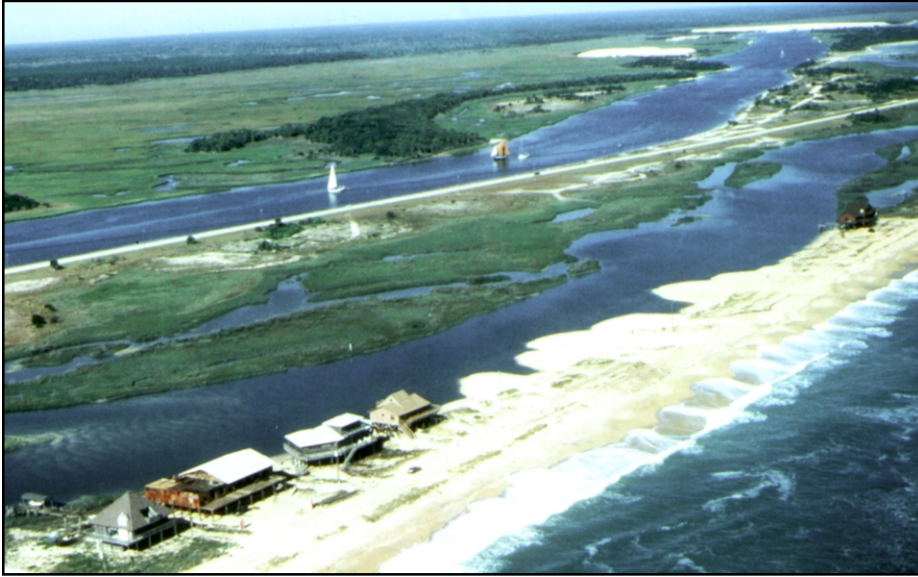
Figure 8-11

Construction along this narrow, low-lying area of St. Johns County, Florida, is routinely subjected to coastal storm effects (photo following November 1984 northeast storm). The lots and buildings are landward of a previous state highway location, now abandoned.

4. Creation of lots along narrow sand spits and low-lying landforms (see Figure 8-11) is not recommended, especially if the shoreline is eroding. Any buildings constructed there will be routinely subject to coastal storm effects, overwash, and other flood hazards.

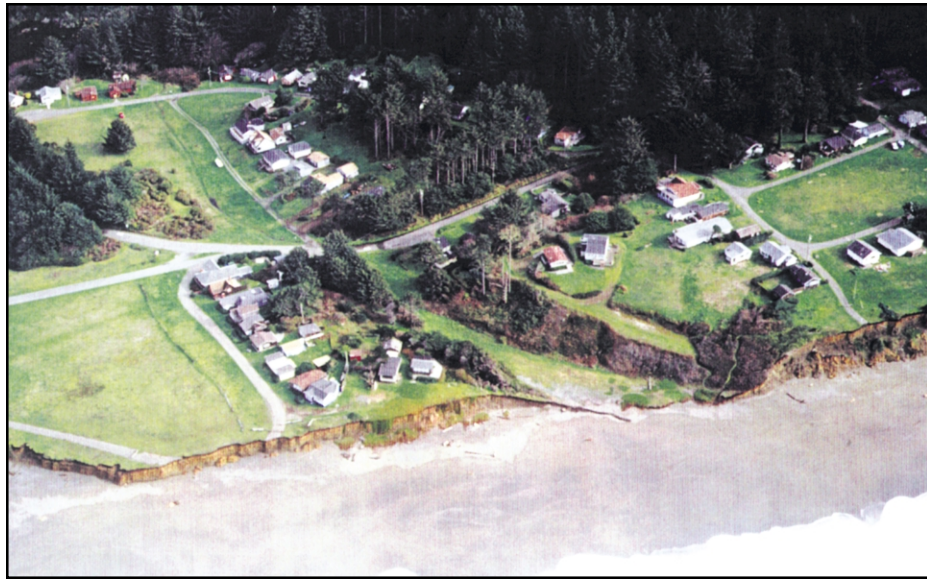
Humboldt County, California, parcel fronting the Pacific Ocean. As buildings are threatened by bluff erosion, they are moved to other sites on the parcel.

7. Another related approach is to occupy a small fraction of the total buildable parcel and to accommodate erosion by moving threatened buildings to other available sites on the parcel. A small Pacific Ocean community in Humboldt County, California, has successfully employed this approach (Tuttle 1987). Figure 8-14 shows a community of 76 recreational cabins on a 29-acre parcel, jointly owned by shareholders of a corporation. As buildings are threatened by erosion, they are relocated (at the building owner's expense) to other sites on the parcel, in accordance with a cabin relocation policy adopted by the corporation.

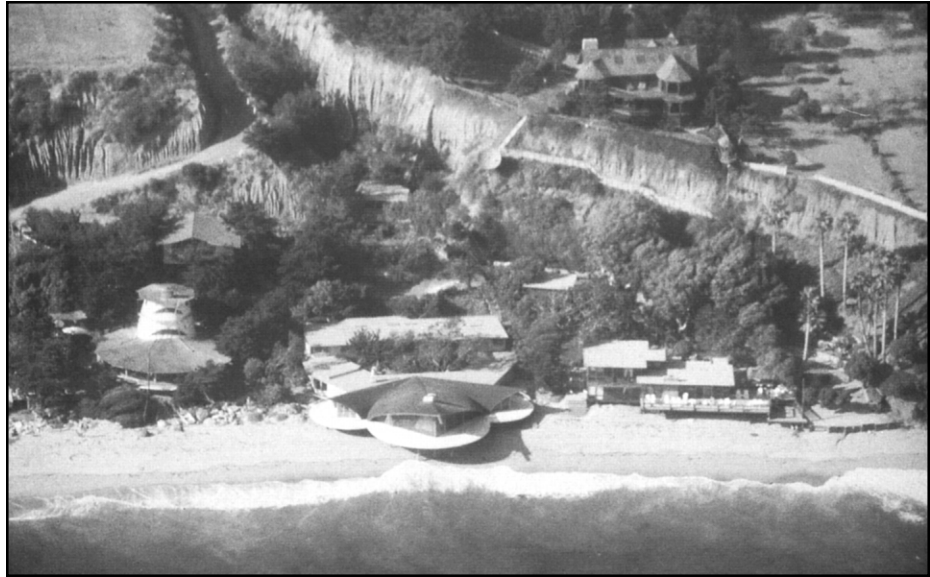
This site near Malibu, California, is an example of a coastal building site subject to multiple hazards—storm waves and erosion, stream flooding and debris flows, and earthquakes. Photo courtesy of *Journal of Coastal Research* (Griggs 1994, in Finkl 1994).

3. Some sites present multiple hazards, which designers and owners may not realize. For example, Figure 8-16 shows southern California homes that have been constructed along the Pacific shoreline at the mouth of a coastal stream. The homes may be subject to storm waves and erosion, stream flooding and debris flows, and earthquakes.

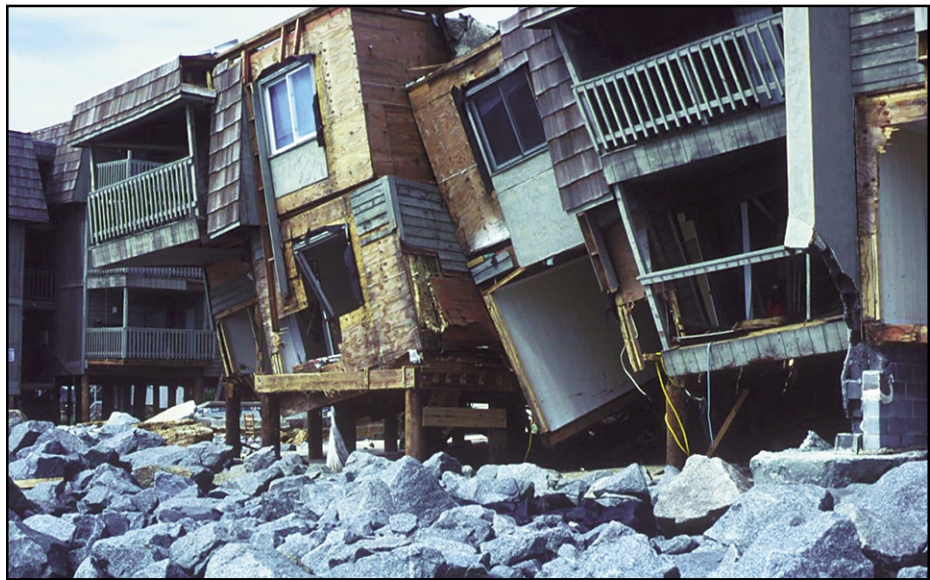
**Figure 8-17**

Hurricane Hugo (1989). Damage to buildings sited close to an eroding shoreline at Garden City Beach, South Carolina. Storm waves often overtop revetments and damage buildings.

4. Siting a building too close to an erosion control structure, or failing to allow sufficient room for such a structure to be built, is another siting practice to avoid. Figure 8-17 shows an example of buildings that were constructed near the shoreline, only to be damaged by storm effects and erosion. Subsequent construction of a rock revetment will provide some protection to the buildings, but not as much as if there were a greater distance between the revetment and buildings. Storm waves can easily overtop the revetment and damage the buildings. An alternative to this situation is simply to plan ahead by siting the building farther landward and providing enough room between the building and the erosion control structure to dissipate the effects of wave and flood overtopping.

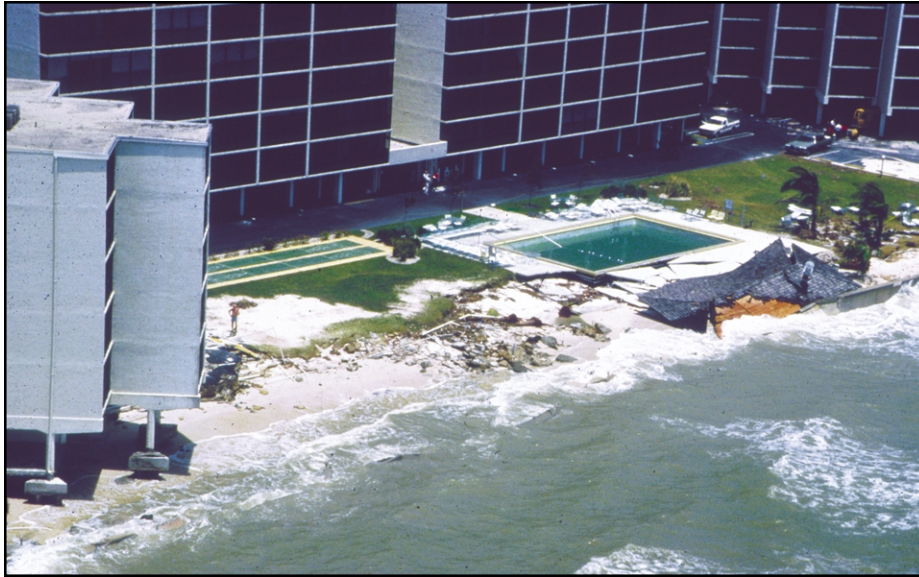
**Figure 8-18**

Damage at Bonita Beach, Florida, from June 1982 subtropical storm. Had this building not been supported by an adequate pile foundation, it would have collapsed. Buildings sited close to an erosion control structure should not rely on the structure to prevent undermining. Photograph by Judson Harvey

A related siting problem (also observed along bay or lake shorelines, canals, manmade islands, and marina/townhouse developments) is the construction of buildings immediately adjacent to bulkheads (see Figure 8-18). The bulkheads are rarely designed to withstand a severe coastal flood and are easily overtopped by floodwaters and waves. During severe storms, landward buildings receive little or no protection from the bulkheads. In fact, if such a bulkhead fails, the building foundation will be undermined and the building may sustain additional damage or be a total loss.

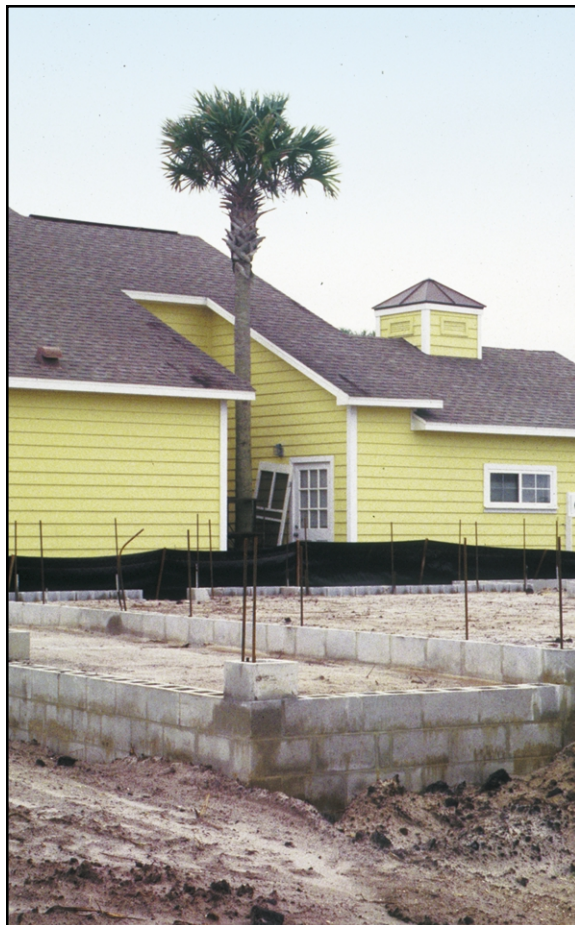
Figure 8-19

Siting and designing buildings to accommodate large trees is important for a variety of reasons. However, notching the building and roofline to allow placement around a tree can lead to roof and envelope damage during a high-wind event and is not a recommended practice.
