Hydrogen Sulfide Release at Waterflood Station in Odessa, Texas

U.S. Chemical Safety and Hazard Investigation Board

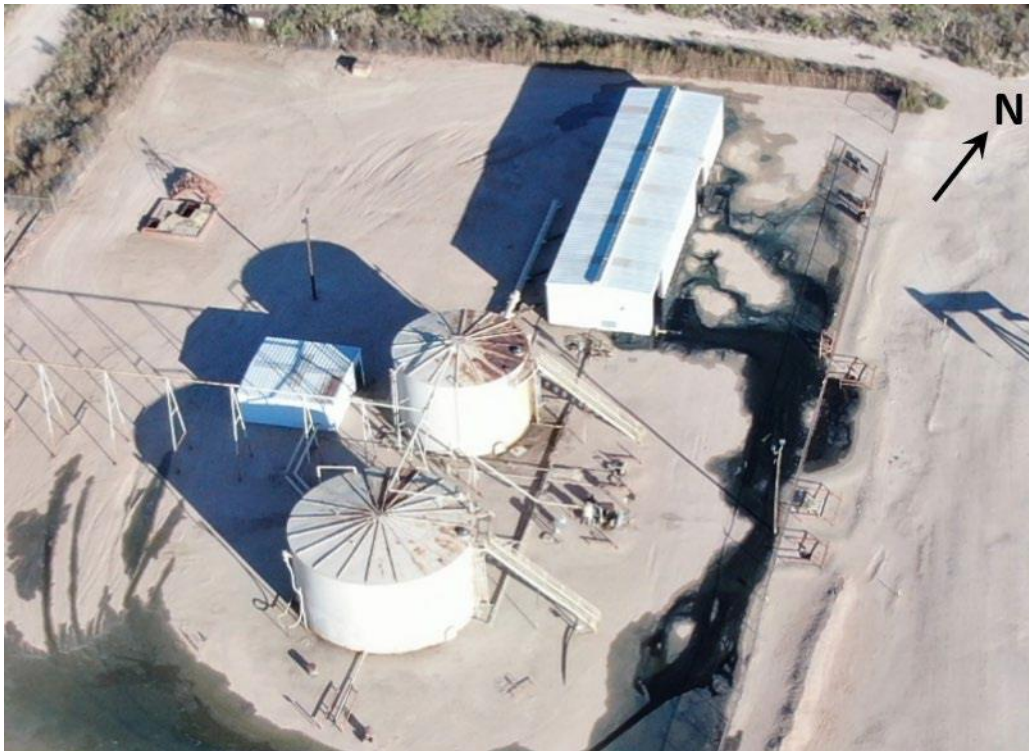
The incident occurred at the Foster D waterflood station, operated by Aghorn Operating Inc. (Aghorn) in Odessa, Texas (**Figure 1**). The waterflood station receives *produced water*, a by-product of oil extraction in the area, from approximately 68 crude oil wells in the Foster Field of the Permian Basin.^a The station is used to inject produced water back into the oil-bearing formation to improve the extraction of oil from underground oil reservoirs.

Figure 1. Aghorn Foster D waterflood station in Odessa, Texas. (Credit: Ector County Sheriff's Office)

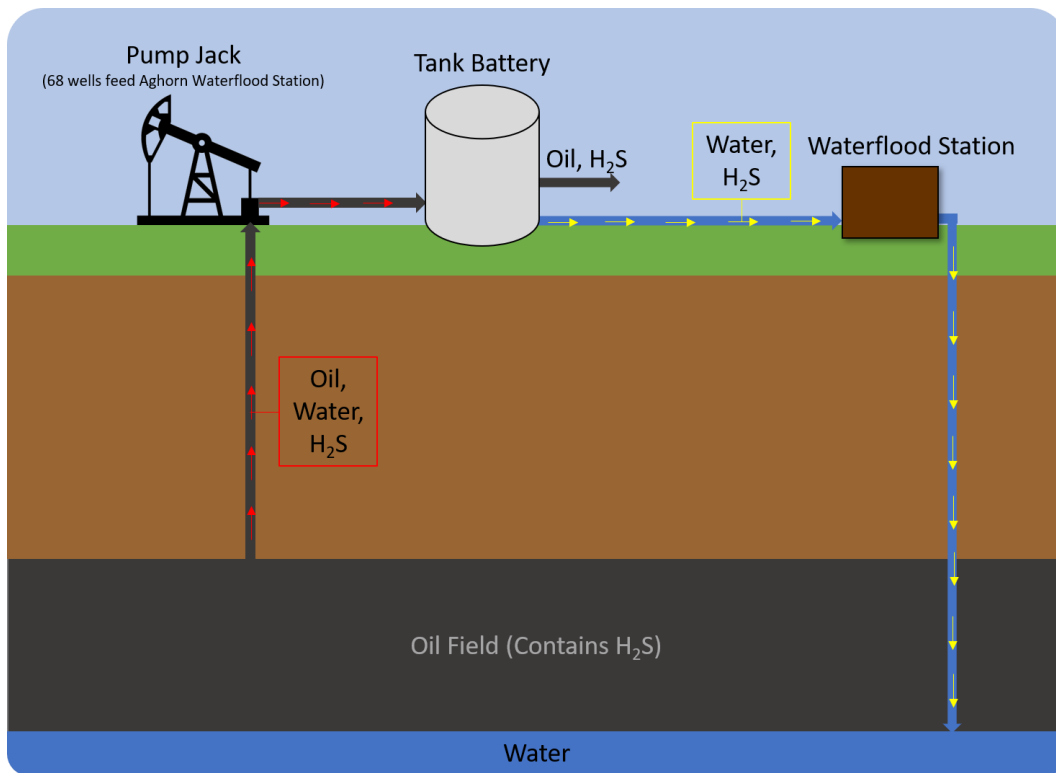
Figure 2 illustrates the Aghorn oil extraction and waterflooding processes. Large pumps, called *pump jacks*, extract oil from underground oil reservoirs and transfer the oil to a tank battery^a through pipes. At the tank battery, the oil is stored in large tanks, where produced water separates from the oil.^b Produced water typically contains other components, including hydrogen sulfide (H₂S), a toxic gas known to be present in oil and gas reservoirs in the area.^c After it is separated from the oil, other pipes transfer the produced water from several tank batteries to a waterflood station. The waterflood station pumps the produced water back into the oil reservoir.

Figure 2. Simplified illustration of the Aghorn waterflooding process. (Credit: CSB)

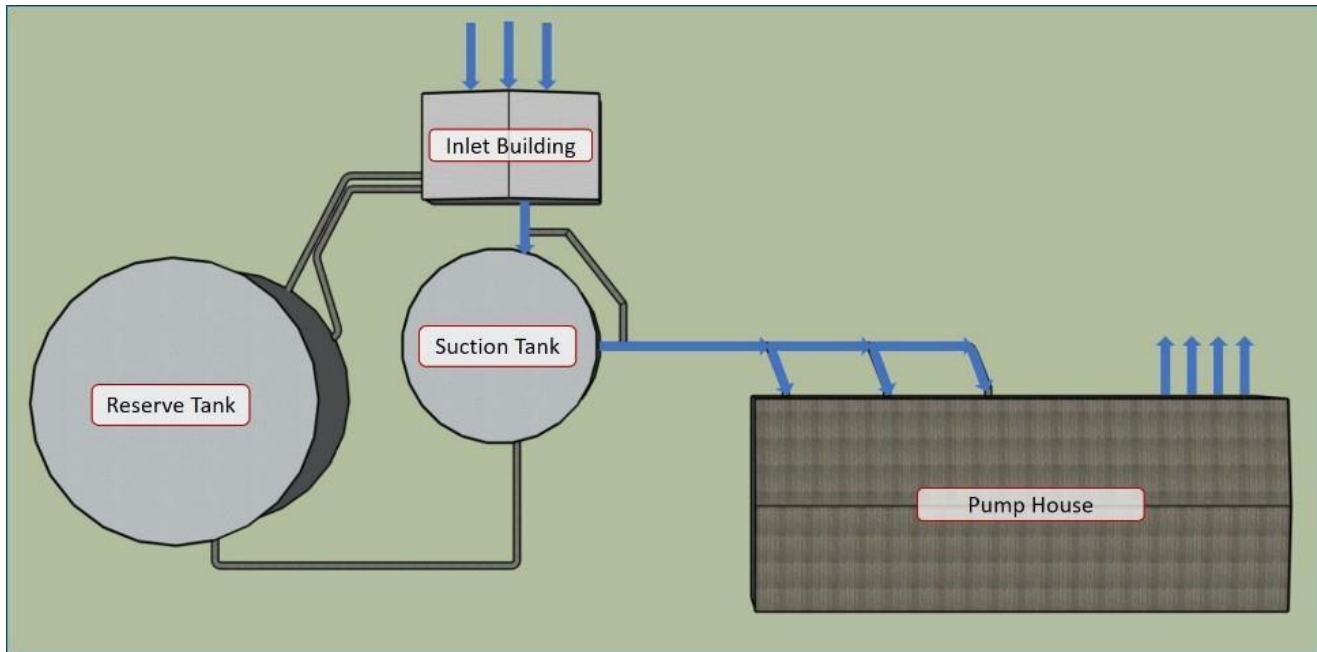
The produced water from several tank batteries first enters the waterflood station at the *inlet building*. The produced water is then routed to a temporary storage tank called the *suction tank*. From there, the water flows through a pipe to the *pump house*, where positive displacement pumps pressurize the water to approximately 900 pounds per square inch gauge (psig). The produced water then exits the facility through a series of pipes and is injected back into the oil reservoir. The *reserve tank* is typically used as an overflow during maintenance and is not part of the normal process flow.

Figure 3. Illustration of the Foster D waterflood station. (Credit: CSB)

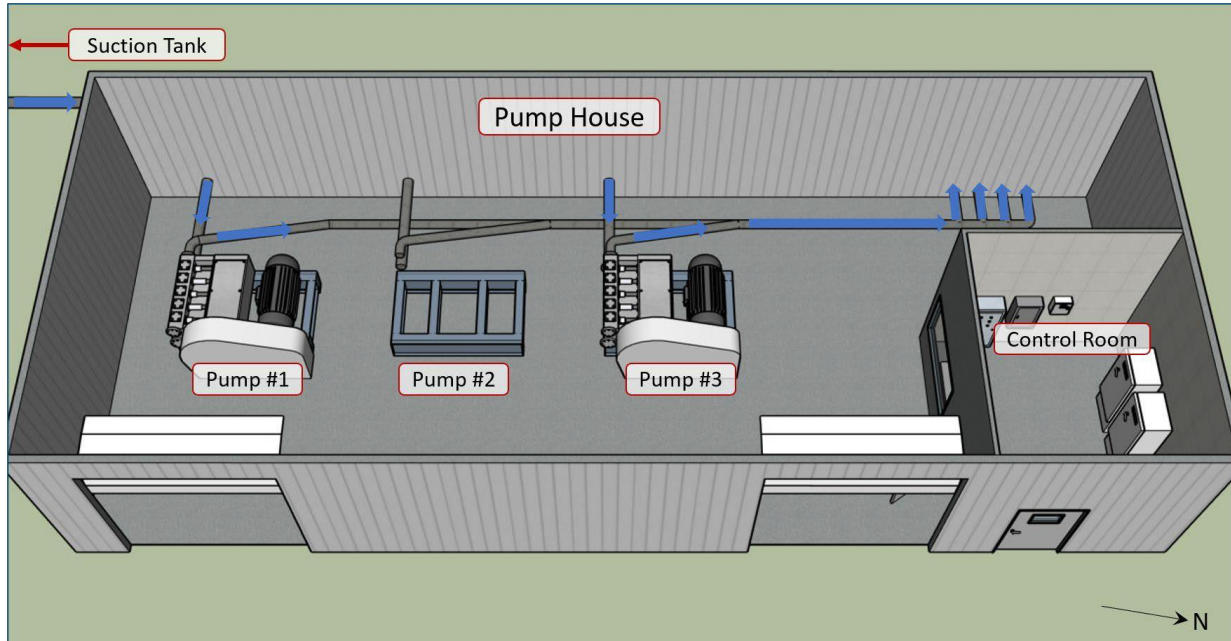
The waterflood station's control room is in the northeast corner of the pump house (**Figure 4**). A programmable logic controller (PLC) monitors all process equipment on a control board inside the control room (**Figure 5**) and automatically operates pumps based on the liquid level in the suction tank. The power switch on the control board has three positions: “hand,” meaning the pump is turned on manually by a person; “off,” which turns the pump off; and “automatic,” which causes the pumps to be controlled by the PLC. Aghorn communicated to the CSB that at the time of the incident, the PLC was programmed to turn on Pump #1 and Pump #3 when the liquid level in the suction tank reached a preset level. According to Aghorn, when the liquid reached the preset level, Pump #1 would automatically turn on and, approximately 15 seconds later, Pump #3 would automatically turn on.

Figure 4. Depiction of pump house. (Credit: CSB)

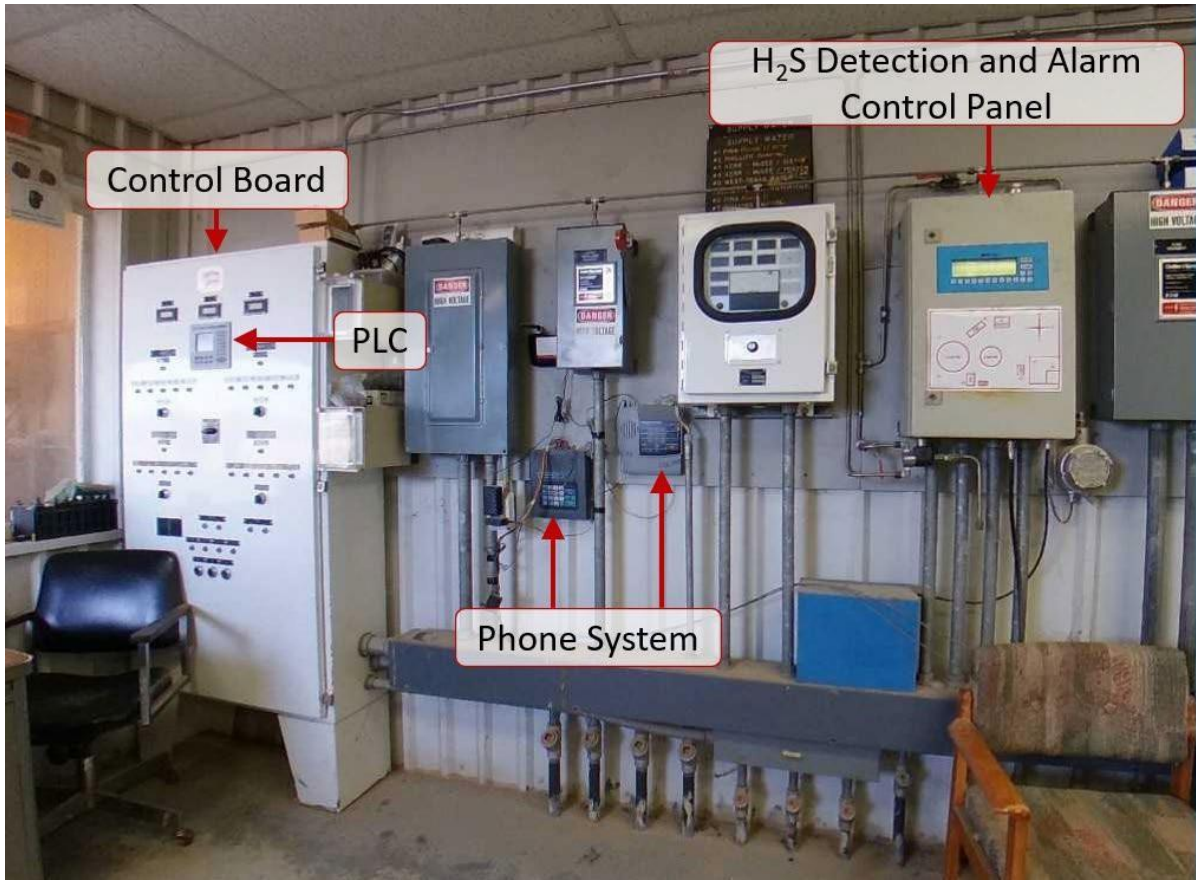
Figure 5. Control room layout. (Credit: CSB)

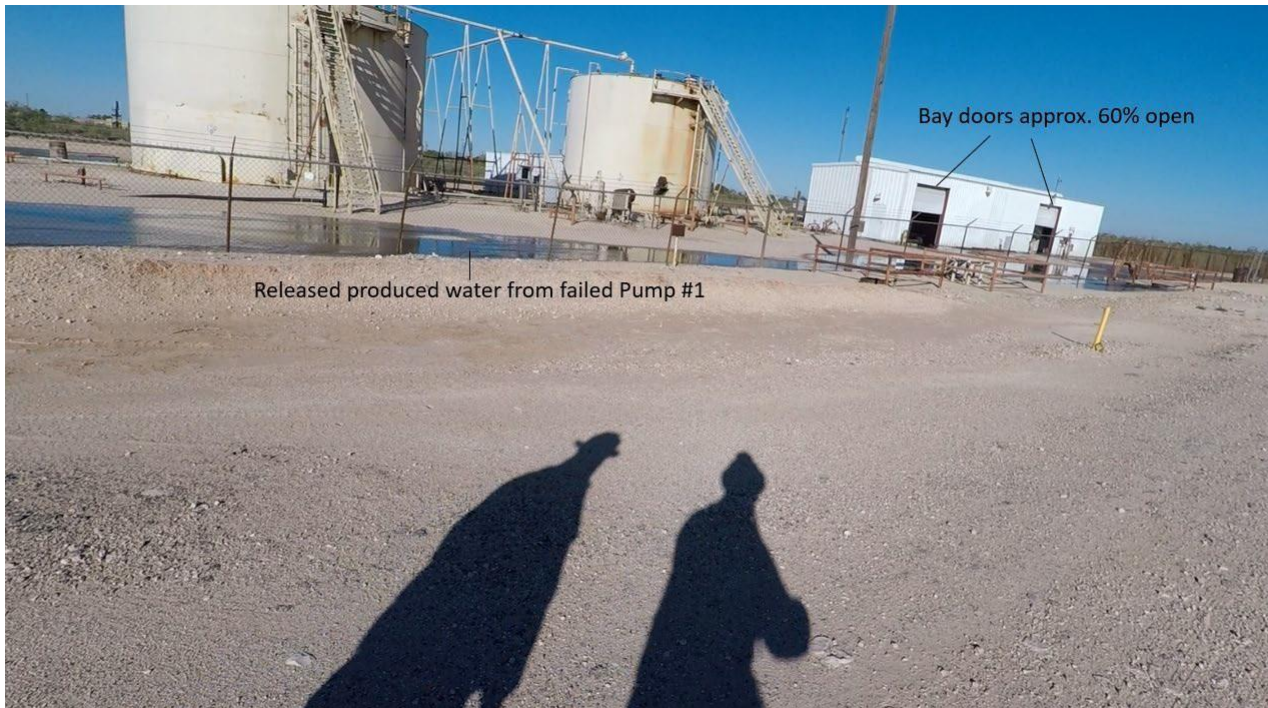
Figure 6. Video still showing bay door positions and released produced water. (Credit: Ector County Sheriff's Office)

3. The H₂S warning signs to the left of the gate entrance at the public road were corroded;
4. Produced water was observed spilling out of Pump #1 (**Figure 17**). Water was also present exterior to the pump house (**Figure 6**). Such water presence is abnormal at the facility and indicative of an equipment malfunction;

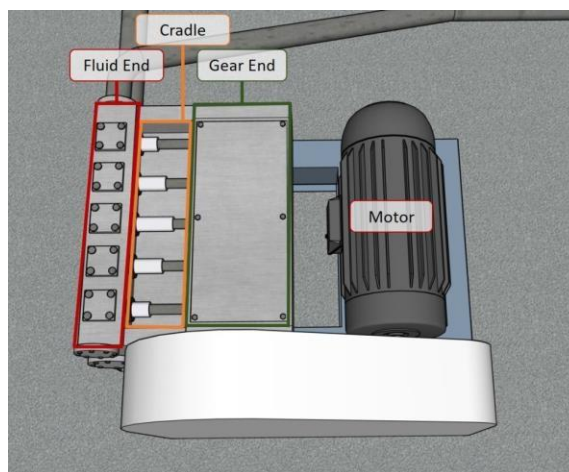
Pump #1 is a National-Oilwell type J-275 quintaplex plunger pump. The pump is a positive displacement pump. Shown in **Figure 7**, the primary components of plunger pumps are

- the motor, which provides the driving force for the pump;
- the gear end, which converts the rotational motion of the motor to the horizontal motion of the pump;
- the cradle, an open section in the pump between the fluid end and the gear end; and
- the fluid end, which contains valving and seals required for the pump to pressurize water.

Figure 7. Major components of a plunger pump. (Credit: CSB)

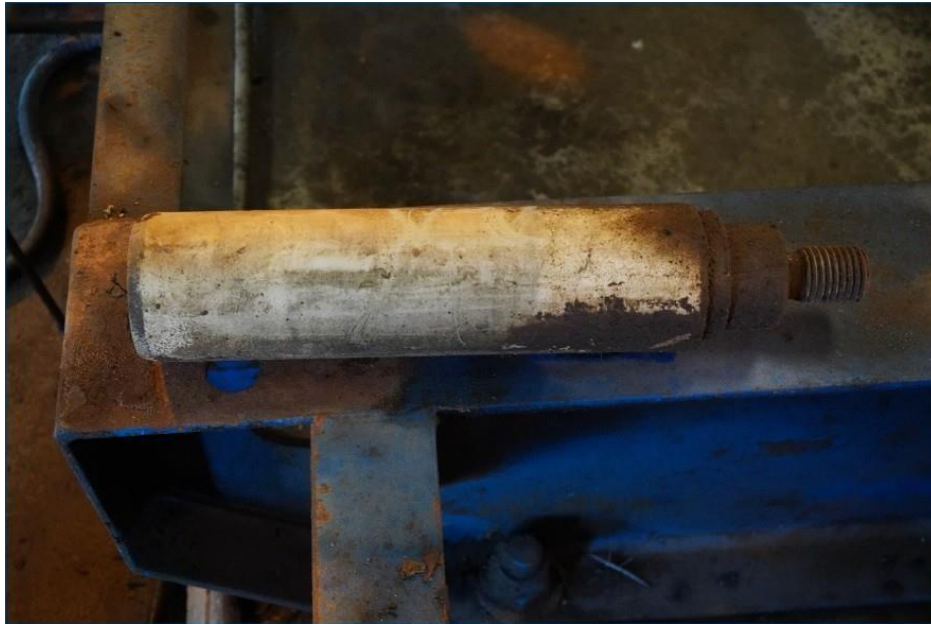
Between the gear end and the fluid end, inside the cradle, five ceramic plungers (**Figure 8**) pressurize the produced water. The gear end pulls the plungers into and out of the fluid end, which draws water from the suction tank and pressurizes the water into the discharge piping [3, p. 3]. **The stuffing box is designed to seal around the plunger and prevent the produced water from leaking out of the fluid end. Shown in Figure 9, the stuffing box contains the components required to seal around the plunger to prevent any leaks.** Valves inside the fluid end (orange highlight) open to allow water in from the suction line (light blue arrows), the plunger presses on the water, and another valve opens to allow the pressurized water to flow into the discharge line (dark blue arrows). Pump #1 had a maximum discharge pressure of 1,020 psig and was usually run at around 900 psig.

Figure 8. A spare ceramic plunger. (Credit: CSB)

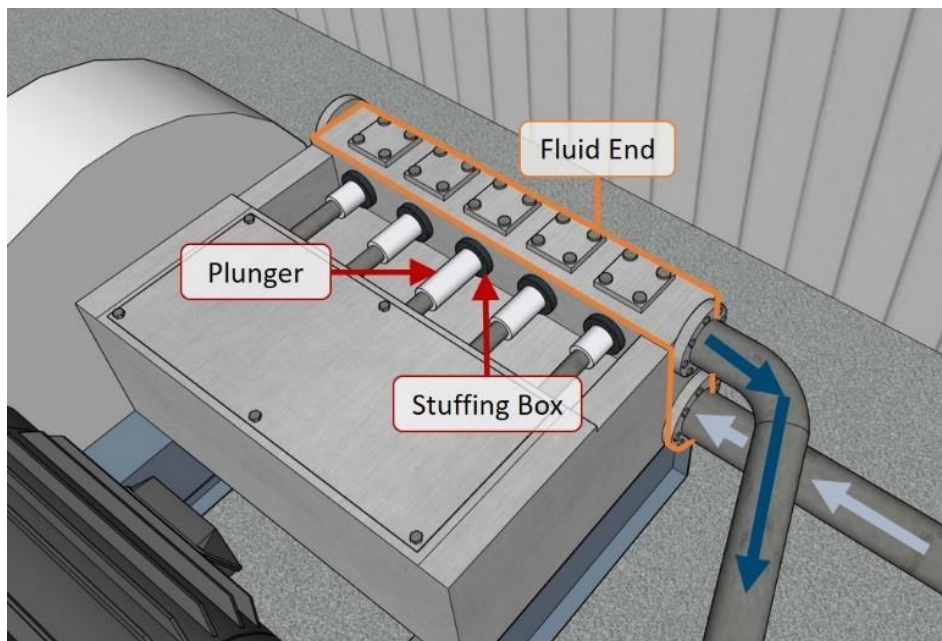
Figure 9. View of a plunger pump's main components. (Credit: CSB)

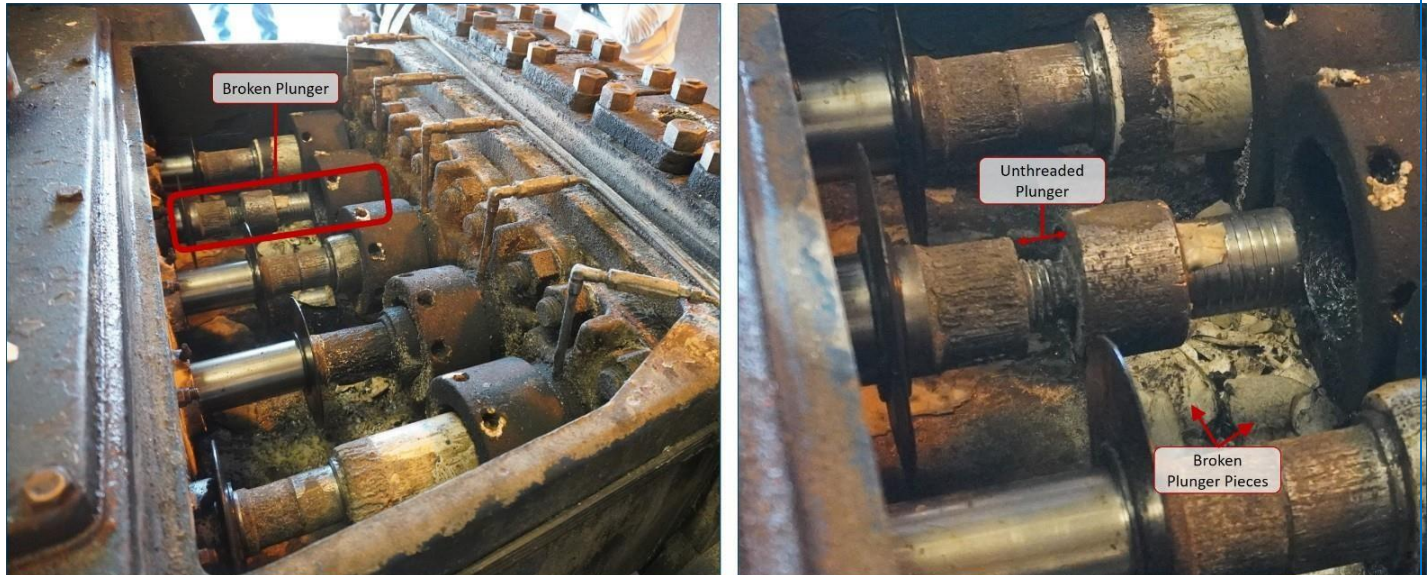
The CSB inspected Pump #1 after the incident. The inspection found that one of the pump's plungers had backed off its threaded connection to the gear end, and the ceramic was shattered. The fragments of the plunger could be seen in the bottom of the cradle (**Figure 10**). The inspection also revealed that the discharge valve for Pump #1 was in a position indicating approximately 95 percent closed and the position indicator on the suction valve for Pump #1 was about 50 percent closed (**Figure 18** and **Figure 19**).

Figure 10. Photos of Pump #1 cradle and visible broken plunger pieces. (Credit: CSB)

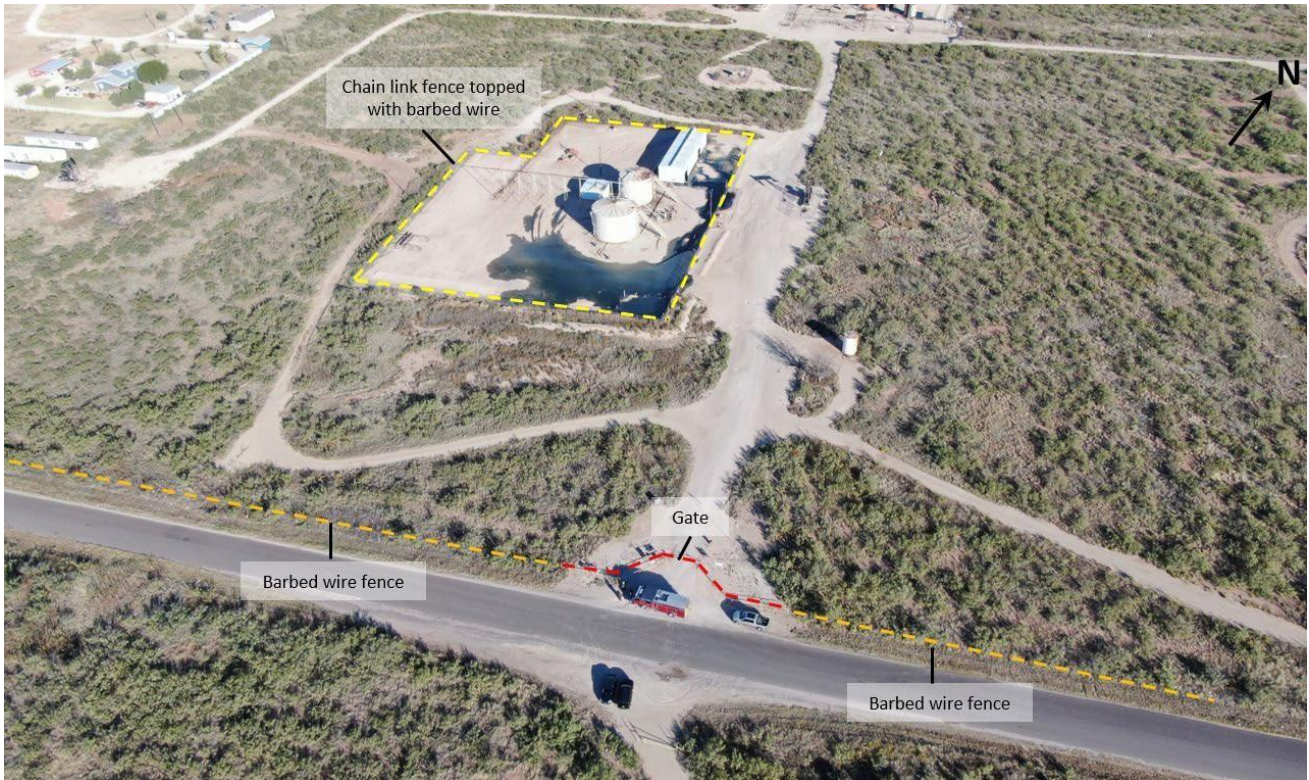
Site security at the facility consists of a gate at the entrance from the public road, a barbed wire fence around the perimeter, and a chain link fence topped with barbed wire around the waterflood station (**Figure 11**). Immediately to the left of the gate to the facility near the public road, signs list several warnings, including warnings about the potential for H₂S gas to be present (**Figure 12**). Additional signs, installed to the left the gate of the interior chain link fence topped with barbed wire, also warn of the potential presence of H₂S (**Figure 13**). Many of the H₂S warning signs were corroded. **The signs were likely not non-corrosive, were not reflective, were not lit, and were likely difficult to read under low light conditions.** Further, vehicles passing through these two open gates in night conditions may not have seen the signs at all, as they would not have been in the direct line of sight. For the internal fence, when the gates were open, a vehicle's headlights would not have been facing the signs upon entry. For the external fence, the vehicle's headlights would have only faced the signs if they arrived from the east.

Aghorn told the CSB they expect the waterflood station access gates to be locked each day after employees complete their tasks. While employees are present at facilities, the gates are typically left open and unlocked. On the night of the incident, both the gate and the chain link fence were left open since Pumper A was working in the pump house.

Figure 11. Aghorn waterflood station security. (Credit: CSB)

The CSB recommends to Aghorn for all Aghorn facilities, develop a site-specific, formalized and comprehensive Lockout / Tagout program, to include policies, procedures, and training, to protect workers from energized equipment hazards, such as exposure to H₂S. Ensure the program meets the requirements outlined in 29 CFR 1910.147 and includes energy control procedures, training, and periodic inspections.

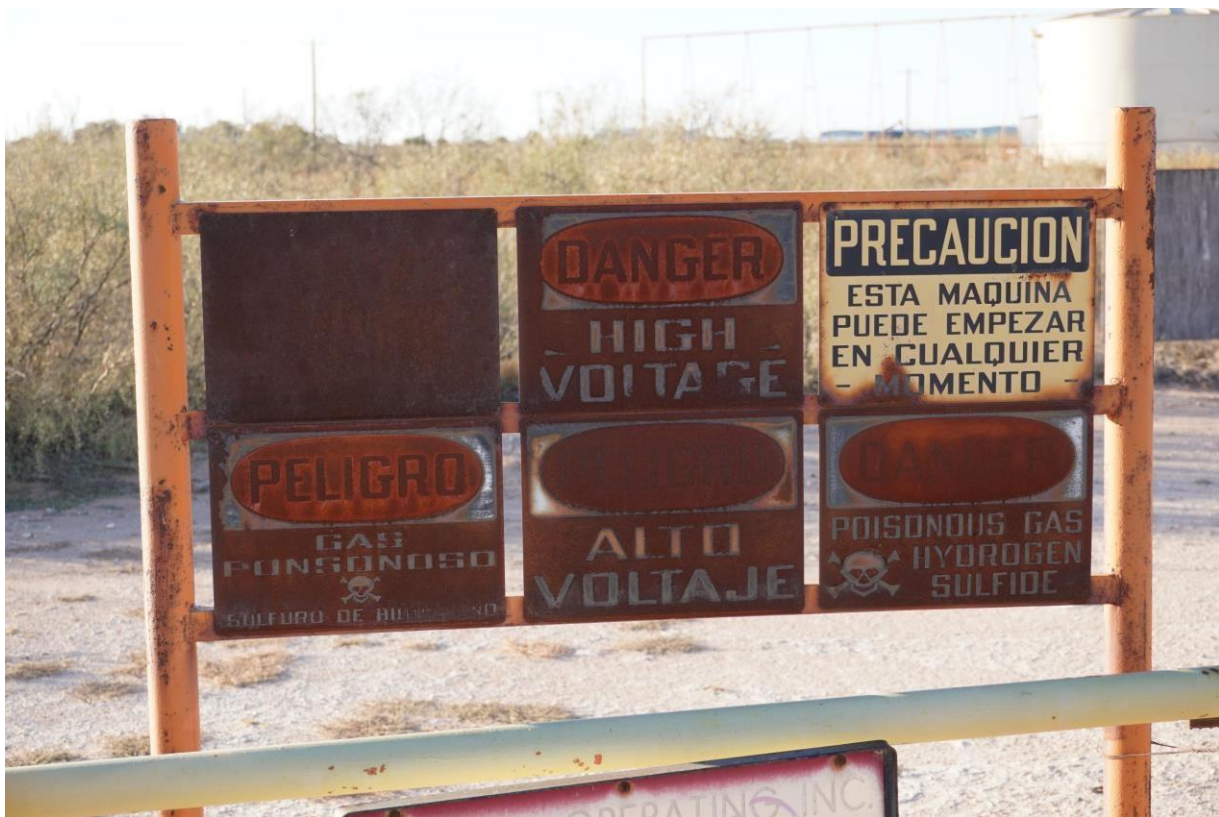
Figure 12. Warning signs to the left of the gate to the facility from the public road. (Credit: CSB)

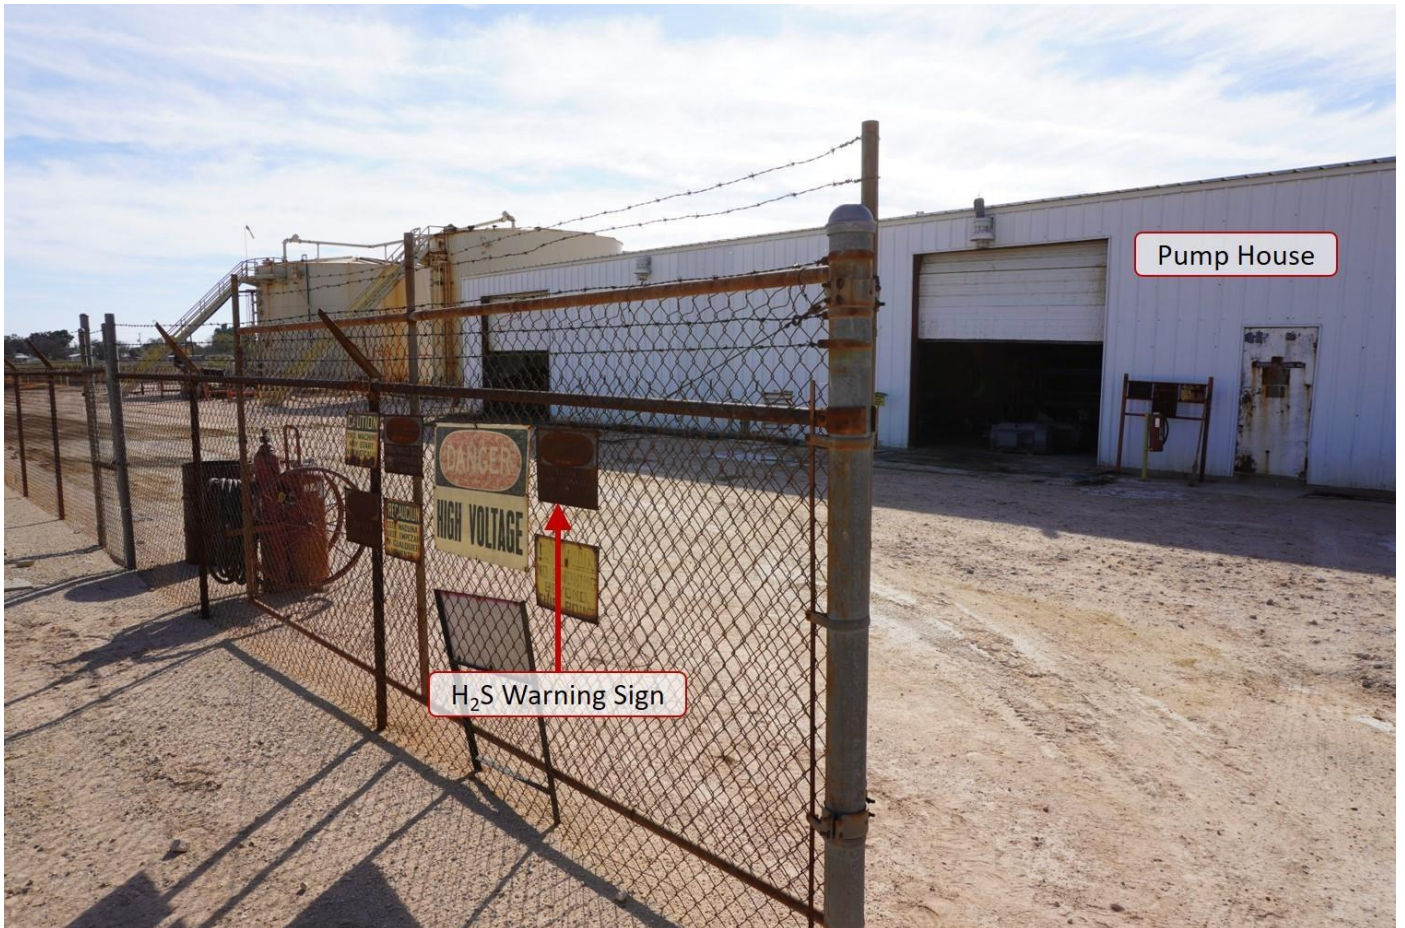
Figure 13. Warning signs and interior fence surrounding the waterflood station. (Credit: CSB)

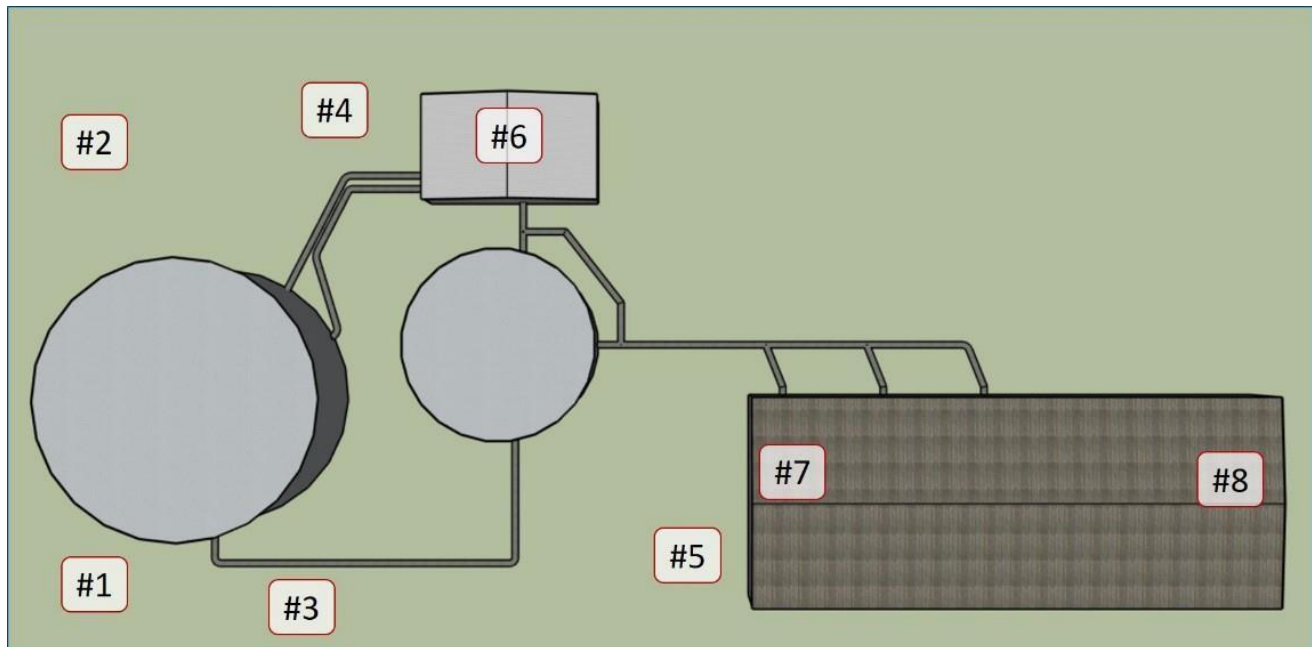
Figure 14. Locations of the eight H₂S point detectors at the waterflood station. (Credit: CSB)

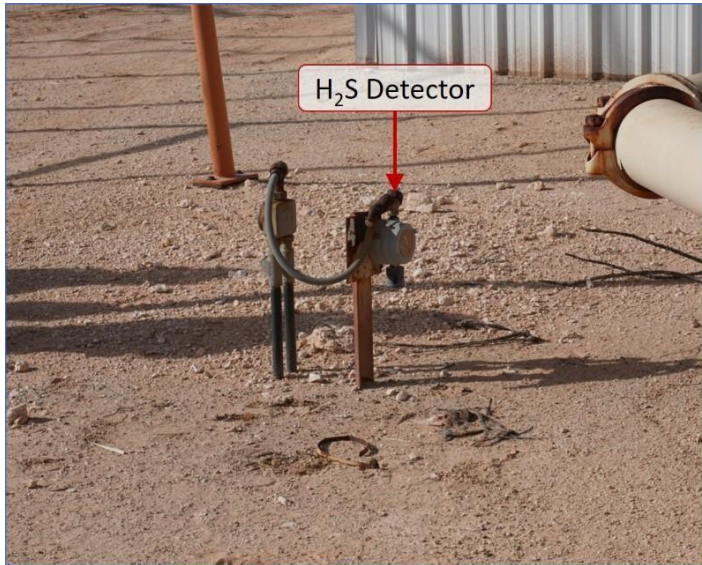
Figure 15. Image of an H₂S point detector. (Credit: CSB)

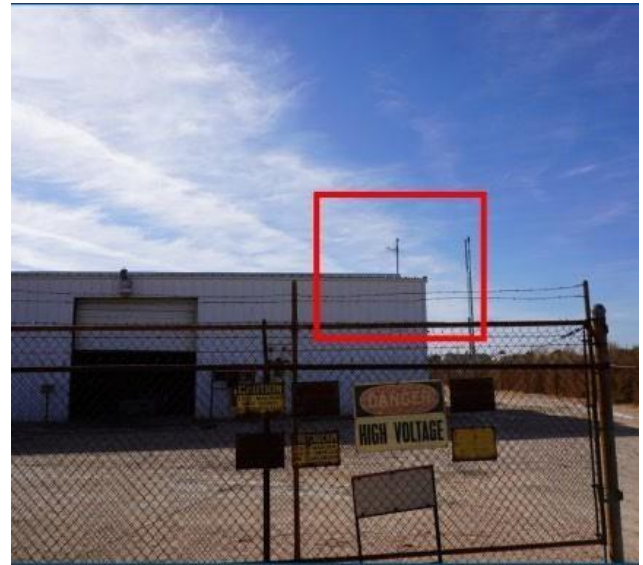
Figure 16. Light designed to illuminate when a dangerous concentration of H₂S is detected. (Credit: CSB)

A fully functional alarm system should alert employees arriving to the facility of any potential H₂S danger. The visual component of the Aghorn system relied on a light to turn on when sensors detected an H₂S release. However, a weakness of this design is that a component failure, such as a burned-out lightbulb, could falsely indicate that a structure is safe to enter during a toxic gas release. Other designs avoid this problem; for example, CSB's DuPont Interim Recommendations Report describes a structure which uses a detection system that does not rely on a light to turn on. Detection systems inside DuPont's structure continuously monitor the atmosphere. If a leak occurs and the atmosphere inside is unsafe for people, an alarm sounds and a green light outside the door, which is normally continuously lit, turns off to indicate it is not safe to enter (**Figure 27**) [13]. A sign on the door states, "Do not enter if green light is off." When the light is off, employees must assume the environment inside the building is not safe.

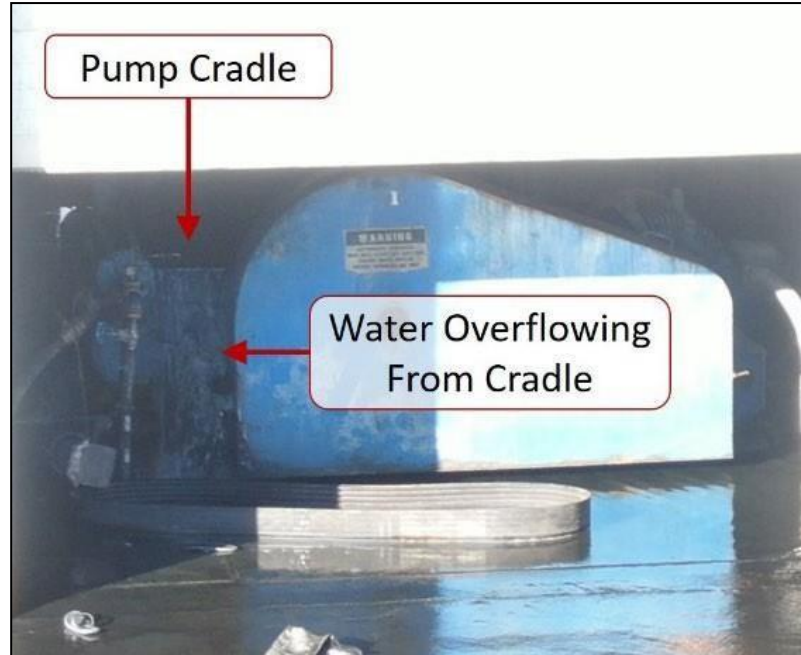
Figure 17. Image of Pump #1 taken on Saturday, October 27, 2019. (Credit: Ector County Sheriff)

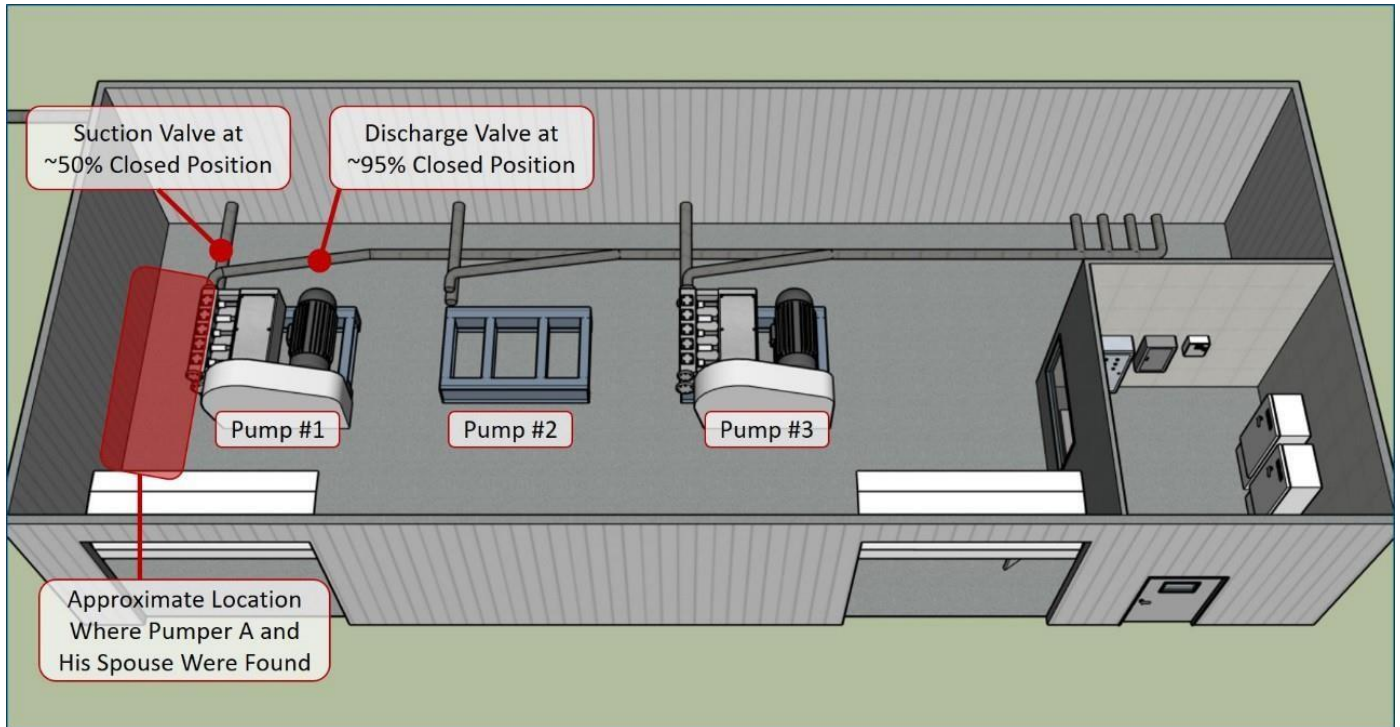
12. The position indicator on the suction valve for Pump #1 was about 50 percent closed (**Figure 18** and **Figure 19**);
13. Pumper A’s personal H₂S detector was found in his work truck. It was in an alarm state, meaning it had detected dangerous levels of H₂S;

14. Pumper A was found deceased near the suction valve of Pump #1 (**Figure 18**); and
15. Pumper A’s spouse was found deceased next to the body of Pumper A.

Figure 18. Suction and discharge valve positions of Pump #1, and approximate location where Pumper A and his spouse were found. (Credit: CSB)

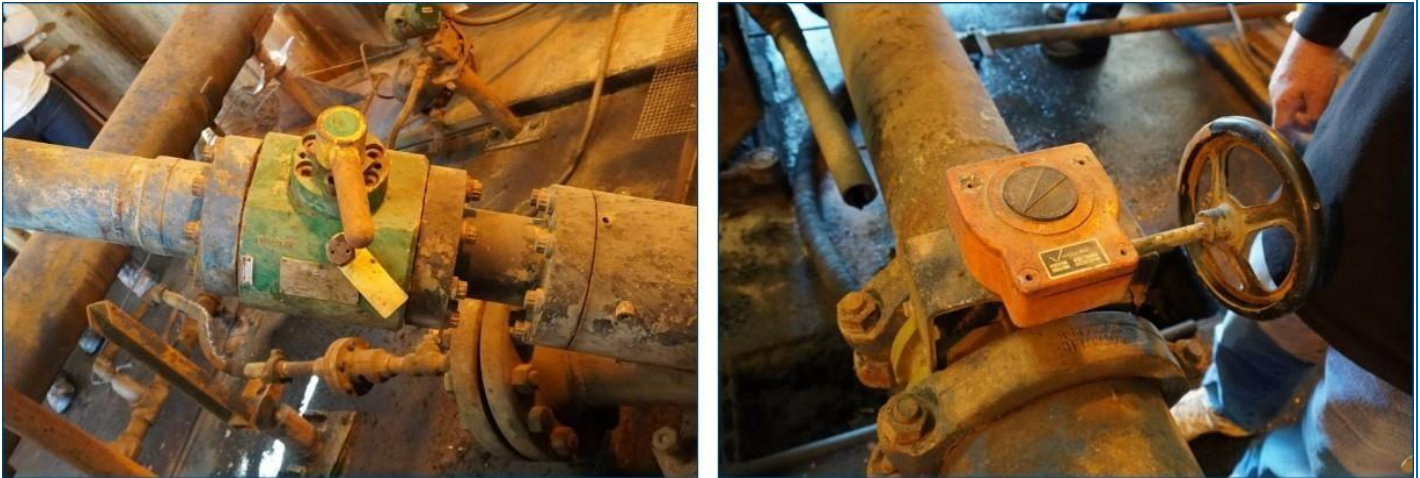
Figure 19. Position of the discharge (left) and suction (right) valves on Pump #1. (Credit: CSB)

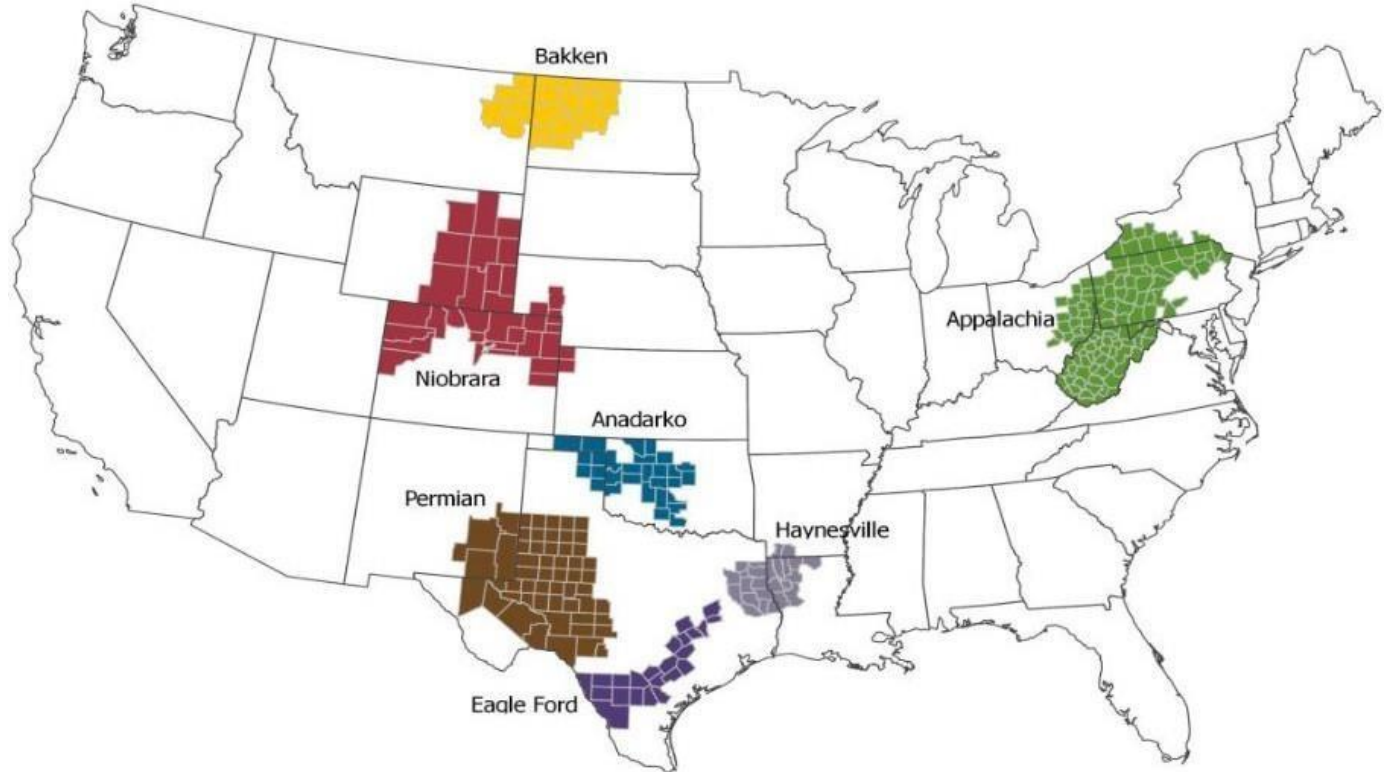
H₂S forms naturally in some geologic formations from decomposing underground organic matter, such as decaying plant matter [8, p. 17]. H₂S is found in underground formations throughout the United States, and is prevalent in the Permian Basin, an oil and gas basin located in west Texas and southeast New Mexico (**Figure 20**). A 2017 study found that over 85% of the natural gas produced from the Permian Basin contains greater than 100 ppm H₂S [9]. The U.S. Energy Information Administration (EIA) March 2021 Drilling Productivity Report indicates that U.S. oil production is highest from the Permian Basin—at over 4,000 barrels per day—and natural gas production is second highest from the Permian Basin—at almost 18,000 million cubic feet per day (**Figure 21**).

Figure 20. Prominent U.S. oil and gas regions. (Credit: EIA [10])

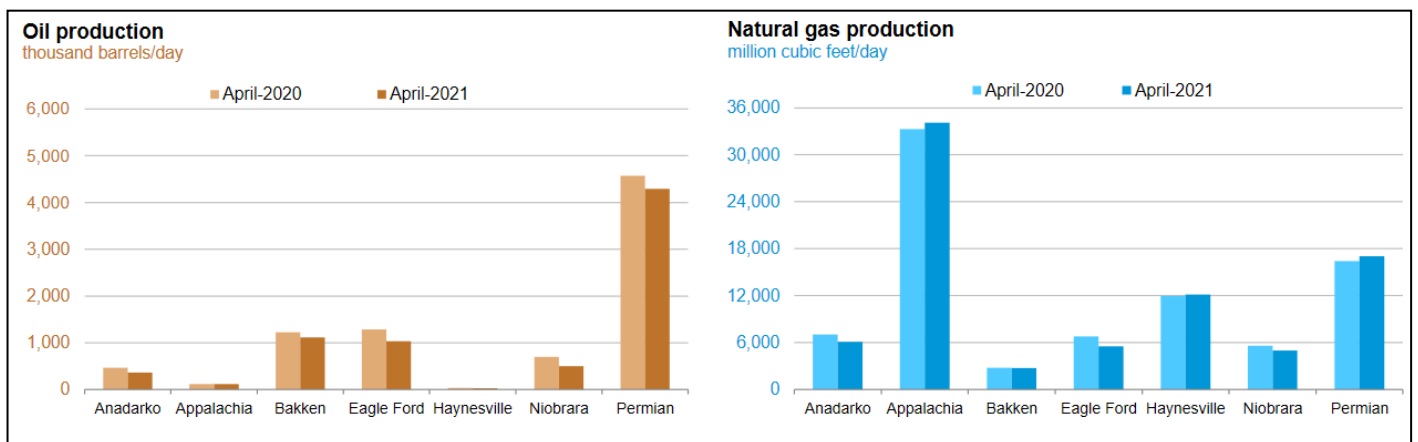
Figure 21. Oil and gas production in the United States. (Credit: EIA [10])

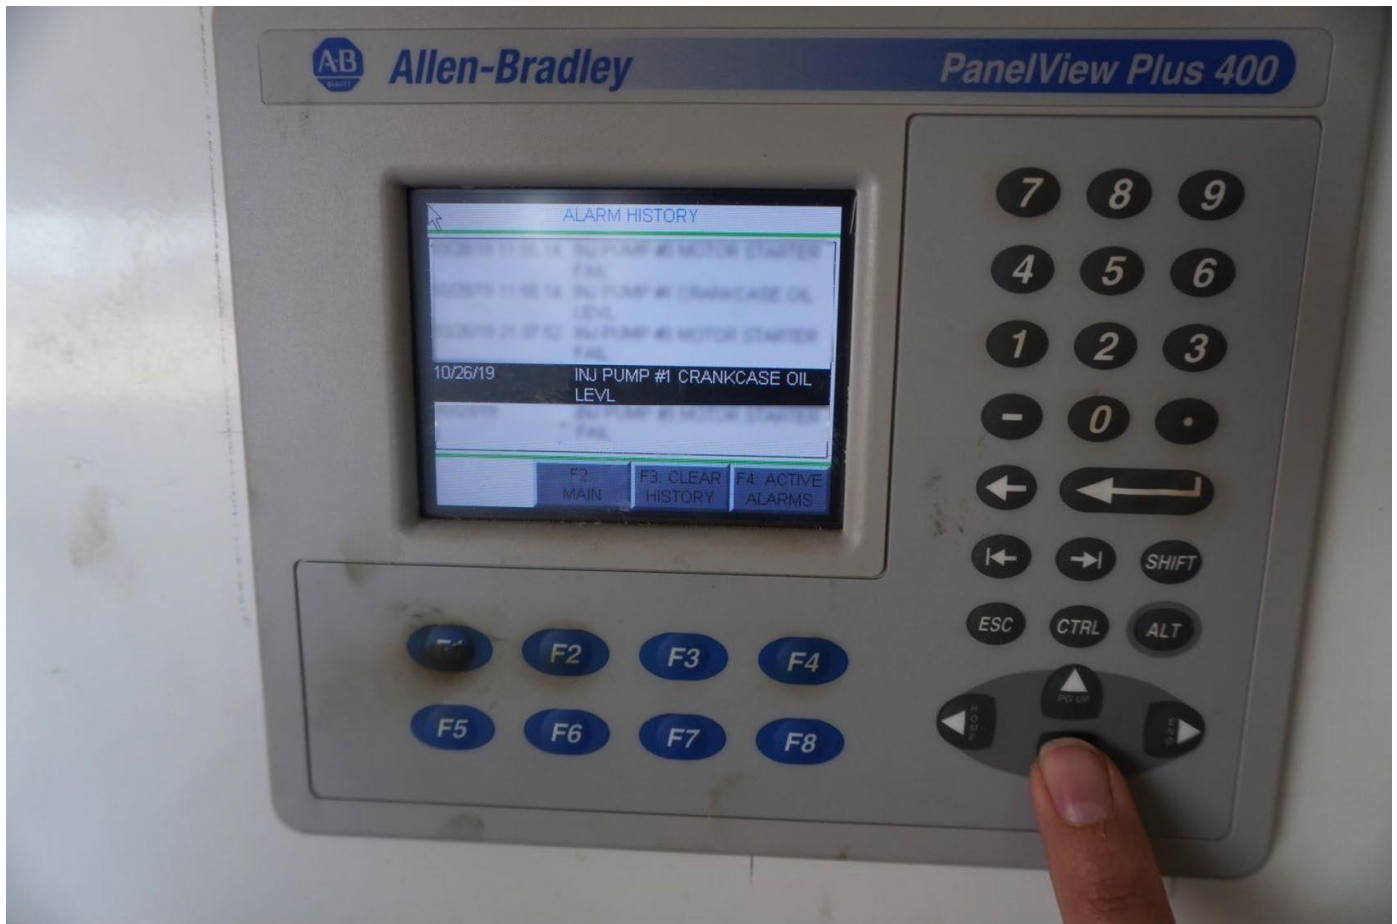
During the evening of October 26, 2019 after Pumper A's second visit to the waterflood station, at 6:38 p.m., the PLC triggered a Pump #1 crankcase oil level alarm on the control board. Five minutes later, at 6:43 p.m., the phone system sent an automated audio message to Pumper A, which stated, "Alarm Alert Condition 3. Please acknowledge." Alarm Alert Condition 3 indicates a pump malfunction of some kind. To determine the precise alarm, Pumper A was then required to go to the waterflood station and access the PLC in the control room to obtain more detailed information about the alarm. Pumper A then acknowledged the alarm on his phone by pressing "555."

Figure 22. PLC screen displaying Pump #1 crankcase oil level alarm. (Credit: CSB)

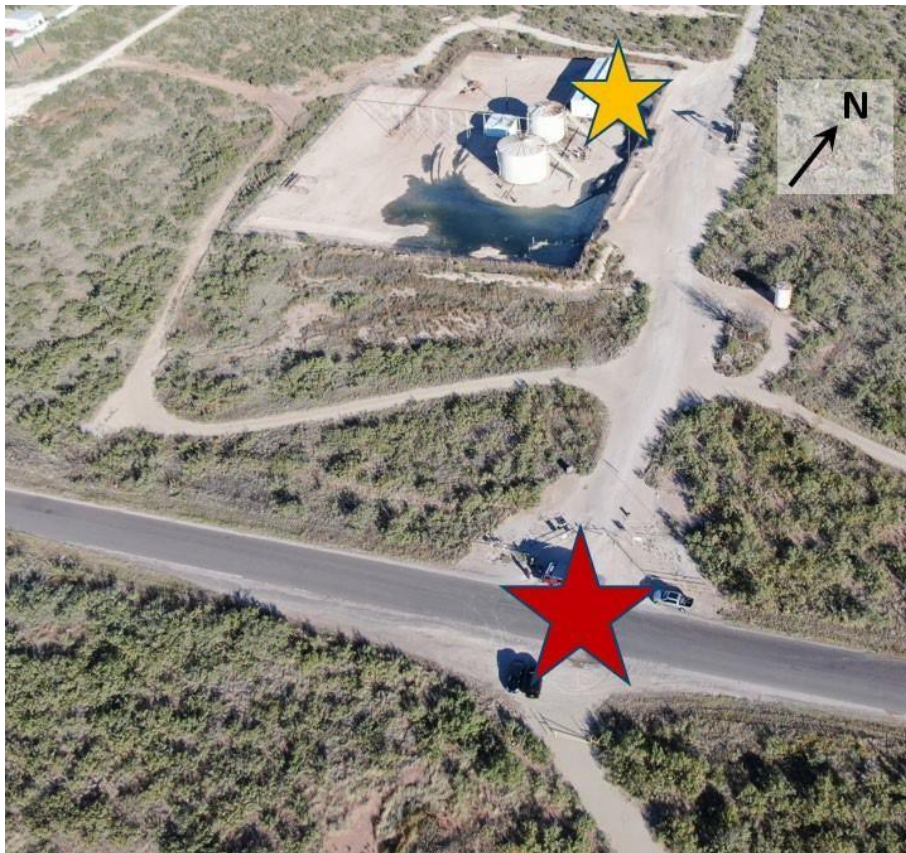
Figure 23. Location of the incident command post (red star) and incident location (gold star). (Credit: Ector County Sheriff’s Office)

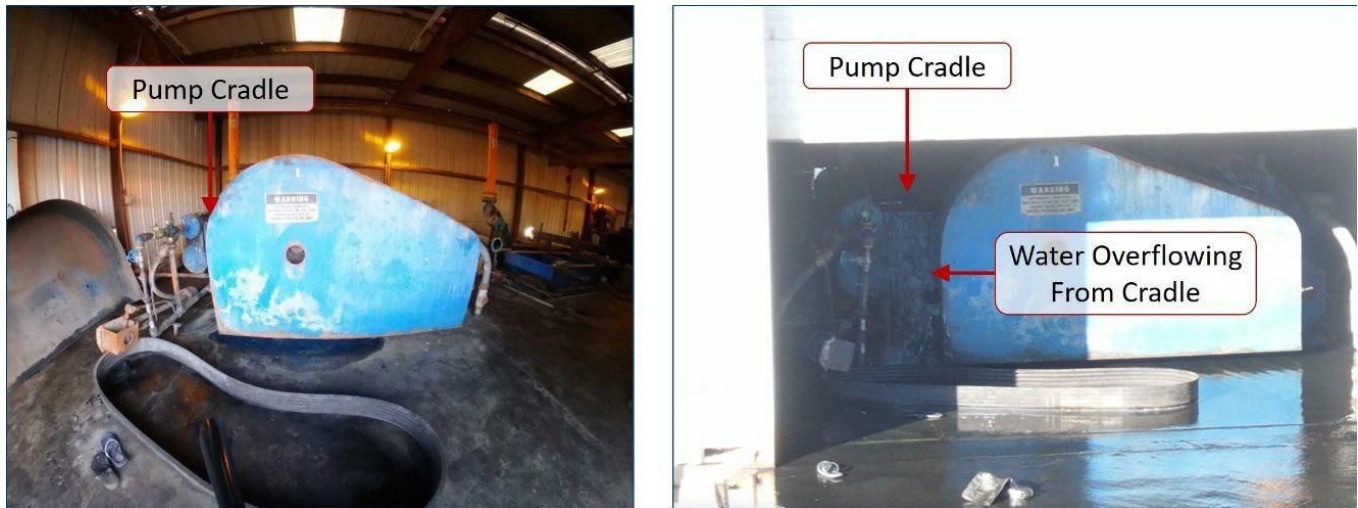
Aghorn employees started to arrive at the scene. One employee could see that Pump #1 was still running and water was pouring out of the pump’s cradle (**Figure 24**). Via phone, the Aghorn vice president directed the employees to close valves to isolate all the wells connected to the waterflood station. After arriving at the site

Figure 24. Images of Pump #1. (Left Credit: CSB; Right Credit: Ector County Sheriff)
