Hydrogen Sulfide Release at Waterflood Station in Odessa, Texas

U.S. Chemical Safety and Hazard Investigation Board

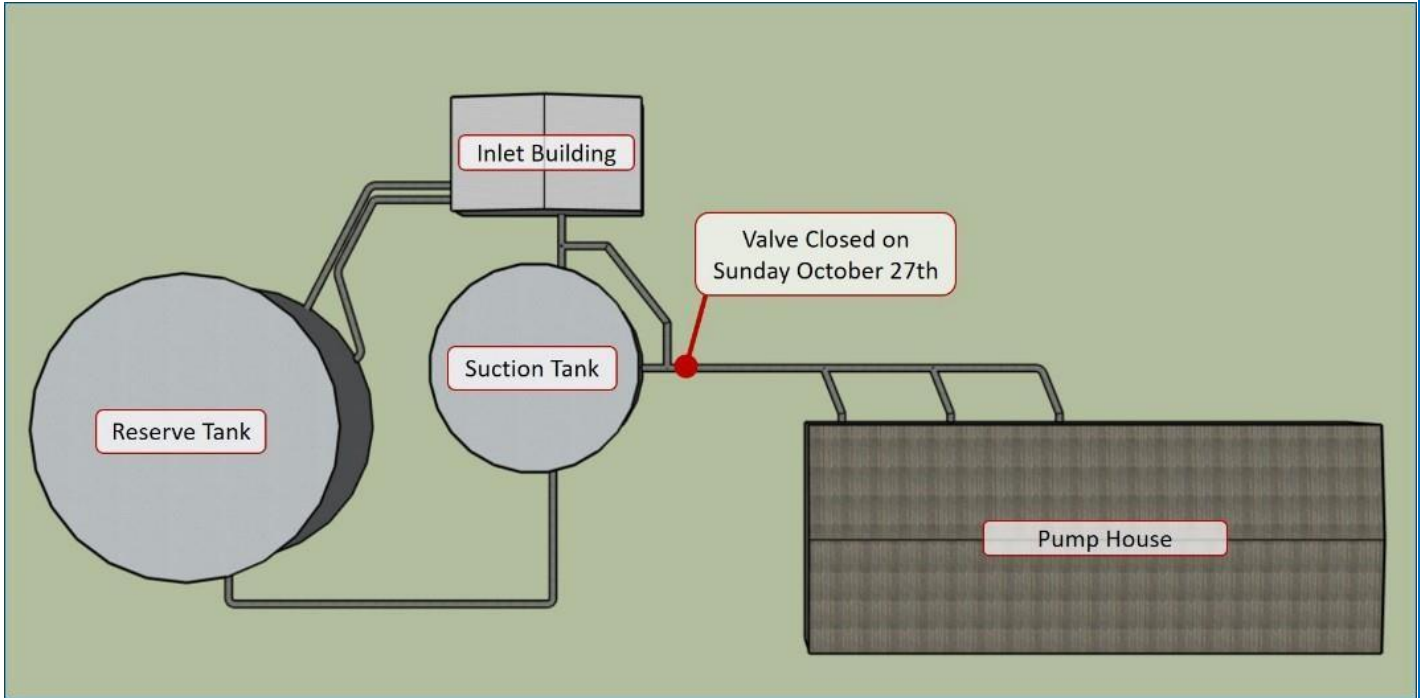
At approximately 9:00 a.m. on Sunday, October 27, 2019, the Aghorn vice president then met with Odessa Fire Rescue at the gate to the waterflood station. Several firefighters donned SCBA and walked to the waterflood station. They reported that they could still see water coming out of the pump and were measuring high H₂S gas levels. To stop the water flow, the vice president directed the fire department to close the valve at the bottom of the suction tank (**Figure 25**). The firefighters closed the valve, and the water stopped spilling from the pump.

Figure 25. Location of final valve closure that stopped the release of water from the failed Pump #1. (Credit: CSB)

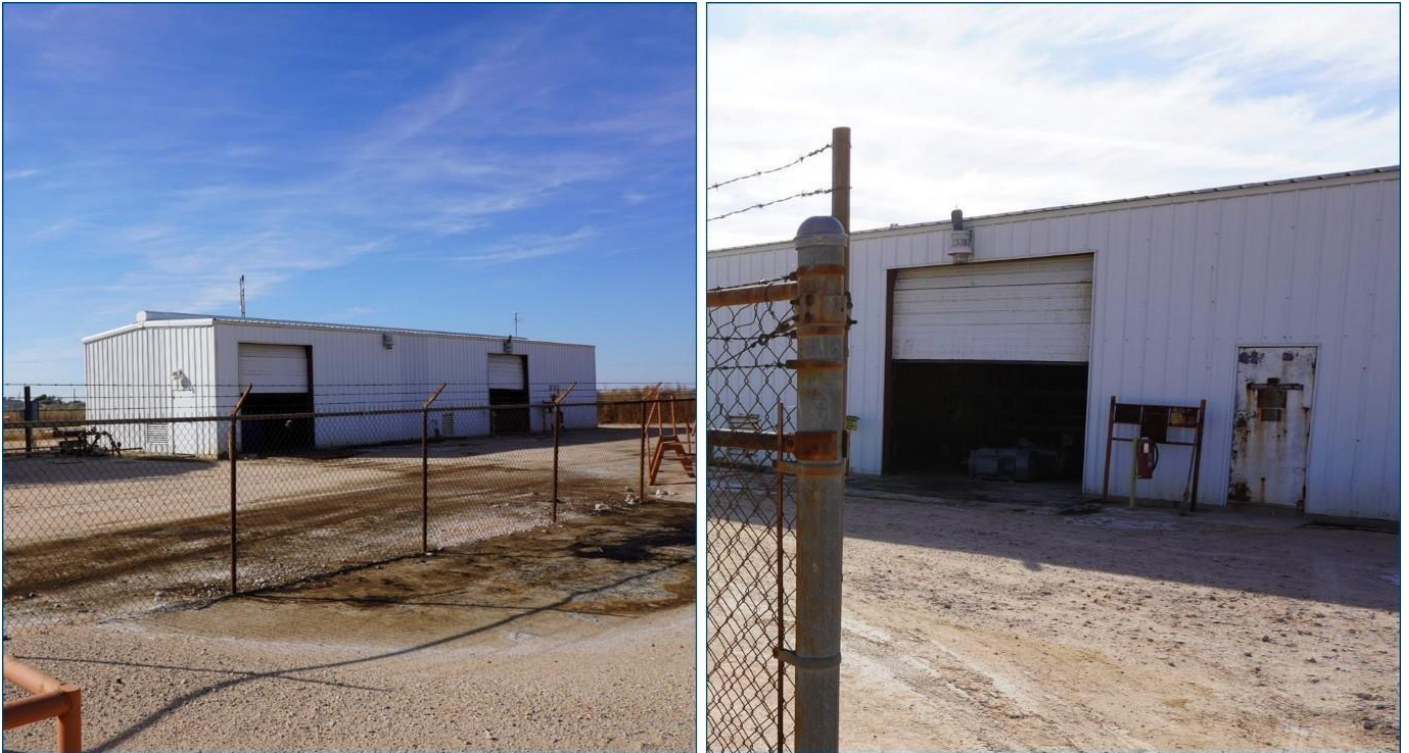
The pump house was ventilated by the two bay doors on the east side of the pump house (**Figure 26**). On the night of the incident, these doors were approximately 60% open. These open bay doors and any other available ventilation methods, however, did not adequately ventilate toxic H₂S gas from the building during the incident, contributing to the high H₂S levels to which Pumper A and his spouse were exposed. Due to the limitations of

the available evidence, the CSB was unable to confirm whether the pump house exhaust fans were operational at the time of the incident.

Figure 26. Photos showing bay door positions. (Credit: CSB)

The CSB recommends to Aghorn for all waterflood stations where the potential exists to expose workers to H₂S concentrations at or above 10 ppm, commission an independent and comprehensive analysis of each facility design vis-à-vis ventilation and mitigation systems to ensure that, in the event of an accidental release, workers are protected from exposure to toxic gas levels.

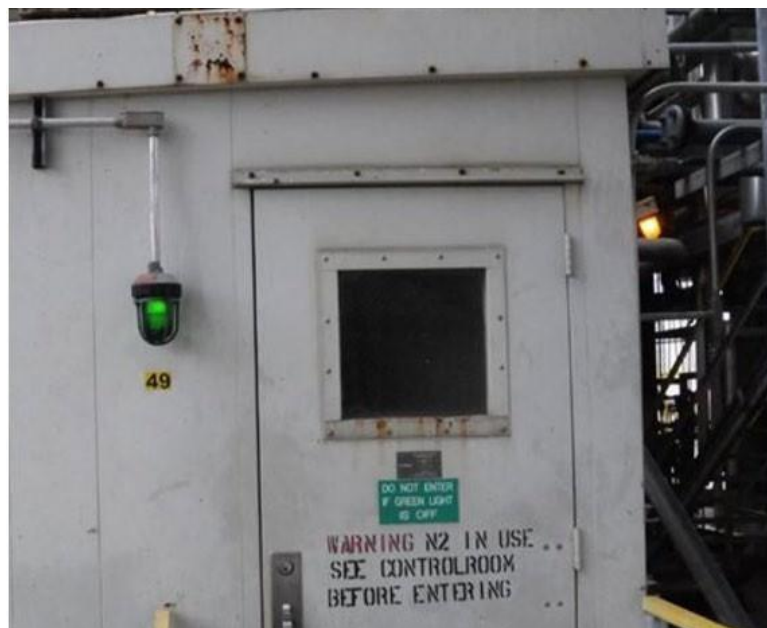
Facilities that are not continuously occupied, such as the Foster D waterflood station, can implement a system similar to this DuPont design. If employees arrive at the facility and the light is off, they would be required to

Figure 27. An alternative detection system design. (Credit: CSB)

treat entering the structure as if the hazard, such as H₂S, exists at dangerous levels on the other side of the door. Installation of this type of design would significantly increase safety at facilities where equipment processes toxic fluids.
