Trench Collapse

**Professional Development Hours (PDH) or
Continuing Education Hours (CE)
Online PDH or CE course**

The Project

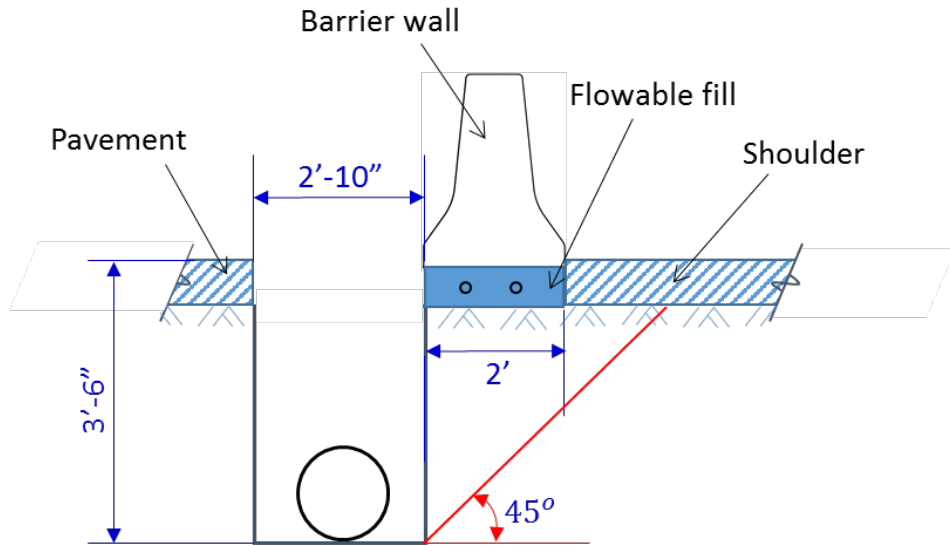
Figure 3 Typical section of the excavation prior to the collapse – looking north

The trench cross section, shown in Figure 3, is based on the observations and measurements obtained from our field visit on February 6, 2018. The concrete barrier wall sat directly on the utility trench, which was backfilled with flowable fill. Other than the subgrade soil underneath, the concrete barrier wall was not supported by or secured to any other structures, such as an inlet or pavement shoulder, see Figures 4 to 6.

The loads imposed on the subgrade soil from the concrete barrier wall was not limited to the immediate area of the wall, but also extended some distance away from the wall. This distance can be estimated as being equal to the depth of the excavation. Thus, a critical plane is formed sloping up from the bottom of the excavation toward the wall at an angle of 45 degrees, see Figure 3. Since the footing of the concrete barrier wall remained completely above the critical plane, according to the discussions in the preamble to OSHA's excavation standards (at 54 Federal Register 45924, October 31, 1989), the stability of the concrete barrier wall was endangered by the excavation operations. Therefore, per OSHA standard CFR 1926.651(i)(1) support systems should have been provided to ensure stability of the concrete barrier wall to protect employees working the trench.

After Archer Western installed the buried drainage pipe involved in the incident, video evidence from the pipeline video inspection indicated that the pipe was either damaged during construction or mis-installed. Therefore, Archer Western decided to open a trench to repair/replace the pipe, see Figure 3, and had its employees to hand-dig the trench along the concrete barrier wall. The trench was approximately three and one-half feet deep, approximately 2 feet 10 inches wide and more than one hundred and thirty feet long. The concrete barrier wall involved in the incident was approximately 121 feet long, see Figure 4.

- 1) The cause of the failure was the instability of the concrete barrier wall. The instability of the concrete barrier wall was caused by the trench excavation operations.
- 2) No support systems such as shoring, bracing, or underpinning were provided by Archer Western to ensure the safety of employees and the stability of the concrete barrier wall, prior to, during and after the trench was opened.
- 3) Archer Western violated the OSHA standard CFR 1926.651(i)(1) by not providing a support system, such as shoring, bracing, or underpinning to ensure stability of the concrete barrier wall for the protection of the employees.
- 4) Archer Western violated the OSHA standard CFR 1926.651(k)(1) by not conducting any inspection of the excavation and the adjacent areas by a competent person prior to the start of the work or as needed throughout the shift, on or prior to 02/04/2018.

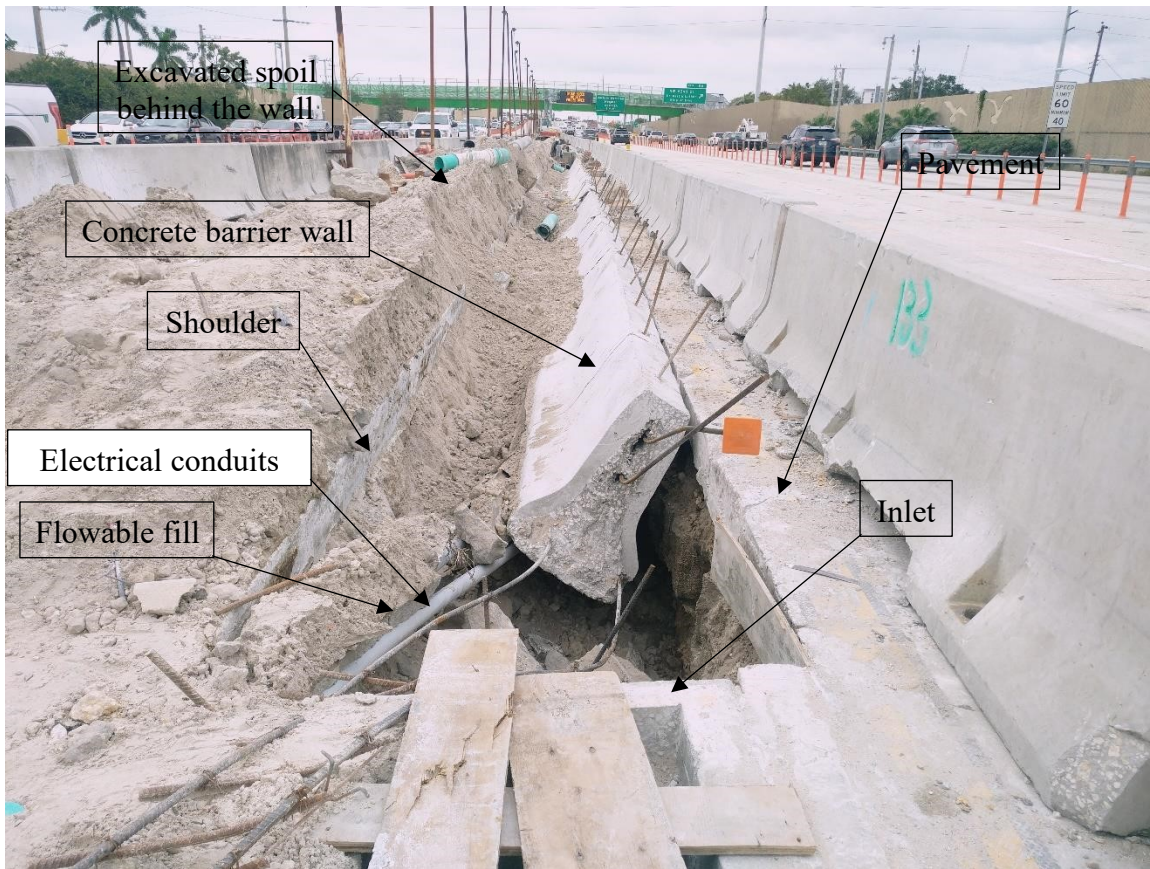
Figure 5 Scene of incident – looking south (North end of the barrier wall)

During our site visit, the excavated soil was classified as OSHA Type C soil according to the site conditions and natural characteristics of the earth deposits, see Figures 5 and 6. Based on the OSHA laboratory test (see Appendix A), the sample of earth deposits collected at the incident site was further classified as granular sand with no cohesion, corresponding to OSHA Type C soil.

The soil sample contained 91.7% sand and gravel. At the incident site, it was also observed that large clumps of excavated spoil broke into small pieces without difficulty. Besides, approximately 0.1 inches of rain fell within

24 hours of the incident (see Appendix B for national climatic data). These facts confirmed that the subgrade soil at the incident site was not able to sustain the concrete barrier wall when the collapse occurred.
