US CHEMICAL SAFETY AND HAZARD INVESTIGATION BOARD

INVESTIGATION REPORT VOLUME 1

EXPLOSION AND FIRE AT THE **MACONDO WELL**

DEEPWATER HORIZON RIG

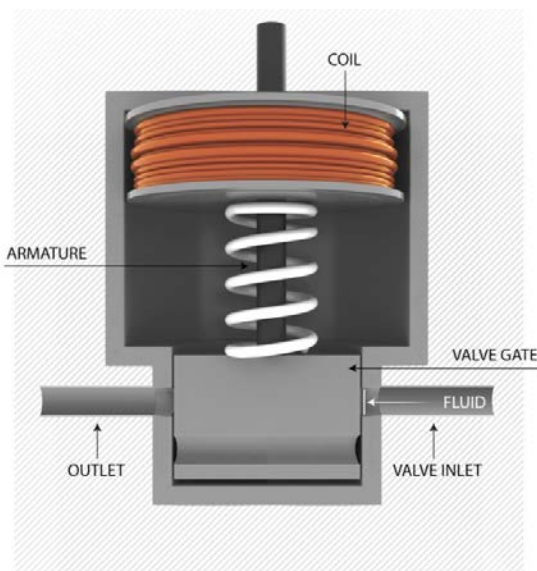
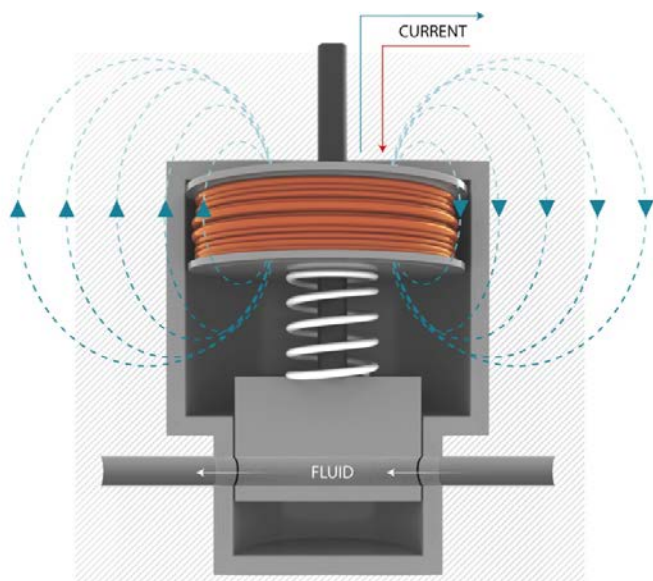
A critical solenoid valve in the yellow pod of the Deepwater Horizon BOP was miswired, which could have prevented it from opening during the AMF/deadman sequence. (See Section 3.2.1.2.) A solenoid-operated valve, such as the one that was miswired, opens and closes as the result of an electric/magnetic action (Figure 2-6). The solenoid valve has a spring which pushes a plunger down, blocking the flow of fluid through the valve. Surrounding the spring is a tightly wound wire coil that produces a magnetic field when current runs through it. To move the plunger, the coil is energized and a resulting magnetic field attracts the iron plunger, which then pulls it up, thus allowing fluid to pass through.^a

Figure 2-6. The top image depicts a solenoid with no current running through it. The plunger is down, and no fluid can flow through the solenoid. When actuated, current running through the solenoid produces a magnetic field which creates a force that pulls the plunger up, allowing fluid to flow.

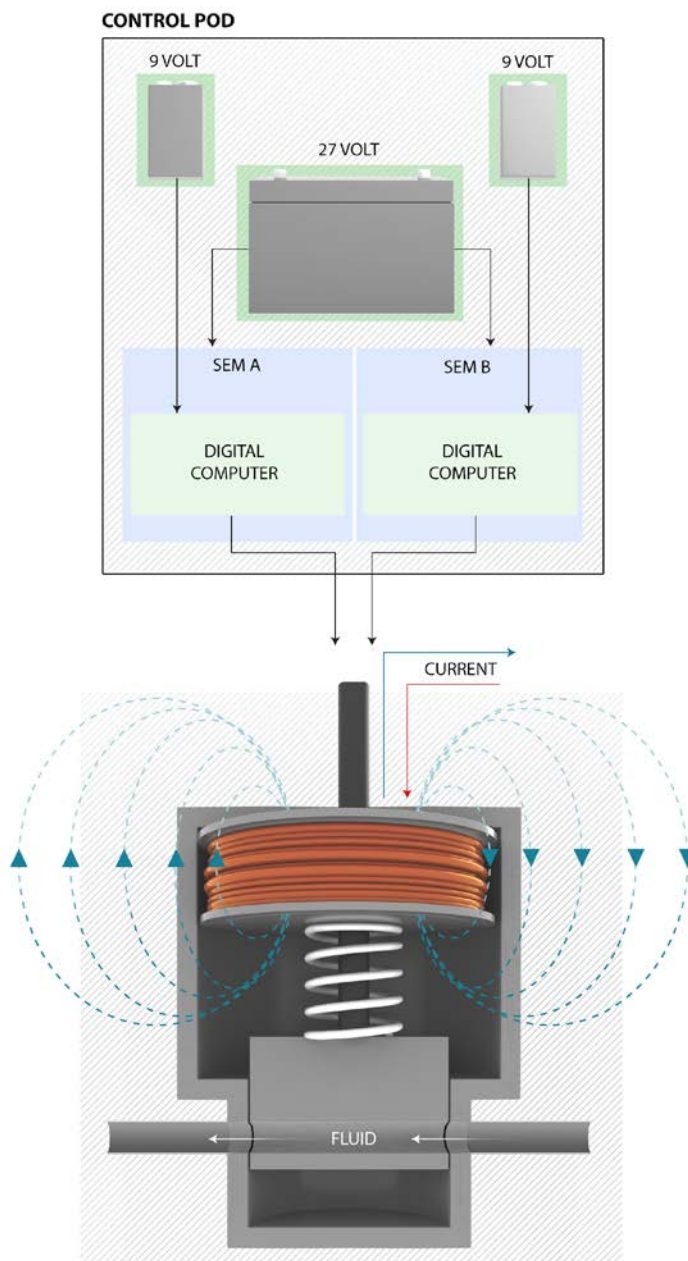
Each coil was controlled independently by one of the two digital computers (SEM A and SEM B) contained in the SEM enclosure. During activation of the emergency AMF/deadman system, SEM A and SEM B were powered by separate 9-volt backup batteries located in the SEM enclosure. SEM A and SEM B were designed to simultaneously initiate the command to power their respective coils. Once the command was sent, the solenoid valves drew power from the shared 27-volt battery to open (Figure 2-7). If

either the SEM A or SEM B 9-volt battery were to fail, the initiating command would not be sent; thus, the remaining SEM would send its command, and the solenoid valve would open from one coil. If both 9-volt batteries were operable but the shared 27-volt battery failed, neither coil would receive power, and the solenoid valve would remain closed. (See Appendix 2-B for more details.)

Figure 2-7. Simplified schematic of the control pod battery arrangement.

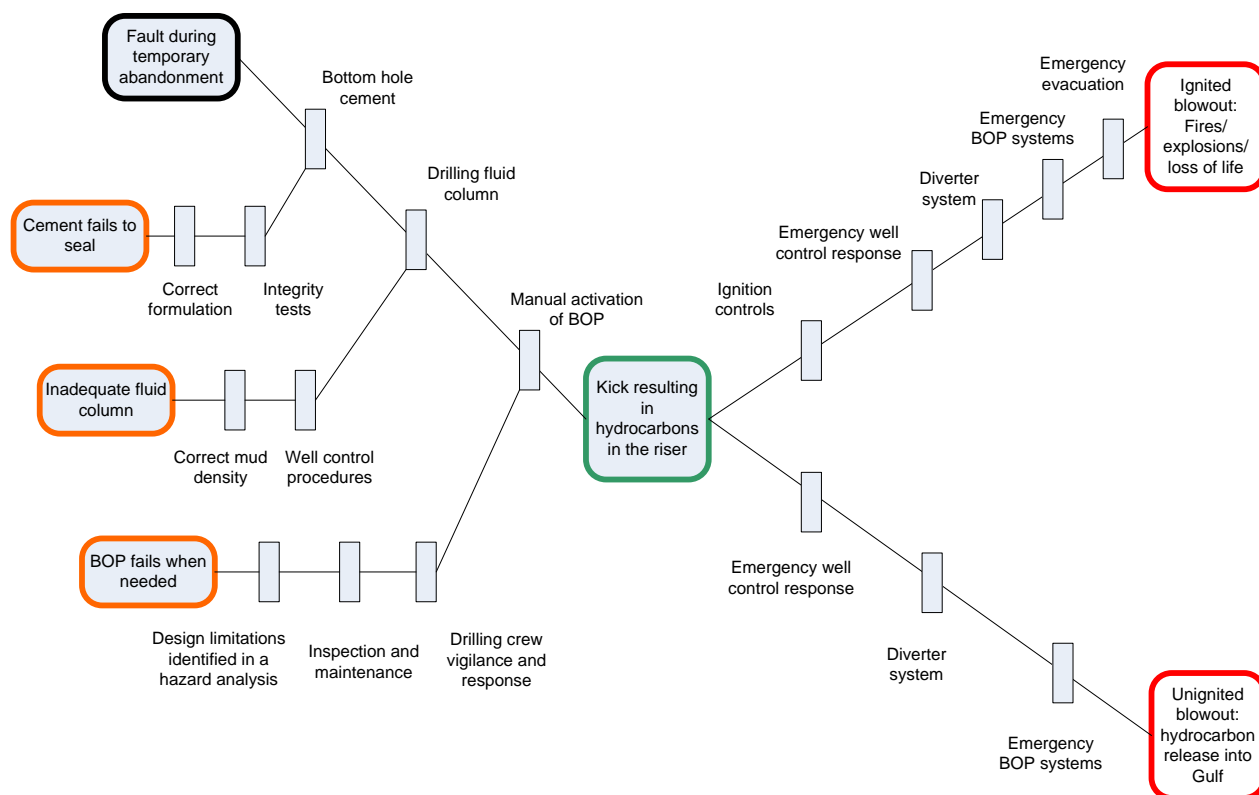
Figure 4-3. Bowtie diagram showing potential decay mechanisms of the technical barriers intended to prevent a fault during temporary abandonment activities.

By tracing the lines leading from a threat to a consequence, and any barrier decay mechanisms listed, one can follow how the scenario would evolve. In the case of a fault during the temporary abandonment process, Figure 4-3 demonstrates that the following must occur:

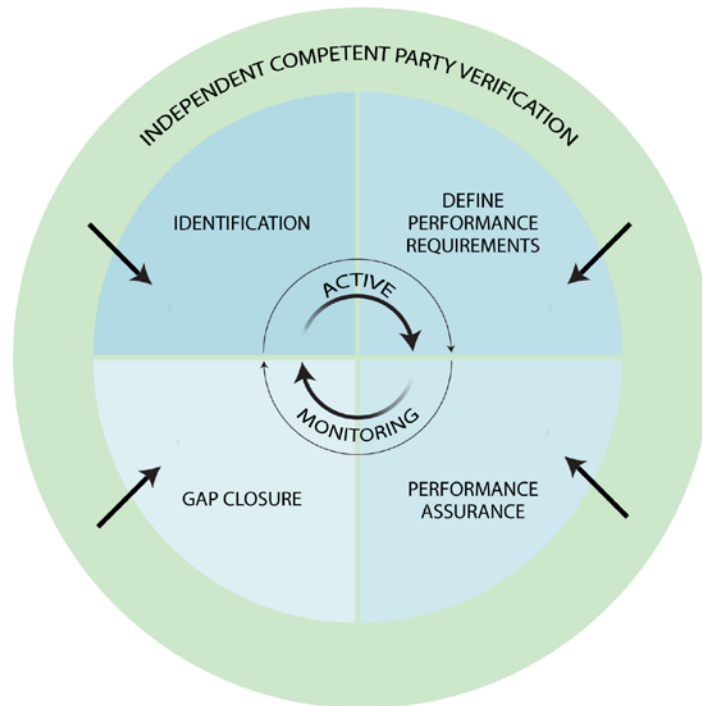
Figure 5-1. Simplified representation of the management system for the lifecycle of a safety critical element

While Transocean identified the Deepwater Horizon BOP as safety critical in a hazard analysis, it operated the BOP beyond its design limits for reliable drillpipe shearing and did not track modifications to individual components that ultimately affected the reliability of the emergency systems. As required by regulations,⁸⁵ regular testing of some BOP functions was performed, but this testing did not assess the emergency systems and were could not detect the latent failures presented in Chapter 3.0. The CSB concludes that post-incident testing changes now required in the United States are not sufficient to ensure industry will detect deficiencies like those found in the Deepwater Horizon BOP.

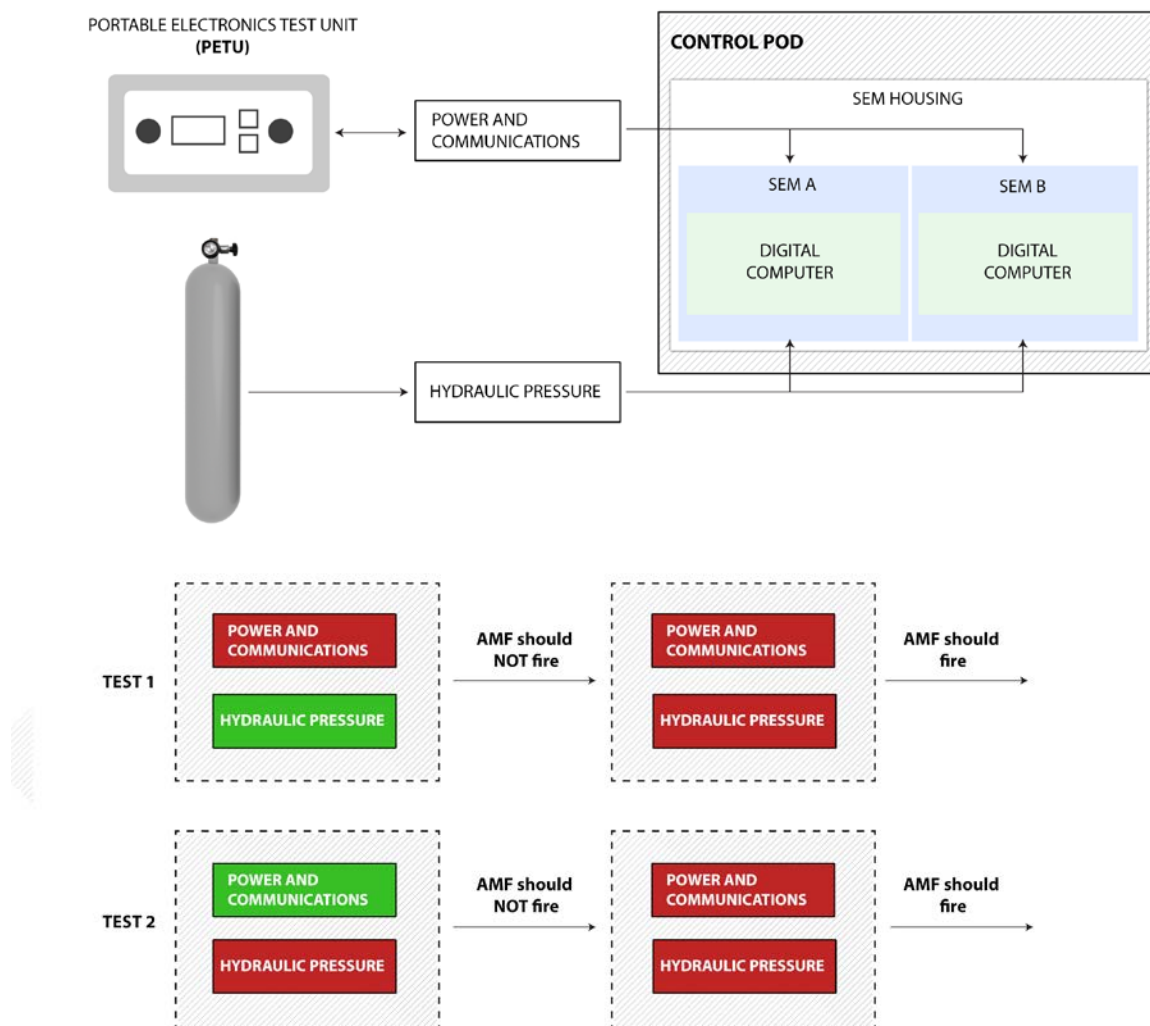
Figure 5-2. Simplified schematic of the Cameron FAT procedure to test the AMF/deadman.

Determining the most effective means to verify a BOP's performance may lie, in part, with factory acceptance testing developed by BOP manufacturers. The deficient wiring found in the blue pod and solenoid Y103 could not have passed Cameron factory acceptance testing (FAT) procedures. In contrast with the testing recommended by API Std 53 and BP, Cameron's FAT procedure for the AMF/deadman system is completed through SEM A and SEM B of each control pod separately. Two tests are completed for each SEM (A and B) to verify that each can independently complete the AMF/deadman sequence (Figure 5-2):^a

Important to highlight is that the user is instructed to switch the sequence in which the power and hydraulics are being disconnected from the SEM. By testing the SEMs in this way, if the wire deficiencies in the blue pod existed at the time of testing, the AMF/deadman system would have initiated after step (a) in Test 1, a result which should have indicated a problem to the user. (See Appendix 2-B.)
