# Gas Well Blowout and Fire at Pryor Trust Well 1H-9

# Investigation Report

Published: June 12, 2019

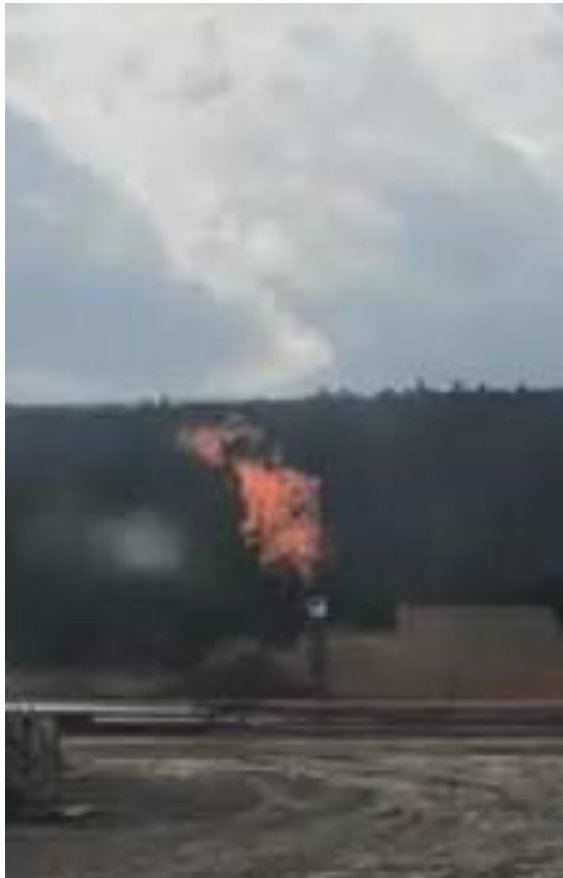
<sup>e</sup> A text message timestamp confirms that the flare was still activating at 6:21 pm, which had been after about two-and-a-half “bottoms up” circulations.

<sup>f</sup> The CSB considered whether the flare might have been produced by “drilled gas,” which is gas contained in the drilled rock cuttings. The CSB concluded that the flare likely was not produced by drilled gas because during the two-and-a-half bottoms up circulations, most, if not all, drilled gas would be circulated out of the well. The flaring at 6:21 pm indicates the well was likely underbalanced.

Figure 9. Video still of flare at 11:10 am on January 21, 2018.

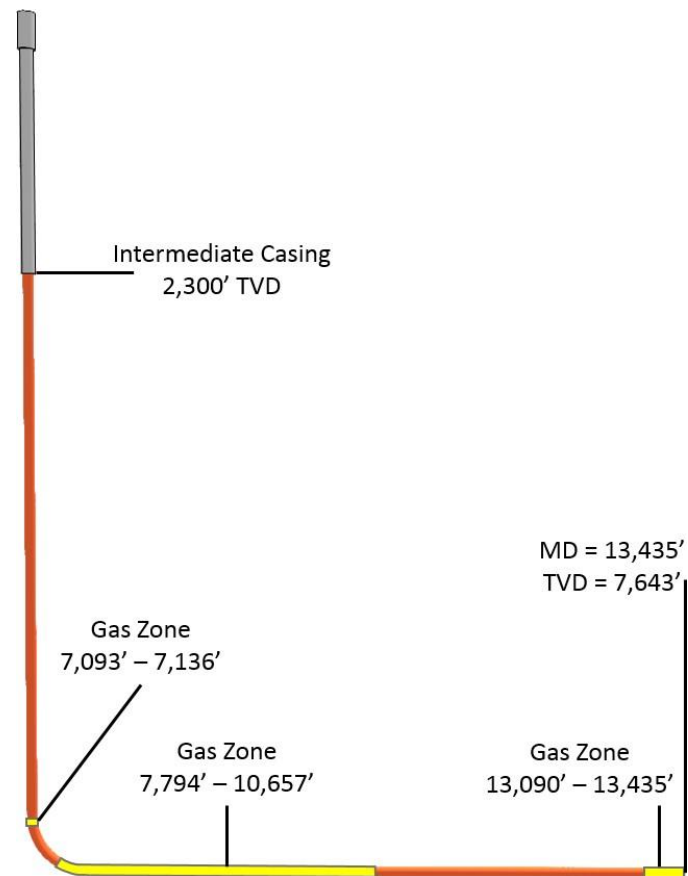
The well profile at this point is shown in Figure 10. Post-incident analysis of the well data shows that the 11,000 feet of uncased, open wellbore included three areas where some amount of gas had entered the well while drilling, as interpreted from measured gas units during the drilling operation and the flaring at the surface that occurred on January 21.

Figure 10. Areas where gas entered the wellbore while drilling.

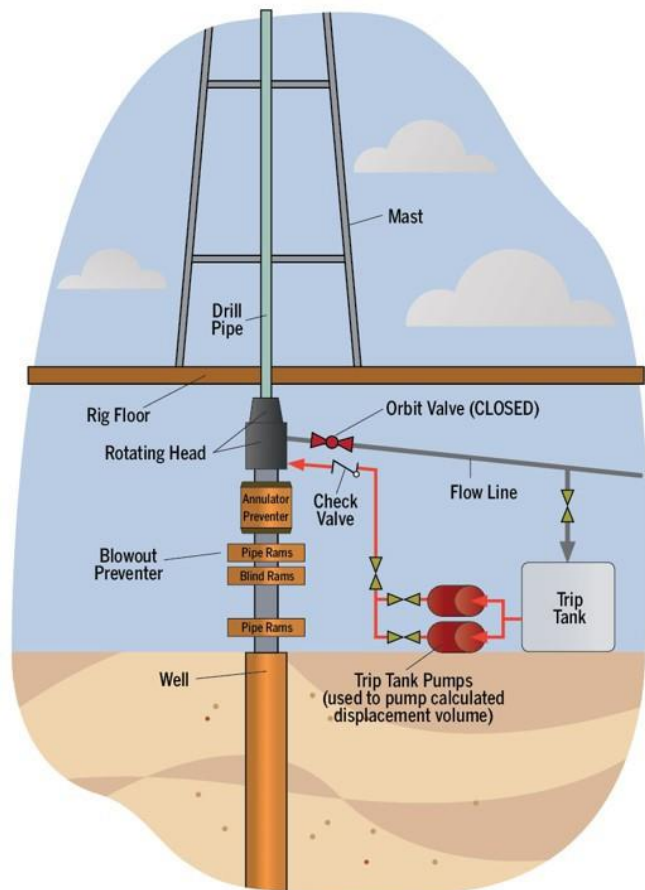
The Calculated Fill tripping method involved stopping all mud flow from the well by closing the *flow line isolation valve* (commonly called the *orbit valve* by Patterson, the drilling engineer, and the company man) with the pressure-containing *rotating head* installed. The plan was then to periodically pump a calculated volume of mud into the well with the intent to replace the calculated volume of the drill pipe removed by turning on and off the trip tank pumps (Figure 12). For example, for five drill pipe stands removed, the driller would need to pump 3.2 *barrels* of mud into the well to replace the drill pipe. The drilling engineer communicated to the CSB that, using this method, there was extra protection against gas influx into the well by, if needed, allowing surface pressure to build against the closed orbit valve and rotating head. The thinking was that if the well did flow, there would be no outlet for the mud, so this would keep the well contained.

Discussed below, by the time the drill bit reached the top of the curve, 20 barrels of mud less than the calculated drill pipe displacement volume had been pumped into the well. While the well appeared to be filled to the surface, the volume discrepancy is an indication that gas had entered the well, occupying this 20-barrel portion of the drill pipe displacement volume (Sections 5.1.2.1 and 5.1.2.2). The company man and drilling engineer were aware the well did not take proper fill, but the full extent of the discrepancy might not have been known because the driller had difficulties with the electronic trip sheet used to track the calculated drill pipe displacement against measured fill volumes during the tripping operation (Section 6.3).

In summary, during the tripping operation out of the horizontal section of the well (1) not enough mud was pumped into the well to replace the drill pipe displacement volume, (2) there were gains in the trip tank volume likely caused by pressurized mud backflow through the trip tank pump discharge line, and (3) at one point, the trip tank pumps started deadheading against the surface pressure in the well. Post-incident, these clearly are indications that gas was in the well, but these indications were not effectively acted upon to stop operations and restore the primary well control barrier, hydrostatic pressure produced by mud.

Figure 12. Equipment configuration during Calculated Fill tripping method

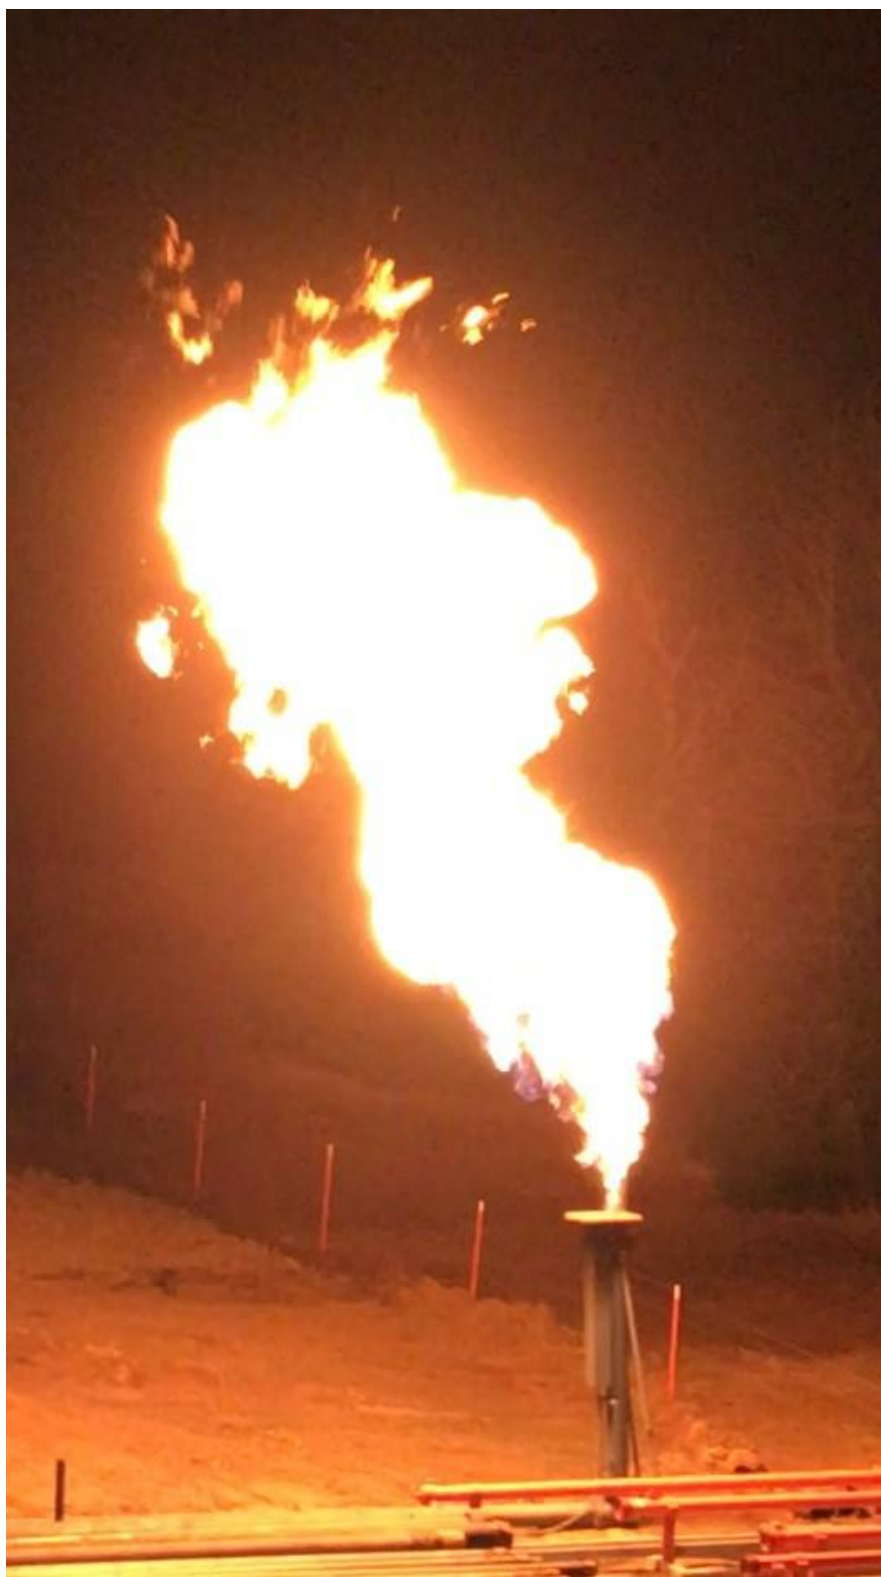
Accepting the indications of a successful flow check, the driller ramped up the mud pumps at 11:02 pm and proceeded with circulating the well by pumping mud down through the drill string with the mud returning to the surface and flowing through the flow line. The crew remembered the flare activating during this activity (Figure 19), indicating gas was coming out of the mud returning at the surface, and then going out at 6,700 strokes of the positive displacement mud pumps (11:57 pm)<sup>a</sup> (Figure 20). Appendix F shows a comparison of Figure 20 with a circulation operation performed days earlier, illustrating the difference in the appearance of the data. While circulating, the slug that had been pumped into the drill pipe at about 6:30 pm before tripping exited the drill pipe and entered into the annulus, adding additional pressure to the well until the slug was circulated out of the annulus during the operation.

<sup>a</sup> The driller told the CSB the flare died out at 6,700 strokes, which was at 11:57 pm.

*Figure 19. Image of flare from video captured at 11:06 pm on January 21, 2018.*

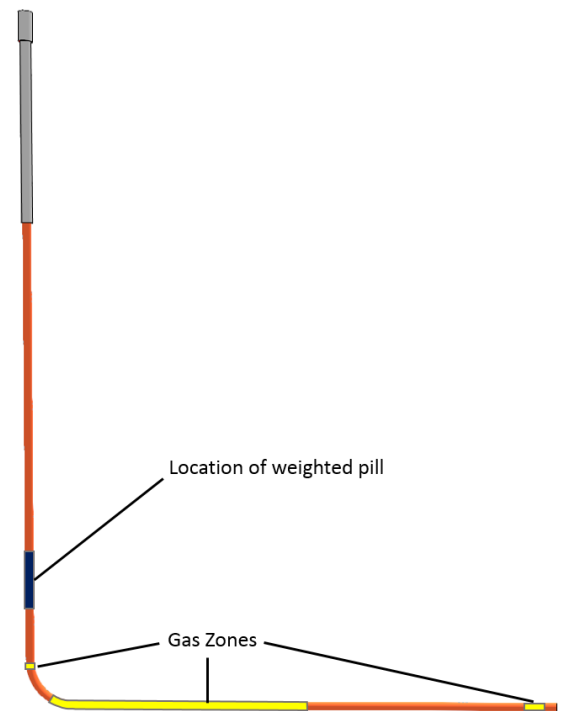
At 12:35 am, the drilling crew pumped 46 barrels of the pill into the drill pipe. Following the pill with mud, they pumped the pill out of the bottom of the drill pipe and into the annulus with the bottom of the pill at a depth of about 6,500 feet, and with the top of the pill at about 5,800 feet (Figure 21). Some of the pill material remained in the bottom of the drill pipe.

Figure 21. Depiction of well with gas zones and location of weighted pill.

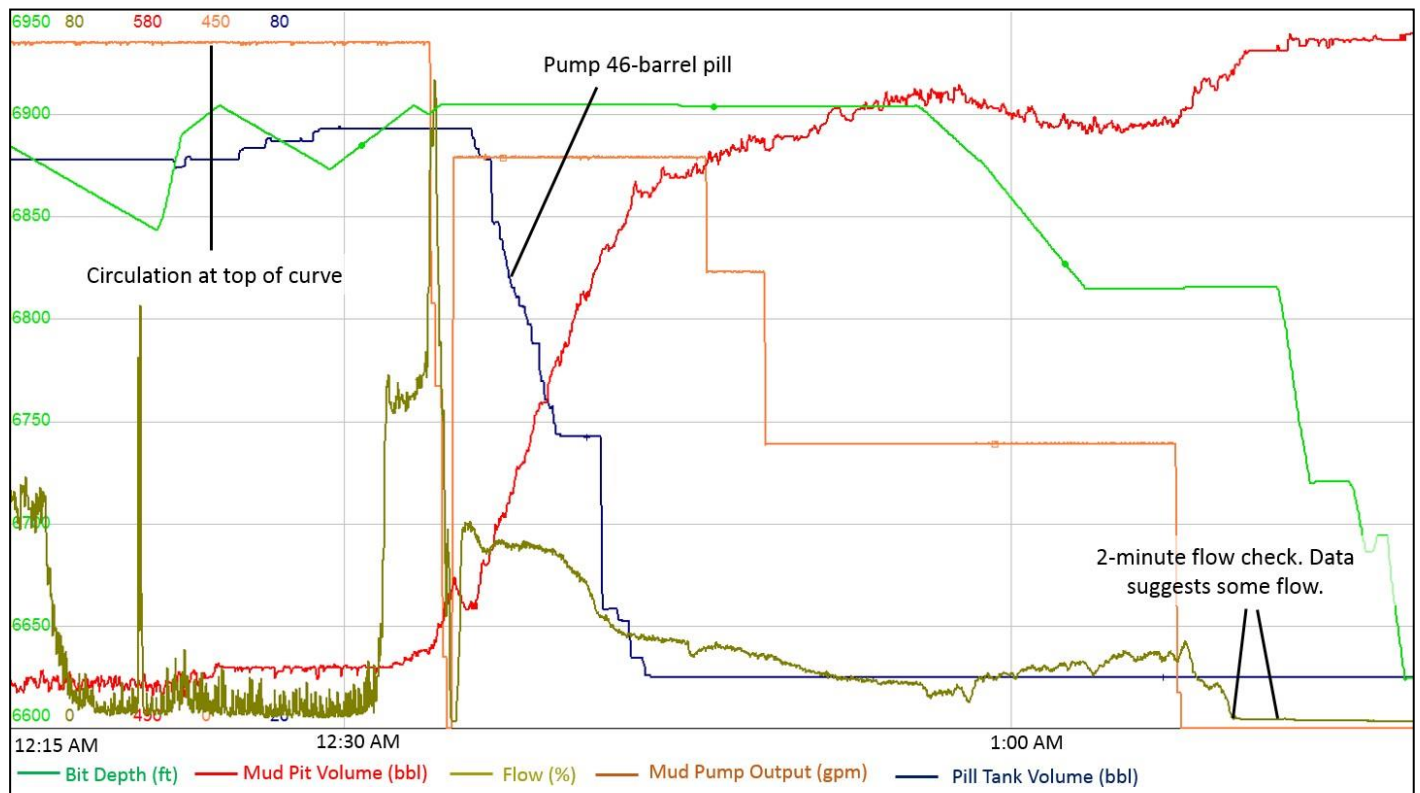
After spotting the pill, at about 1:10 am the crew performed a visual, 2-minute flow check. The flow check passed. However, the CSB could not verify that the crew observed no flow during this flow check. The return flow meter data indicates some very small flow (1% of the flowmeter scale) during this flow check (Figure 22). Despite the flow check result, gas was still entering or expanding in the well. The 50-barrel volume and 10-pound-per-gallon weighted pill did not produce the hydrostatic pressure necessary to prevent gas from entering the vertical portion of the well. After pumping the weighted pill, the well was still underbalanced and the primary well control barrier was still not in place (Section 6.5).

Figure 22. Data during pumping of pill and subsequent flow check.

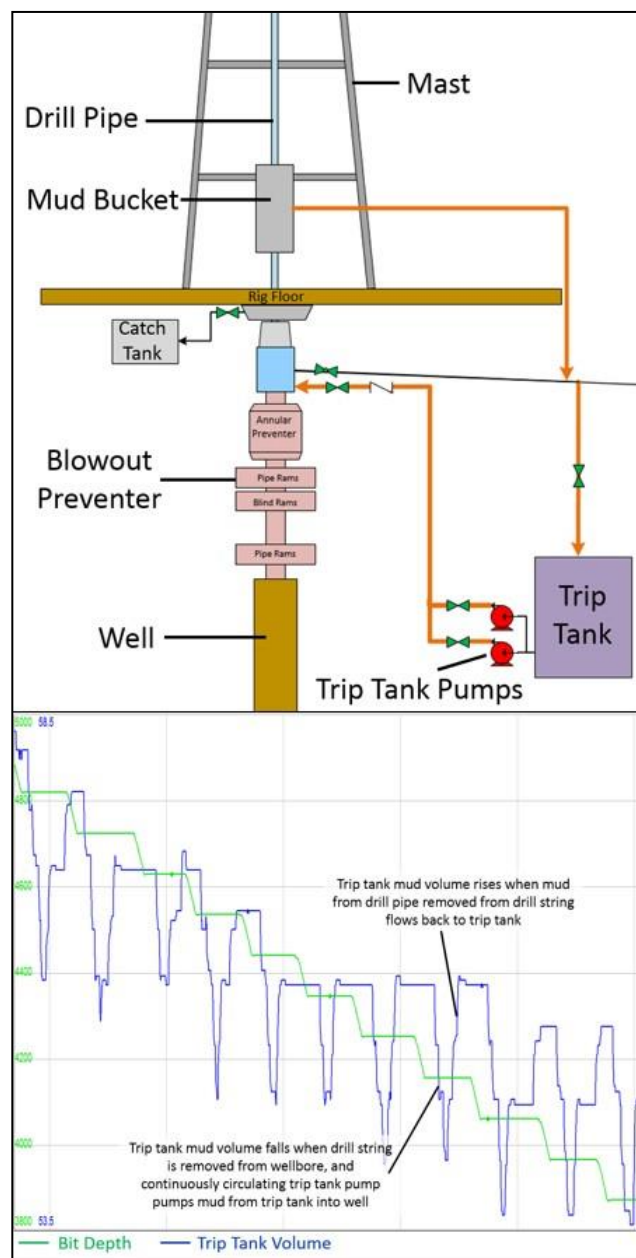
On Rig 219, the mud bucket discharge was routed to the trip tank. Level changes in the trip tank are a key indicator of mud gains or losses while tripping, and adding the mud into the trip tank from the mud bucket during the tripping operation confounded that information for the driller and company man. As the crew tripped out pipe, the trip tank volume fluctuated up and down from mud draining into the trip tank and from mud being pumped out of the trip tank (Figure 24). The driller communicated that he had never before tripped wet pipe out of the well with this lineup, and all of the volume fluctuations in the data made monitoring for the correct volume reduction in the trip tank difficult.

Figure 24. Rig equipment alignment and data during tripping operation out of vertical portion of well. The crew was tripping wet pipe, and the mud from the pipe stands removed drained back to the trip tank, causing the trip tank volume to fluctuate.

<sup>a</sup> This calculation considers the tripping operation between 2:13 am and when the final stand above the BHA reached the surface at 4:50 am. During this period, 60 stands of drill pipe were removed from the well. The last stand was plugged with the pill material. The calculated displacement volume of these 60 drill pipe stands is 39.5 barrels. About 16.8 barrels of mud were pumped into the well during this time period to replace the drill pipe removed. Only about 43% of the drill pipe volume was replaced with mud.

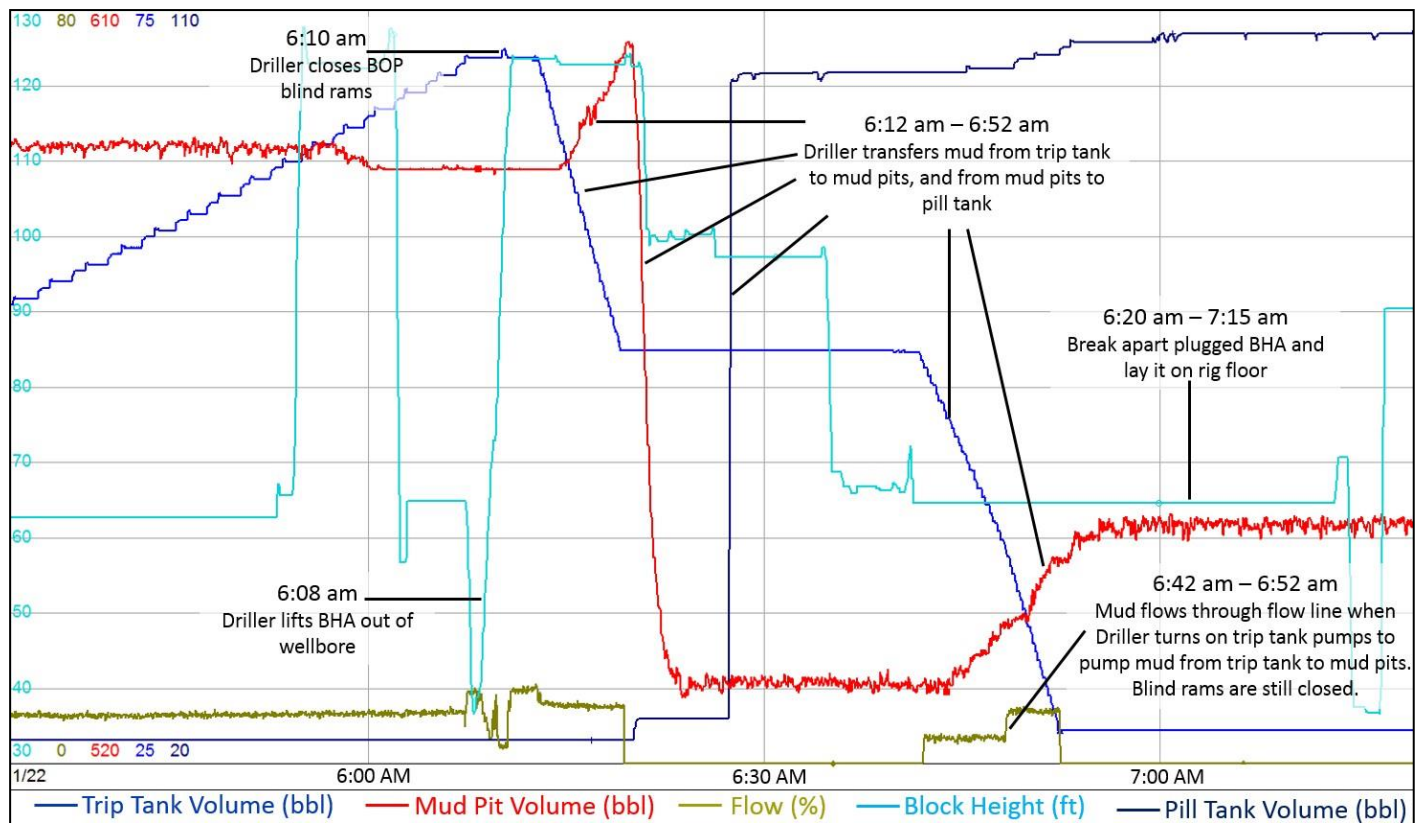
At 6:08 am, the day shift driller lifted the BHA out of the wellbore. At 6:10 am, with the BHA out of the wellbore, the driller closed the BOP blind rams.<sup>a</sup> The driller then transferred mud from the nearly-full trip tank to the mud pits. The mud pits were also nearly full of mud, and mud was transferred from the mud pits to the pill tank.

By 7:15 am, the day crew had broken apart the plugged BHA and laid it on the rig floor (Figure 27).

Figure 27. Rig Data between 5:32 am and 7:20 am on Monday, January 22, 2018 (day of incident).

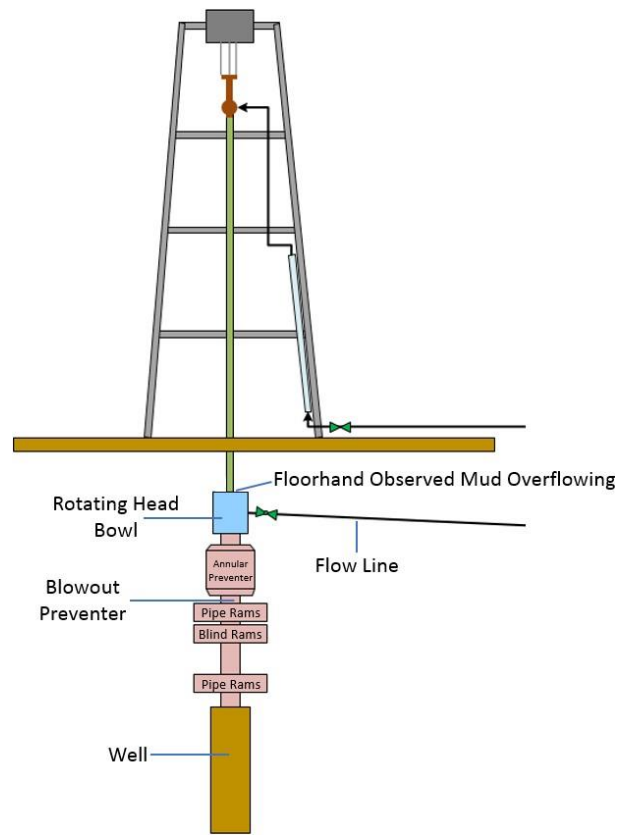
The driller lowered the BHA into the well, until only about 2-3 feet of it remained above the rig floor. At 8:09 am, with the piping now aligned so that flow from the well was routed to the mud pits, the driller reset the mud Gain/Loss indicator on his rig data monitor to zero. He then turned on the pumps to test the BHA tool. A floorhand observed—and told the driller—that when the pumps turned on, mud was coming up out of the top of the rotating head bowl (Figure 28).<sup>b</sup> A crewmember told the CSB that this was expected because the rotating head rubber was not installed. At some point during the testing, the same floorhand observed that mud had stopped coming over the rotating head bowl. He communicated his observation to the driller.

Figure 28. Depiction of where floorhand observed mud coming out of BOP stack while BHA was being tested.

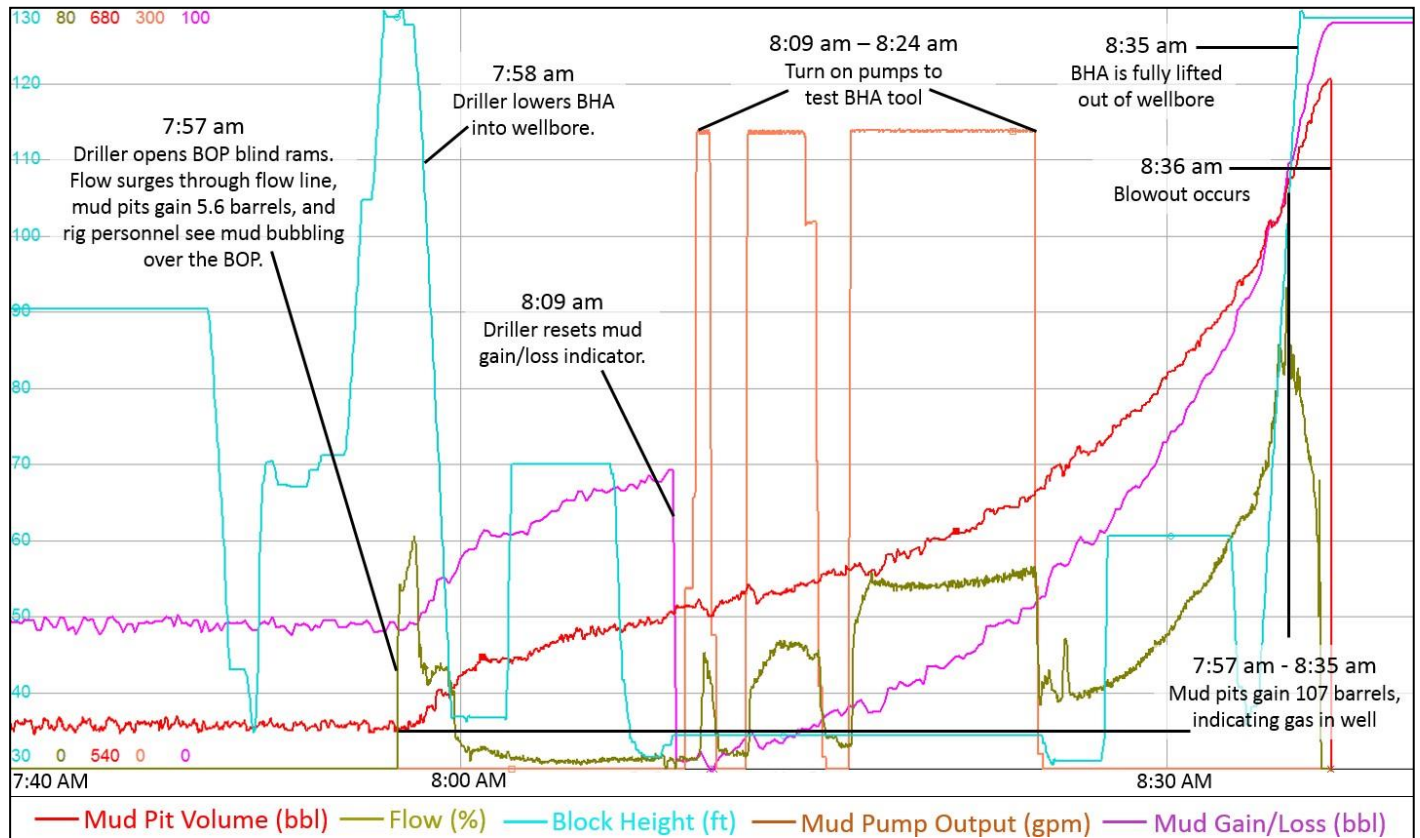
From the time the BOP blind rams were opened at 7:57 am through the completion of BHA testing and removal from well at 8:35 am, the mud pits gained 107 barrels of mud due to gas influx/gas expansion within the well (Figure 29), a

significantly large volume. It is unknown if the driller saw this gain, which would have displayed as a number on a monitor in front of him (Figure 37). No action was taken to shut in the well.

Figure 29. Rig Data between 7:40 am and 8:41 am on Monday January 22, 2018 (day of incident).

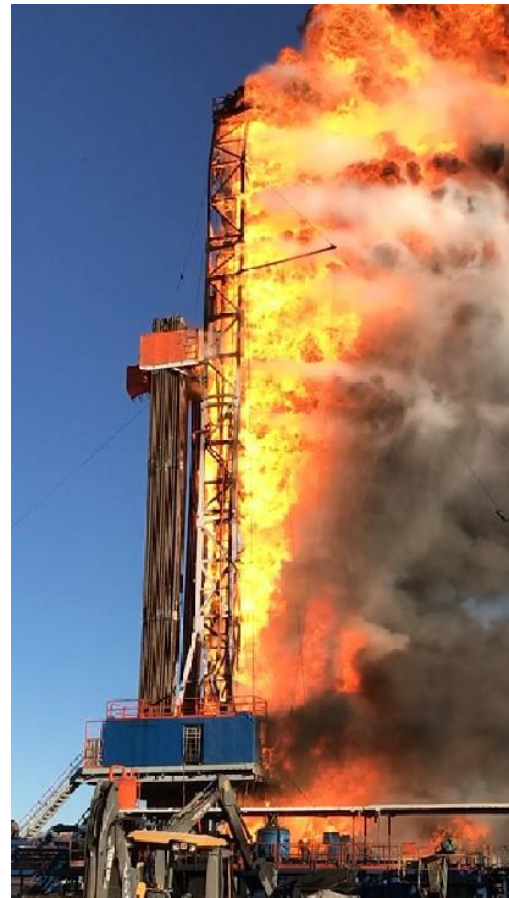
At 8:36 am,<sup>a</sup> shortly after the driller communicated that he was going to close the blind rams, mud started spraying out of the well. The floorhand saw the motorhand and the second floorhand open the door to the driller's cabin so they could run into it from the rig floor. The mud continued to spray out of the well and covered the windows of the driller's cabin. The floorhand moved behind the drill pipe rack on the rig floor with the rig manager. Very quickly after the mud started spraying out of the well, the diesel oil-based mud and gas escaping the well caught on fire (Figure 30).<sup>b</sup> Between the removal of the BHA from the well at 8:35 am and the blowout at 8:36 am, the mud pits gained an additional 12 barrels of mud, totaling to a 119-barrel gain since the blind rams had been opened at 7:57 am.

Figure 30. Video still of the blowout and fire taken shortly after it started.

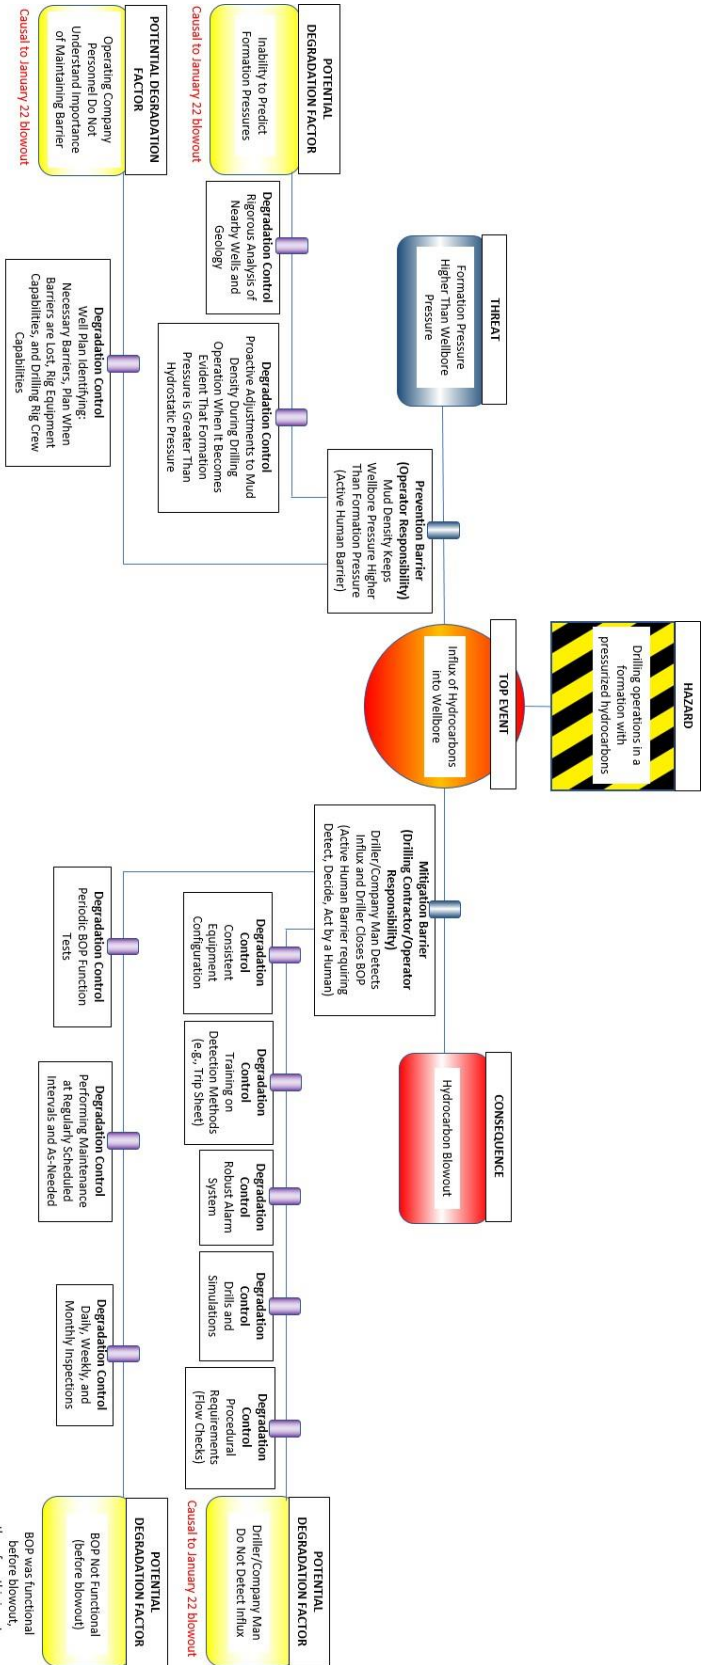
The CSB created a bowtie diagram (Figure 34) to illustrate the two planned barriers to prevent a blowout. Both barriers had associated degradation factors that could, and ultimately did, reduce the reliability and availability of the barriers.

Figure 34. Bowtie diagram of Pryor Trust Well 1H-9 barriers

Like any barrier, the mud barrier was subject to failure. Figure 34 shows two main degradation factors that contributed to the failure of the mud from preventing a gas influx, and no sufficient degradation controls were in place to prevent those degradation factors from leading to failure of the barrier.

Shown in Figure 34, a number of "degradation controls" could have been in place to reduce the likelihood that rig workers would miss the signs of gas influx. These controls include:

An effective alarm system is one of the “degradation controls” shown in Figure 34 to help ensure that the mitigation barrier, the detection of an influx by rig workers and closure of the BOP, would function as expected. In this case, however, shutting down the alarm system nullified it as a degradation control, thereby increasing the likelihood that the detect-influx-and-activate-BOP mitigation barrier would fail, which is what ultimately happened. Had the alarm system been on, the existing alarm system likely also would have nullified the system as a degradation control, since most of the alarms would not have been warning of the ongoing well control event (Appendix E). The alarm system would not have been effective in alerting the driller to the imminent blowout.

Shown in Figure 34, drills are an important control to increase the likelihood that the driller will detect a gas influx. Without drills, the degradation factor that "driller does not detect influx" is a greater risk, increasing the likelihood of failure of the secondary "Driller Detects Influx and Closes BOP" barrier.

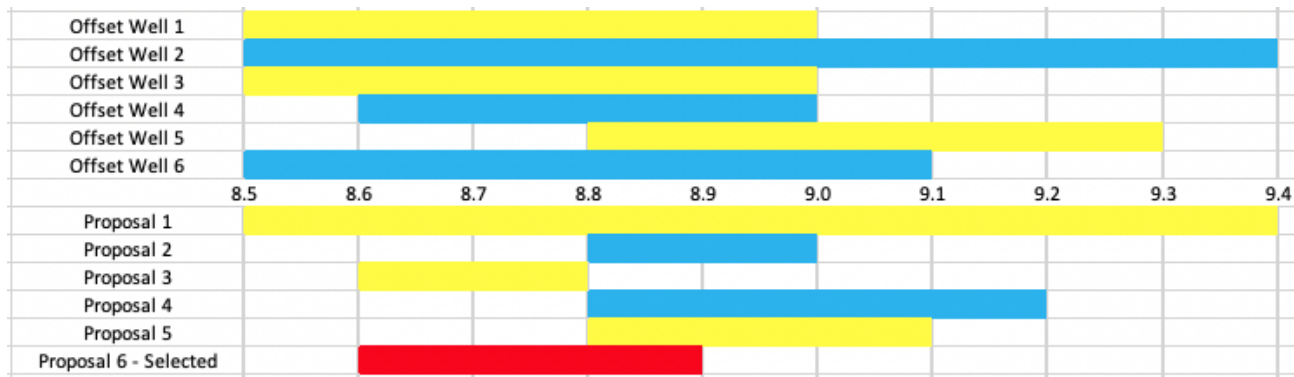
A common method for mud program evaluation in a region where other wells have already been drilled is to review what earlier wells have used. RMO evaluated at least six offset wells in Pittsburg County targeting the Woodford formation in its planning phase for Pryor Trust well 2H-16, the well drilled before 1H-9 (incident well). The offset wells used the following mud weights (densities) during the drilling operations (Figure 35):

RMO received six different proposals from mud companies for the mud program for Pryor Trust well 2H-16, which were based on the following mud weights for the “production zone” (2,340 ft - 15,929 ft)—the portion of the well where gas was anticipated (Figure 35):

1. 8.5-9.4 ppg
2. 8.8-9.0 ppg
3. 8.6-8.8 ppg
4. 8.8-9.2 ppg
5. 8.8-9.1 ppg
6. 8.6 - 8.9 ppg (Program selected by RMO)

Figure 35. Comparison of the offset well mud weights, and the proposed mud weights provided in the various mud program proposals for the 2H-16 well.

During the drilling of 2H-16, the well experienced lost returns at 1,950 ft MD at a mud weight of 8.8 ppg, losing about 200 barrels of mud to a formation. After this loss event, the mud weight was reduced. The goal was “to keep [mud weight] as low as possible,” and the crew used a mud weight as low as 8.15 ppg while drilling the production zone. They drilled the remainder of the well without incident.

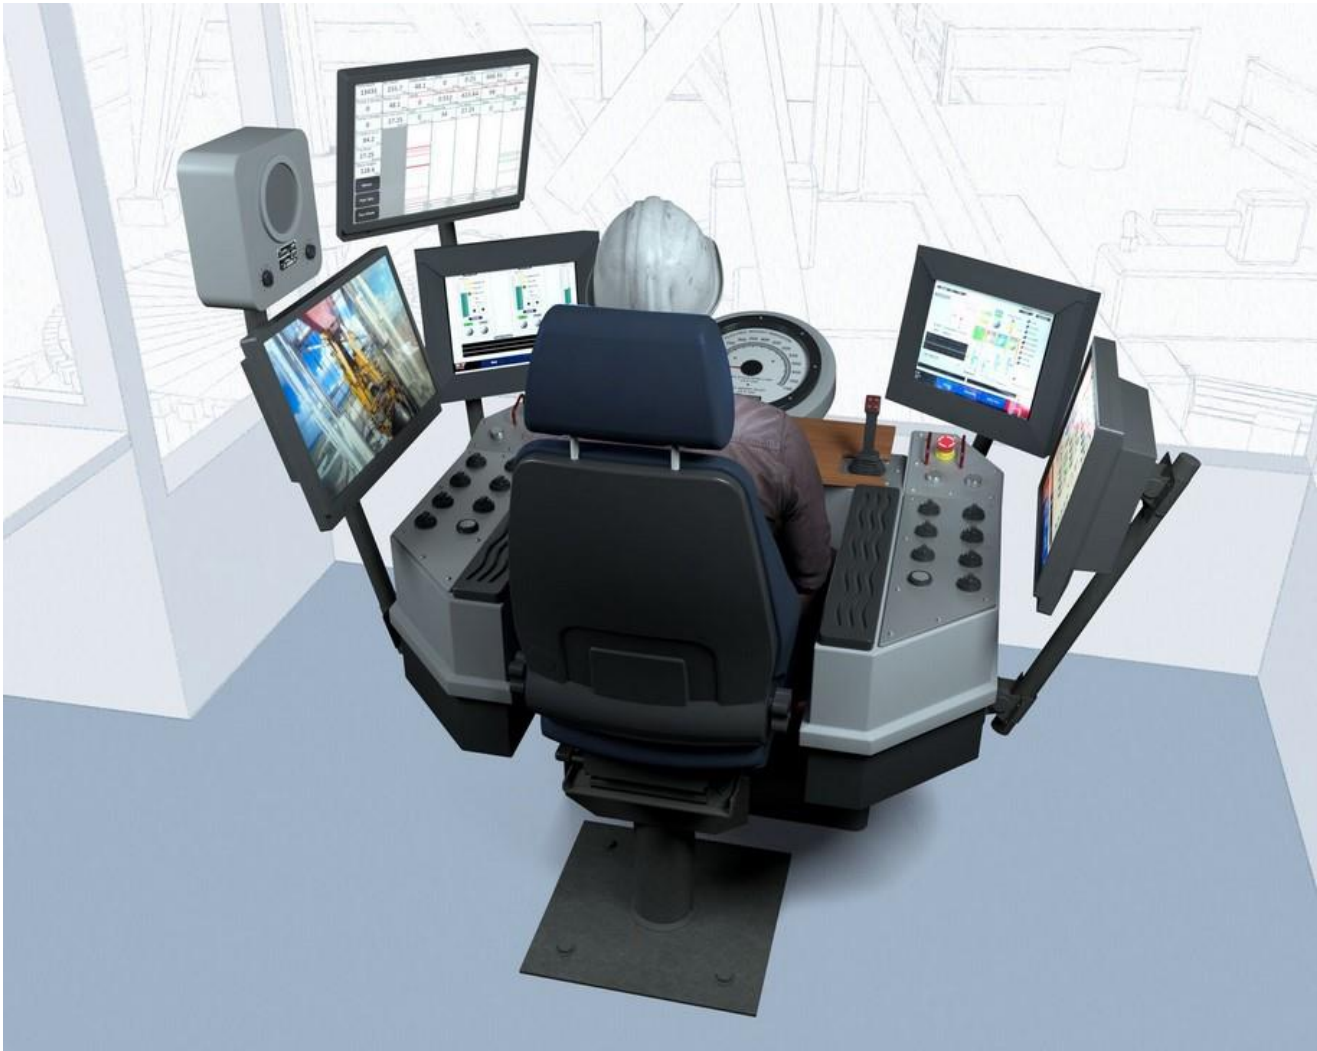
The driller's cabin was equipped with several monitors displaying data and camera footage essential to the drilling operation. A re-creation of the setup is shown in Figure 37. The top screen to the left of the driller displayed an aggregate of the drilling data, including drill bit depth, weight on bit, torque, stroke count, mud pit volumes, trip tank volume, gain/loss, mud return flow, and other parameters. The other monitors in front of the driller displayed data for the drawworks,<sup>a</sup> pump parameters, top drive parameters,<sup>b</sup> and camera feed to watch drill pipe latching operations.

*Figure 37. Depiction of driller console on Rig 219. The upper screen to the left of the driller displayed the aggregate of the drilling data.*

On the drilling data monitor (upper left monitor), the driller could adjust alarm set points, silence individual alarms, silence all alarms for all parameters by turning the alarm horn off, or completely deactivating the alarm system so that both the horn and visual indications of alarms would be disabled. The data system installed was provided by Pason,

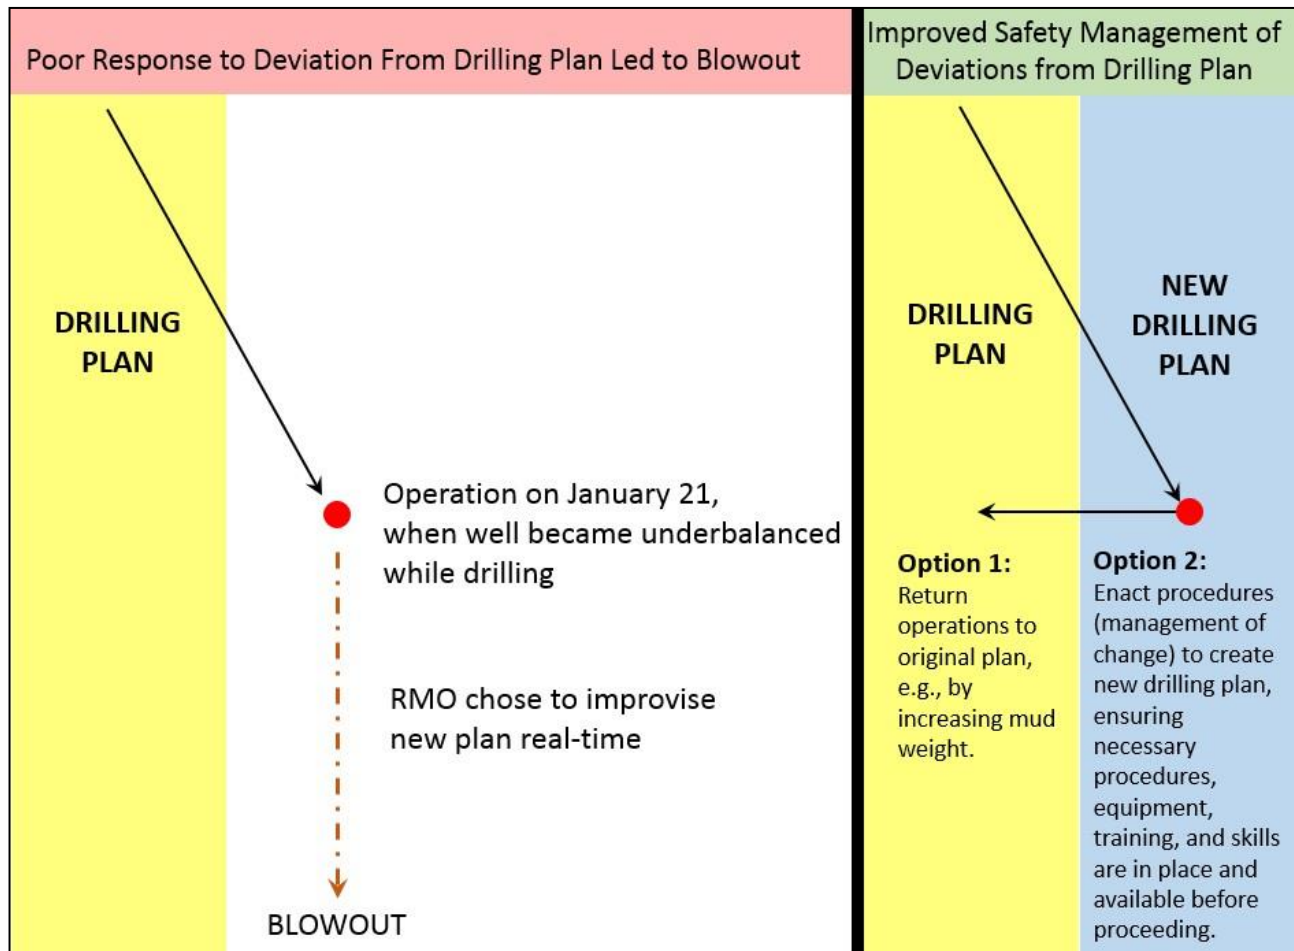
Sometimes operational excursions from original drilling plans are possible due to the inability to accurately predict geological behavior and formation pressures. Figure 39 below shows how RMO and its representatives responded to the deviation from the original drilling plan, which did not include underbalanced drilling. On January 21, when the well suddenly was underbalanced, RMO and its representatives chose to improvise a new plan as they proceeded real-time. This decision led to RMO and its representatives not fully considering the hazards of the operation or considering the need for specialized equipment and procedures.

In operations with a healthy safety management system, when deviations from the original drilling plan occur, one of two options should be enacted, as shown in Figure 39. One option is to adjust parameters to return to the original drilling plan, which in this case would have required increasing the mud weight to return to overbalanced drilling. The second option is to stop operations and create a new drilling plan—using a management of change process—ensuring that necessary procedures, equipment, training, and skills are available so that the new plan can be performed safely before proceeding.

Figure 39. Depiction of RMO's and its representatives' response to deviation from drilling plan (left), and improved safety management of deviations from drilling plan (right)

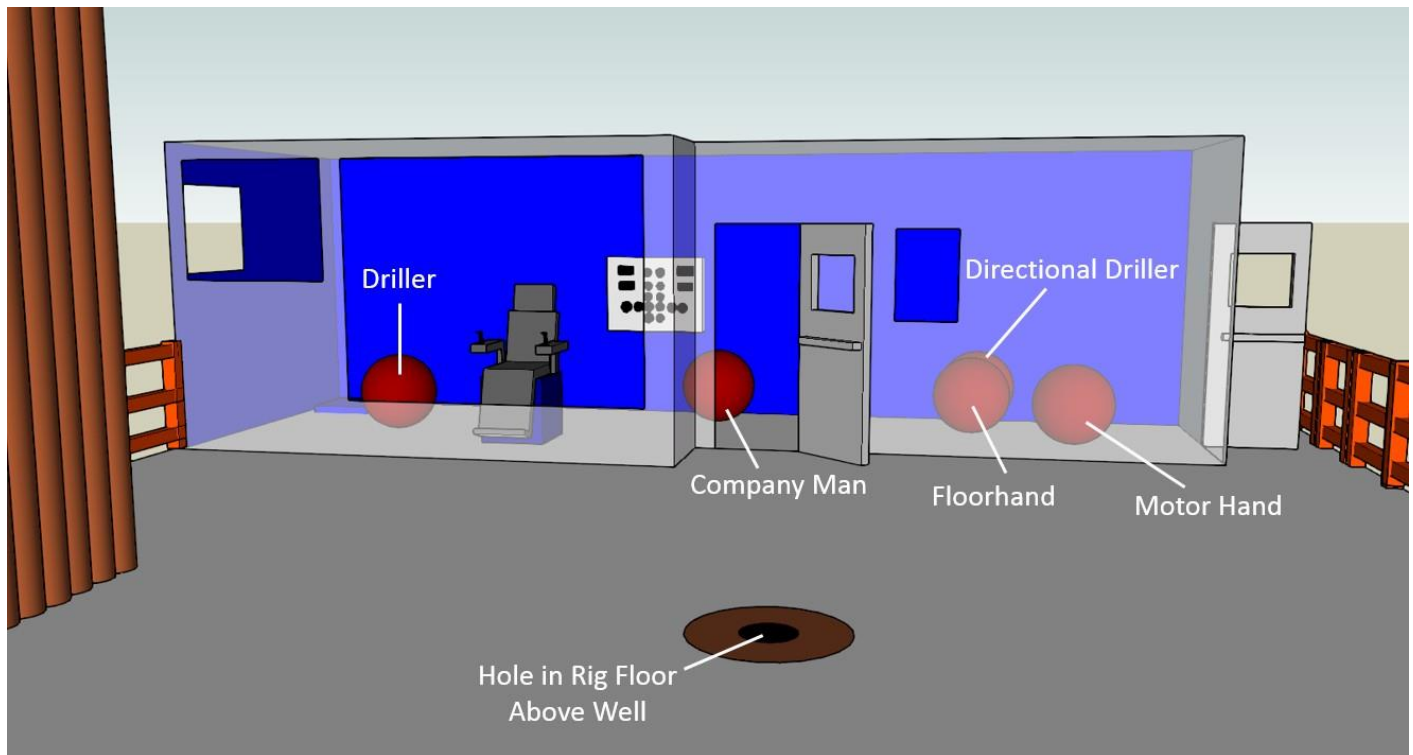
At the time of the blowout when mud started erupting from the well, the motorhand and second floorhand entered the driller's cabin. The driller, company man, and directional driller were already inside the driller's cabin when the blowout started. All five personnel were victims of the blowout and post-incident were found deceased in the driller's cabin. The locations where the victims were found is shown in Figure 42. Autopsies determined that all victims died from thermal burn injuries with found or probable smoke and soot inhalation.

Figure 42. Locations where victims were found in the driller's cabin

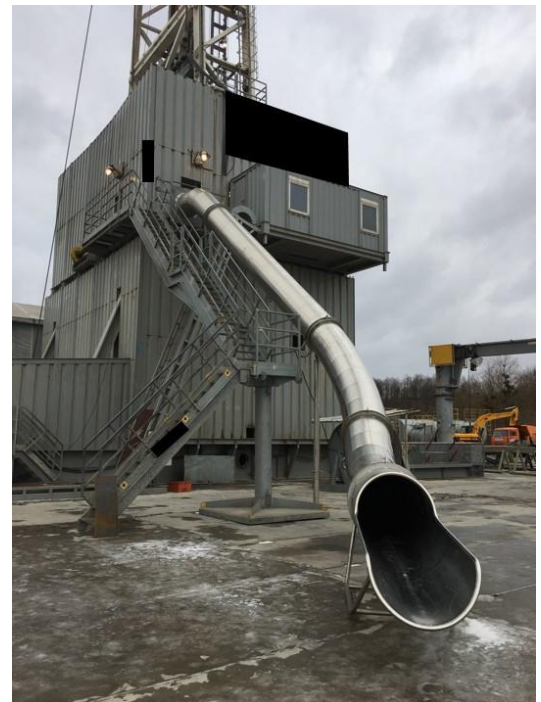
The design and location of the driller's cabin on Rig 219 appears to be typical across the industry. Drilling rig design changes are needed to help protect workers on the rig floor and in the driller's cabin from blowout and fire hazards, and to allow quick escape from the rig. Had the fire rating of the driller's cabin been ensured for a minimum time (e.g., 10 minutes), with emergency escape options from the driller's cabin floor (e.g., an escape hatch) or from the back wall, there could have been a better chance for the workers in the driller's cabin to survive this incident. As an example of a quick evacuation design, the CSB was informed that escape slides are required in Ukraine for the safety of drilling rig workers (Figure 47). This and other escape options would need to be evaluated by the U.S. drilling industry.

Figure 47. Example design strategy to provide quick egress from drilling rig during a blowout.

- Protect drilling cabin occupants from blowout hazards including heat, blast overpressure, and projectiles; and
- Establish the minimum required evacuation methods from the drilling cabin, rig floor, and mast in the event of a blowout so personnel can quickly escape in variable hazard location conditions.

The drilling industry should also consider alternative design methods, such as locating the driller's cabin at a safe distance from the well, for example at ground level. Such a design could incorporate the use of cameras to allow the driller to view and direct rig floor activities, keeping workers in the driller's cabin out of range of fire and explosion hazards. [**Recommendation 2018-01-I-OK-R5**]

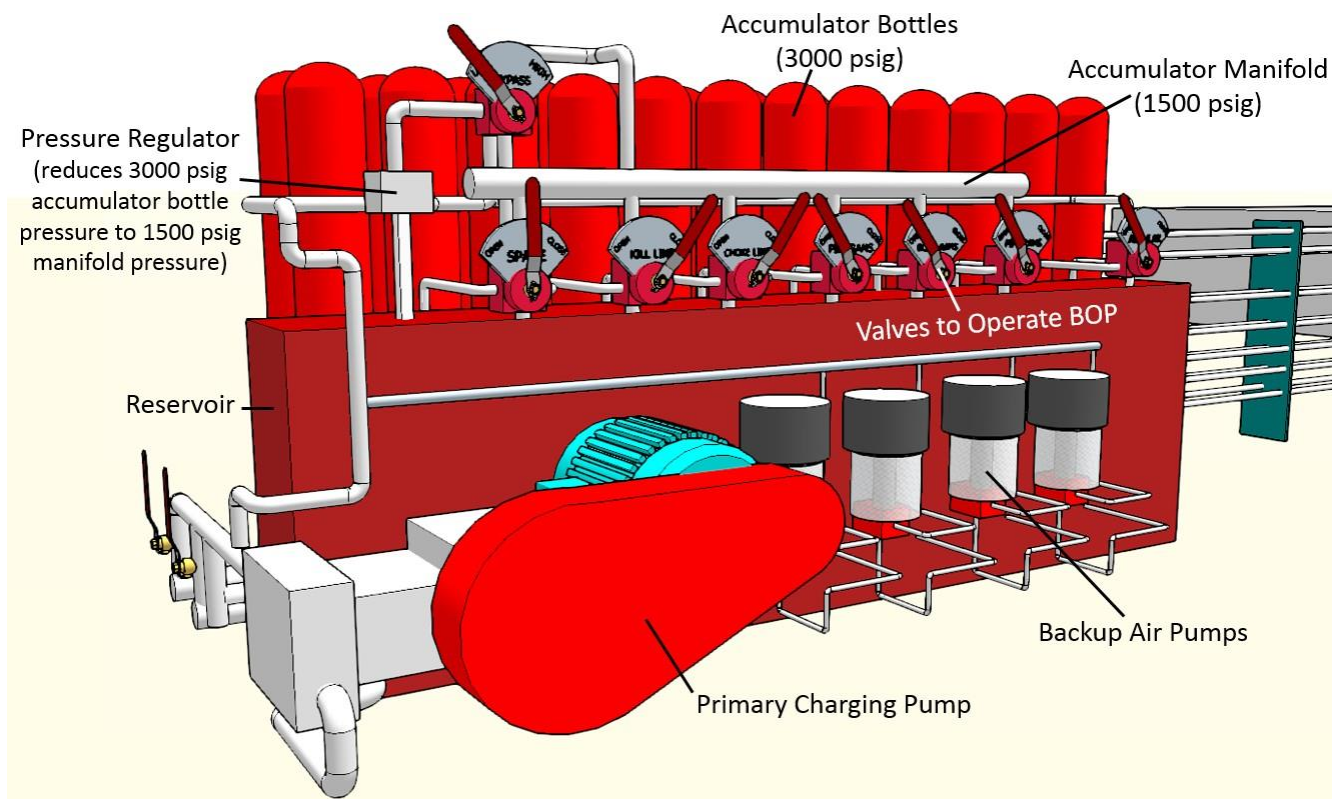
Blowout preventers are hydraulically operated equipment, using high-pressure hydraulic fluid stored in an accumulator.<sup>a</sup> A depiction of the Rig 219 accumulator is shown in Figure 48.<sup>b</sup> Hydraulic fluid at 3,000 psig is stored in the accumulator bottles. That pressure is reduced to 1,500 psig through a pressure regulator for the manifold. Hydraulic fluid in the accumulator manifold is used to function the blowout preventer.

<sup>c</sup> Discussed in Appendix A, post-incident testing found that the charging pump activated at an accumulator pressure of about 2,000 – 2,100 psig and automatically switched off when the accumulator pressure reached 2,800 psig. Based upon information from Patterson rig crew members that the accumulator pressurized normally to 3,000 psig pre-incident, this change to the accumulator pump set points may have been a result of the fire and post-incident activities.

Figure 48. Depiction of the Patterson Rig 219 accumulator. The top valve on the accumulator is the Bypass valve. From left to right, the bottom valves are Spare, Kill Line, Choke Line, Bottom Pipe Rams, Blind Rams, Top Pipe Rams, and Annular Preventer.
