# Gas Well Blowout and Fire at Pryor Trust Well 1H-9

# Investigation Report

Published: June 12, 2019

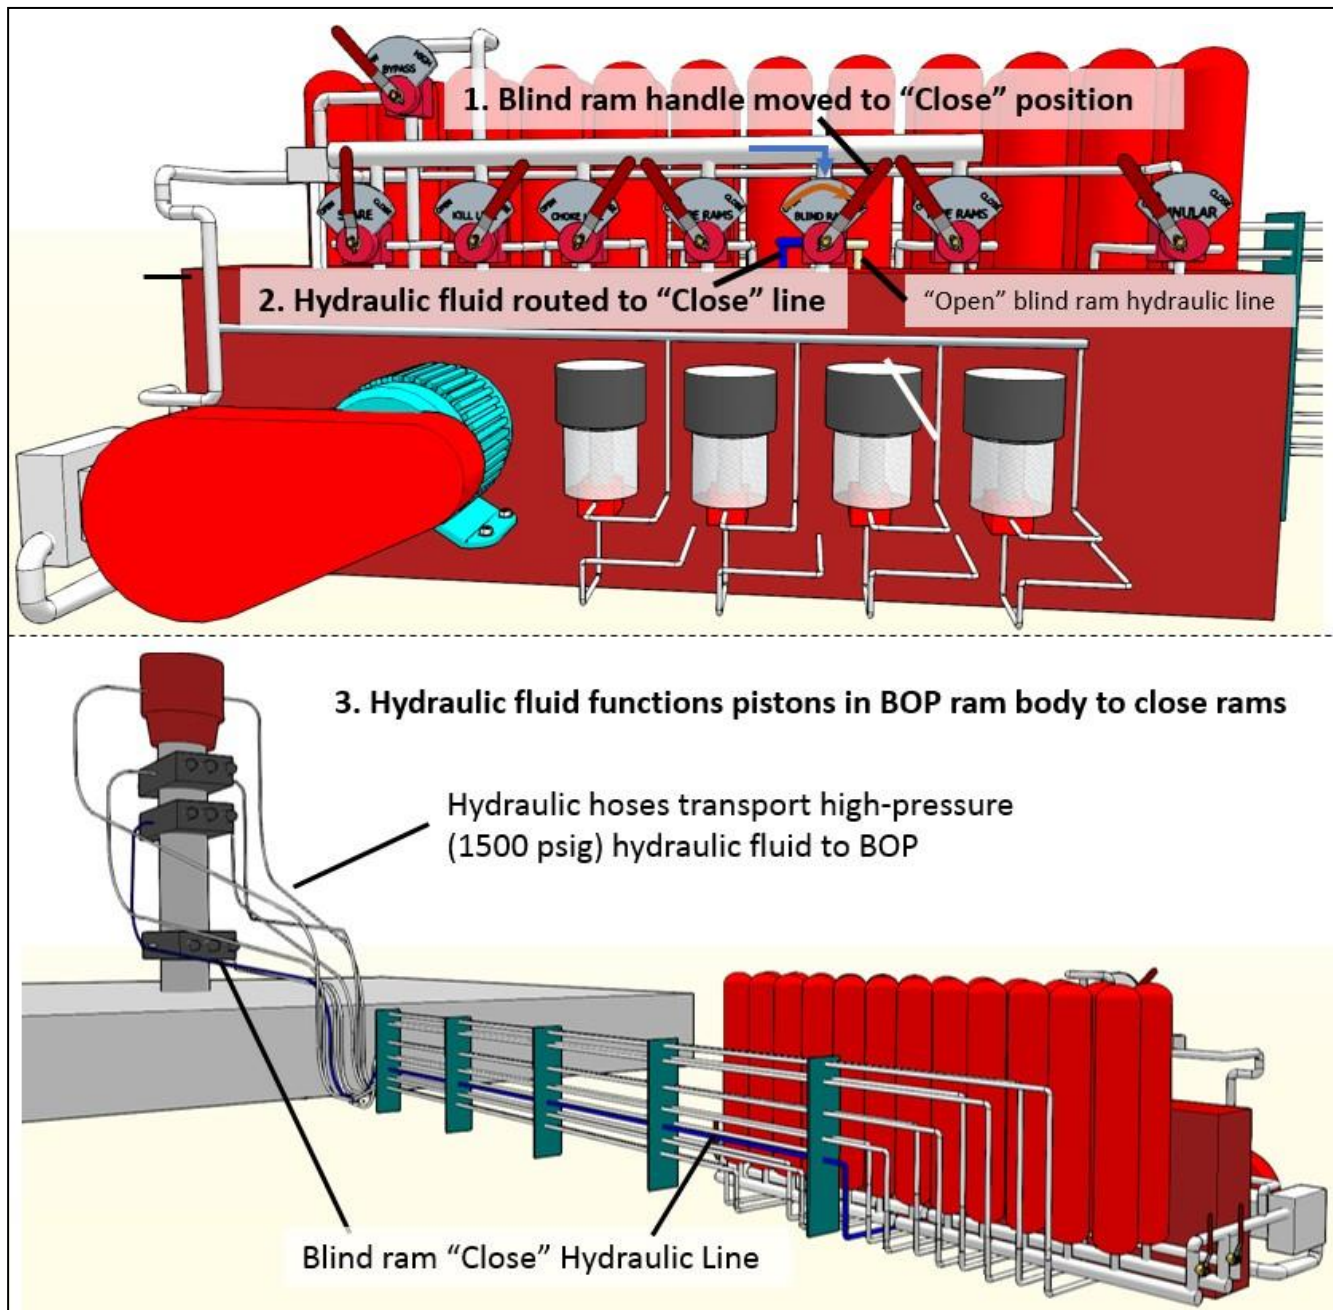
Figure 49 illustrates how the accumulator is used to function the blowout preventer. When a person moves an accumulator handle to its “close” position for, for example, the blind rams, 1500 psig hydraulic fluid from the accumulator manifold is routed to the blind ram “close” hydraulic line, which then moves two pistons inside the ram body to close the rams. The pressurized hydraulic fluid that was in the “open” piston chambers and hydraulic line drains into the accumulator reservoir. When a person then moves the handle to the “open” position, high-pressure hydraulic fluid is routed to the blind ram “open” hydraulic line, which then moves the pistons in the ram body in the opposite direction to then open the rams. The pressurized hydraulic fluid that was in the “close” piston chambers and hydraulic line drains into the accumulator reservoir.

Figure 49. Illustration of how hydraulic fluid in the accumulator functions the blowout preventer blind rams when the blind rams valve is moved to the "close" position. The portion of the hydraulic lines in the support racks is hard piping, and the portion of the hydraulic lines between the support rack and the blowout preventer is flexible hose.

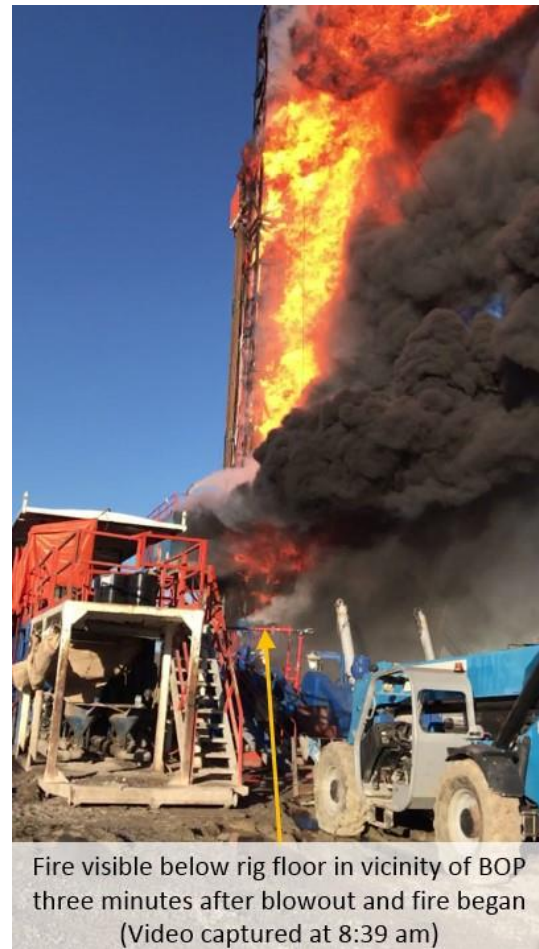
Figure 51. Video still of Patterson Rig 219 fire, taken 3 minutes after blowout began.

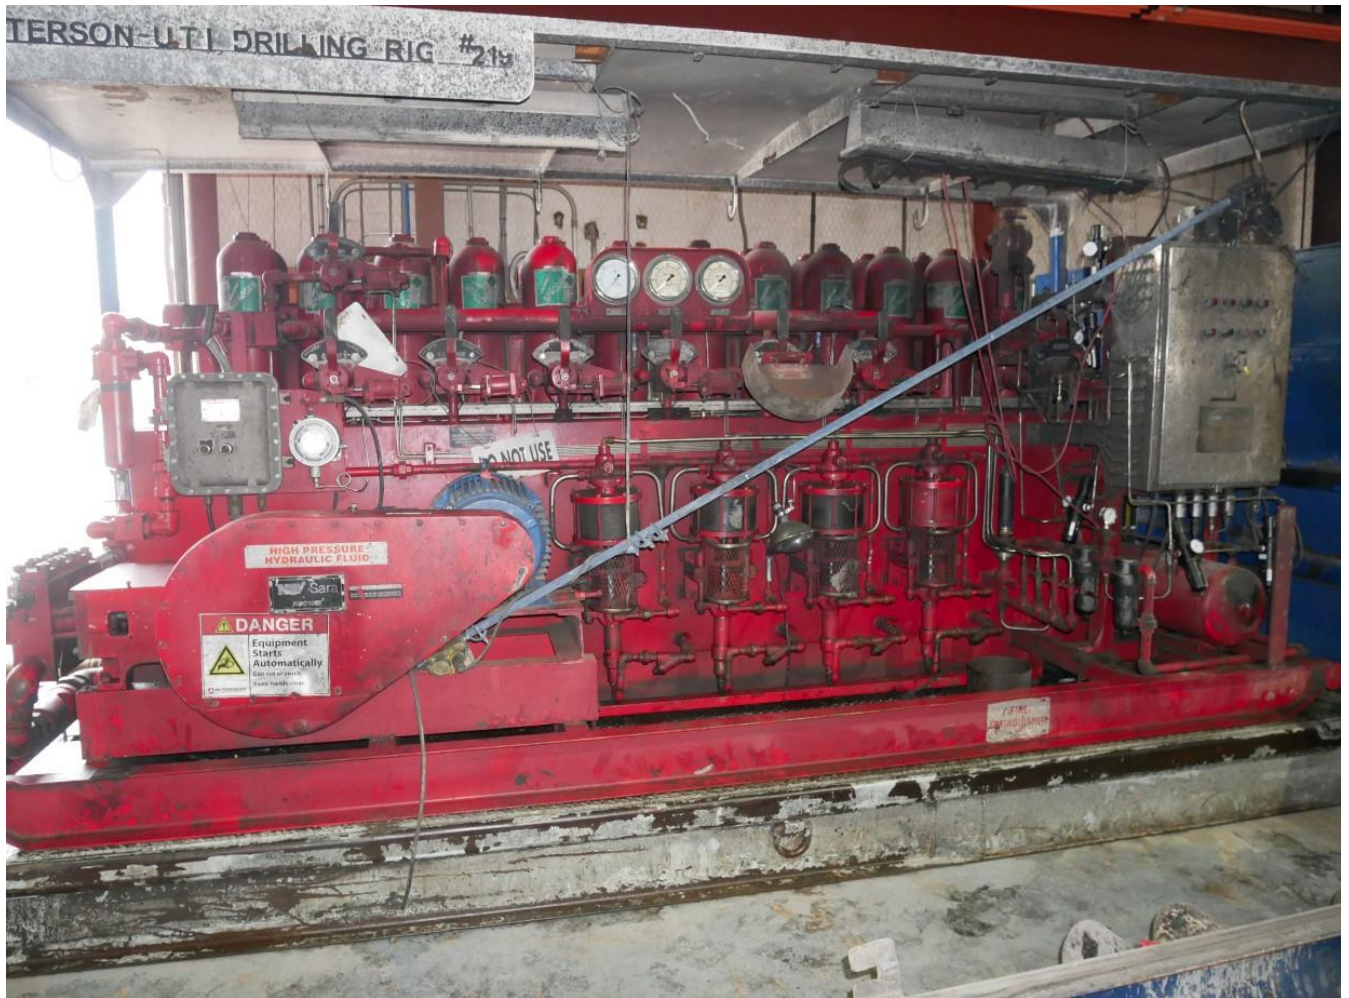
- The accumulator was manufactured by NOV SARA INDIA (P), LTD. It was manufactured in 2008 (Figure A-1).

Figure A- 1. Photo of Patterson Rig 219 accumulator

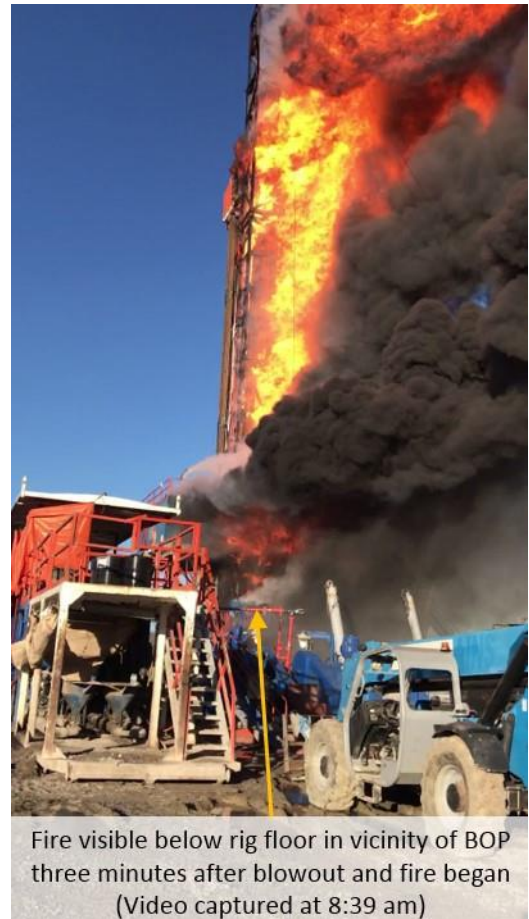
Figure A- 6. Video still of Patterson Rig 219 fire, taken 3 minutes after blowout began.

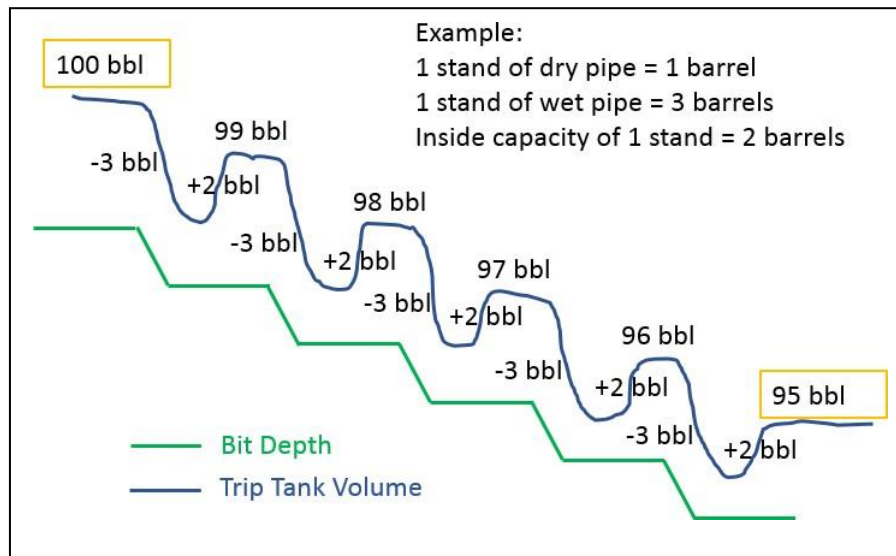
Figure C- 1. Example trip tank fluctuation pattern when tripping wet pipe when mud bucket drains to trip tank.

- In this example, tripping five stands of drill pipe containing mud (each stand has dry volume of 1 barrel) with the mud bucket draining to the trip tank results in a five-barrel decrease in the trip tank volume. This is a volume reduction of the *dry volume* of the drill pipe stand even though the drill pipe was being pulled “wet.”
- This calculation assumes there is no mud leakage or mud spilled on the drill floor during the tripping operation.
- The *Guide to Blowout Prevention*, created by the company Well Control School (WCS) states:

- Routing drill pipe/mud bucket drainage elsewhere (e.g., a catch tank) requires usage of wet volume for trip sheet calculations. This will also reduce trip tank volume fluctuations and can reduce crewmember confusion. The CSB was informed, however, that the general standard in the North Sea for wet tripping is that the fluid from the mud bucket is routed to the trip tank so that if the float (a type of check valve preventing back flow) fails in the drill string and the well starts to kick up the drill string, then the kick can be identified.

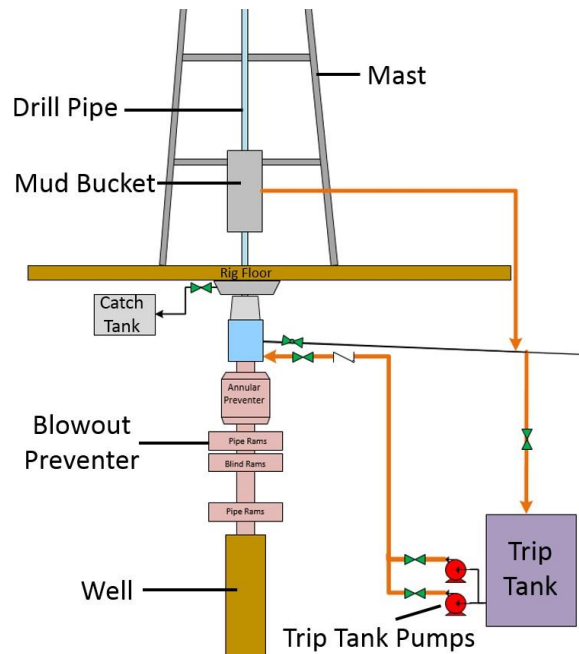
Figure C- 2. Example equipment alignment that could cause the trip tank volume fluctuations shown in Figure C- 1.

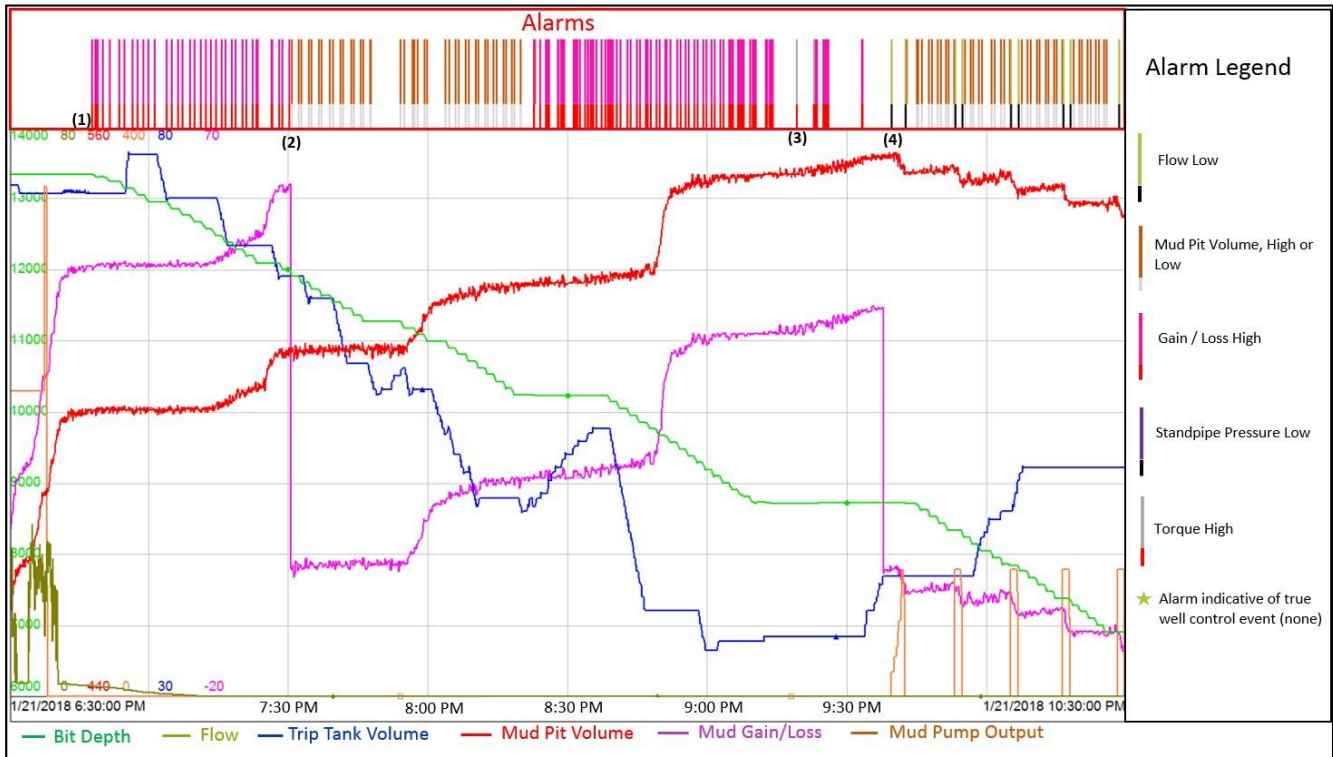
Figure E- 1. Information from alarm system data, indicating what alarms would have activated between 6:45 pm and 10:30 pm during the trip out of the lateral section, had the alarm system been turned on. Information about the specific alarms is in Table E- 1 below. The numbers in parentheses correspond with the note numbers in Table E- 1.

- (1) During the trip out of the lateral part of the well, the orbit valve in the flow line was closed. This valve alignment prevented any mud to flow from the well into the mud pits. The Gain/Loss alarm activates when a significant change occurs in the mud pit volume (the alarm was set to activate at a change of minus 40 or plus 15 barrels. Because the orbit valve was closed, the changes in mud pit volume during this tripping operation were caused by other operations, such as mud transfers, unrelated to the tripping operation. The Gain/Loss alarm would not have been indicative of the gas influx in the well and would therefore have been a nuisance or non-critical alarm.

- (4) The flow alarm was set to alert low flow when the mud pumps were running and the flow value was less than 5%. When the driller turned on the mud pumps during the tripping operation, the closed orbit valve prevented mud flow through the flow line. The low flow alarm would not have been indicative of a well control event. (Note: this alarm could still indicate a hazardous equipment lineup if the driller did not intend to close the orbit valve, which was not the case here.)

- (5) Gains in the trip tank volume were a result of pressure at the surface of the well caused by a gas influx pushing mud to the trip tank through the trip tank discharge line. There were no alarms on the trip tank to alert the driller to the trip tank volume gain. The trip tank was equipped only with a high- and low-volume alarm to alert the driller when the trip tank was almost full or almost empty. The driller is expected to identify indications of gas influx by completing a trip sheet, comparing the calculated volume of mud expected to be pumped to the actual amount of mud pumped into the well from the trip tank. The CSB was told that the general standard in the North Sea is the driller can set a gain/loss alarm for trip tank level.

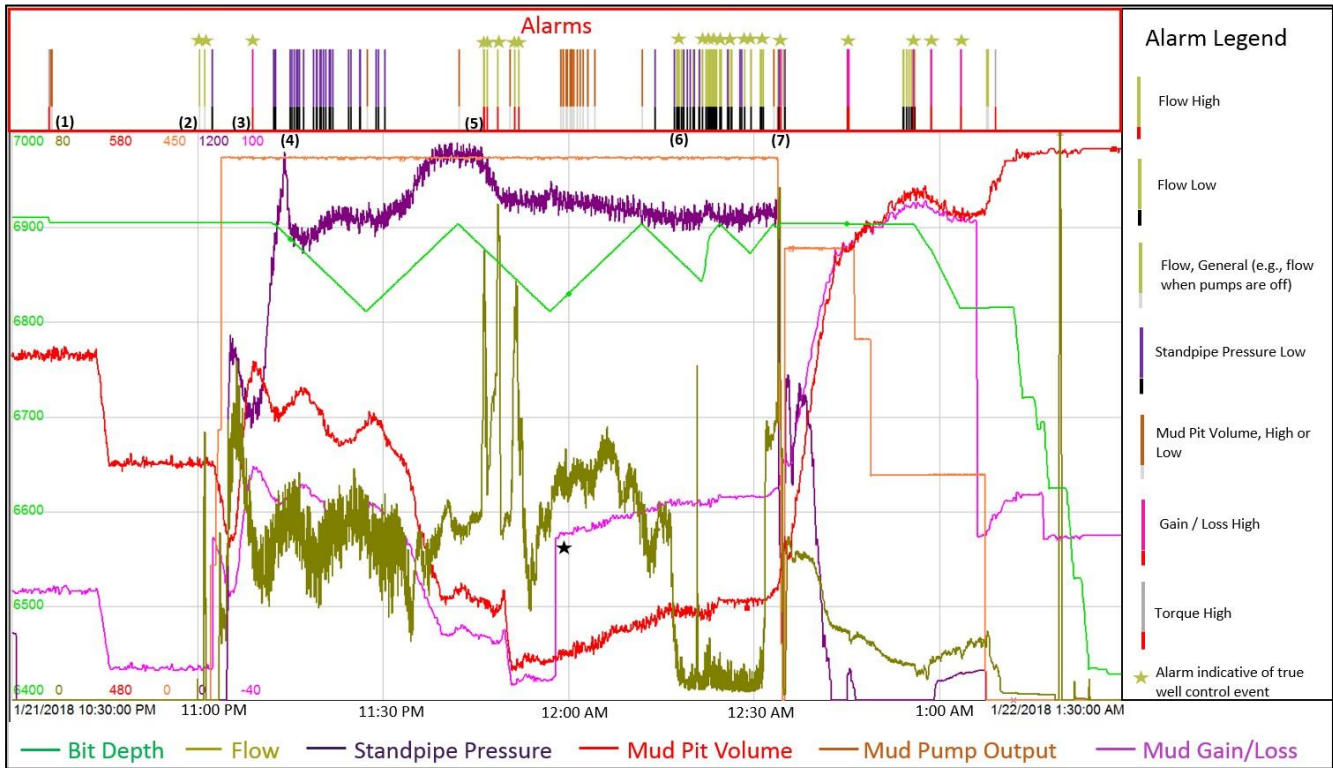
While circulating at the top of the curve, had the alarm system been active, some of the active alarming would have been potentially indicative of the well control event, but the bulk of the active alarming would have been non-critical alarms (Figure E- 2). More information about the specific alarms is in Table E- 2.

Figure E- 2. Information from alarm system data, indicating what alarms would have activated between 10:30 pm and 1:10 am while circulating at the top of the curve, had the alarm system been turned on. Some of these alarms could have alerted to the well control event. Information about the specific alarms is in Table E- 2 below. The numbers in parentheses correspond with the note numbers in Table E- 2.

- (4) The Standpipe Pressure Low alarm would have been triggered early during the circulation operation. The standpipe pressure increased again between 11:30 pm and 12:00 am during the well circulation, corresponding to a gas release from the well (Section 5.2), which would have caused the low pressure alarm to stop activating. Had the alarm system been active, the standpipe pressure alarm could have been used as a well control event indication if the setpoints been adjusted to make the information significant. At the current set points, however, this alarm would not have been warning of the well control event.

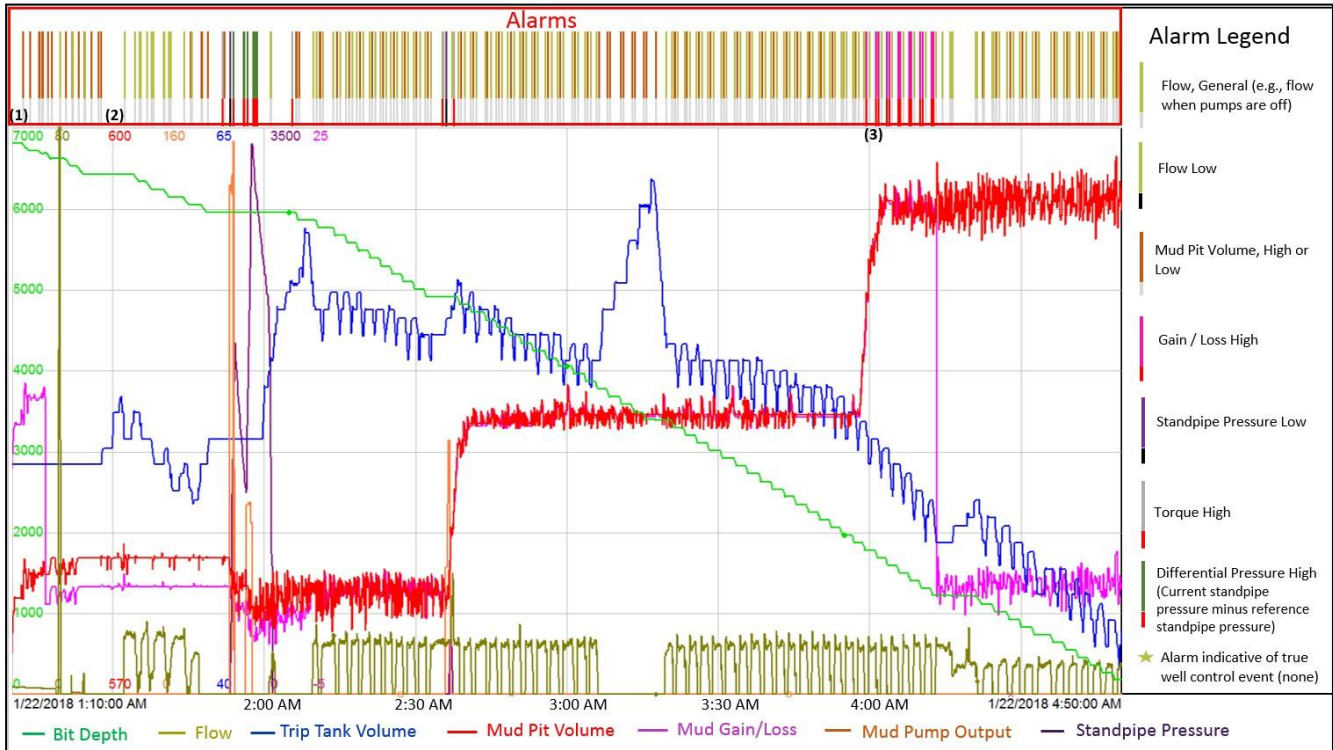
The tripping operation out of the vertical portion of the well occurred between 1:10 am and 4:50 am. During this period, alarms would have activated had the alarm system been on for parameters including mud pit volume, flow, Gain/Loss high, differential pressure, standpipe pressure, and torque. These alarms would have been activated by other rig operations (e.g., transferring mud) or parameters that would be pertinent to the drilling operation but were irrelevant to the tripping operation. As such, all alarming would have been non-critical alarms not indicative of the well control event. No alarms would have activated that warned of a potential well control event during the tripping operation.

Figure E- 3. Information from alarm system data, indicating what alarms would have activated between 1:10 am and 4:50 am while tripping out of the vertical section of the well, had the alarm system been turned on. None of the alarms would have alerted to the well control event. Information about the specific alarms is in Table E- 3 below. The numbers in parentheses correspond with the note numbers in Table E- 3.

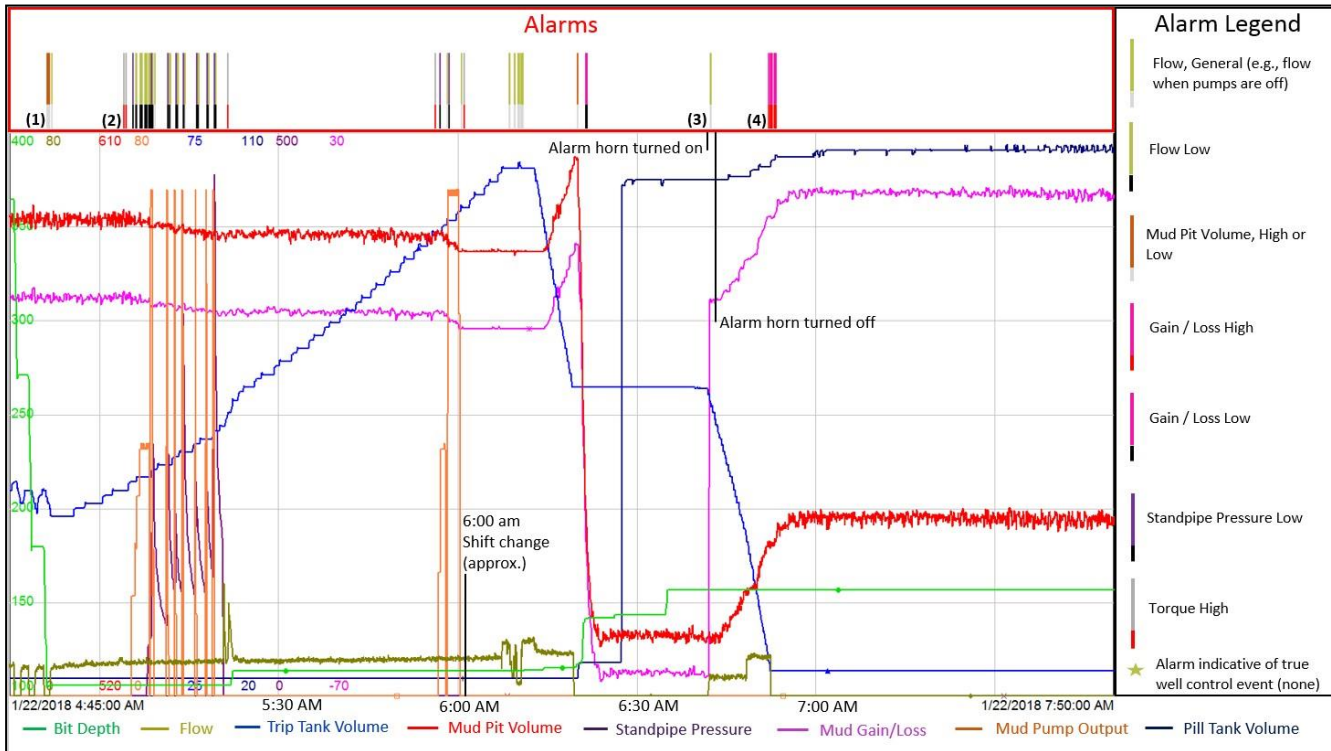
During this period a shift change occurred at around 6:00 am. At 6:42 am, the alarm system was reactivated, likely by the new driller on tour. Non-critical alarms would have been continuously sounding while the alarm system was on. Twenty seconds after the alarm system was turned on, it was turned off again. The alarm horn remained off through the blowout at 8:36 am.

Figure E- 4. Information from alarm system data, indicating what alarms would have activated between 4:50 am and 7:50 am during the rig floor operations, had the alarm system been turned on. None of the alarms would have alerted to the well control event. Information about the specific alarms is in Table E- 4 below. The numbers in parentheses correspond with the note numbers in Table E- 4.

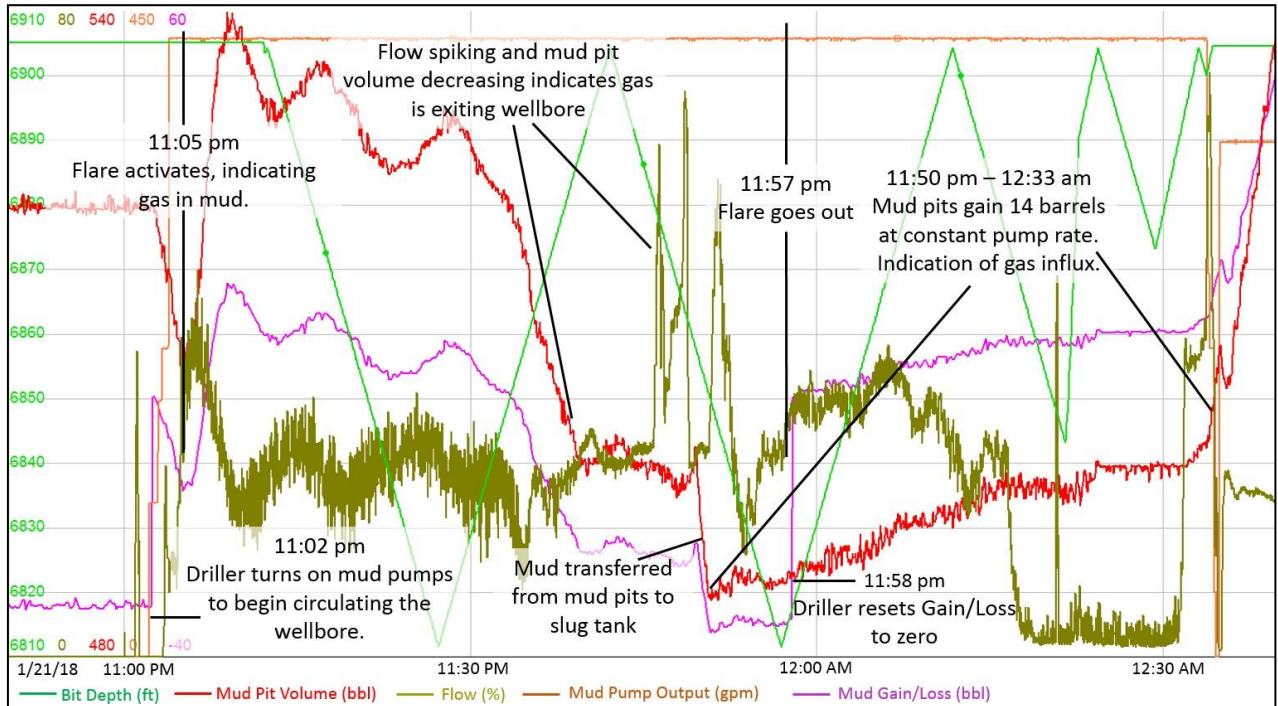
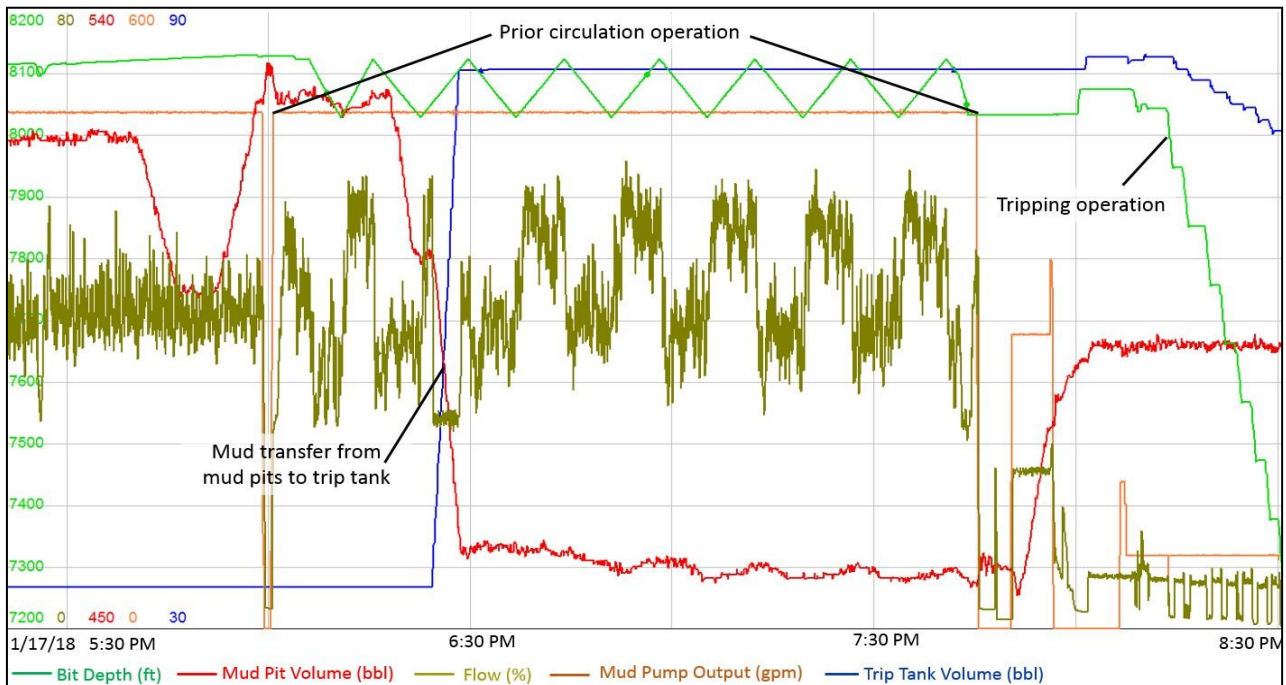
The top graph below shows rig data while circulating the wellbore at the top of the curve. The flare activated while circulating, indicating gas in the mud. Between 11:50 pm and 12:33 am, the mud pits gained 14 barrels while the mud pumps were circulating at a constant pump rate. This pit gain indicates there was a gas influx (kick). For comparison purposes, the bottom graph shows a normal circulation operation performed on January 17, 2018 on Pryor Trust Well 1H-9.
