Excavation Collapse

1. SUMMARY

On August 22, 2006, around 11:00 a.m., a more than 40 foot high, steep excavated slope suddenly collapsed. The collapsed earth deposits buried a nearby excavator and killed the operator inside the cab. The excavator was cleaning the base of the slope when the incident occurred.

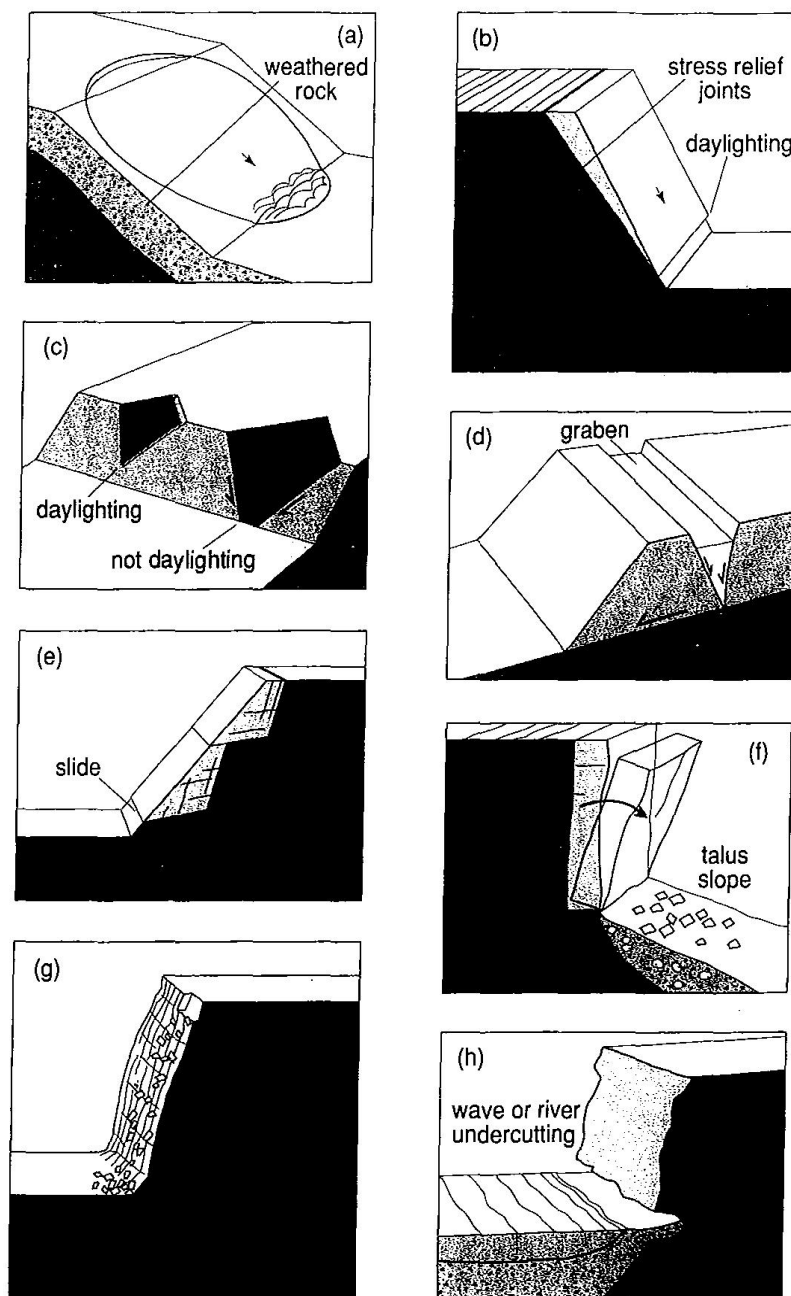
Figure 24. Type of Rock Slide Mechanisms (Modified from Franklin and Dusseault, 1991)

The figure on the cover of this report presents the overall shape of the collapse. As shown, the collapse was in a near circular or spoon shape. Based on references presented in Figures 23 and 24, a collapse of this shape would mostly occur in overburden soil, weathered rock, waste rock or heavily fractured rock. Therefore, the earth deposits in the collapsed area could only be residual soil, weathered rock or heavily fractured rock. They were more soil-like than rock-like deposits.

Slide mechanisms. (a) Spoon-shaped; (b) slab; (c) wedge; (d) graben; (e) stepped path; (f) toppling; (g) raveling; (h) erosion and undercutting mechanisms.
