Investigation of the Failures of Three Hammerhead Cranes on September 10, 2017, in Miami and Fort Lauderdale in the Wake of Hurricane Irma

U.S. Department of Labor
Occupational Safety and Health Administration
Directorate of Construction

September 2018

**Report Prepared by
Mohammad Ayub, P.E., S.E.
Alan Lu, Ph.D., P.E.
Office of Engineering Services
Directorate of Construction**

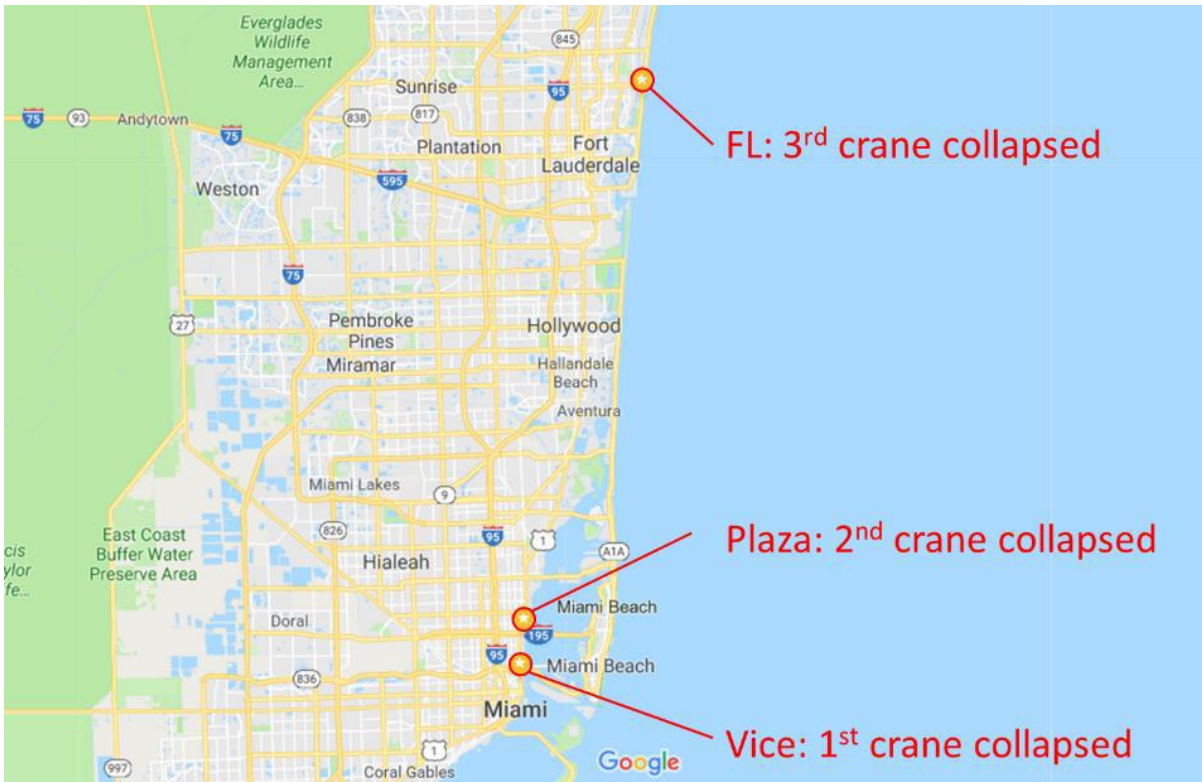
Figure 1 Locations of the three failure sites
(Courtesy of Google Map)

A hammerhead tower crane, model SK-315, manufactured by Terex Peiner, and another hammerhead tower crane, model SK-315, manufactured by Noell, collapsed in the wind on Sunday within hours of each other. Both cranes were located in the downtown Miami area approximately two miles apart (see Figure 1). No injuries were reported as all construction activities ceased the night before and the streets were deserted. A few hours later another hammerhead tower crane, also a model SK-315, failed in Ft. Lauderdale some 35 miles north of Miami (Figure 1). No other cranes failed either in Miami or Ft. Lauderdale during the tropical storm.

Locations of the three hammerhead tower crane cranes that collapsed are shown in Figure 1. The three sites were either very close to or on the coast. The sites were expected to receive the maximum force when the wind was blowing from the ocean.

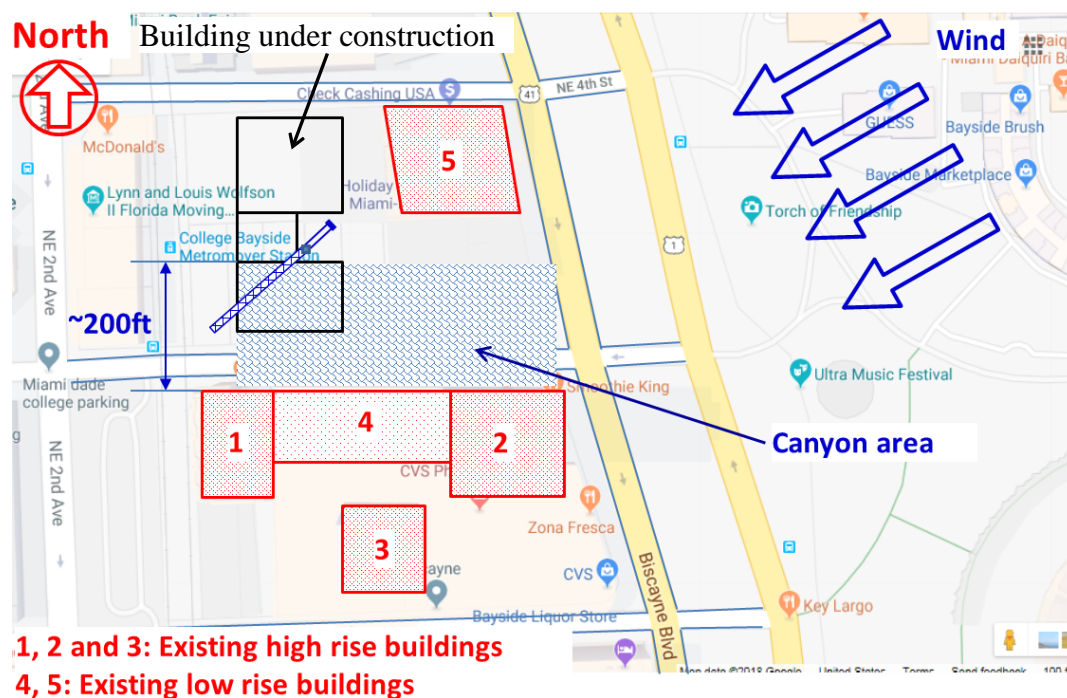
Figure 8 Surrounding environment of the first failure site
 (Courtesy of Google Map)

The surrounding environment of the first failure site is shown in Figure 8. Jib location and wind direction were determined based on video taken when the crane collapsed.

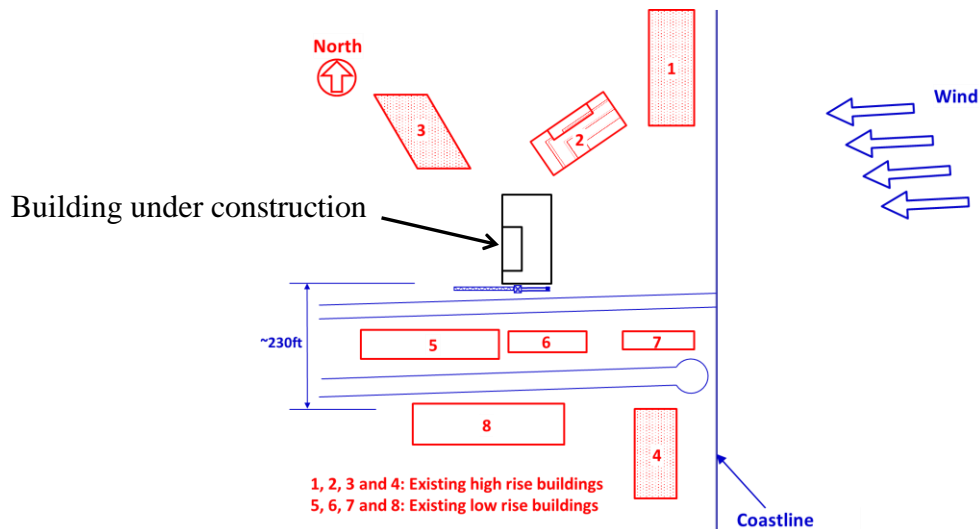
Figure 11 Surrounding environment of the second failure site

The surrounding environment of the second failure site is shown in Figure 11. Jib location and wind direction were determined based on video taken prior to the collapse of the crane.

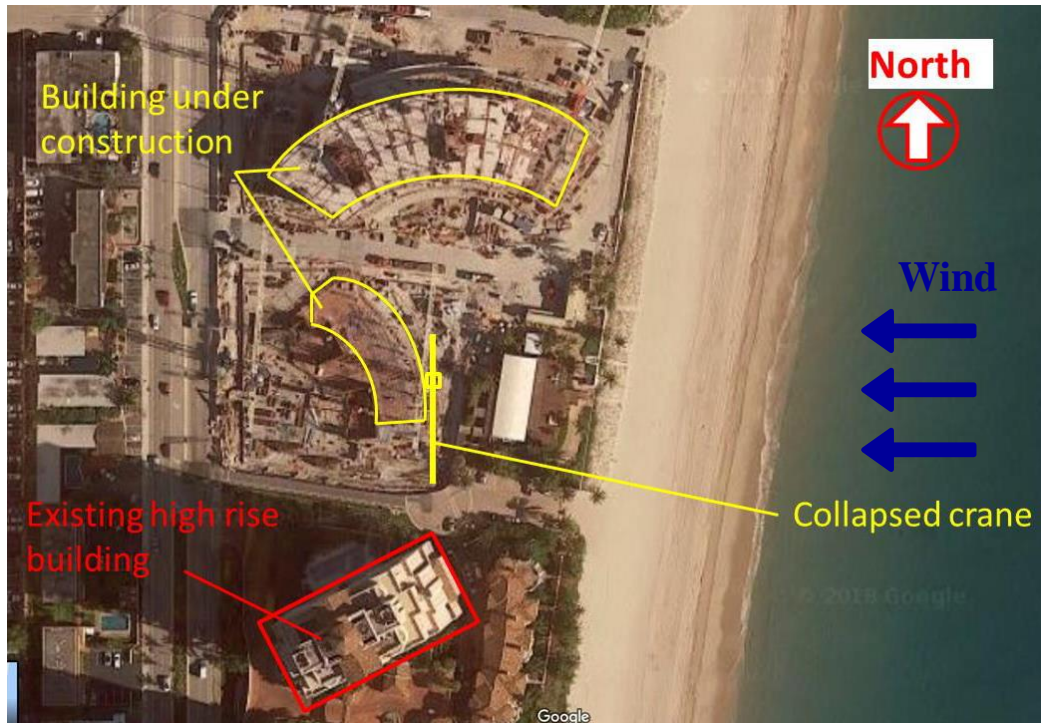
Figure 13 Surrounding environment of the third failure site
(Courtesy of Google Map)

The built environment of the third failure site is shown in Figures 13, 14 and 24. Wind direction and probable jib location were determined based on video footages and photographs taken before and after the incident, see Figure 24.

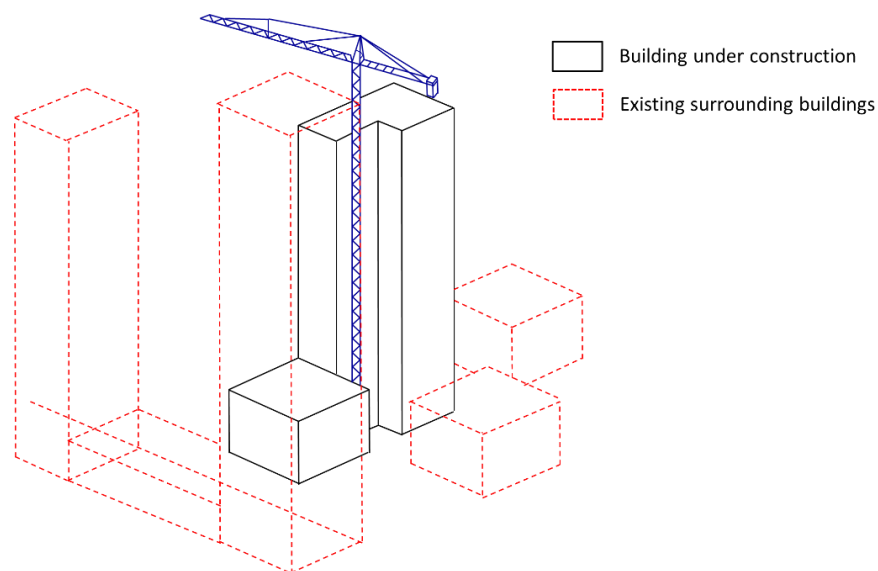
Figure 16 ISO view of the first failure site and surrounding buildings

At the first failure site, the two existing high-rise buildings across the street were taller than the crane, see Figure 16. The building under construction and the existing high-rise buildings across the street formed a small open channel, see Figures 16 and 17. Within the channel area, Venturi effect is normally expected. Therefore, the speed of wind increased when it funneled through this small opening. The severity of the Venturi effect is a function of width, length, height, and size of the opening in the canyon. The local wind acceleration effects are extremely difficult to describe and to schematize. However, it is clear that the local building configuration made the wind accelerate in this restricted area. Meanwhile, the crane tower was in front of the building, facing the strong wind from the ocean. Prior to the collapse, the jib was within a shear and separation zone beside and behind the building, see Figure 18. Therefore, wind speed and aerodynamic loads at the jib side were expected to be elevated. Moreover, vortex flow beside and behind the building was expected near the jib because of the high rise buildings across the street. This was proven by the fact that upward turbulent wind was observed underneath the jib in the video footage taken when the collapse took place, see Figure 19. Since the crane's jib was approximately 70 ft. above the completed structure, it was also likely that the jib and the counterjib were above the turbulent layer, and in a more stable laminar flow.

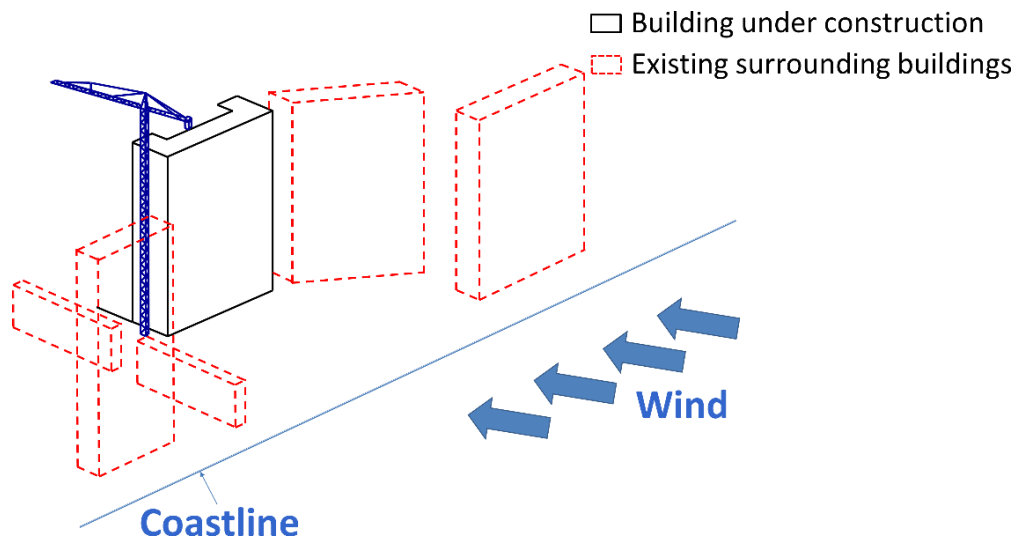
Figure 20 ISO view of the second failure site and surrounding buildings

At the time of the failure, the bottom of the jib was approximately 100 ft. above the completed structure. The crane tower was against the side wall of the building, facing the strong wind from the ocean, see Figures 20 and 21. The nearest existing high-rise building in the area, which was about the same height of the completed structure, was more than 250 ft. away from the tower crane, see Figure 21. The location of the jib and the counterjib prior to the collapse was unknown. Similar to the first failure, the building under construction and the existing high-rise buildings across the street formed an open channel similar to the first failure site, as shown in Figure 21. Again, the crane was much taller than the completed structure and the nearest existing high rise building. Whether the crane was located in an area that local turbulent winds were expected was not clear. Video footage captured on September 8, 2017, showed the initial position of the two cranes less than 24 hours prior to the landfall of the storm. Compared with two other videos captured during the storm, it is confirmed that positions of the jibs of the two cranes at this site changed after the storm made landfall, as shown in Figure 22. One of the two videos captured during the storm, but prior to the crane collapse, showed the crane involved in the incident and the nearby SK415 crane,

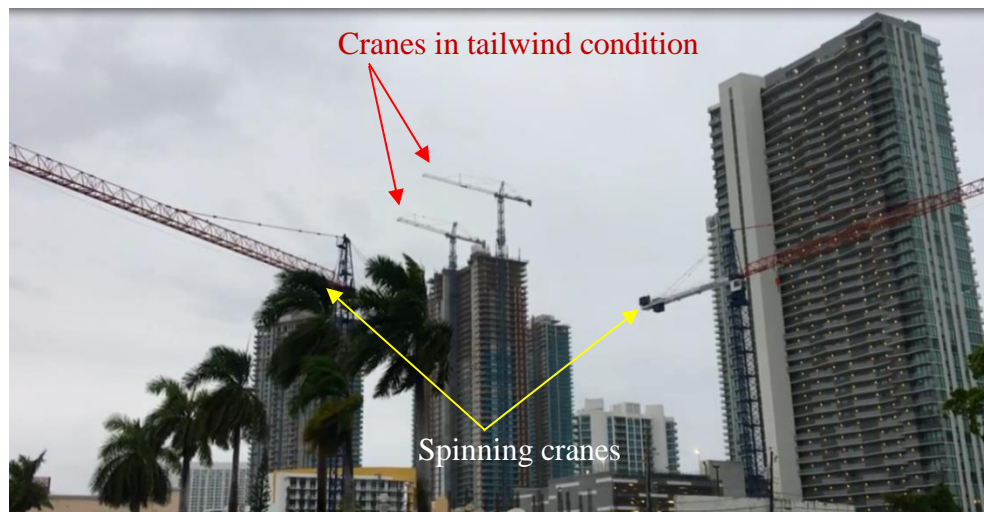
Figure 23 Tailwind condition of cranes at the second failure site – looking northeast
 (Courtesy of Mr. Peter Zalewski)

were in tail wind condition, while the two lower cranes behind the high-rise buildings were spinning due to fluctuating winds, see Figure 23.

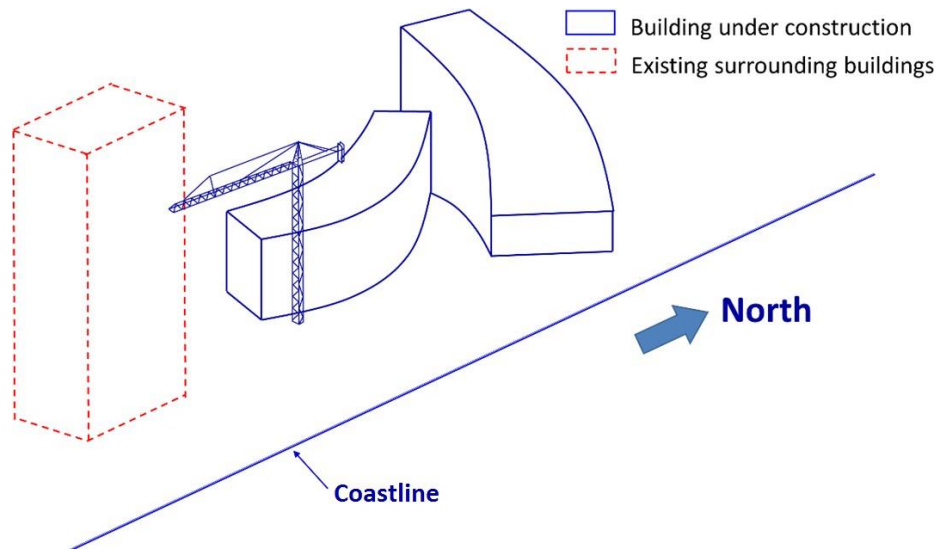
Figure 24 ISO view of the third failure site *

The crane tower was in front of the building, facing the strong wind. The bottom of the jib was approximately 80 ft. above the completed structure. The buildings under construction and the nearby existing high-rise building interfered. The local surroundings created a complicated situation where the wind was not guided but accelerated in restricted areas. The local wind acceleration effects were extremely difficult to describe and to schematize. However, it is believed that the local building configuration made the wind accelerate in this restricted area. Therefore, wind speed and aerodynamic loads at the jib were expected to be elevated. The local turbulent wind had significant effect on the crane. This was proven by the construction camera photographs taken before the collapse of the crane, which showed that the crane rotated due to local turbulent winds, see Figure 25.

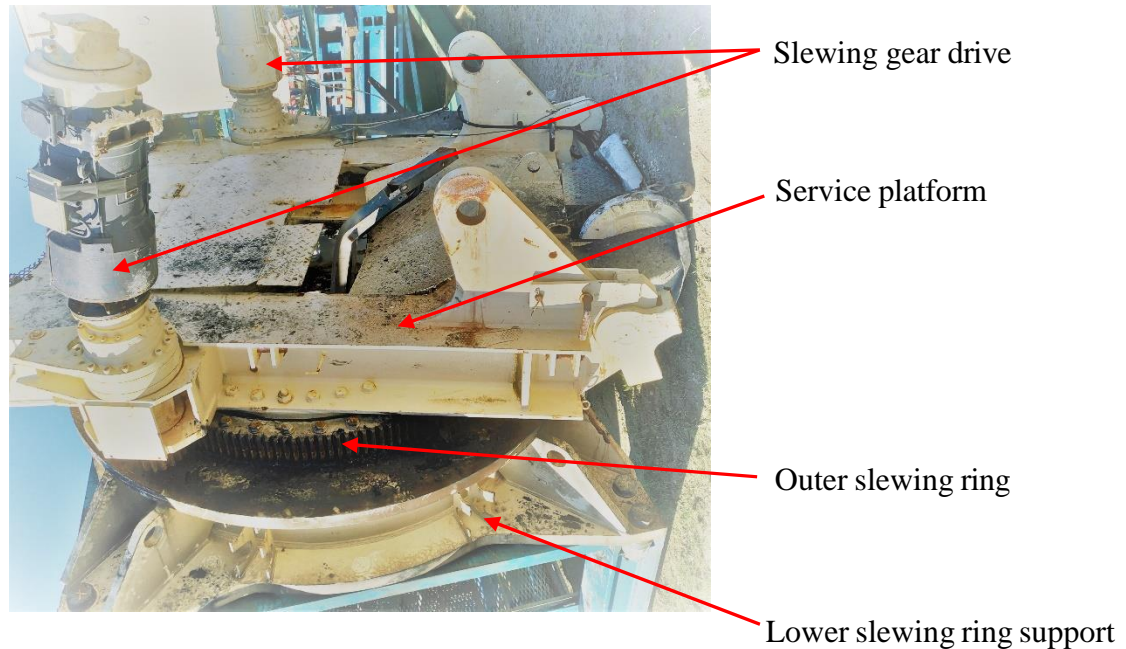
Figure 27 Slew assembly (the first failure)

The field observations of the slewing assembly focused on signs of worn slewing bearings, and on whether the slewing rings were greased and were set to weathervane as described in Section 3.2. Visual examination of the slewing bearings of the three cranes revealed that all three slewing bearings were greased, and no broken parts or missing teeth were found on the outer rings. Deadlock from debris of the slewing rings and possible jammed rings were not discovered. The wind release cases and the slewing gear brakes of the three cranes were also dismantled to verify that the cranes were set to weathervane and were able to revolve freely prior to the collapses. The disk brakes of the first and the third failure cranes were disassembled, since the wind release assemblies broke during the collapses. The brake linings of the two gear breaks had not worn down to the minimum thickness, and it was confirmed that the two cranes were set to weathervane prior to the collapses. The wind release assembly of the second failure crane was opened, and it was found that the flap was still in blocking position, which means the crane was set to weathervane.

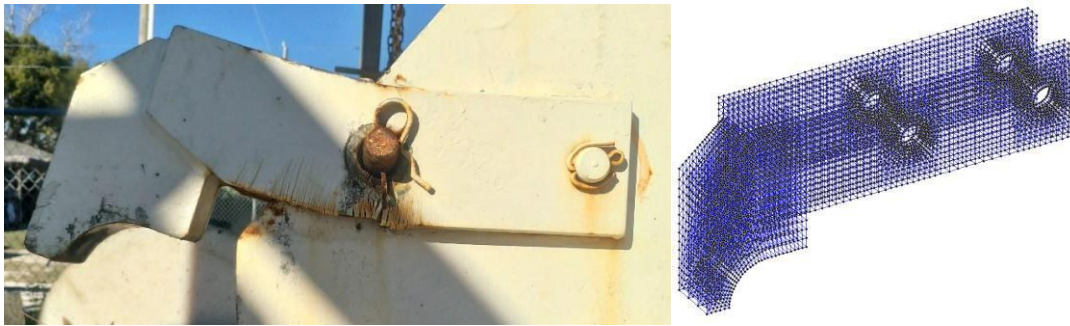
Figure 39 Turntable cradle clamp and 3D solid model

The turntable cradle clamp was modeled using 3d solid element in Staad Pro, as shown in Figure 39. Force was applied at the tip of the clamp to simulate the pulling of the pins on the bottom jib chord foot. The material grade for the clamp was S355J2G3, with a yield stress of 52 kilopounds per square inch (ksi). A minimum pulling force from the bottom jib chord pin to yield the clamp steel was determined to be 32 kips. It is noted that the existing clamp design is not able to secure the jib foot from separating, once the force from one jib bottom chord exceeded 32 kips. No design calculation or analysis documents or proof loading test results were made available to OSHA. Further evaluation could be required.

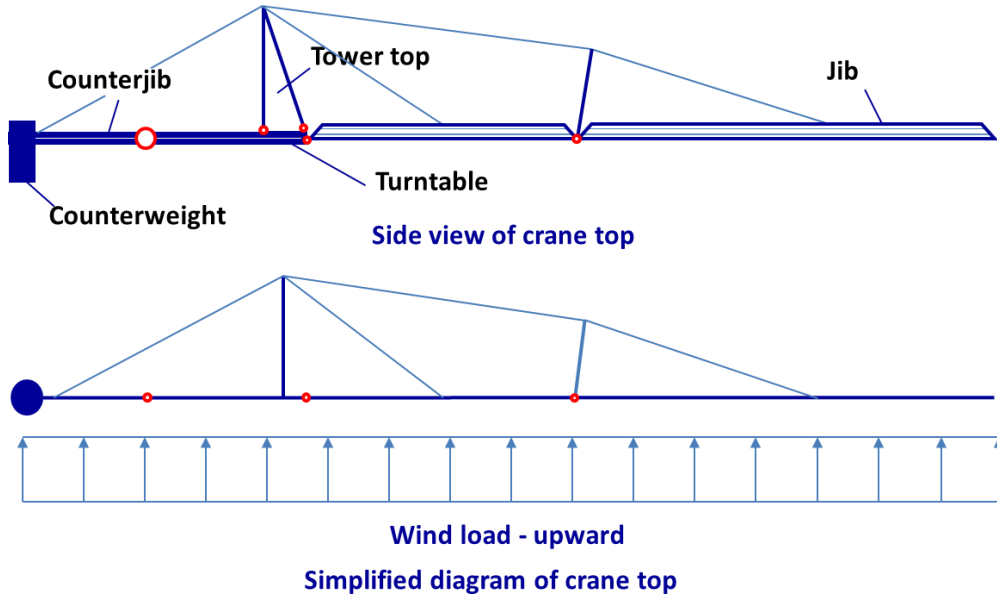
Figure 42 Tower crane top under upward transient wind

Therefore, to determine the probable causes of the three incidents, both upward and lateral transient wind loads were considered applied on the jibs at 90 degrees to represent the possible situations where crane jibs were hit by a strong vortex or impulse wind, as shown in Figures 42 and 43. In contrast to typical design practices—which considered a complete crane, including mast, tower top, jib and counterjib, to evaluate its stability and integrity—only the dynamics effects of the jib introduced by the sudden rise in wind speed (or pulse effect) were examined in this study.

It should be noted that the two analytical conditions in this section are beyond the design usual practice and are served as a study to determine the probable causes of the three crane collapses. The effects of transient wind on tower crane structures, especially on crane jibs, are not usually included in the structural design of tower cranes.

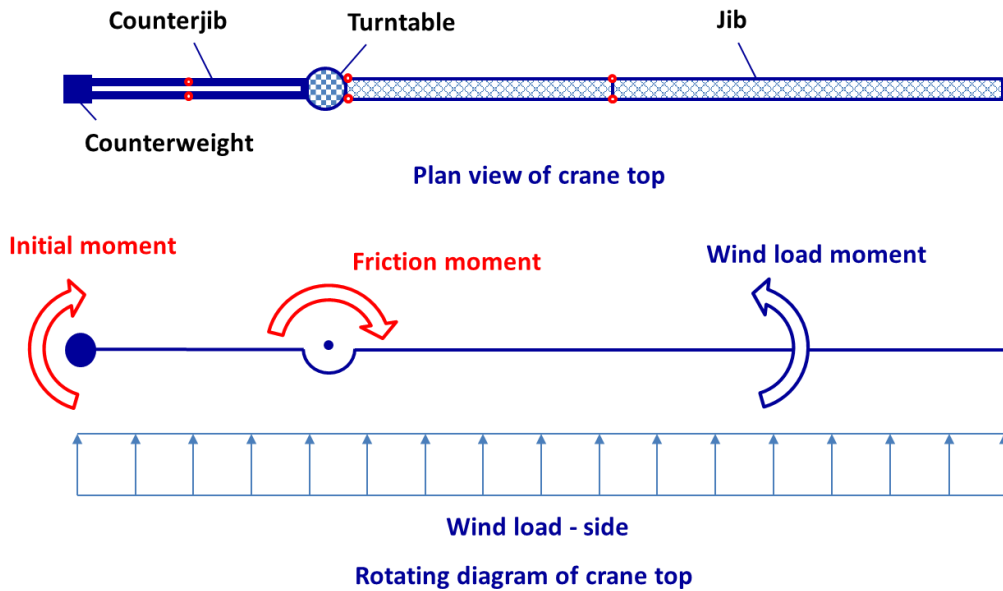
Figure 43 Tower crane top under lateral transient wind

is able to overcome the frictional moment to rotate the turntable, see Figure 43. During this process, the rotational acceleration is very small, and the initial effects due to the mass of the counterweight and other rotational components are limited. However, if the wind load is transient, pulse effect must be considered. When the transient wind strikes the jib, the inertial moments due to the mass of the counterweight and other rotational components, as well as the friction moment, would resist the rotation of the turntable due to the horizontal wind. The equation of motion of the rotating part of the crane is given as:

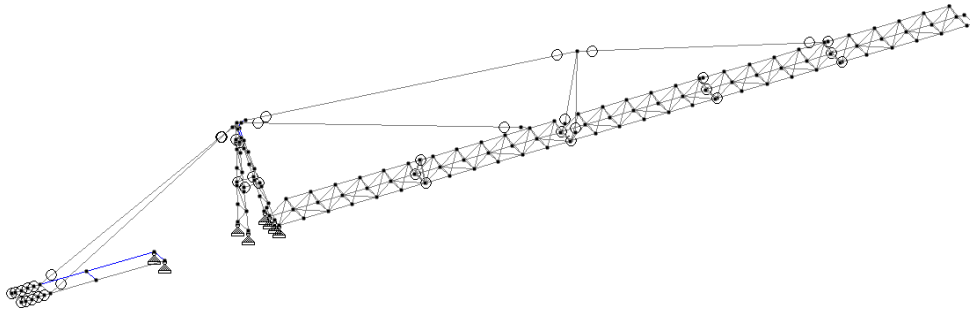
Figure 44 3D structural model of the mobile part of the crane (1st failure crane)

The 3D structural models of the three cranes, including the tower top, jib and counterjib, were developed as shown in Figure 44.

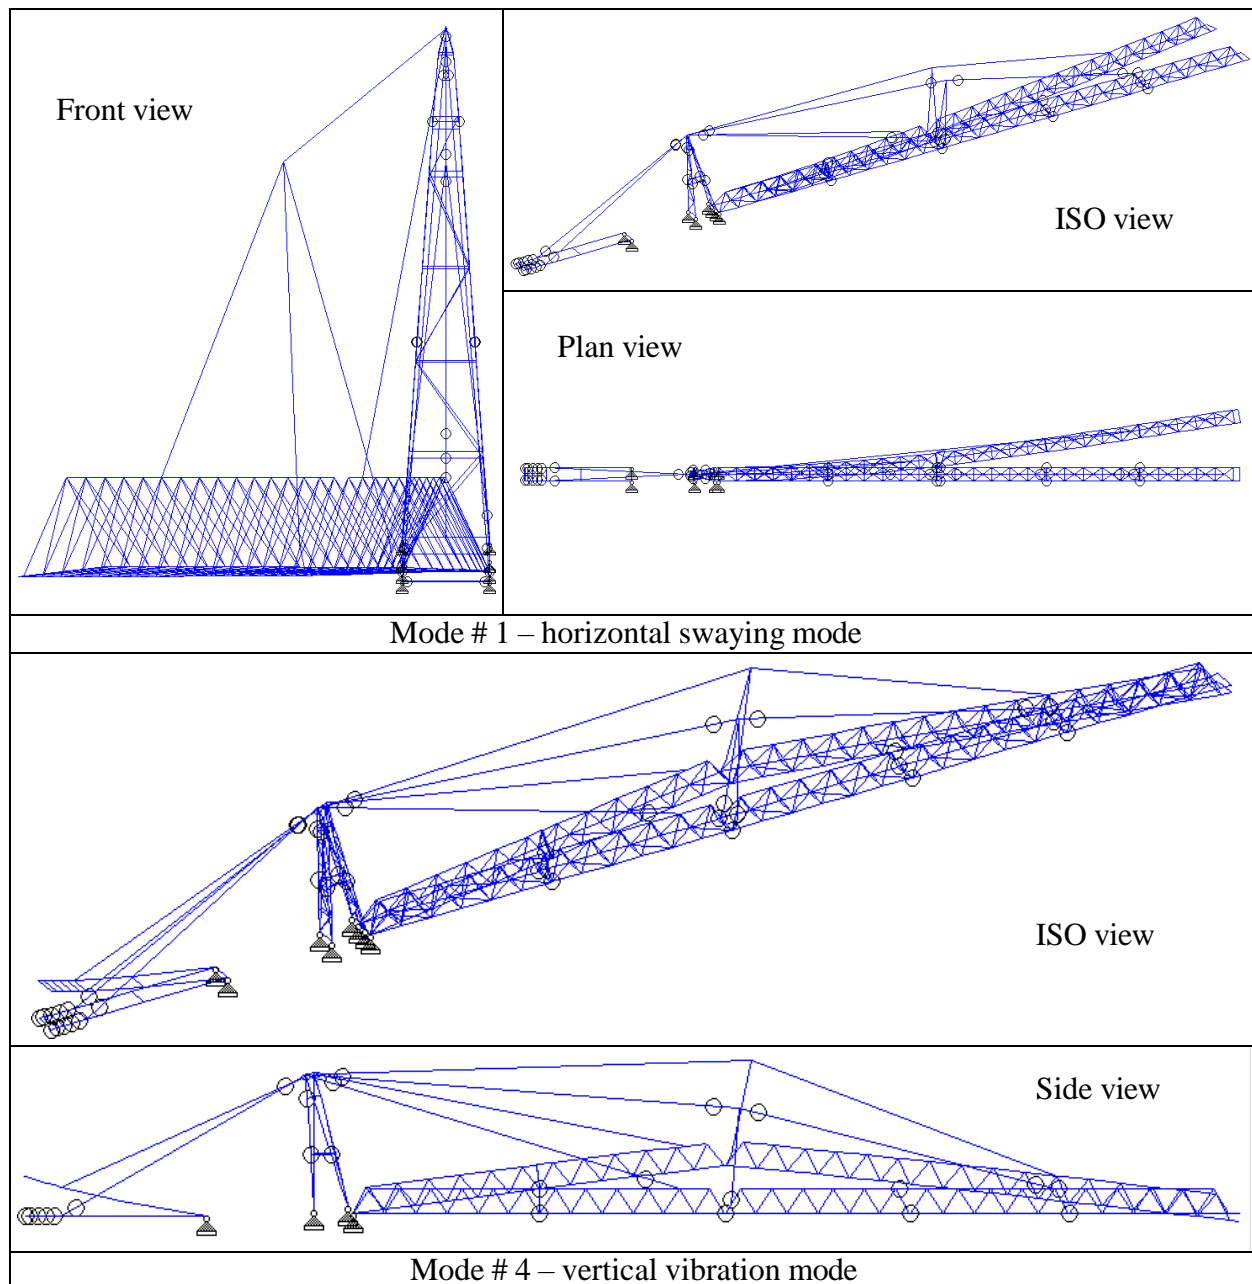
Figure 45 First two dominant modes of the crane mobile parts (1st failure crane)

It was found that the dominant modes of the crane mobile parts included both transvers swaying of the jib and vertical shaking of the jib and counterjib, as shown in Figure 45.

As mentioned previously, the cranes involved in the first two collapses were in tailwind condition prior to the collapses; and, for the third failure, jib rotation speed prior to the collapse was not known. Whether the rotational frequency is able to excite the jib structure's natural modes, especially the transverse mode, as shown in Figure 45, is not clear.

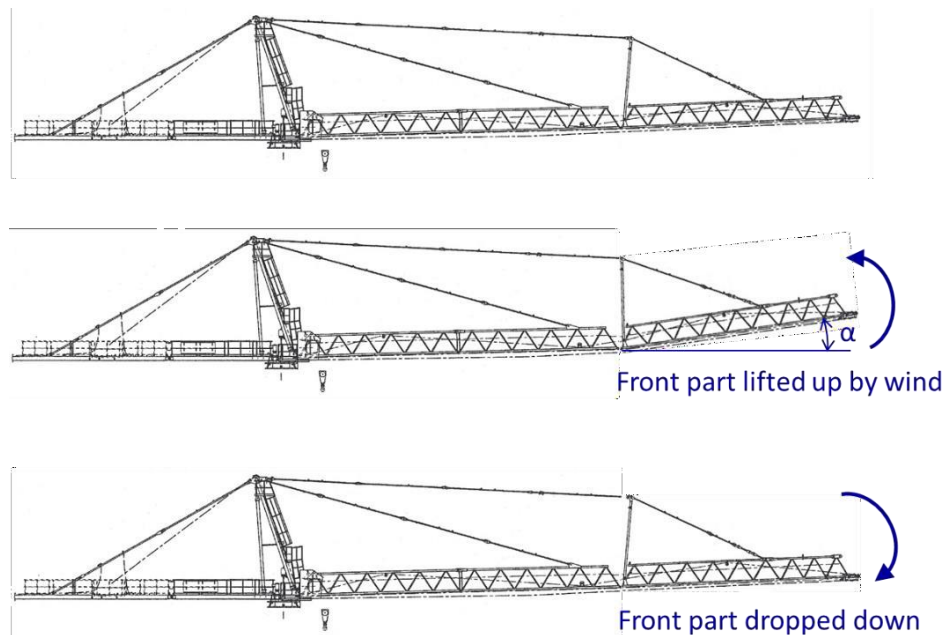
Figure 46 Front jib dropping failure

Static analyses were conducted to determine the minimum vertical wind speed to overcome the self-weight of the front part of the jib involved in the third collapse, and the minimum wind speed is about 173 miles per hour. Then, impact loads in the front pendants and the two posts of the A-frame were determined by assuming the front part of the jib as a rigid body dropping from different heights. It was found that the pendants and the A-frame would fail due to the impact force of the dropping of the front part jib if the front part of the jib were lifted up about 2° ($\alpha=2^\circ$ in Figure 46).

Therefore, it is possible that the front part of the jib involved in the third collapse was lifted by a strong vertical wind when the wind disappeared the jib section dropped down, and a significant impact force acted on and failed the A-frame. Once the jib started swaying to the side due to unbalanced suspension forces, the collapse of the jib, counterjib and tower top occurred.

Since the A-frames of the first two collapse were found intact after the collapses, the probable cause discussed in this section is only applicable to the crane involved in the third failure.

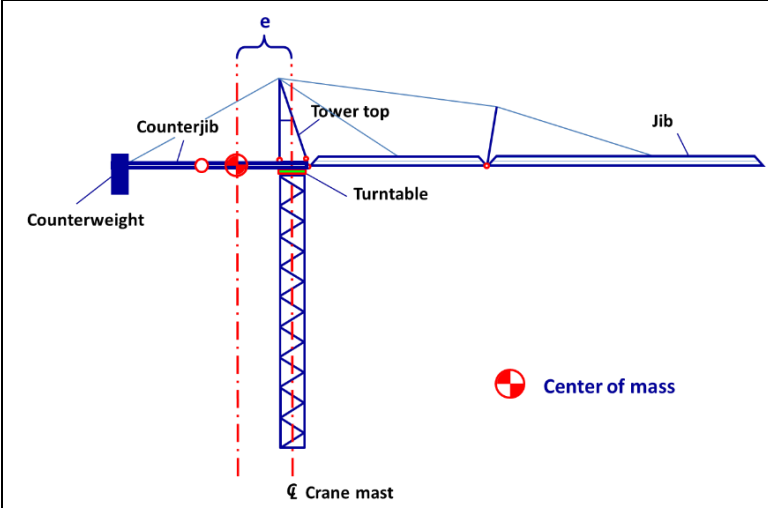
Table 5 Loading conditions of the counterjib side tower top columns – out-of-service

1 st Failure	2 nd Failure	3 rd Failure
	e (ft.)	22	25	27
	F (kips)	115	119	119
	σ (ksi)	22	23	23

The material grade for the columns was S355J2H, with a yield stress of 52 ksi. The governing critical load for the buckling was 984 kips on the major axis. This critical load would cause uniform stress of 197 ksi, which exceeded the yield stress of the steel (52 ksi), and the two columns would yield before buckling. Therefore, dynamics analyses are necessary to determine the possible failure mode of the tower top under transient loads, as provided in the following section.

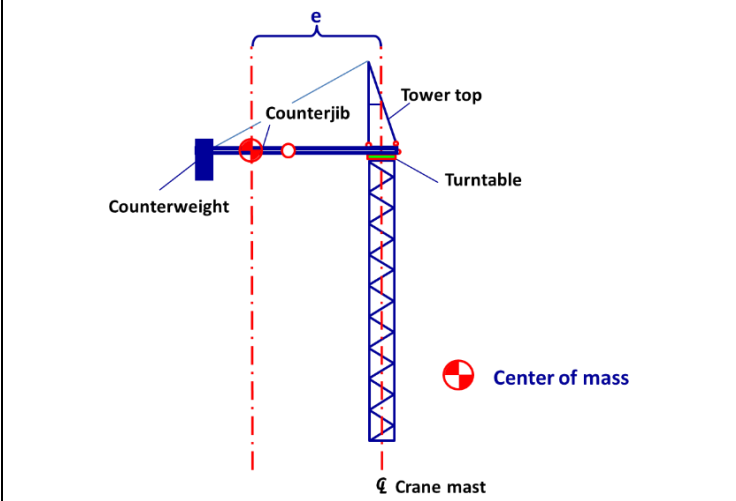
Table 6 Loading conditions of the counterjib side tower top columns – without jib

1 st Failure	2 nd Failure	3 rd Failure
	e (ft.)	59	58	58
	F (kips)	207	177	167
	σ (ksi)	40	34	33

When the tower top is loaded from the counterjib only, the maximum compressive stress in the two columns toward the counterjib is about 77% of the yield strength of the steel for the crane involved in the first failure, and about 65% for the crane involved in the second failure and 63% for crane involved in the third failure.

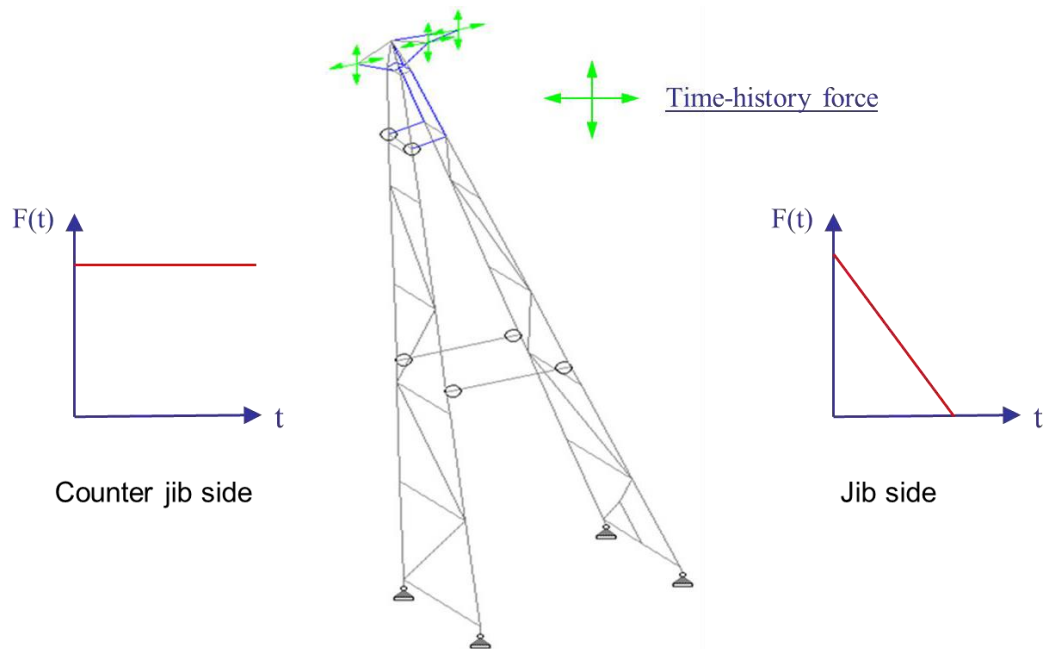
Figure 47 Frame model of tower top for dynamic analysis

As discussed in previous sections, the jib pendants were released in a short period due to the falling of the jib once it detached from the turntable. Per the video footage taken at the first failure site as discussed in Section 4.1, the time duration of the entire process could be less than 0.1 seconds. Dynamic time history analyses were carried out on 3D frame model of the tower top only, as shown in Figure 47. A linear time-history function to simulate the sudden disappearance of the pendant tension from the jib side was adopted in the analyses, as shown in Figure 47. Results indicate that the two tower top columns towards the counterjib side were overstressed and failed due to the sudden release in tension in the jib pendants. The maximum combined compressive stresses in the upper sections of the two columns toward the counterjib are 63 ksi for the crane involved in the first failure, and 59 ksi for the cranes involved in the rest two failures.

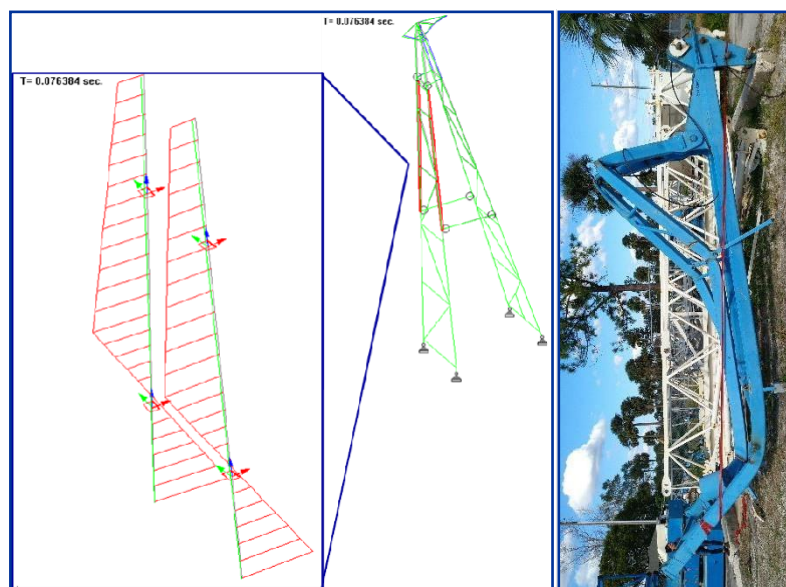
Figure 48 Strong axis bending moment diagram of the columns vs. deformed columns

The diagram of the governing bending moment in the upper sections of the two columns toward the counterjib is shown in Figure 48. It is found that the maximum compressive stress occurred at

the side of the column section toward the jib. The deformed columns of the tower top toward the counterjib are consistent with the bending moment diagrams, as shown in Figure 48.

10. To prevent catastrophic collapses of the crane tower top in the future, it is recommended that tower tops be evaluated and designed with a higher safety margin, and the design should also be based with loads applied from only the counterjib.
