# Fire during Hot Work at Evergreen Packaging Paper Mill

# Investigation Report

Published: September 24, 2021

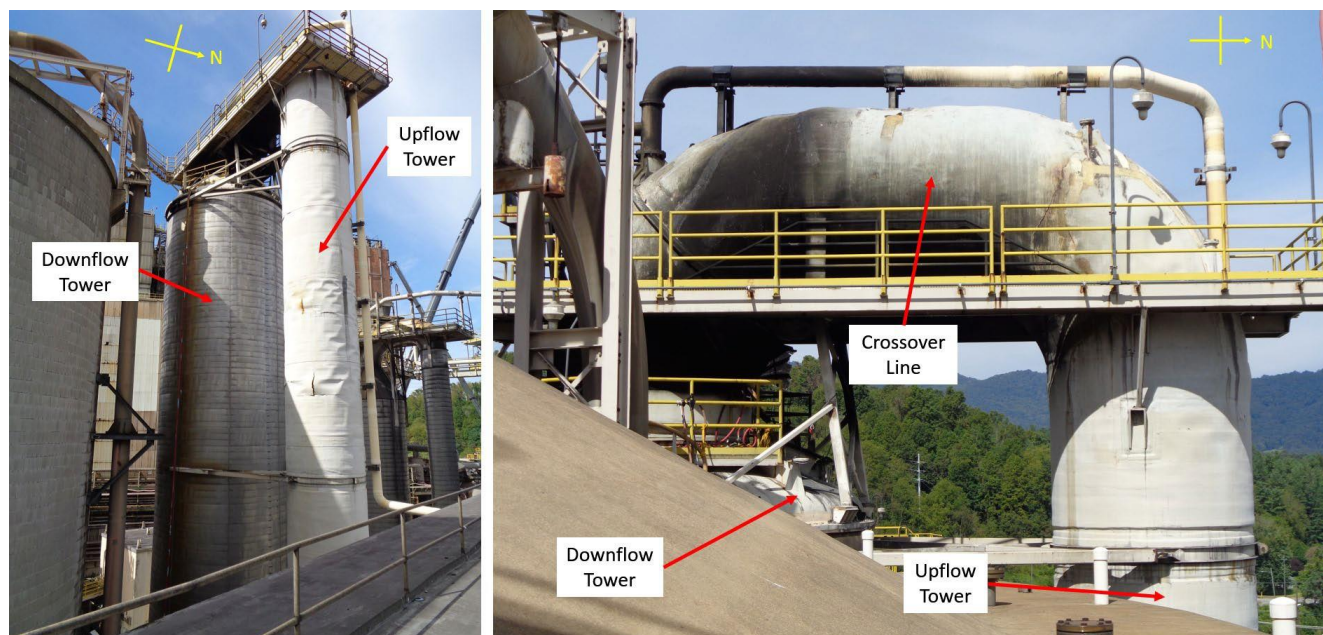
**Figure 1.** Typical bleach reaction stage at Evergreen. (Credit: CSB.)

The incident occurred in one of Evergreen's bleaching units, called the #2 Fiber line bleaching unit, which removes color from wood pulp to make white paper products. The bleaching process occurs in three reaction stages. Each stage consists of a pair of process vessels: the first, called the "upflow tower" and the second, called the "downflow tower." The two vessels are connected at the top by a large diameter pipe, called the "crossover line" (**Figure 1**).

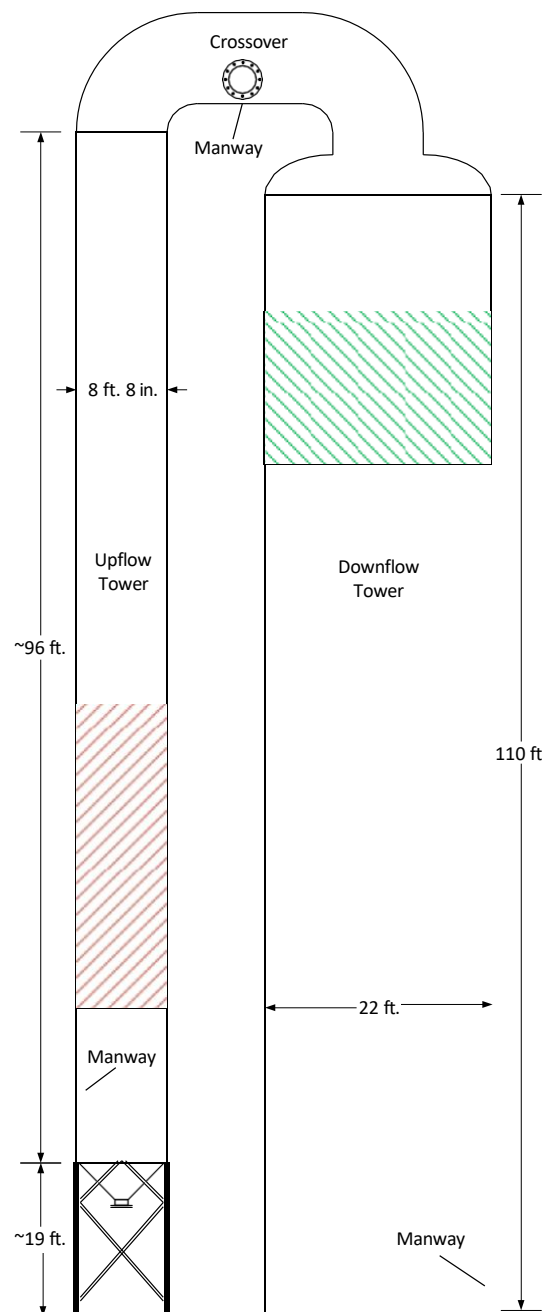
**Figure 3.** Diagram of the #2 Fiber Line D2 towers. (Credit: CSB.)

The #2 Fiber line D2 upflow tower was constructed of fiber-reinforced plastic (FRP) and was approximately 96 feet tall and almost nine feet in diameter (**Figure 3**). The downflow tower was constructed of a carbon steel shell, lined internally with a urethane membrane covered with fireclay acid brick laid in vinyl ester mortar. The downflow tower was 110 feet tall and roughly 22 feet in diameter. These two towers were connected by a crossover line, which was approximately the same diameter as the upflow tower, and which was also constructed of FRP.

Blastco’s scope of work for the shutdown was, among other tasks, to perform FRP maintenance on four upflow towers in Evergreen’s bleaching units. For the #2 Fiber line D2 upflow tower, Blastco’s work scope was to repair approximately 30 feet of FRP, illustrated with red shading in **Figure 3**. This scope of work involved grinding away old material until acceptable base material was found, followed by applying alternating sheets of new fiberglass with layers of resin, until the desired thickness was reached. To accomplish this work, traditional scaffolding was built up from the ground to the entry manway of the upflow tower, which was located 23 feet above the ground. Inside the tower, additional scaffolding platforms were assembled so that workers could access the entire inside surface that was to be repaired.

Rimcor's scope of work was to re-line approximately 15 feet of the #2 Fiber line D2 downflow tower, illustrated with green shading in **Figure 3**. This work involved using pneumatic jackhammers to remove the old brick, mortar, and urethane membrane, and abrasive blasting to remove residual membrane material, until the bare steel shell was exposed. Once the steel subsurface was prepared, the next step involved applying new membrane material and lastly installing the new brick lining. To accomplish this, Rimcor used a special kind of scaffolding, called a "suspended" scaffolding, inside the downflow tower. This scaffolding consisted of a circular engineered steel scaffold with wooden decking, suspended from mounting points on the roof of the vessel via steel cables. Workers entered the tower via the manway at ground level and assembled the scaffolding platform inside the tower. Once the platform was built and suspended, six workers simultaneously used cable winches to slowly raise the platform to the desired height. Moving the platform was a slow process—it took six workers approximately four hours to raise the platform to Rimcor's work location inside the downflow tower. The platform had a barricaded hole in the middle which workers used along with a hoist to raise and lower tools, materials, and other workers, via chairlift, to and from the platform. At the time of the incident, two Rimcor workers were inside the upflow tower performing abrasive blasting operations.<sup>a</sup>

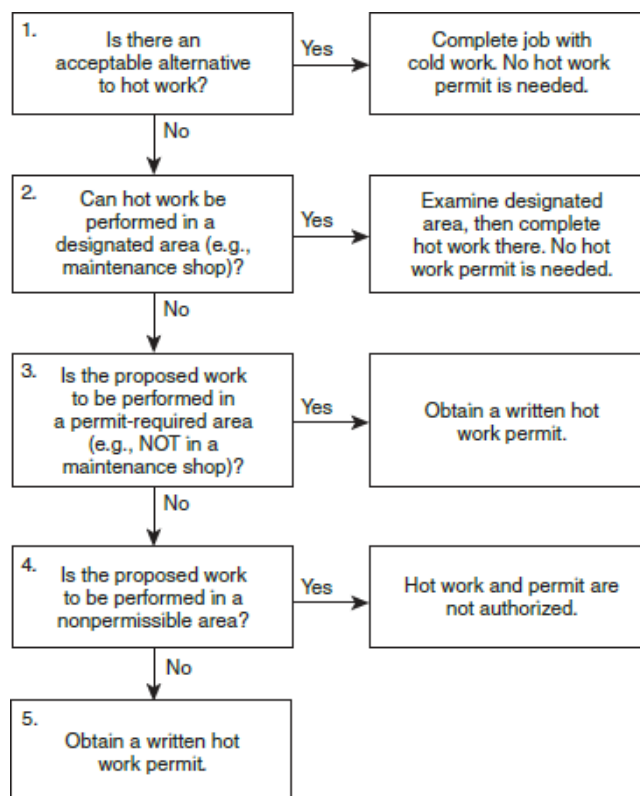
**Figure 11.** NFPA hot work decision tree. (Credit: NFPA [10].)

NFPA guides companies and workers to avoid hot work—in this case, the use of the heat gun—altogether if there is a suitable alternative. NFPA 51B contains a decision tree (**Figure 11**) for hot work permitting, encouraging users to ask the question “Is there an acceptable alternative to hot work [10, p. 13]?”

As discussed in Sections 1.8 and 2.2, Blastco workers attempted several alternatives to hot work. According to Blastco, the company had two drum heating bands available at the time of the incident. However, the two heaters were stored separately on Blastco’s two job

trailers, at least one of which was undergoing renovation and reorganization. According to a Blastco worker, the reorganization was not complete at the time of the trailer's use for the job at Evergreen. The worker stated that when they searched for drum heating bands, the bands were not in their usual location, and that they could not locate the bands. The worker resorted to using a heat gun instead.
