Masonry Wall Collapse

The Division of Occupational Safety and Health of the State of Tennessee requested the Directorate of Construction, OSHA National Office, to provide assistance in the investigation and causal determination of the April 18, 2013 collapse of a masonry wall during construction of the Goodwill Retail Store in Hendersonville, TN. As a result of the wall collapse, two employees were killed and one was injured. Our investigation and evaluation were based on the information provided by the Division of Occupational Safety and Health of the State of Tennessee. Please note that we did not visit the incident site.

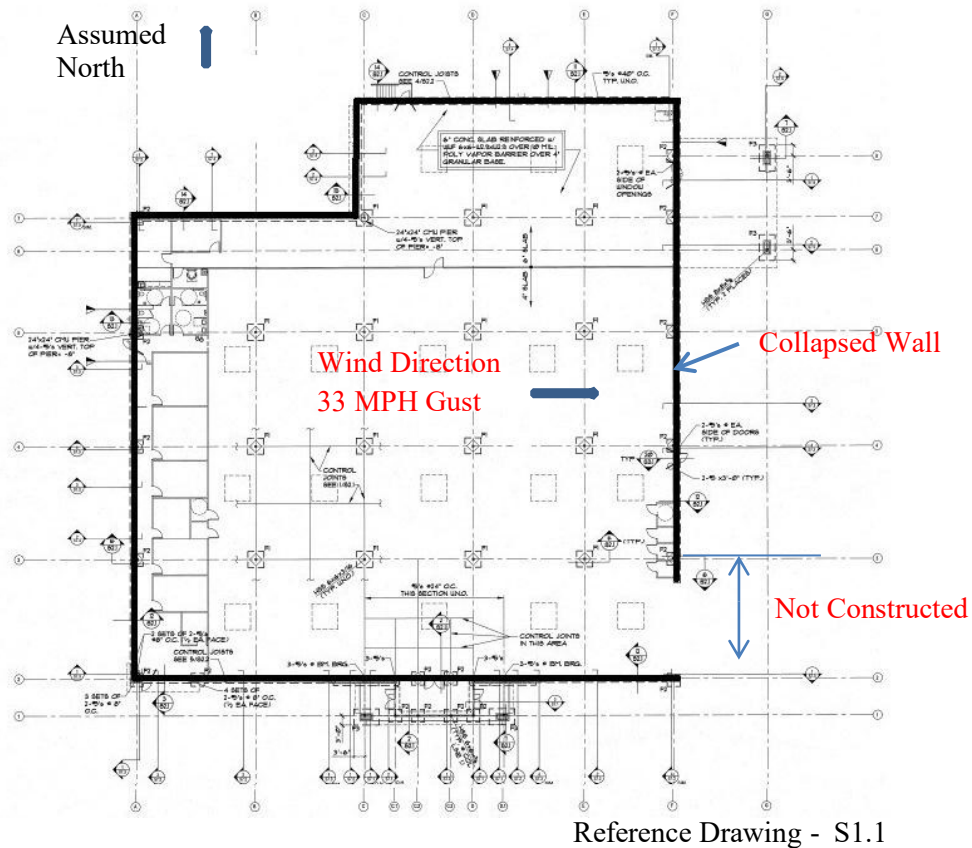
Figure 1 – CMU wall Plan

The project consisted of construction of a one-story Goodwill Retail Store, approximately 170' wide x 180' long (see figure 1).

For the purpose of this report, the wall that fell is identified as the east wall by the field personnel, although contract drawings identify it as the north wall. The exterior non-load bearing walls consisted of 8" thick partially grouted Concrete Masonry Units (CMU) supported on 2' wide x 1' deep concrete footing (see Figures 1 to 3).

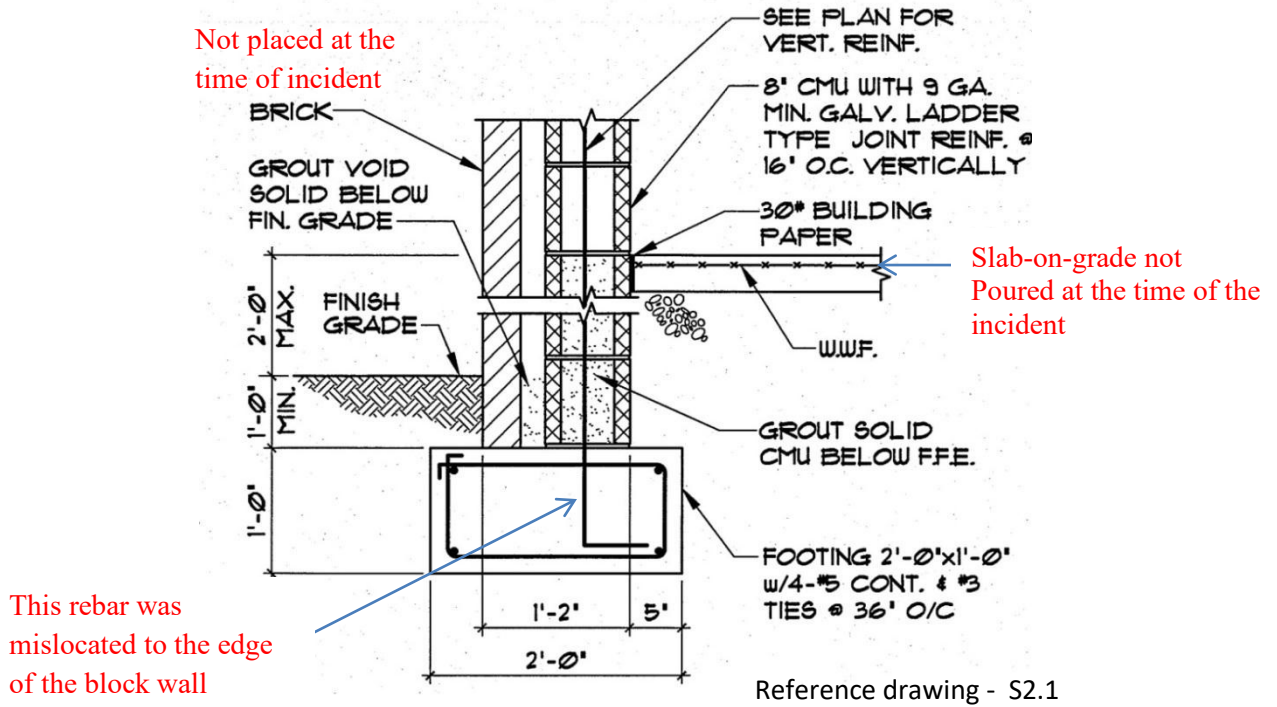
Figure 4 – Exterior Wall Section

The CMU walls consisted of hollow concrete blocks and were partially grouted using a low lift grouting method. The wall was reinforced with #5 rebars at 40" on center (see Figure 4).

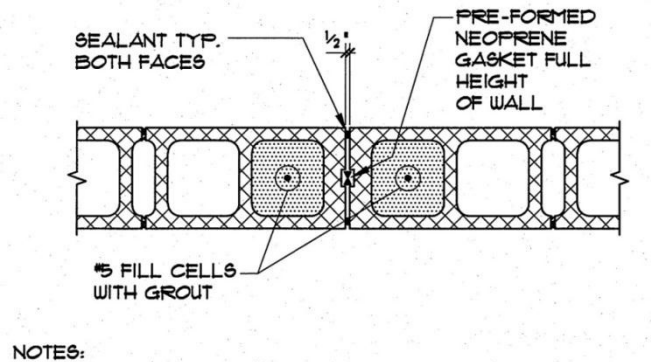
Figure 5 – Control Joint detail

The architect specified the maximum spacing of the control joints to be at 25' on center in the horizontal direction (see Figure 5).

The masonry contractor provided too few braces between the control joints of the 150'-long masonry wall that fell. In this project, the control joints in the masonry wall were designed and detailed as a complete separation (see Figure 5) similar to an expansion joint which necessitated a minimum of two braces for the masonry walls between the control joints (see Figure 11). Only three interior and three exterior braces for the entire wall were provided instead of the twelve specified in the industry standard, "Standard practice for Bracing Masonry Walls under construction" developed by the Council for Masonry Wall Bracing. Two exterior braces of the east wall were removed a few days prior to the collapse. All required braces should have been left in place until permanent supporting elements were constructed, e.g., the roof deck and its attachments to the bond beam at the top of the wall. If the masonry contractor had provided an adequate number of braces as per the industry standard, this incident could have been avoided.

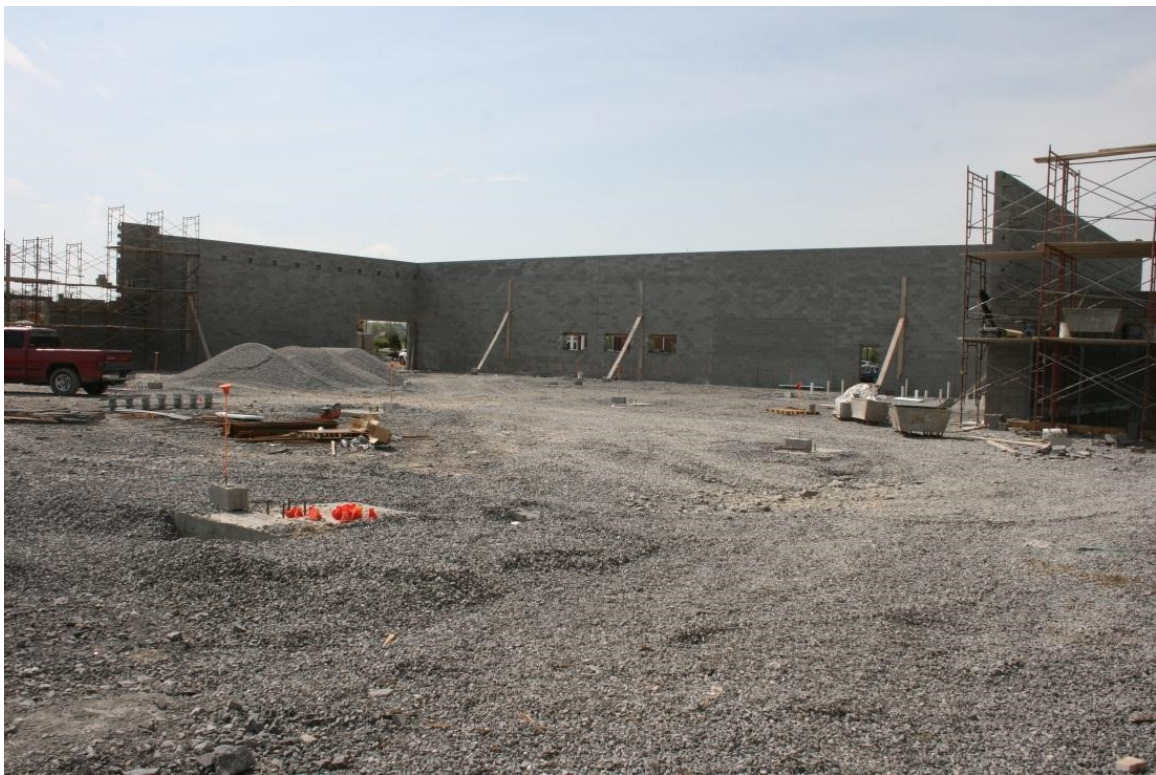
Figure 6 – Typical interior bracing detail

Bond beams were used at window openings, roof level and at the top of the parapet. The bond beams at the top of the masonry wall were reported to be discontinuous at the control joints. The ground floor slab, also known as the first floor slab, was not poured at the time of the incident. During construction, the masonry contractor had provided six bracings against wind for the entire length of each wall. Three braces were located at the interior (similar to Figure 6) and three on the exterior faces of each wall.
