Pedestrian Bridge Collapse in Miami, Florida

1. Executive Summary

On March 15, 2018, at approximately 1:45 p.m., a pedestrian bridge under construction in Miami, Florida, collapsed. One employee and five motorists were fatally injured, and another employee permanently disabled, when the bridge fell as the motorists waited for the traffic light underneath the bridge and as the employees were performing work activities on top of the bridge structure. The bridge at the present stage of construction consisted of a single concrete truss spanning approximately 174 feet and weighing approximately 930 tons. It was placed over the piers just five days prior to the collapse. An adjoining span of concrete truss was to be constructed next over the canal to make a continuous bridge of 289 feet. The concrete bridge was cast at a nearby off-site location using what is known as Accelerated Bridge Construction (ABC) and then transported to its final location. ABC provides minimal traffic disruption. The bridge was financed through federal grants, and constructed at the campus of Florida International University (FIU) in Miami. The FIU project was a class A Local Agency Program (LAP) project. The

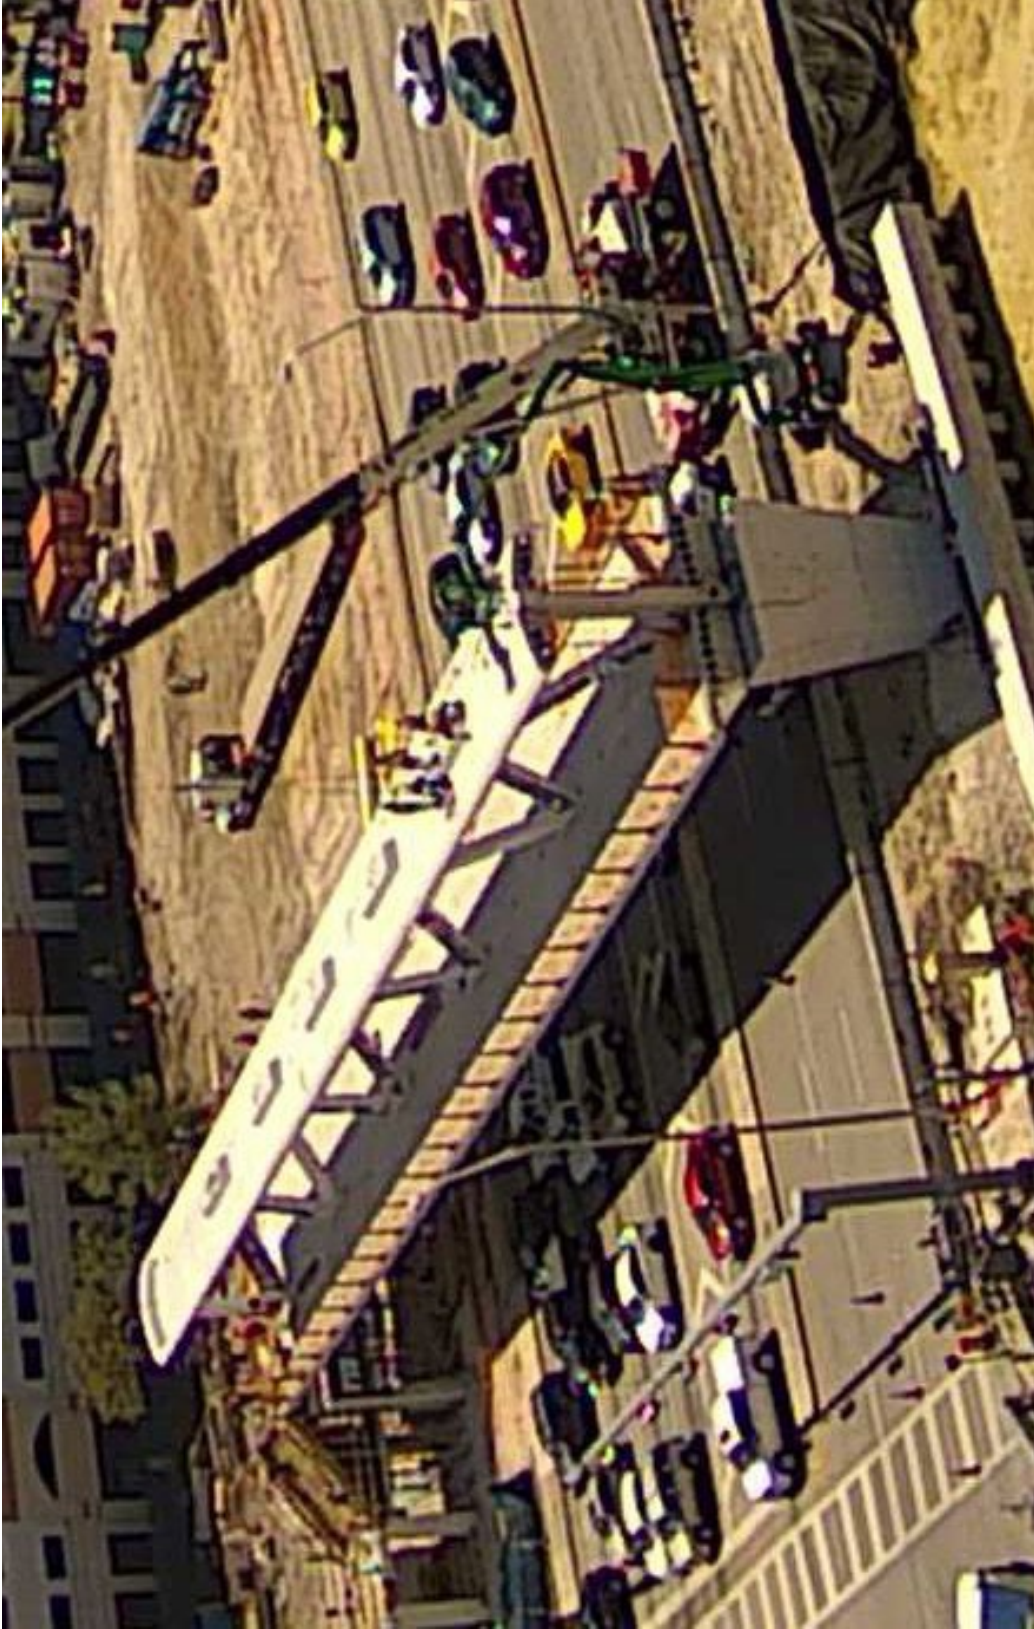
Figure 48 Bridge immediately prior to the collapse, March 15, 2018 – camera #2

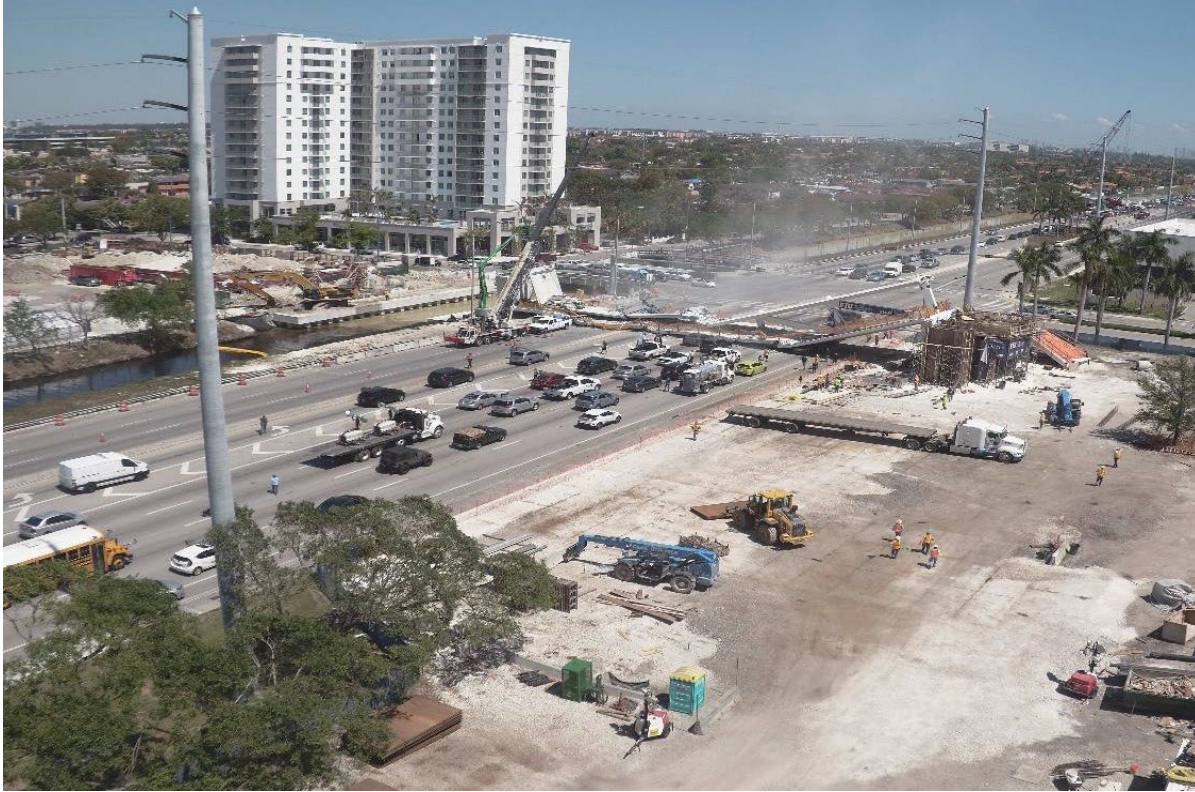
Figure 51 Bridge immediately after the collapse, March 15, 2018
 – camera #3 (north on the left and south on the right)

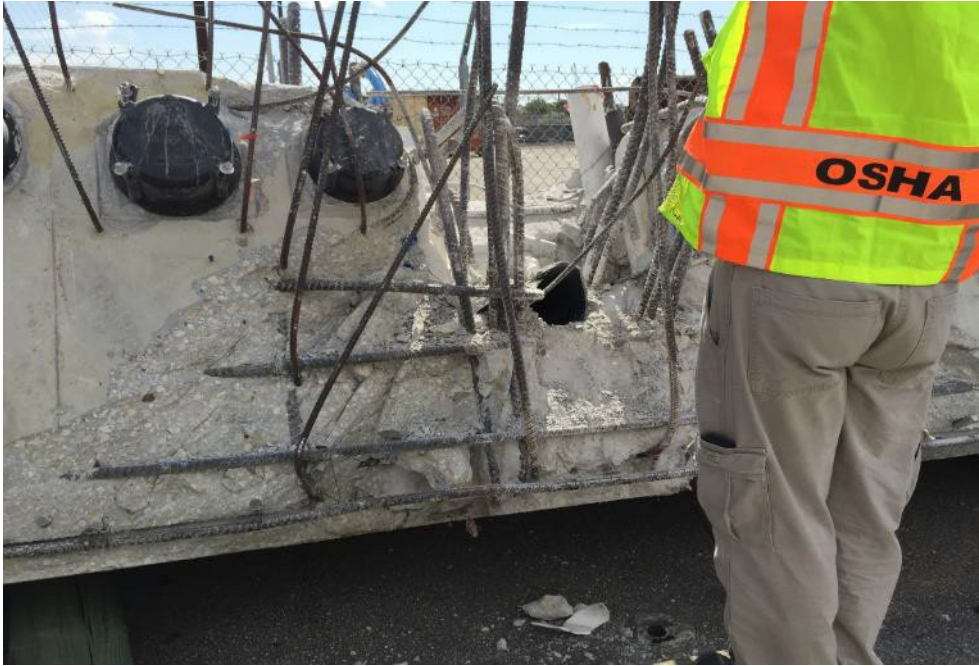
Diaphragm II experienced a blow-out of concrete at the junction of diagonal 11 and column 12 creating a hole shown below in Figure 58 through Figure 70. As a result, column 12 lost support over the pylon and failed with the top tilting approximately 80 degrees towards the south, as shown in Figure 52. The base of column 12 shifted a few feet towards the north but remained on the top of the pylon. Thereafter, collapse of the canopy, diagonal 11 and the deck followed. The canopy partially remained attached to column 12. The remaining diaphragm II and the deck fell approximately 18 ft. to the ground below, see Figure 52. One end of the diagonal 11 remained

Figure 66 Punched hole in Diaphragm II at the time of the bridge collapse – from south looking towards north, April 9, 2018, by OSHA

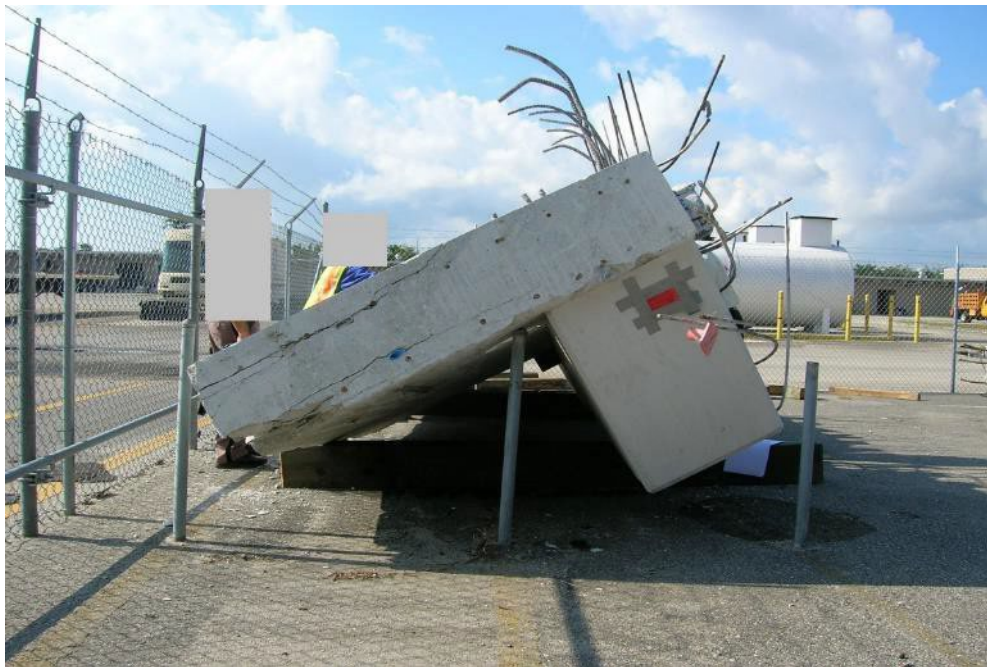
Figure 71 Side view of the saved portion of the diaphragm II in storage yard, April 9, 2018, by OSHA

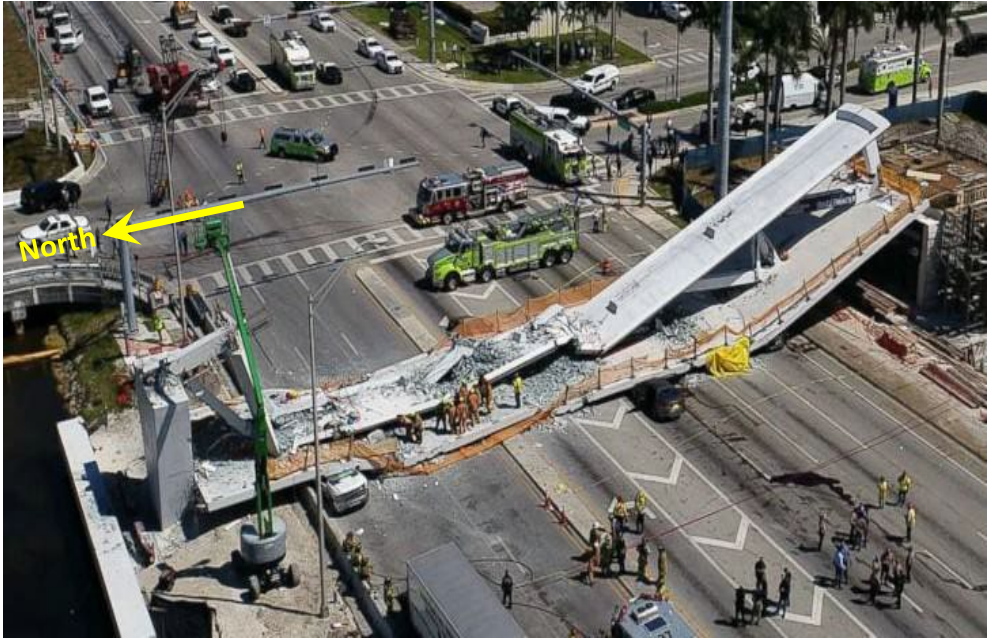
Figure 72 Aerial view of the collapsed bridge, March 15~18, 2018

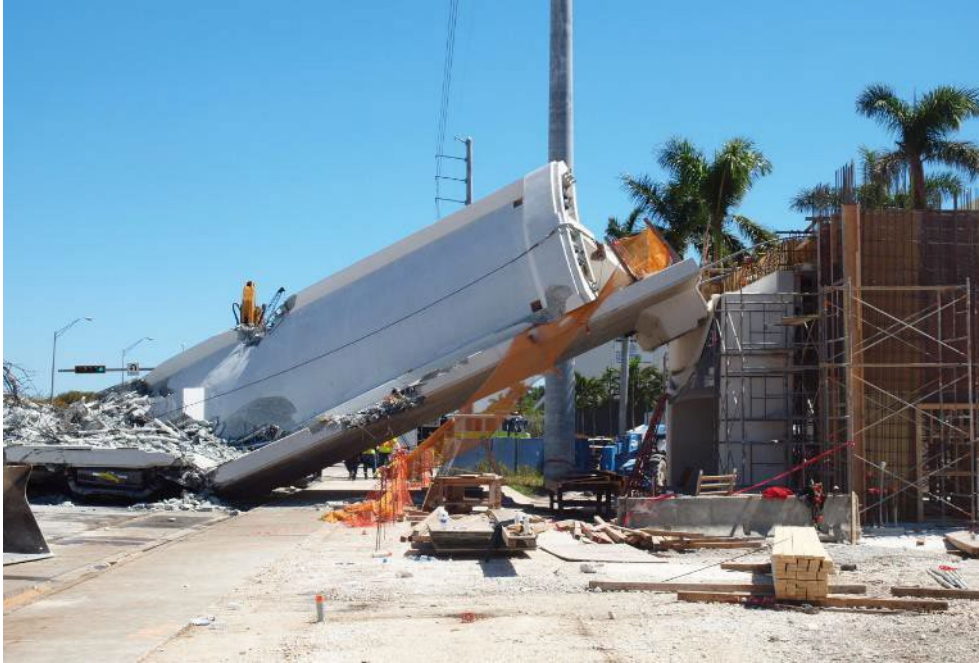
Figure 74 South end of the bridge after collapse – looking east

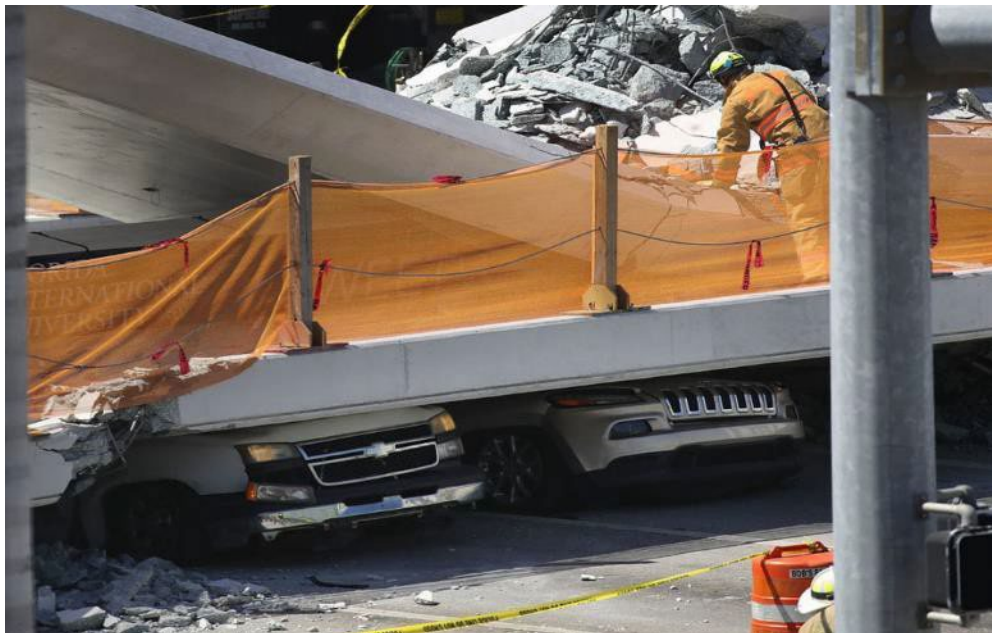
The collapse crushed five motorists in their cars that were stopped at the traffic light at the time of the collapse, see Figure 75. As stated earlier, one VSL employee was fatally injured and another VSL employee was critically injured.

Figure 75 Vehicles crushed by falling bridge
