U.S. Department of Labor  
Occupational Safety and Health Administration  
Directorate of Construction

# **Structural Investigation of the January 20, 2014 Plant Collapse at International Nutrition Facility in Omaha, NE**

July 2014

Report Prepared by  
Mohammad Ayub, P.E., S.E.  
Office of Engineering Services  
Directorate of Construction

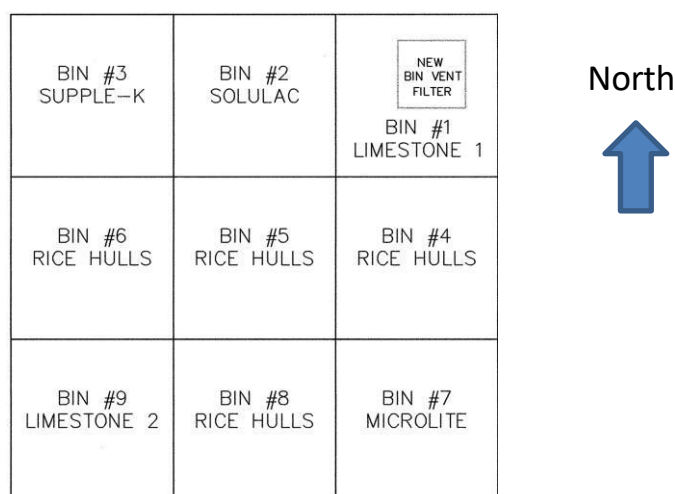
It is interesting to note that on one of the KBC drawings, F1.8 dated July 2, 1996, there is a sketch showing nine bins with limestone in two diagonally opposite bins, Microlite in one corner bin, supple-K in the fourth corner bin, with the rest of the bins having rice hulls (see Fig. 8, below).

**Fig. 8** Bin layout (Taken from drawing F1.8 by Ken Bratney Company, 1996)

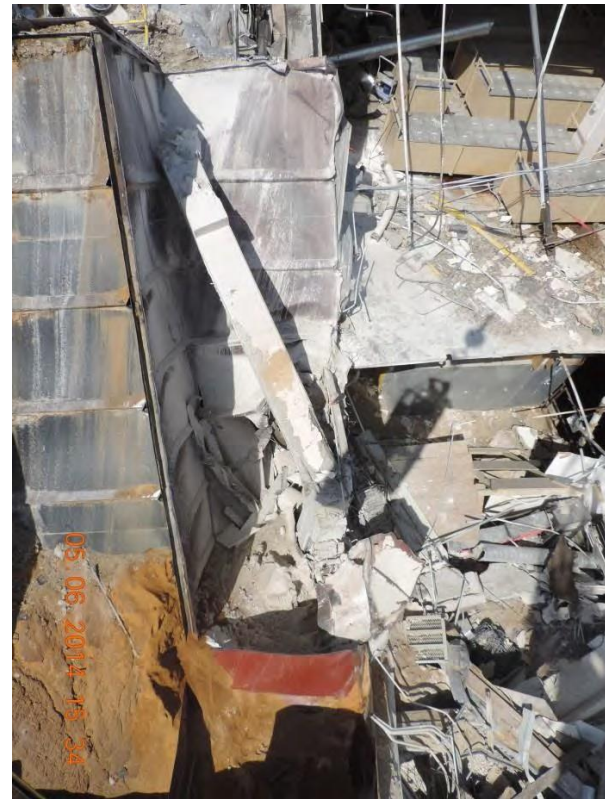
**Fig. 13** NE concrete column in bin No. 1

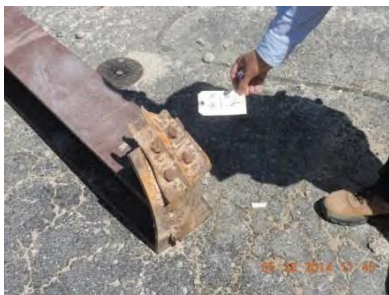
**Fig. 34**– Joint 1 – East truss

All four beam-bearing connections on the east and west exterior trusses failed when the 3/8" stiffener plate buckled. The four connecting bolts remained mostly intact, see Figs. 34, 39 and 44. The north and south trusses are shown in Figs. 86 and 87 respectively. Their joints are shown in Figs. 16 thru 33 below.

The weakest link in the structure was the four stiffened seated connections of the top chords of the east and west trusses at each end. The bottom flanges of the top chords of the east and west exterior trusses, W6x15, were bolted with four bolts to the ½” cap plate of the corner column projecting beyond the column flanges. The cap plate was welded to the column. A stiffener plate 3/8” thick was provided underneath the cap plate. The seated connection was subjected to a vertical load coming from the east and west trusses and a horizontal force equivalent to the compressive force in the truss top chords. Both the vertical and horizontal forces created eccentricity on the connection, and it was determined that a single stiffener plate would overstress the seated connection to failure. If either a north or south connection was provided with a sliding joint to relieve the horizontal force, the connection with only one stiffener plate would have been able to resist the loads satisfactorily. Alternatively, if two stiffener plates were provided as was done in the cases of the interior trusses, the stresses would be satisfactory. As stated earlier, all four stiffened seated connections failed, see Figs. 34, 35, 38, 44 and 47.

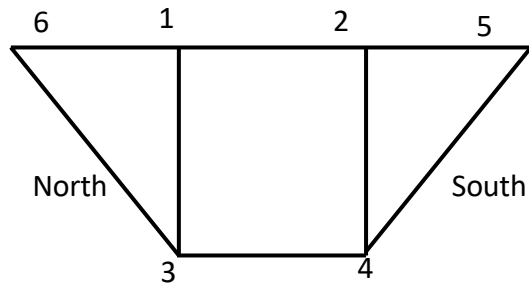
**Fig. 108**– East Interior Truss

The east and west interior trusses are shown in Figs. 108 and 109 respectively. Their joints are shown in Figs. 52 thru 63 below.

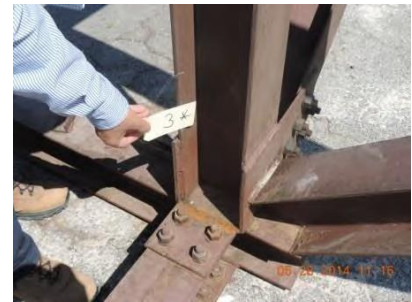
**Fig. 54** – Joint 3 – East interior

and were connected to the east and west exterior trusses by four bolts on an extended gusset plate. The top chords of the east and west interior trusses were simple spans and were connected by two bolts to the north and south interior trusses. It is noteworthy that the bottom panel joints of all four interior trusses were practically undamaged; see Figs. 54, 55, 59, 60, 66, 67, 74 and 75.

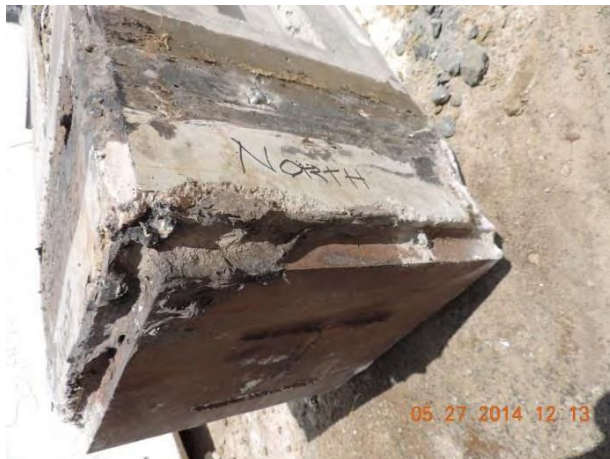
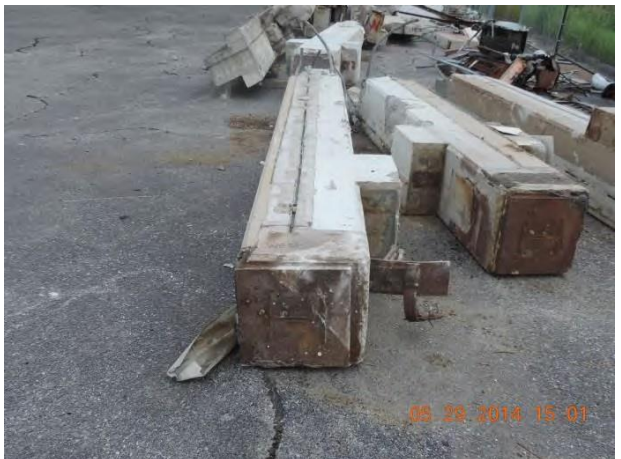
The four corner columns, W8x40, remained intact and did not exhibit any signs of distress. The failure occurred at the bottom of the columns where the welds to the column base plate failed, see Figs. 78 thru 85. The column base plate remained connected to the embed plates of the concrete columns; see Figs. 78 thru 85 and 95. For typical hoppers pictures after they have been retrieved from the debris, see Figs. 96 thru 98.

**Fig. 84** – W8x40 base plate

**Fig. 85** – W8x40 base plate

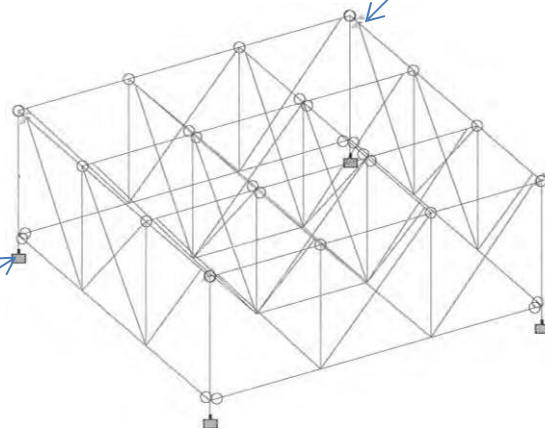
Fig. 90

Seated beam support at east and west truss ends (typ. @ 4 places).

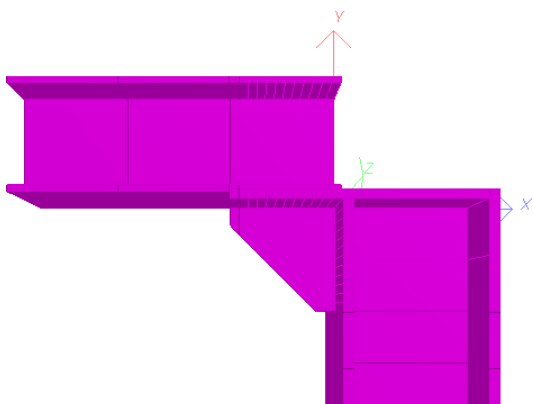
**Fig. 94** Finite element model

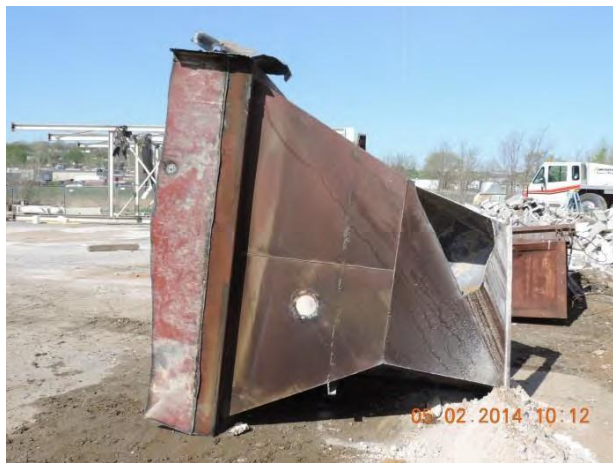
The walls of the bins were reinforced by welding 5x3x1/4" steel angles to the steel plate at 4' o.c., vertically. There was a common wall between the bins. The hoppers were welded to the bins, and were integrated to each other with a lip bearing over the top flange of the top chords of the external and internal trusses. Thus, the bins and the hoppers were one integrated structure resting over the steel beams, see Figs. 96 thru 98.

**Fig. 96** – Typical hopper

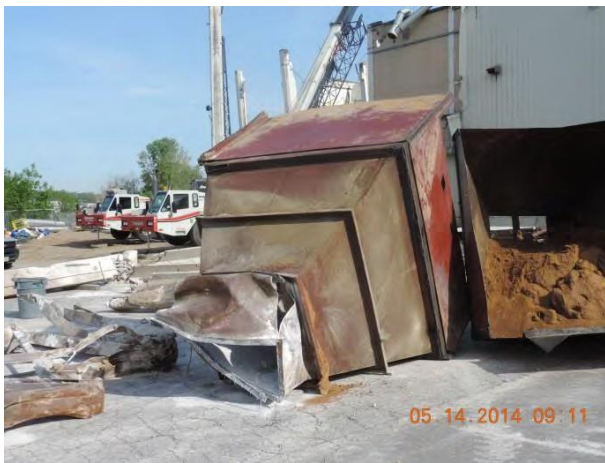
**Fig. 97**-Typical hopper

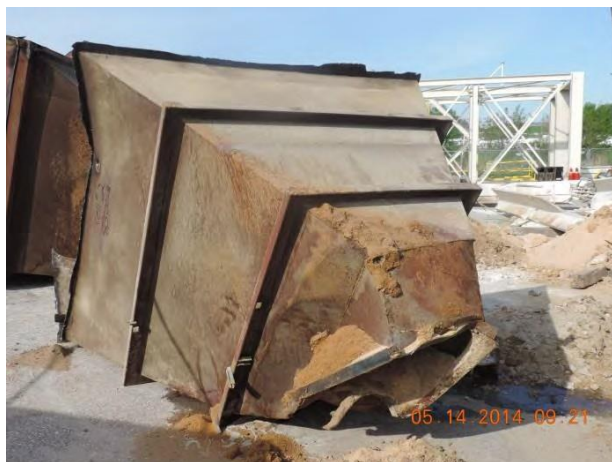
**Fig. 98** – Typical hopper
