# Pressure Vessel Explosion at Loy-Lange Box Company

# Investigation Report

Published: July 29, 2022

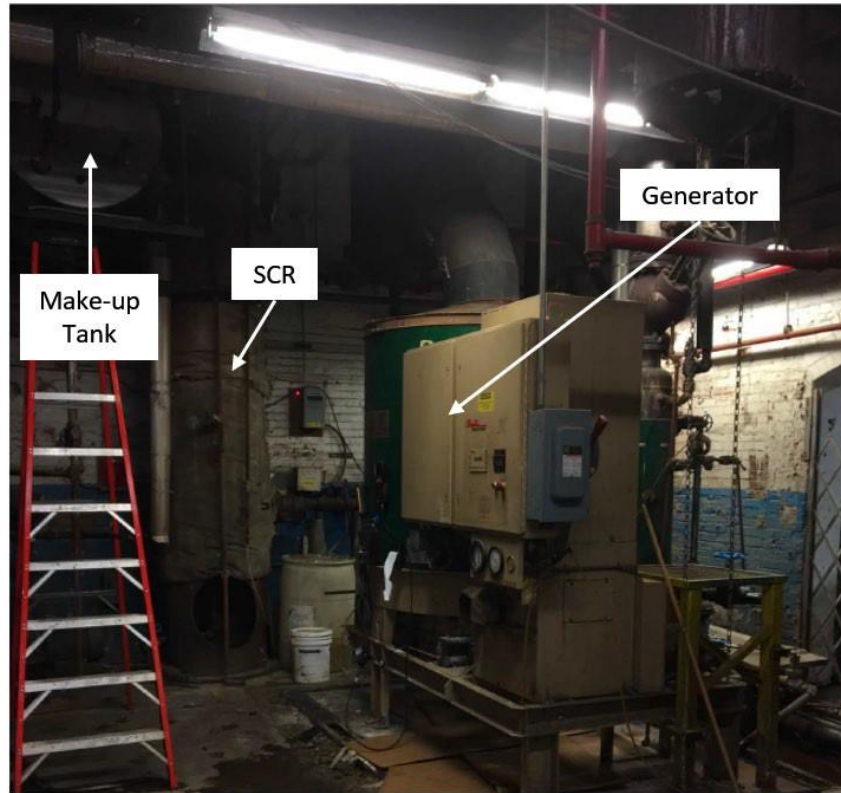
**Figure 3.** Pre-incident photo of the Loy-Lange steam generation equipment. (Credit: Clayton. Annotated by CSB.)

A pre-incident picture of the Loy-Lange steam generation room is shown below in **Figure 3**, which also shows the close proximity of the SCR to one of the steam generators.

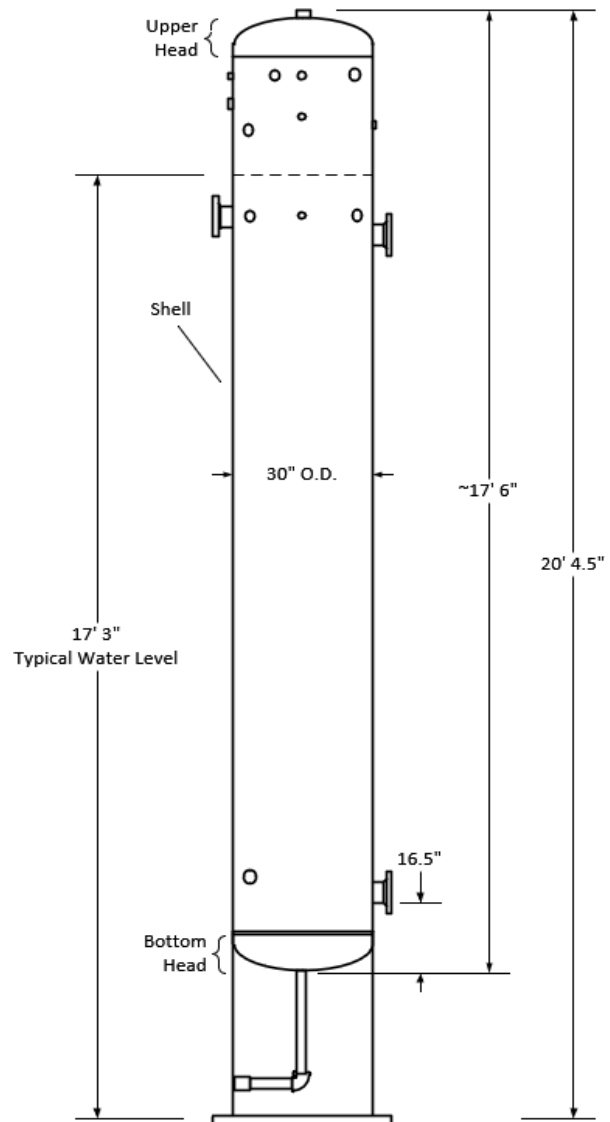
**Figure 4.** Diagram of SCR. (Credit: Clayton, edited by CSB)

The Loy-Lange SCR was a cylindrical pressure vessel with an outside diameter of 30 inches and a length of about 17.5 feet (**Figure 4**). The SCR was mounted roughly three feet above grade on top of a support cylinder, or *skirt*. The cylindrical center portion of a pressure vessel is called the *shell*, and the pieces that enclose the ends of the shell are called *heads* [3]. The SCR was located near one of the steam generators (**Figure 3**).

According to the vessel's U-1A form,<sup>a</sup> the SCR was designed by Chicago Boiler with a nominal thickness of 0.250 inches, a maximum allowable working pressure (MAWP) of 150 psi, and a maximum design temperature of 450°F. Additionally, it was designed for non-corrosive service and was designed with no corrosion allowance. The upper and lower heads of the SCR were designed and fabricated with a 2:1 elliptical ratio. The SCR's design minimum thickness<sup>b</sup> was 0.2204 inches. According to Clayton, the SCR was originally equipped with a pressure relief valve set at 150 psi. After the incident, the SCR was found to be

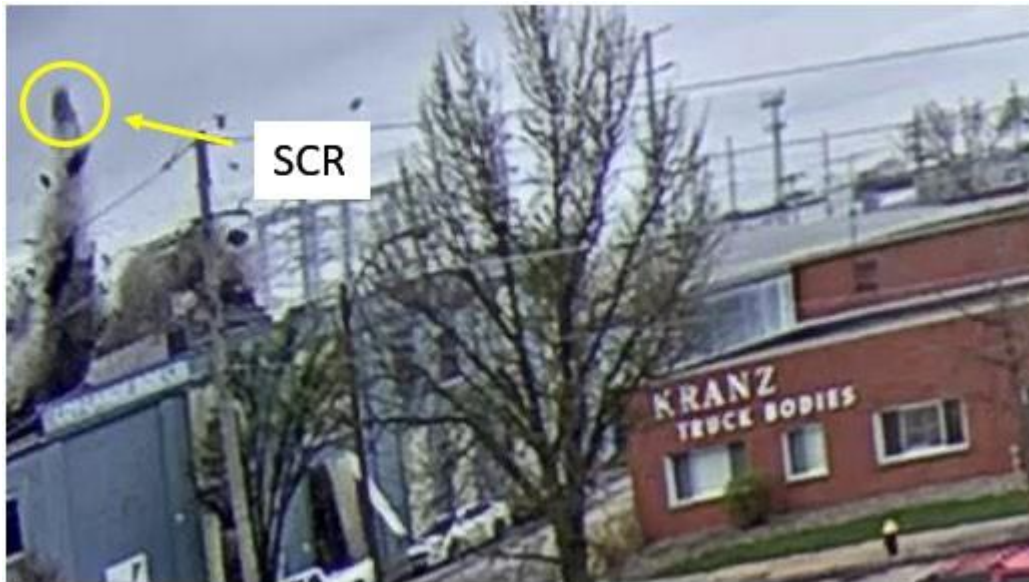
**Figure 9.** Surveillance video still capturing explosion. (Credit: Kranz Body Co., annotations by CSB)

On Friday, March 31, 2017, Loy-Lange stationary engineers observed a leak that appeared to be coming from underneath the SCR. One stationary engineer took photos of the underside of the vessel to confirm the leak. Another contacted a local welding company and requested that it assess the vessel and make a repair recommendation. The welding company was not available to visit the Loy-Lange facility until the following Monday, April 3, 2017. Loy-Lange continued operating the leaking pressure vessel throughout the remainder of the Friday production schedule and shut down the steam system as normal that evening. The following Monday a Loy-Lange stationary engineer began his normal start-up routine at about 6:00 a.m. At around 7:20 a.m. on April 3, 2017, the SCR bottom head catastrophically failed. The SCR was launched from the Loy-Lange building and into the air (**Figure 9, Figure 10**).

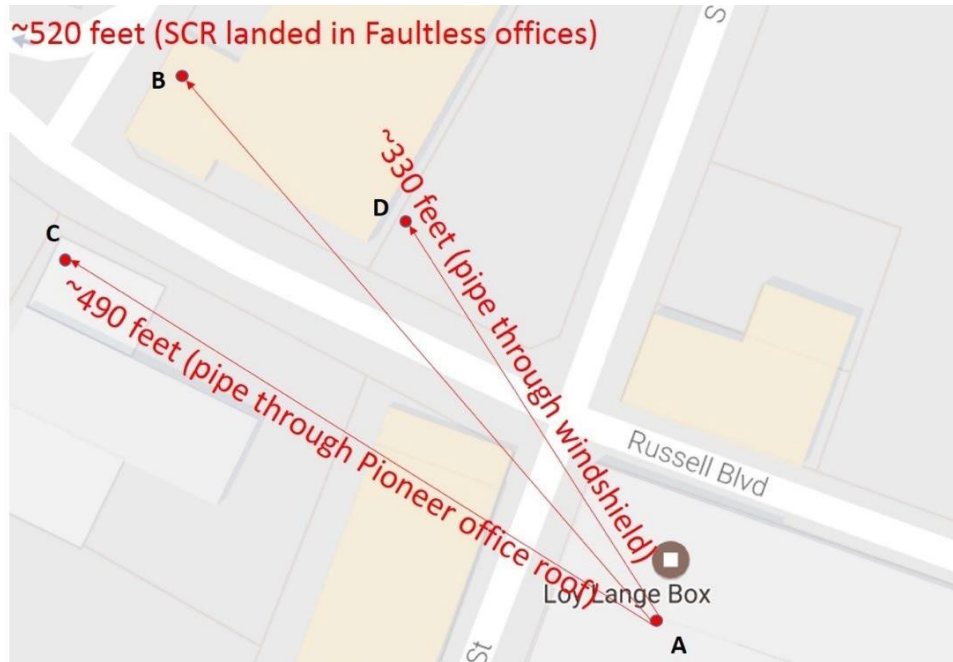
Figure 12. Debris map from incident. (Credit: Google, annotations by CSB)

The vessel remained airborne for approximately 10 seconds<sup>a</sup> and traveled laterally approximately 520 feet (**Figure 11A, Figure 12**). The SCR fell through the roof of the nearby Faultless Healthcare Linen company one block away, where it came to rest (**Figure 11B**). Various other pieces of debris from the explosion also fell into the surrounding area. A third building in the vicinity, owned by Pioneer Industrial Group, suffered damage when a large piece of pipe from the Loy-Lange explosion punctured the roof and ruptured its water sprinkler system

(**Figure 11C**). A section of 1.5-inch pipe approximately seven feet in length pierced the windshield and embedded in the dashboard and through the floorboard of an unoccupied pickup truck parked in the area (**Figure 11D**). A map of the debris field is shown in **Figure 12**. As a result of the incident, one stationary engineer at Loy-Lange was fatally injured. At Faultless Healthcare Linen, three employees were fatally injured when the SCR fell through the roof.

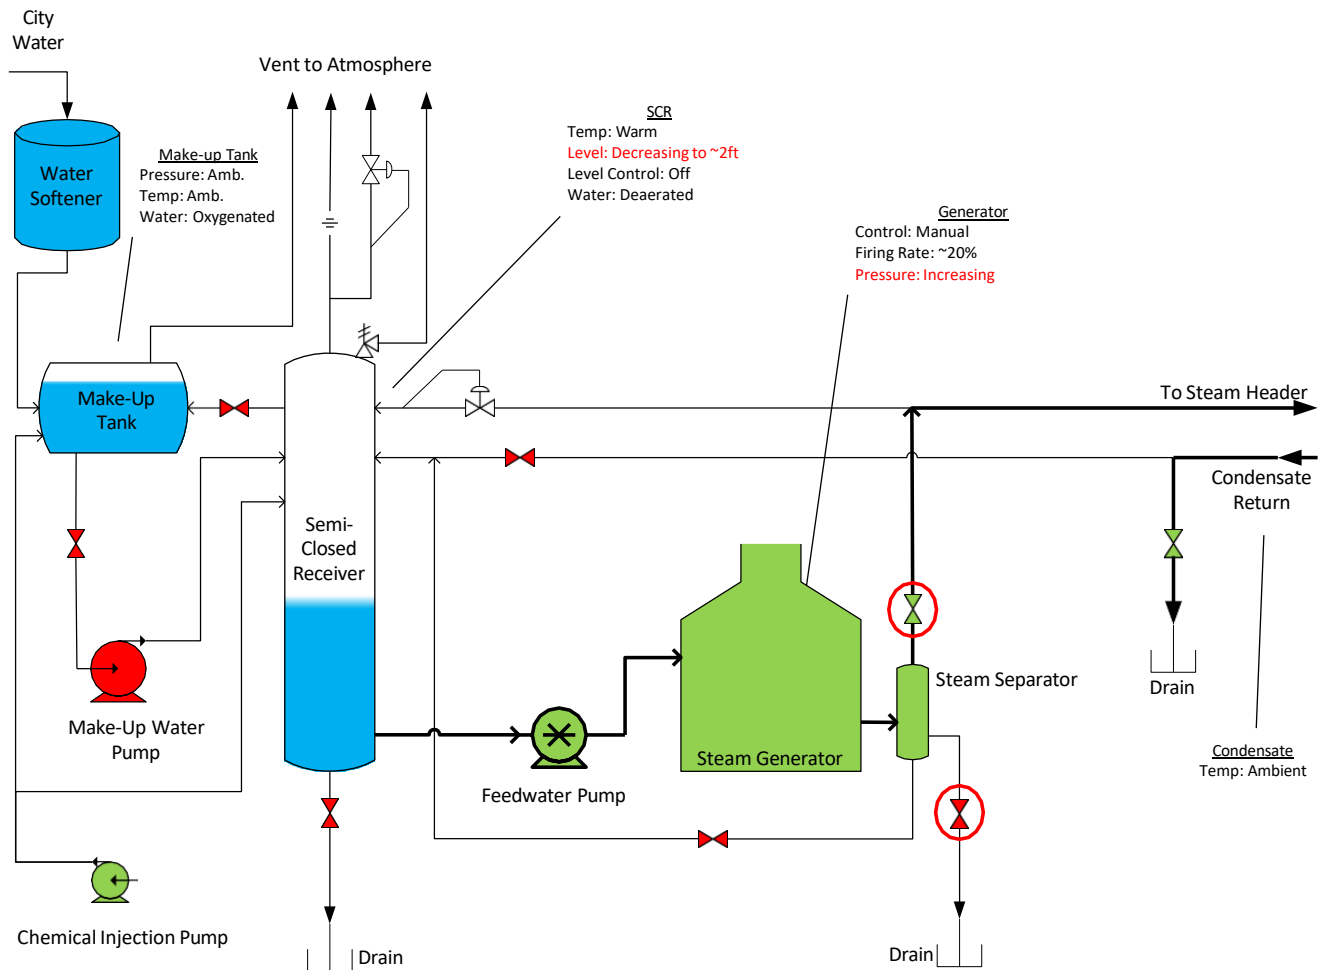
**Figure 24.** Simplified process flow diagram illustrating steam flowing to the steam header. (Credit: CSB)

4. Once the generator was producing steam, operators slowly opened the valve isolating the steam generator and separator from the process steam header, allowing steam to flow out to the corrugation process equipment.
5. During this time, the liquid level inside the SCR slowly fell from approximately 14 feet to approximately 2 feet,<sup>a</sup> nearly emptying the SCR (**Figure 24**).

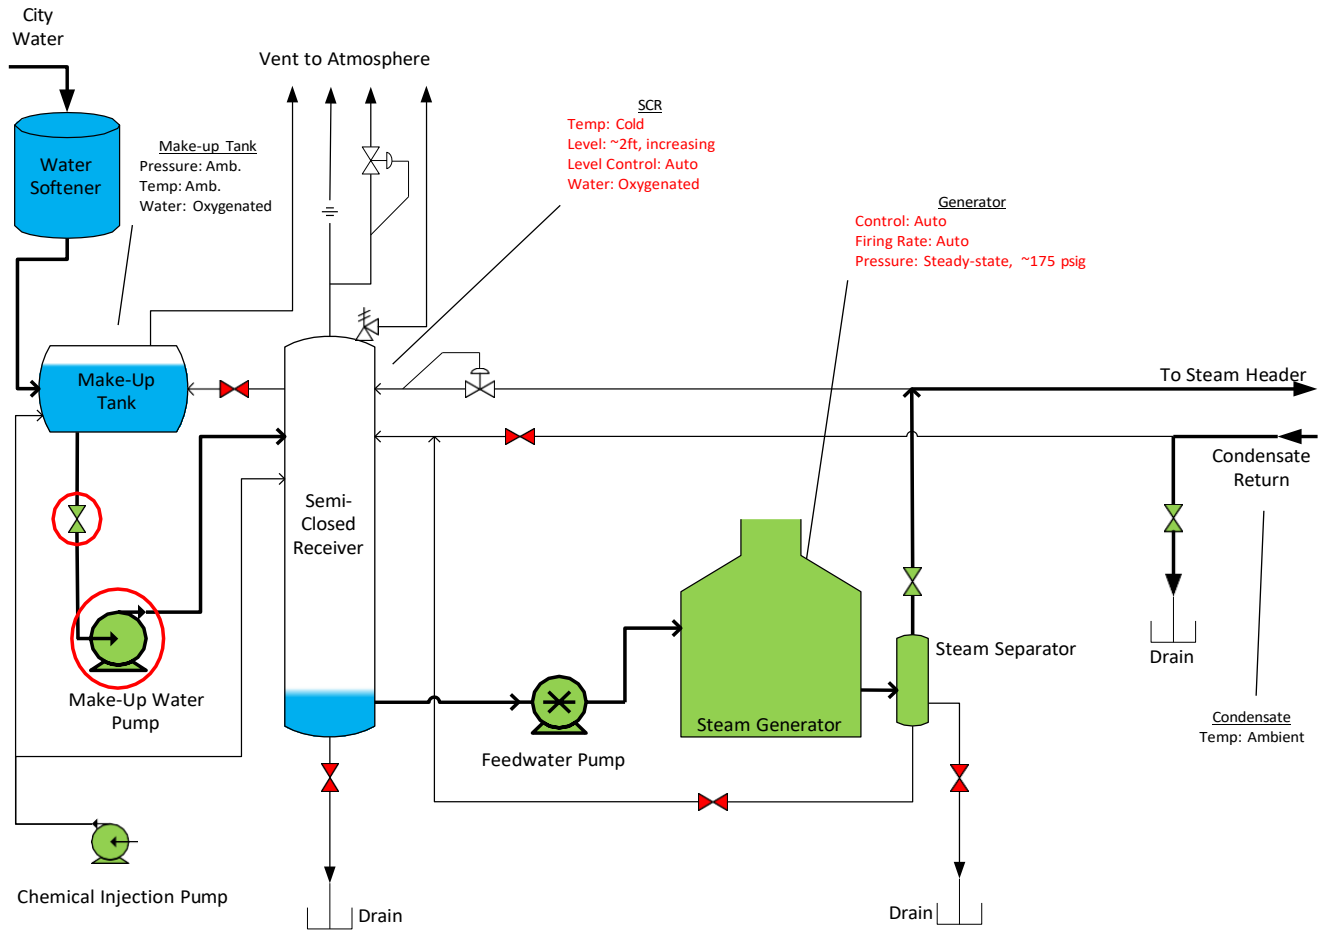
**Figure 25.** Simplified process flow diagram illustrating the introduction of make-up water. (Credit: CSB)

- Once the SCR was nearly empty, operators placed the SCR level controller in automatic and opened the make-up water supply valve to the SCR. The level controller began calling for make-up water, which turned on the make-up water pump, refilling the SCR with make-up water (**Figure 25**). Because Loy-Lange claimed that its relevant records were destroyed in the explosion, the CSB could not review documentation or data<sup>a</sup> indicating that the make-up tank water was effectively heated by steam and mechanically deaerated—which would occur at temperatures between 190-200°F—before the water was introduced to the SCR. In the event the makeup tank was not heated to the requisite temperature before the water was introduced to the SCR, oxygenated water would be fed to the SCR at this point during the steam system startup operation.

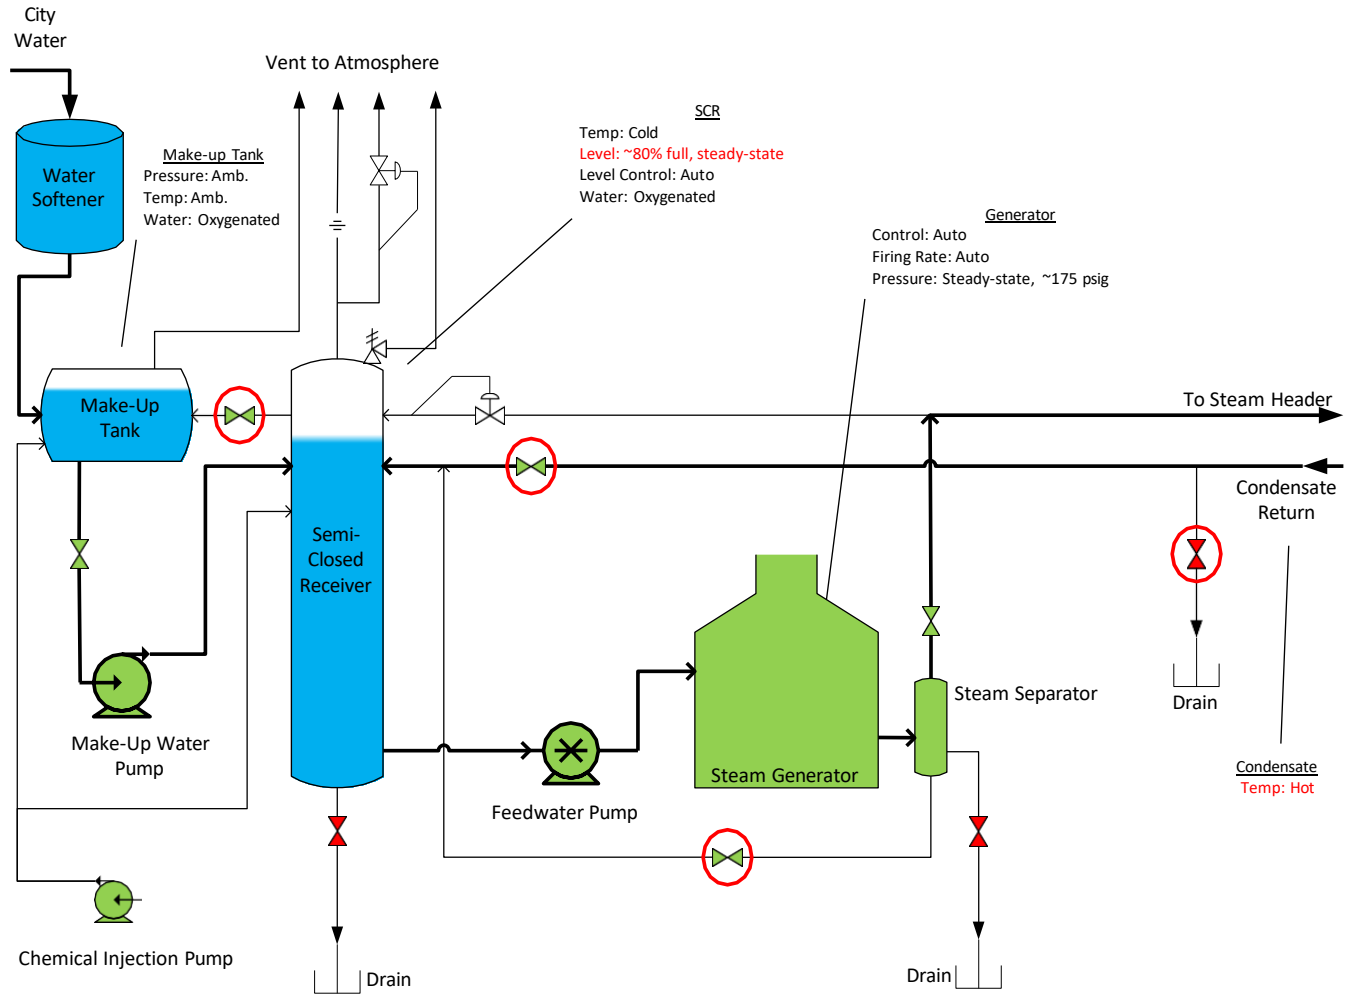
Figure 26. Simplified process flow diagram illustrating steady-state conditions. (Credit: CSB)

7. Eventually, operators routed the returning condensate back to the SCR instead of to drains (circled valves in **Figure 26**).
8. Unless operators performed a procedure called *blowdown* (see **Figure 27** and Section 1.7.3), a portion of water in the SCR below the outlet nozzle likely was trapped in the bottom head.

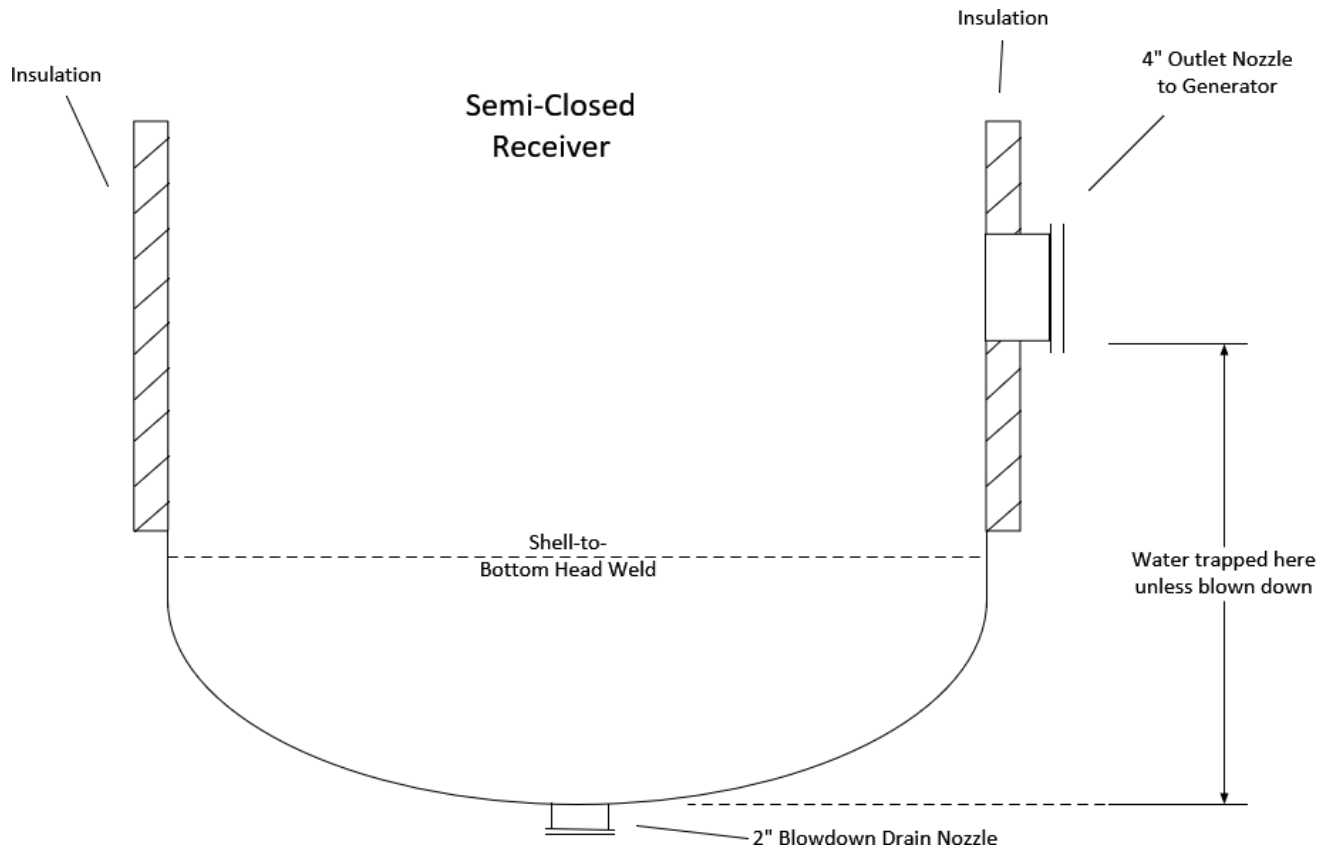
**Figure 27.** Conceptual diagram of the SCR bottom head. (Credit: CSB)

Water in the SCR bottom head remained stagnant during normal operation. To achieve flow in the bottom head of the SCR, operators had to manually open the drain line (blowdown) (**Figure 4, Figure 27**). Blowdown was intended by Clayton to drain precipitated solids produced by the water treatment chemicals. Clayton's 1995 operation manual recommended blowdown of the SCR weekly at minimum. In the absence of daily water tests, the manual requires a blowdown frequency of every 10-12 hours. Loy-Lange operators told the CSB that the vessel was rarely and irregularly blown down prior to 2012. In 2012, after the repair to the SCR bottom head (discussed in Section 1.3), they increased the blowdown frequency to weekly.

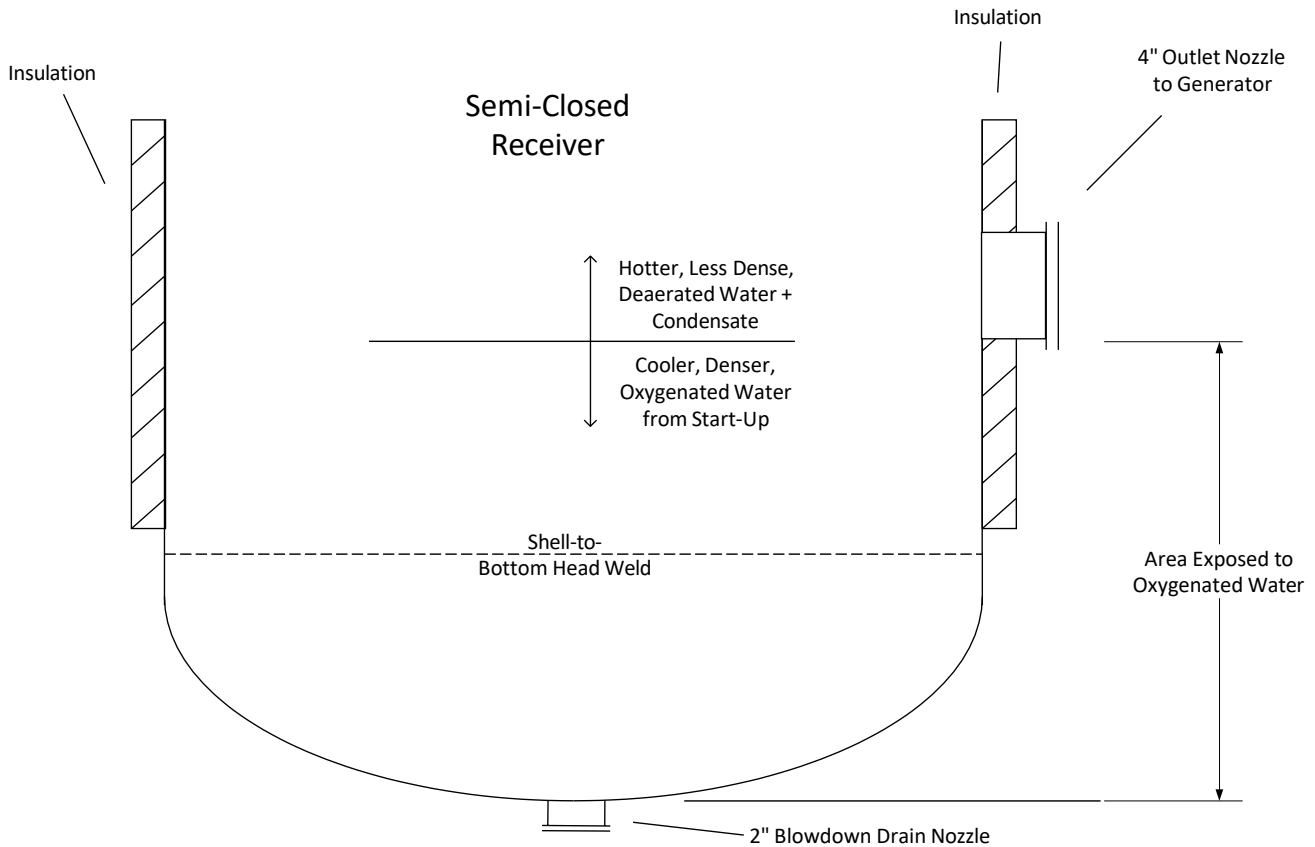
**Figure 32.** Conceptual diagram of the SCR bottom head. (Credit: CSB)

This oxygen, likely introduced into the SCR during daily startup operations, was the result of either insufficient mechanical deaeration, chemical deaeration, or both. Because the SCR bottom head trapped water below the SCR outlet nozzle (illustrated by **Figure 32**), some oxygenated water from startup would remain trapped at the bottom of the vessel until operators performed the weekly blowdown. Although blowdown was not expressly intended by Clayton to remove dissolved oxygen from the system (Section 1.7.3), given that oxygenated water likely remained trapped in the SCR bottom head, it is likely that blowing down the SCR daily after startup would have drained oxygenated water from the bottom head and filled it with treated water. The CSB concludes that Loy-Lange likely introduced oxygen into the SCR during its daily startup operation.

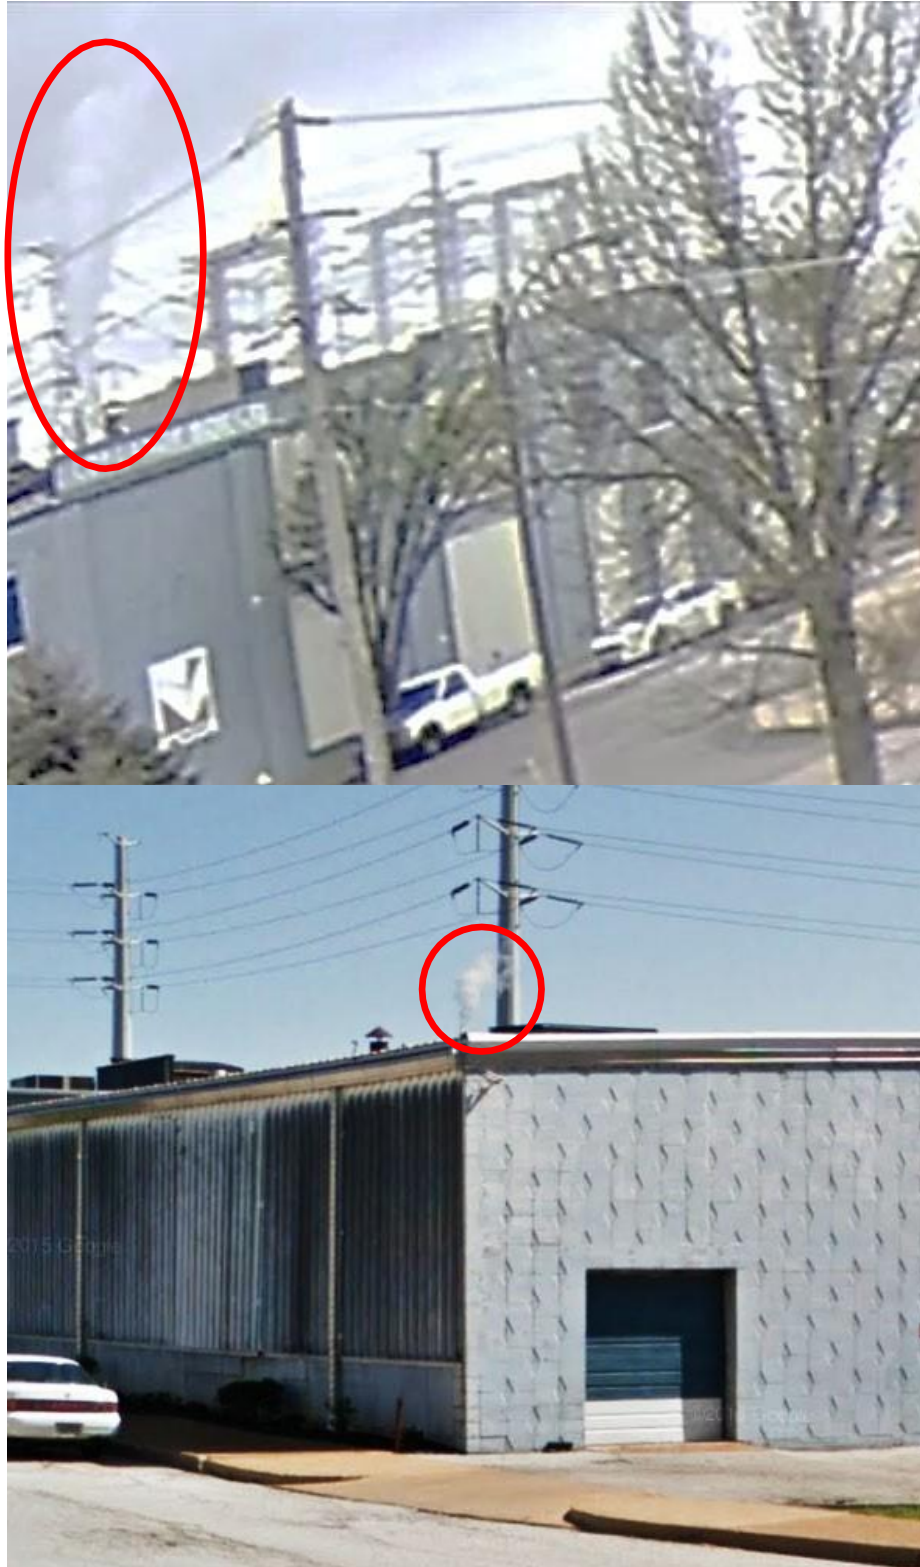
**Figure 36.** Steam plume comparison. (Credit: Top: Kranz; Bottom: Google, edited and annotated by CSB)

Evidence available to the CSB suggests that a steam system process upset may have occurred during the steam system startup on April 3, 2017. A surveillance video capturing the explosion shows a large plume of steam venting with high velocity from the roof of the building just before the incident (**Figure 36**, top). This steam plume appears substantially larger than the normal plume seen venting from the building historically.

For comparison, using Google Earth® and Google Street View®, the CSB evaluated historical images of the Loy-Lange facility. These images show a small white steam plume emanating from the roof of the facility, which may be from the normal venting of vapor during the deaeration process to remove dissolved gases [31]. One representative photo of the typical steam plume is shown in **Figure 36**.

One of the Loy-Lange stationary engineers confirmed to CSB investigators that the vapor venting from the roof of the facility immediately before the SCR rupture was abnormally large. After seeing the surveillance video, the stationary engineer said:
