# BUILDING PERFORMANCE ASSESSMENT REPORT

PRELIMINARY REPORT

## *Midwest Tornadoes of May 3, 1999*

FEDERAL EMERGENCY MANAGEMENT AGENCY  
Mitigation Directorate, Washington DC and Region VI, Denton, TX  
and Region VII, Kansas City, MO

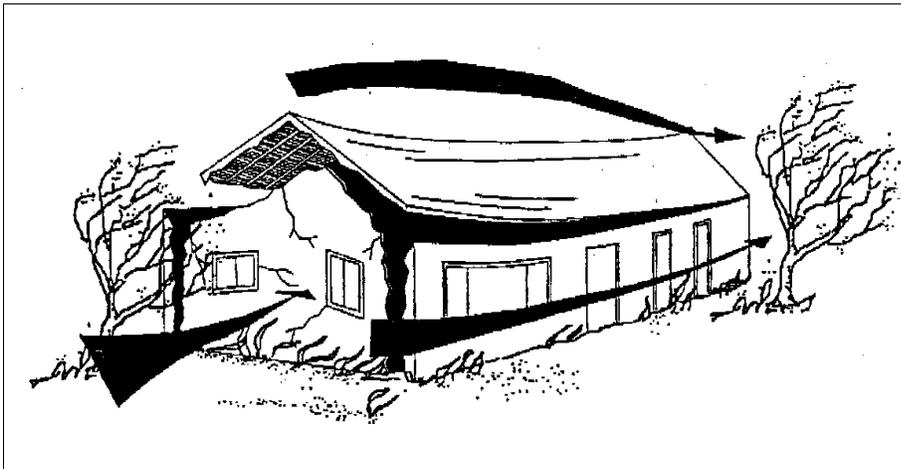
**FIGURE 3-2:** This building failure is the result of inward wind forces and uplift wind forces acting on a building or structure during a high wind event.

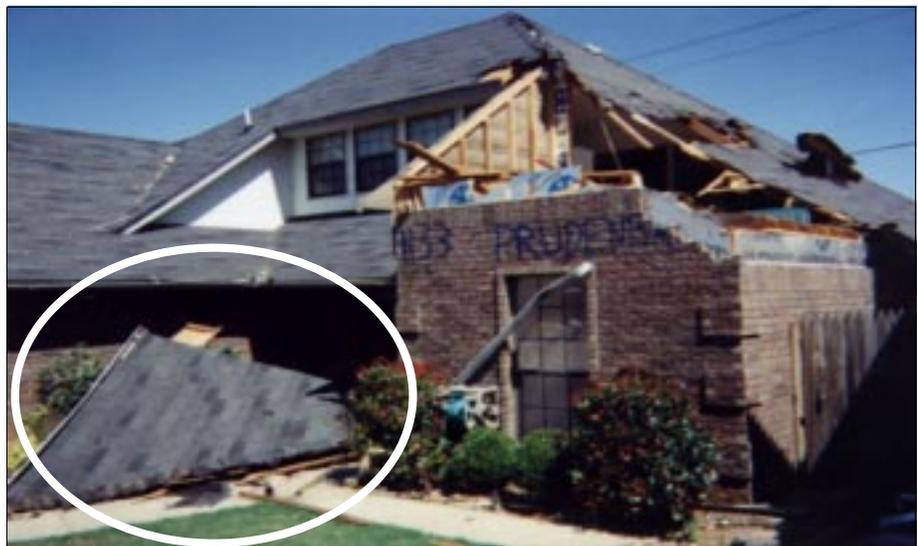
**FIGURE 3-5: Failure of hip roof due to internal pressures and leeward wind forces acting together. This house, which was exposed to inflow winds of a violent tornado, was located in a suburb of Oklahoma City, Oklahoma.**

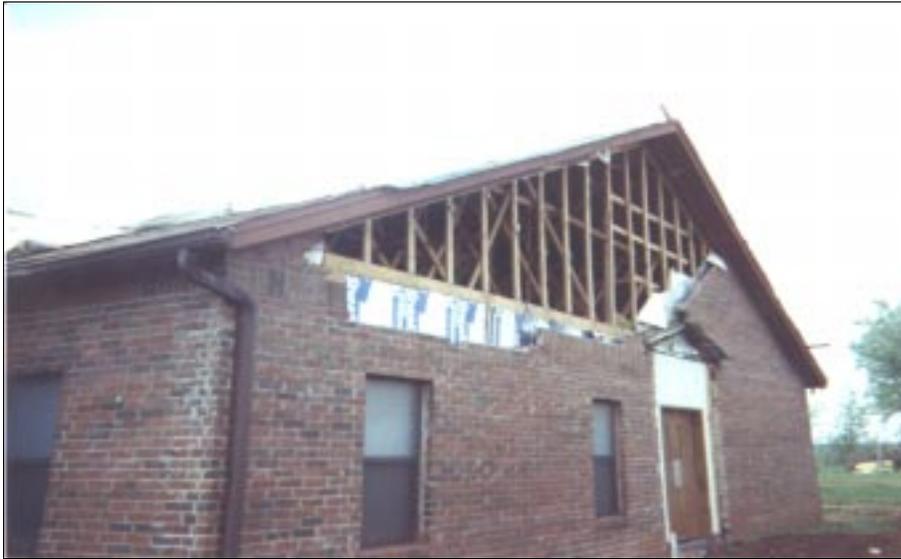
**FIGURE 3-6:** Failure of this gable wall section was due to wind suction forces of the leeward wall. This house was on the outer edge of a violent tornado path.

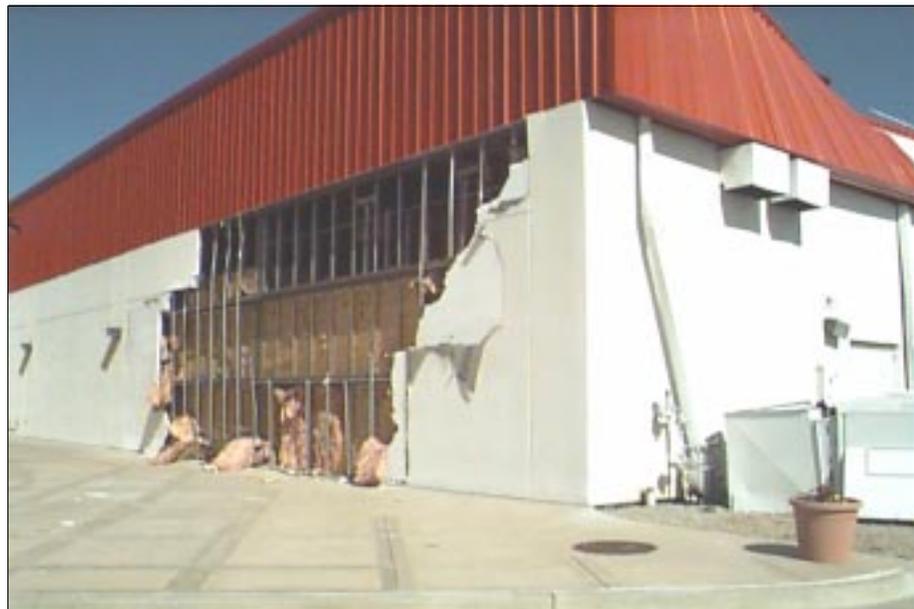
**Figure 3-8: EIFS and metal component damage at the regional outlet mall in Stroud, Oklahoma.**

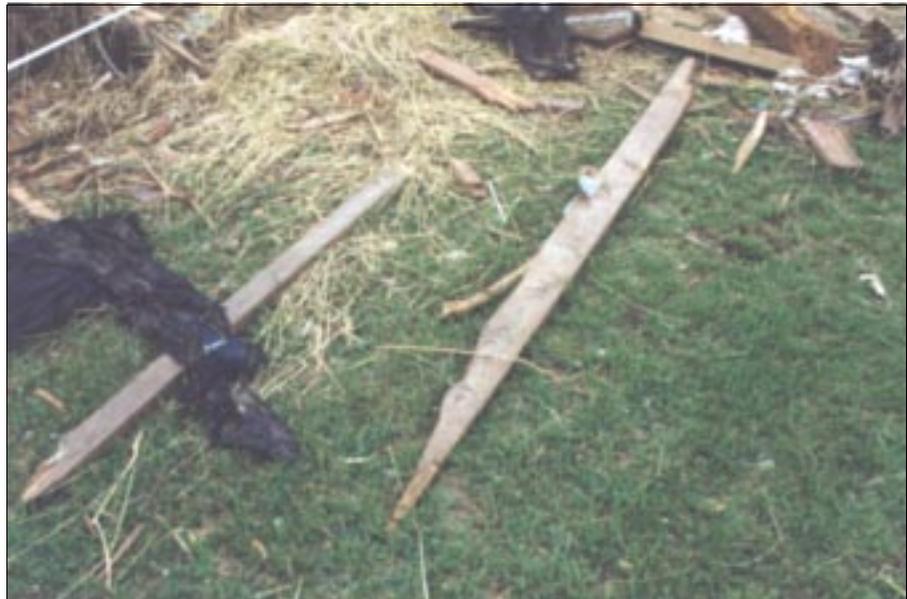
**FIGURE 3-11: Small missiles commonly observed during the field investigations.**

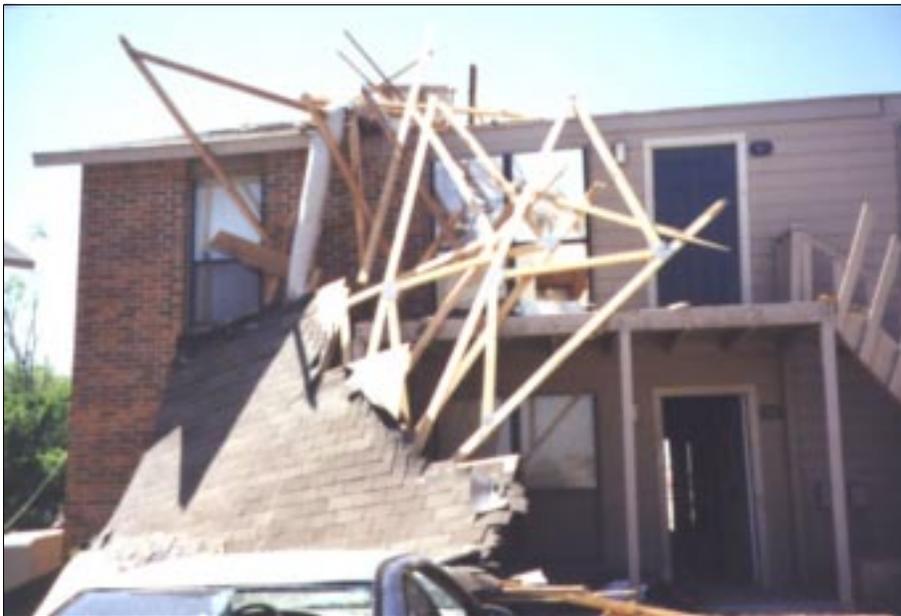
**FIGURE 3-13:** *These trusses and roof covering (still attached to the roof sheathing) was displaced by the winds of a violent tornado and are capable of becoming large, windborne missiles.*

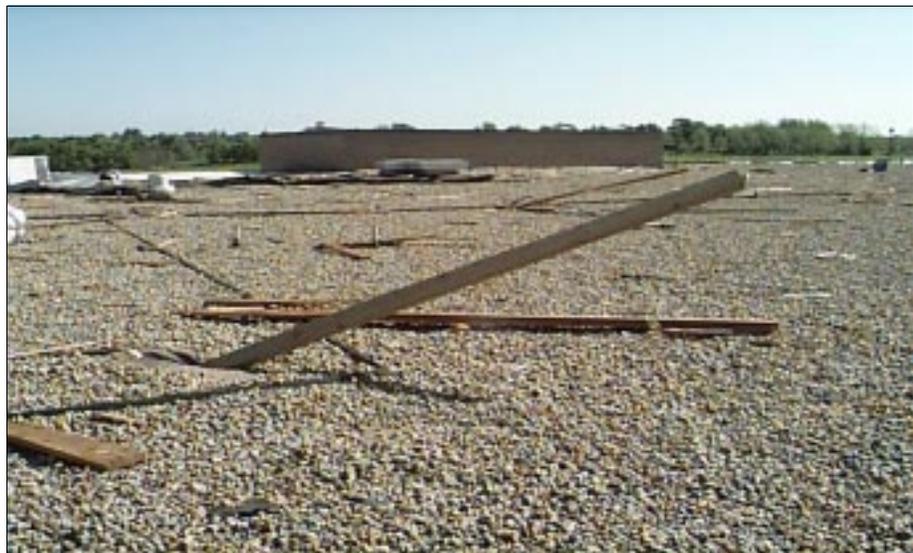
**FIGURE 3-14:** *In the foreground, a medium sized missile, a double 2-in by 6-in, 13 feet long board can be observed sticking out of Westmoore High School's roof, Moore, Oklahoma. A larger missile, double 2-in by 10-in, 16 feet long board is lying in the background.*

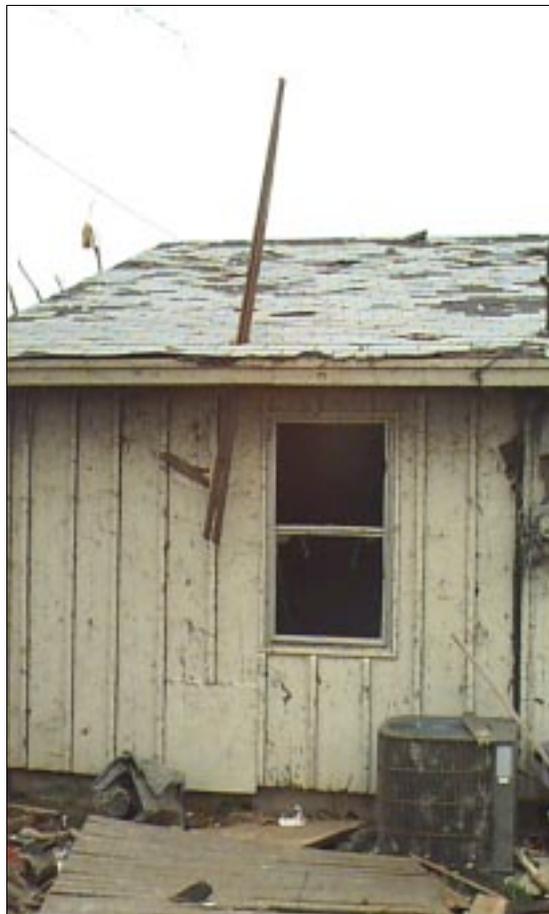
**FIGURE 3-16: A missile vertically striking the roof of a home in Mid West City, Oklahoma. It fell nearly vertical illustrating the importance of a strong cover over the top of a tornado shelter to protect against free-falling debris.**

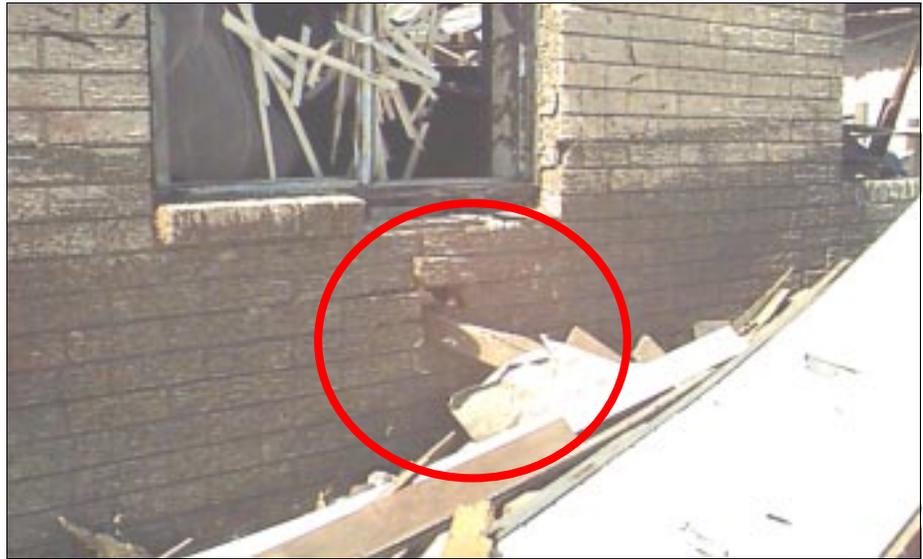
**FIGURE 3-17:** A 2-in by 6-in can be seen completely penetrating the brick veneer of a home in Moore, Oklahoma.

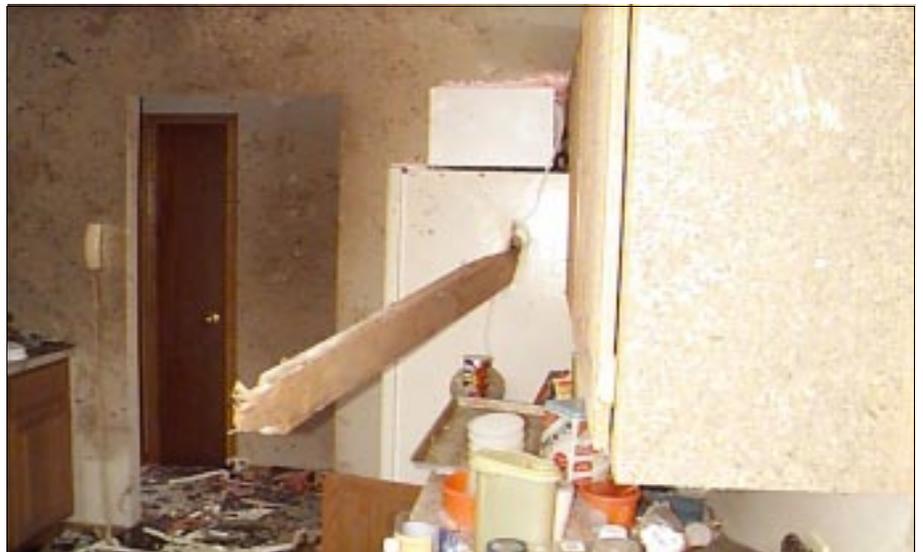
**FIGURE 3-18:** A 2-in by 6-in board missile penetrating a refrigerator located inside a home in Country Place subdivision outside Oklahoma City, Oklahoma.

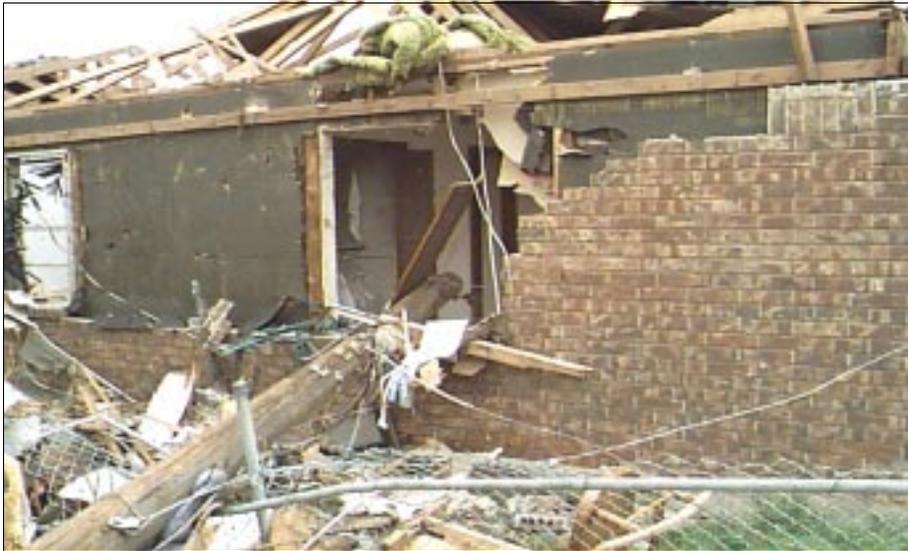
**FIGURE 3-19:** This power pole penetrated a window and extended several feet into the house after traveling approximately 40 feet from its original location. This home was located in Moore, Oklahoma, along the track of a violent tornado.

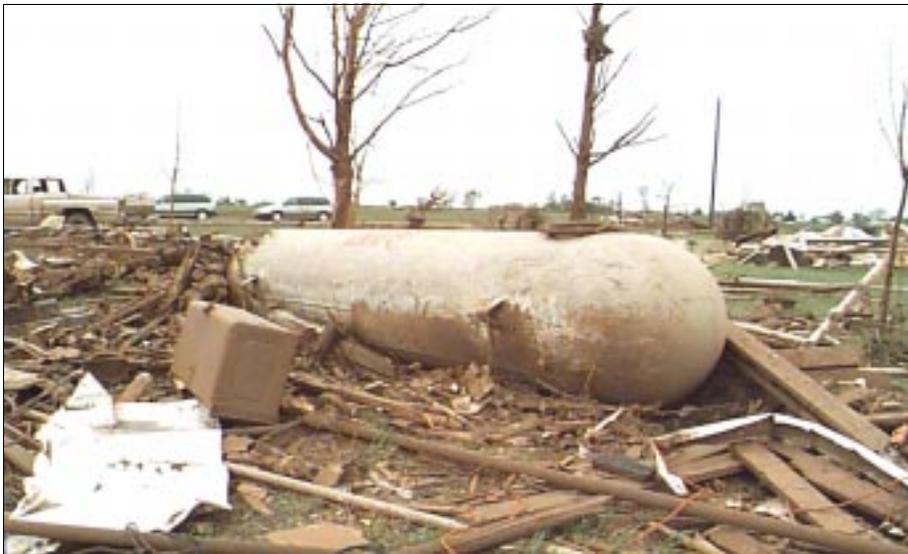
**FIGURE 3-20:** Wind displaced this very large propane tank in Bridge Creek, Oklahoma; its original location could not be determined. This area was hit by the vortex of a violent tornado.

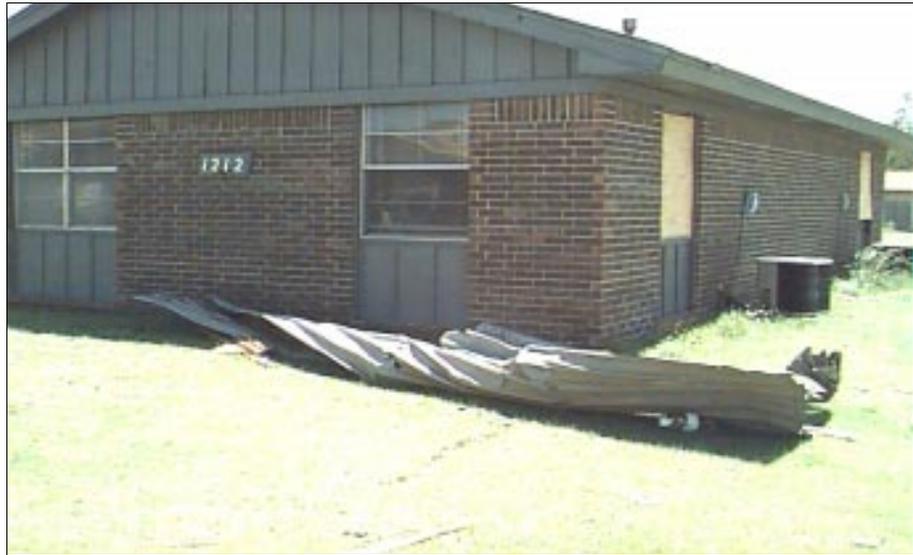
**FIGURE 3-21:** *This piece of steel deck landed at the periphery of a violent tornado damage area in Moore, Oklahoma. The building it likely came off of was a few hundred feet away.*

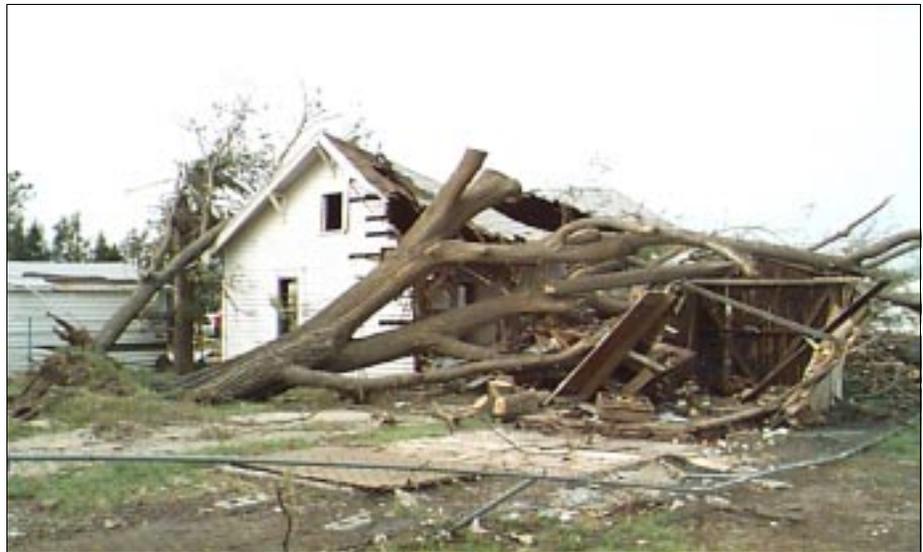
**FIGURE 3-22:** *This building was on the periphery of a violent tornado damage area in Haysville, Kansas. One large tree fell near the corner of the house and collapsed a large portion of the roof and the corner walls. A smaller tree caused minor damage on the other corner of the house.*

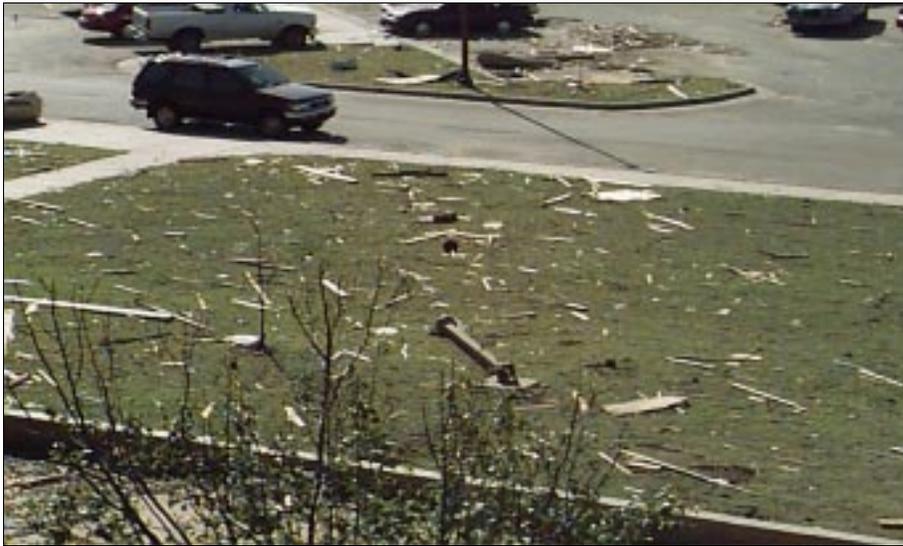
**FIGURE 3-23:** Wood framing members and plywood sheathing near the periphery of a violent tornado damage area in Moore, Oklahoma, displaying quantity of flying debris.

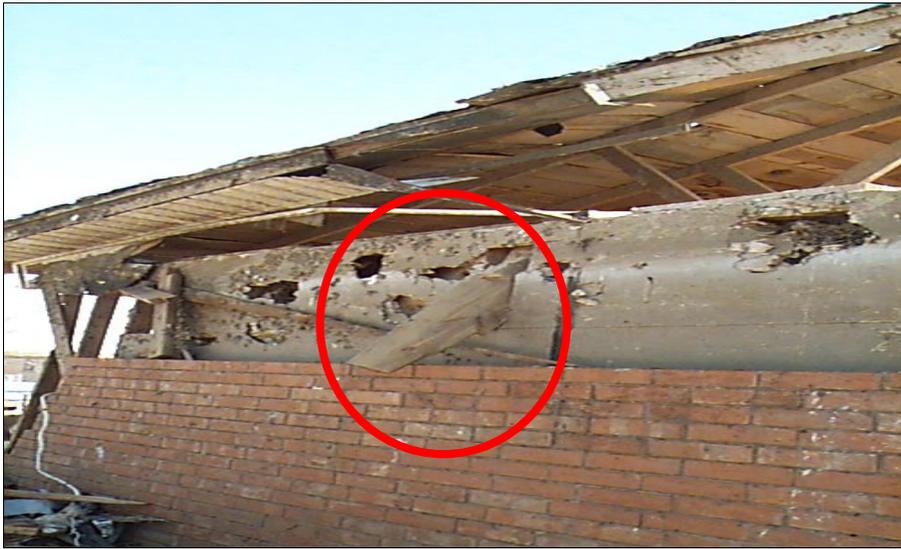
**FIGURE 3-27:** Several missiles struck the wall of this house in Del City, Oklahoma, including a medium sized piece of debris in the center of the picture. For scale, the square metal fastener plates near the board corners are 3-in by 3-in.

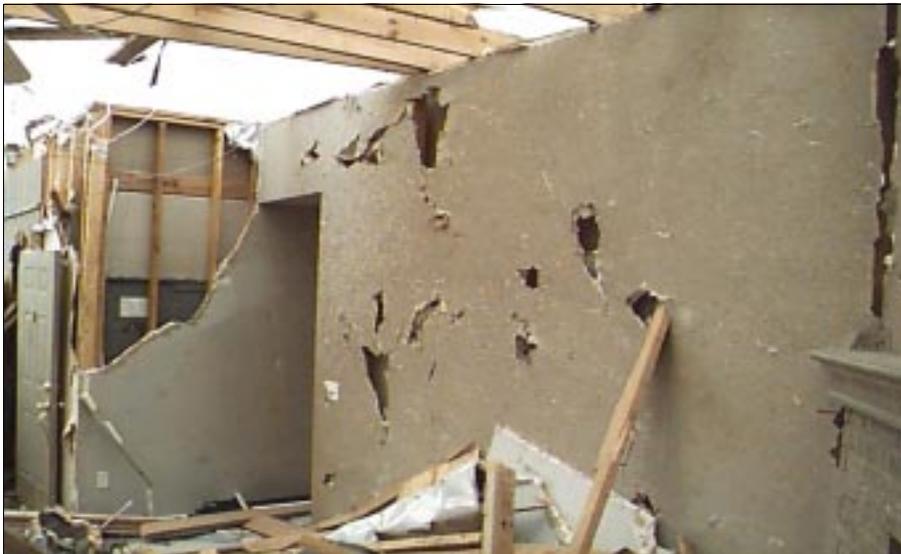
**FIGURE 3-28:** Several missiles struck and perforated the interior wall of this house in Moore, Oklahoma.

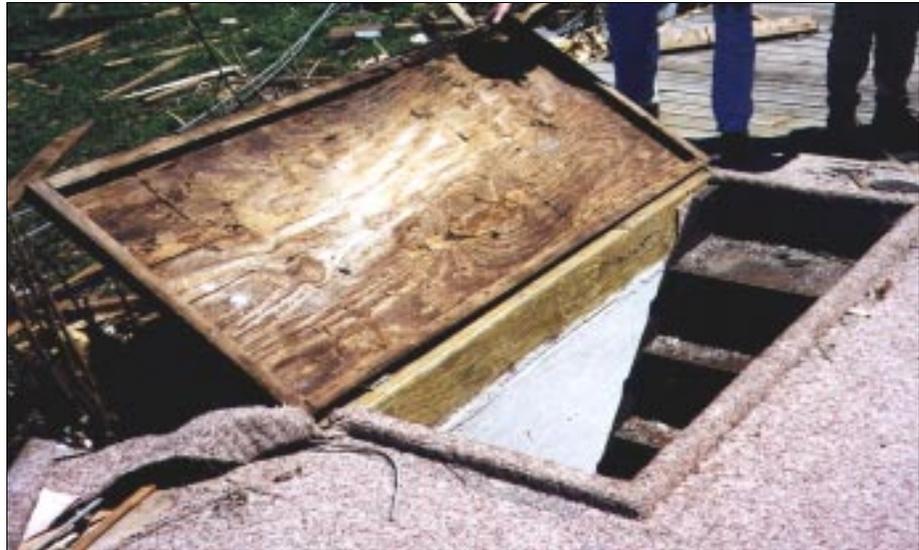
**FIGURE 3-29:**  
***Underground residential shelter, viewing door and stairway leading down to shelter. This shelter was located outside a residence.***

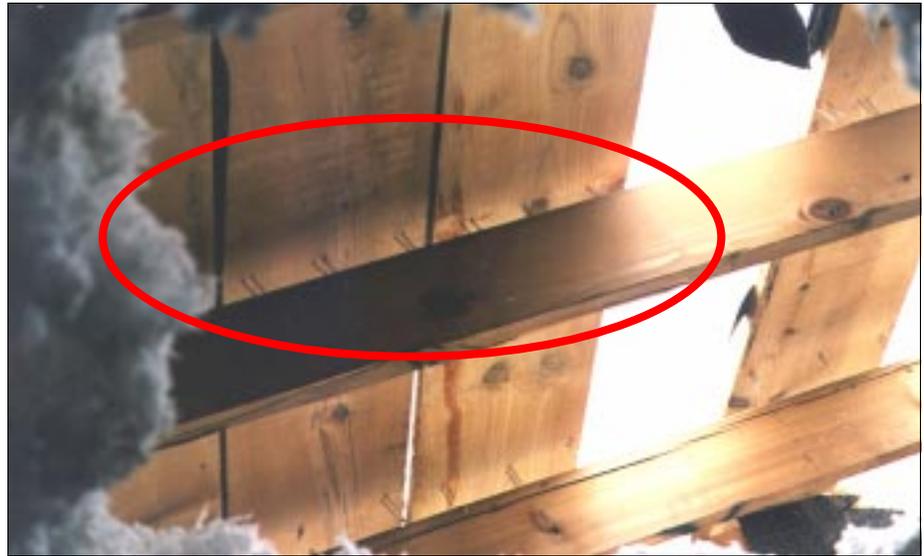
**FIGURE 4-4: Although roof sheathing was lost at this Wichita, Kansas, home code requirements of staggering joints in sheathing applications was observed. This house experienced inflow winds from a severe tornado.**

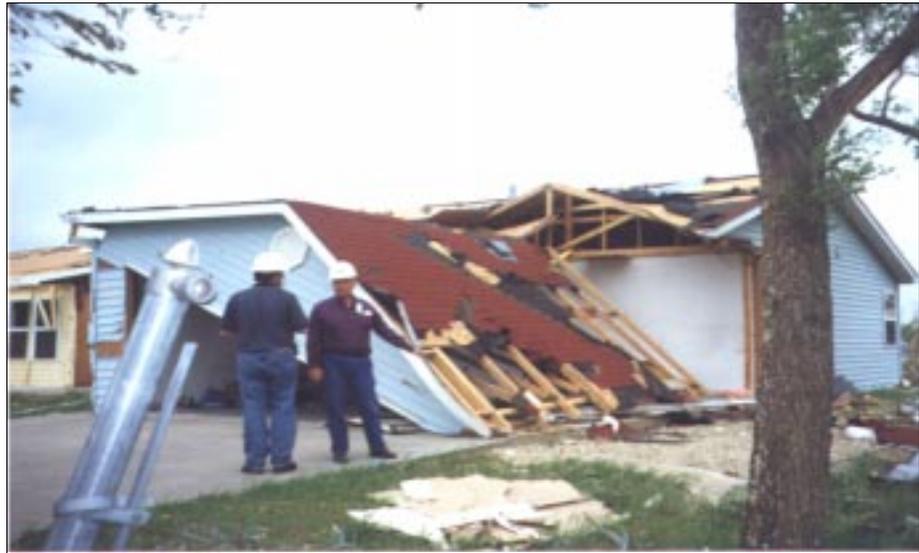
One example of an inadequate lateral load-resisting element that was observed was the garage end walls or returns that act as the frame for the garage door. A normal code minimum width for the return is four feet. This one measures 22-in which is clearly inadequate to resist code-required loads. At least one of the model building codes has a minimum width of such panel as 32-in with a special web and special hold anchors. Also, there were a number of cases where the garage bearing walls failed and the garage roof fell to the ground essentially intact. An example of this failure is presented in Figure 4-6 from a house that experienced inflow winds from a severe tornado in Wichita, Kansas.

**FIGURE 4-6: Wall failure due to inadequate lateral load resistance in Wichita, Kansas. The return wall at the garage inadequate to carry loads may have led to this failure.**

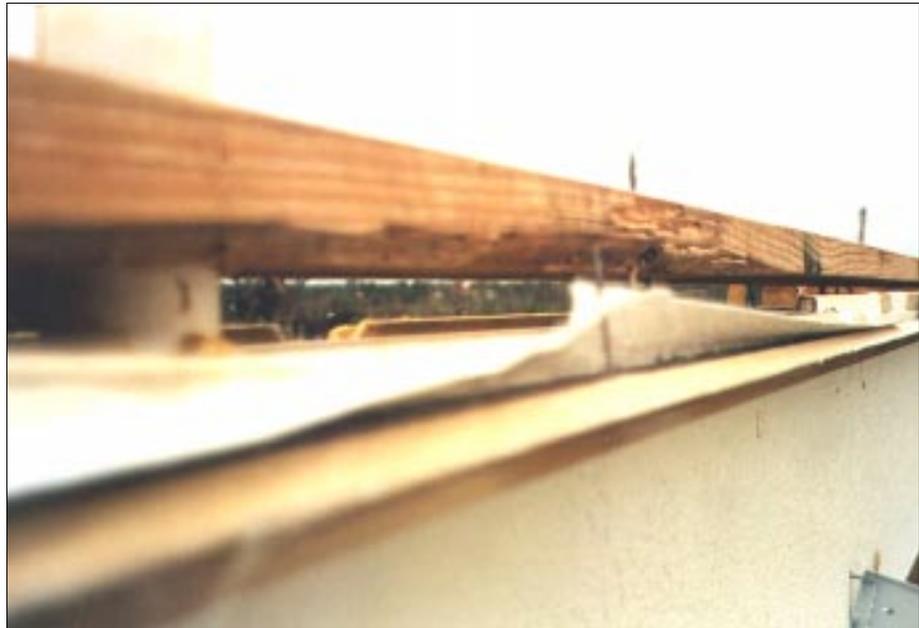
**FIGURE 4-8: Failure of a double top-plate. The uplift of the roof truss previously attached to this double top-plate caused separation of the two members that comprise this top-plate.**

Figure 4-8 shows a seldom seen type of failure that may have been caused by a combination of uplift, diaphragm chord forces, and horizontal bending of the double 2-in by 4-in members commonly used as a top-plate. There were few observed failures of the connection of the double-top-plate to the supporting studs below, although one example is shown in Figure 4-9. With platform construction, the walls are typically framed while lying flat on the floor of the house.

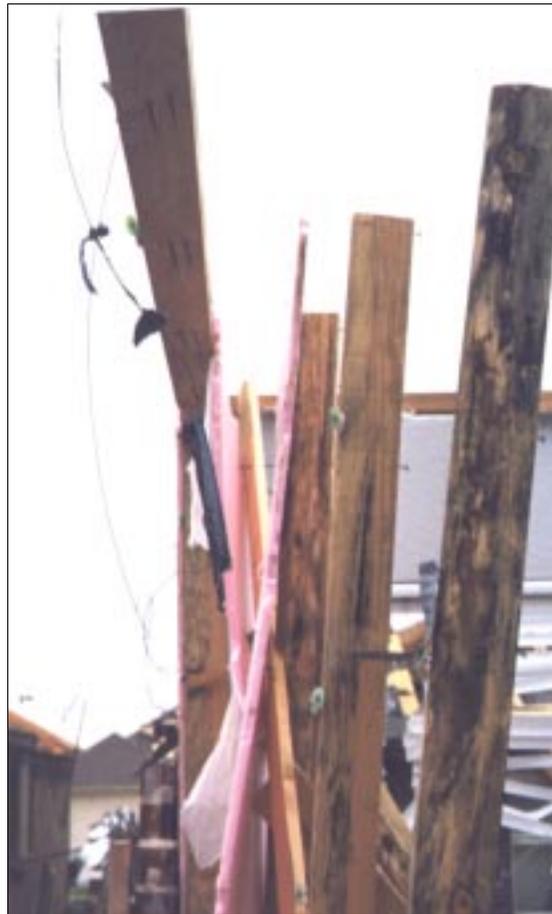
**FIGURE 4-9: Failures of the connection of the double-top-plate to the supporting studs below by home located in Moore, Oklahoma. This home was located along the periphery of a violent tornado.**

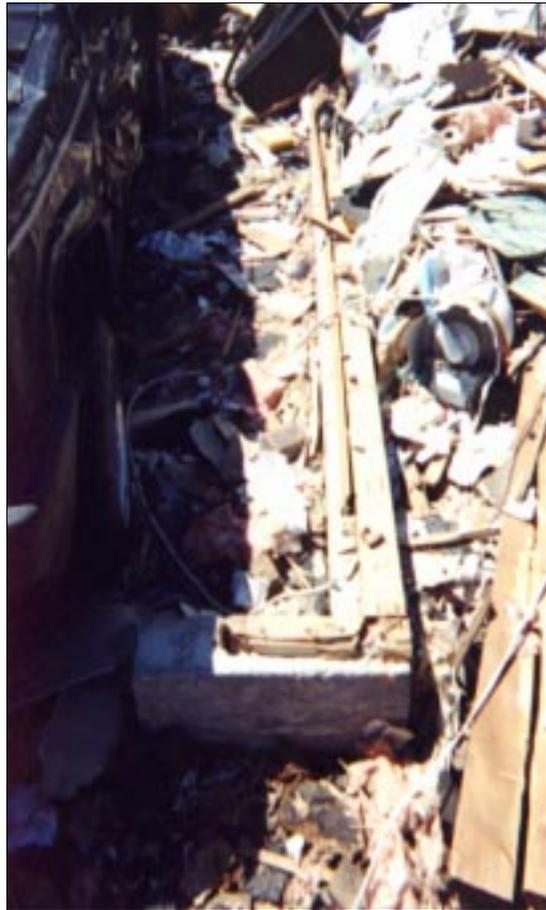
Once the wall is erected, the sill plate should be connected to the foundation. In Oklahoma, the foundation was typically a slab-on-grade foundation. In Kansas, basement and crawl space foundations were more common than slab-on-grade construction. Figure 4-10 represents one of many observed failures of the wall-to-sill-plate connection. In this instance, the sill plate remained anchored to the foundation but the toe-nailed or face-nailed connection of the studs to sill plate were inadequate to resist uplift loads from a severe tornado that struck this Oklahoma home.

**FIGURE 4-10: Wall framing to sill plate failure. This house in Del City, Oklahoma, experienced a direct hit from the vortex of a violent tornado.**

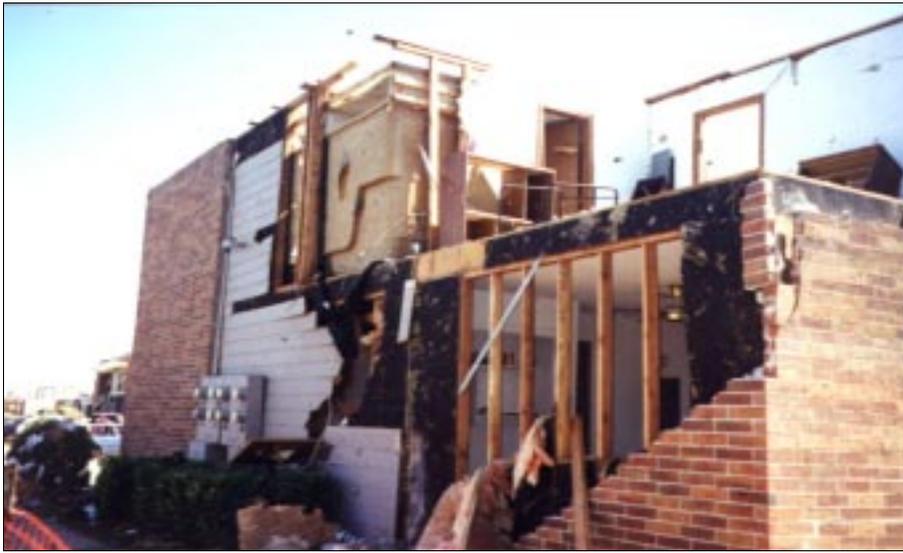
Failures between the sill plate and the foundation or floor below were observed. Some of these failures occurred when the sill plate itself failed due to extreme winds associated with the vortex of a violent tornado, as seen in Figure 4-11. In this figure, anchored bolts were used to secure the sill plate to the foundation. In both Oklahoma and Kansas, bolts, nails, and epoxy anchors were observed securing sill plates to foundations. In one instance in Oklahoma, straps from the foundation were observed securing the sill plate to the foundation. Another factor observed that contributed to failures of wall systems was that the bottom-plate (sole- or sill-plate) was not integral with the siding or other means of transferring the force. The connection was weak as seen in Figure 4-12.

**FIGURE 4-11: Stud-wall and sole-plate-to-floor failure on a second story wall. This multi-family residence in Wichita, Kansas, was located approximately a few hundred feet from the vortex of a violent tornado and was exposed to inflow winds.**

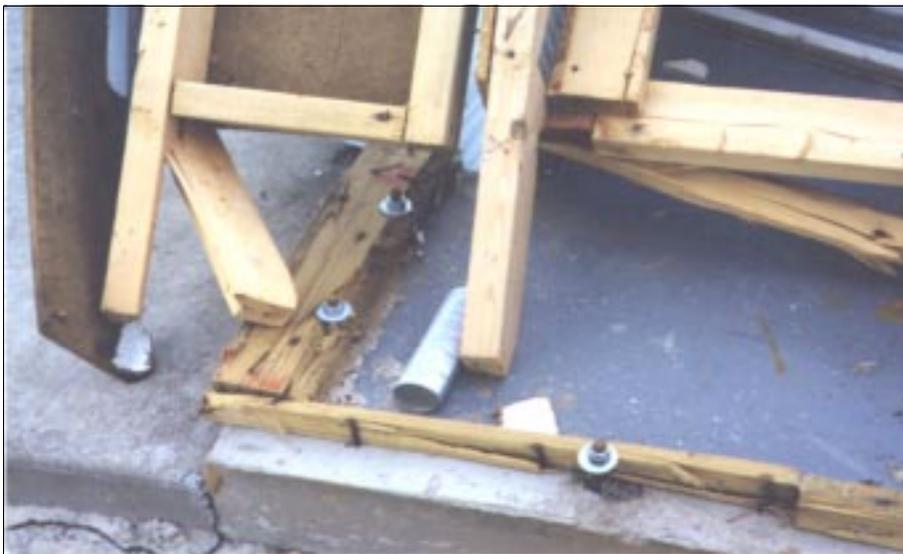
**FIGURE 4-12: Failure at base of wall between wall studs and sill-plate. The sill-plate, which was connected to the foundation slab with anchor bolts and nails, has splintered.**

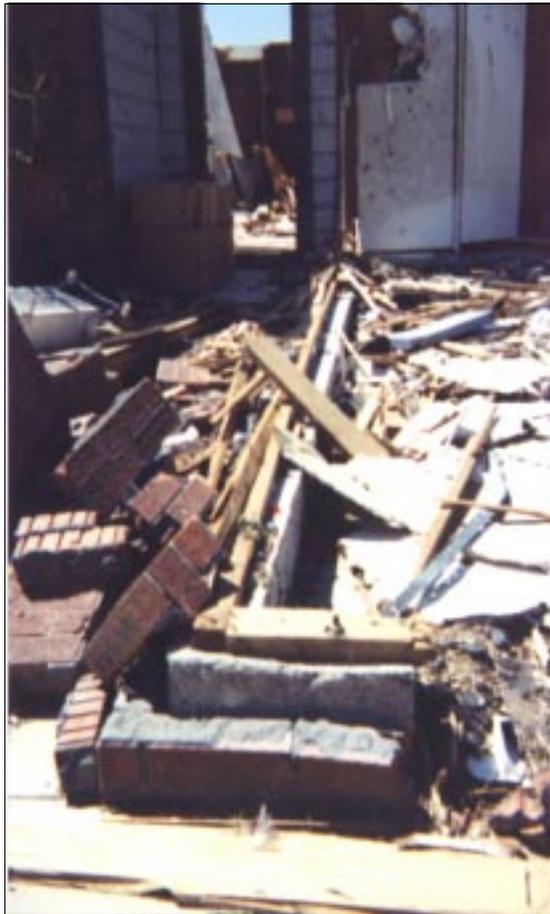
**FIGURE 4-13:** Failure of this sill-plate to foundation connection occurred at this home outside Oklahoma City, Oklahoma. The vortex of a violent tornado passed very close to this home.

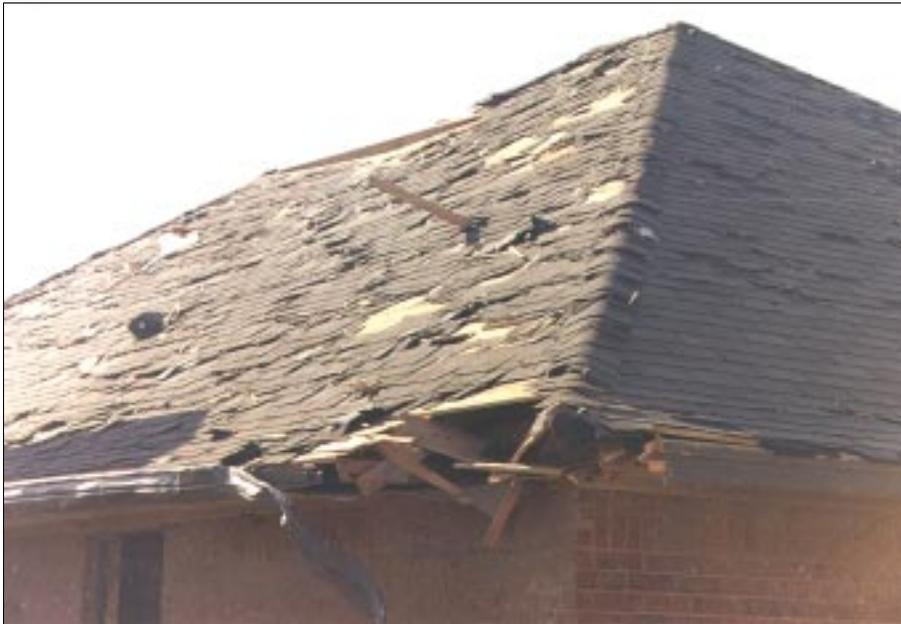
**FIGURE 4-14:** Asphalt shingles covering roof of residential home.

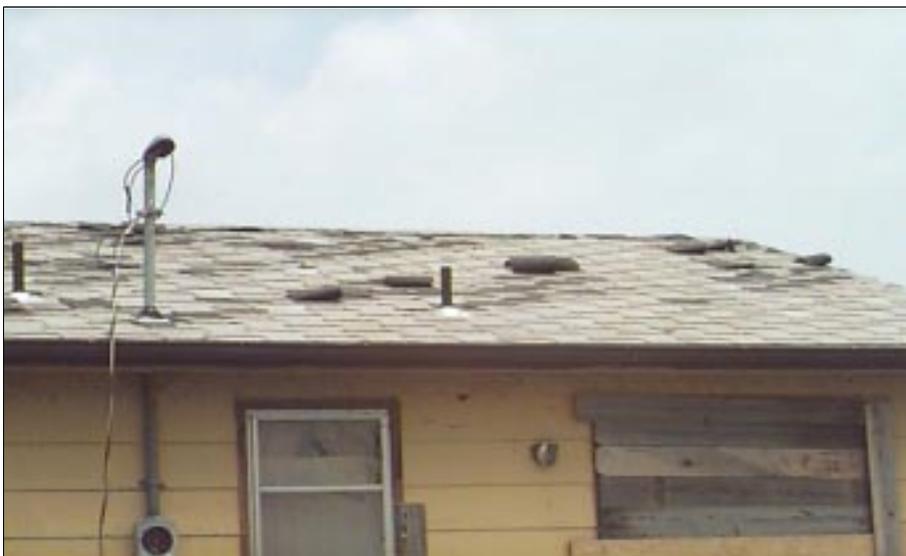
**FIGURE 4-15:** Several T-lock shingles on this house were lifted and torn. This house was on the periphery of the damage track left from a moderate tornado in Wichita, Kansas.

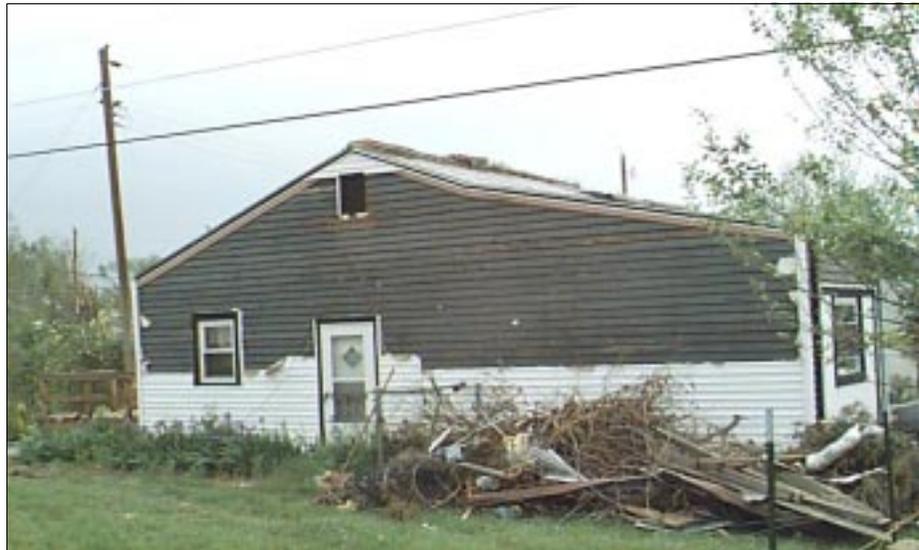
**FIGURE 4-16:** *The vinyl (white) that was installed over wood siding experienced damage; however, the wood siding was undamaged. The home was located along the periphery of a violent tornado in Wichita, Kansas.*

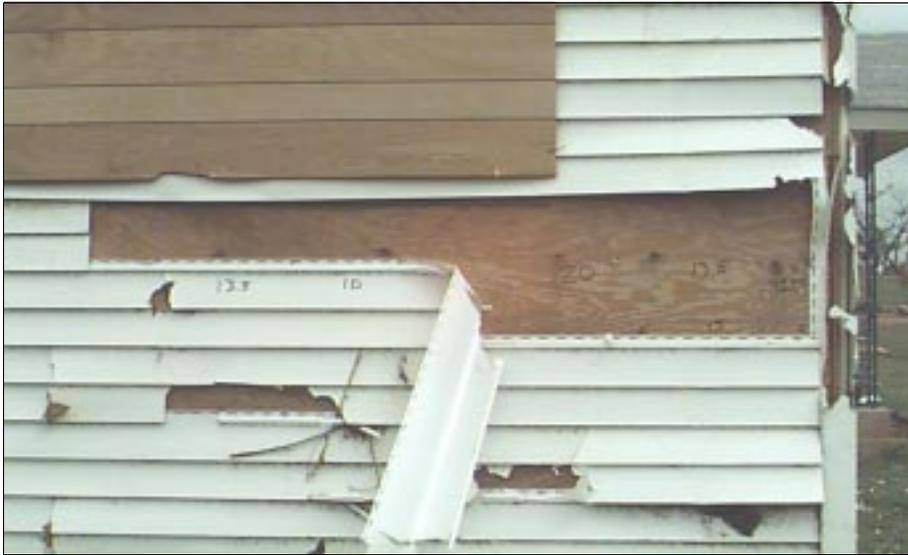
**FIGURE 4-17:** *Some pieces of vinyl siding were blown off and in other areas the siding was torn away by missiles. The home was located along the periphery of a violent tornado in Mullhall, Oklahoma.*

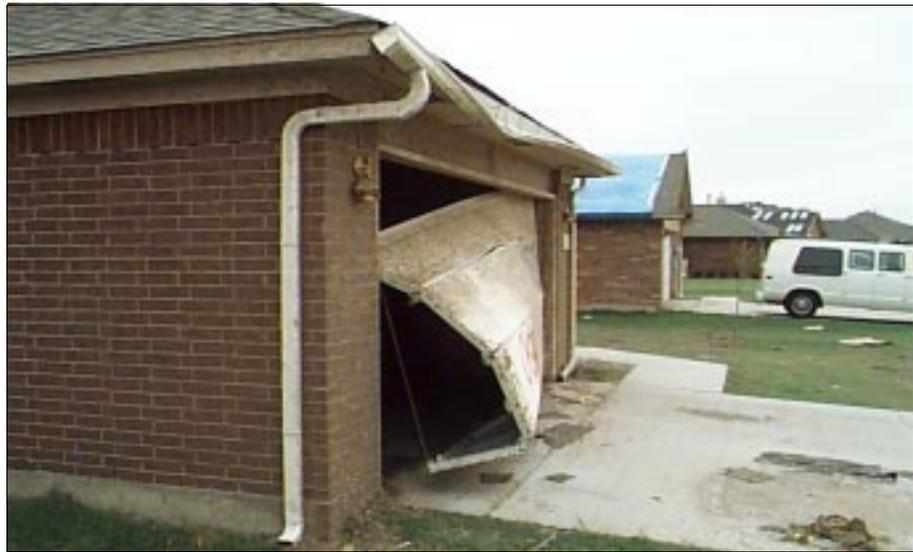
Along the track periphery, it was common to see residential garage door failures (Figure 4-18). The door in this figure likely had a tested load resistance of 12.5 psf; a common test pressure for doors of similar construction. The design load on this door would be 13 psf using UBC 1997 and 18 psf using ASCE 7-98. Hence the load derived from ASCE 7-98 is 44 percent higher than the tested resistance of the door. Had this door met the wind loading derived from ASCE 7-98, this failure may have been avoided. Most of the investigated doors were made of thin metal. Failures were typically caused by wind pressure, rather than by missiles. The most common failure mode observed was the door rollers disengaging from the door tracks. This was likely caused by excessive door deformation (see Figures 18A-18D). Door failure resulted in increased load on the building.

**FIGURE 4-18:** This double-width garage door failed under a suction load in Moore, Oklahoma.

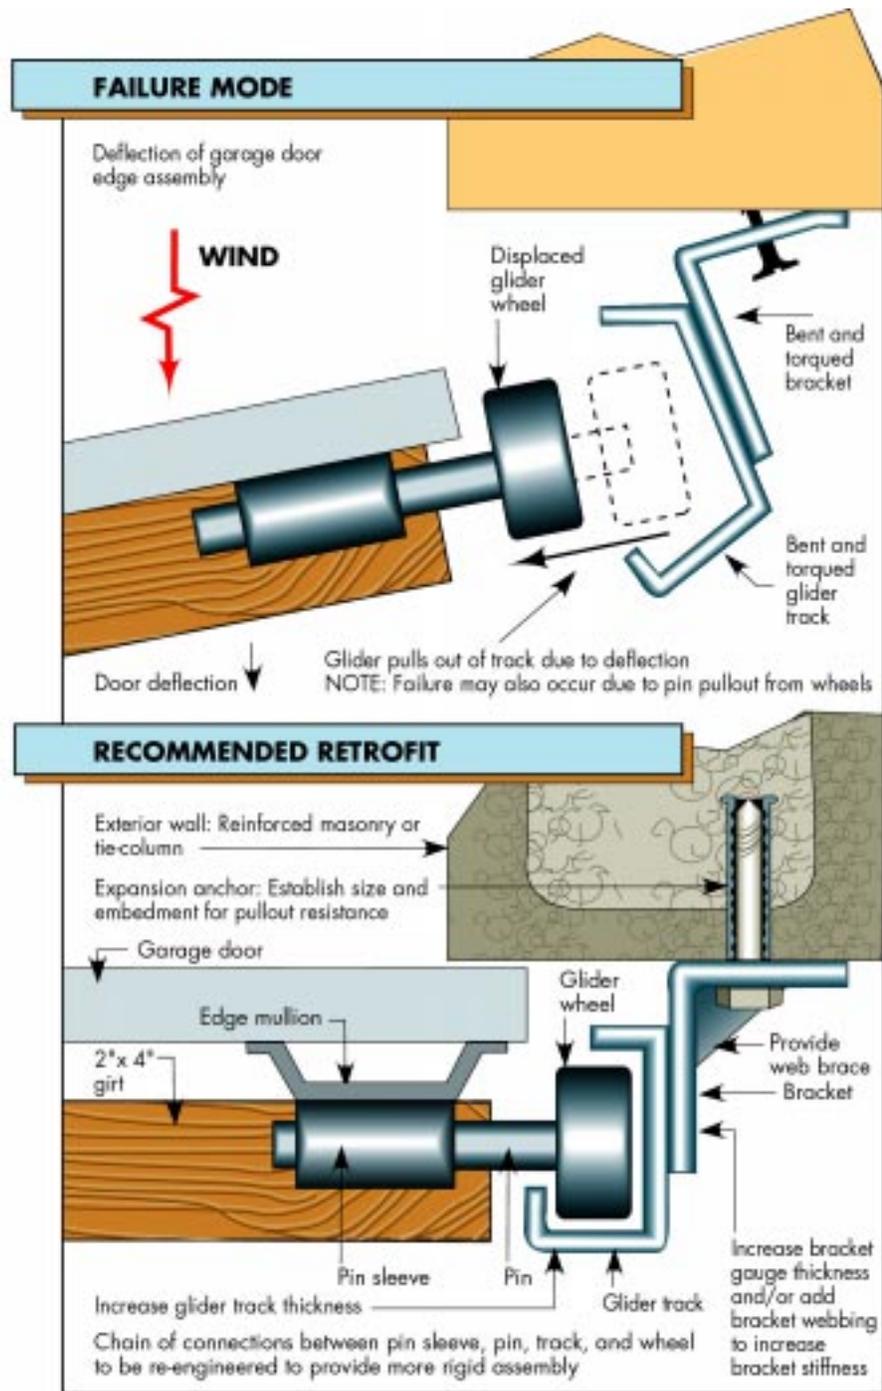
**Detail B from Figures 18 e door failure at track and recommend assembly improvements.**

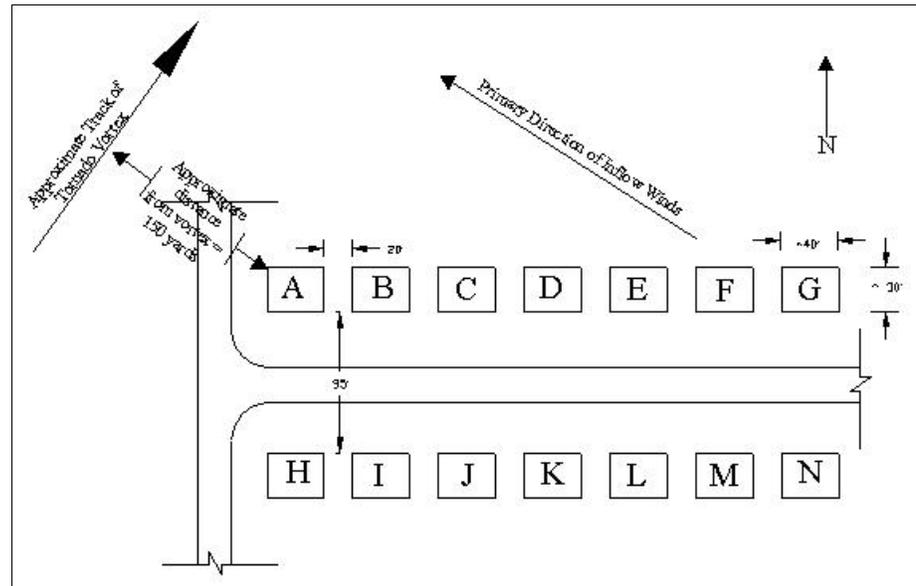
Homes located at H and A are shown in Figure 4-20. The damage states of the two homes are significantly different even though they are located directly across the street from one another, approximately 95 feet, and may have experienced relatively similar wind conditions based on the approximate track location (Figure 4-19). The home located at H had seven broken windows, primarily at the back of the home as a result of debris generated from a failed wooden fence. It also had one breached glass entry door, and lost approximately 60% of its roof covering. The home located at A lost its entire roof and several exterior walls. For the remaining structures, similar “across-the-street” damage gradients were observed between the homes, A through G and H through N, with the exceptions of the home at location F, which did not lose its entire roof, and the home at location G, which did not lose any roof, but did sustain severe roof framing damage due to uplift. Table 4-1 (**not included at this time**) lists observed damage states for all homes shown in Figure 4-19, illustrating the expected decreasing damage gradient as the distance between home and storm track increases.

**FIGURE 4-19: Partial schematic map of an Oklahoma City subdivision that was affected by inflow winds from a violent tornado.**

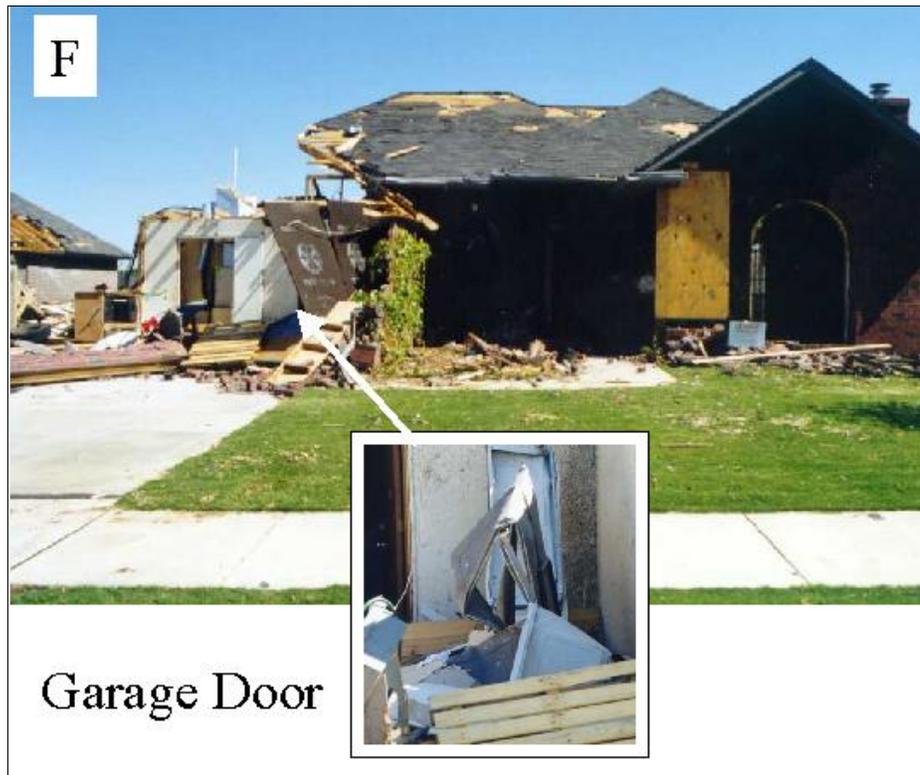
**FIGURE 4-22:** Garage door failure possibly resulting in the localized partial roof failure on the left side of this home located in Moore, Oklahoma.

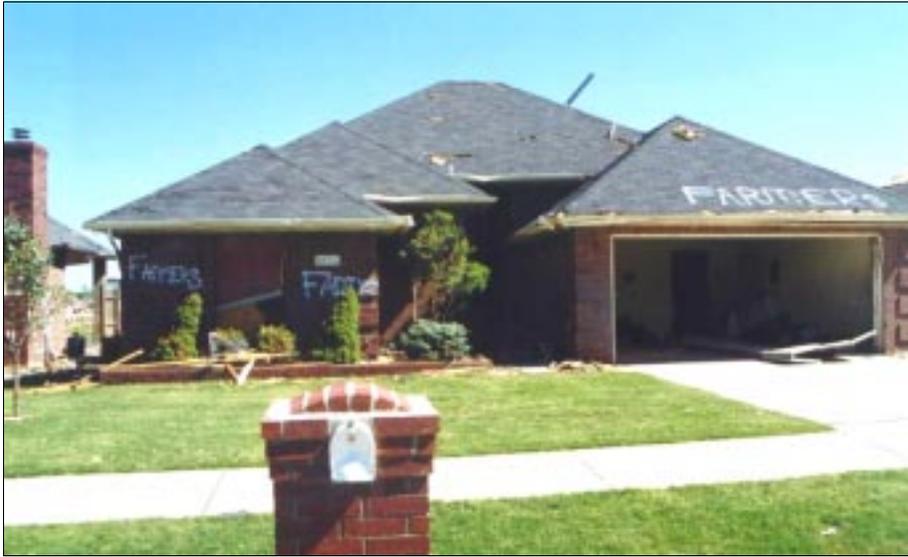
A final example of observed internal pressurization and roof uplift is shown in Figures 4-23 and 4-24 for the house located at G. The garage door failed by positive pressure and was found inside the garage. Figure 4-24 shows strong evidence of the early stages of roof uplift between the garage roof and exterior wall. The ceiling was observed to have pulled away from the exterior wall perimeter, indicating that the whole roof frame was lifted up. The space shown in Figure 4-24 was apparent along most of the perimeter of the garage ceiling. Figure 4-21 shows an exterior view of the roof and wall interface where the initiation of roof uplift was observed. Tension cracks in the brick

**FIGURE 4-23:** A view of home G with a garage door that failed due to positive or inward acting wind loads.

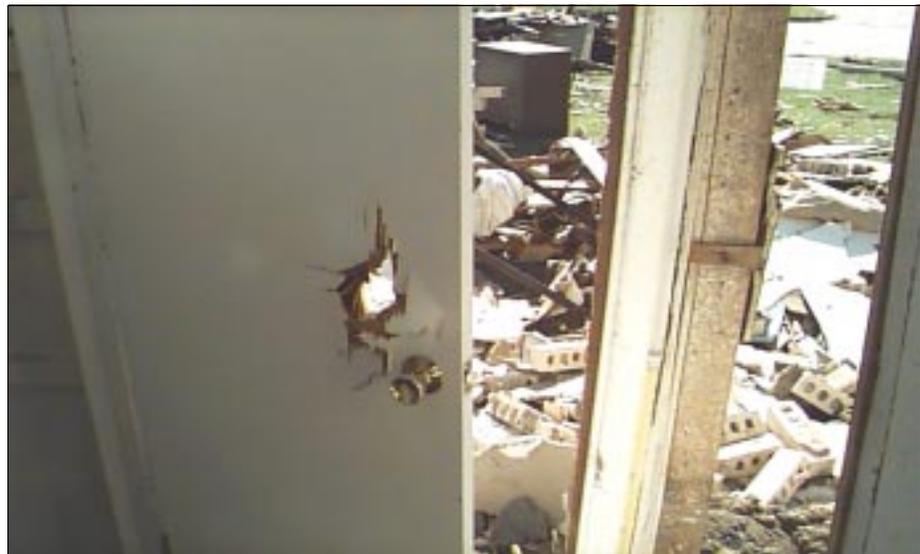
**FIGURE 4-25: A missile penetrated this exterior door in Del City, Oklahoma. Interior hollow-core doors typically offer even less missile protection than common exterior doors.**
