# BUILDING PERFORMANCE ASSESSMENT REPORT

PRELIMINARY REPORT

## *Midwest Tornadoes of May 3, 1999*

FEDERAL EMERGENCY MANAGEMENT AGENCY  
Mitigation Directorate, Washington DC and Region VI, Denton, TX  
and Region VII, Kansas City, MO

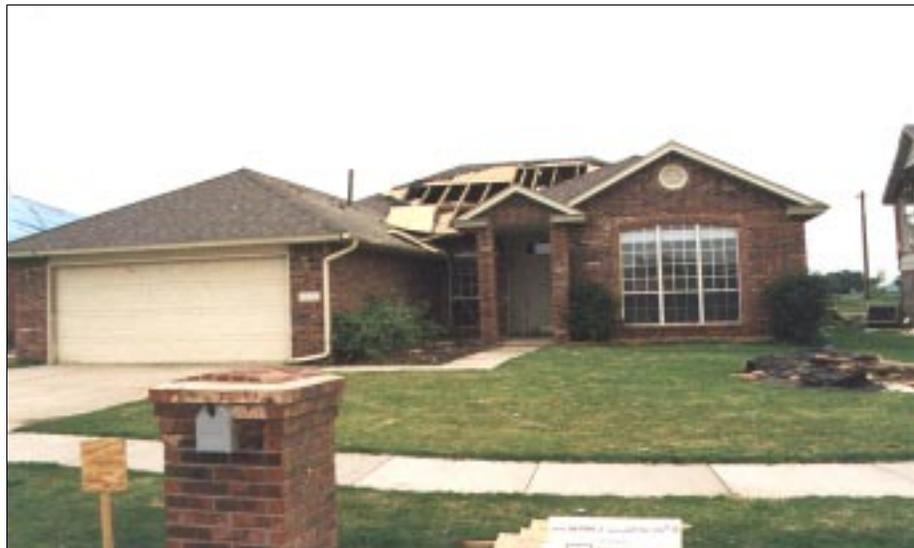
**FIGURE 4-27:** *Front of home in Figure 4-26 where several pieces of roof decking failed.*

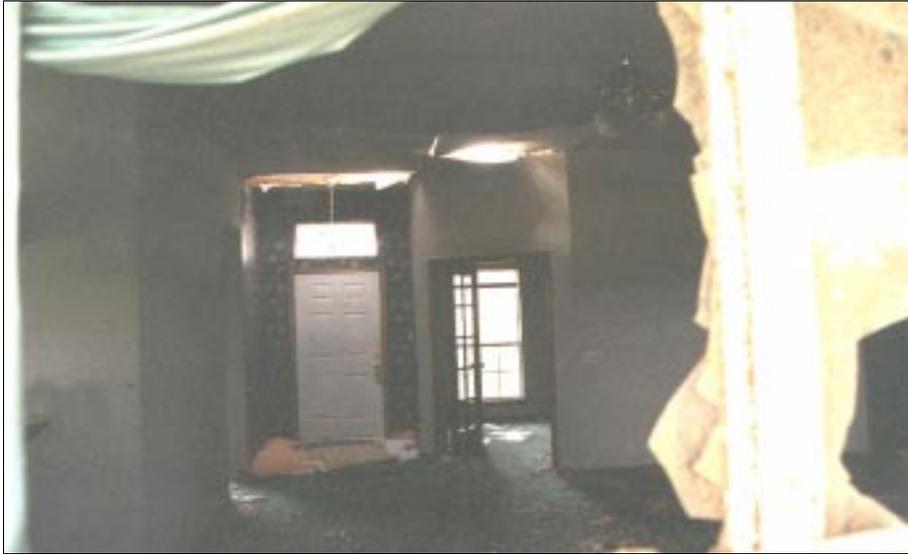
**FIGURE 4-28: View of interior of home in Figures 4-26 and 4-27.**

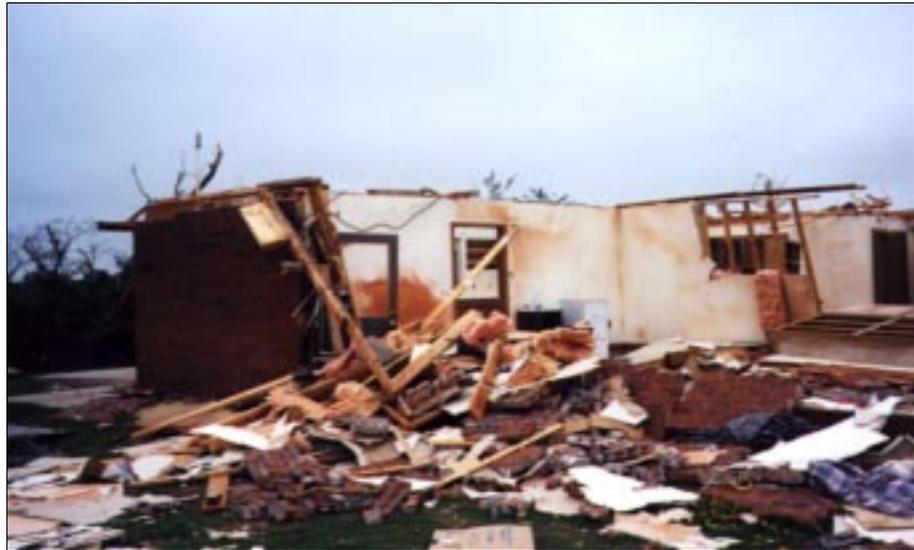
The BPAT observed brick masonry veneer construction and its failure from moderate wind loads was at numerous locations throughout the inspected subdivisions of the Oklahoma City metroplex and the Willow Lake Estates in Bridge Creek, Oklahoma. In Figure 4-30, the north wall of a house had been framed with 2-in by 6-in studs with 1-in by 4-in let-in corner bracing, covered with 1-in thick plastic foam insulation boards and brick veneer. Several studs remained upright, but the brick veneer lay on the ground. Corrugated metal brick ties remained fastened to the studs, and had pulled out of mortar joints. Onsite evaluation indicated that much of the damage had been caused by straight inflow winds near ground level associated with a nearly severe tornado, similar to that experienced from severe thunderstorms or other typical design events and not from a tornado vortex (Figures 4-30 and 4-31).

**FIGURE 4-30: Failure of brick masonry veneer construction. The vortex of the severe tornado that caused the winds at this site passed approximately 30 feet from this building in Bridge Creek, Oklahoma.**

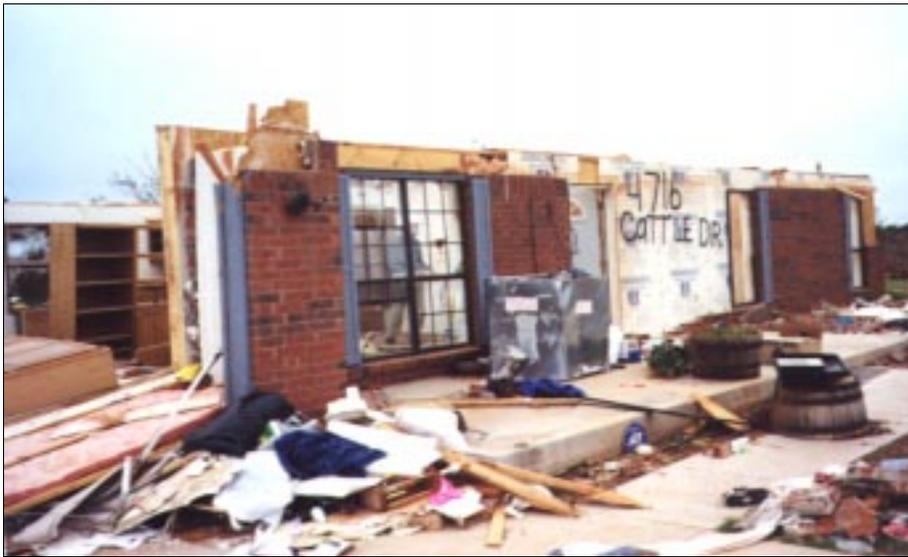
**FIGURE 4-31: Brick veneer failure at the house shown in Figure 4-30.**

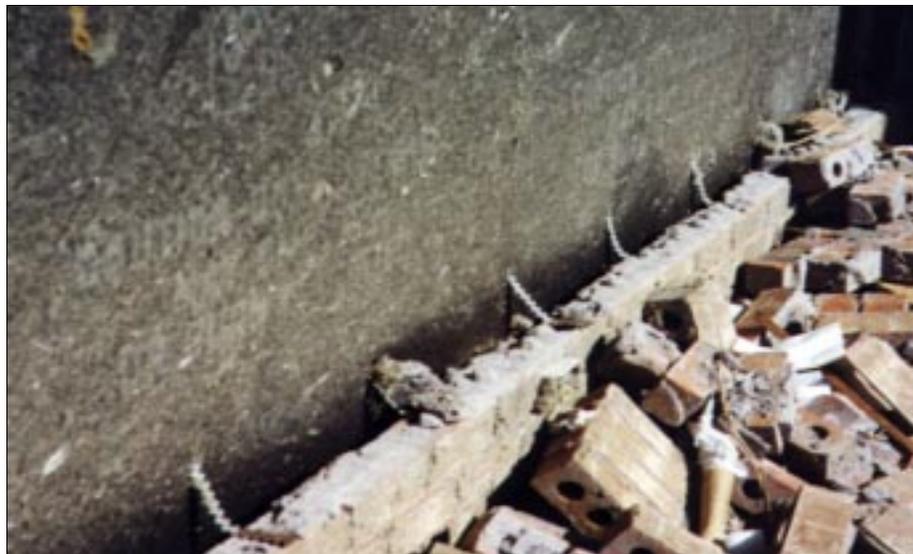
**FIGURE 4-33: Failure of masonry veneer wall, close-up view, Moore, Oklahoma. This home was located along the periphery of a violent tornado.**

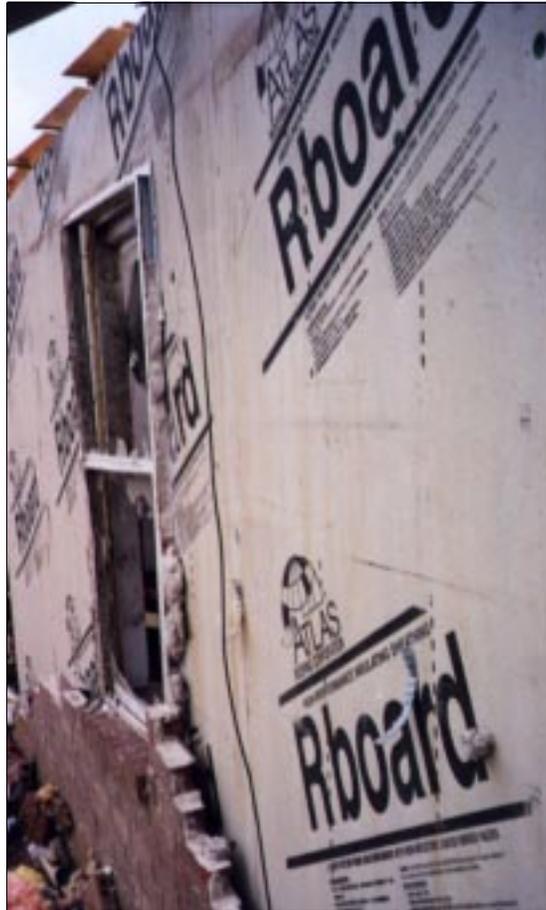
The BPAT also observed several problems that led to premature failure of the brick veneer, such as inadequate bonding of mortar to galvanized brick ties, inadequate bonding of mortar to brick, and nail pull-out at brick ties. The BPAT observed that brick veneer was generally constructed using 3-in brick, which appeared to be a dense brick of low porosity. Location and number of brick ties varied considerably, from 16-in on center vertically and horizontally, to ties at top, midheight, and near bottom of walls. There were several walls with up to 1.5-in to 2.0-in gaps behind brick and with brick ties only inserted  $\frac{3}{4}$ -in to 1.0-in into mortar joints. Most ties were fastened through foamboard sheathing into studs with one 6d common nail per tie.

**FIGURE 4-34: Inadequate bonding of mortar to galvanized brick ties, Bridge Creek, Oklahoma.**

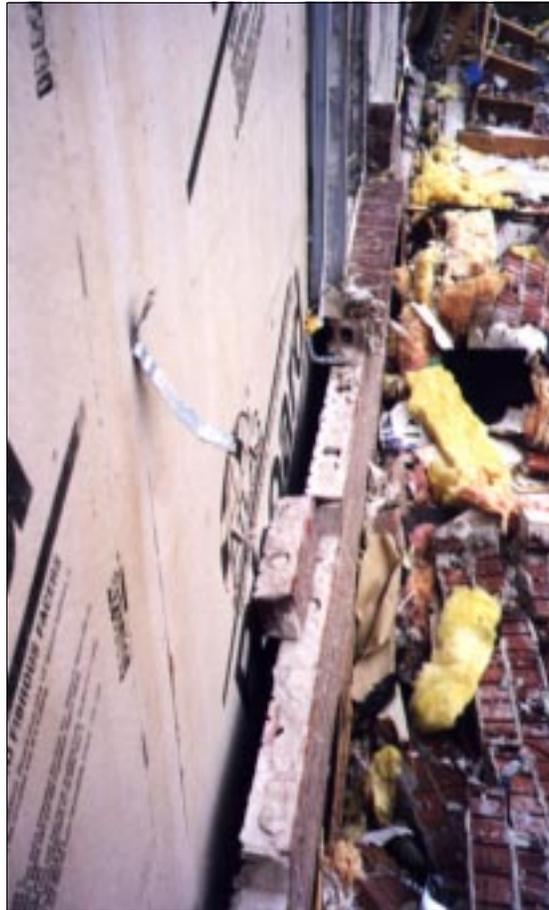
**FIGURE 4-35: Inadequate bonding of mortar to galvanized brick ties, Bridge Creek, Oklahoma.**

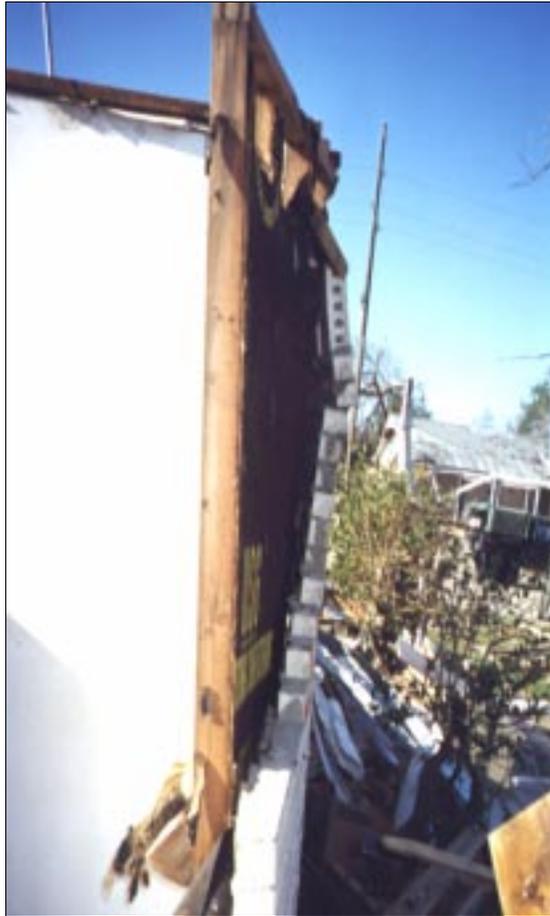
**FIGURE 4-36: Failure of masonry veneer wall, Del City, Oklahoma.**

In Del City and Mid West City, in the southeast suburbs of Oklahoma City, the BPAT observed several more examples of brick veneer (both clay and concrete brick) failure. Most of the failure appeared to have been caused by negative wind pressure (suction) on leeward and side walls (Figures 4-36, 4-37, 4-38, and 4-39). These walls were also in an area that was in the inflow wind area of a violent tornado, but outside the vortex.

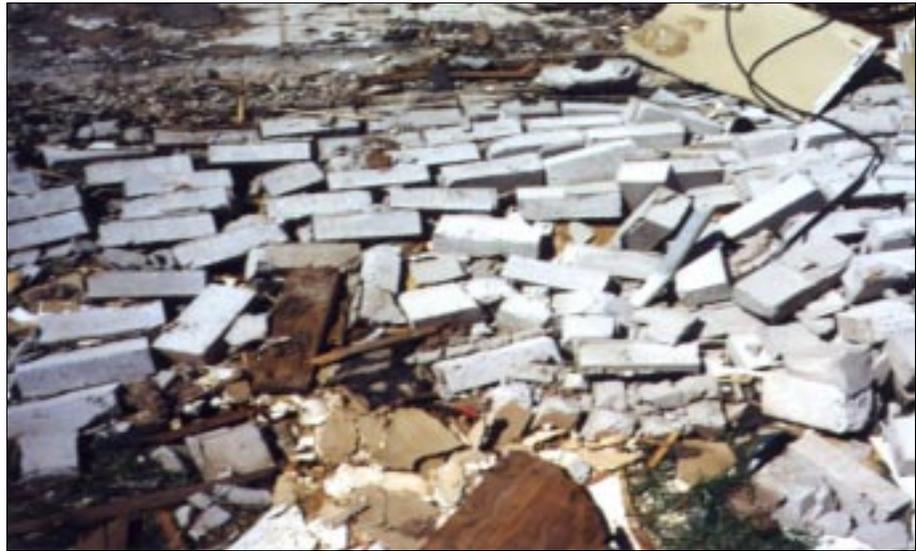
**FIGURE 4-37:** Failure of masonry veneer wall, viewed collapsed on the ground. This home, located in Oklahoma City was in the vortex of a violent tornado.

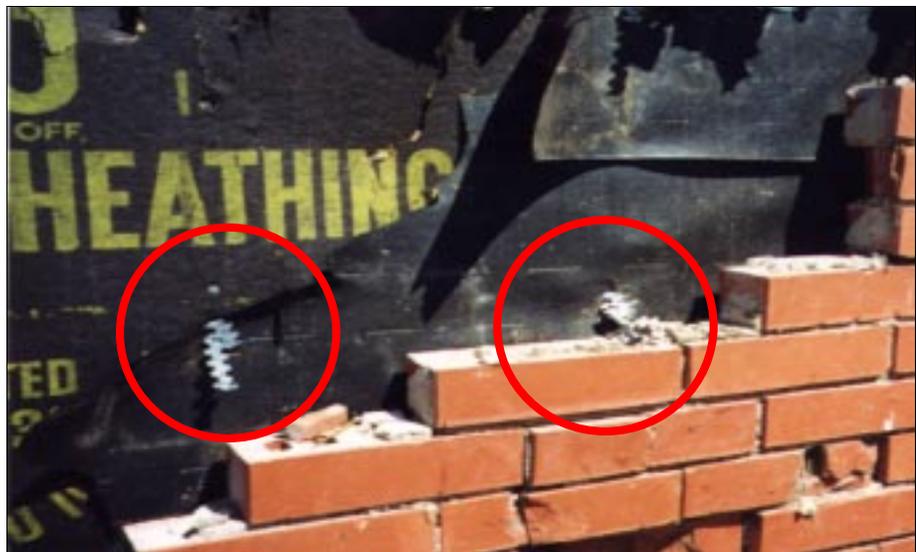
**FIGURE 4-38:** Failure of masonry veneer wall of home located along the periphery of a violent tornado in Oklahoma City. Masonry ties are circled.

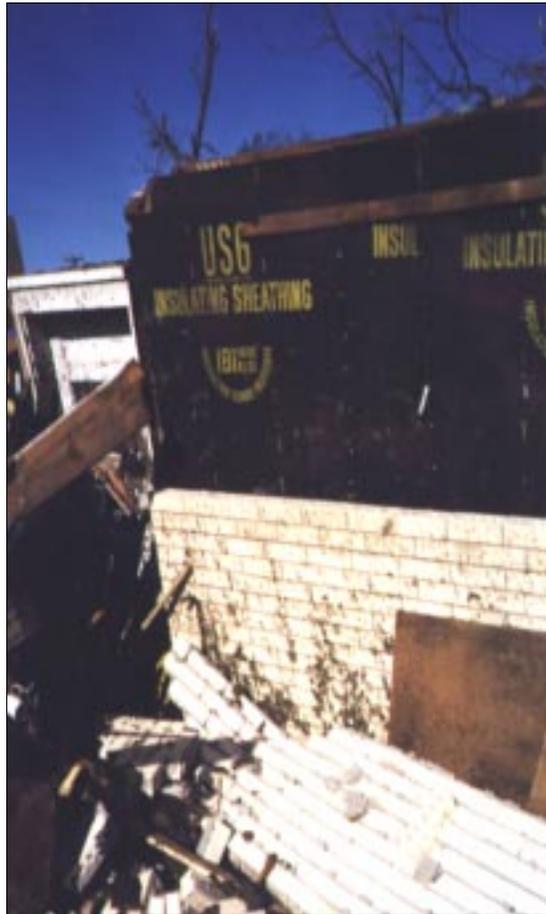
**FIGURE 4-39: Failure of masonry veneer wall of home located along the periphery of a violent tornado, Del City, Oklahoma.**

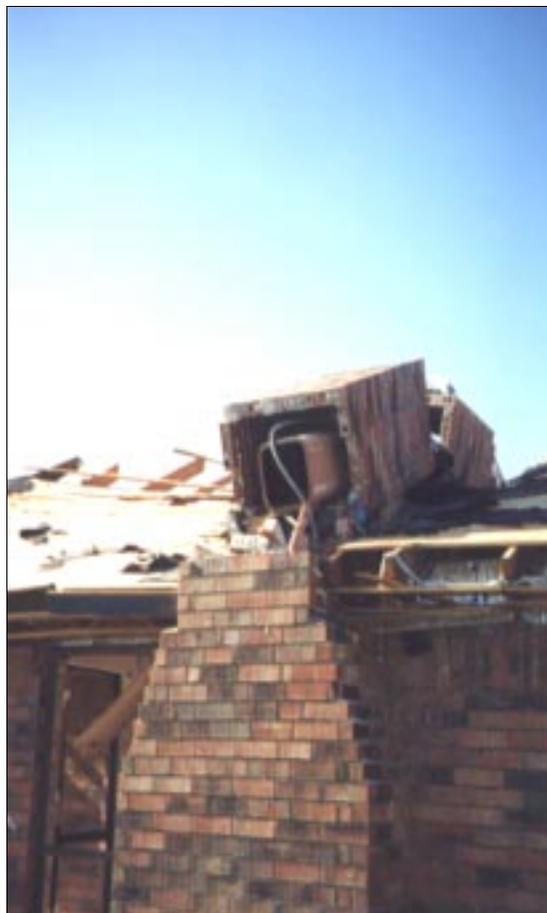
In Moore, Oklahoma, at a subdivision south of Westmoore High School that was in the direct path of a violent tornado, newer homes located in the periphery of the damaged areas approximately a few hundred feet from the vortex had failures of brick chimneys and brick veneer walls. Brick chimneys snapped off near the eave and crashed through the house roof, breaching the building envelope and placing occupants at risk of injury or death from falling masonry and other debris. Masonry veneer walls appeared to fail from suction (negative) loads pulling the veneer away from the stud framing. Again, the majority of masonry veneer was single width, 3-in brick. Chimneys were 28-in wide by 24-in deep and made of 3-in brick, with a 10-in by 10-in clay tile flue in the center, leaving a large gap between flue and exterior brick. The height of chimney was about 8-ft above eave height. No vertical or horizontal reinforcement was present. Ages of houses did not appear to make any difference on bonding of mortar to brick ties or bonding of mortar to brick., as some were 30 years old and others only one year old. This type of chimney construction should perhaps be limited in its maximum unsupported height, even when considering nominal (non-tornadic) design wind loads(see Figures 4-40 through 4-42).

***FIGURE 4-41: Close-up view brick chimney failure in Figure 4-40.***

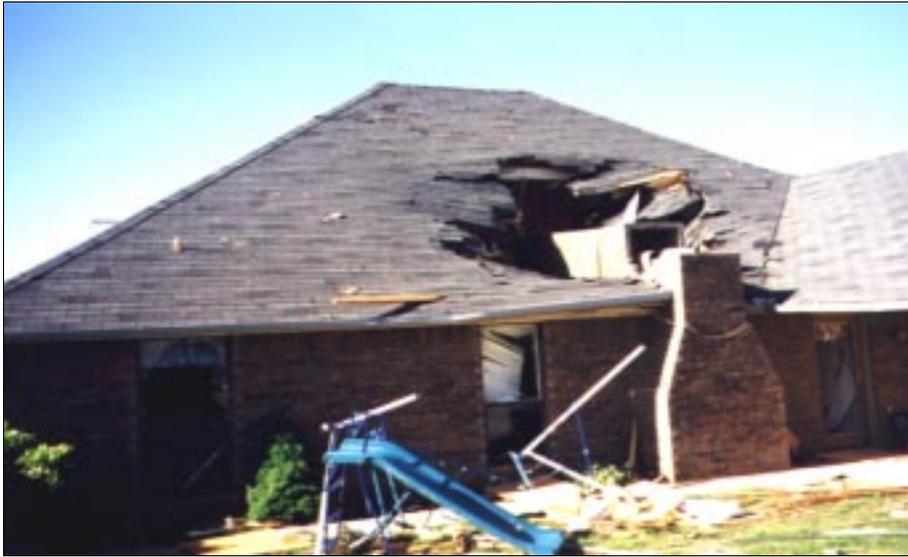
**FIGURE 4-42: Failure of brick chimney onto top of home located along the periphery of a violent tornado, Moore, Oklahoma.**

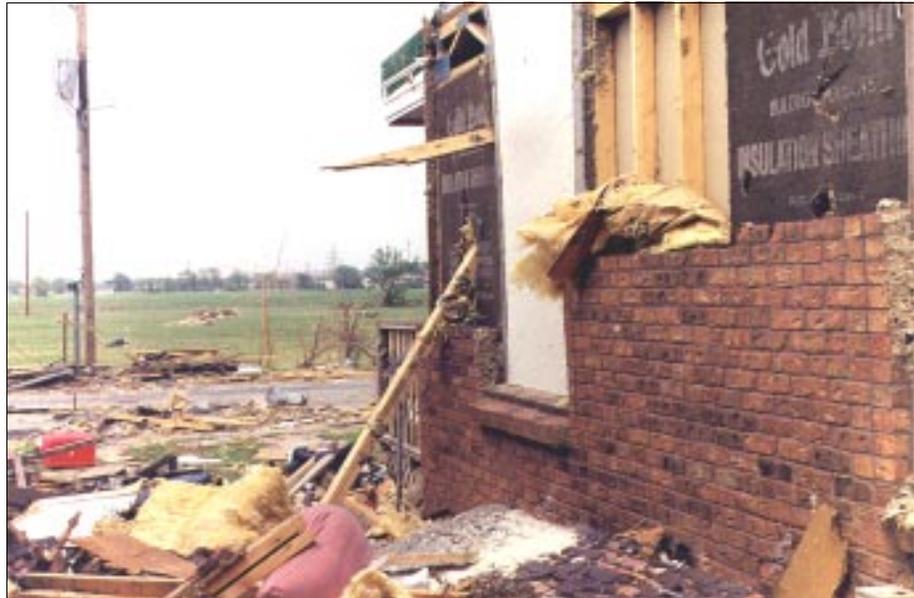
***FIGURE 4-44: Failure of masonry veneer at a multi-family housing unit in Wichita, Kansas. This building experienced inflow winds from a severe tornado.***

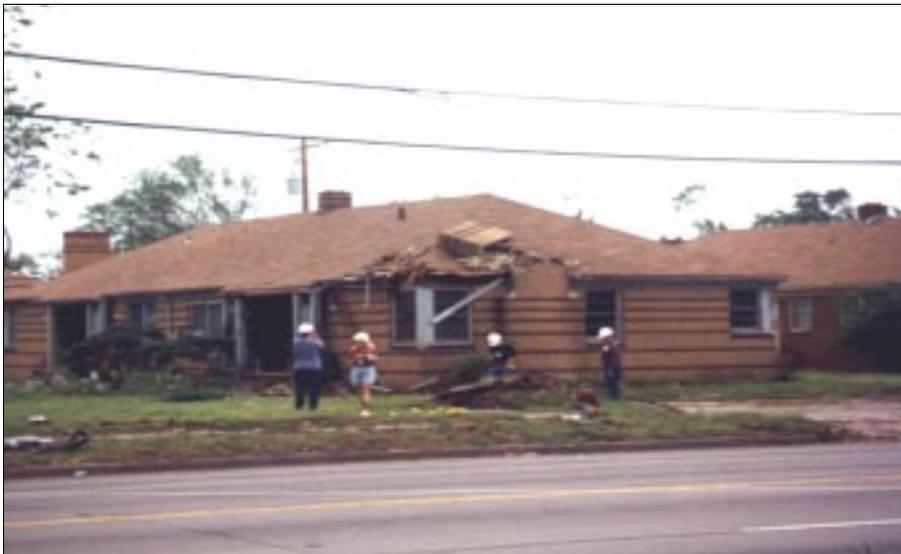
**FIGURE 4-46:** Chimney failure onto roof of single family attached housing, Wichita, Kansas. This building was located along the periphery of a severe tornado.

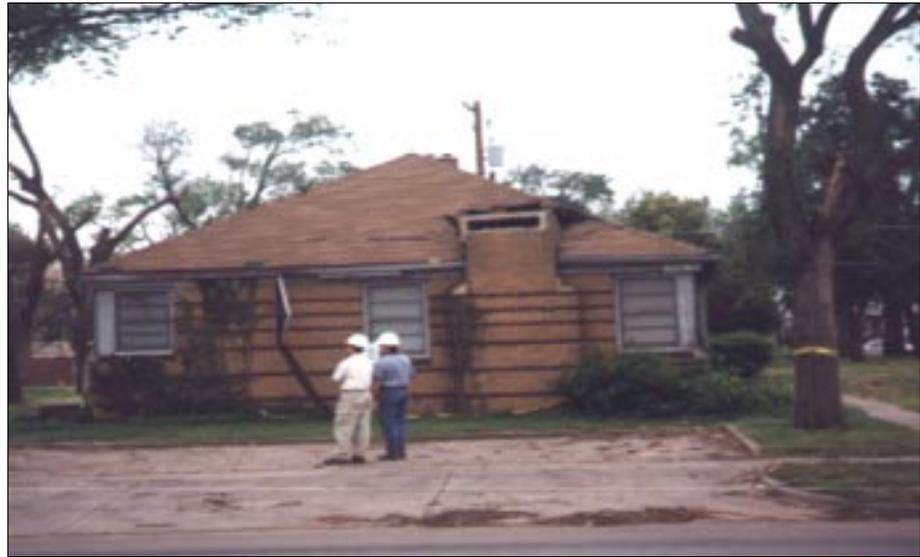
**FIGURE 4-47: Chimney failure onto roof of single family attached housing located along the periphery of a severe tornado, Wichita, Kansas.**

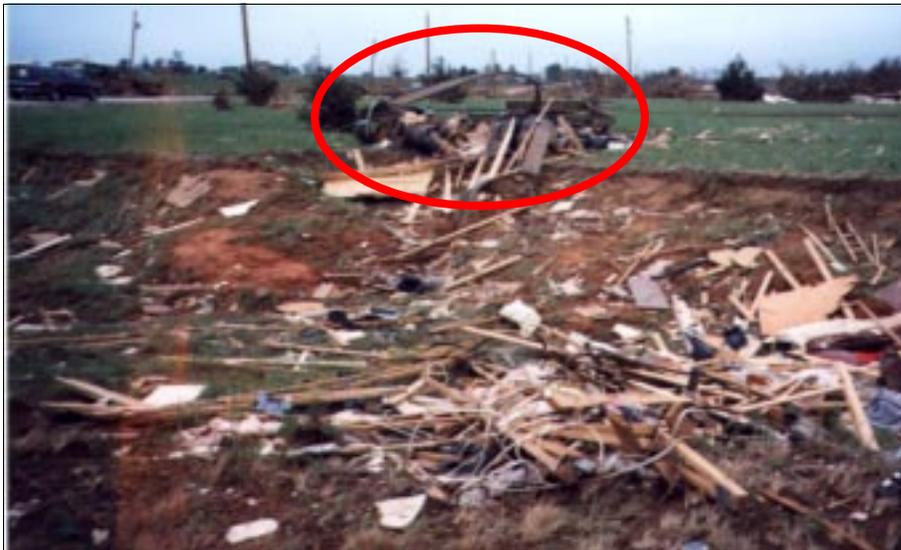
Foundation support was typically provided by ungrouted (dry stacked) concrete masonry unit (CMU) piers at six to eight feet on center under each chassis beam. The total number of anchors per home varied considerably, from four to eight per home. The most spectacular failure observed was a 14-ft by 60-ft manufactured home chassis found about 200 yards to the northeast

**FIGURE 4-48:** This 14-ft x 60-ft manufactured home chassis in the background of this picture moved about 200 yards from its original anchoring site in Figure 4-49, Bridge Creek, Oklahoma.

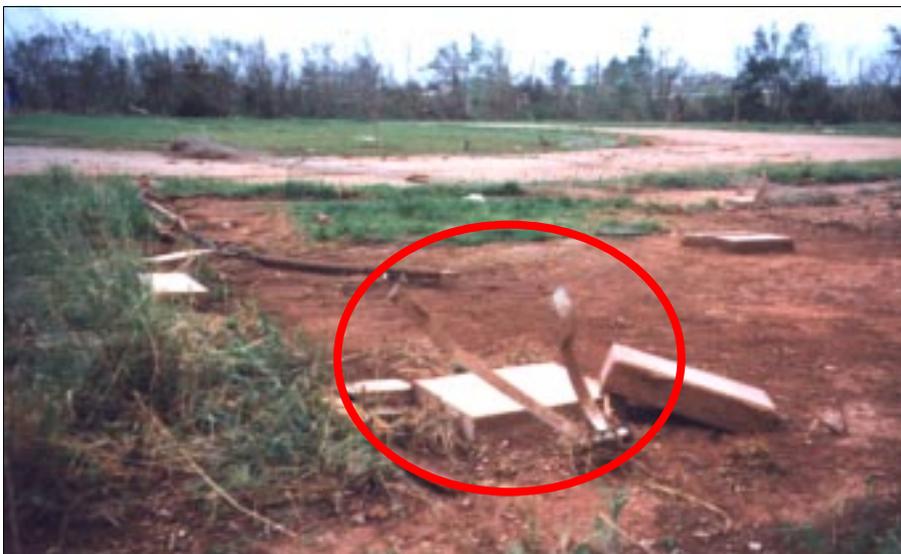
**FIGURE 4-49:** Failed straps at the anchorage of a manufactured home in Bridge Creek, Oklahoma. This site was 300-400 feet from a violent tornado vortex.

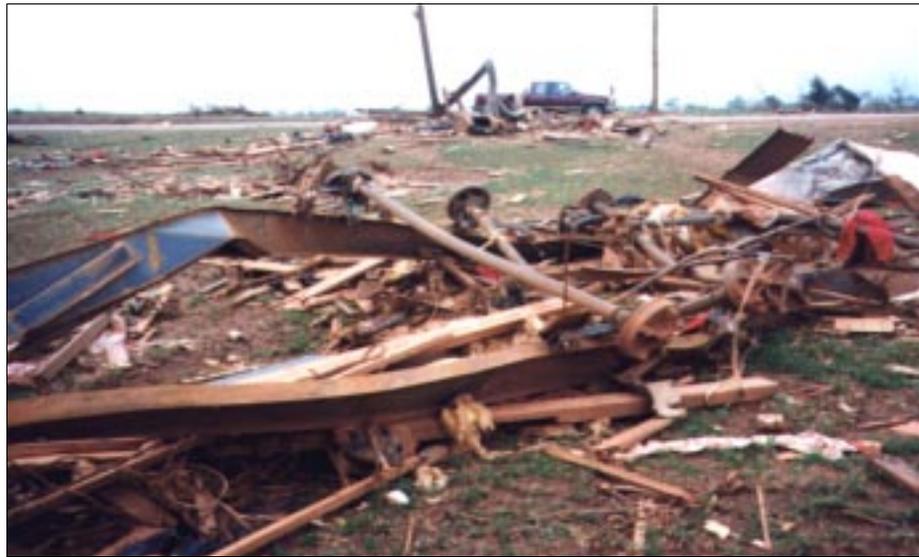
of its original anchorage site (Figure 4-48). This home was not affected by the vortex of a tornado, rather, it was affected by the inflow winds whose violent tornado vortex was approximately 300-400 ft away from this home. At the original site, vertical and diagonal straps remained attached to the ground anchor, but had failed about two to three feet from the anchors (Figure 4-49). The first anchors had been fastened about 12-feet from the east end. Both the number of anchor straps and tensile capacity of the straps were inadequate to resist wind uplift forces (Figure 4-50).

**FIGURE 4-50: Strap anchoring failure most likely led to the displacement of this chassis, Bridge Creek, Oklahoma.**

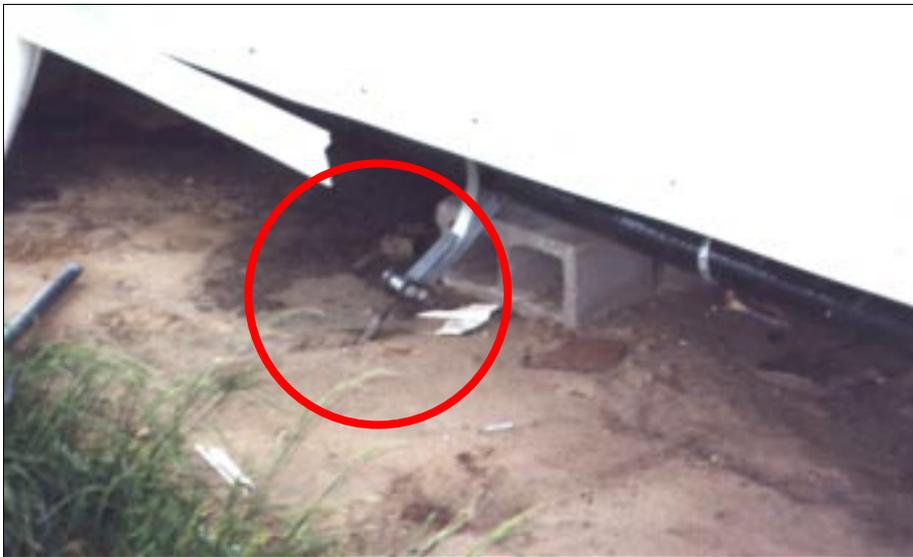
**Figure 4-52: Anchor of manufactured home bent and pulled up from soil. This home in Wichita, Kansas, was located within the inflow area of a severe tornado.**

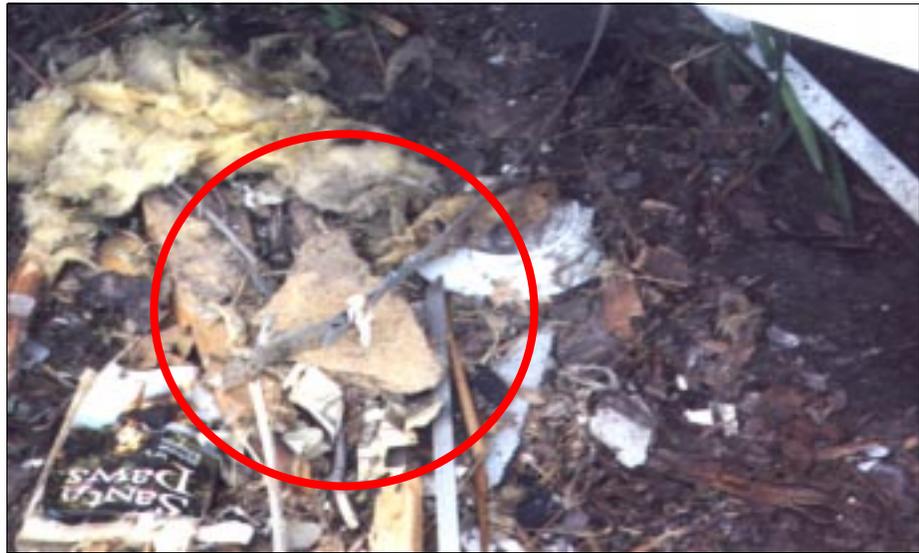
**Figure 4-53: Strap torn off from chassis of manufactured home. This home in Wichita, Kansas, was located within the inflow area of a severe tornado.**

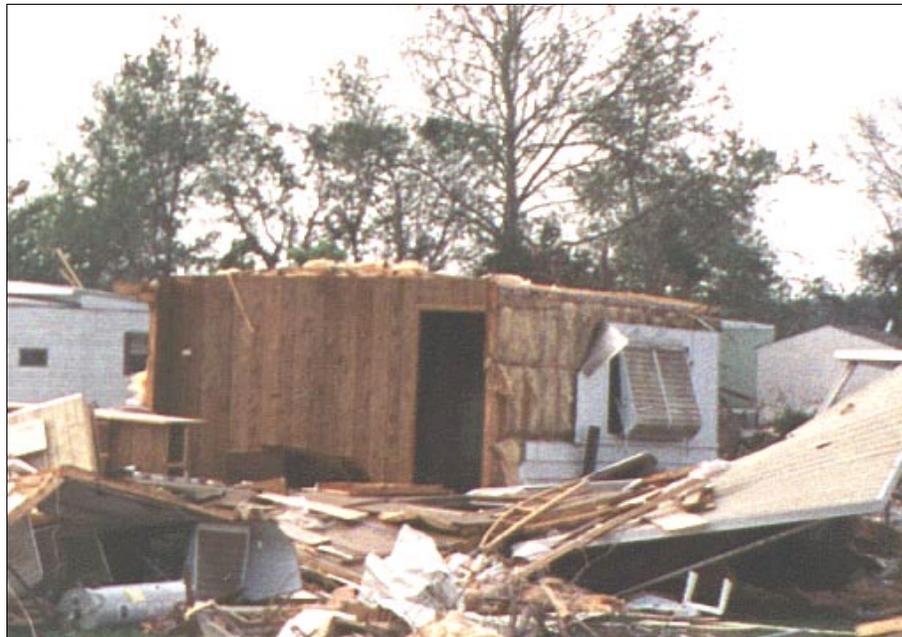
Several manufactured homes had lost plywood roof sheathing and roof trusses, and some only lost asphalt roof shingles. Fastening of the roof sheathing and roofing materials was inadequate to resist wind uplift (Figures 4-54 and 4-55) from inflow winds of a severe tornado.

**Figure 4-54: Roof and wall damage experienced due to inadequate resistance to lateral and uplift wind forces associated with straight inflow winds of a moderate tornado, Wichita, Kansas.**

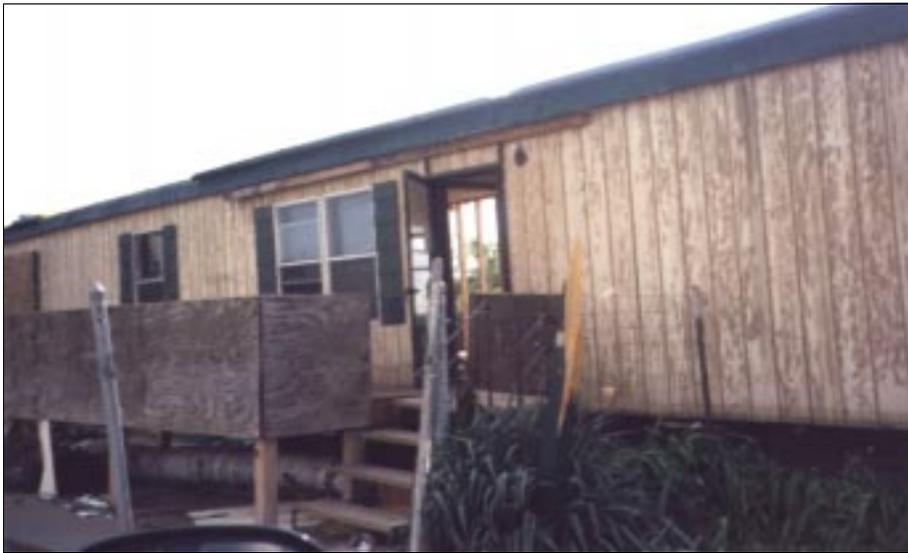
**Figure 4-55: Damage to a manufactured home located on the periphery of a severe tornado, Wichita, Kansas.**

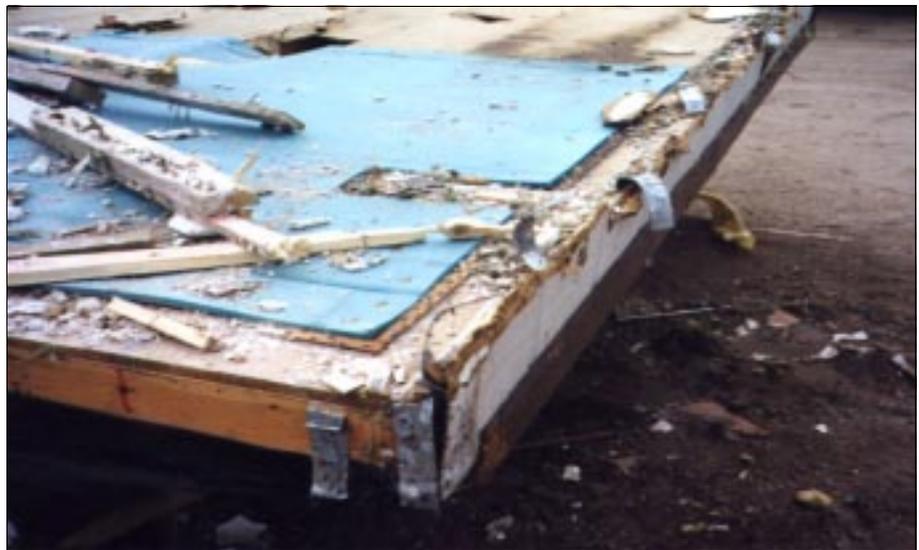
In Haysville, Kansas, the BPAT visited the Sunset Field Addition on South 65<sup>th</sup> Street near the historic district, where several double-wide manufactured housing units were constructed on permanent concrete crawl space foundations. It was reported that roofs and several walls of the units had been destroyed, but that the floors had remained on the foundation walls. Later, during demolition, the floor system and steel chassis beams with steel outriggers and steel angle bracing had been lifted off the foundation. Although the floors had remained on the concrete walls, there were no bolts or positive connections between the chassis or perimeter wood joist and the sill-plate, pockets in the concrete walls, or center piers (Figure 4-56). Straps that had been stapled to wall studs and to perimeter joists did not appear adequate to resist wind uplift or lateral loads (Figure 4-57), and fastening of the roof system to walls had been inadequate.

**FIGURE 4-57:** *A close up of the manufactured home floor and chassis after it was removed from the permanent foundation in Figure 4-56.*

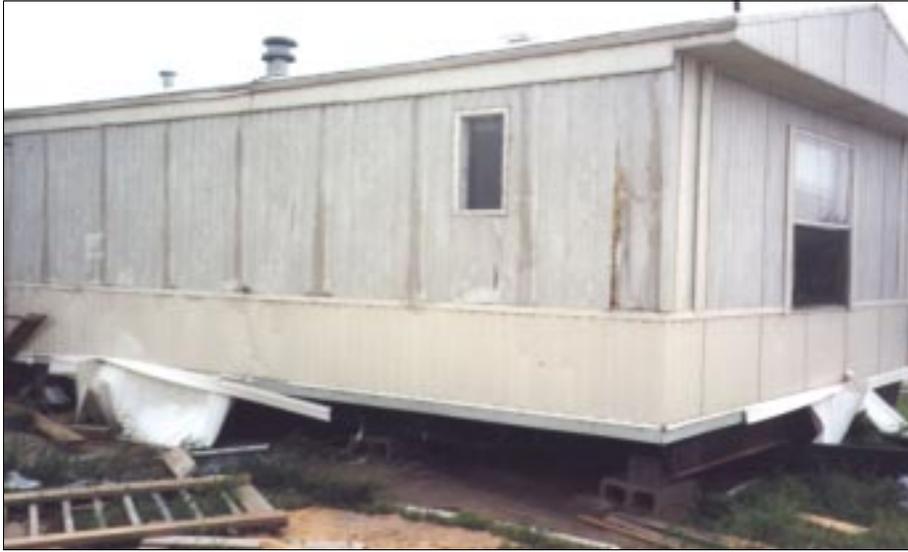
Several double-wide manufactured housing units partially survived high wind forces. However, ground anchors were pulled out of the soil, or they were bent over, loosening up tie-down straps. Homes shifted laterally from wind forces and fell off unreinforced and ungrouted CMU block piers. In some cases, tie-down straps with metal clips for attachment to chassis beams were loose and lying on the ground (Figures 4-58 through 4-61). **(location and wind?)**

**FIGURE 4-58:** *This manufactured home laterally shifted from wind force generated along the periphery of a violent tornado, Haysville, Kansas.*

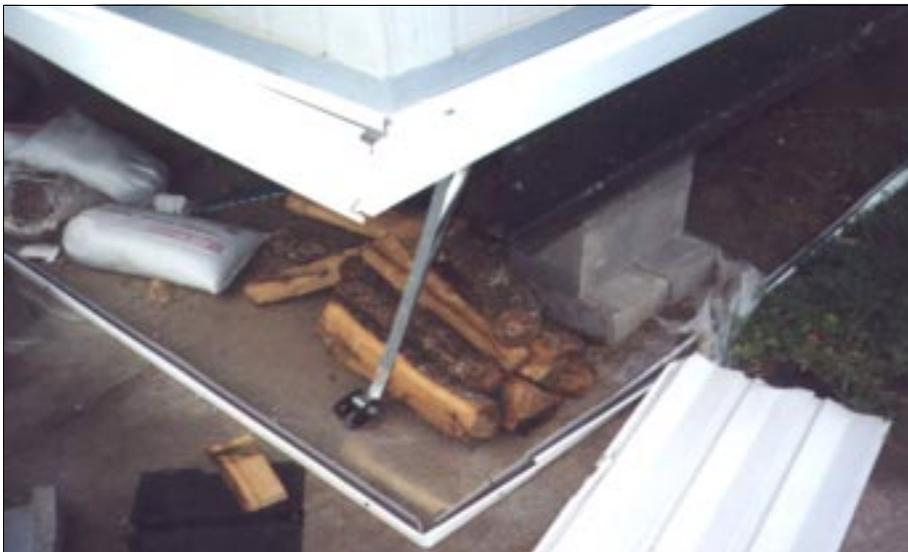
**FIGURE 4-59:** *View of anchor strap and attachment indicating lateral shifting of a manufactured home, Haysville, Kansas. This home was located along the periphery of a violent tornado.*

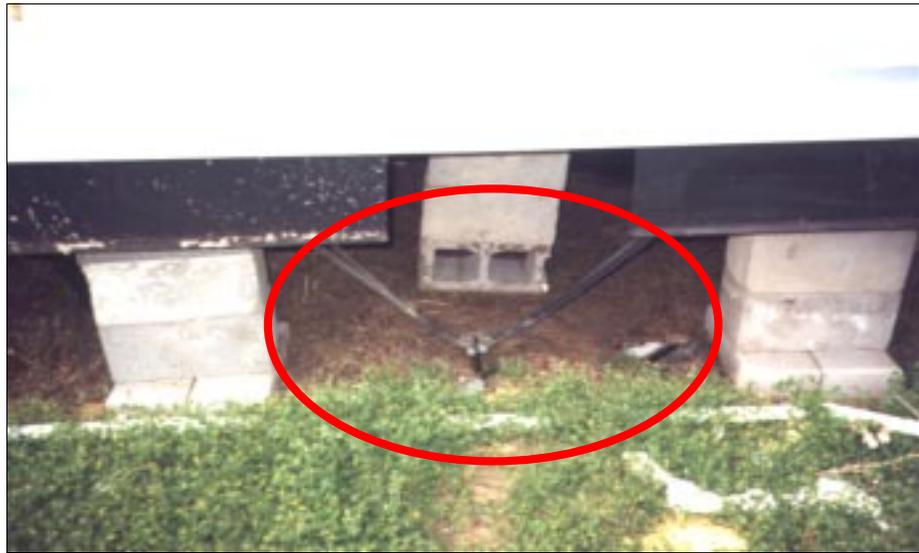
**FIGURE 4-60:** View of anchor strap and attachment indicating some lateral shifting of a manufactured home located along the periphery of a violent tornado, Wichita, Kansas.

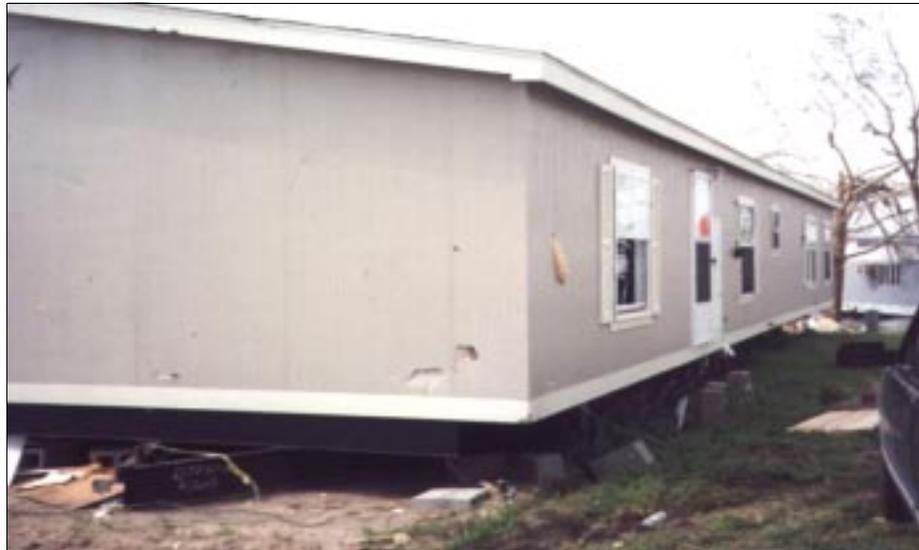
**FIGURE 4-61:** Manufactured home laterally shifted from wind force generated along the periphery of a violent tornado, Wichita, Kansas.

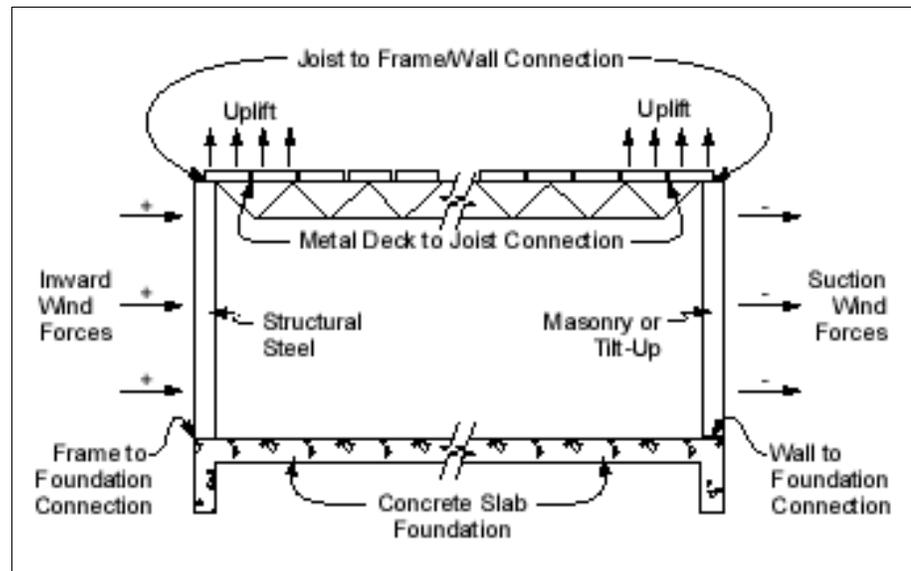
A continuous load path from the roof structure to a building foundation is essential for a building. This load path, the members and connections between members, is capable of withstanding gravity or downward design loads. However, during high wind events such as tornadoes, lateral loads and uplift loads will act on the building and test the capacity of the continuous load paths. Figure 5-1 shows critical connections in the continuous load paths for representative types of non-residential buildings that sustained structural damage. In addition to the lateral wind forces that are often considered in design, significant uplift loads generated by the high wind velocity associated with tornadoes act on the roofs. To resist these loads, adequate connections must be provided between the roof decking and roof structural support, bar joists or other structural roofing members and walls, and foundation and walls or structural columns. Each of these connections must be capable of resisting uplift and lateral loads as well as gravity loads.

**FIGURE 5-1: Critical connections that failed in the load path resulting in structural damage or collapse.**

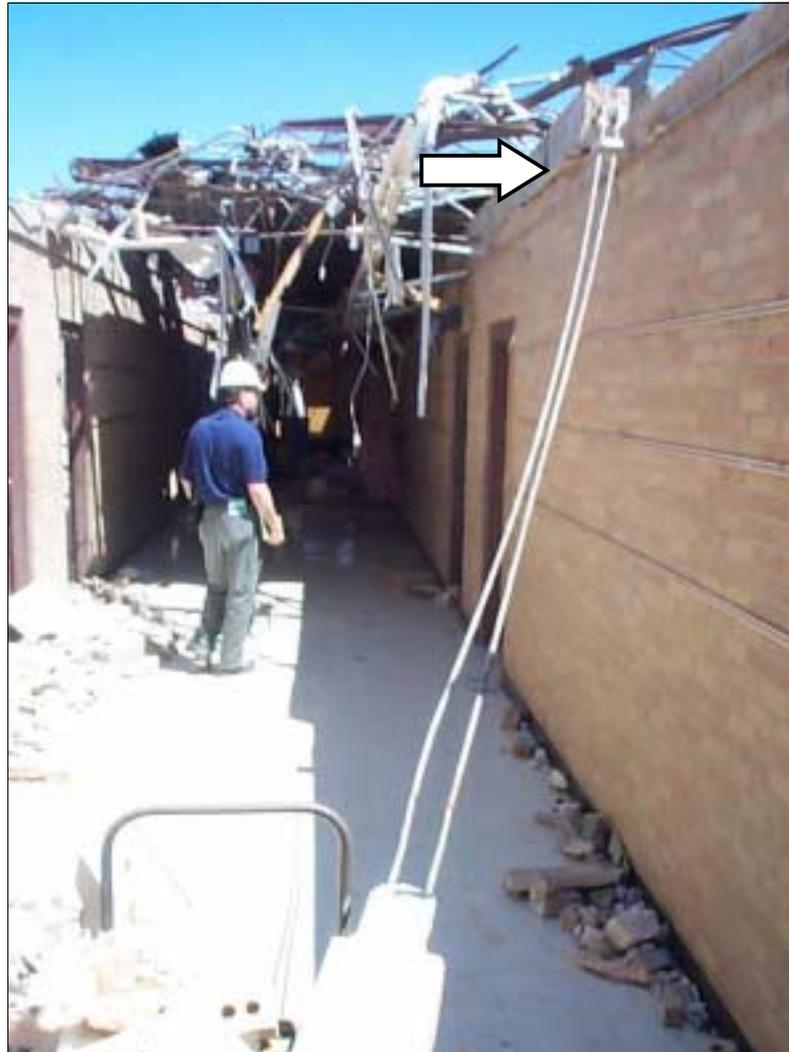
This section discusses the damage associated with the masonry wall section of the building; Section 5.1.3 will discuss the steel frame section of the school. Figure 5-3 shows damage to the Kelly Elementary School. Arrows show separation between the bond beam and its supporting wall and separation between the bond beam and roof bar joists. At both locations, connections between the bond beam, joists, and walls were adequate for gravity load, but could not carry the high uplift loads that were caused by winds associated with the violent tornado.

**FIGURE 5-3: Kelly Elementary School, in Moore, Oklahoma, hit by vortex of violent tornado. Damage to school displaying separation between the bond beam and supporting wall and separation between bond beam and roof bar joists.**

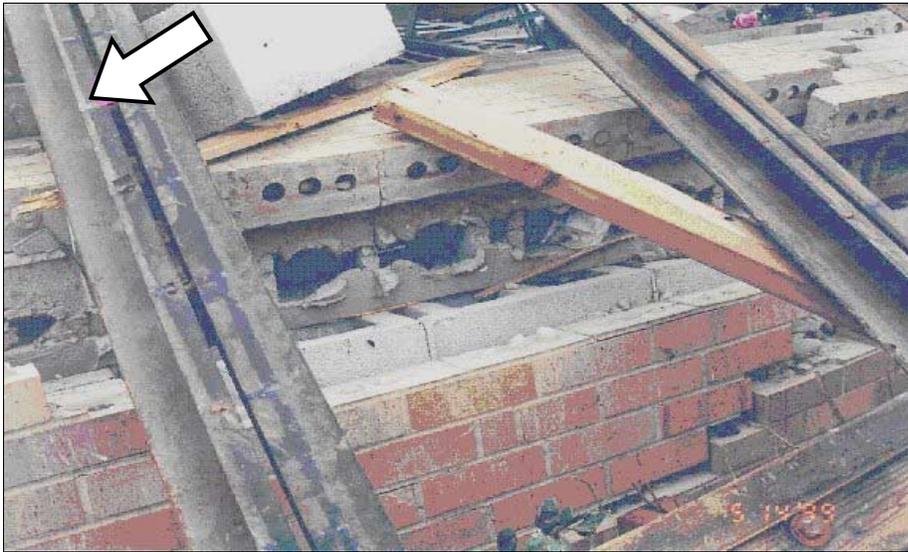
Figure 5-4 shows a close-up of a joist end over the old cafeteria. The arrow shows a location where the roof deck was supported for gravity load, but not welded for uplift. Below the arrow, broken welds can be seen. Also visible in Figure 5-4 is the lower portion of the external wall. As illustrated in the photograph, no effective vertical reinforcement was found in the wall. Consequently, the wall had low resistance to uplift in combination with high lateral wind loads.

**FIGURE 5-4:** Failed structure showing broken deck welds, and no effective vertical reinforcement. Kelly Elementary School, Moore, Oklahoma, hit by vortex of violent tornado.

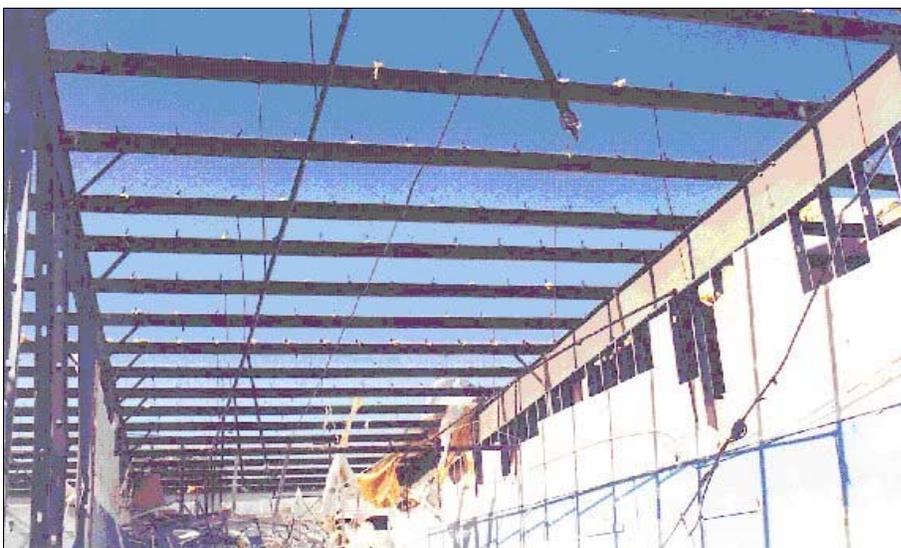
The BPAT visited a regional outlet mall in Stroud, Oklahoma, where the entire roof was blown away and significant damage to the building was evident. This mall was struck by a moderate tornado that collapsed the central portion of the building's steel frame and damaged many of its masonry and steel frame walls. Figure 5-5 shows standing seam roof attachments of the decking to the purlins in one area of the mall that failed under the uplift loading. It was observed that threaded fasteners used to attach portions of the exterior cladding to the frame performed better than the standing seam roof attachments.

**FIGURE 5-5:** Metal roof deck of regional outlet mall, Stroud, Oklahoma, blown off when hit by moderate tornado vortex.

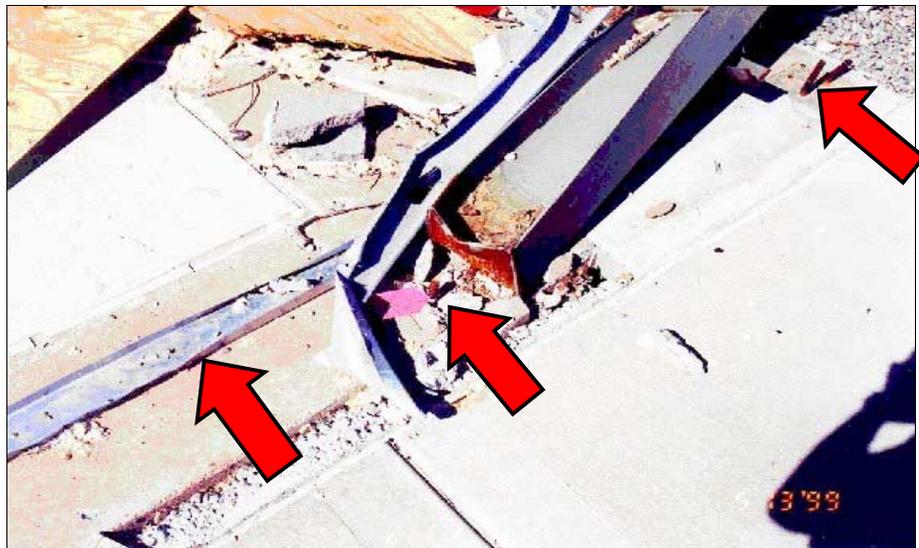
Figure 5-6 shows the attachment of columns to the foundation and attachment of the wall bottom plates to slab concrete. At the arrow on the right in Figure 5-6, anchor bolts were provided but the apparent lack of nuts on the anchor bolts permitted the column to lift off of the foundation. At the center arrow, anchor bolts with properly attached nuts provided a high level of restraint to column lift off. The arrow at the left of Figure 5-6 shows a wall bottom plate that was attached to the concrete slab by power driven nails. Although the plate held at this location, lack of penetration by the nails into the concrete permitted the plate to pull out at many other locations. Additional nail penetration would be needed to assure consistent attachment of wall bottom plates to the slab.

**FIGURE 5-6: Attachment of columns to foundation and attachment of wall bottom plates to concrete slab. Regional outlet mall, Stroud, Oklahoma, hit by moderate tornado vortex.**

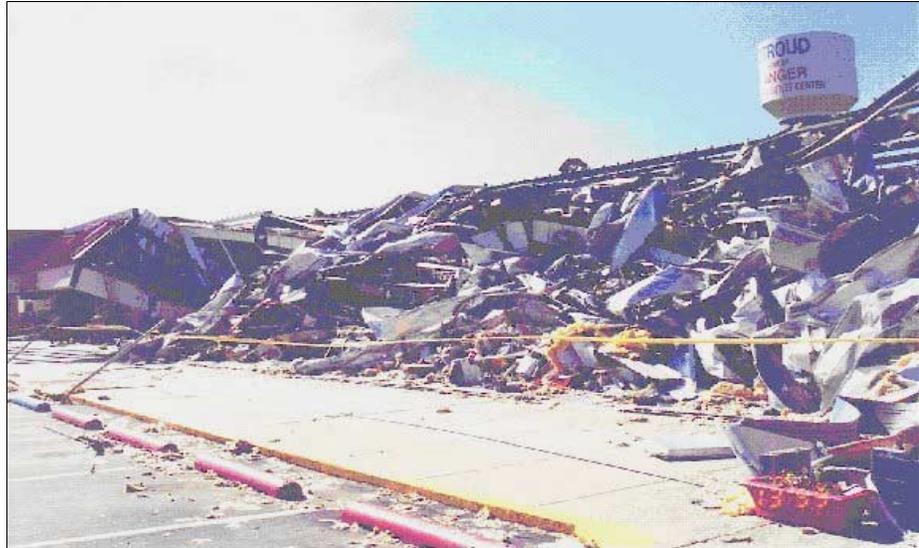
The BPAT investigated the regional outlet mall that was destroyed in Stroud, Oklahoma. Figure 5-9 shows damage to the outlet mall. In this structure, most of the metal roof deck was blown off by the tornado. In addition, much of the metal curtainwalls used above lower, exterior masonry walls were destroyed.

**FIGURE 5-9: Stroud Regional Outlet Mall, Stroud, Oklahoma was struck by the vortex of a moderate tornado.**

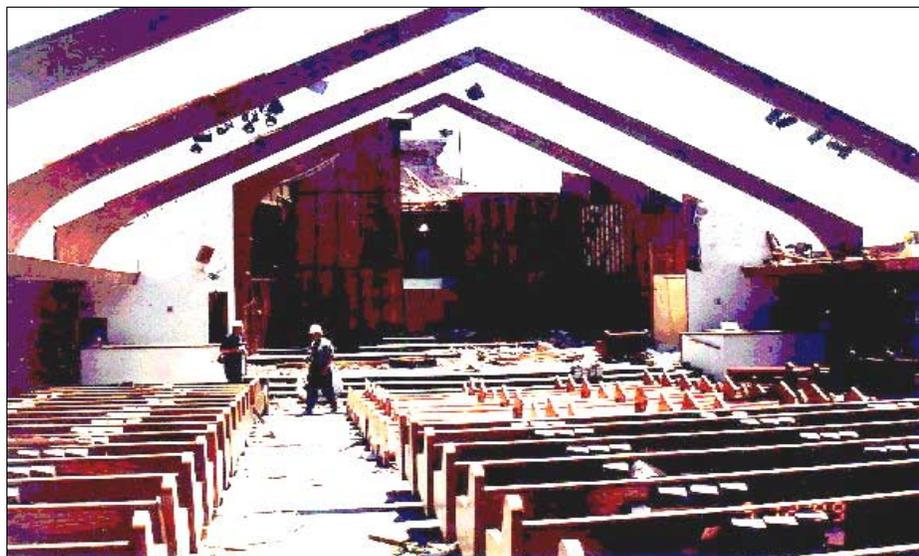
Lack of load path also resulted in severe damage to the Regency Park Baptist Church in Moore, Oklahoma. This building was approximately one block north and across the street from Kelly Elementary School. The vortex of a violent tornado passed approximately a few hundred yards to the south. Figure 5-10 shows the rigid frames remaining after the roof had been removed by the tornado. Loss of load path between the rigid frames and the roofing resulted in severe damage to the facility.

**FIGURE 5-10: This church suffered loss of roof due to lack of load path between the rigid laminated wood arches and the roof purlins which supported roof sheathing. Inflow area of a violent tornado, Moore, Oklahoma.**
