# BUILDING PERFORMANCE ASSESSMENT REPORT

PRELIMINARY REPORT

## *Midwest Tornadoes of May 3, 1999*

FEDERAL EMERGENCY MANAGEMENT AGENCY  
Mitigation Directorate, Washington DC and Region VI, Denton, TX  
and Region VII, Kansas City, MO

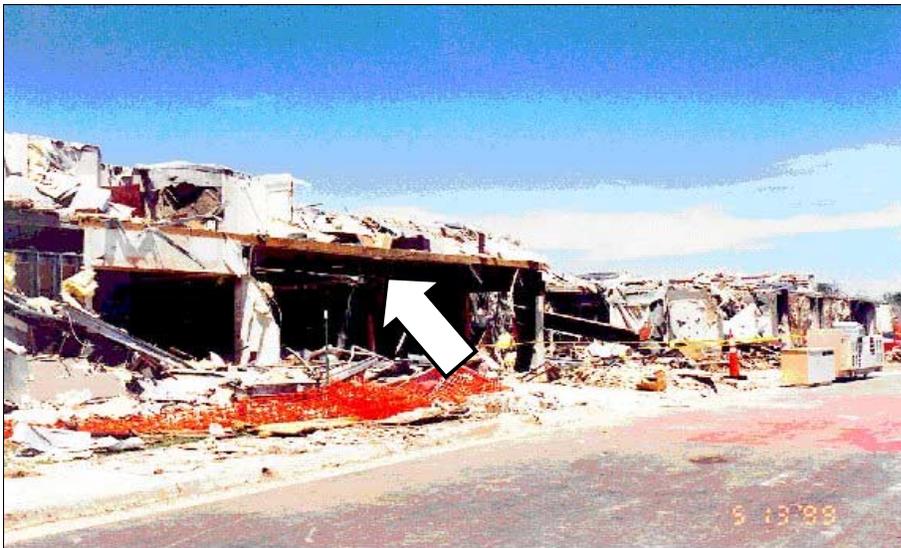
In several locations, combined effects of upward suction wind loads with horizontal wind loads caused unexpected damage to structures. When a continuous load path for uplift and lateral loads did not exist, roof failures and upper level floor failures were observed. Figure 5-11 shows the remains of a motel in Mid West City, Oklahoma, hit by a violent tornado vortex. The arrows show a steel beam that had been deflected inward significantly when the floor slab was lifted during the tornado. There was no positive connection between the steel beam and the floor above.

**FIGURE 5-11: Motel in Mid West City, Oklahoma that experienced major damage when struck by the vortex of a violent tornado.**

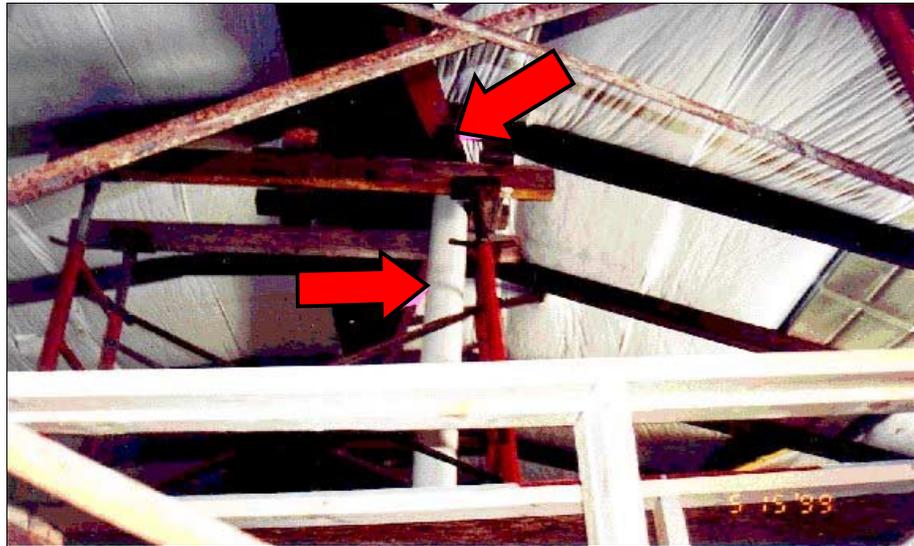
At a plastics manufacturing plant in Haysville, Kansas, a combination of upward and horizontal wind loads when the plant site was hit by a violent tornado caused out-of-plane buckling of the bottom flange of a main girder supporting the roof (Figure 5-12). One arrow shows the column that supports the girder, while the other arrow shows the bottom flange of the girder. It can be seen that the bottom flange has displaced significantly sideways in relation to the top flange of the girder. Inspection along the length of the girder indicated that the bottom flange was braced along its length at every purlin except at the location of the supporting column. This lack of bracing permitted buckling and out-of-plane displacement of the bottom flange. However, due to the light gravity loads left on the roof after the wind forces diminished, collapse did not occur.

**FIGURE 5-12: Out-of-plane buckling of the main girder supporting the roof created by a combination of uplift and horizontal wind loads. Plastics plant, Haysville, KS hit by violent tornado. This building was in the inflow area of a severe tornado.**

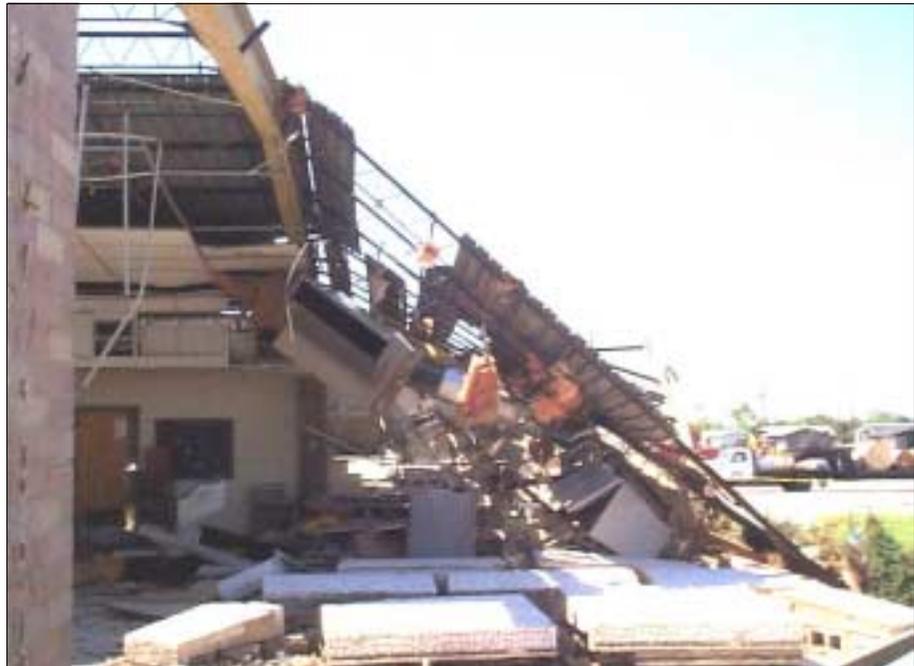
Another example of the effects of uplift and horizontal wind forces is seen in Figure 5-13 at Kelly Elementary School in Moore, Oklahoma. The exterior wall collapsed inward indicating that the roof had lifted up as the wind loads acted inward on the wall. Failure to have a continuous load path from the joists supports into the masonry wall to resist uplift forces contributed to collapse of the wall. The exterior masonry wall is seen lying on the floor beneath the collapsed roof structure.

**FIGURE 5-13: Collapsed roof structure and exterior at Kelly Elementary School in Moore, Oklahoma struck by the vortex of a violent tornado.**

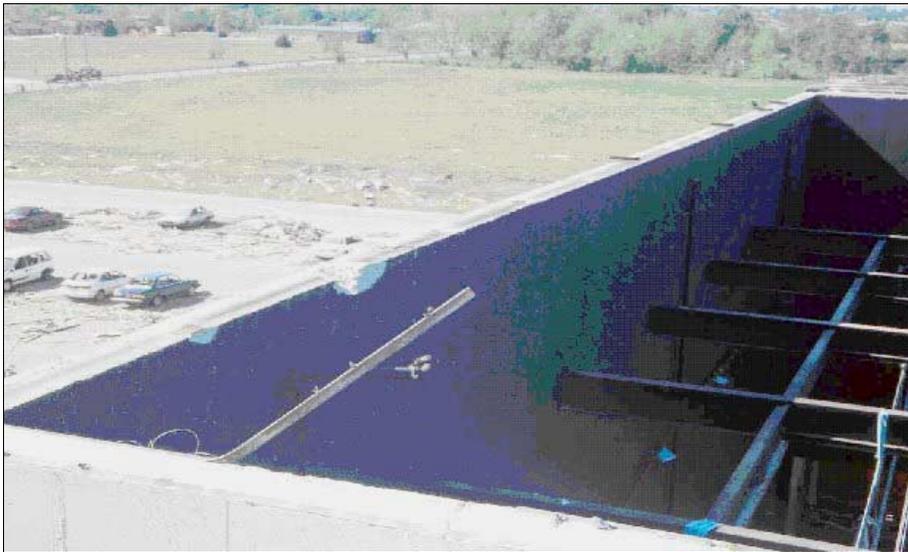
The Westmoore High School in Moore, Oklahoma, was a relatively new structure that was within 100 yards of the vortex of a violent tornado. Although most of the roofs stayed on this building, the roof over the auditorium stage was blown off. Figure 5-14 shows the walls where the bar joists had been attached prior to the tornado. In all cases, welds failed between bar joist ends and embedments in the walls in the auditorium stage roof. This loss of load path permitted the roof to be lifted up off of the reinforced concrete walls.

**FIGURE 5-14: Roof blown off over top of auditorium at Westmoore High School, Moore, Oklahoma hit by inflow winds of violent tornado.**

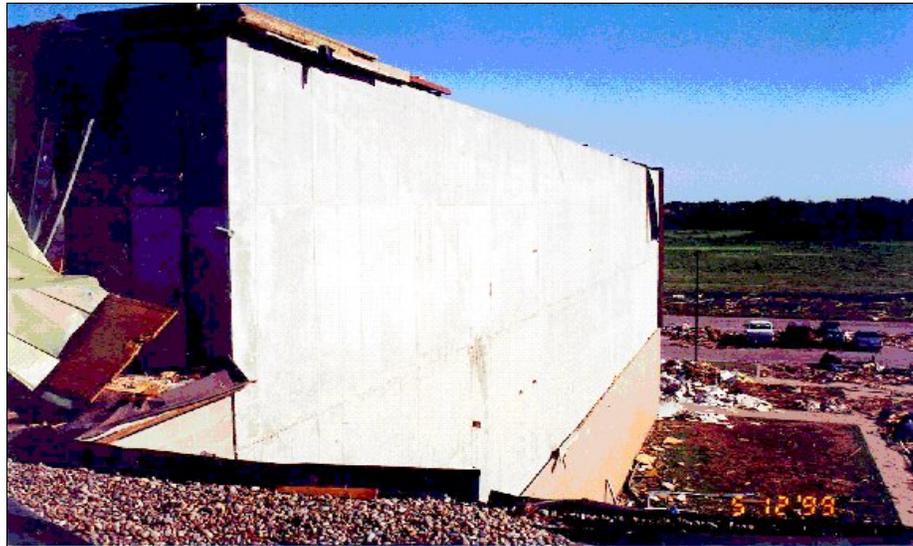
Figure 5-15 shows the exterior of the reinforced concrete wall at Westmoore High School following the tornado. This 12-in thick by approximately 35-ft-tall wall remained essentially undamaged, even though the diaphragm action of the roof was lost. The construction of the stage area integrated an I-beam horizontal frame, shown in Figure 5-14, with the reinforced concrete walls. This frame provided diaphragm action that helped stabilize the walls. Prior to the tornado, the bare concrete had been covered with a decorative metal curtainwall. The entire curtainwall blew off during the tornado while brick masonry veneer on the lower wall remained, with virtually no damage.

**FIGURE 5-15: Exterior view of an undamaged reinforced concrete wall, Westmoore High School, Moore, Oklahoma, hit by inflow winds of a violent tornado. Note: decorative metal wall covering was peeled from this wall.**

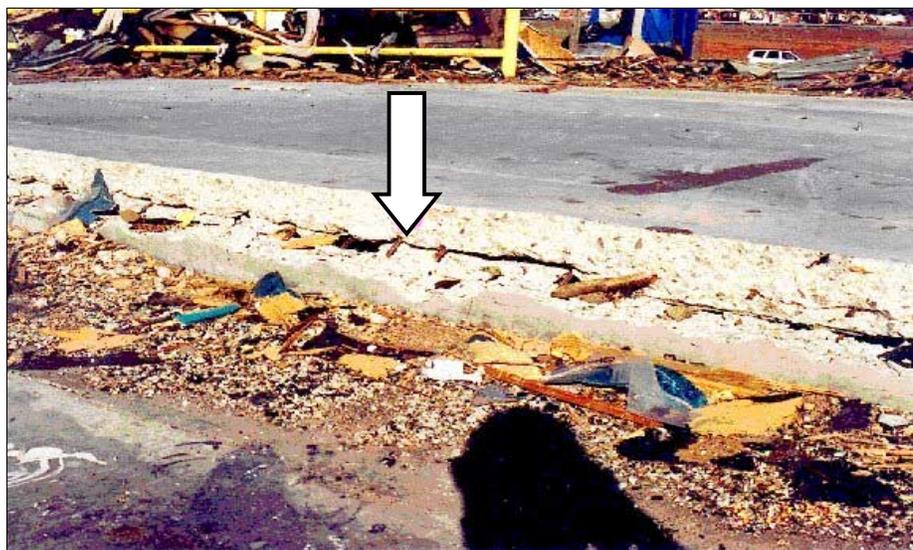
Figure 5-16 shows a tilt-up concrete wall that failed after loss of an interior diaphragm made up of steel joists and metal deck. This building was located approximately 200 yards from a violent tornado vortex near Del City, Oklahoma. As can be seen in Figure 5-16, the wall was well attached at the foundation level. However, loss of diaphragm at the top of the wall permitted the wall to blow outward and collapse.

**FIGURE 5-16: Failure of tilt-up concrete wall in Del City, Oklahoma, hit by inflow winds of a violent tornado.**

A factor contributing to collapse of the tilt-up wall was the placement of the vertical reinforcement. Close inspection of the broken surface indicated that reinforcing bars were placed near the exterior face of the wall. In tilt-up construction, the bars commonly are placed at mid-thickness of the wall. Placement of the reinforcement, as indicated by the arrow in Figure 5-16, significantly reduced the resistance of the wall to outward deflection or movement.

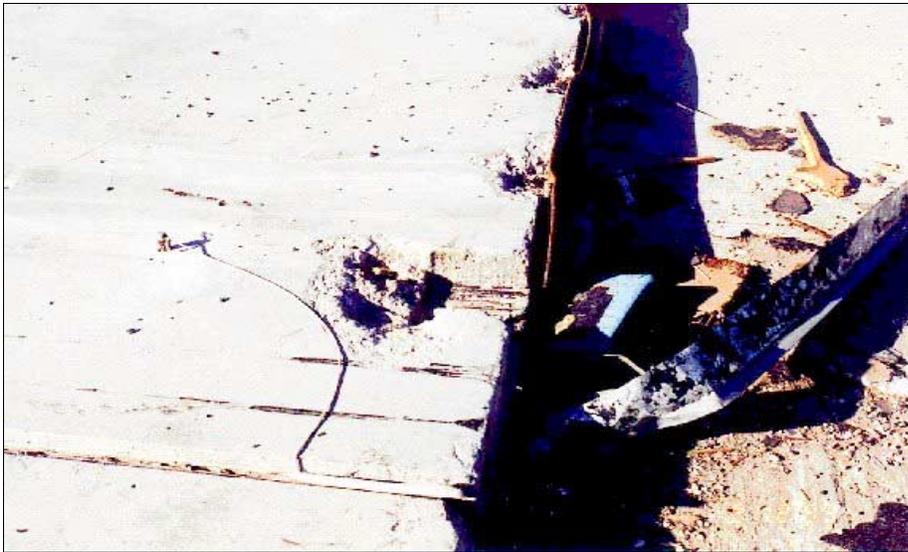
Figures 5-17 and 5-18 show the top of the tilt-up precast concrete wall that failed. Figure 5-17 shows that diaphragm action provided by a beam supported by the wall was lost when the beam pulled out of the wall pocket. Failed welds tying the roof into the top of the tilt-up wall can also be seen in Figure 5-18. Visual inspection showed that only one of the four walls of the building collapsed. The other walls had part of the diaphragm action provided by remaining portions of the roof.

**FIGURE 5-17: Top of failed tilt-up wall.**

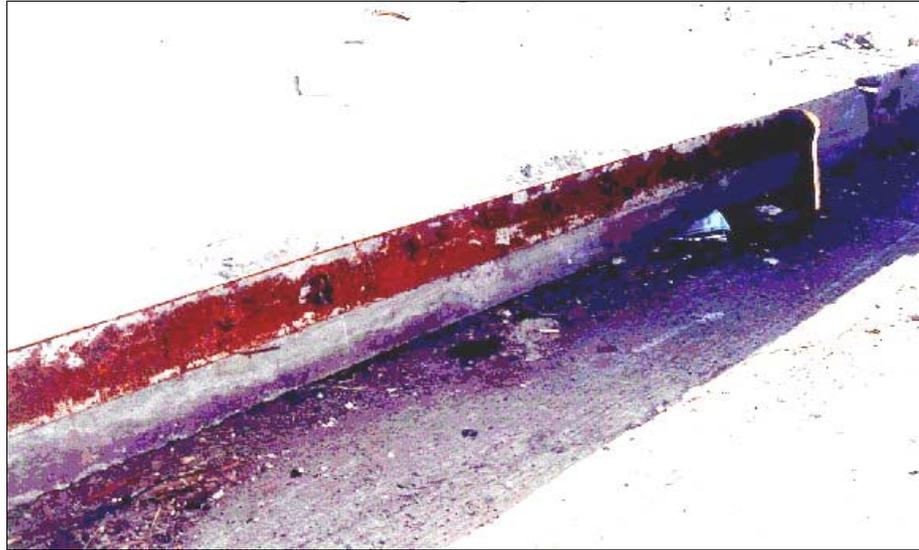
**FIGURE 5-18: Top of failed tilt-up wall.**

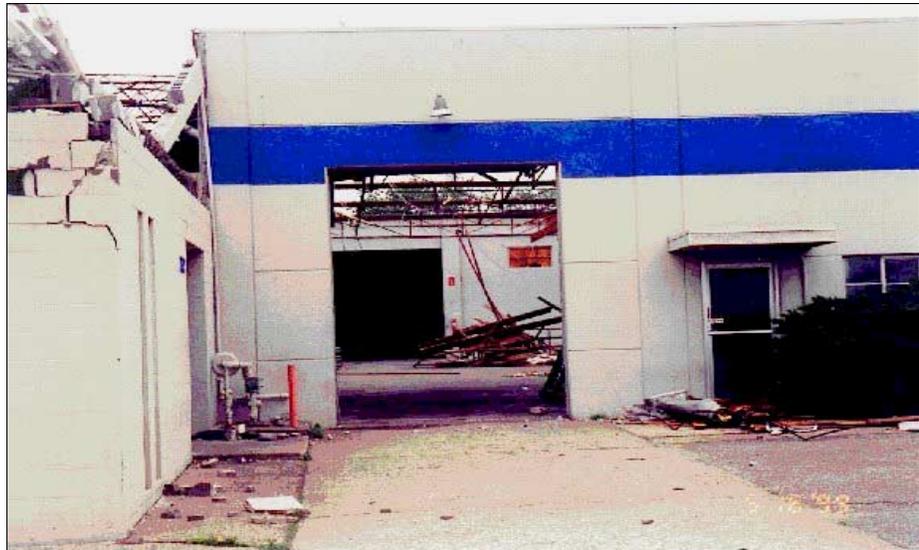
Tilt-up walls at a facility that was located under the vortex of a moderate tornado in Wichita, Kansas, survived virtually undamaged, despite loss of metal deck roofing. As can be seen in Figure 5-19, trusses spanning the open area maintained diaphragm action.

**FIGURE 5-19: The tilt-up precast concrete walls in this building did not fail when the roof system failed. Note: many roof joists are still in place. Building was located in Wichita, KS and was hit by moderate tornado vortex.**

In Figure 5-19, damage to a portion of the building having a steel joist roof supported on masonry walls can be seen at the left. Walls in this portion of the building collapsed when subjected to the vortex winds of a moderate tornado. Even though some diaphragm action was maintained, the masonry

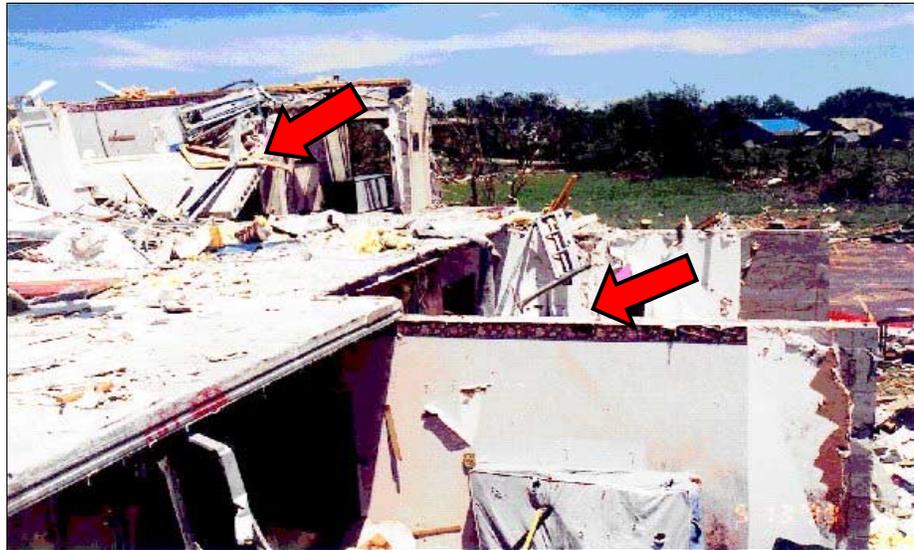
Figure 5-21 shows the location where hollow core plank had formed the second floor. The arrow at the right shows a dowel from the masonry wall into grout between the ends of two hollow core panels. One of the panels that had been at the edge of the building was found up on the second level and across on the far side of the building as shown by the arrow on the left of Figure 5-21. Apparently the uplift wind forces from the tornado were large enough to overcome the tie-down force provided by the very short dowels. The hollow core plank appears to have been lifted and blown across the width of the building.

**FIGURE 5-21:** *Hollow-core plank formed on second floor of a Midwest City, Oklahoma, hotel that was struck by the vortex of a moderate tornado.*

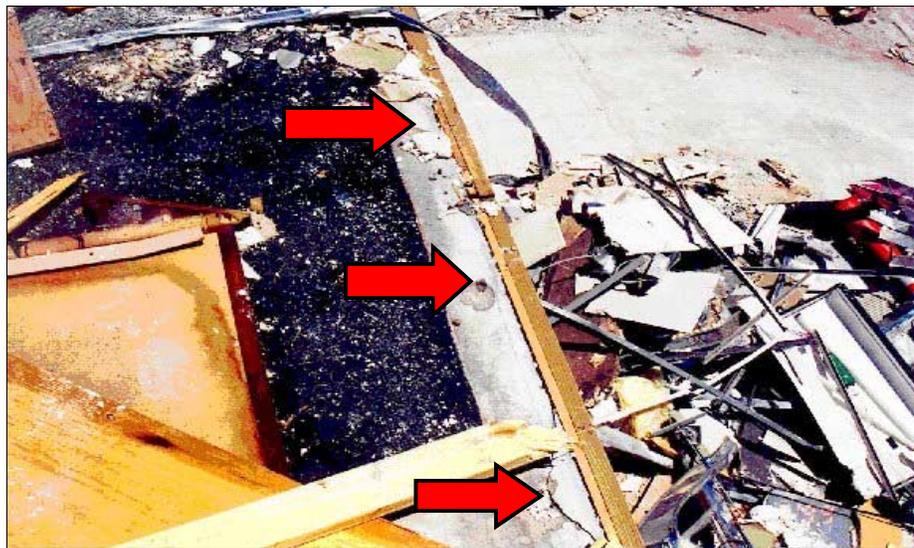
Elsewhere along the edge of the second floor of the motel, failure occurred between the hollow core planks and exterior walls of the building. As shown in Figure 5-22, lower plates for the walls had been attached to the hollow core planks using power driven anchors. As indicated by the arrows, the powder driven anchors pulled out during the tornado.

**FIGURE 5-22:** *Attachments of lower plates for wall to hollow core plank using power driven anchors failed when required to carry loads generated by the winds of a moderate tornado vortex. This motel was located in Midwest City, Oklahoma.*

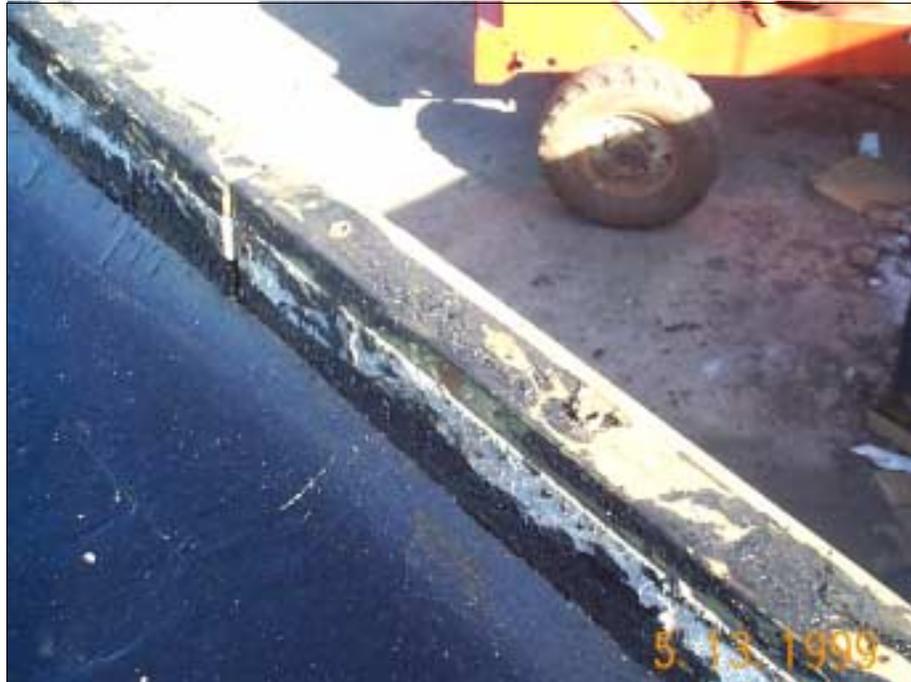
In one case, loss of a large portion of a built-up roof with aggregate ballast resulted in significant rainfall water infiltration into a hospital in Stroud, Oklahoma. After the storm, the hospital was closed and the patients moved to a facility about 30 miles away, which significantly reduced the availability of emergency medical services over this area of rural Oklahoma. The characteristics of the damage to the hospital were not indicative of tornado winds due to its distance from the tornado vortex. Rather, it is likely that the damage was caused by thunderstorm winds. The failure initiated when the coping lifted or with lifting of the nailer the to which the coping was attached (Figure 5-22). The nailer was poorly attached to a 4-in CMU that formed the parapet wall. In some areas, the CMU block parapet lifted slightly.

**Figure 5.23: Nailer at the roof of the hospital in Stroud, Oklahoma. The roof surface in this photo was replaced prior to this photo, but the same nailer was used again.**

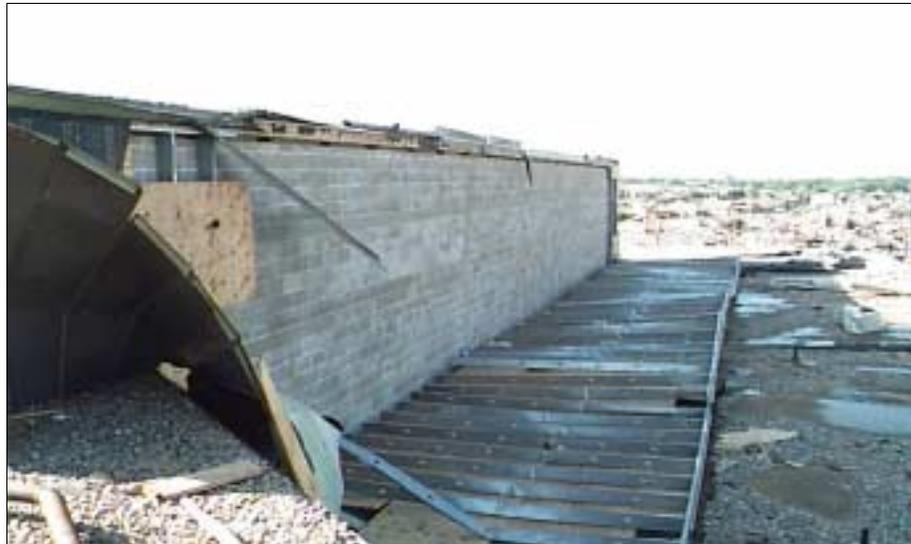
Brick veneer is discussed in Section 4.1.3.2. Some metal wall coverings over steel studs collapsed (Figure 5-24). Some Exterior Insulating Finishing System (EIFS) failures were observed.

**FIGURE 5-24: This metal-clad wall covering collapsed and in other areas it was blown completely away.**

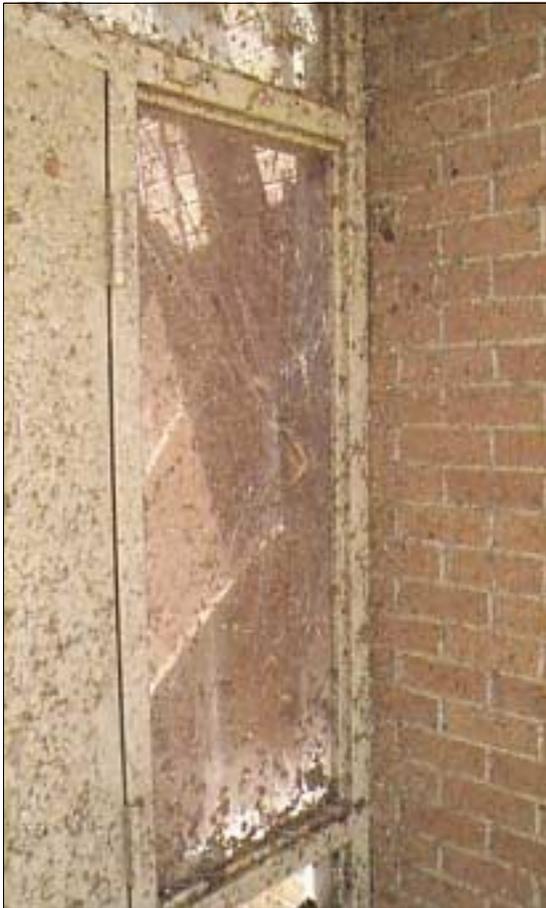
In a few instances, examples of laminated glass performance were observed. In some cases the glass remained in the frame after windborne missile impact (Figure 5-25). In another case, the glass was punched out of its frame. The school in Figure 5-25 is located adjacent to Regency Park Baptist Church in Moore, OKLAHOMA in Figure 5-10. The vortex of a violent tornado passed a few hundred yards south of this building.

**FIGURE 5-25: The corner of a table penetrated this laminated glass, but the glass remained in its frame. This school suffered major damage from inflow winds of a violent tornado in Moore, Oklahoma.**

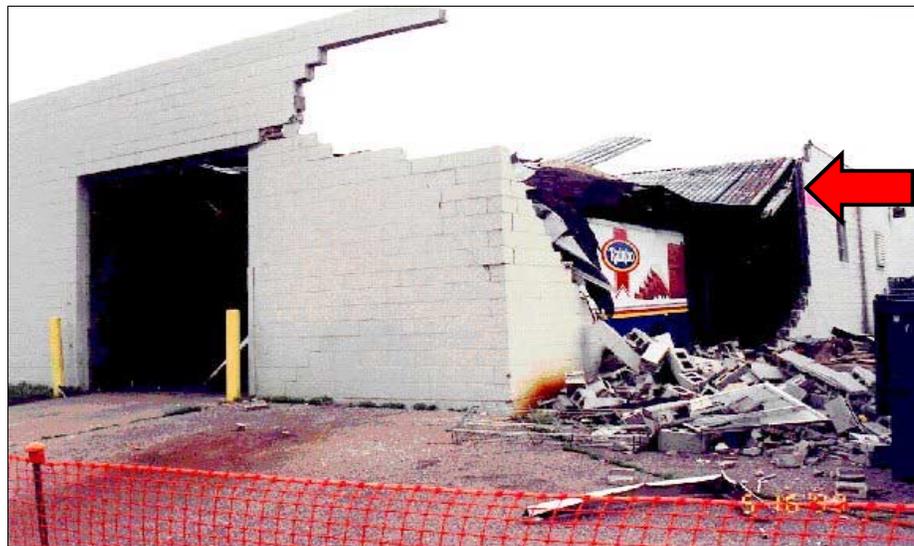
The breach of overhead commercial doors caused internal pressurization of the structure leading to significant load increases. Not unlike the residential case, a breach in the building envelope was observed, in some cases, to initiate a partial or total failure of primary structural systems. This was particularly true for pre-engineered buildings, which typically had little redundancy in load transfer of their structural systems. Figure 5-26 shows a breached commercial overhead door belonging to a bread manufacturing and

distribution center in Wichita, KS. The building exterior walls were constructed using both concrete masonry block and tilt-up concrete panels. The roof deck was standing seam metal on a Z purlin system. The door failure appears to be a result of positive (inward) pressure. The breach may have caused a sufficient enough rapid increase in load to produce failure of the URM block wall. It is worth noting the location of the failed door is near a corner where high negative suction or (outward) pressure is likely to occur on the adjacent wall. As a result of the exterior wall collapse, severe damage to the roof system occurred due to the loss of the load bearing exterior support wall. However, notice that the roof collapsed to the interior of the building, which may indicate that uplift loads acting on the roof were insufficient to cause progressive peeling failure of the roof system.

**FIGURE 5-26: Failure of roof and walls on structure due to increased loads caused by initial failure of garage door, Wichita, Kansas.**

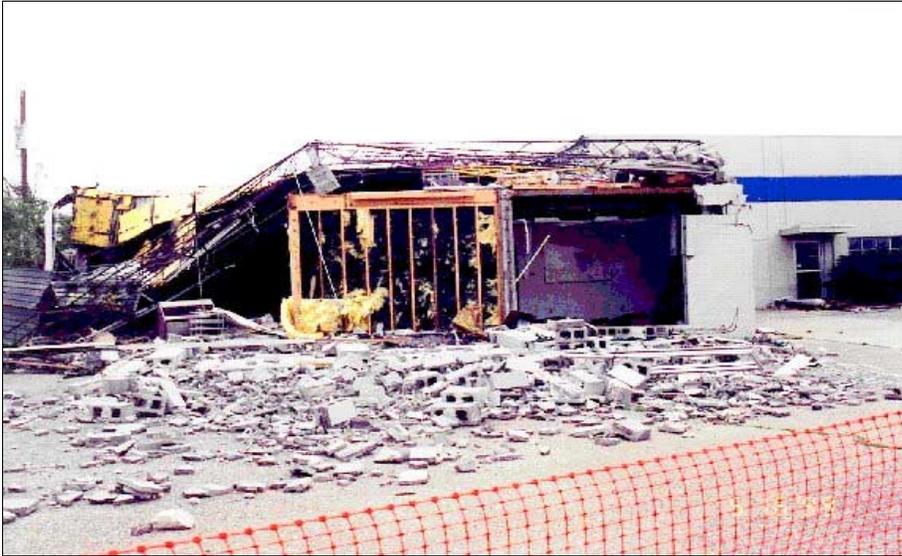
Figure 5-27 illustrates another condition in Wichita, KS where breach of the building envelope contributed to additional structural damage. In this case, loss of showroom windows and an overhead door greatly increased loads in the showroom and on the wall at the left of the photograph. These increased loads caused the walls to fail and the roof to partially collapse, thereby greatly increasing structural damage in the building.

**FIGURE 5-27: Additional structural damage caused by breach of envelope in Wichita, Kansas.**

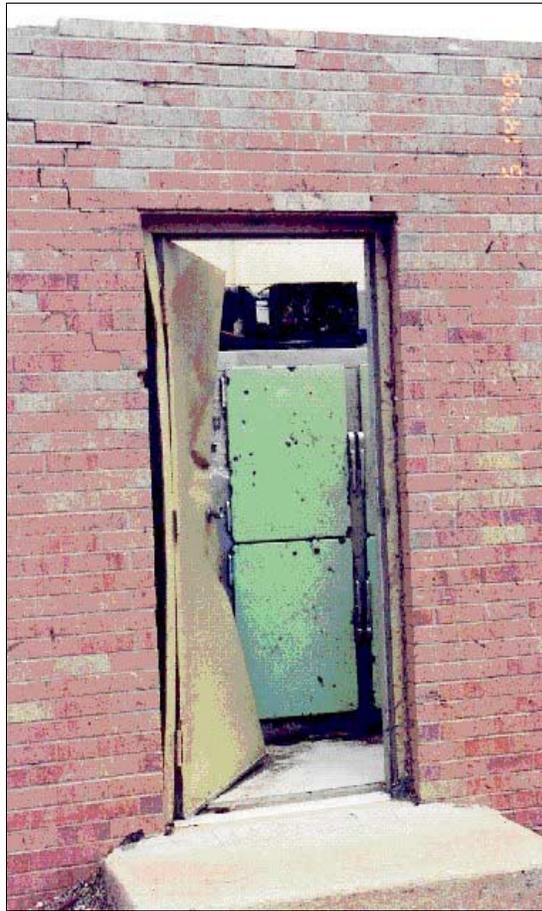
Figure 5-28 shows a steel door that appears to have been opened by impact of a heavy object. This door at Kelly Elementary School in Moore, Oklahoma, led into an area where the roof was completely missing. The breached door may have caused an increase in load that propagated damage to that part of the building envelope. A nearby door, which was also heavily impacted, but did not open, was located in an area of the school that saw less damage to the wall and roof of the building.

***FIGURE 5-28: Damaged door most likely opened by impact with heavy object. Kelly Elementary School, Moore, Oklahoma.***

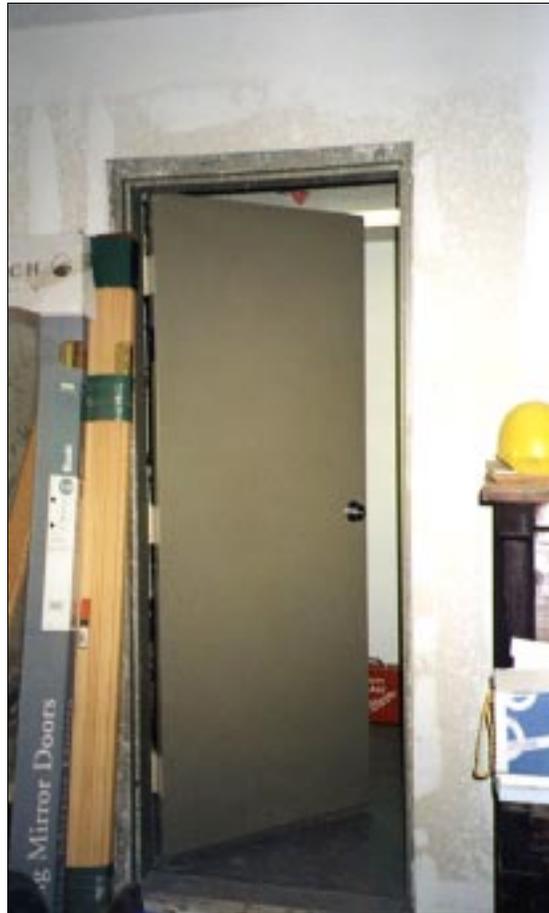
**FIGURE 6-3: Entrance to the ICF shelter in Bridge Creek, Oklahoma. This residence and shelter were on periphery of the inflow winds of a violent tornado, and damage was limited to light missile impacts.**

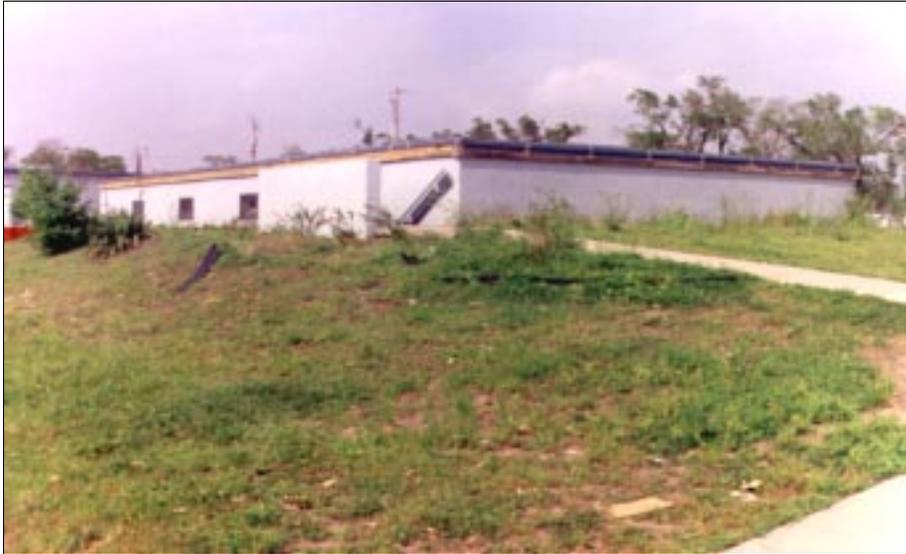
**FIGURE 6-6: Community Shelter at a Wichita, Kansas, manufactured home park. While the park was directly hit by a severe tornado, the shelter was not within the damaged area.**

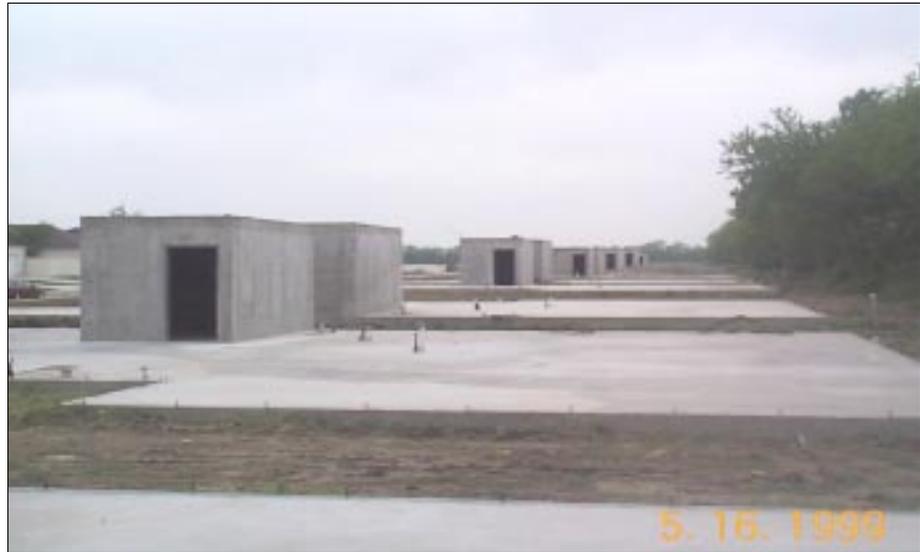
**FIGURE 6-7: Above ground in-residence shelters under construction in Wichita, Kansas.**

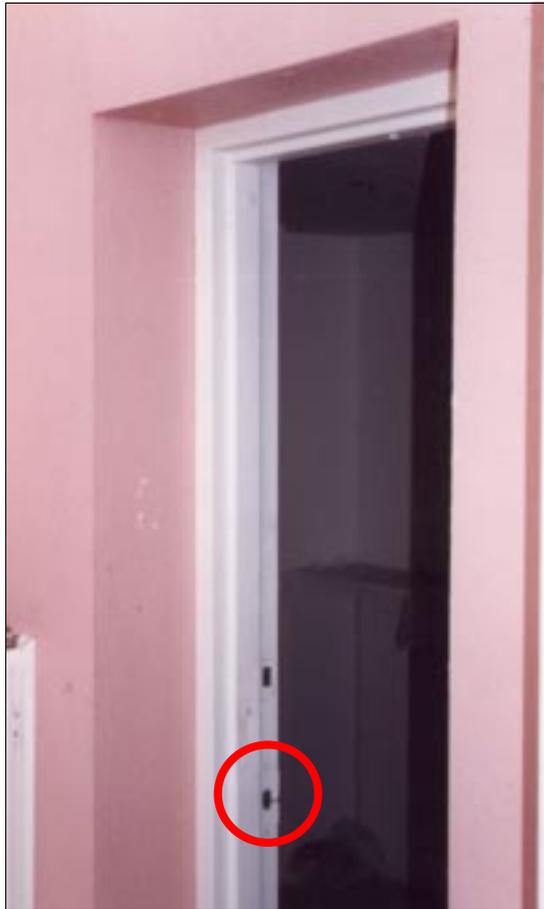
**FIGURE 6-14: Shelter door of home in Del City, Oklahoma, showing an insufficient deadbolt locking device. The circled area on the door frame is the catch for the only latching mechanism on the door.**

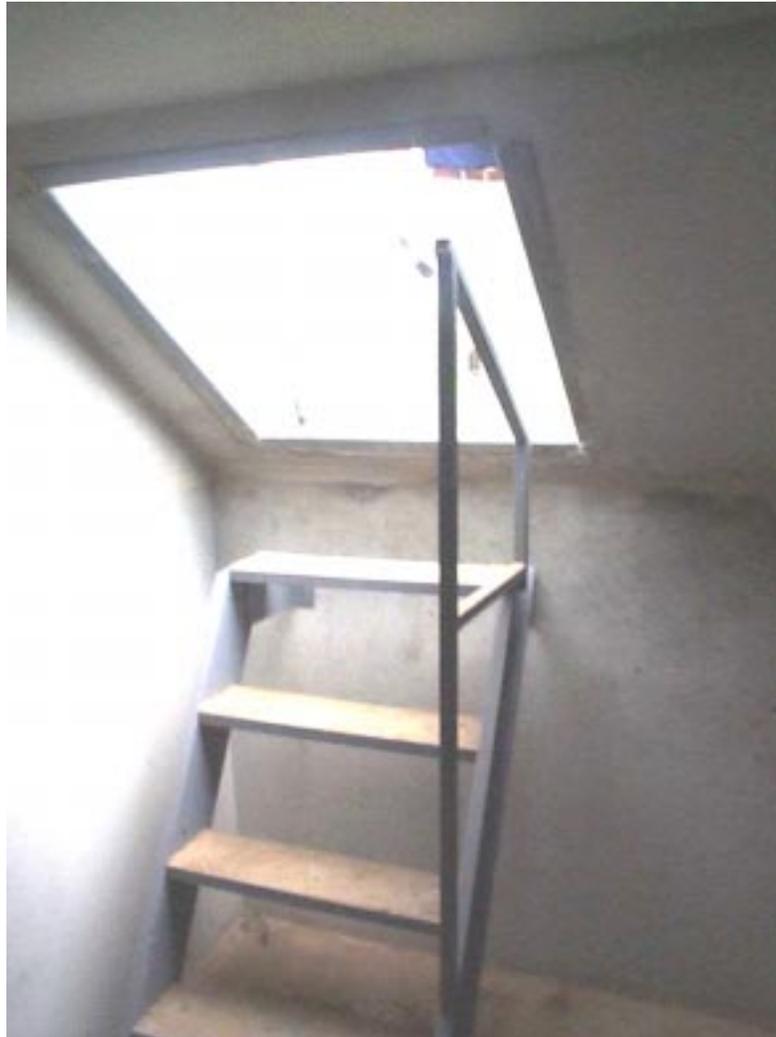
The observed above ground in-residence shelters were easily accessible by the home occupants. Observed door widths would have allowed access by wheelchair or otherwise disabled occupant. The group or community shelters observed by the BPAT had restrictive entrances that may have hampered access to the shelters by persons with disabilities. Figure 6-16 shows stairs leading to the entrance of a community shelter in Kansas. Additionally, several of the community shelters were locked and required authorized admission. Access to the community shelter in Figures 6-10 and 6-16 was restricted to community members without pets and the travel distance from the far end of the development to the shelter was approximately several city blocks. The group shelters observed also require access via stairs at both the plastics manufacturing plant and the manufactured home rental development. Figure 6-17 shows the stairs required to access the group shelter and the manufactured home rental development.

**FIGURE 6-17: Stairway access to group shelter at manufactured home rental development, Wichita, Kansas. This development was not affected by any of the tornadoes that struck on May 3, 1999.**

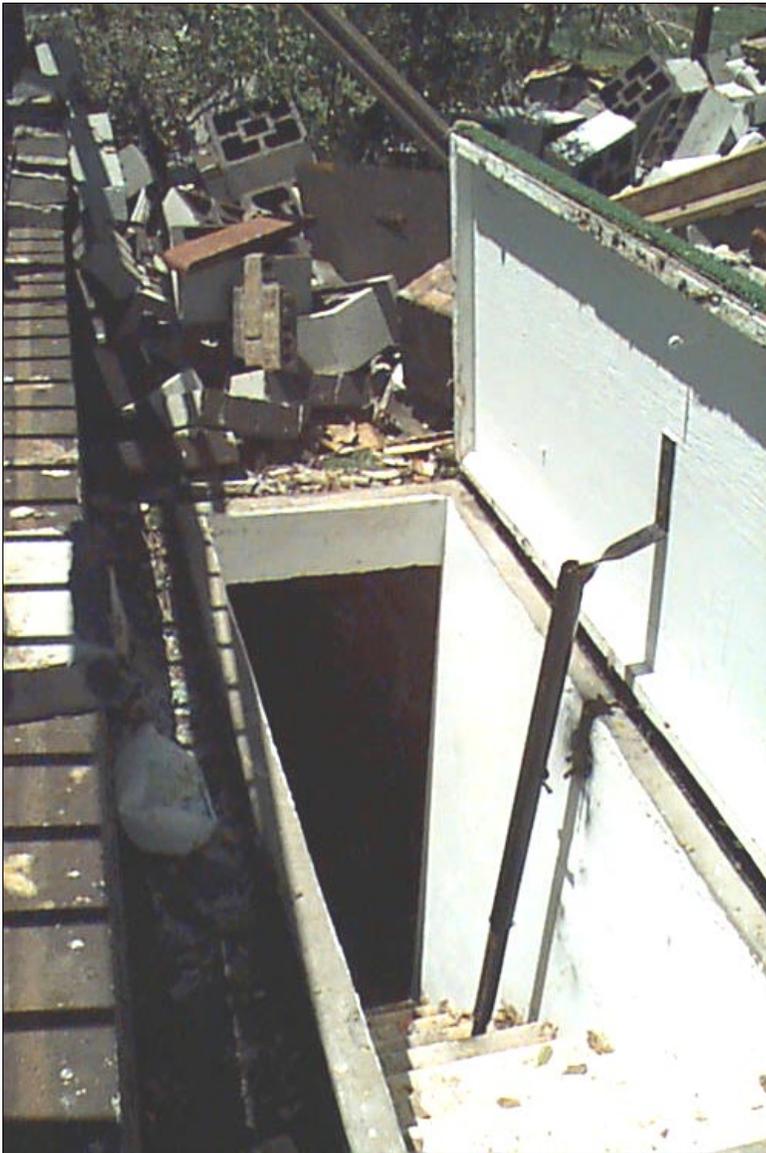
Storm cellars (underground cellars) were located either in the front, side, or rear yards of the homes. Front yard locations were vulnerable to vehicular traffic and water runoff. The side and rear yard cellars were also vulnerable to water runoff (Figure 6-20). In many cases, the cellar entrance was insufficiently raised above grade and would have allowed for easy entrance of water.

**FIGURE 6-20:** *This below ground shelter is susceptible to water runoff.*

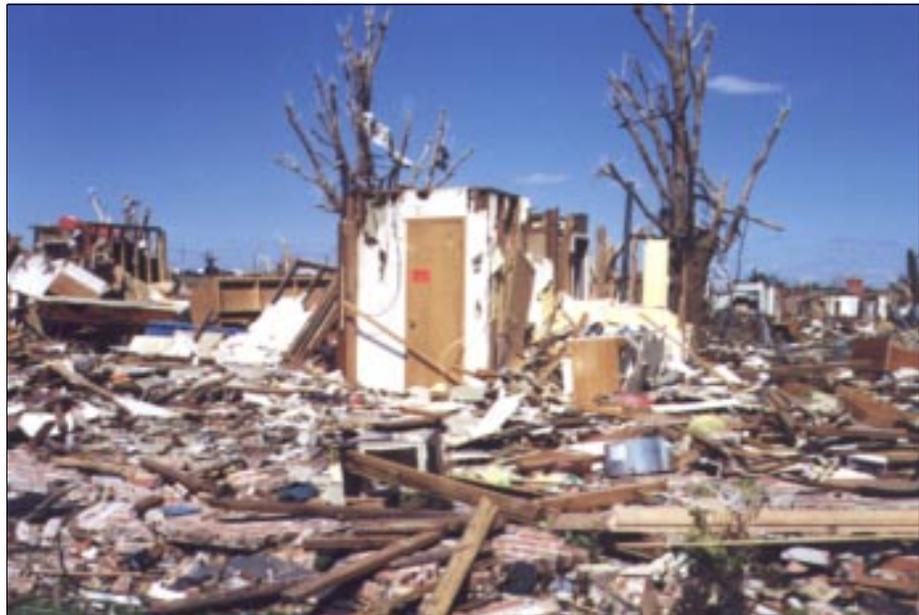
For conventionally-constructed residences without basements or specially designed tornado shelters, observations following the Oklahoma and Kansas tornadoes, as well as previous post-tornado damage investigations, consistently revealed that interior bathrooms and closets offer the greatest occupant protection. Interior bathrooms and closets are small rooms that do not have an exterior wall (Figure 6-21).

**FIGURE 6-21: Remains of an interior room or core of a home in a Moore, Oklahoma, subdivision that was hit by a violent tornado.**

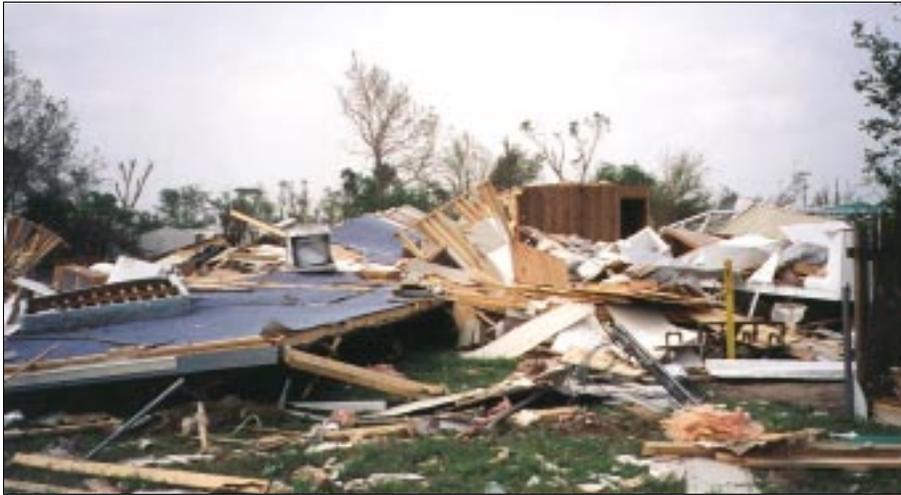
Based on the BPAT observations, persons taking refuge in bathrooms or closets in manufactured houses not attached to properly constructed permanent foundations appear to be at significantly greater risk of injury or death than persons taking similar refuge in conventionally constructed housing (Figure 6-28). The bathrooms and closets of manufactured houses typically provide very little protection. The BPAT observed a possible exception in some of the newer manufactured homes placed on proper

**FIGURE 6-28: Damaged and destroyed manufactured homes in Wichita, Kansas, that were in the direct path of a severe tornado.**

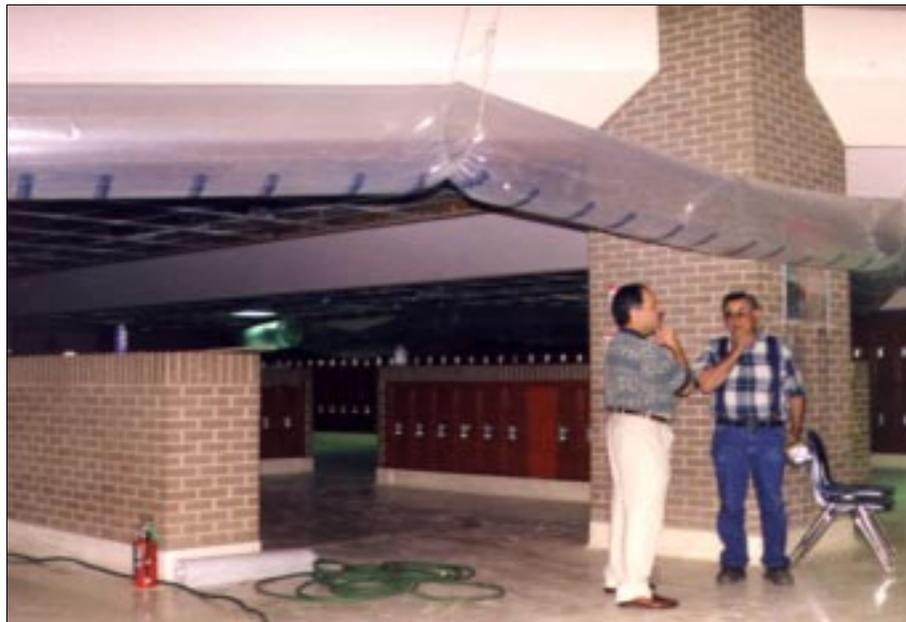
The emergency plans of five public schools were reviewed by the BPAT. Westmoore High School, located in the City of Moore, was within 100 yards of the vortex of a violent tornado and received building envelope and roof structure damage. Just prior to the storm, several hundred students and parents occupied the auditorium. In accordance with the emergency plan, most of the students and parents were moved to a predetermined area in a central core of the building where they successfully took refuge (Figure 6-29). Other individuals reportedly took refuge in a reinforced concrete stairwell adjacent to the auditorium.

**FIGURE 6-29: Westmoore High School, Moore, Oklahoma, central locker core - a designated place of refuge.**

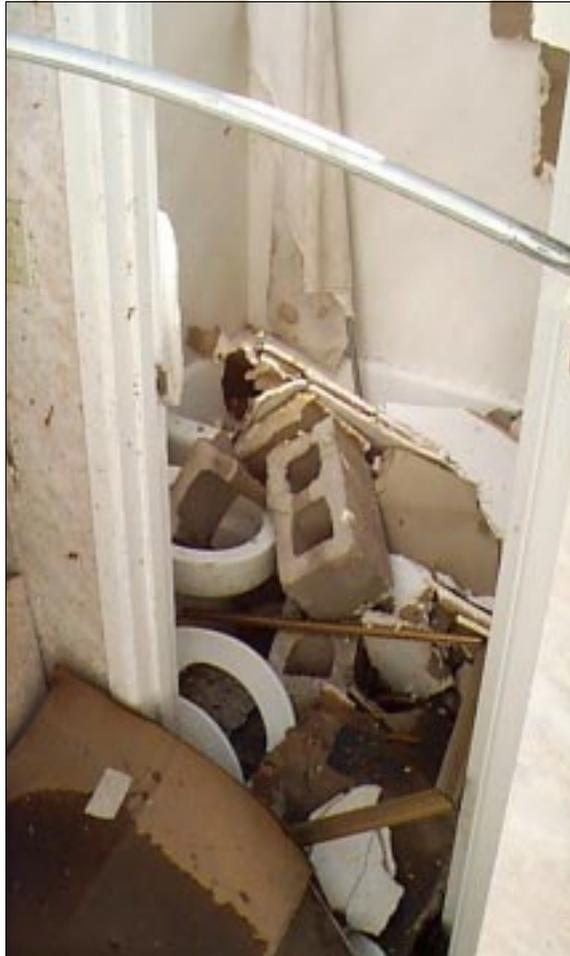
**FIGURE 6-36:** *The roof and ceiling over this interior bathroom blew off. CMU from a firewall a few feet away blew into the bathroom, which was located on a motel's second floor in Mid West City, Oklahoma. This bathroom was not a safe refuge when impacted by the vortex of a severe tornado.*
