Tank Explosion in West Virginia

Investigation Report

Published: December 2019

On May 24, 2017, an explosion occurred at the Midland Resource Recovery (MRR) facility in Philippi, West Virginia, killing two workers^a and severely injuring another worker. The founder and president of MRR was one of the victims. The CSB initiated an investigation of the incident and deployed an investigative team on May 28, 2017. While the CSB was investigating this incident, the MRR facility experienced a second explosion, on June 20, 2017. This explosion fatally injured a contractor^b employed by Specialized Professional Services, Inc. (SPSI). MRR had hired SPSI to perform investigation and mitigation work at its Philippi facility following the May 24, 2017, explosion.

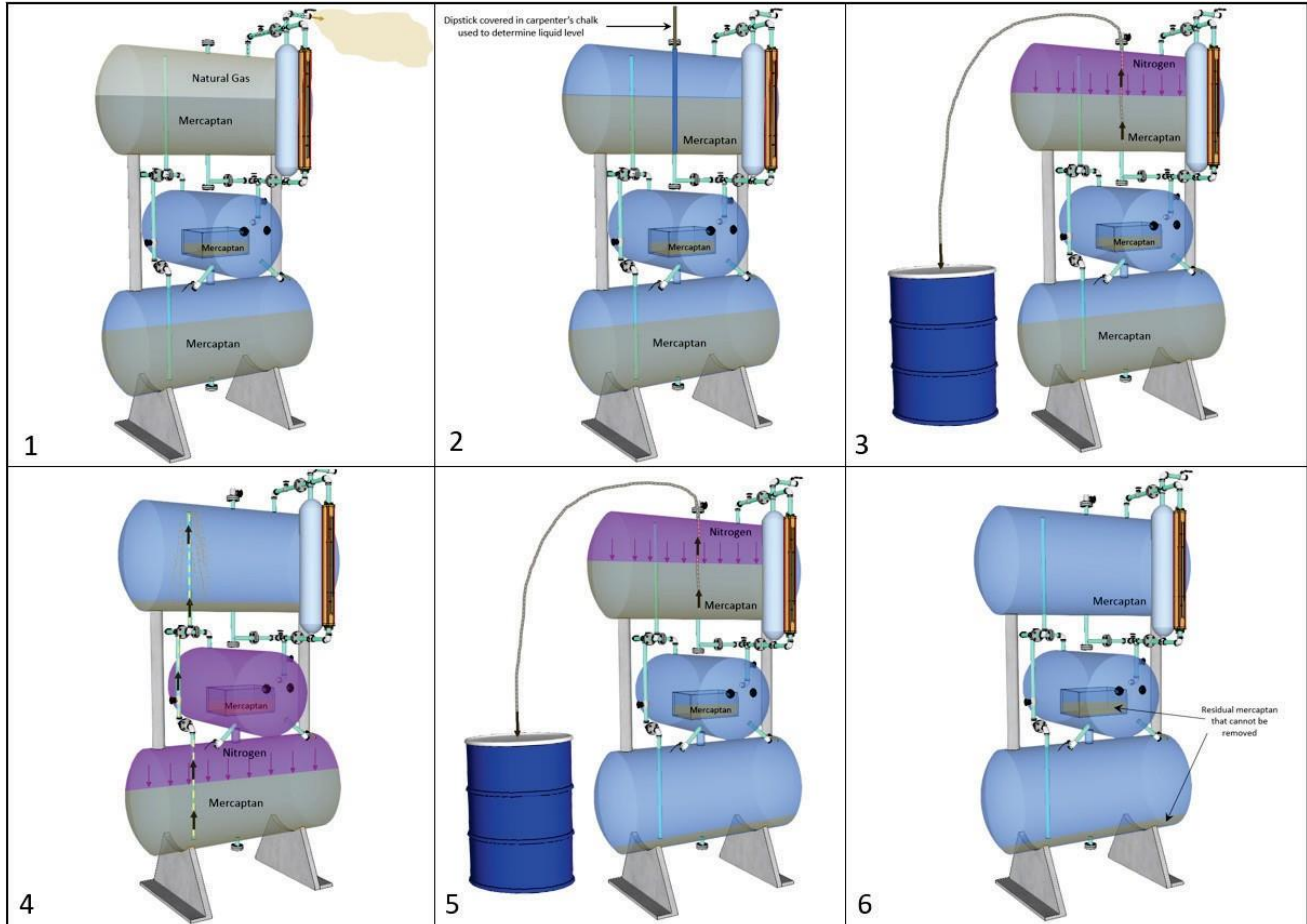
MRR technicians do not perform any testing to analyze or characterize what chemicals are present in the MP odorizer. Also, due to the design of the odorizer itself and the decommissioning process MRR established, MRR technicians do not have a way to remove all the uncharacterized liquid from the bottom chamber or the middle chamber.^a

Figure 3. Odorizer Decommissioning and Draining. These graphics outline the steps MRR technicians typically performed to drain liquid from MP odorizers tanks in preparation for transport and chemical treatment. (Credit: CSB).

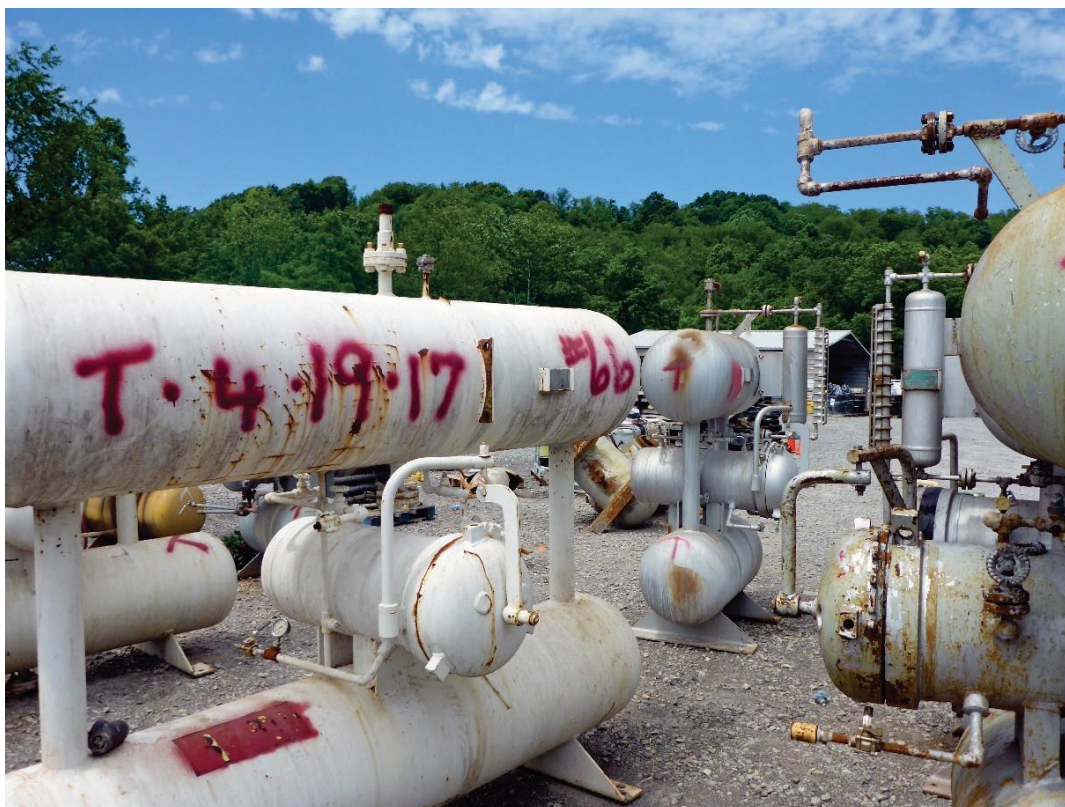
Figure 7. Treatment Status. This photo shows how MRR technicians used red spray paint to record the date the MP was chemically treated, April 19, 2017. (Credit: CSB).
