A Policy Guide to Steel Moment Frame Construction

A Policy Guide to Steel Moment-frame Construction

SAC Joint Venture

November, 2000

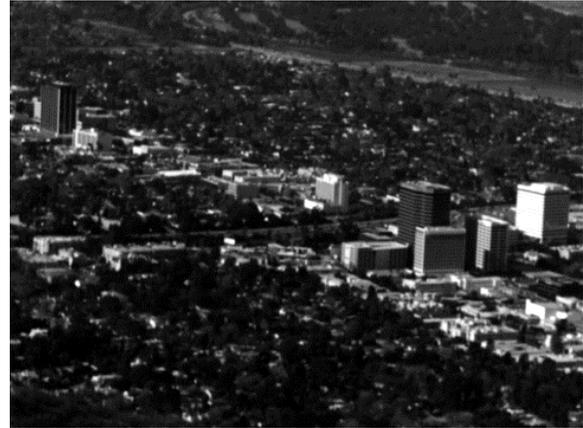
Ventura Boulevard in the San Fernando Valley. Many of these buildings had hidden damage.

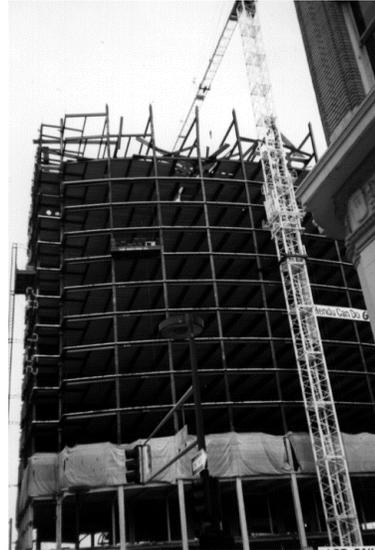
Construction of a modern steel frame building in which the ends of beams are rigidly joined to columns by welded connections.

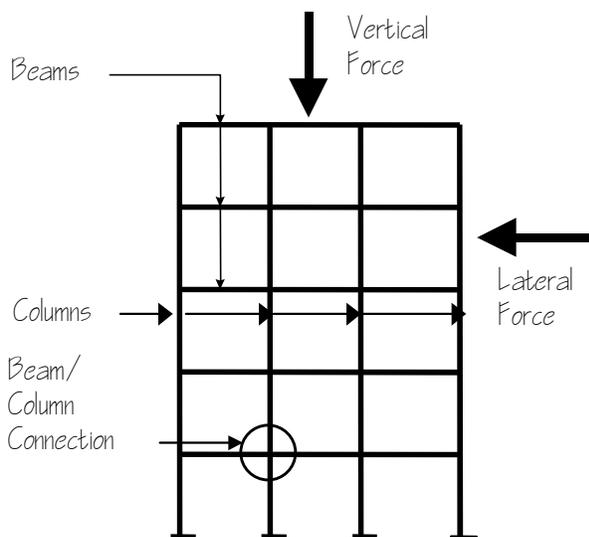
A steel moment-frame is an assembly of beams and columns, rigidly joined together to resist both vertical and lateral forces.

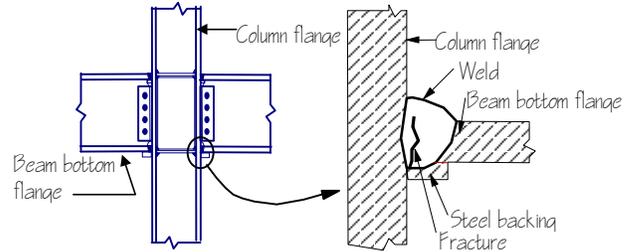
Damage consists of fractures or cracks that initiate in the welded joints of the beams to columns.

The damage discovered in WSMF buildings consists of a fracturing, or cracking, of the welded connections between the beams and columns that form the frame, or skeleton, of the structure. This damage occurs most commonly at the welded joint between a column and the bottom flange of a beam. Once a crack has started, it can continue in any of several different patterns and in some cases has been found to completely sever beams or columns.

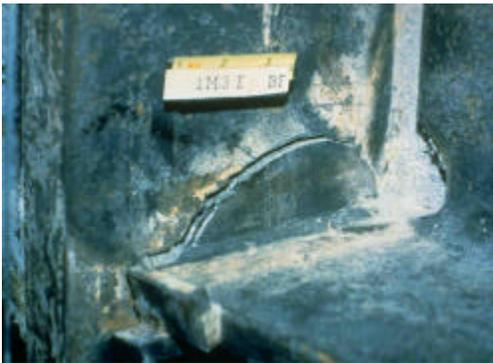
Damage ranges from small cracks that are difficult to see, to much larger cracks. Here, a crack began at the weld and progressed into the column flange, withdrawing a divot of material.

There are several common types of damage, each of which looks somewhat different. The most common cracks initiate in the weld itself or just next to the weld. These cracks often are very thin and difficult to see. In a few cases, cracks cannot be seen at all. In some cases, cracks cause large scoop-like pieces of the column flange, called divots, to be pulled out. In still other cases, the cracks run across the entire column, practically dividing it into two unconnected pieces.

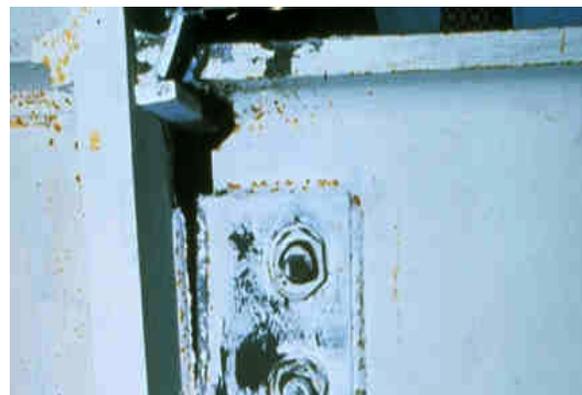
Fracturing of welded connections can lead to damage to the bolted connections that hold the beams onto the columns, creating potential for localized collapse.

WSMF buildings rely on the connections between their beams and columns to resist wind and earthquake loads. When the welded joints that form these connections break, the building loses some of the strength and stiffness it needs to resist these loads. The magnitude and significance of this capacity loss depends on the unique design and construction attributes of each building, as well as the extent and type of damage sustained. Few buildings were damaged so severely in the Northridge earthquake that they represented imminent collapse hazards. However, significant weakening of some buildings did occur. Once the welded joints fracture, other types of damage can also occur including damage to bolted joints. Damage that results in the complete severing of beams or columns or their connections poses a serious problem and could result in the potential for localized collapse.

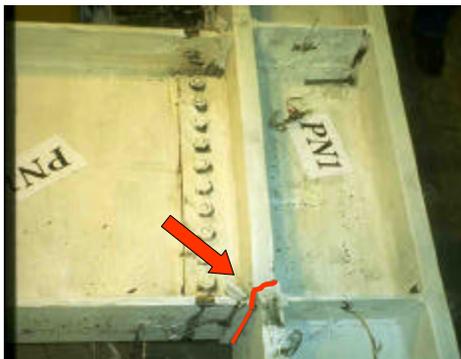
Fractures commonly initiate at the welded joint of the beam bottom flange to column.

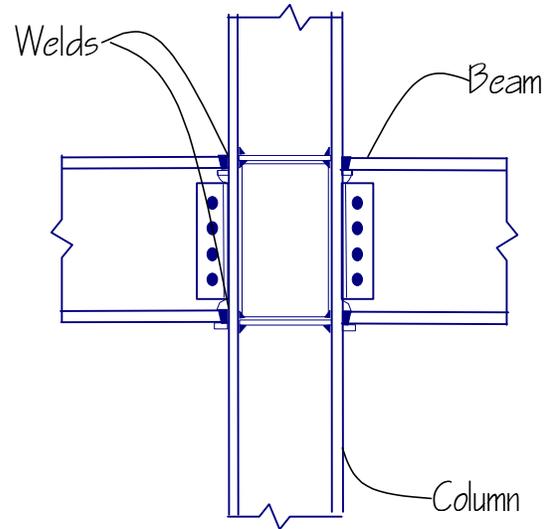
The typical connection used prior to 1994. Severe stress concentrations inherent in its configuration were not considered in the design.

We now understand that the vulnerability of WSMF structures is a result of a number of inter-related factors. Early research, conducted in the 1960s and 70s suggested that a particular style of connection could perform adequately. Designers then routinely began to specify this connection in their designs. However, the particular style of connection tends to concentrate high stresses at some of the weakest points in the assembly, and in fact, some of the early research showed some potential vulnerability. As the cost of construction labor increased, relative to the price of construction materials, engineers adopted designs that minimized the number of connections in each building, resulting in larger members and increased loads on the connections. At the same time, the industry adopted a type of welding that could be used to make these connections more quickly, but sometimes resulted in welds that were more susceptible to cracking. Although building codes required that inspectors ensure the quality of this welding, the inspection techniques and procedures used were often not adequate. Finally, the steel industry found new ways to economically produce structural steel with higher strength. Although the steel became stronger, designers were unaware of this and continued to specify the same connections. Often, these connections did not have adequate strength to match the newer steel material and were therefore, even more vulnerable. In the end, the typical connections used in WSMF buildings were just not adequate to withstand the severe demands produced by an earthquake.

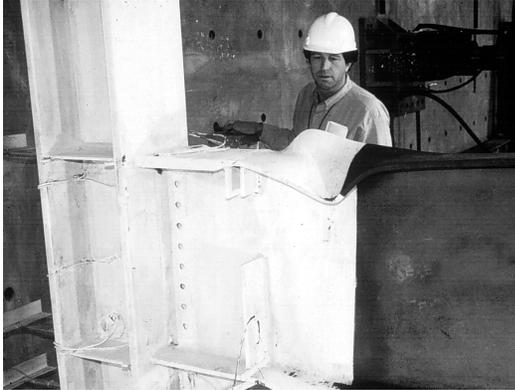
Engineers expect steel to be ductile, capable of extensive bending and deformation without fracturing, as shown in this test specimen. The development of cracks in the steel at relatively low levels of loading was unexpected.

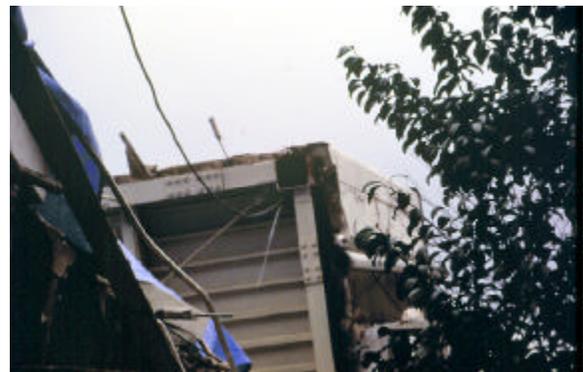
Many steel moment-frame buildings were damaged in the 1995 Kobe earthquake. The building shown here, lying on its side, is one of more than 50 older steel buildings that collapsed.

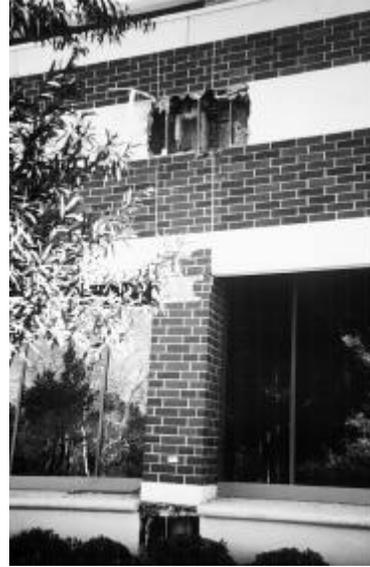
The most severely damaged buildings will often lean to one side. However, there may be no obvious indications of the damage in some buildings.

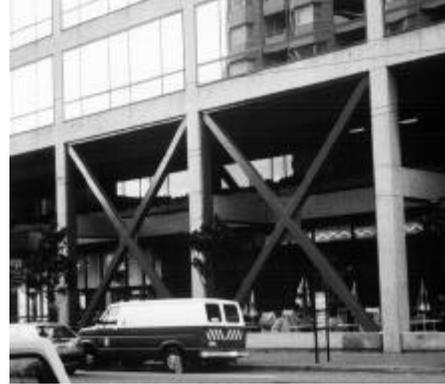
Buildings can be upgraded by modifying connections, adding braces and other methods.

It is technically feasible to upgrade an existing steel moment-frame building and improve its probable performance in future earthquakes. The most common methods are upgrades of the individual connections, addition of steel braces, concrete or masonry walls, or addition of energy dissipation systems. Each of these approaches may offer advantages in particular buildings.

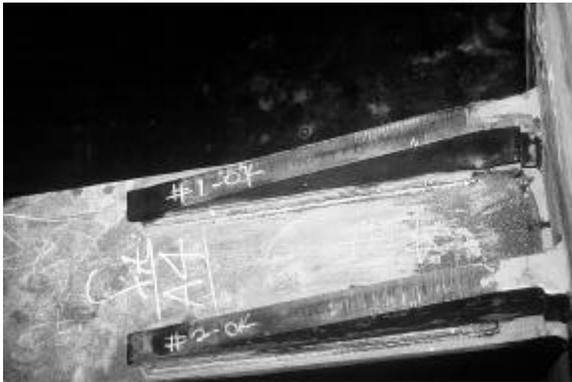
Connections can be upgraded by welding or bolting new plates onto the beams and columns to change the connection shape and reduce stress concentrations. In some cases, it may also be appropriate to replace defective welds and welds with low toughness with welds with improved toughness and workmanship.

Connection upgrades are the most direct approach to improving the seismic performance of an existing steel moment-frame structure. As previously discussed, existing connections can fracture because their shape results in the development of large stress concentrations; some welds have large defects that reduce their strength and the weld metal itself may be of low toughness and unable to resist the large stresses imposed on it. Connection upgrades address these problems directly by modifying the shape of the connection to reduce the stress concentrations. In addition, depending on the approach used, the upgrade may include replacement of defective welds and welds with low toughness with new welds that have improved toughness and better workmanship. FEMA 351 provides information and design criteria for a number of alternative methods of upgrading connections.

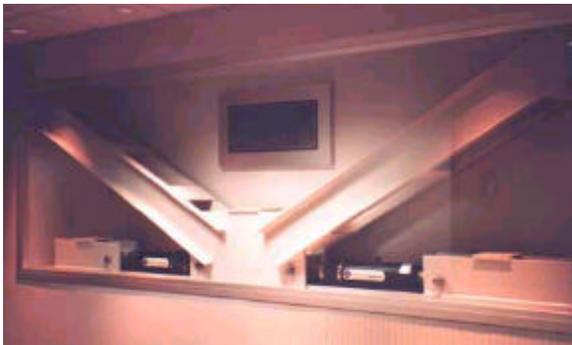
Energy dissipation systems are typically installed in buildings as part of a vertical bracing system that extends between the building's floors.

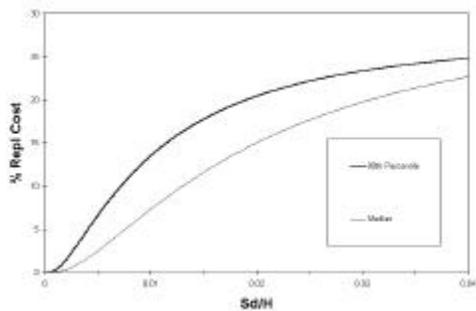
The Simplified Loss Estimation Methodology uses a series of graphs to relate probable earthquake losses to ground motion intensity.

The Simplified Loss Estimation Methodology contained in *FEMA 351* consists of a series of graphs that indicate the probability that WSMF buildings will experience various levels of damage if they are subjected to certain levels of ground motion. These graphs were compiled from data obtained for buildings in the Los Angeles area following the 1994 Northridge earthquake. To use these graphs, an engineer must estimate an intensity of ground motion to which a building will be subjected. Using the graph, an engineer can obtain an estimate of the percentage of the building's connections that will be damaged and the probable cost of connection repairs, if the building experiences an earthquake of a certain intensity. These graphs do not take into account the individual characteristics of a building, except in an approximate manner and, therefore, do not provide precise estimates. Rather, they provide an indication of the potential range of damage and repair costs and the probability that damage and repair costs will exceed certain amounts, based on the behavior of the buildings that were affected by the Northridge earthquake.

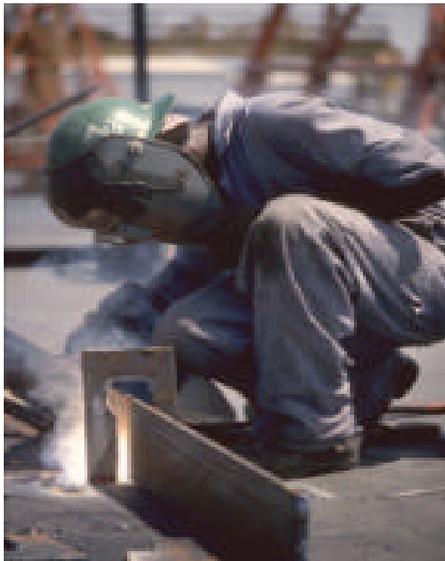
If inadequately constructed, welded joints in moment-frames can be weak links that fail prematurely. FEMA 350 recommends careful control of the materials, workmanship and procedures used to make these joints and verify their adequacy.

FEMA 350 and its companion document, *FEMA 353*, present extensive new recommendations for welding of moment-resisting connections in frames designed for seismic applications. The new recommendations address the types of materials that may be used for this work, the welding processes and procedures that should be followed, the environmental conditions under which welding should be performed, and the level of training and workmanship required of welders and inspectors engaged in this work. In addition, *FEMA 353* provides detailed recommendations for quality control, quality assurance and inspection procedures that should be put into place to assure that this critical work is properly performed. These new recommendations affect all segments of the design and construction process and require designers, producers, fabricators, welding electrode manufacturers, welders and inspectors, among others, to adopt new practices. These recommendations have been submitted to the American Welding Society for incorporation into the structural welding code.

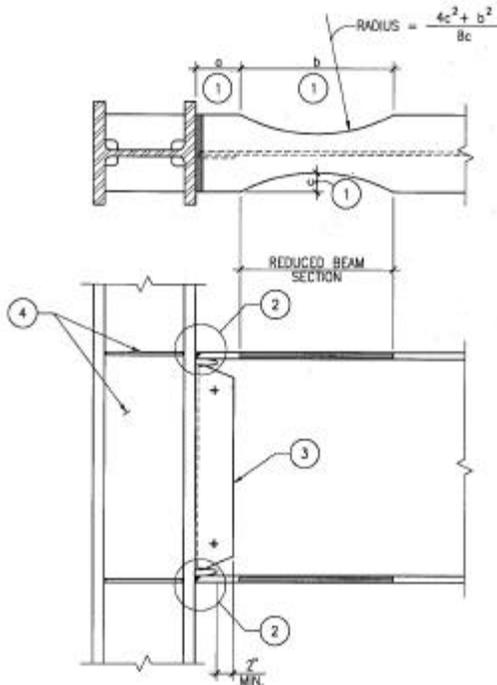
The Reduced Beam Section, or “dog bone” connection is one of 12 different types of prequalified connections that engineers can specify without project-specific testing.

FEMA 350 contains design criteria for twelve different types of prequalified, welded and bolted beam-to-column connections. Each prequalification includes specification of the limiting conditions under which the connection design is valid, the materials that may be used, and the specific design and fabrication requirements.
