Pedestrian Bridge Collapse in Miami, Florida

1. Executive Summary

On March 15, 2018, at approximately 1:45 p.m., a pedestrian bridge under construction in Miami, Florida, collapsed. One employee and five motorists were fatally injured, and another employee permanently disabled, when the bridge fell as the motorists waited for the traffic light underneath the bridge and as the employees were performing work activities on top of the bridge structure. The bridge at the present stage of construction consisted of a single concrete truss spanning approximately 174 feet and weighing approximately 930 tons. It was placed over the piers just five days prior to the collapse. An adjoining span of concrete truss was to be constructed next over the canal to make a continuous bridge of 289 feet. The concrete bridge was cast at a nearby off-site location using what is known as Accelerated Bridge Construction (ABC) and then transported to its final location. ABC provides minimal traffic disruption. The bridge was financed through federal grants, and constructed at the campus of Florida International University (FIU) in Miami. The FIU project was a class A Local Agency Program (LAP) project. The

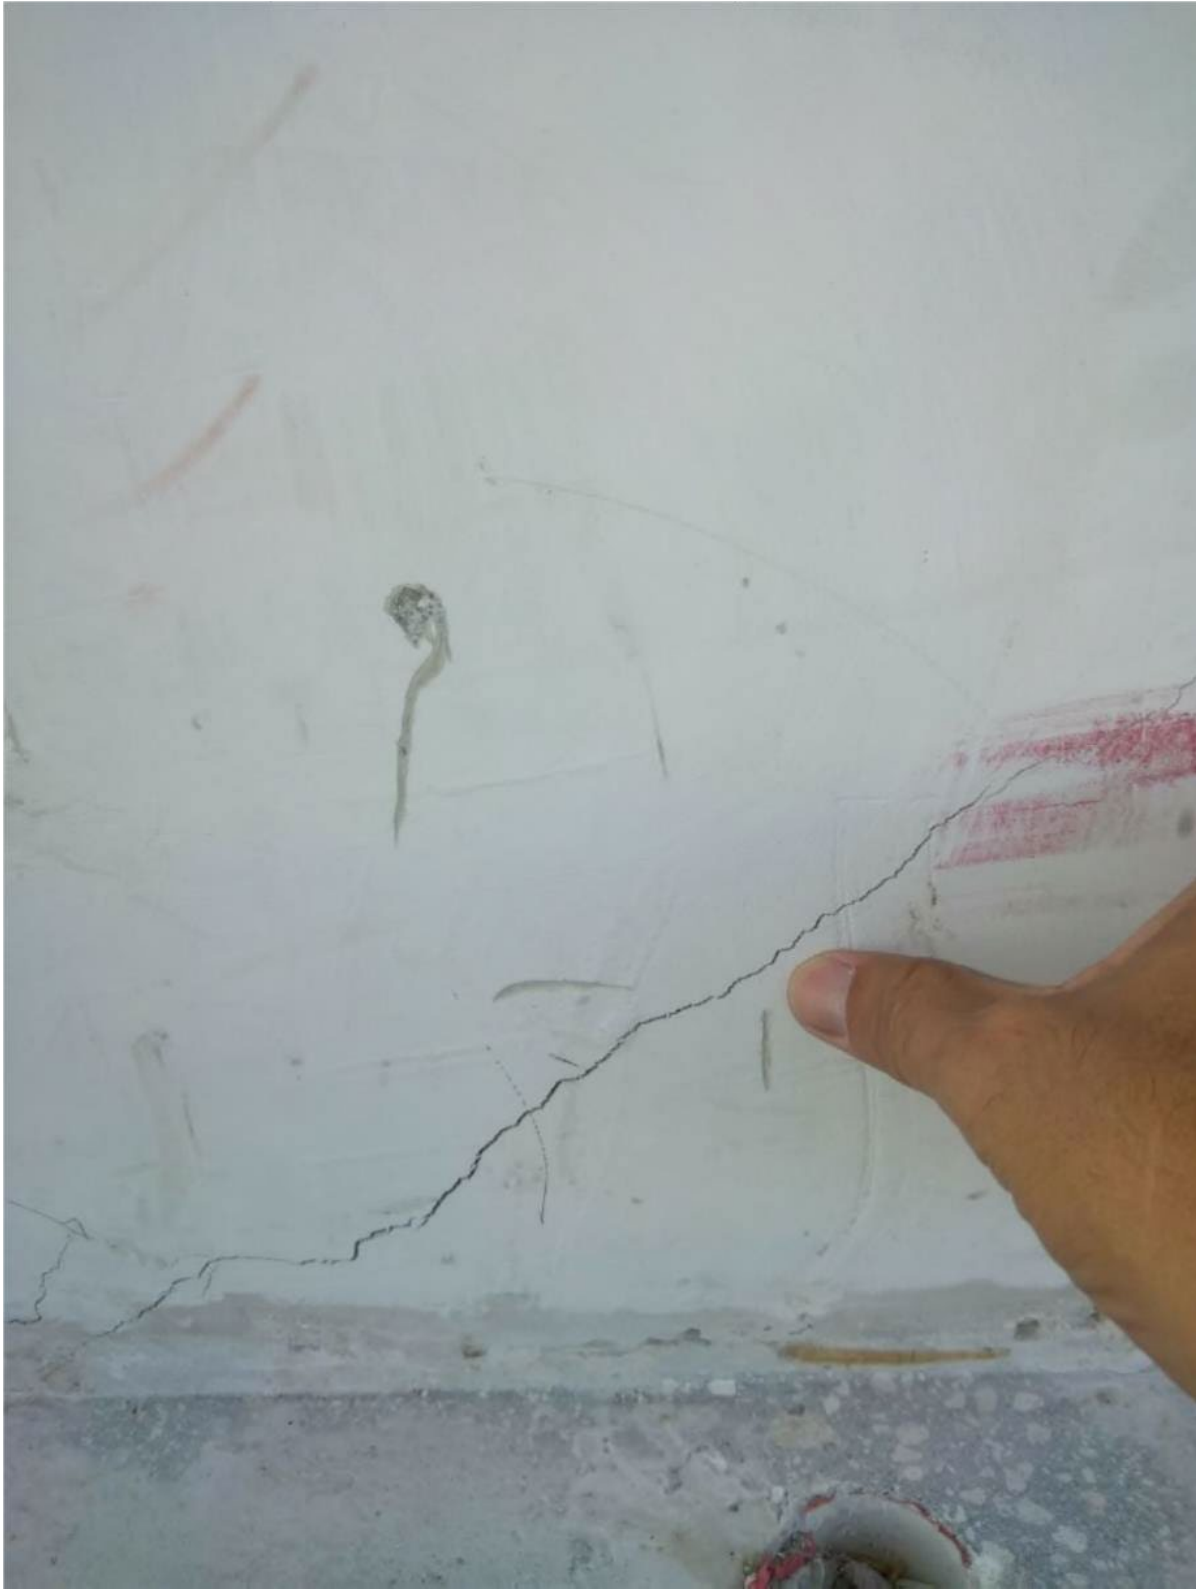
Figure 42 Photo #2 in 2/28/2018 E-mail from MCM to FIGG

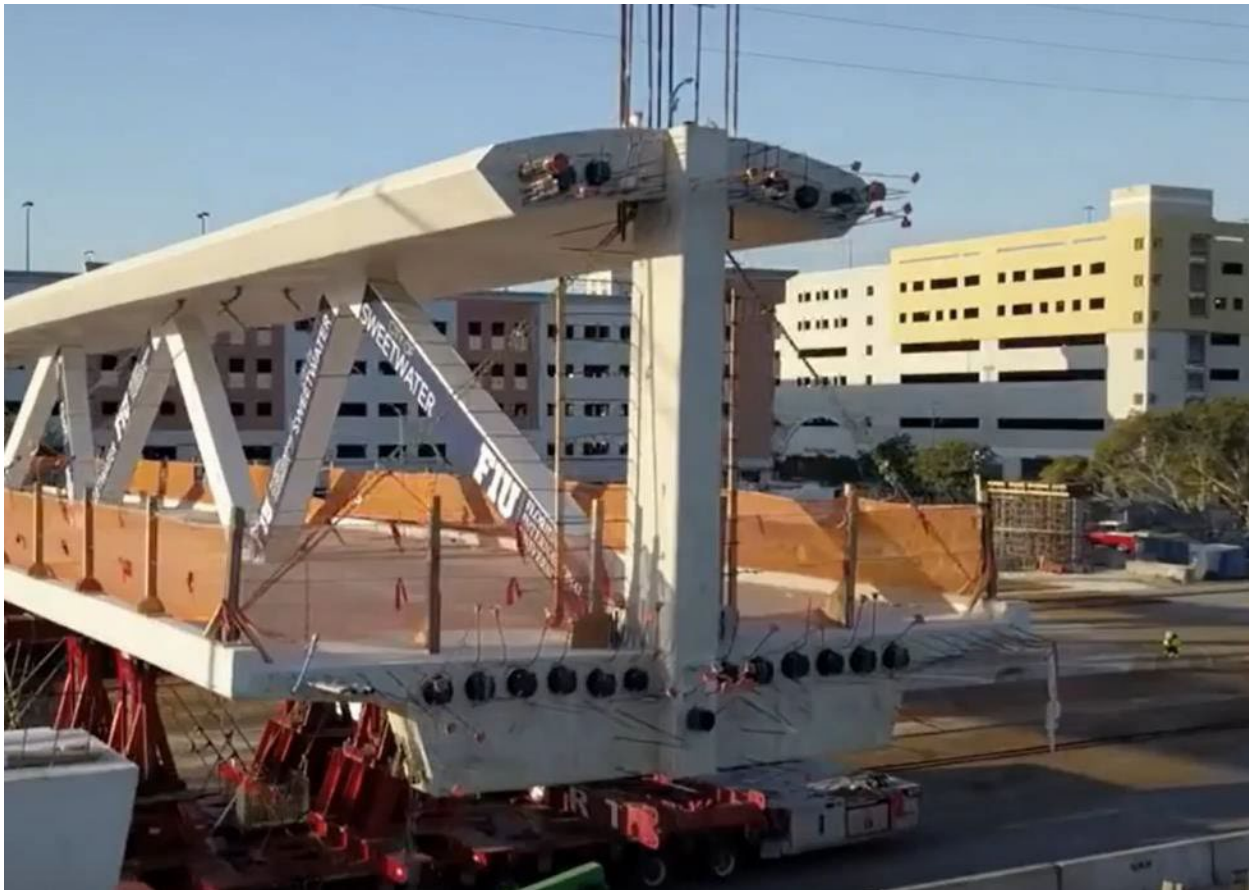
Figure 22 North end of the main span truss during transportation, generally free of cracks

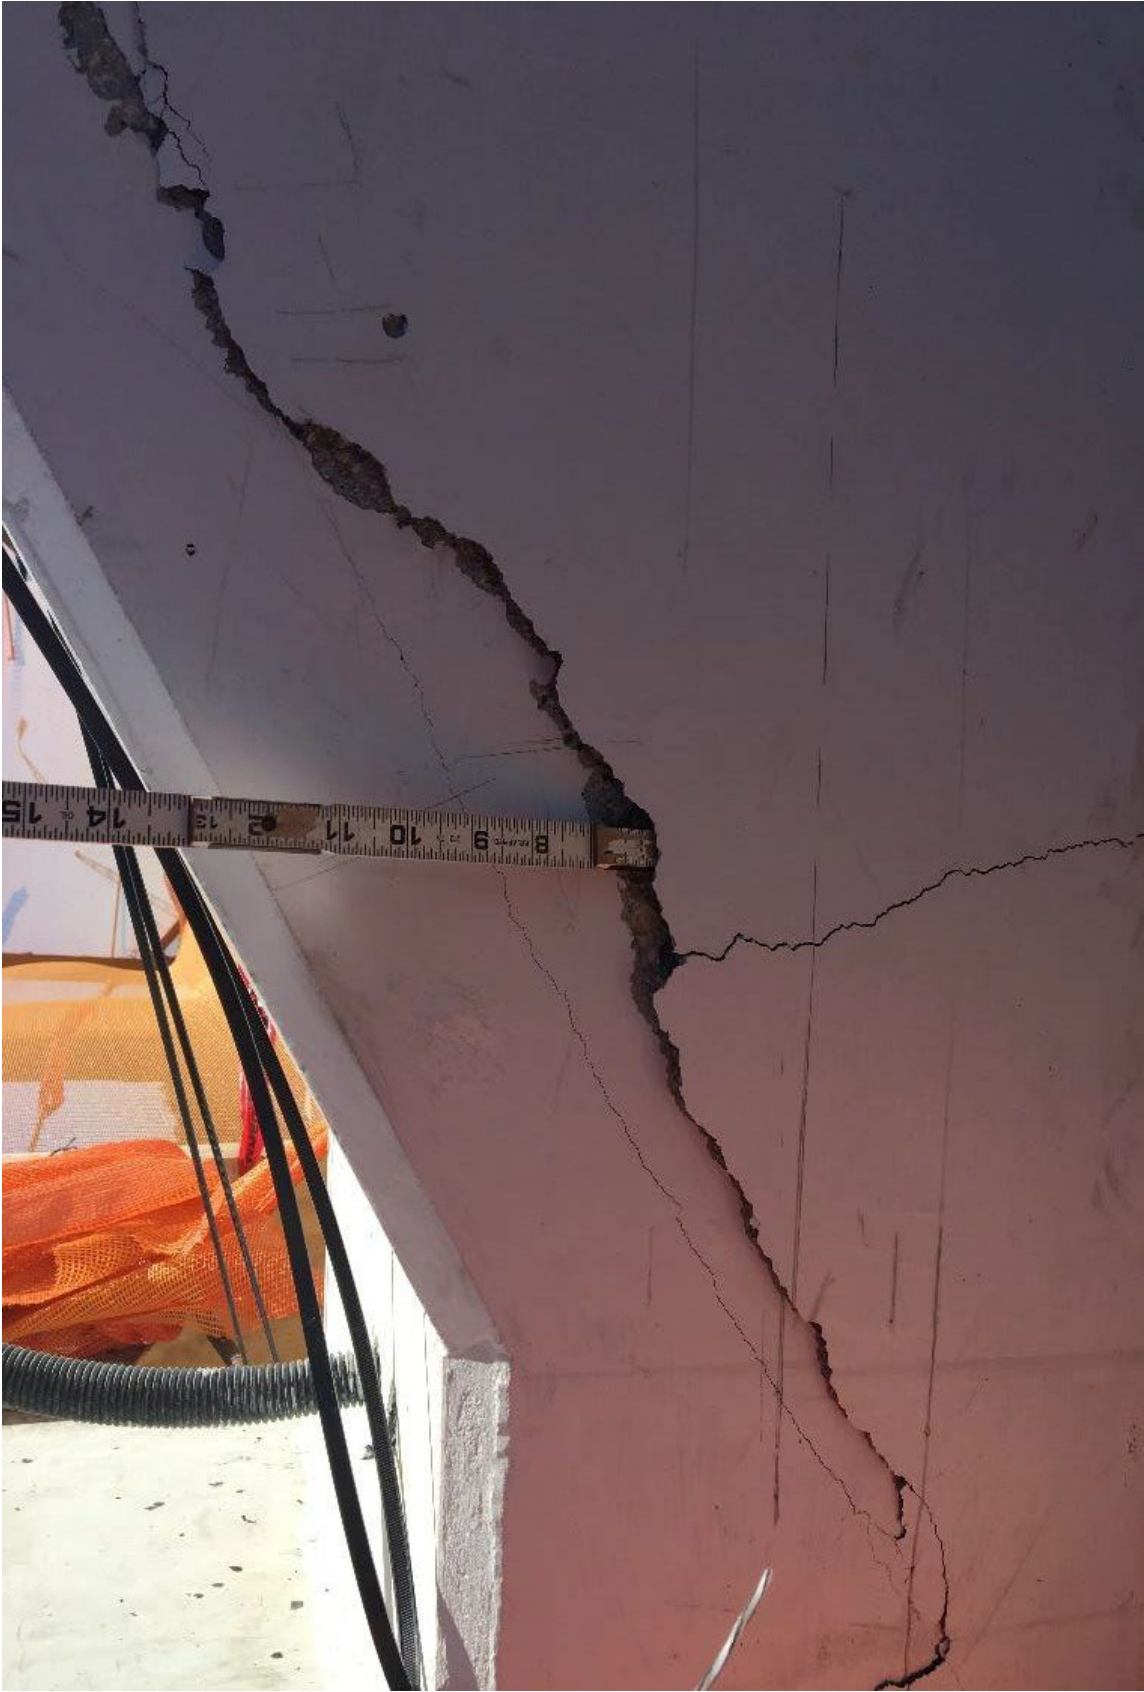
Figure 40 Close-up of longitudinal cracks in diagonal 11 on 3/13/2018 by BPA

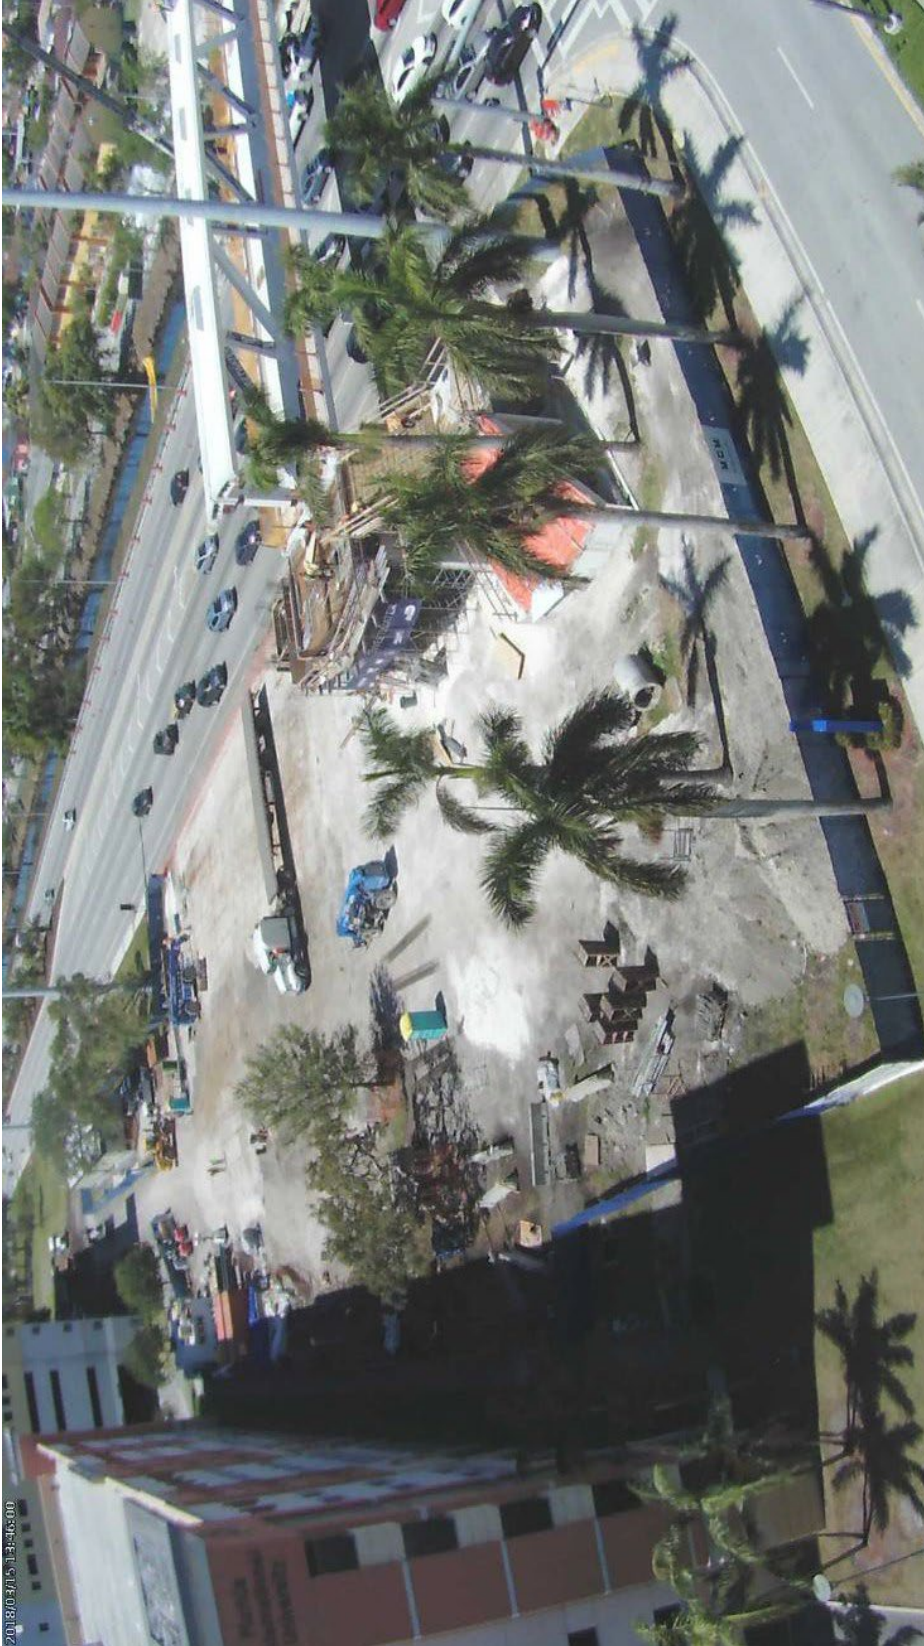
Figure 46 Bridge immediately prior to the collapse, March 15, 2018 – camera #1

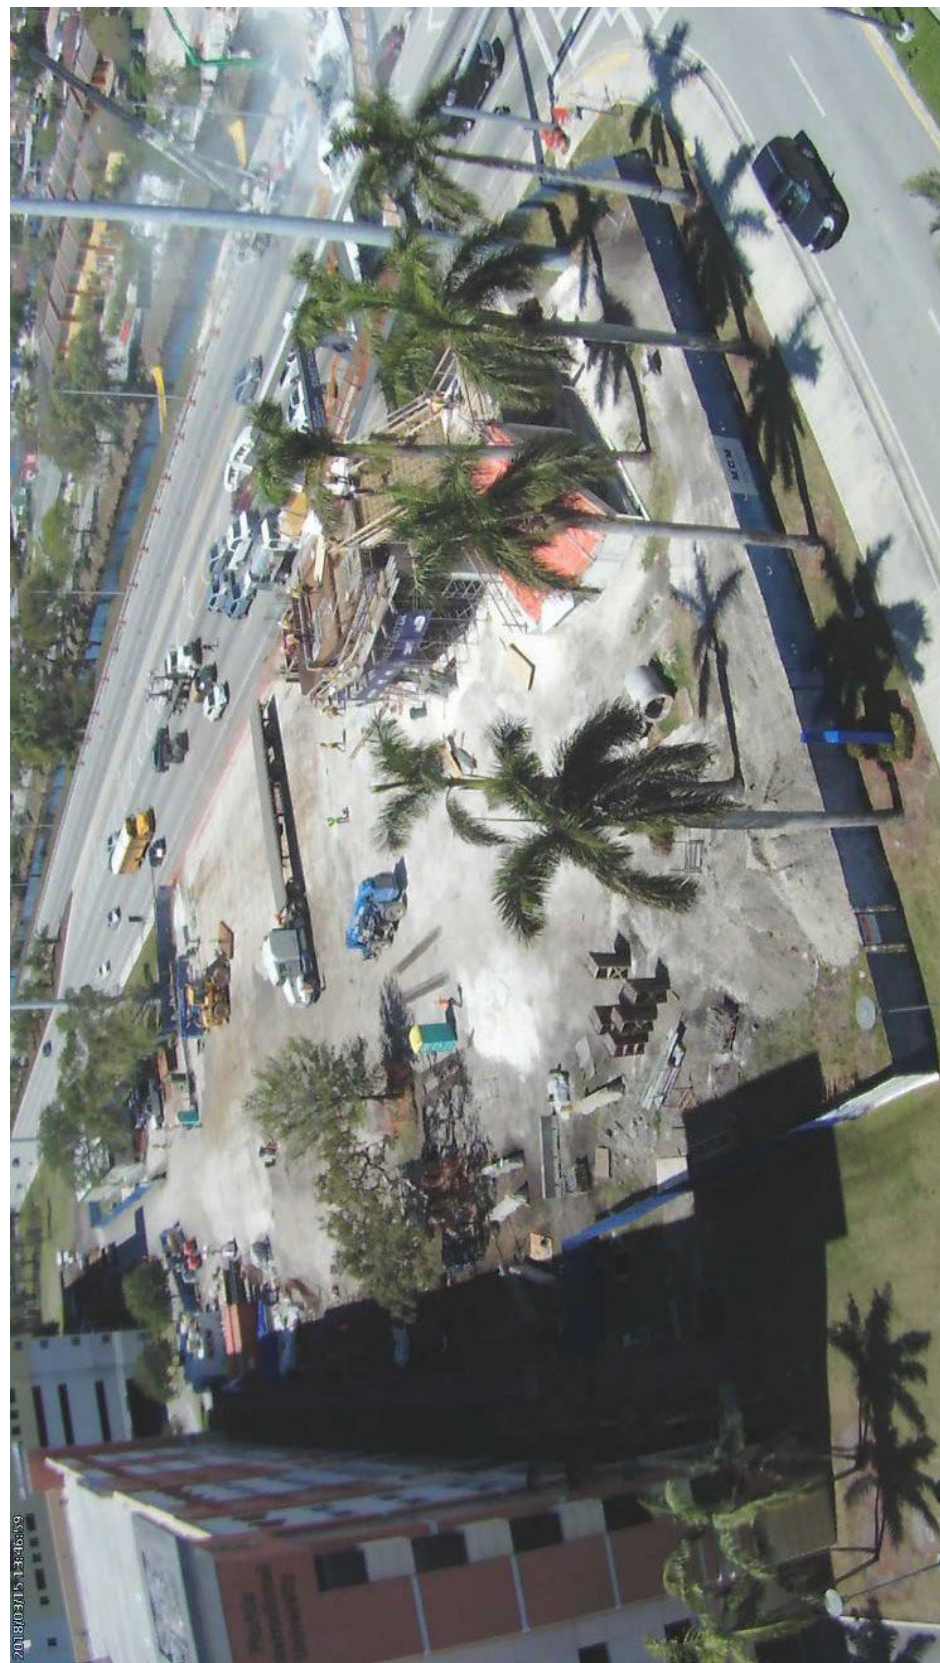
Figure 47 Bridge immediately after the collapse, March 15, 2018 – camera #1

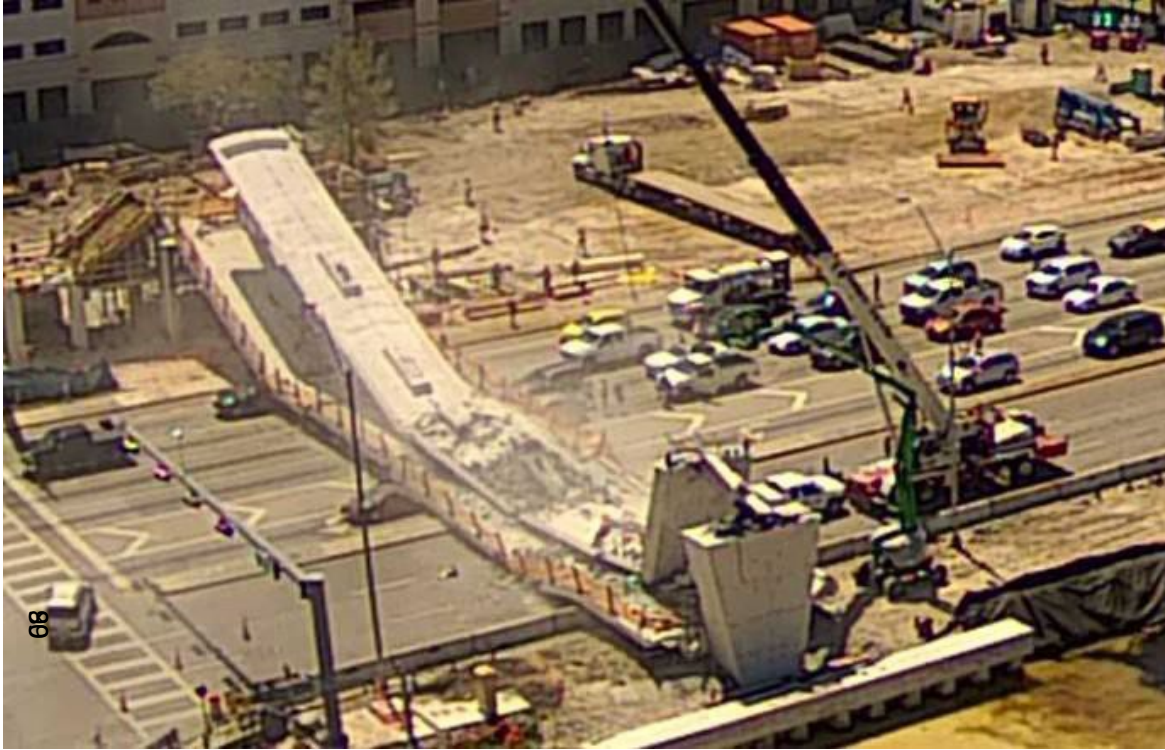
Figure 49 Bridge immediately after the collapse, March 15, 2018 – camera #2 Employees engaged in re-tensioning the PT bars in diagonal 11

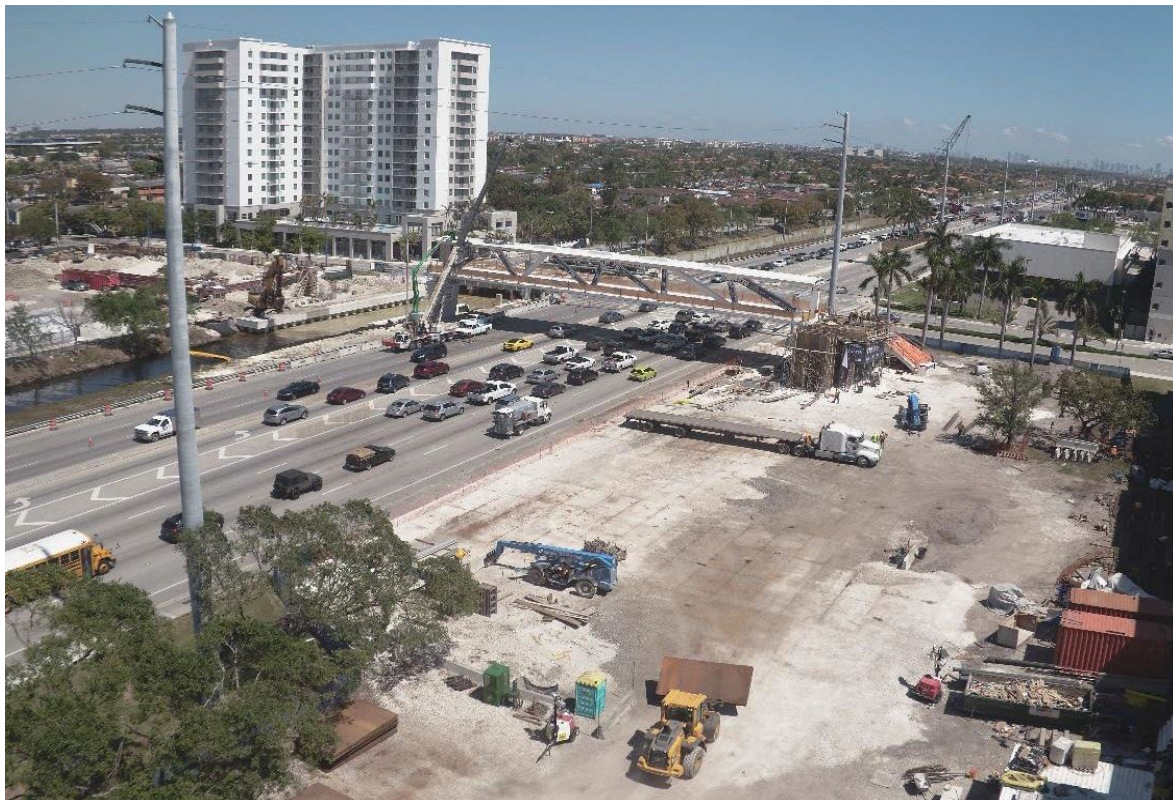
Figure 50 Bridge immediately prior to the collapse, March 15, 2018 – camera #3 (north on the left and south on the right)

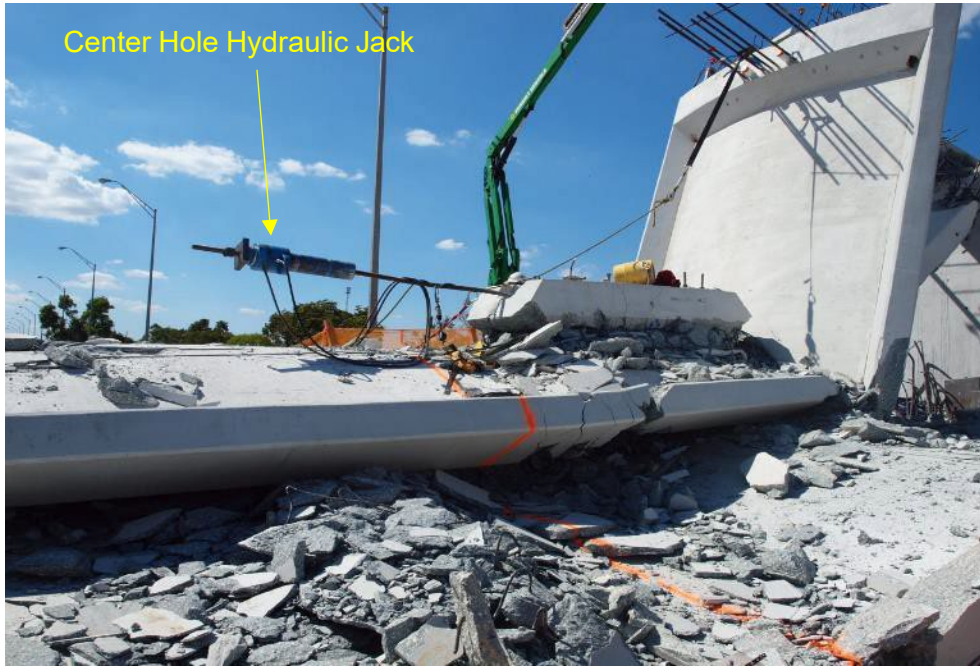
Figure 53 Northernmost blister and hydraulic jack attached to the lower PT bar of diagonal 11 after bridge collapse – side view, March 17, 2018 by OSHA

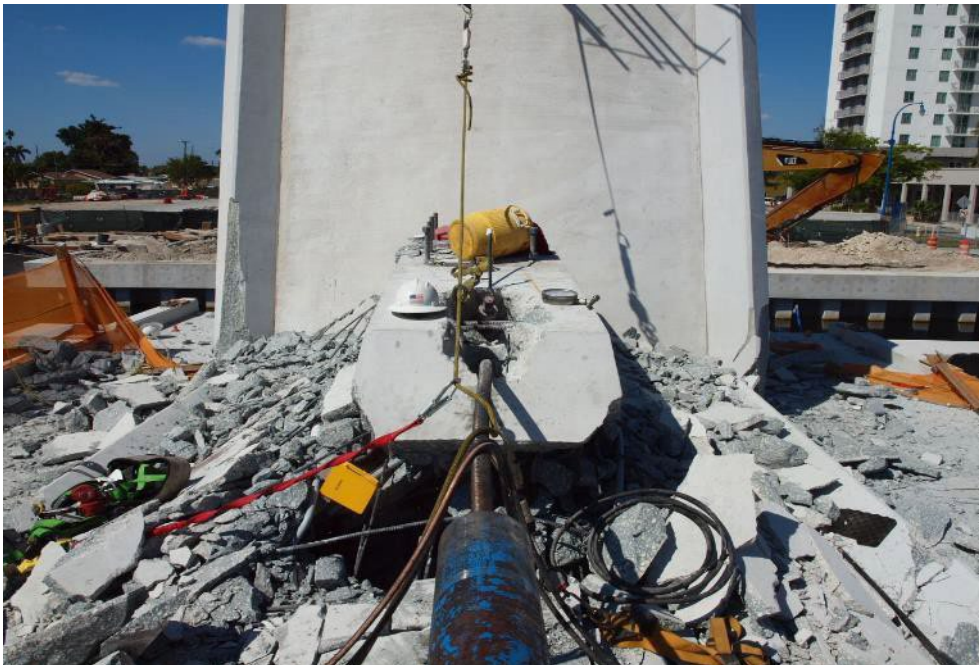
Figure 54 Northernmost blister and hydraulic jack attached to the lower PT bar of diagonal 11 after bridge collapse – front view, March 17, 2018 by OSHA

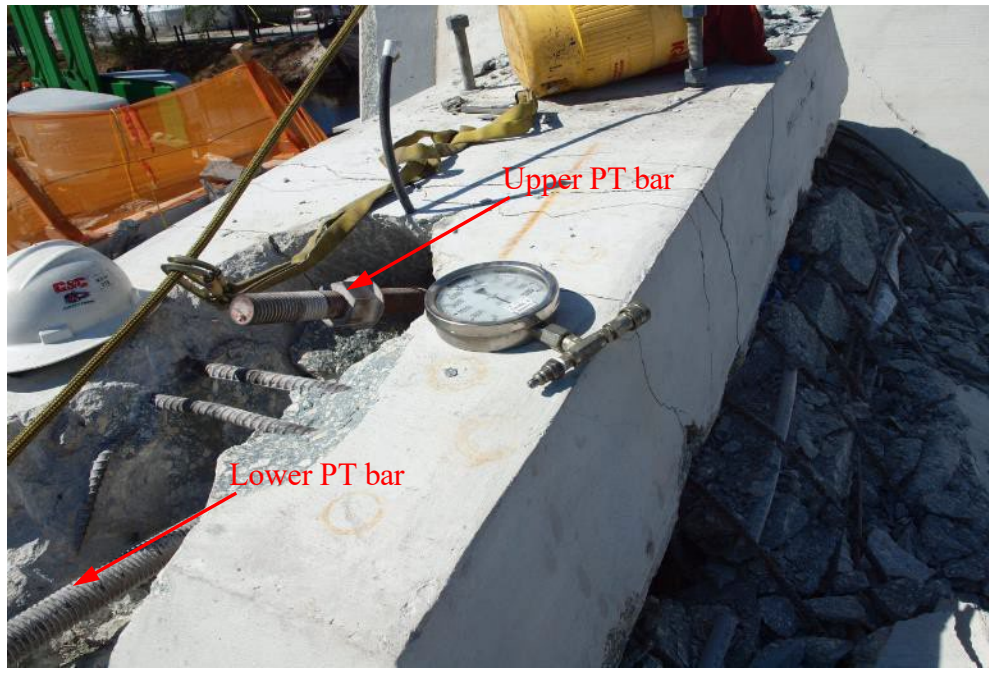
Figure 55 Northernmost blister and pressure gauge, March 17, 2018 by OSHA

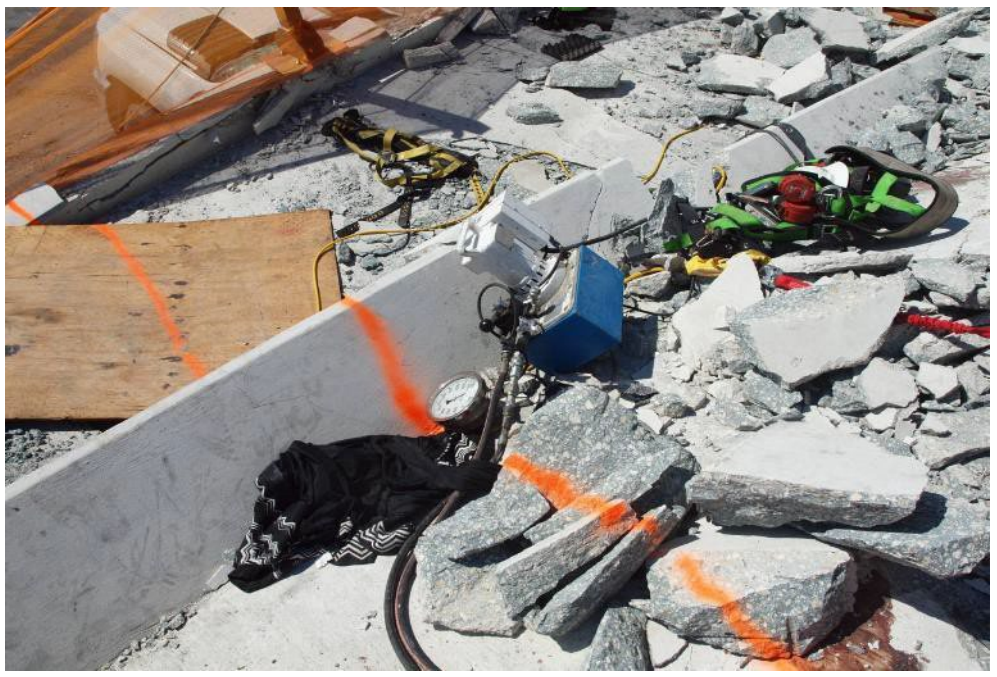
Figure 56 Hydraulic pump for post-tensioning after bridge collapse, March 17, 2018 by OSHA

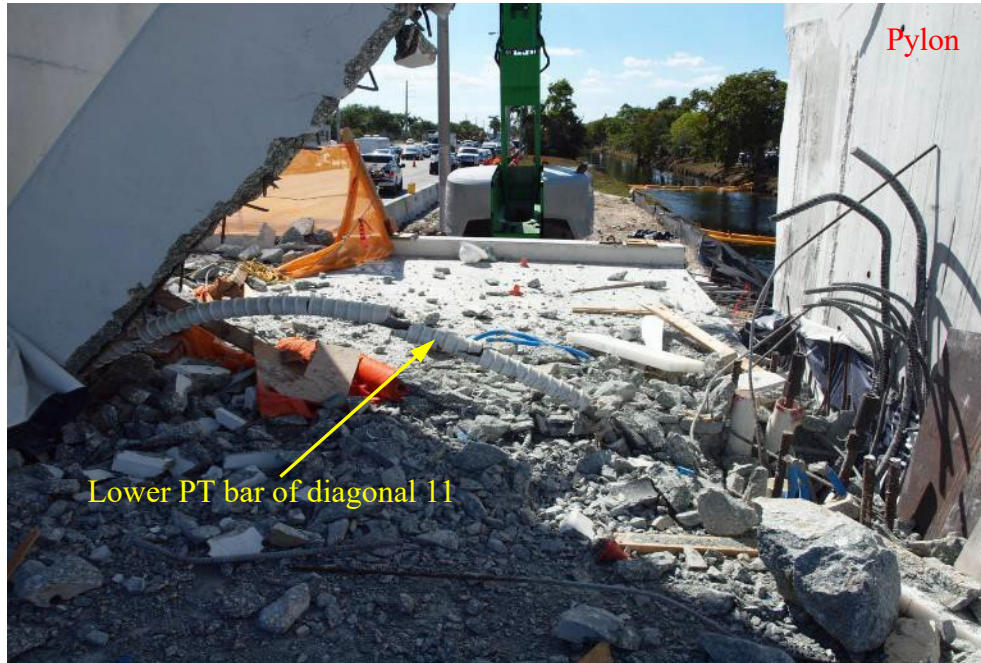
perilously attached to the bottom of the column 12 over the pylon with some rebar, and the other end remained connected to the canopy as shown in Figure 52. As a result of the blow-out, the lower end of the upper PT bar separated from the diaphragm II and rested on the top of the pylon. The lower PT bar of diagonal 11 peeled off from diagonal 11 but remained embedded in the diaphragm. The top ends of the upper and lower PT bars in diagonal 11 remained in the blister. The upper PT bar lost its tension completely and so did the lower PT bar which still carried the Jack used to re-tension the PT bars. The deck laid down approximately 140 feet flat on the ground covering all the four east bound lanes, and three west bound lanes, as shown in Figure 51. The south end of the deck and column 1 were still precariously on the top of the south pier, see Figure 52. The column 1 tilted approximately 15 degrees towards the north with canopy firmly attached. All diagonals other than diagonals 2, 3 and 4 were crushed. The canopy laid flat approximately 80 ft. over the fallen deck. Two blisters on the south side remained intact with the canopy but the rest of the blisters were badly damaged. The blisters at the junction of diagonal 11 and 10 were damaged with the bottom PT bar extending beyond the blister with the ram still attached to the PT bar. As a result of the blow-out, three #7 shear reinforcements at the construction joint of diagonal 11 and the deck were sheared but the southernmost shear reinforcement remained intact. The width of the blow-out was 2 ft. at the southern end gradually enlarging towards the north. The blow-out encompassed

Figure 57 Lower PT separated from the diagonal 11 still embedded in diaphragm after bridge collapse, March 17, 2018 by OSHA

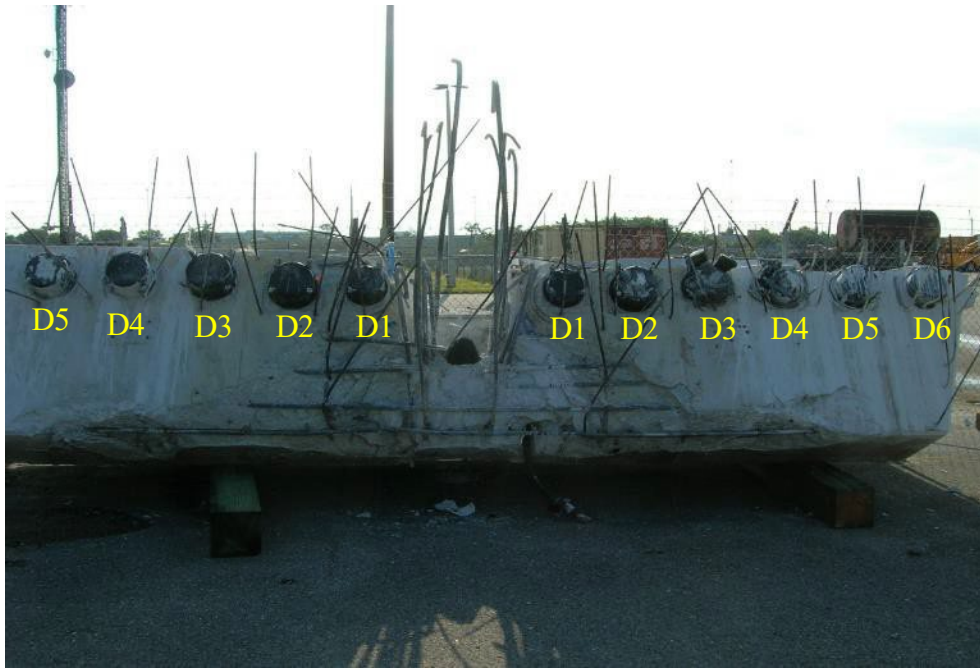
Diaphragm II experienced a blow-out of concrete at the junction of diagonal 11 and column 12 creating a hole shown below in Figure 58 through Figure 70. As a result, column 12 lost support over the pylon and failed with the top tilting approximately 80 degrees towards the south, as shown in Figure 52. The base of column 12 shifted a few feet towards the north but remained on the top of the pylon. Thereafter, collapse of the canopy, diagonal 11 and the deck followed. The canopy partially remained attached to column 12. The remaining diaphragm II and the deck fell approximately 18 ft. to the ground below, see Figure 52. One end of the diagonal 11 remained

Figure 61 Remnants of diaphragm II at the time of the bridge collapse in the storage yard – looking north from south, April 9, 2018, by OSHA

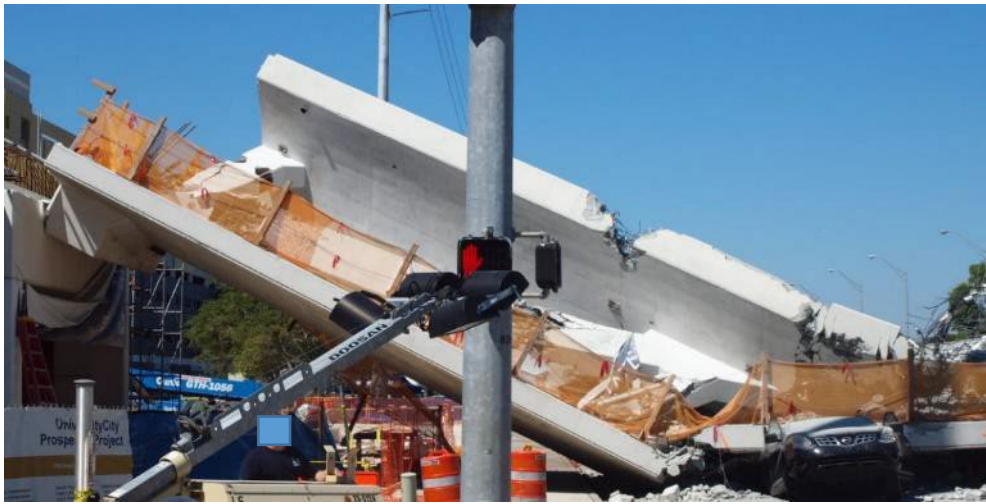
Figure 73 South end of the bridge after collapse – looking west
